Daily Report

Project:	Durham Meadows Pipeline Installation	Date:	August 25, 2021
Location:	Maple Avenue, Durham; Long Hill Road, Middletown	Day of Week:	Wednesday
Project #:	AECOM: 6061487	Report No:	310
Contractor:	Ludlow Construction	Page:	1 of 13

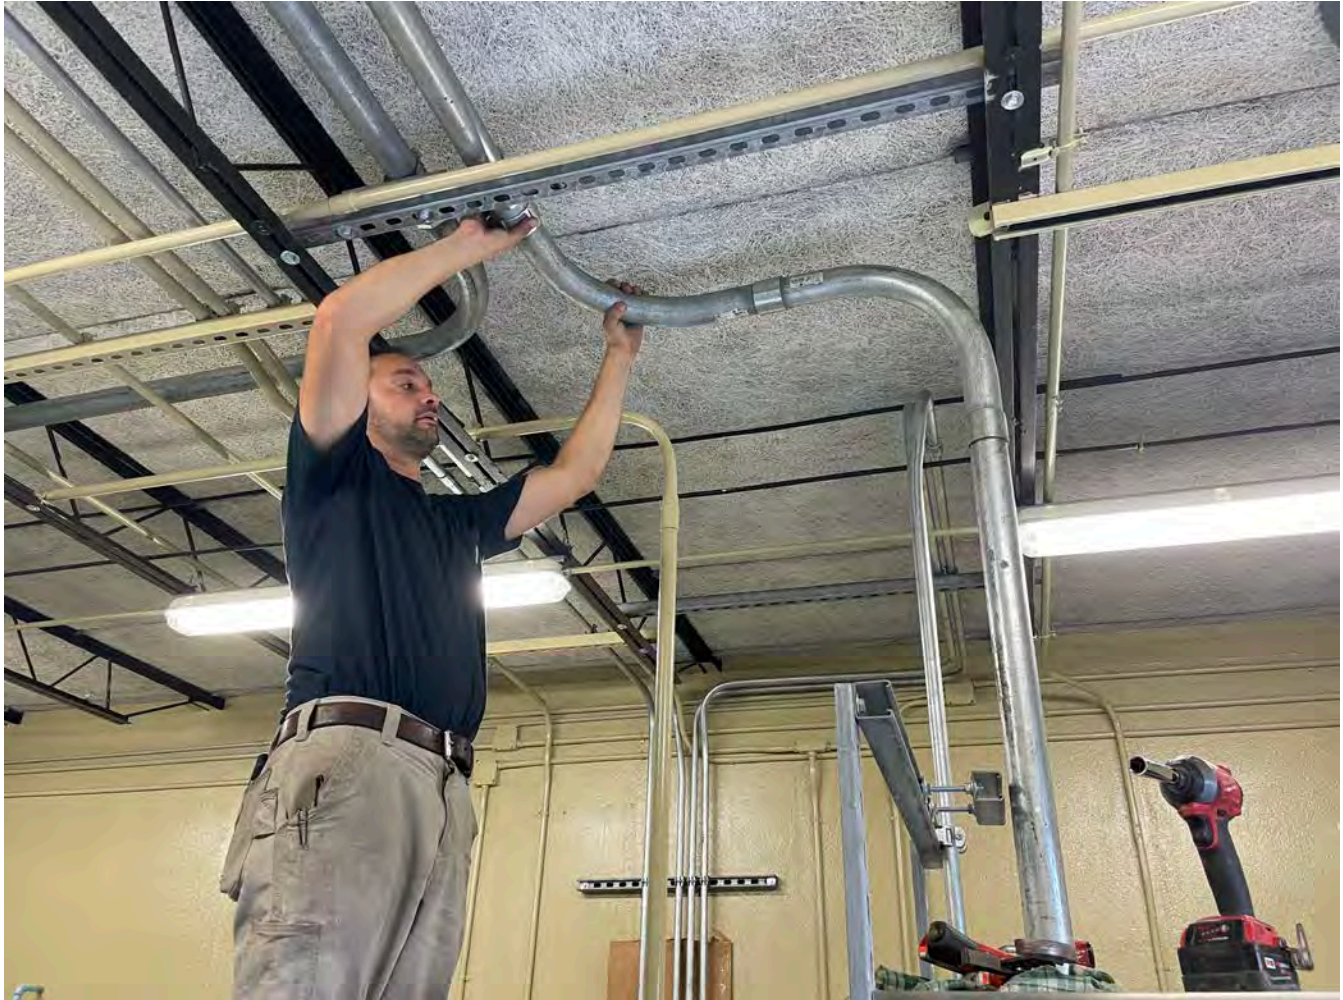
0942: A&R Electrical is currently installing a 2" steel conduit to the top of the P2-VFD cabinet.

Picture 1: A&R Electrical installing a 2" steel conduit at the Long Hill pump station in Middletown.

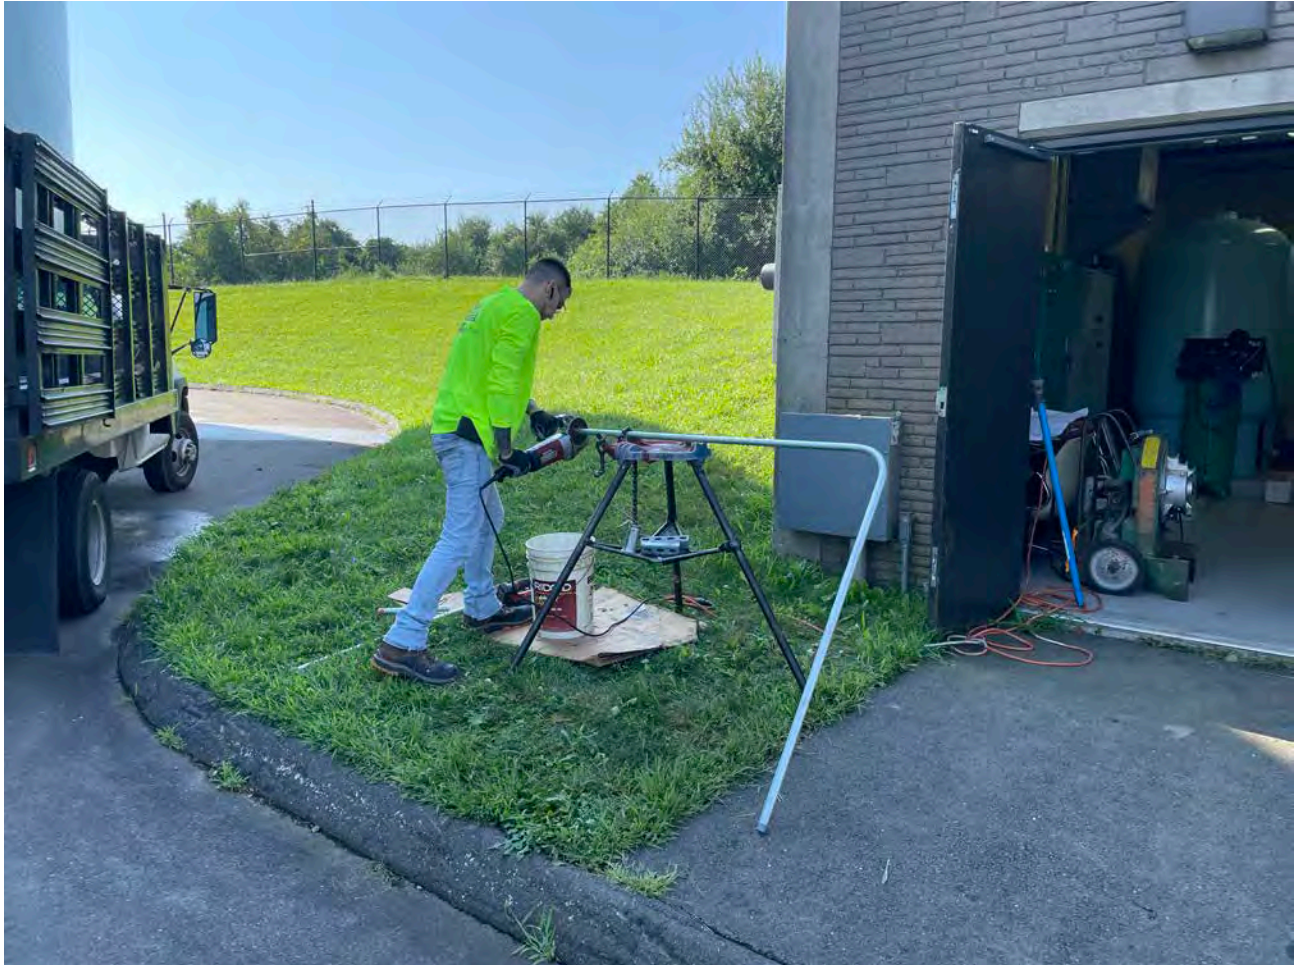
Picture 2: A&R Electrical threading the end of a steel conduit that will be installed inside of the Long Hill pump station in Middletown. View to the southeast.

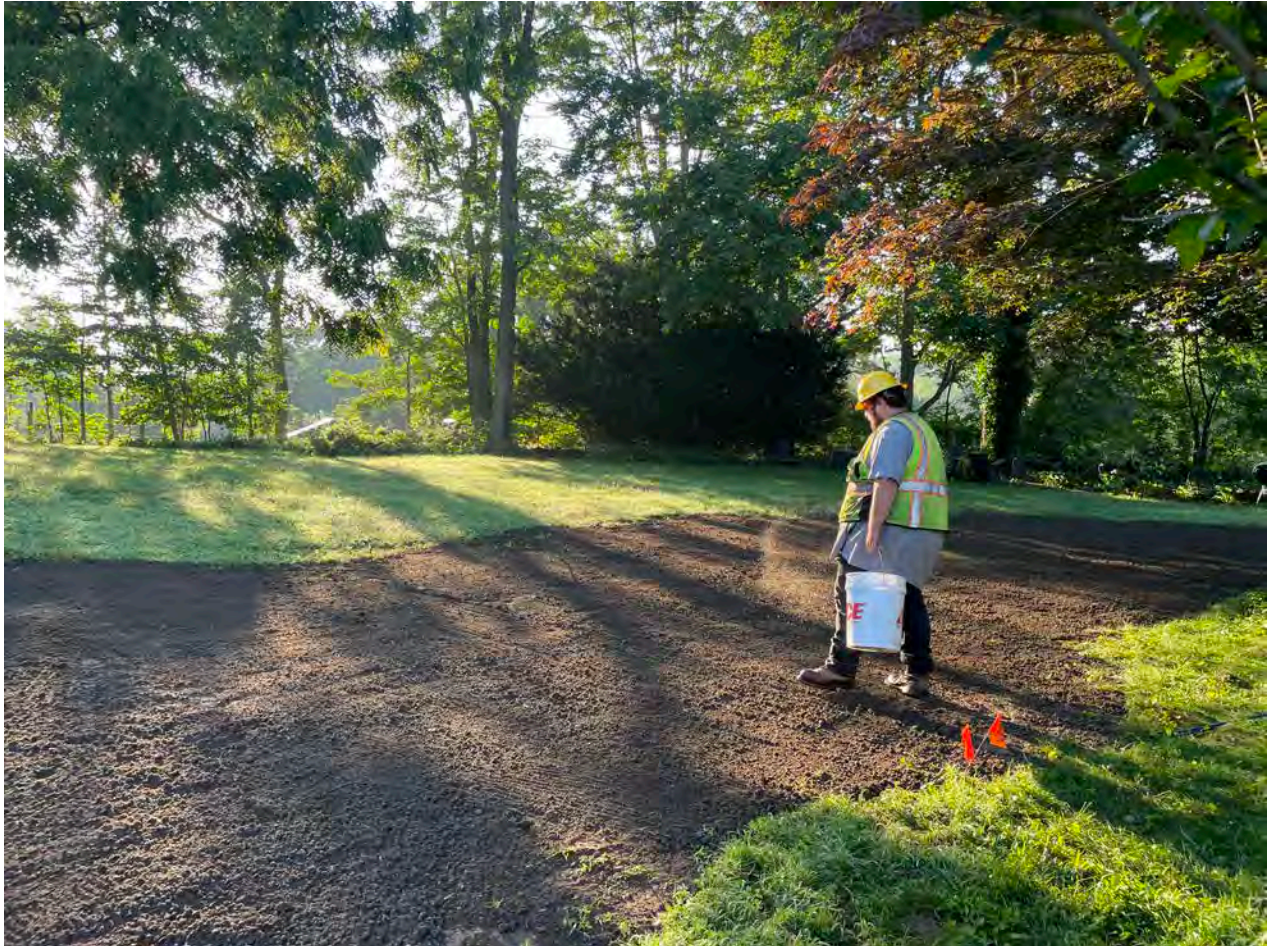
Picture 3: Ludlow placing grass seed over freshly placed loam on the east side of the 95R Maple Avenue residence. View to the southeast.

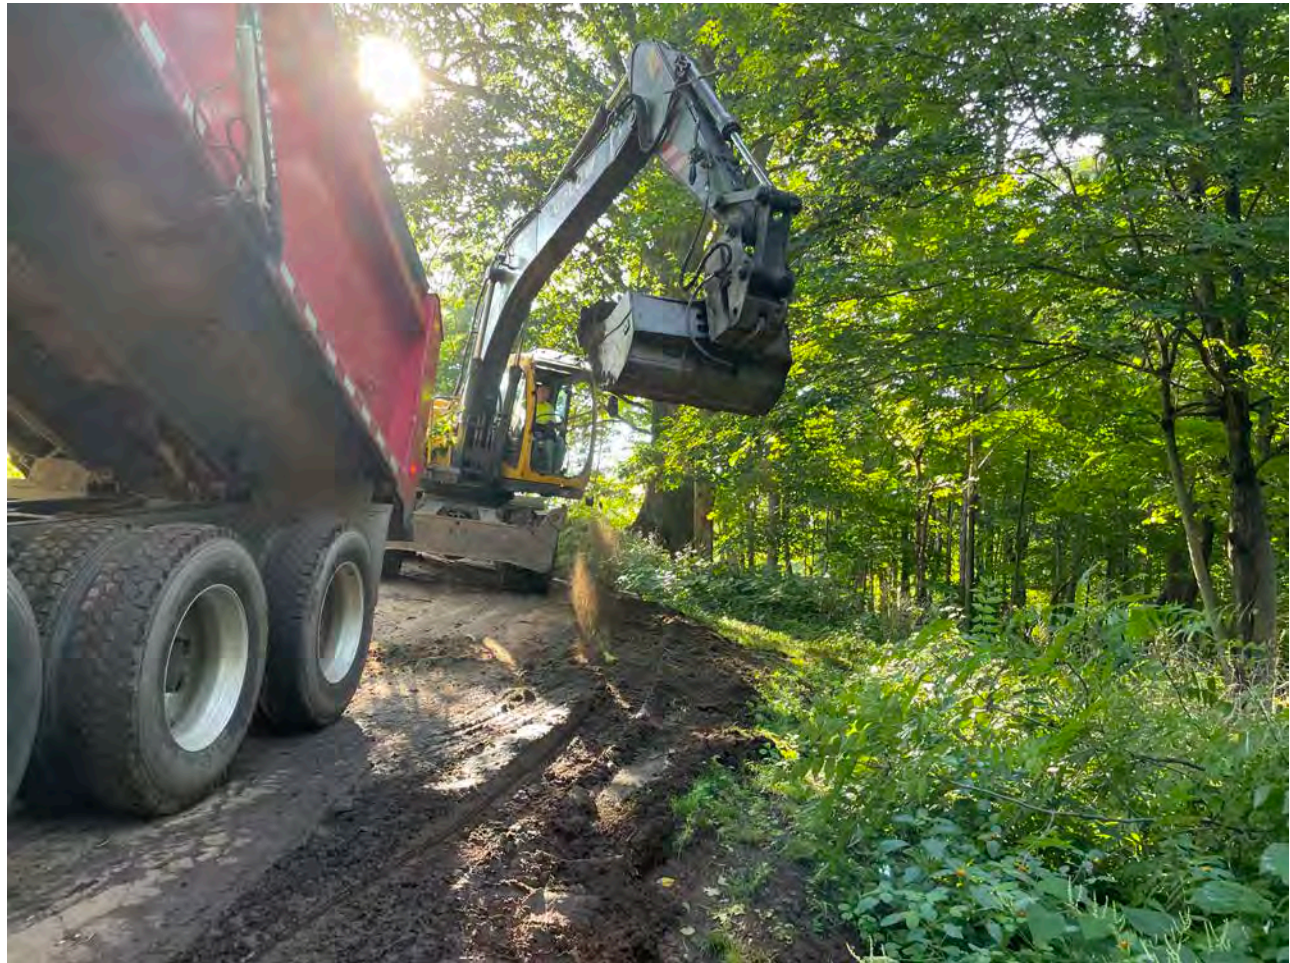
0901: Ludlow is placing loam along the driveway for the 95R Maple Avenue property to repair damage caused by their construction vehicles.

Picture 4: Ludlow placing loam on the south side of the driveway for the 95R Maple Avenue residence. View to the southeast.

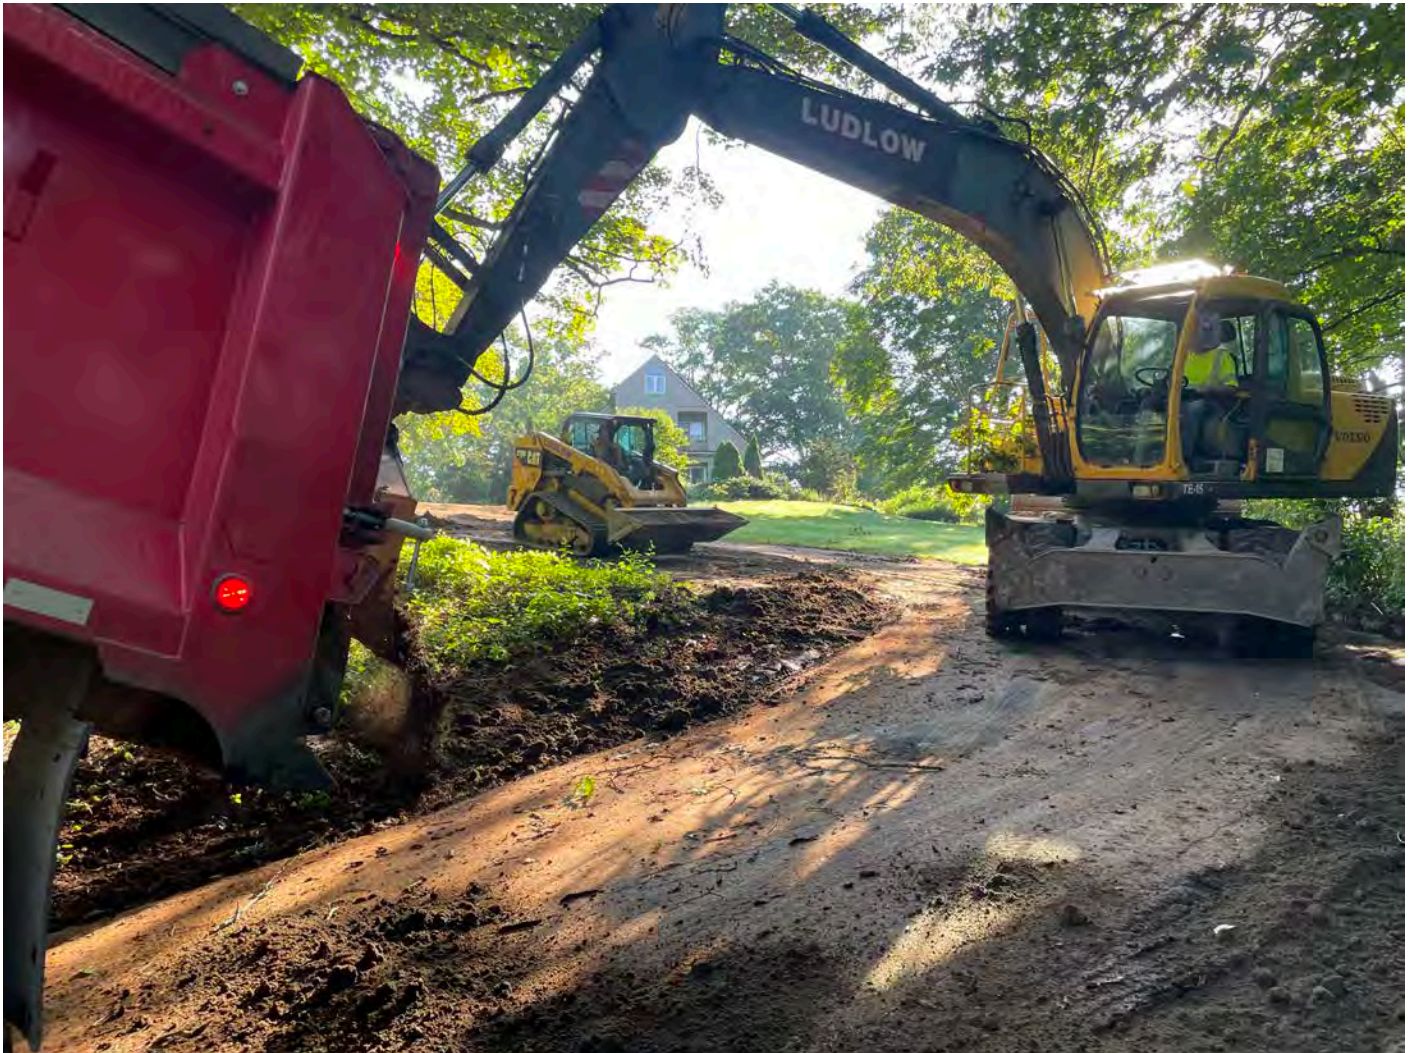
Picture 5: Ludlow placing loam on the north side of the driveway for the 95R Maple Avenue residence. View to the southeast.

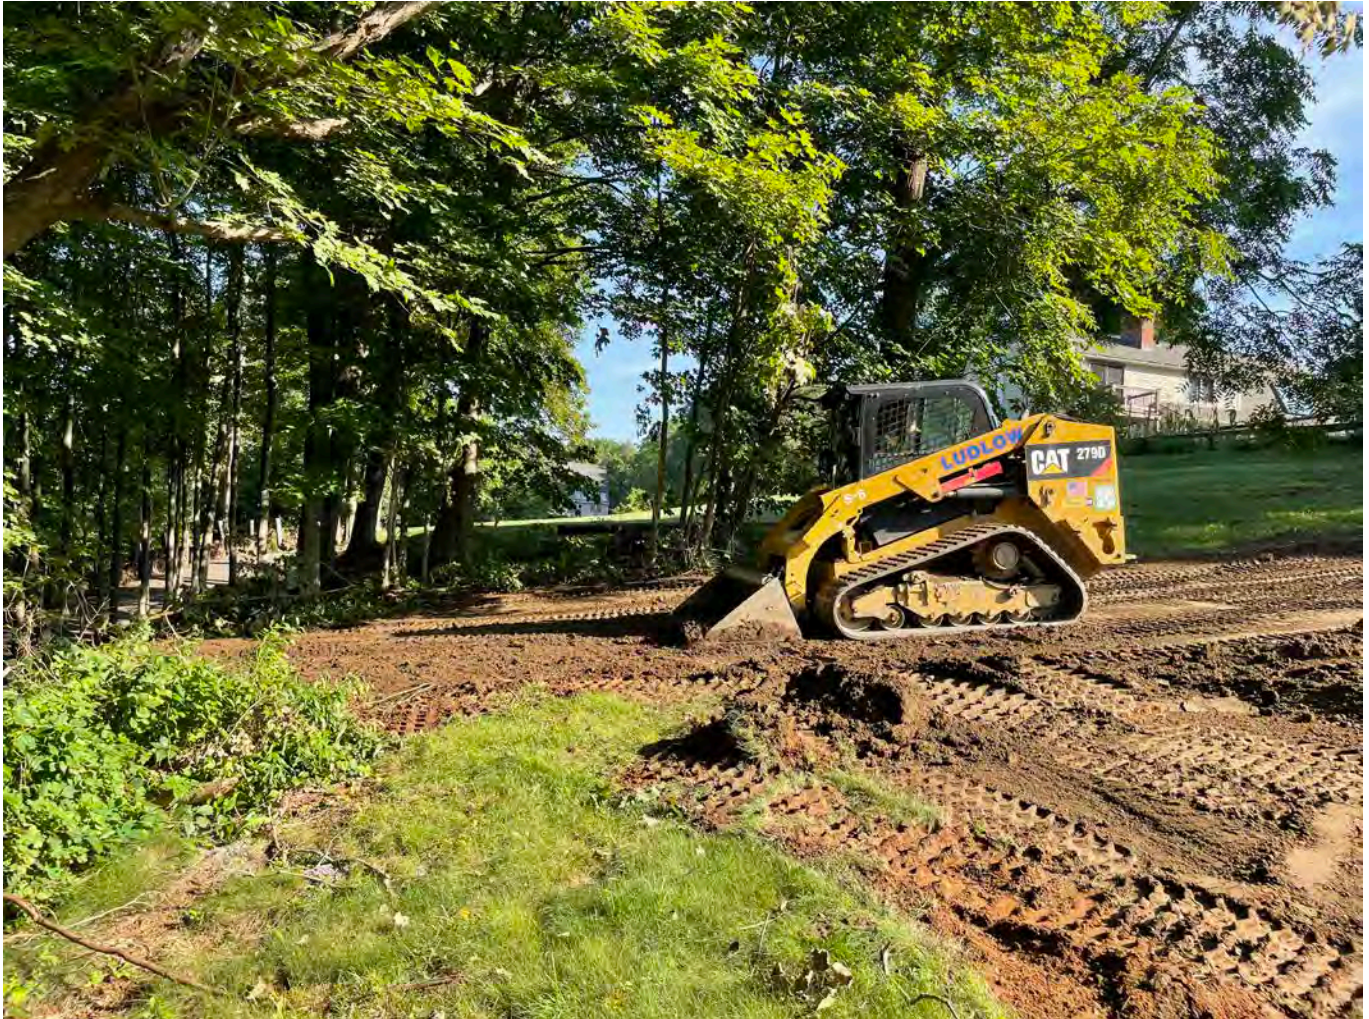
Picture 6: Ludlow grading loam on the 95R Maple Avenue property. View to the north.

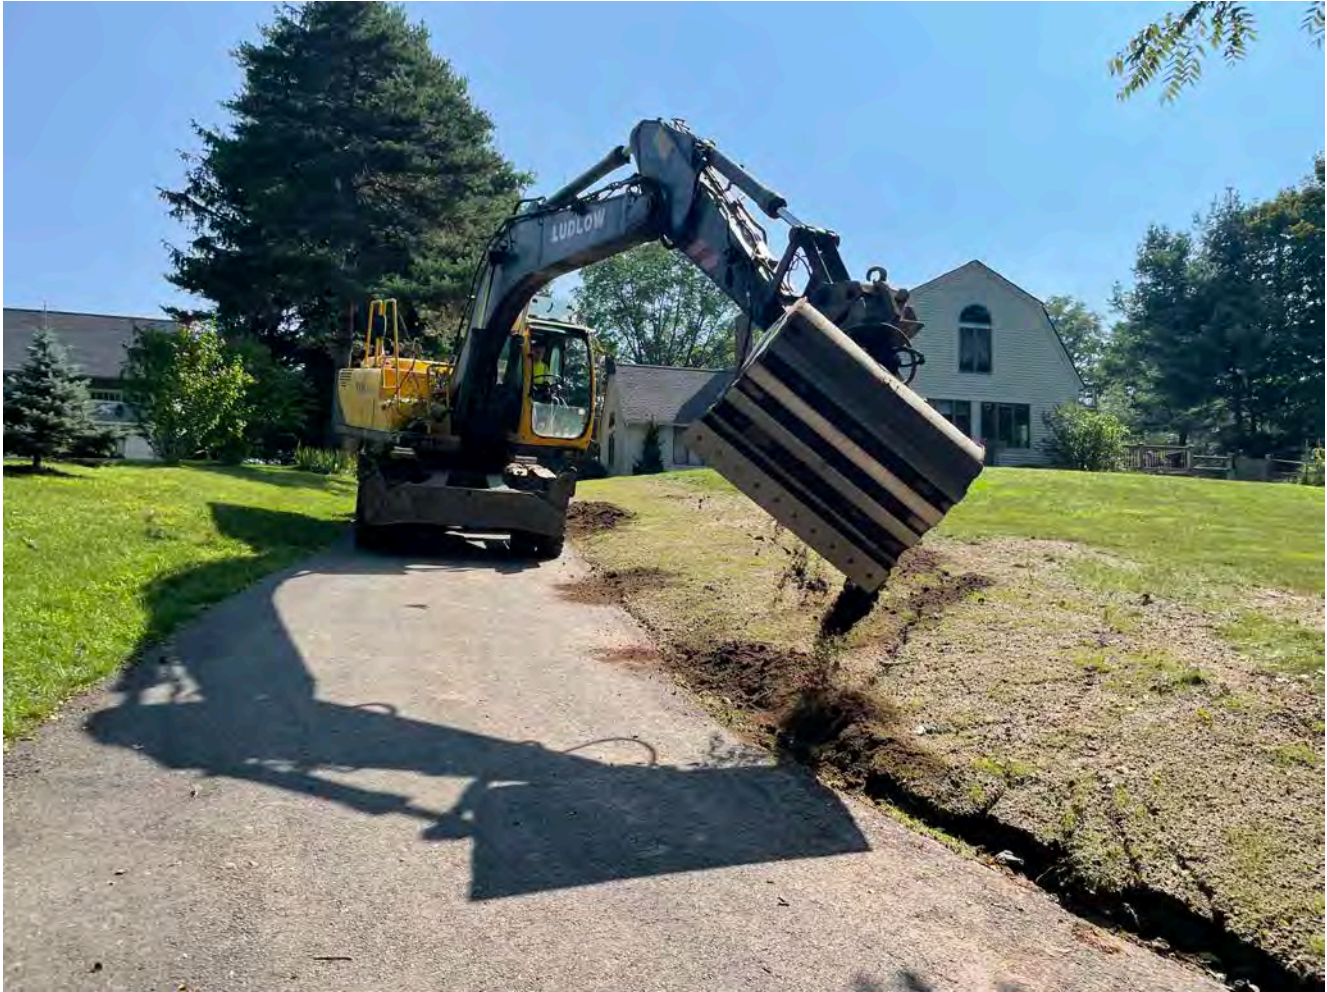
1028: Ludlow is performing some minor repairs to the lawn along the south side of the driveway at 97 Maple Avenue that was eroded by recent storm events.

Picture 7: Ludlow placing loam on the south side of the 97 Maple Avenue property to fix some recent erosion damage to the loam and grass seed they placed recently.

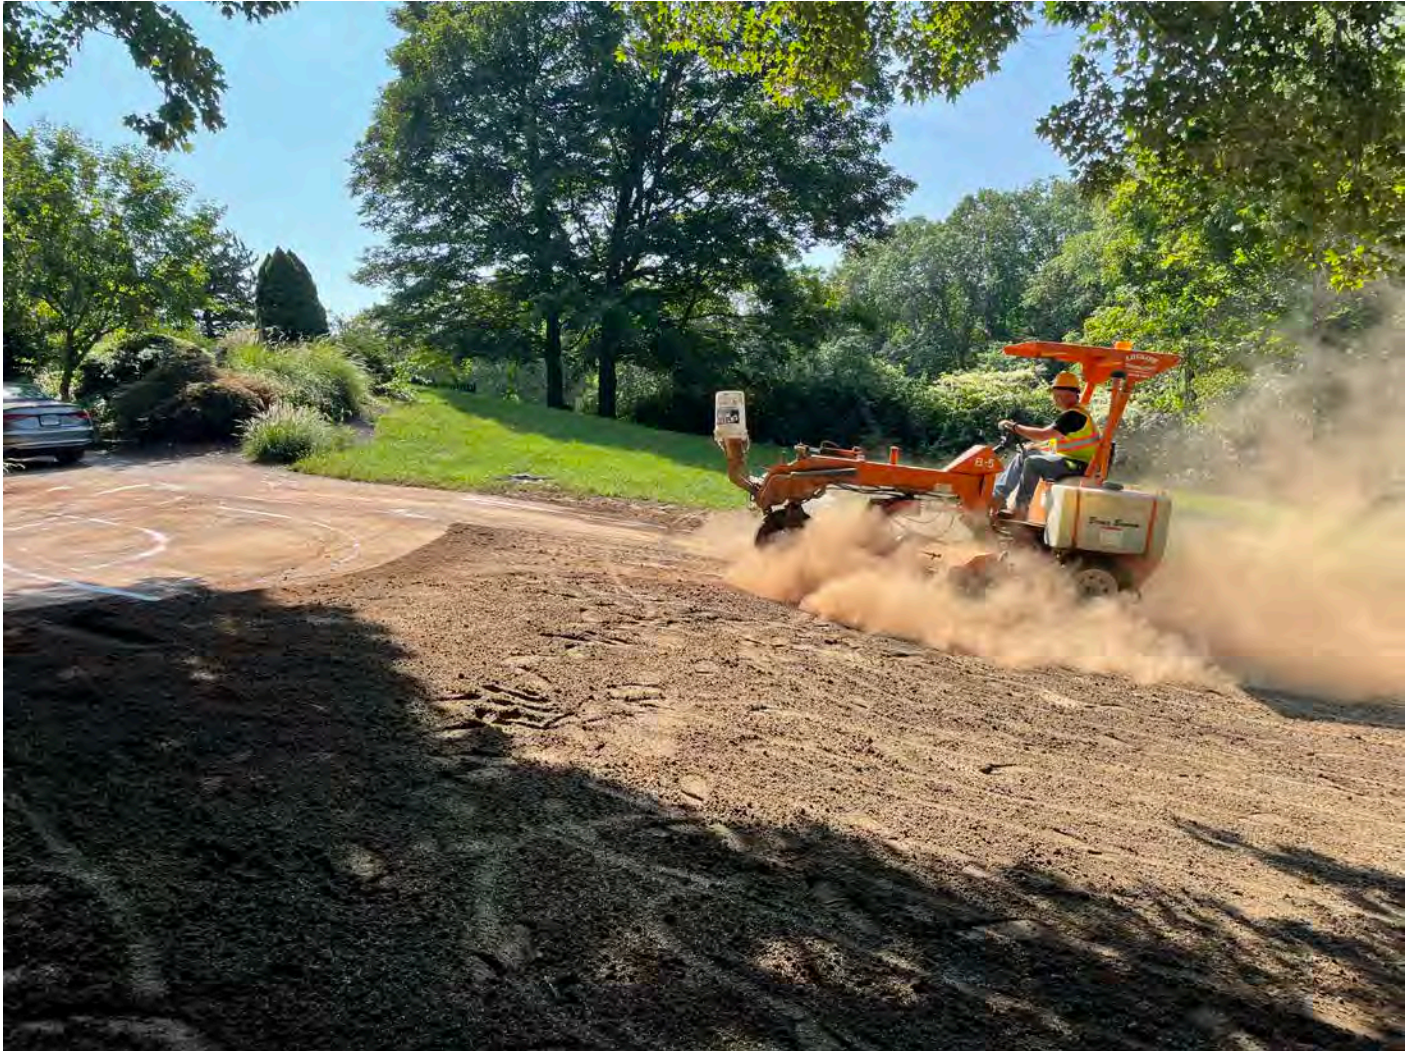
Picture 8: Ludlow using a Broce Broom to clean the driveway of the 95R Maple Avenue property. View to south.

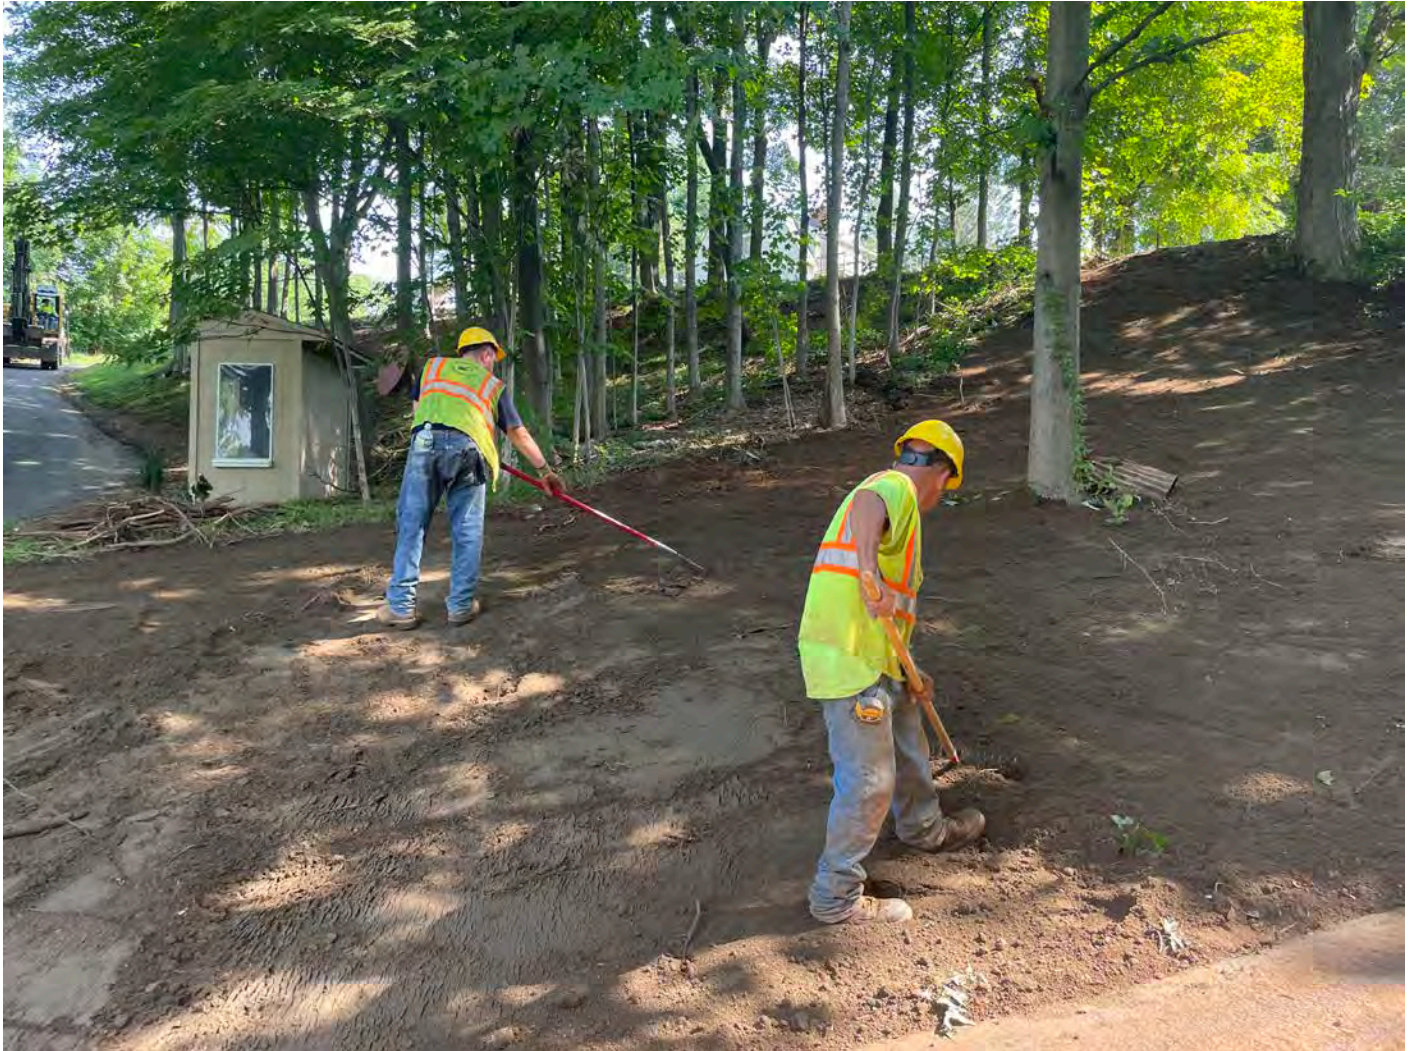
Picture 9: Ludlow grading loam on a portion of the 95R Maple Avenue property that was disturbed during the installation of a 2" copper water service line. View to northeast.

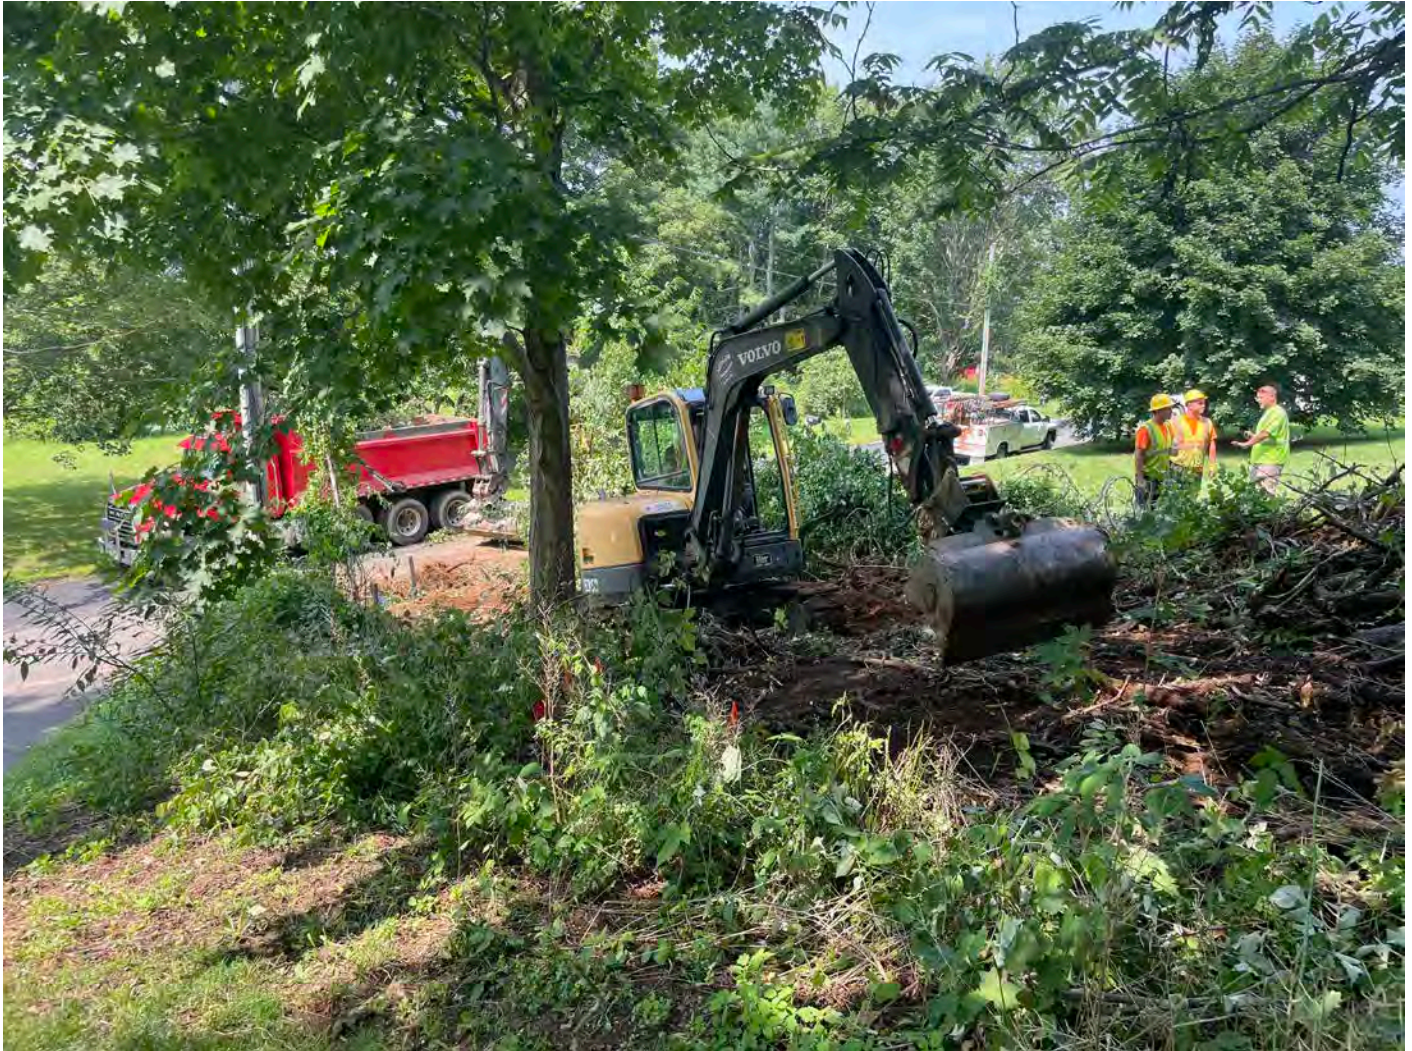
Picture 10: Ludlow grubbing brush on the northern property line of the 109 Maple Avenue property. View to northwest.
