Daily Report

Project: Durham Meadows Pipeline Installation Date: August 26, 2021

Project #:
 AECOM: 6061487
 Report No:
 311

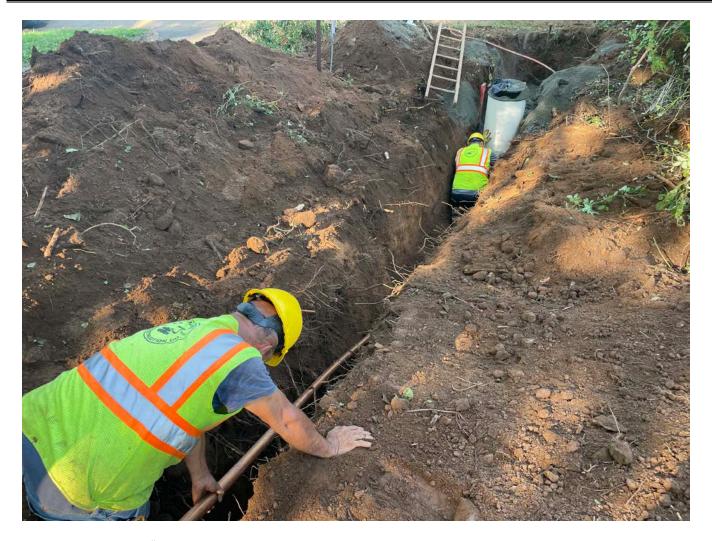
Picture 1: Ludlow placing 2" copper water service line at the 109 Maple Avenue residence. View to the southwest.

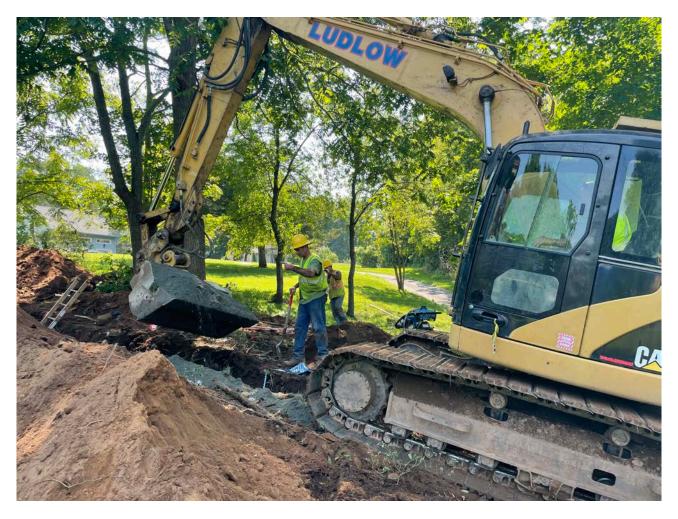
1141: Ludlow is backfilling 2" copper pipe they installed at the 109 Maple Avenue property. Ludlow is placing 6" of sand over the copper pipe, followed by caution tape and then native fill. The fill is being placed in 1' lifts and compacting each lift with a jumping Jack. Ludlow is also continuing to excavate at the 109 Maple Avenue property for the installation of additional 2" copper water service line.

Picture 2: Ludlow placing sand over 2" copper water service line at the 109 Maple Avenue residence. View to the southeast.

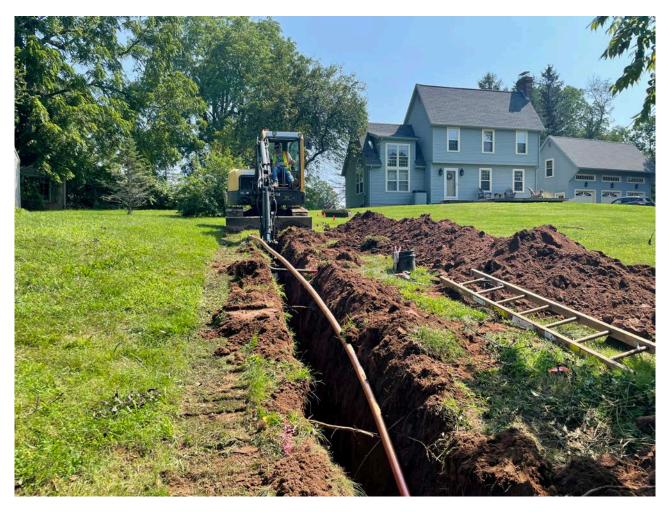
Picture 3: Ludlow excavating a trench ahead of the placement of 2" copper water service pipe at the 109 Maple Avenue property. View to the east.

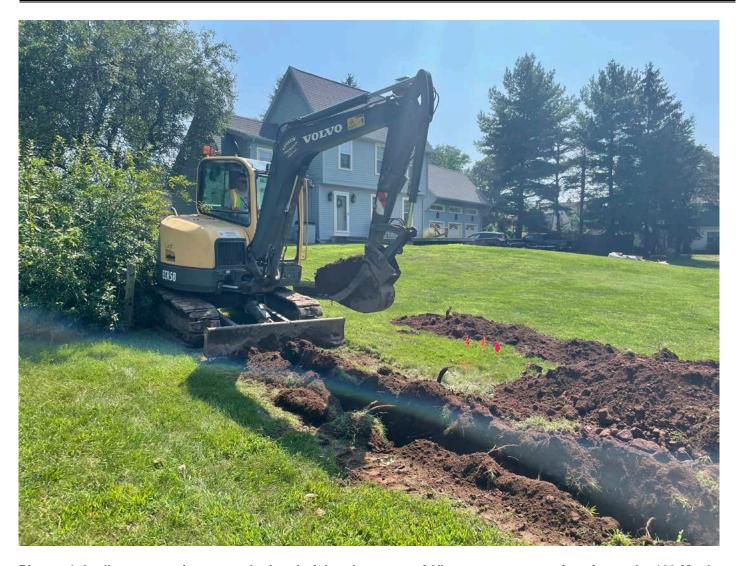
Picture 4: Ludlow excavating a trench ahead of the placement of 2" copper water service pipe at the 109 Maple Avenue property. View to the southeast.

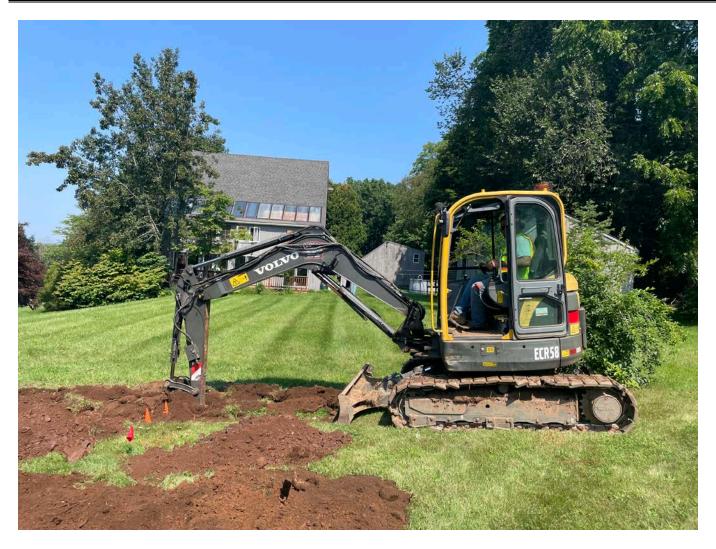
Picture 5: Ludlow excavating a trench ahead of the placement of 2" copper water service pipe at the 109 Maple Avenue property. View to the north.

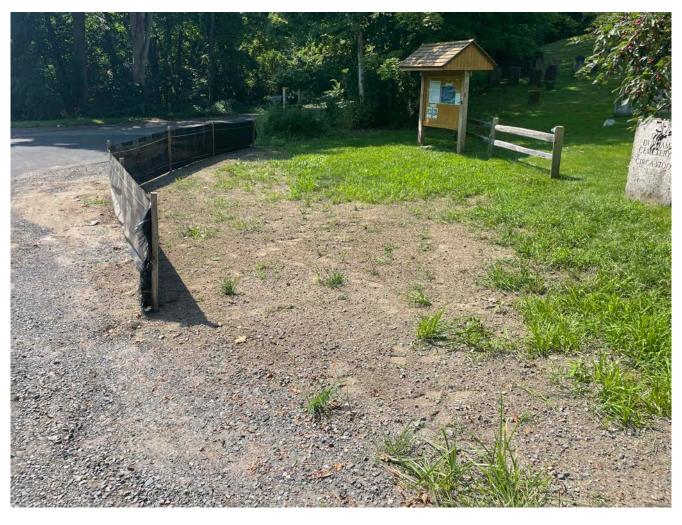
0902: Ludlow has placed loam and grass seed in front of the cemetery located on the corner of Main Street and Old Cemetery Road (168 Main Street). Ludlow placed silt fence on the southeast side of where they placed the loam and seed.

Picture 6: Loam, grass seed, and silt fence placed in front of the cemetery located on the corner of Main Street and Old Cemetery Road. View to southwest.

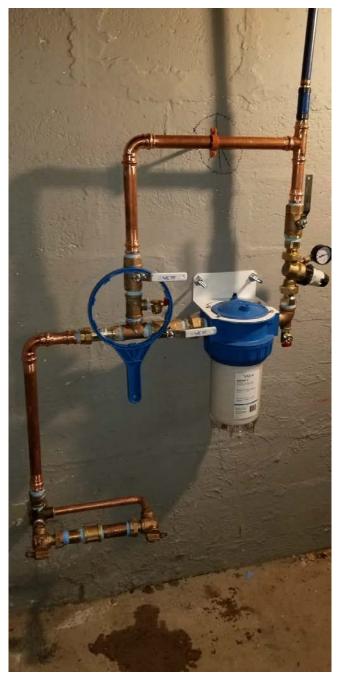
Picture 7: Installation of final water service components at 29 Maple Avenue, Durham.
