Daily Report

Project:	Durham Meadows Pipeline Installation	Date:	August 31, 2021
Location:	Maple Avenue and Maiden Lane, Durham	Day of Week:	Tuesday
Project #:	AECOM: 6061487	Report No:	314
Contractor:	Ludlow Construction	Page:	1 of 14

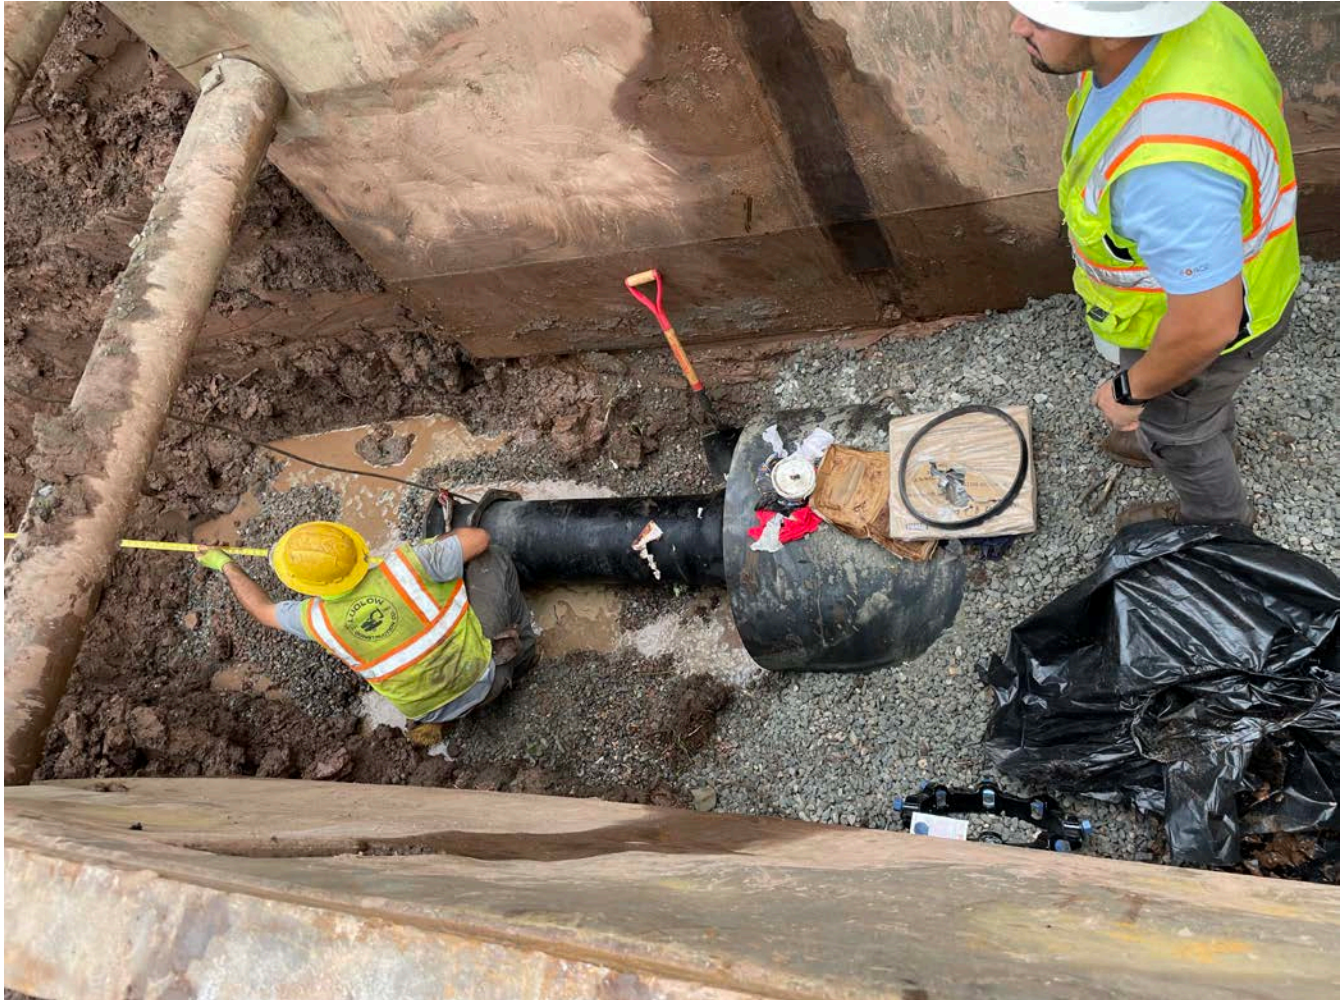
Picture 1: View of the western side of the trench box at the Maiden Lane stream crossing, looking north. Ludlow has connected a short piece of 12" DIP to the section of 12" DIP located inside of the 36" steel conduit and has added a 22.5° DIP bend.

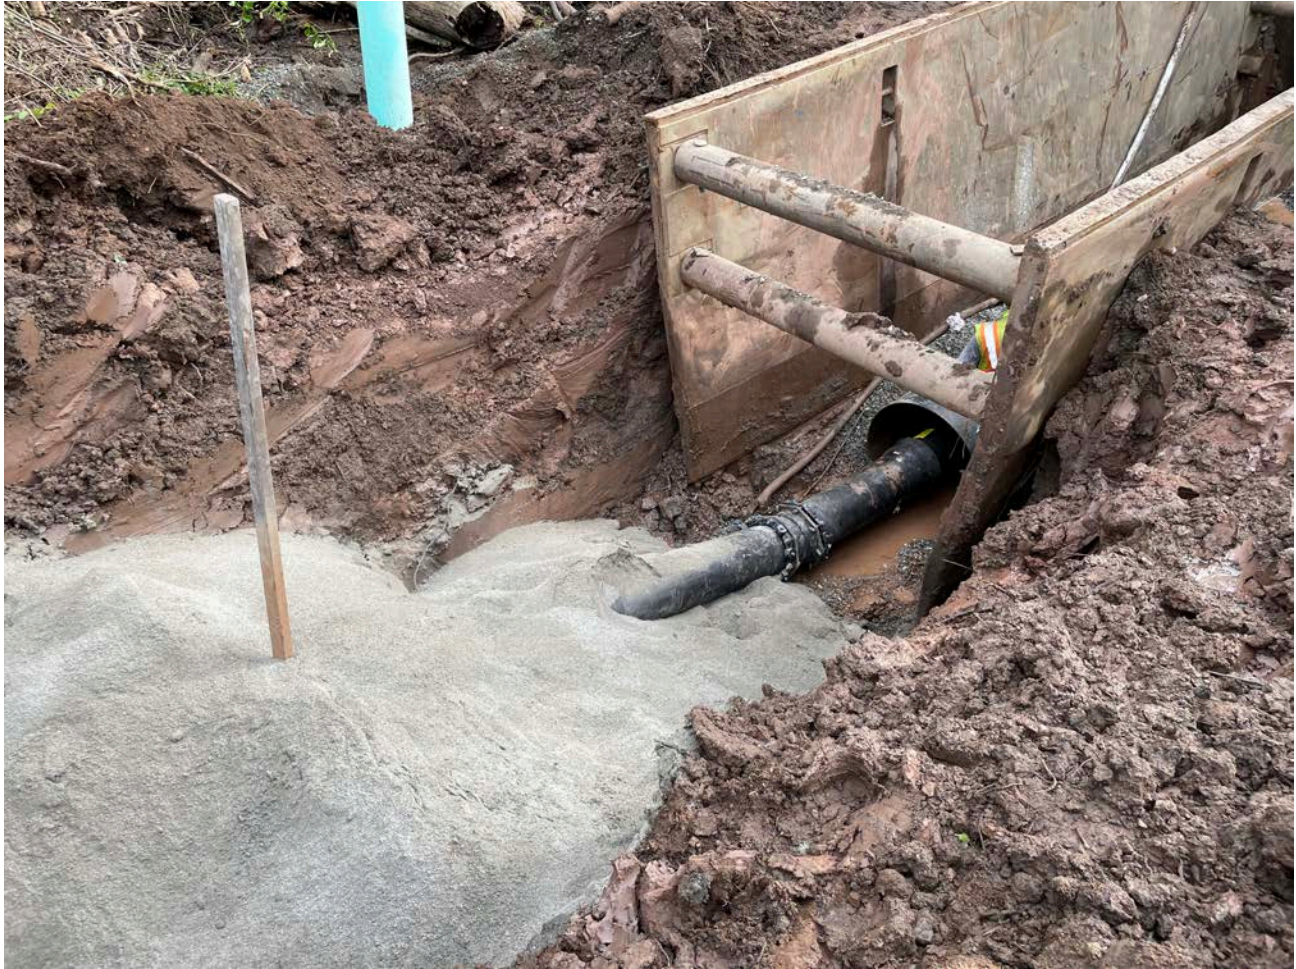
Picture 2: View of the western side of the trench box at the Maiden Lane stream crossing, looking northeast. Ludlow has connected ~12' section of 12" DIP to the 22.5° DIP bend they just installed and has begun to place sand over the DIP.

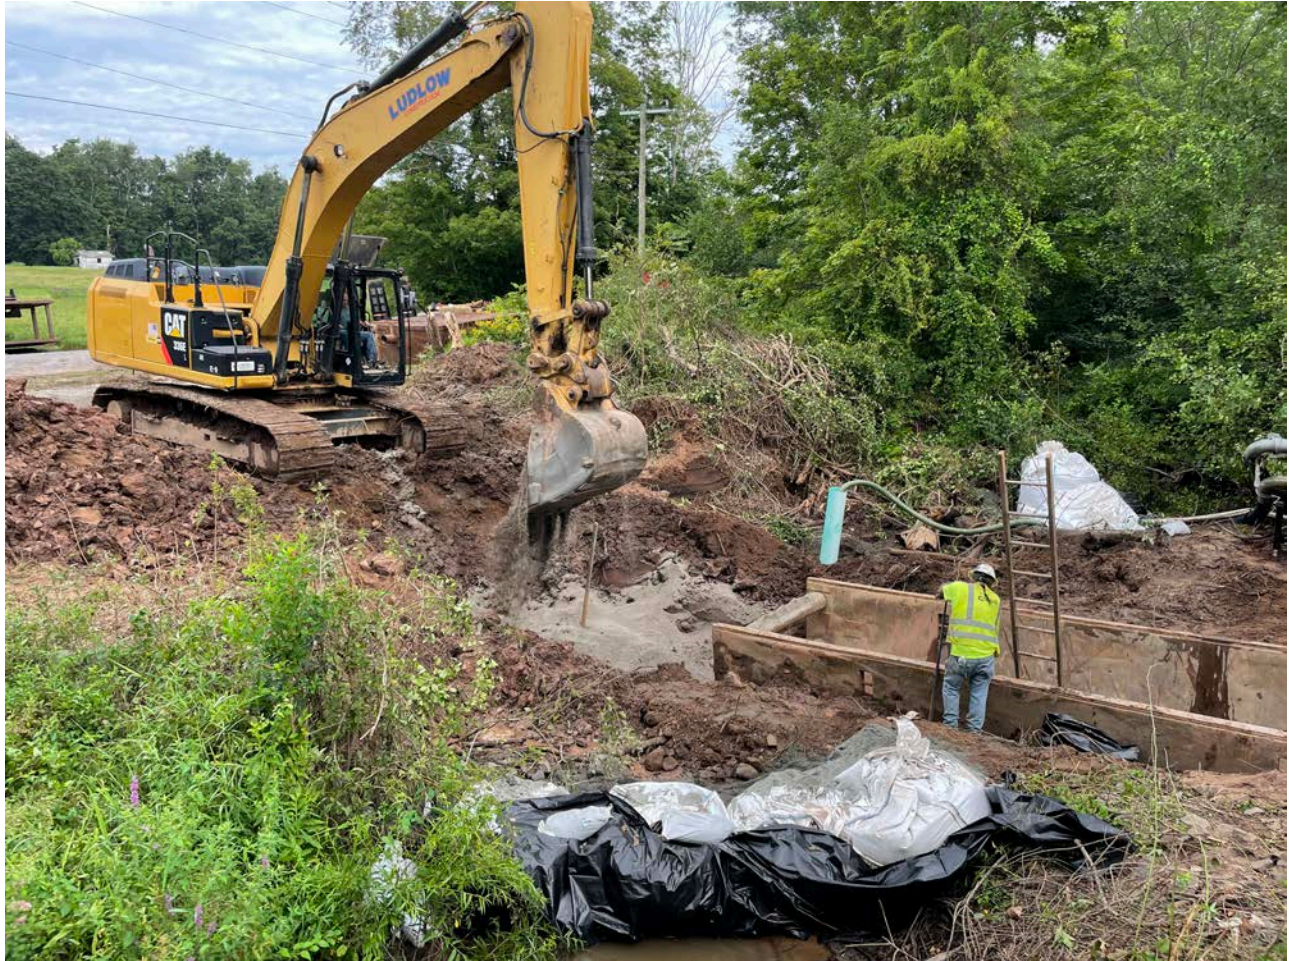
Picture 3: Ludlow placing sand over newly-installed 12" DIP on the west side of the trench box at the Maiden Lane stream crossing. View to the northwest.

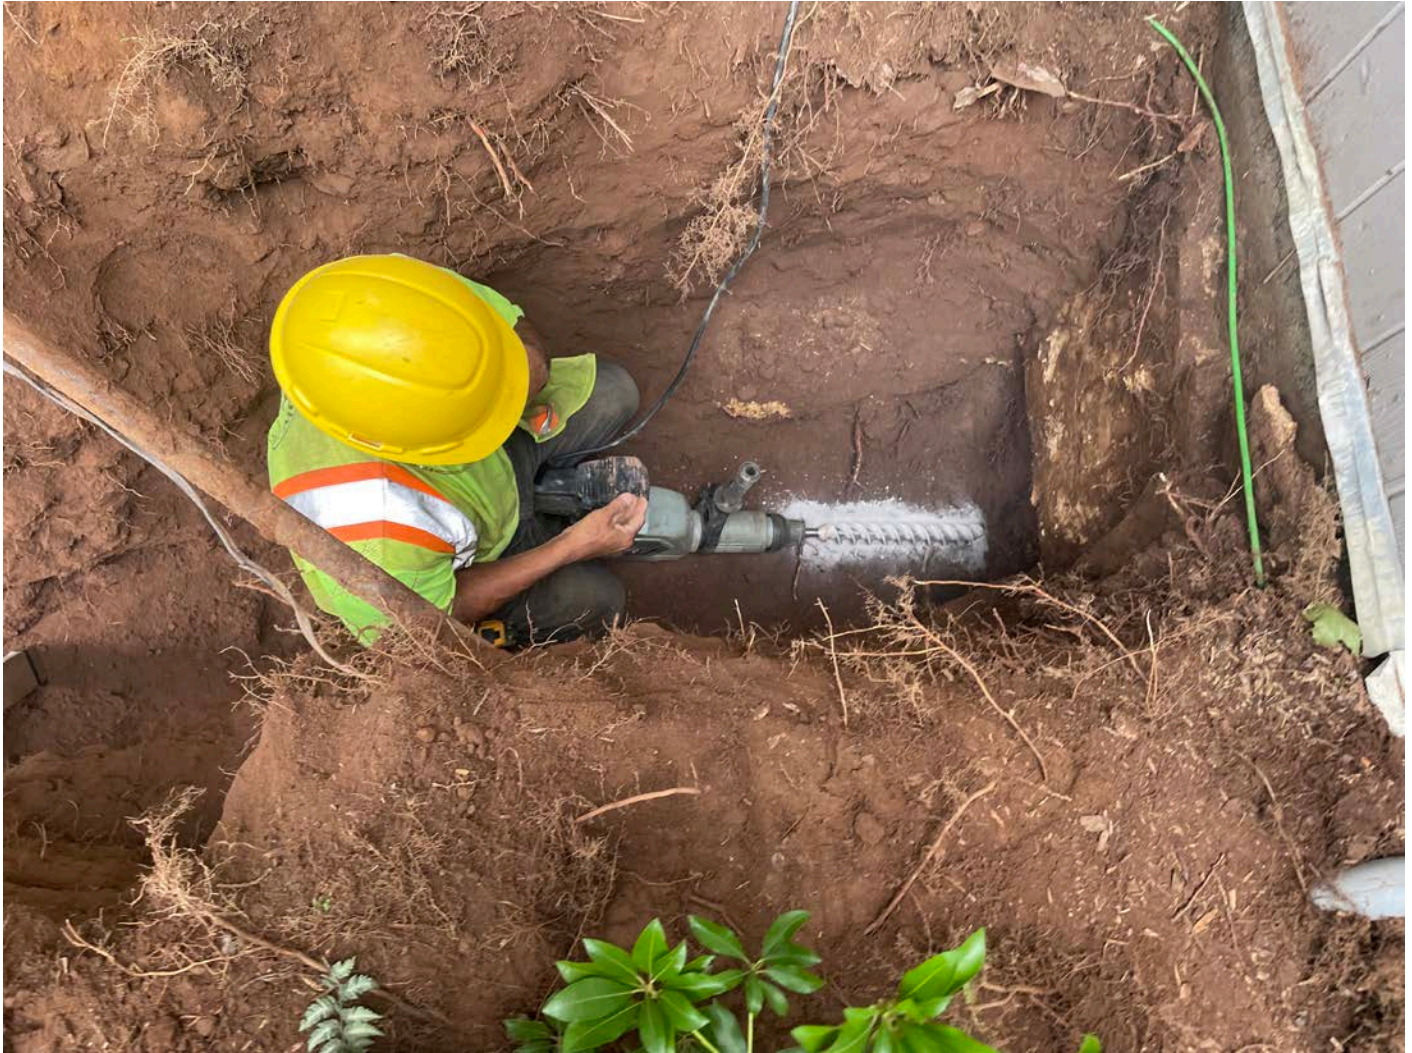
0913: Ludlow is using a rotary hammer to core a hole through the north foundation of the 119 Maple Avenue residence. The penetration point is 40" west of the northeast corner of the house.

Picture 4: Ludlow using a rotary hammer to penetrate the concrete foundation of the 119 Maple Avenue property for the installation of a 1.5" copper water service line.

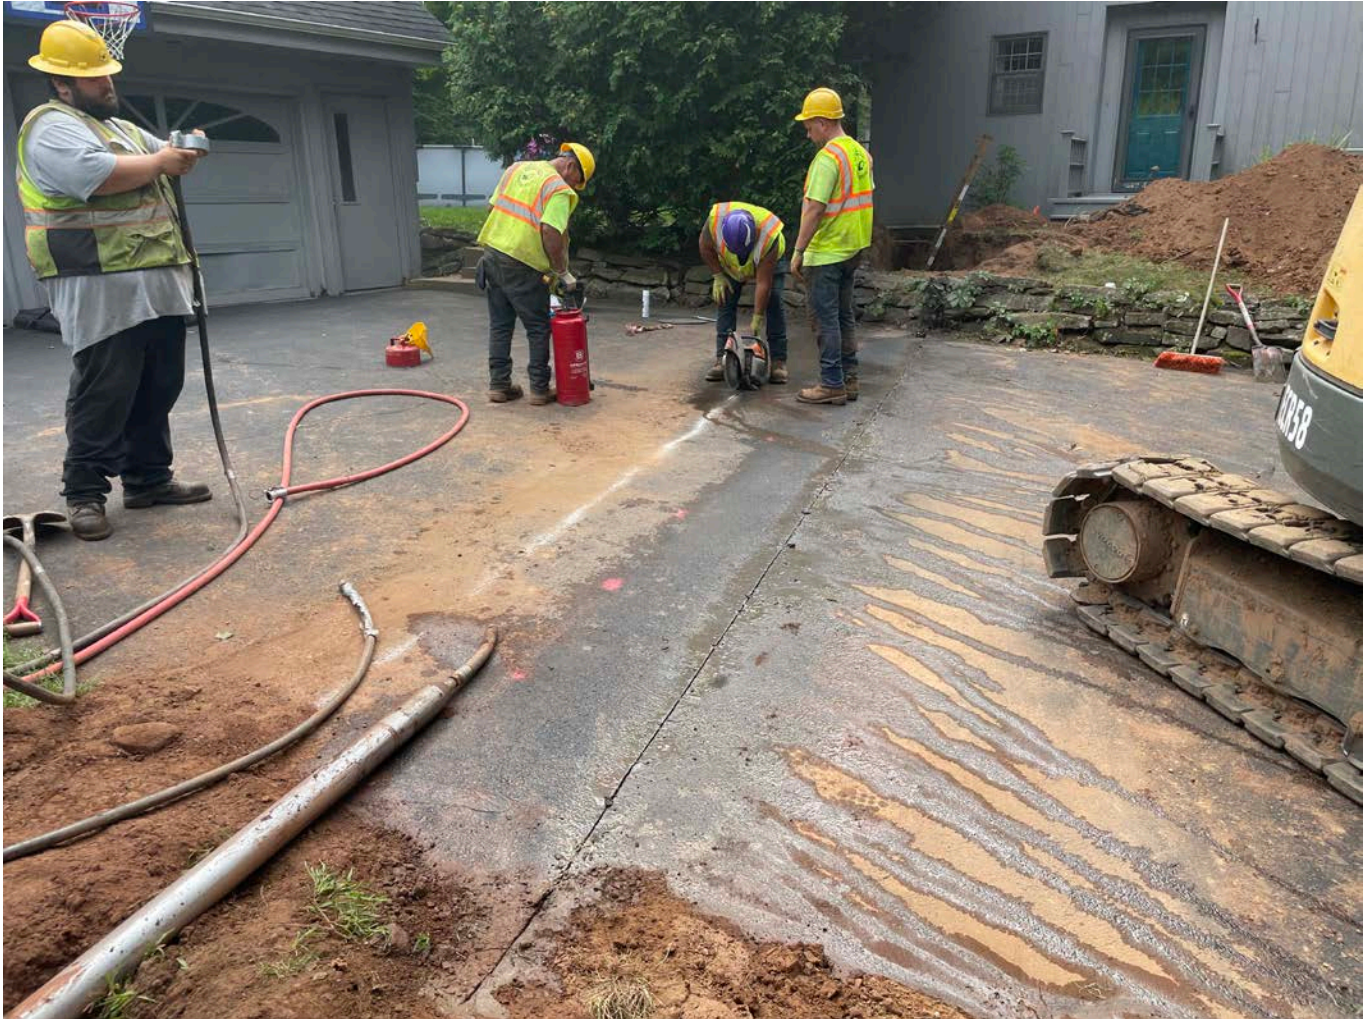
1030: Ludlow has failed a third time to punch a hole beneath the driveway of the 119 Maple Avenue property with the pneumatic mole. Ludlow is now saw cutting across the driveway in order to excavate a trench in order to finish the installation of the 1.5 " copper water line.

Picture 5: Ludlow saw cutting asphalt on the driveway for the 119 Maple Avenue property as part of the installation of a 1.5" copper water service line. View to the southeast.

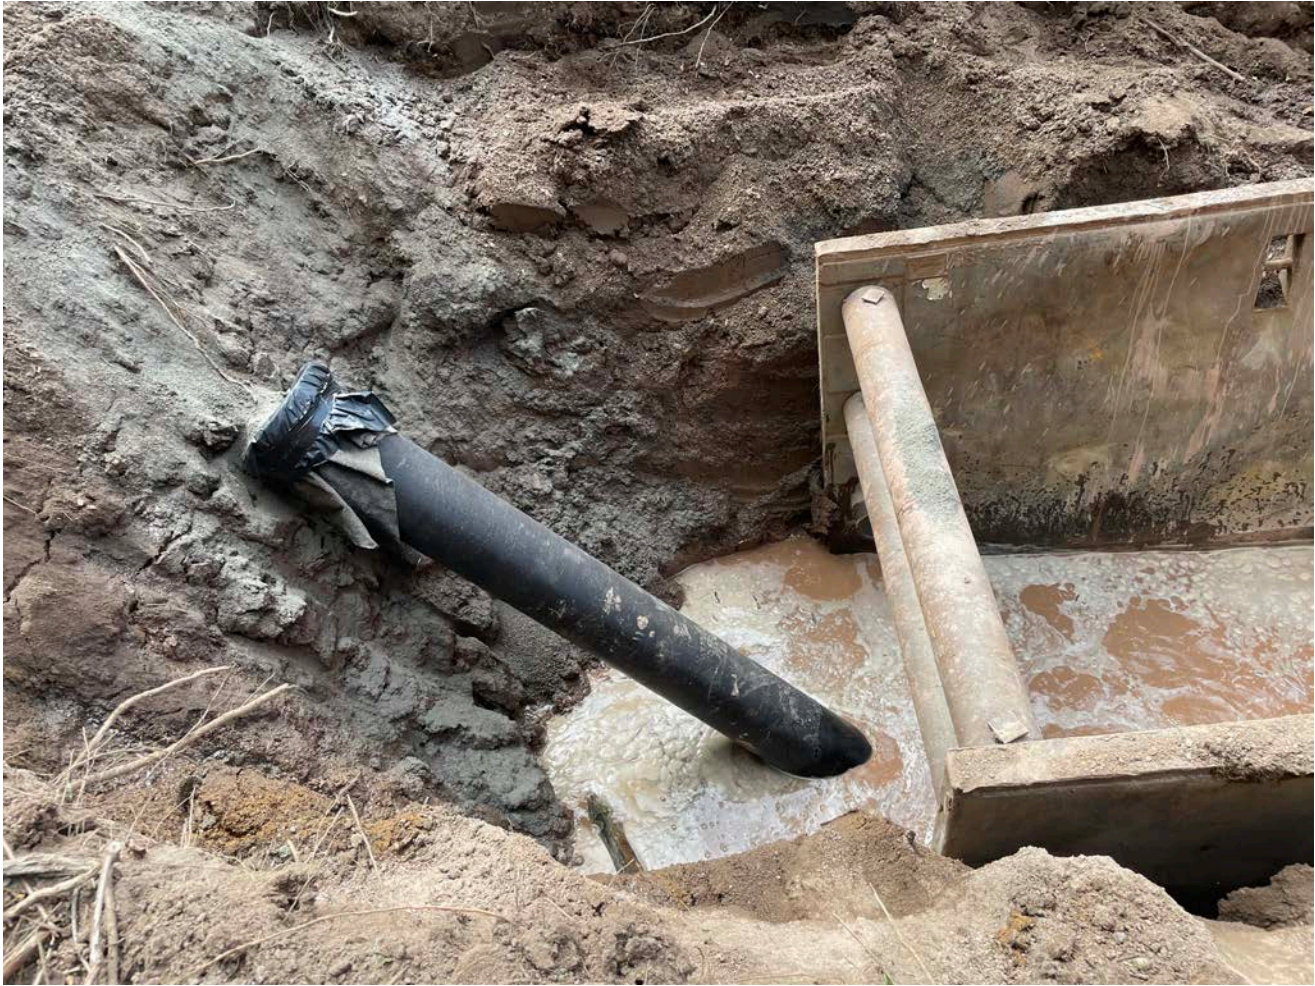
1115: Ludlow is working on the east side of the trench box at the Maiden Lane stream crossing. Ludlow has just installed a 45° DIP bend and a ~10 foot section of 12 " DIP.

Picture 6: View of the eastern side of the trench box at the Maiden Lane stream crossing, looking south. Ludlow has connected a ~10 section of 12" DIP to a 45° DIP bend they just installed.

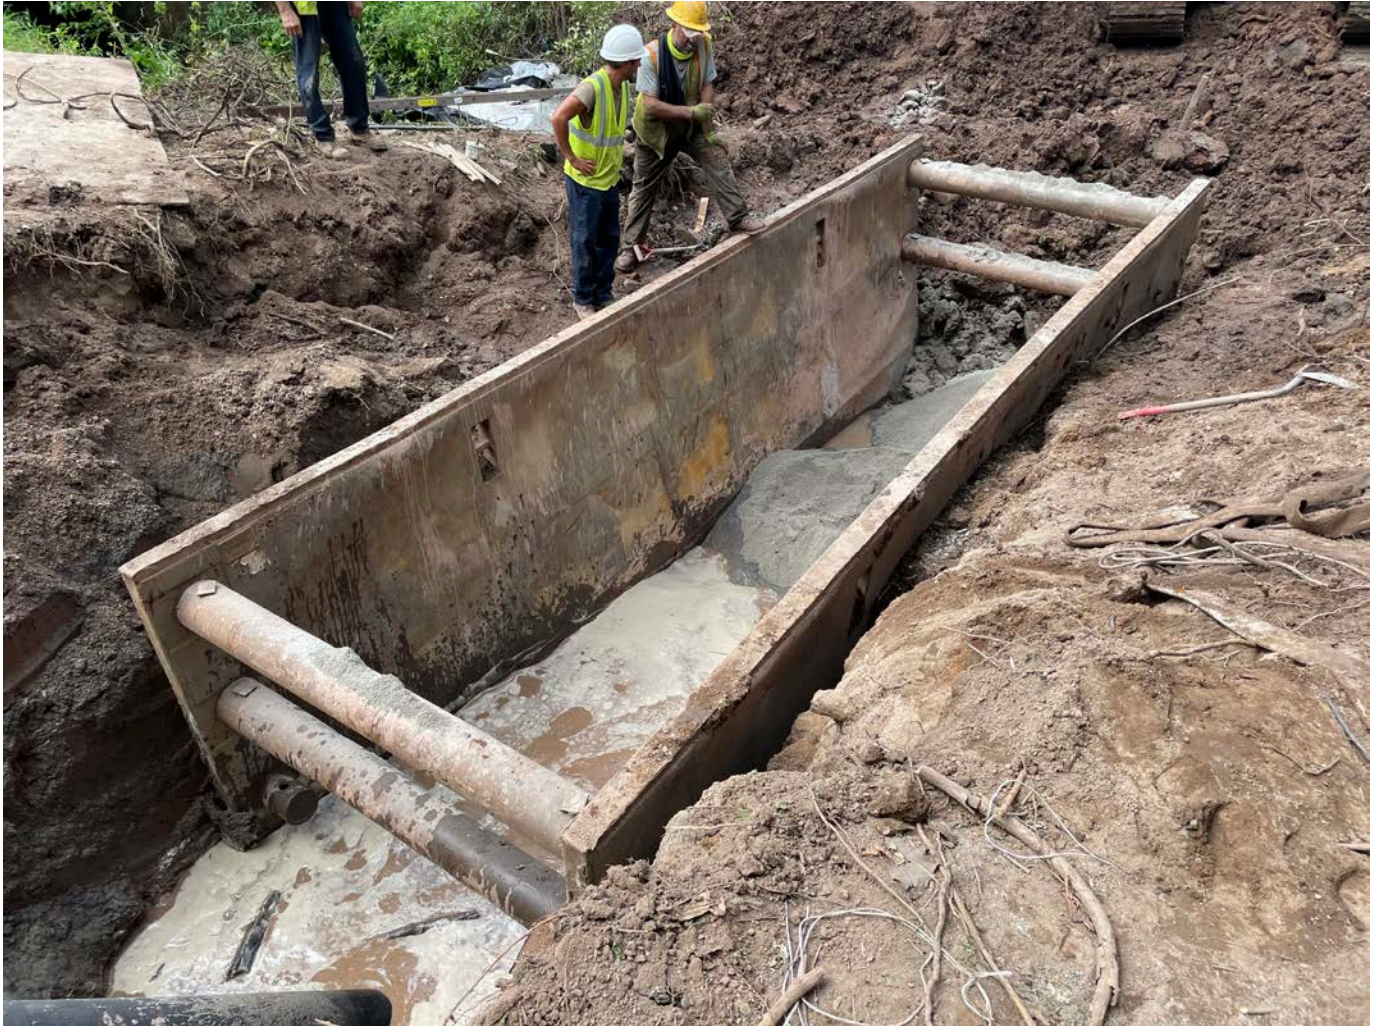
1125: Ludlow removes the trench box from the stream bed at the Maiden Lane stream crossing. Ludlow is placing 2' of sand over the 36 " conduit and some of the 12 " DIP they installed today. Ludlow is placing native fill that was excavated from the stream bed yesterday over the sand they just placed.

Picture 7: Sand that Ludlow has begun to place over the 36" steel casing that is located within the footprint of the trench box at the Maiden Lane stream crossing. View to southwest.

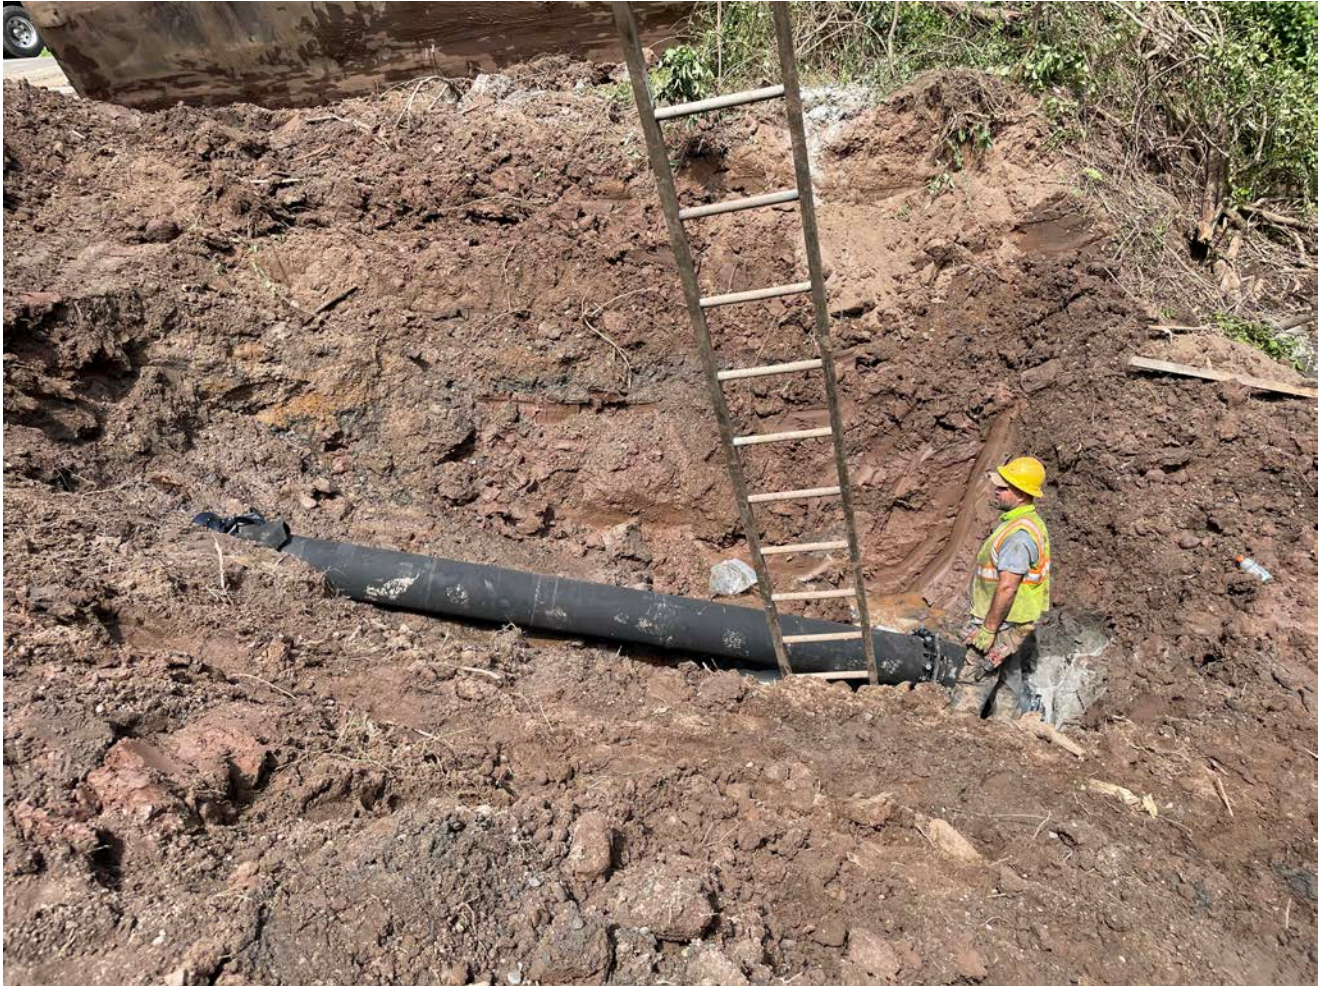
Picture 8: Additional 12" DIP that Ludlow has installed on the western bank of Ball Brook as part of the Maiden Lane stream crossing. View to the north.

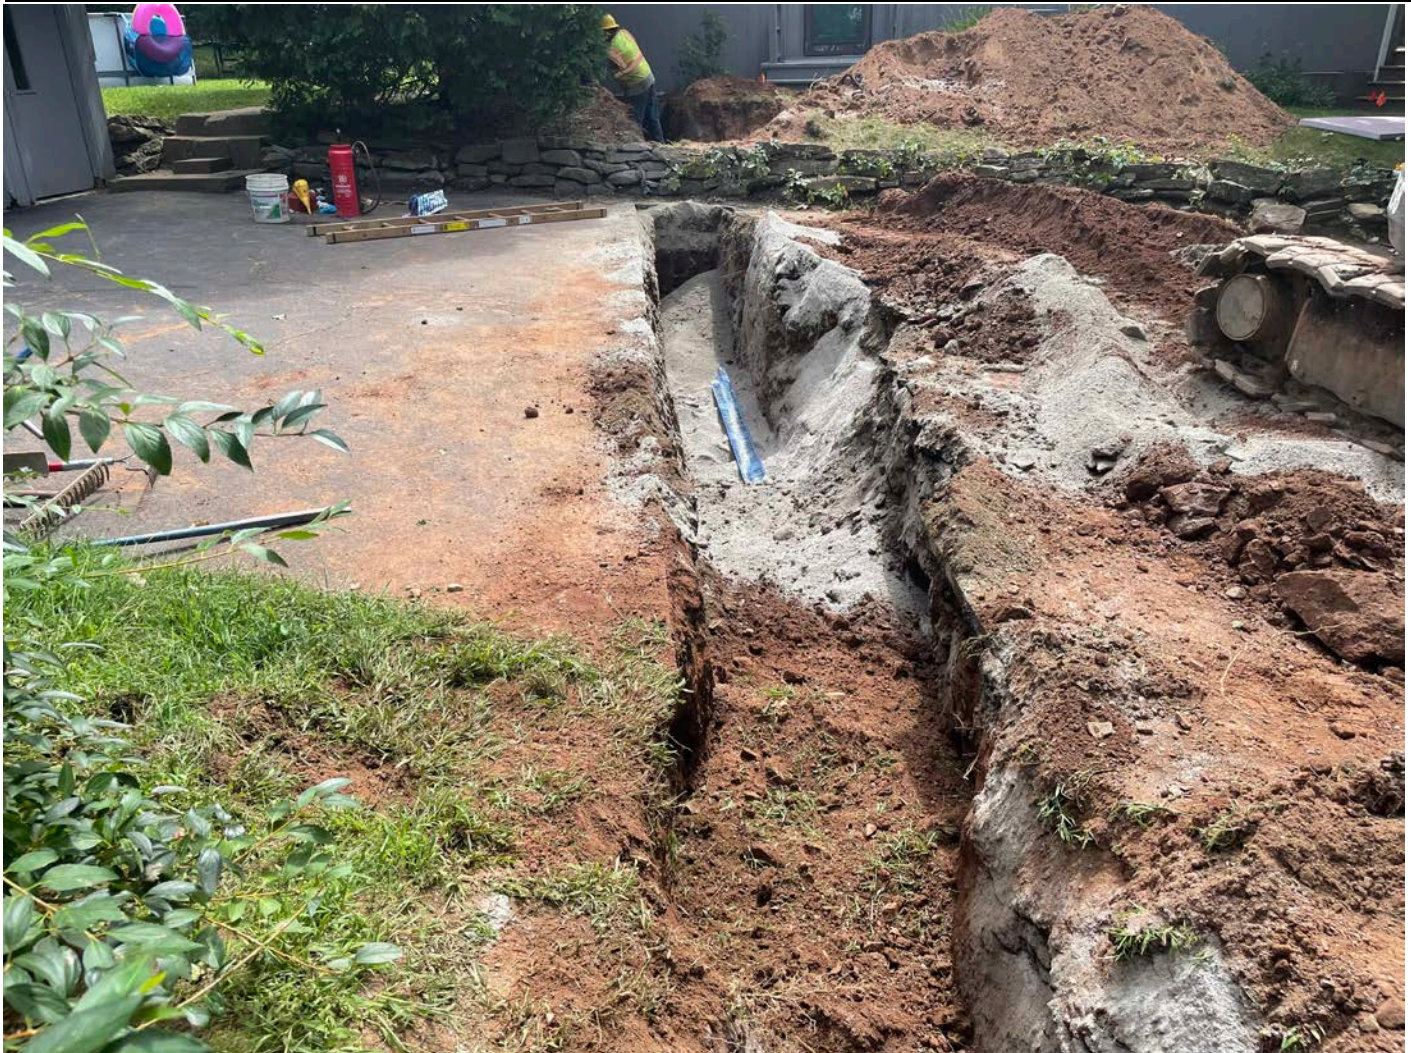
1251: Ludlow is installing 1.5" copper waterline across the driveway at 119 Maple Avenue The pipe has been put into place and Ludlow is currently covering the pipe with 6" of sand, followed by caution tape, followed by native fill placed in 1' lifts and compacted with a jumping jack.

Picture 9: Driveway at the 119 Maple Avenue residence where Ludlow is placing sand followed by caution tape followed by native fill over the 1.5" copper water service line they just installed. View to the south.

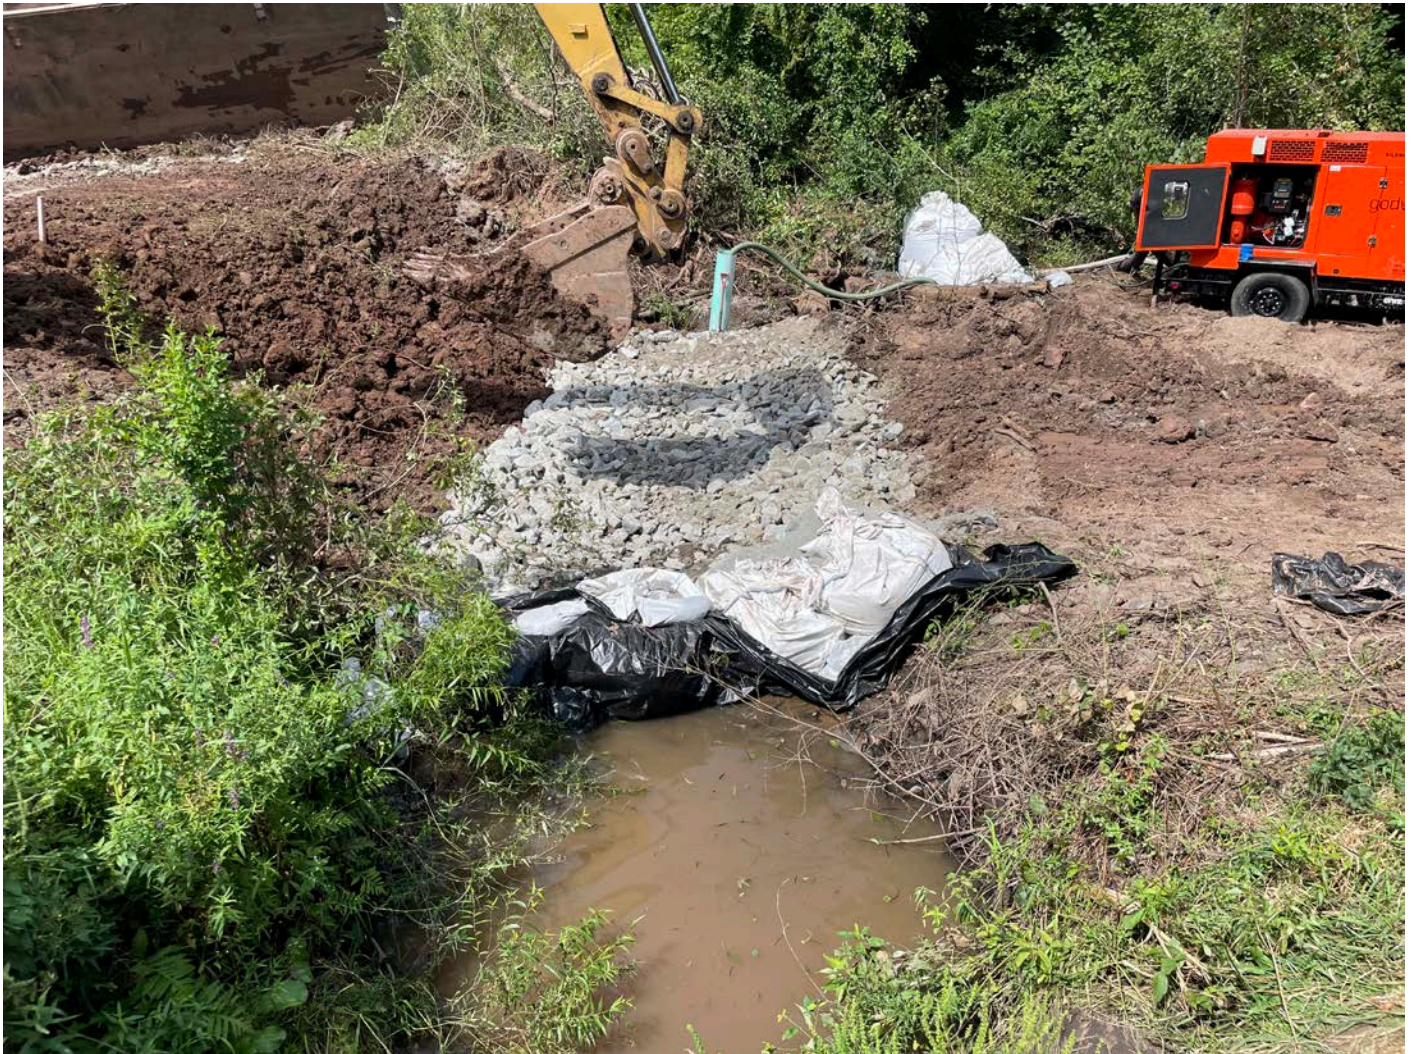
1330: Ludlow has placed 1' minus rip rap in the bed of Ball Brook.

1402: Ludlow had finished work for the day at the Maiden Lane stream crossing. They have roughed out reconstructing the west bank of Ball Brook and have begun to reconstruct the east bank.

Picture 10: Overview of the Maiden Lane stream crossing. Ludlow has placed rip rap on the stream bed of Ball Brook and has begun to reconstruct the west bank of the brook. View to the north.

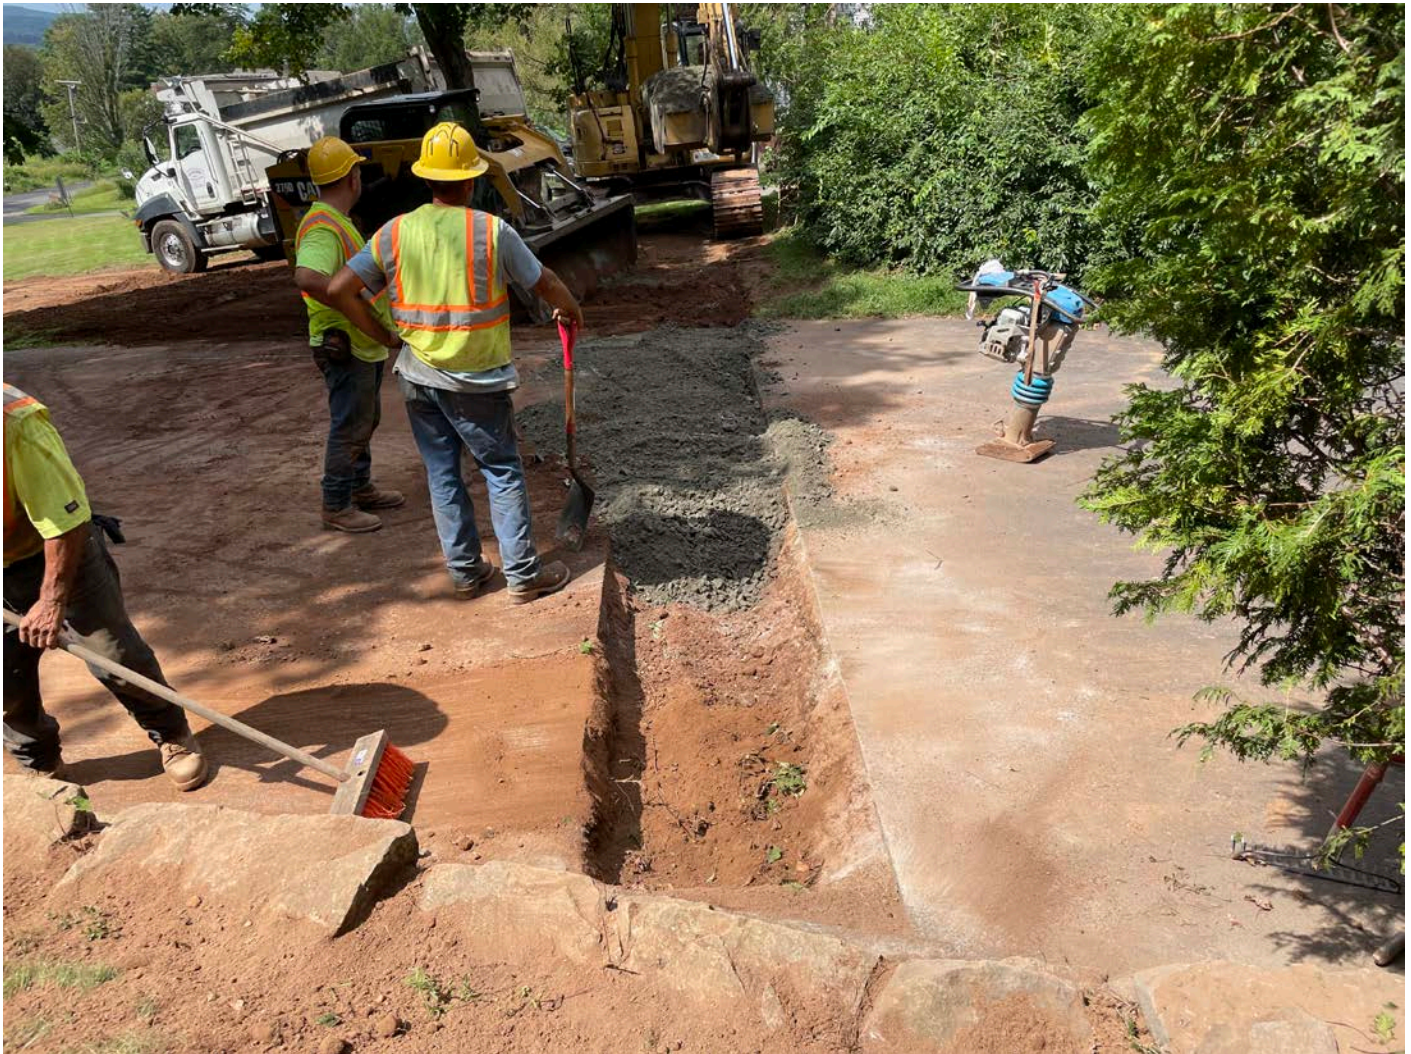
1420: Ludlow continues to backfill the trench they cut across the driveway at 119 Maple Avenue property for the installation of a 1.5 " copper water service line. The top course of backfill is a 1'-1.5' layer of 1.5 "-minus gravel.

Picture 11: Driveway at the 119 Maple Avenue residence where Ludlow is placing 1'-1.5' of 1.5" gravel as the final backfill over the 1.5" copper water service line they just installed. View to the north.
