Dally Report	Daily	y Report	
--------------	-------	----------	--

Project:	Durham Meadows Pipeline Installation	Date:	September 01, 2021
Location:	Maple Avenue and Maiden Lane, Durham	Day of Week:	Wednesday
Project #:	AECOM: 6061487	Report No:	314
Contractor:	Ludlow Construction	Page:	2 of 14

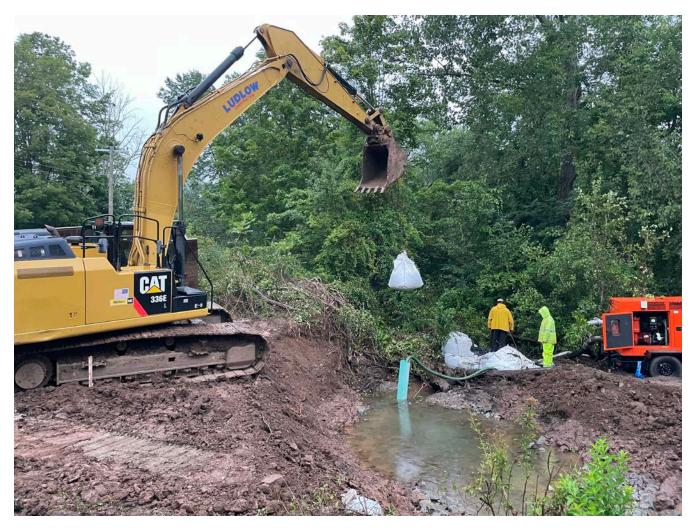
0714: Ludlow has removed the sand bag cofferdam from the downstream side of the Maiden Lane stream crossing work zone. Ludlow is in the process of removing the sandbags that comprise the cofferdam located upstream of the work zone.

Picture 1: Ludlow removing sand bags that served as the upstream segment of the cofferdam for the Maiden Lane stream crossing. View to the north.

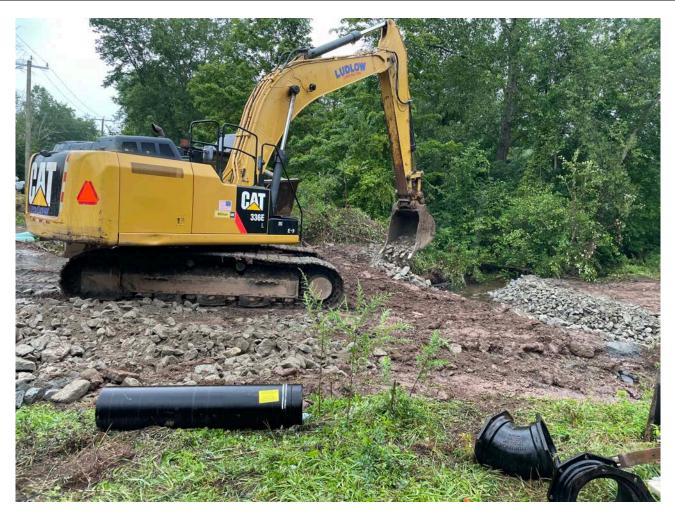
0826: Ludlow has begun placing minus 1' riprap on the west bank of Ball Brook.

Picture 2: Ludlow placing riprap on the western bank of Ball Brook as part of restoration activities following the Maiden Lane stream crossing. View to the north.

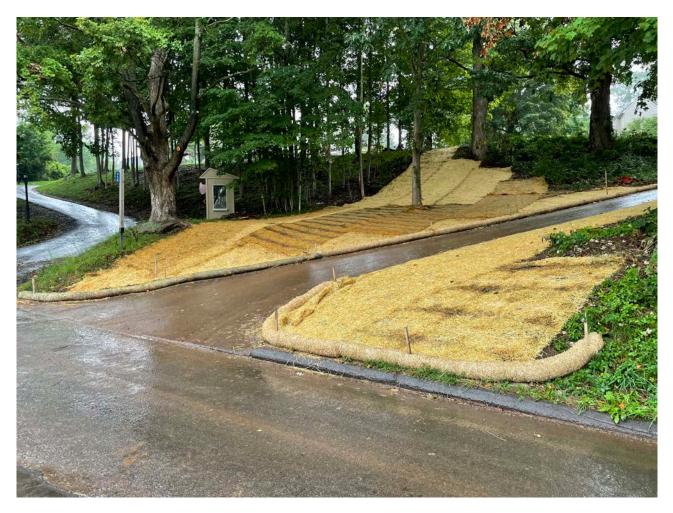
Picture 3: Erosion control that Ludlow has placed on either side of the driveway for the 95R Maple Avenue property. View to the northeast.

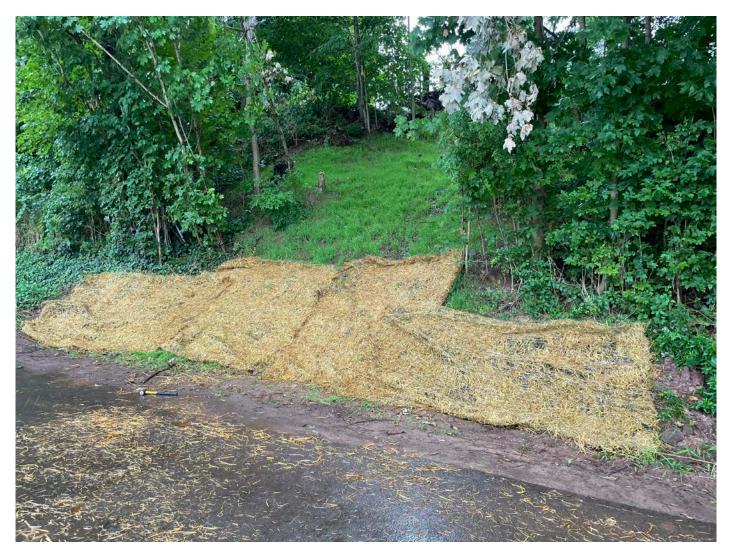
Picture 4: Erosion control that Ludlow has placed on either side of the driveway for the 95R Maple Avenue property. View to the east.

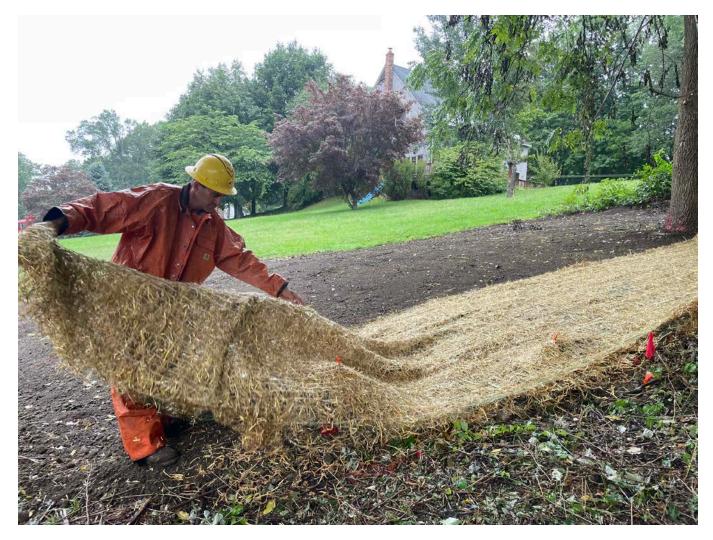
1152: Ludlow has finished placing straw erosion mats over the newly-placed loam and seed at the 119 Main Street property.

Picture 5: Ludlow placing straw mats at the 119 Maple Avenue. View to the north.

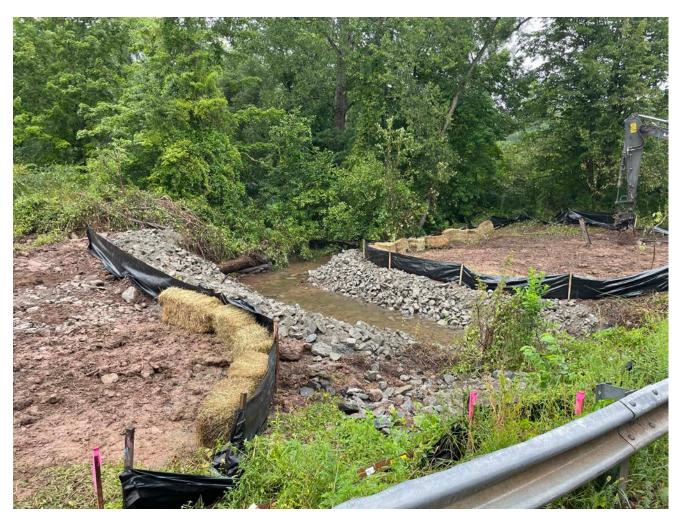
0921: Ludlow has demobilized the trench box from the Maiden Lane stream crossing work zone. Ludlow is setting up silt fence and hay bales on both sides of Ball Brook at the stream crossing work zone. Ludlow has placed riprap on the streambed and the banks of Ball Brook.

Picture 6: Overview of the Maiden Lane stream crossing after Ludlow has placed riprap on the stream bed and the banks of Ball Brook, and has placed silt fence and hay bales along each side of the stream bank. View to the northeast.

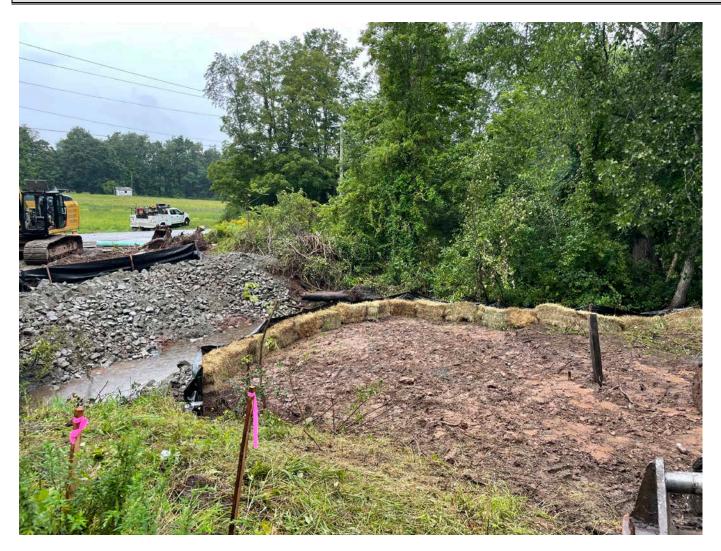
Picture 7: Overview of the Maiden Lane stream crossing after Ludlow has placed riprap on the stream bed and the banks of Ball Brook and has placed silt fence and hay bales along each side of the stream bank. View to the northwest.

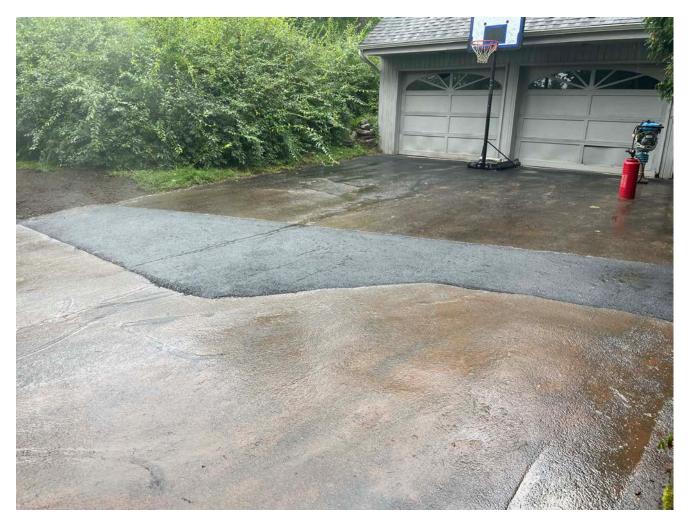
0852: Ludlow has placed straw and straw matting on the areas of the lawns at 95R, 97, 109 Maple Avenue and 10 Johns Way that were disturbed by Ludlow during the installation of copper water service lines. Ludlow continues to work at the 119 Maple Avenue property. Ludlow has placed and compacted two lifts of asphalt over the trench they cut across the driveway at the 119 Maple Avenue property for the installation of a 1.5" copper waterline. Ludlow is preparing to place and compact a final third layer of asphalt.

Picture 8: Asphalt patch that Ludlow placed to close he trench they cut across the driveway for 119 Maple Avenue property during the installation of a 1.5" copper water service line. View to the northeast.

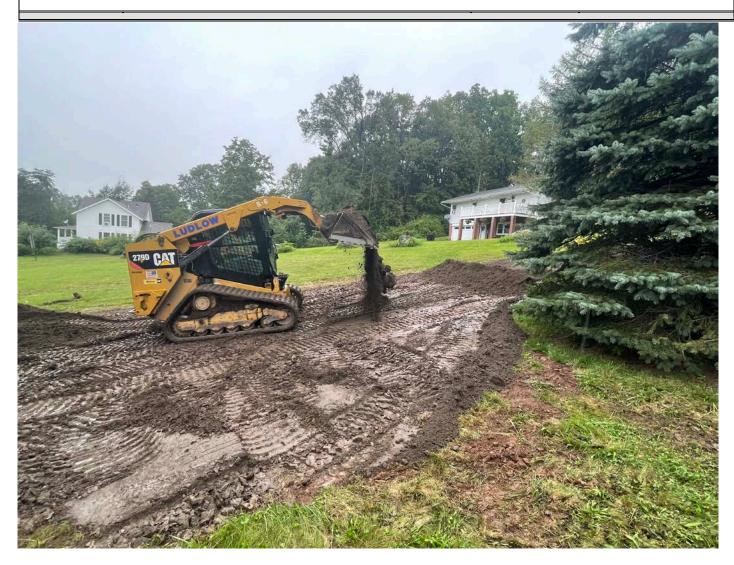
1014: Ludlow is performing restoration work on the sections of the lawn at 119 Maple Avenue, Durham. Ludlow is currently placing loam.

Picture 9: Ludlow placing loam at the 119 Maple Avenue residence to repair the portions of the lawn that were disturbed during the installation of a 1.5" copper water service. View to the northeast.

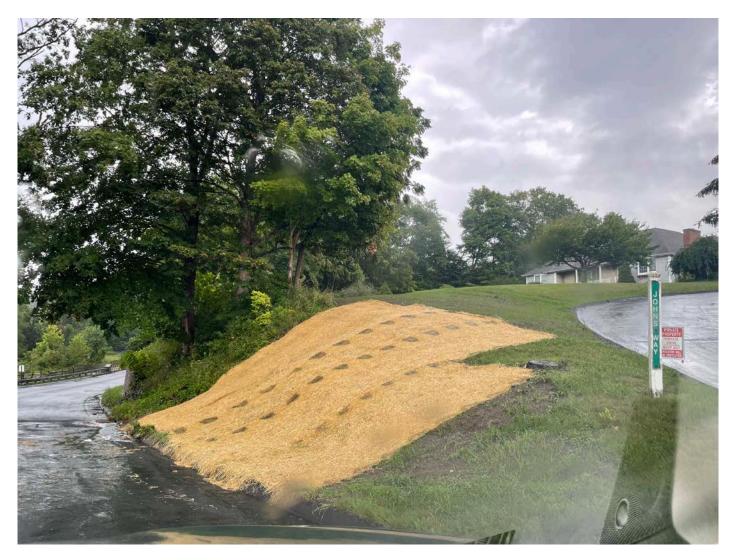
Picture 10: Erosion control that Ludlow has placed at the 10 Johns Way property. View to the northeast.

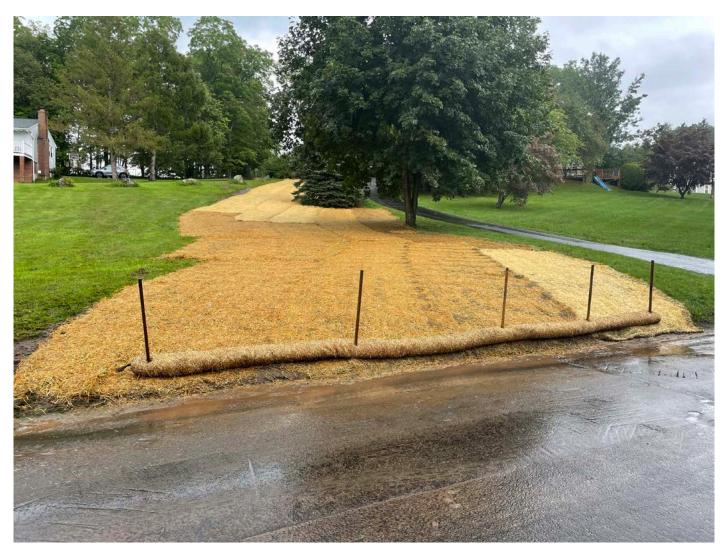
Picture 11: Erosion control that Ludlow has placed at the 119 Maple Avenue property. View to the east.

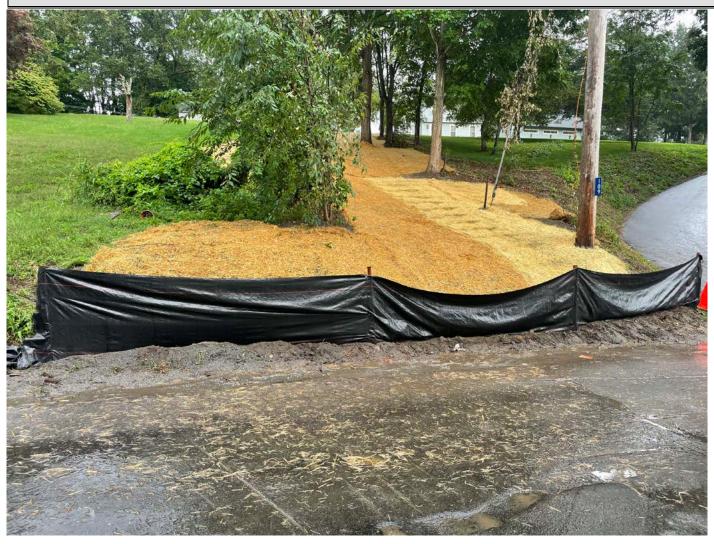
Picture 12: Erosion control that Ludlow has placed at the 109 Maple Avenue property. View to the east.
