Daily Report

Project:	Durham Meadows Pipeline Installation	Date:	September 02, 2021
Location:	Maple Avenue and Maiden Lane, Durham	Day of Week:	Thursday
Project #:	AECOM: 6061487	Report No:	315
Contractor:	Ludlow Construction	Page:	2 of 18

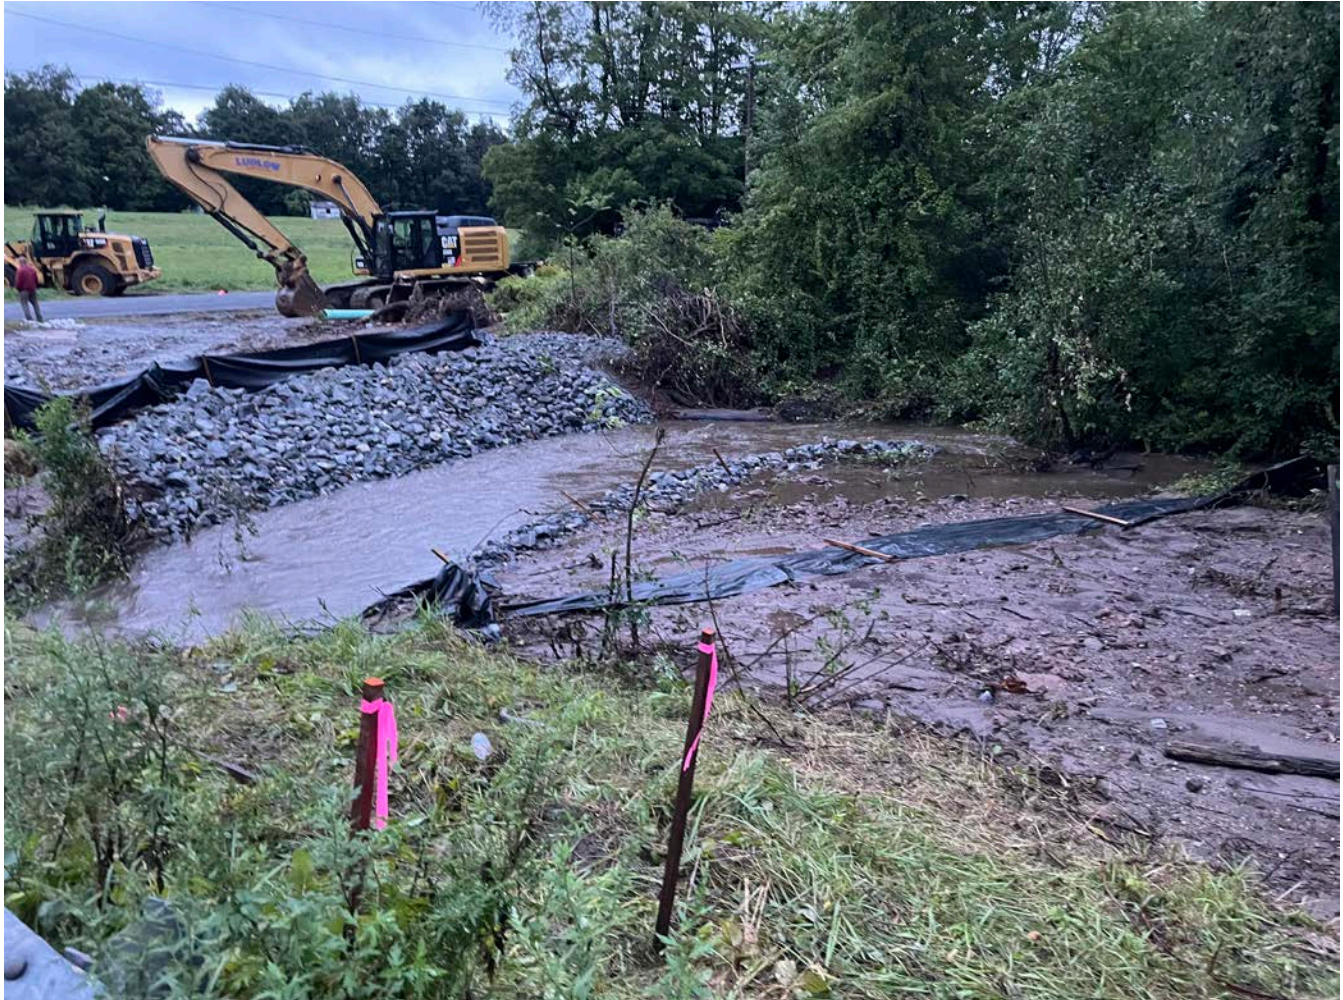
AECOM performed an assessment of erosion at the site after the storm event last night. The erosion control measures that Ludlow placed yesterday for the properties at 10 Johns Way and 95R, 97, 109, and 119 Maple Avenue performed well. A small amount of silt and fines needed to be cleaned up on the downgradient side of the straw wattles place at the edge of the road at 119 Maple Avenue. The meter station, the booster station, and the PRV vault sites all showed no signs of erosion. The Shared Access Driveway also showed no significant signs of erosion. At the Maiden Lane stream crossing, the hay bales on the east side of the brook were swept away by high water flow and the silt fence was knocked flat. On the west bank of the Ball Brook, water pushed past the silt fence and hay bales next to the bridge abutment. Ball Brook was observed to be running very high, but it appears that the rip rap that Ludlow placed on the stream bed and bank remained in place.

Picture 1: The Maiden Lane stream crossing, looking to the northwest. Heavy stream flow from last night's storm event has washed the hay bales that Ludlow placed on the east bank of Ball Brook downstream and flattened the silt fence.

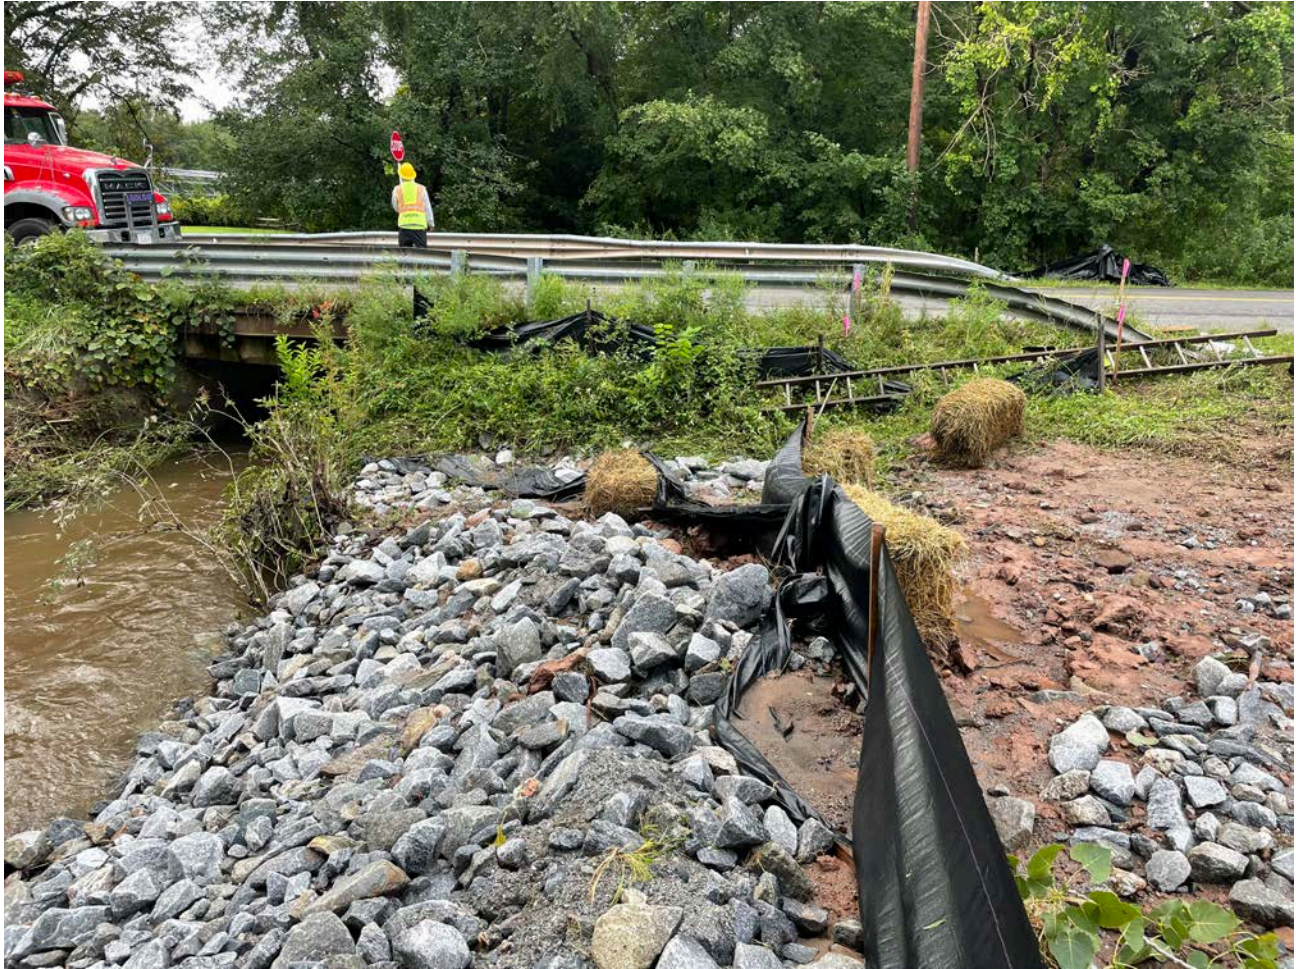
Picture 2: Silt fence and hay bales that Ludlow placed yesterday on the west bank of Ball Brook at the Maiden Lane stream crossing that were moved or damaged by last night's storm event. View to the south.

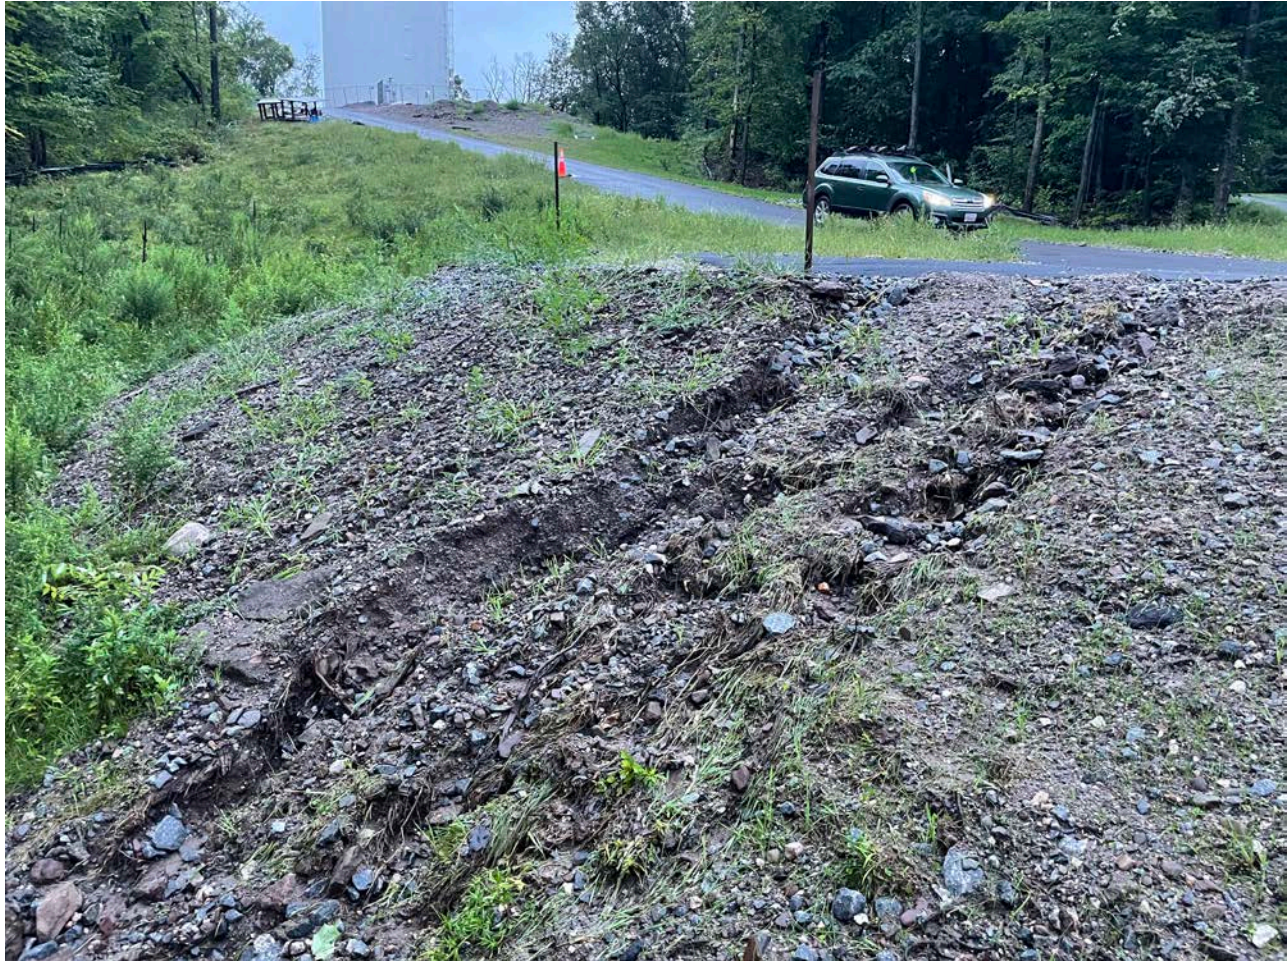
Picture 3: Rills located on the north side of the turnout on the Shared Access Driveway at Station 14+00 that were made deeper by last night's storm event. View to the southeast.

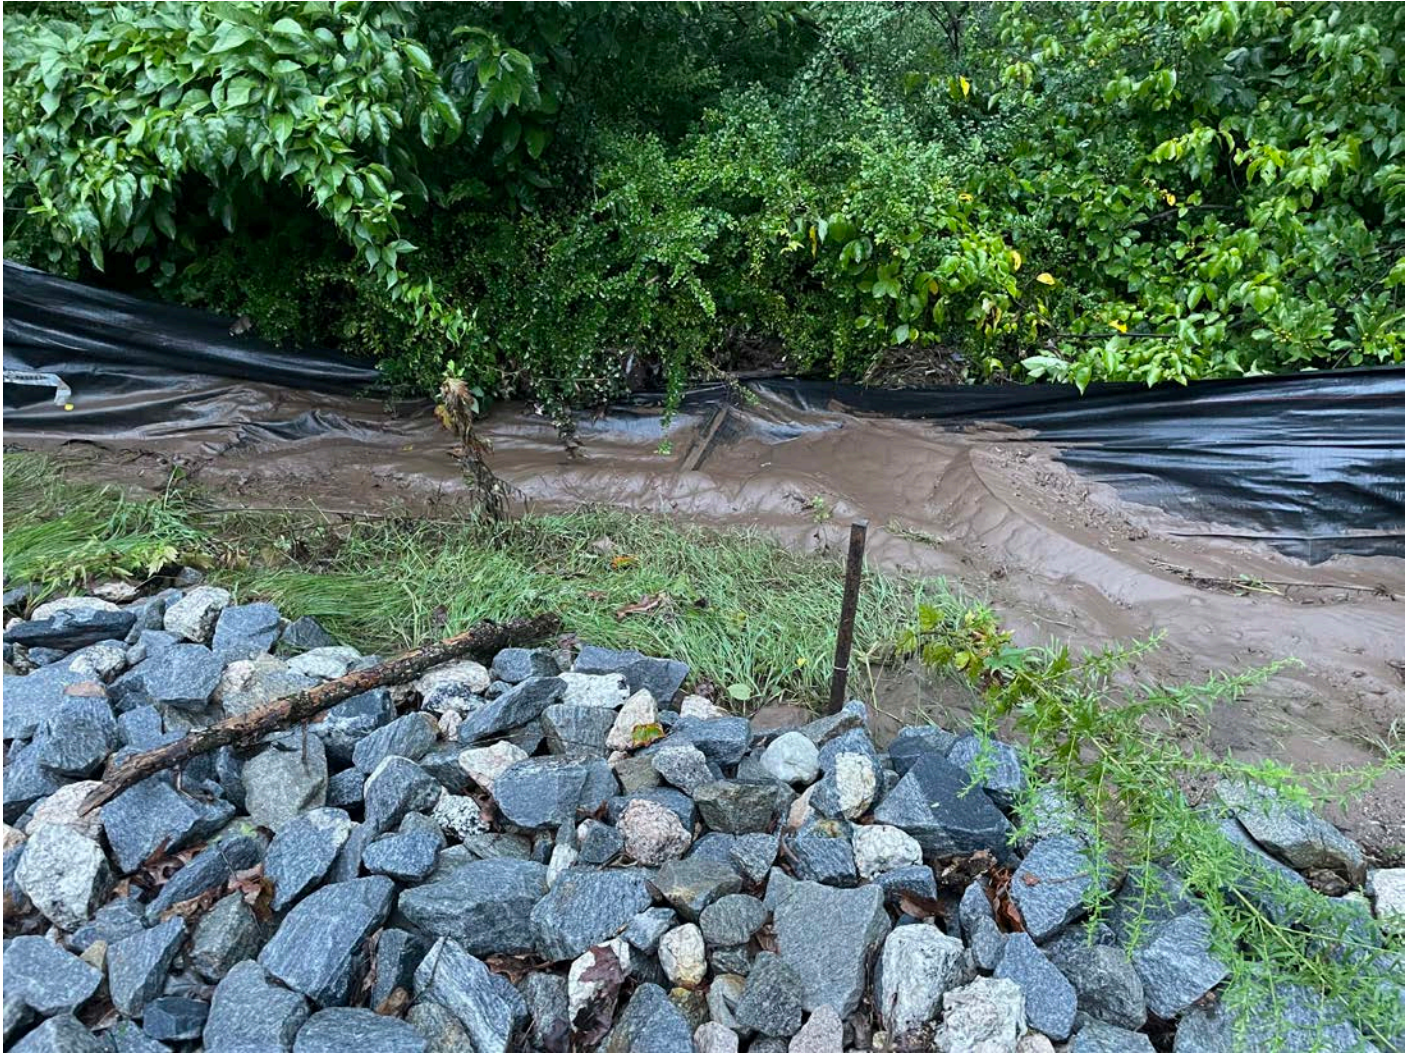
Picture 4: Sediment that has stacked up against the silt fence located on the north side of the Shared Access Driveway at Station 14+00. View to the north.

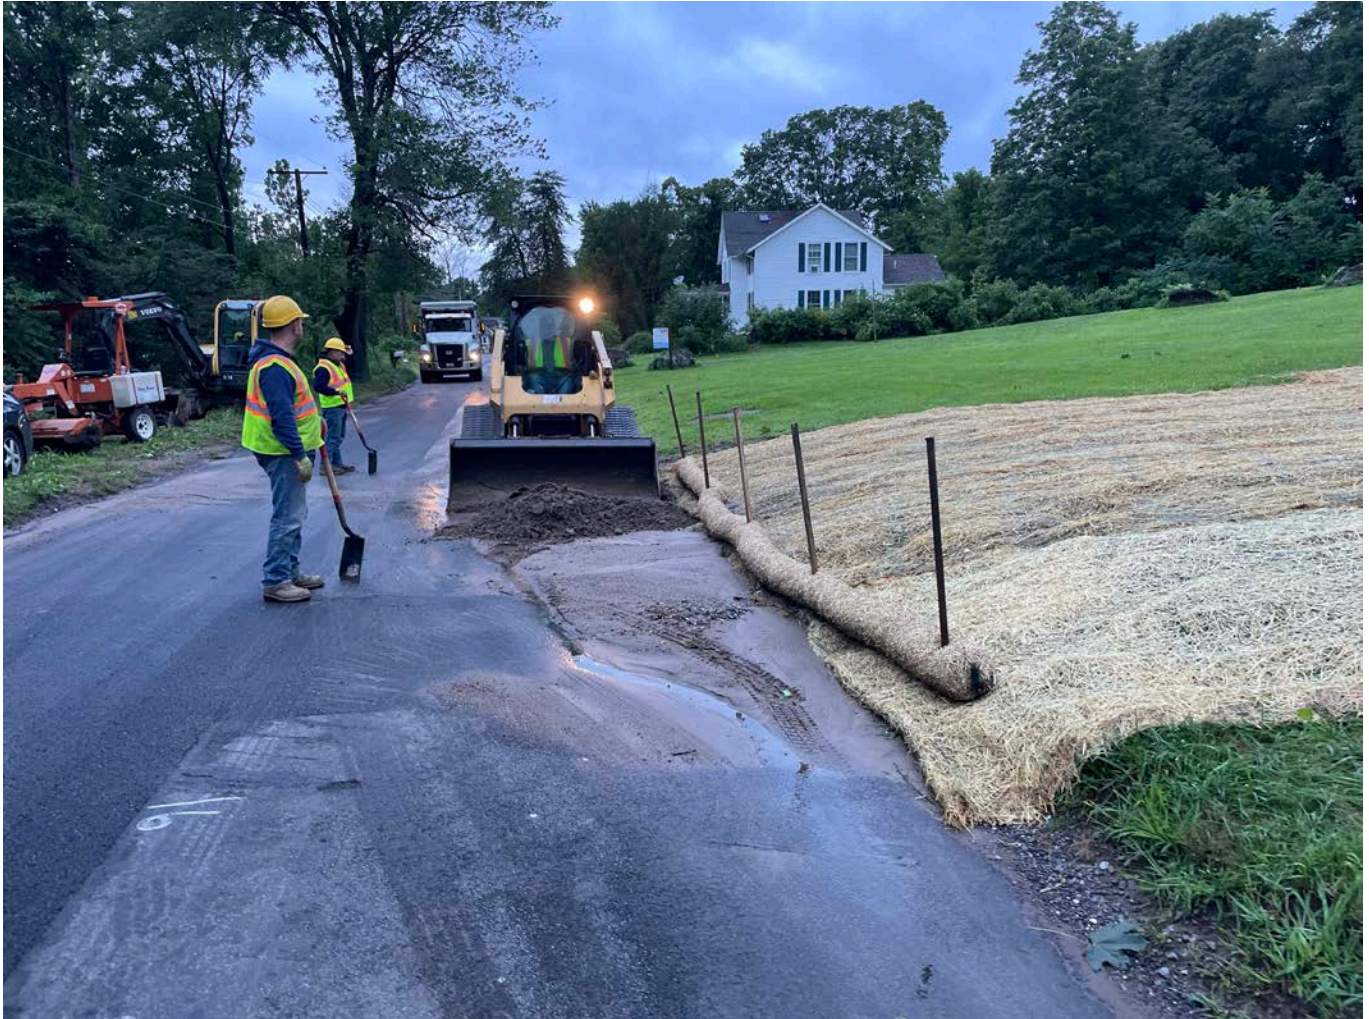
Picture 5: Ludlow cleaning up a small amount of silt/fines that washed off the 119 Maple Avenue property during last night's storm event. View to the north.

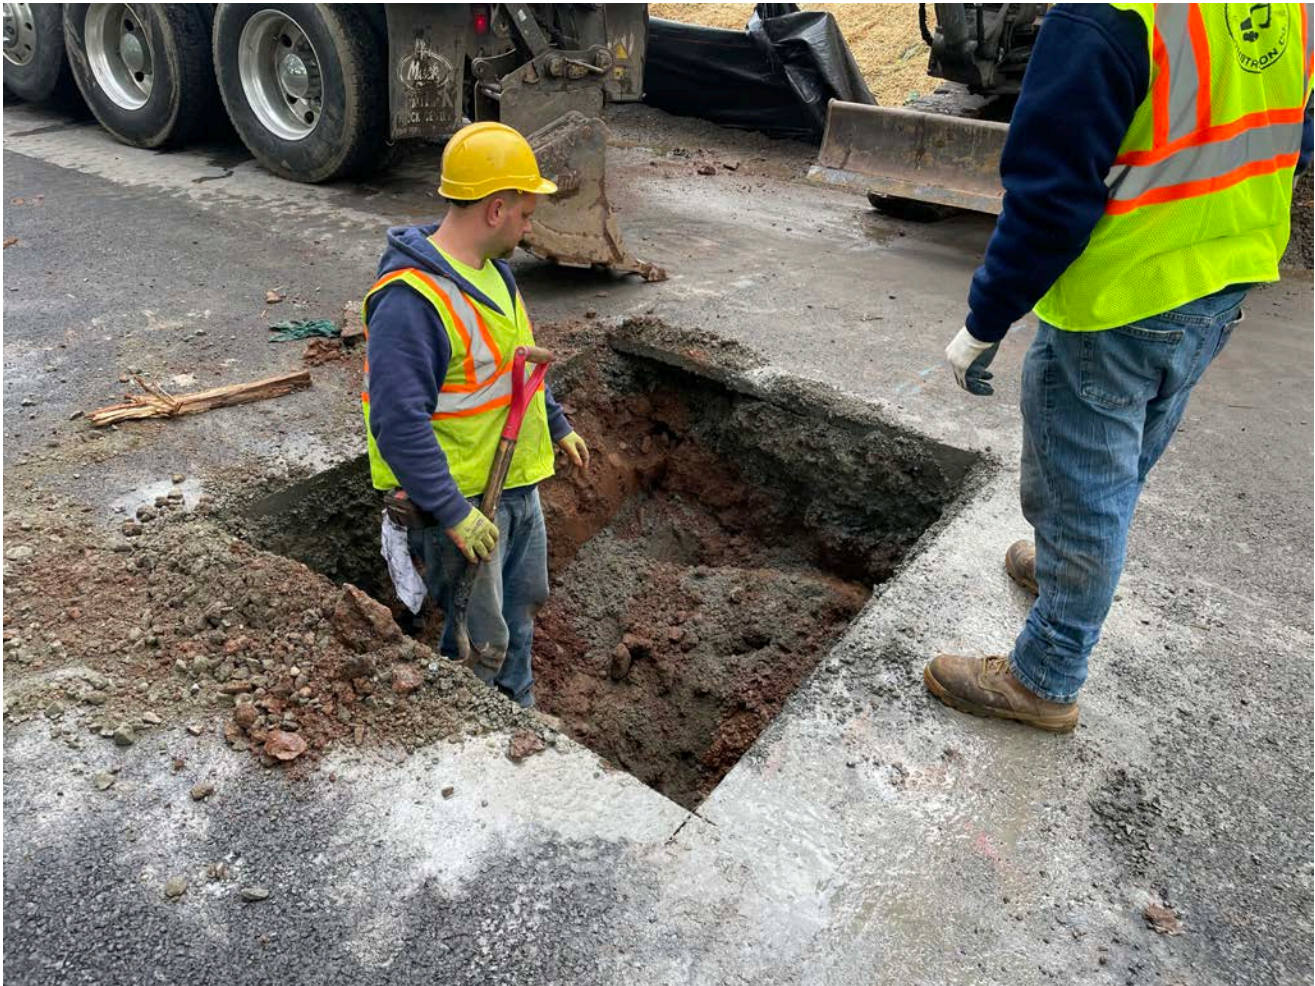
0935: Ludlow is daylighted the corporation stop at 109 Maple Avenue and found that it had been installed correctly. Ludlow has excavated between the curb stop and the meter pit to further investigate the reason they are not getting water to flow east of the meter pit. Ludlow is currently pumping water out of the excavation located east of the curb stop and discharging the water south of the driveway for 109 Maple Avenue into a brushy area.

Picture 6: Ludlow daylighting the southbound lane of Maple Avenue to inspect corporation stop for the 109 Maple Avenue residence. View to the southeast.

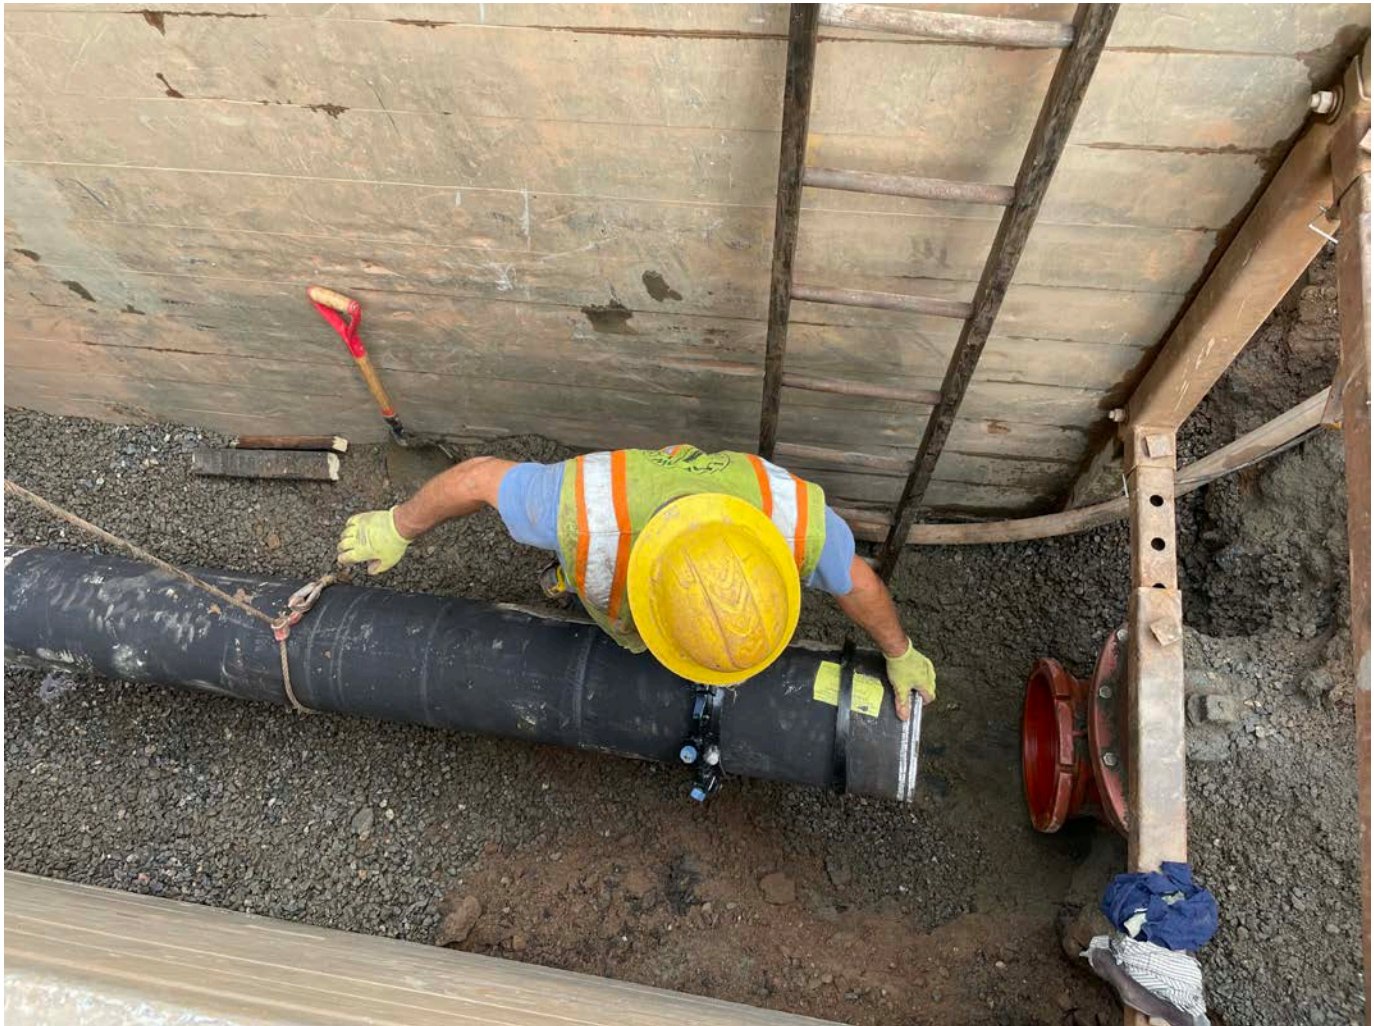
Picture 7: Ludlow inserting a section of 12" DIP into an existing gate valve located at Station 412+20 east of the Ball Brook stream crossing.

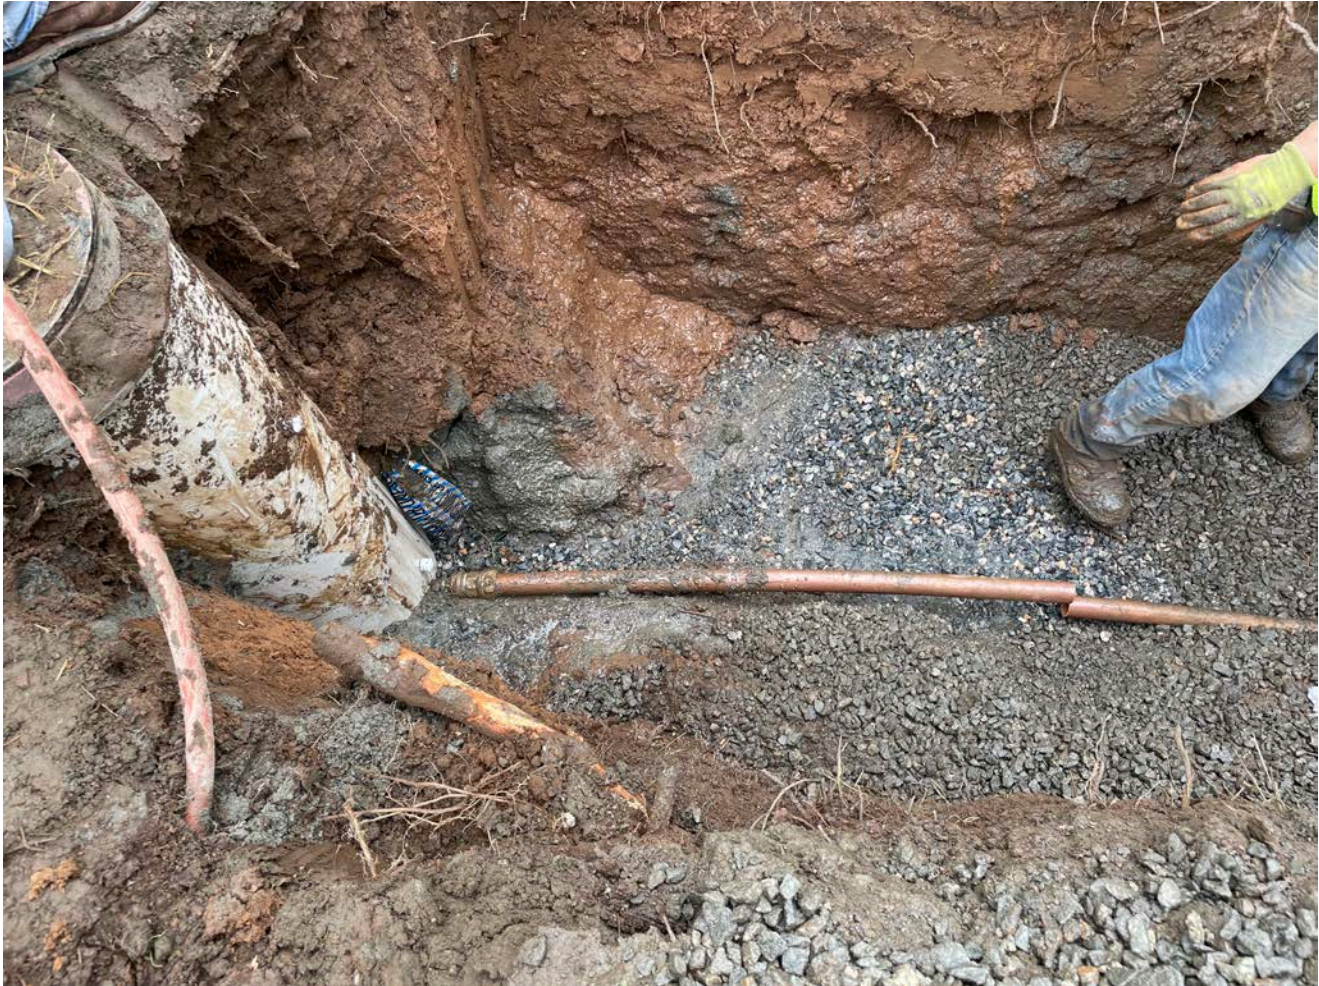
1041: Ludlow is backfilling between the meter pit and the curb stop at 109 Maple Avenue after they discovered that the lack of water flow east of the meter pit was due to a small piece of rag that was plugging up a fitting between the meter pit and the 1.5" copper water line.

Picture 8: Ludlow located and cleared a clogged fitting where the copper water line connects to the west side of the meter pit at 109 Maple Avenue. View to the south.

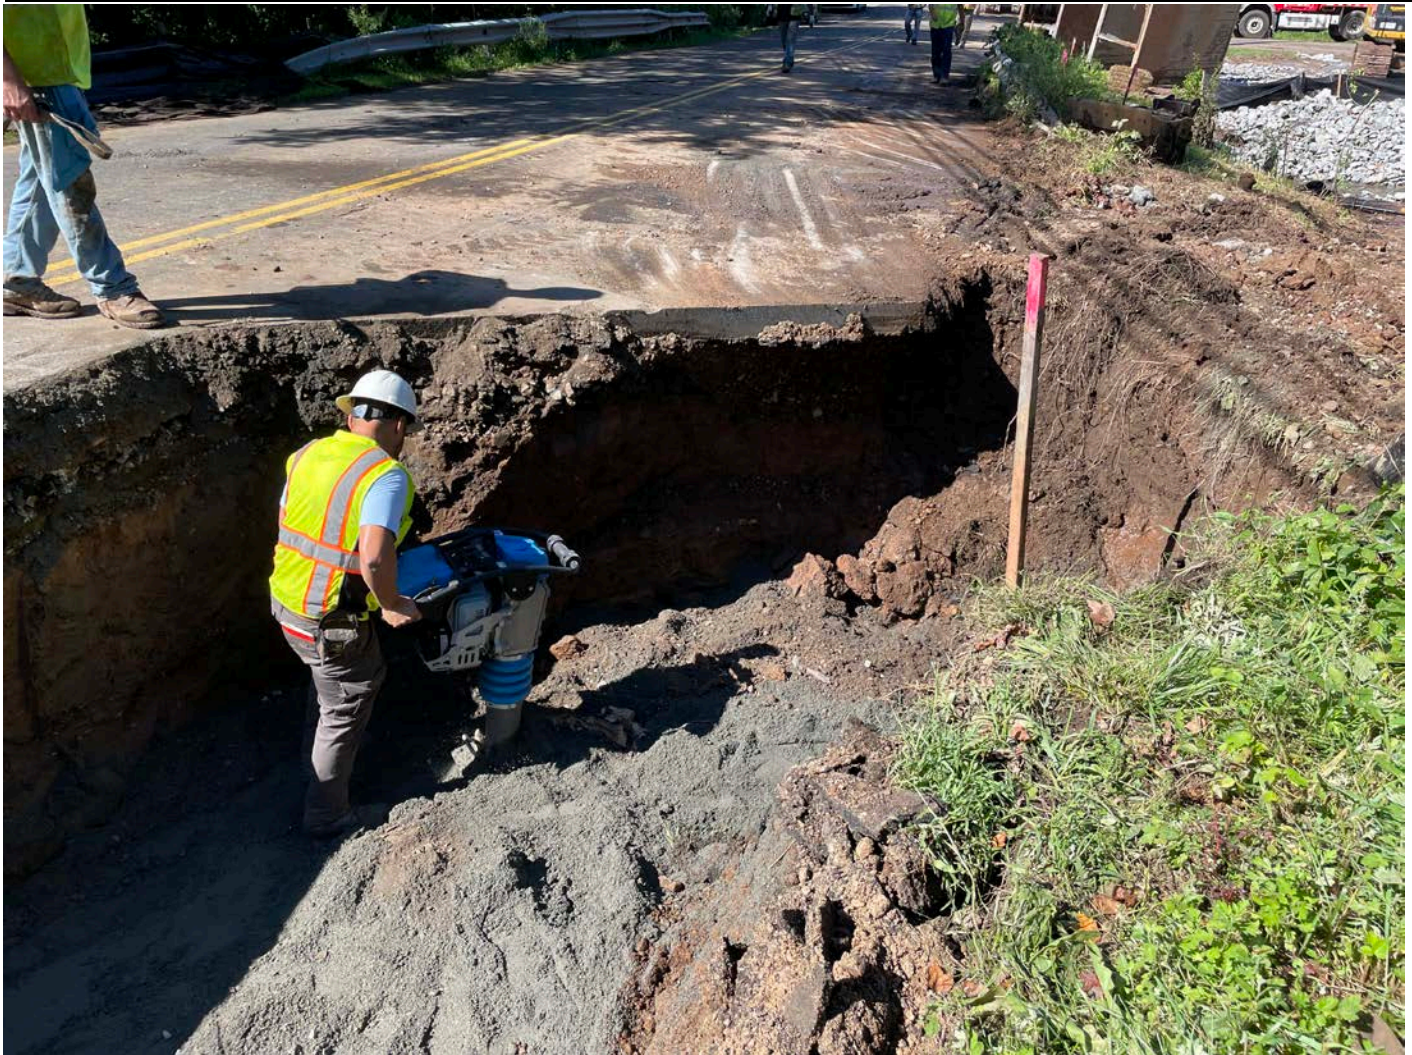
Picture 9: Ludlow compacting sand placed over 12" DIP they installed west of the gate valve at Station 412+20. View to the northwest.

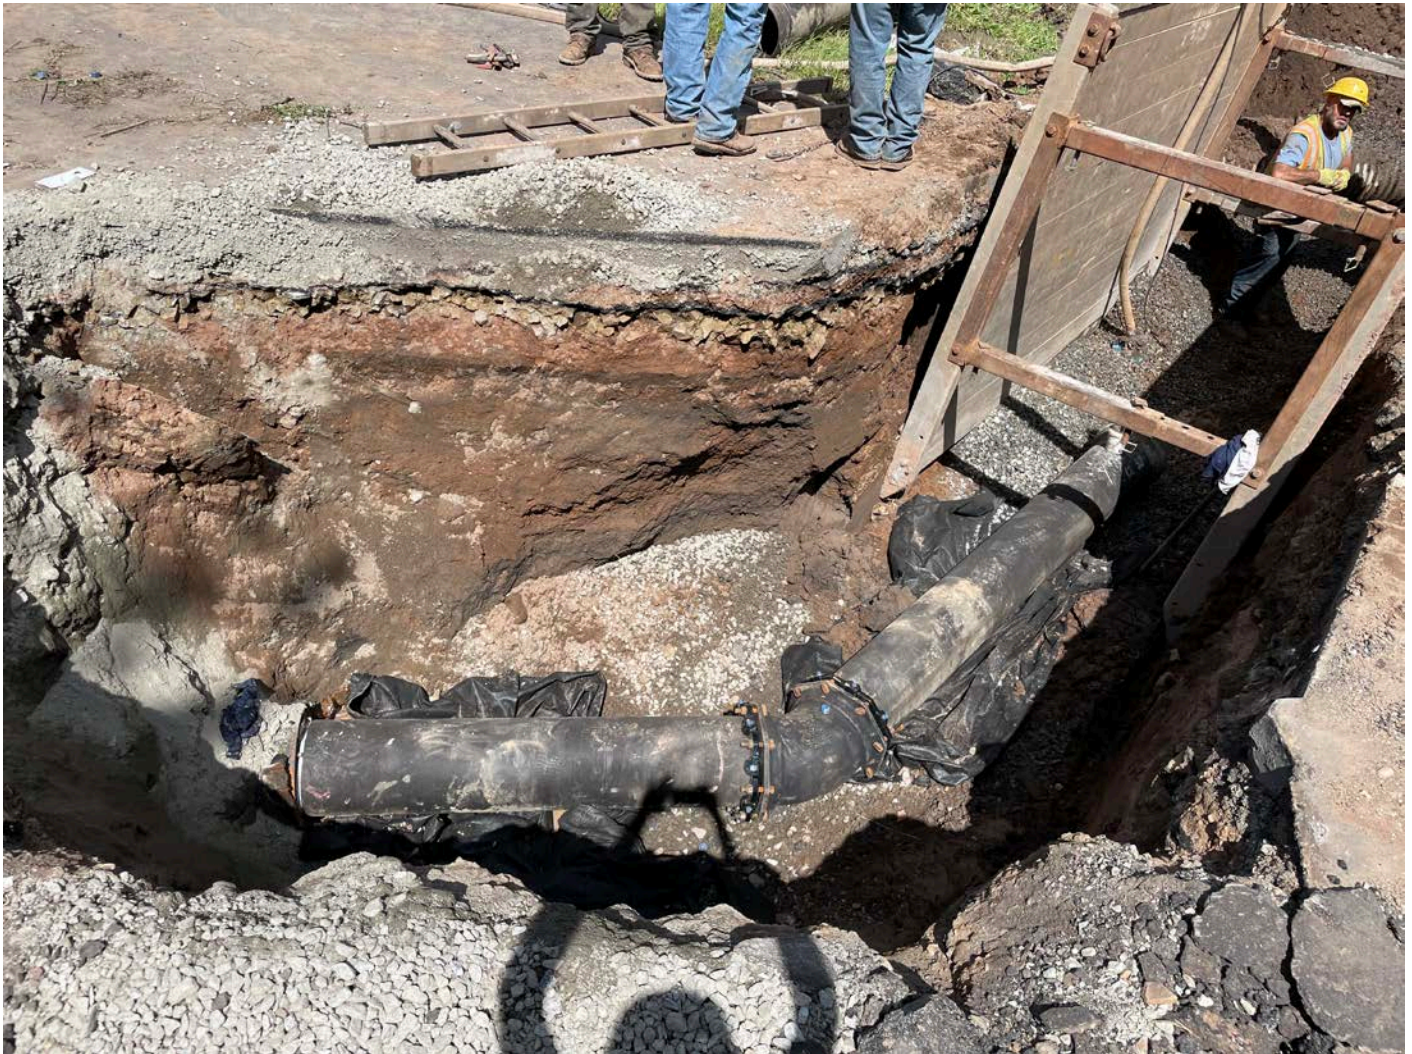
Picture 10: 12" DIP that Ludlow has placed between Stations 410+47 and ~411+30 west of Ball Brook as part of the Maiden Lane stream crossing. View to the north.

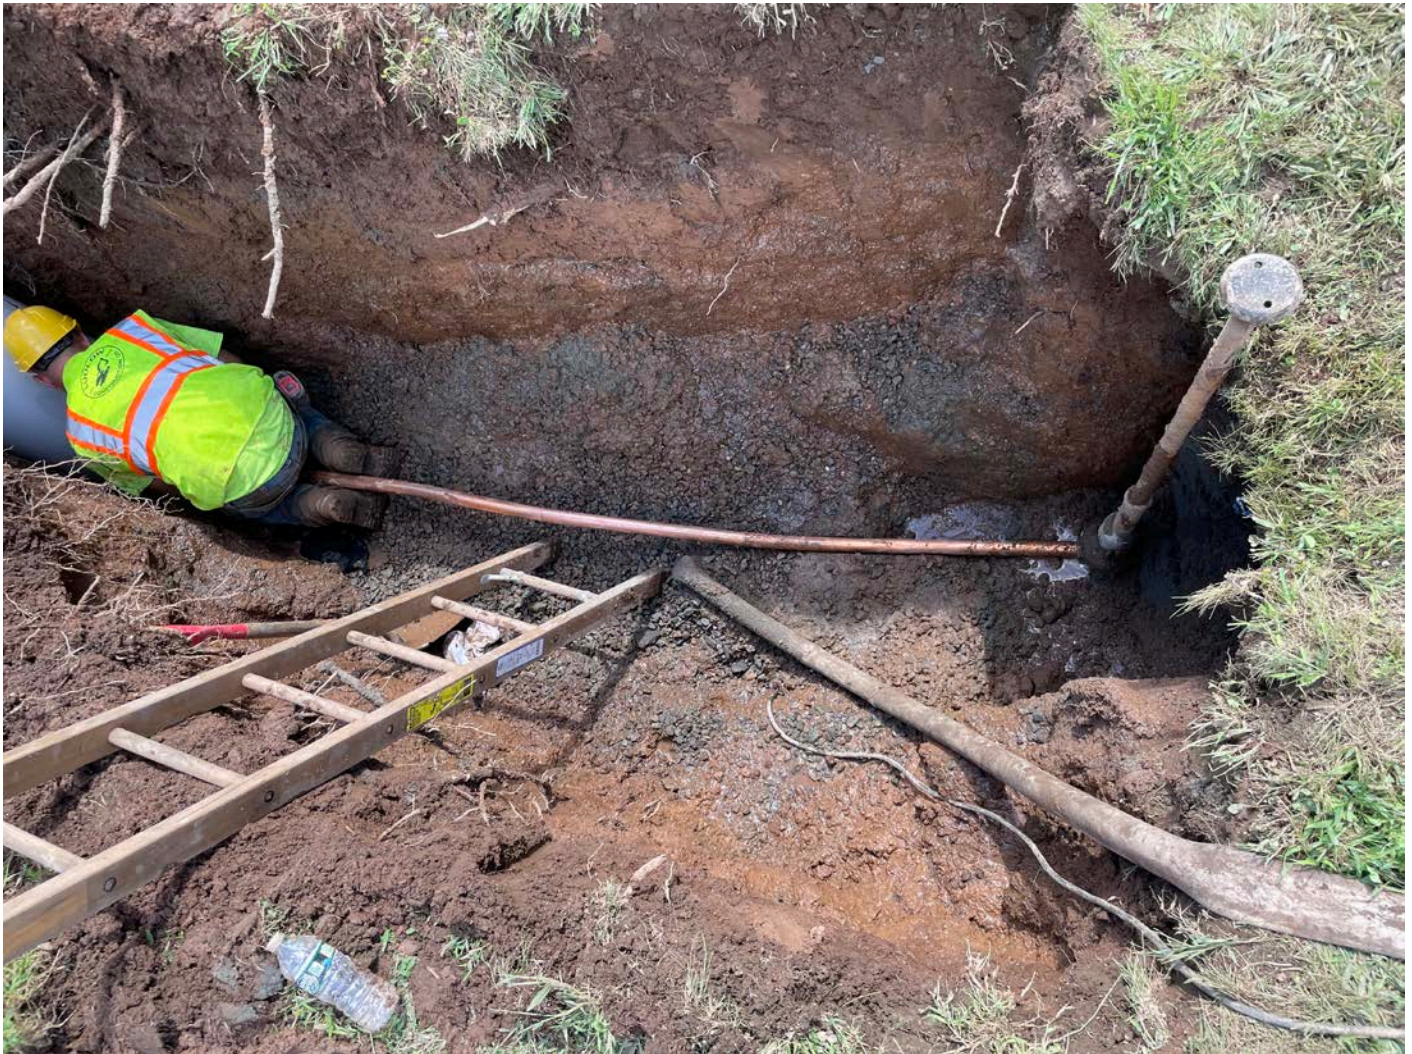
Picture 11: Ludlow placing 1.5" copper water service line between the curb stop and the meter pit for 129 Maple Avenue. View to the south.

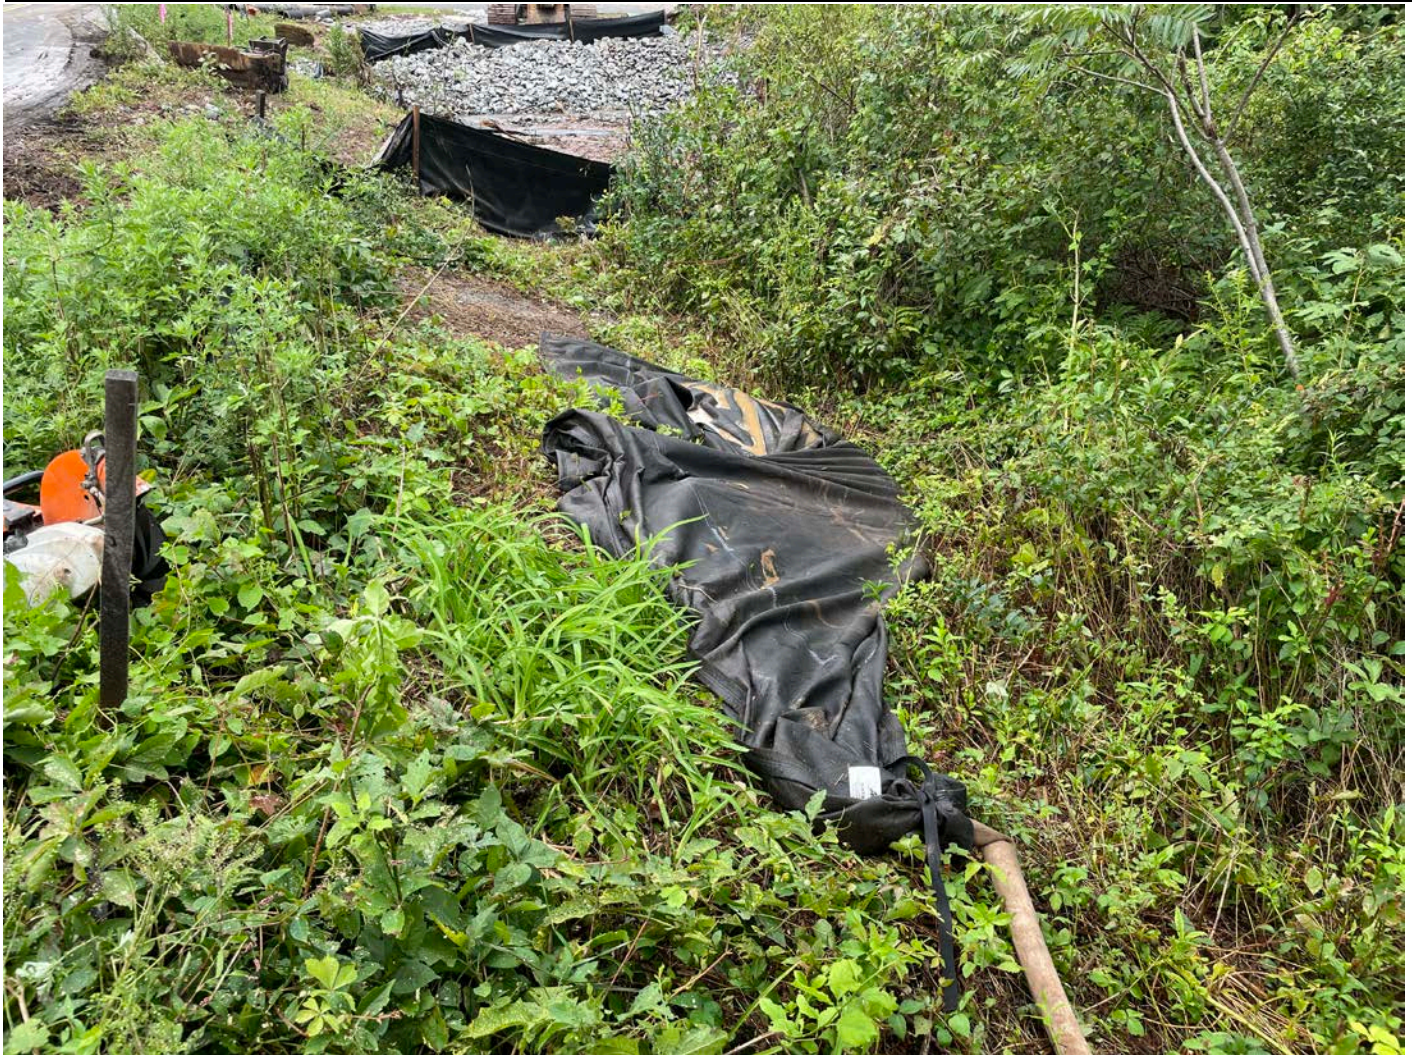
Picture 12: Silt bag Ludlow used to discharge water pumped from the excavation located at Station 412+20 Maiden Lane. View to the northwest.

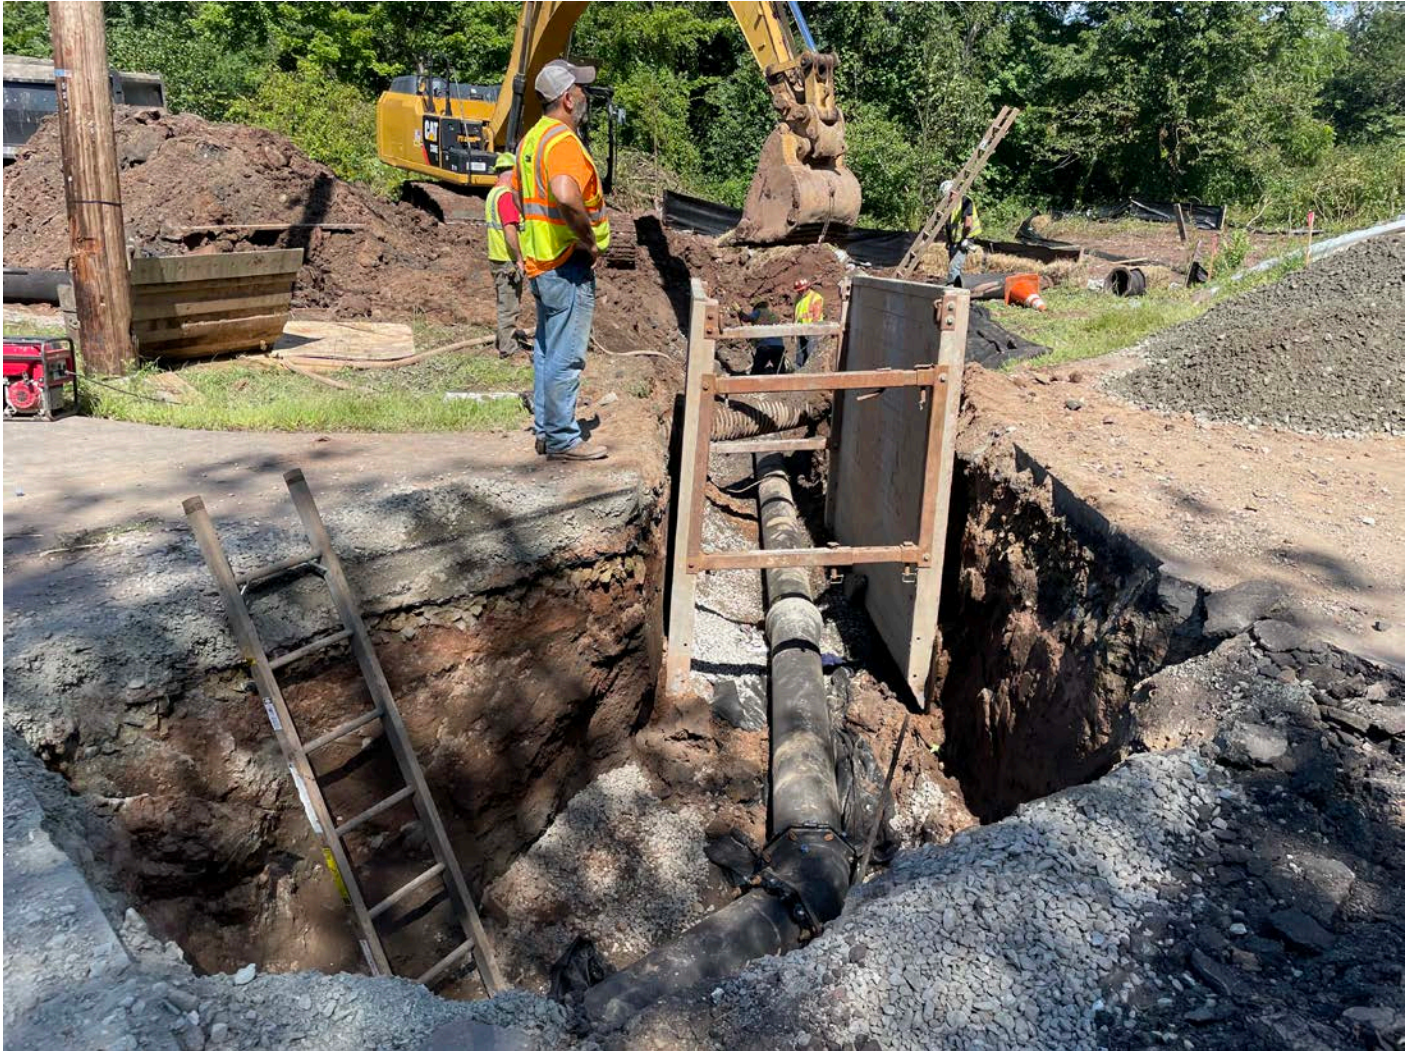
Picture 13: 12" DIP that Ludlow has placed from Stations 410+47 and 411+30 as part of the Maiden Lane stream crossing. View to the northeast.

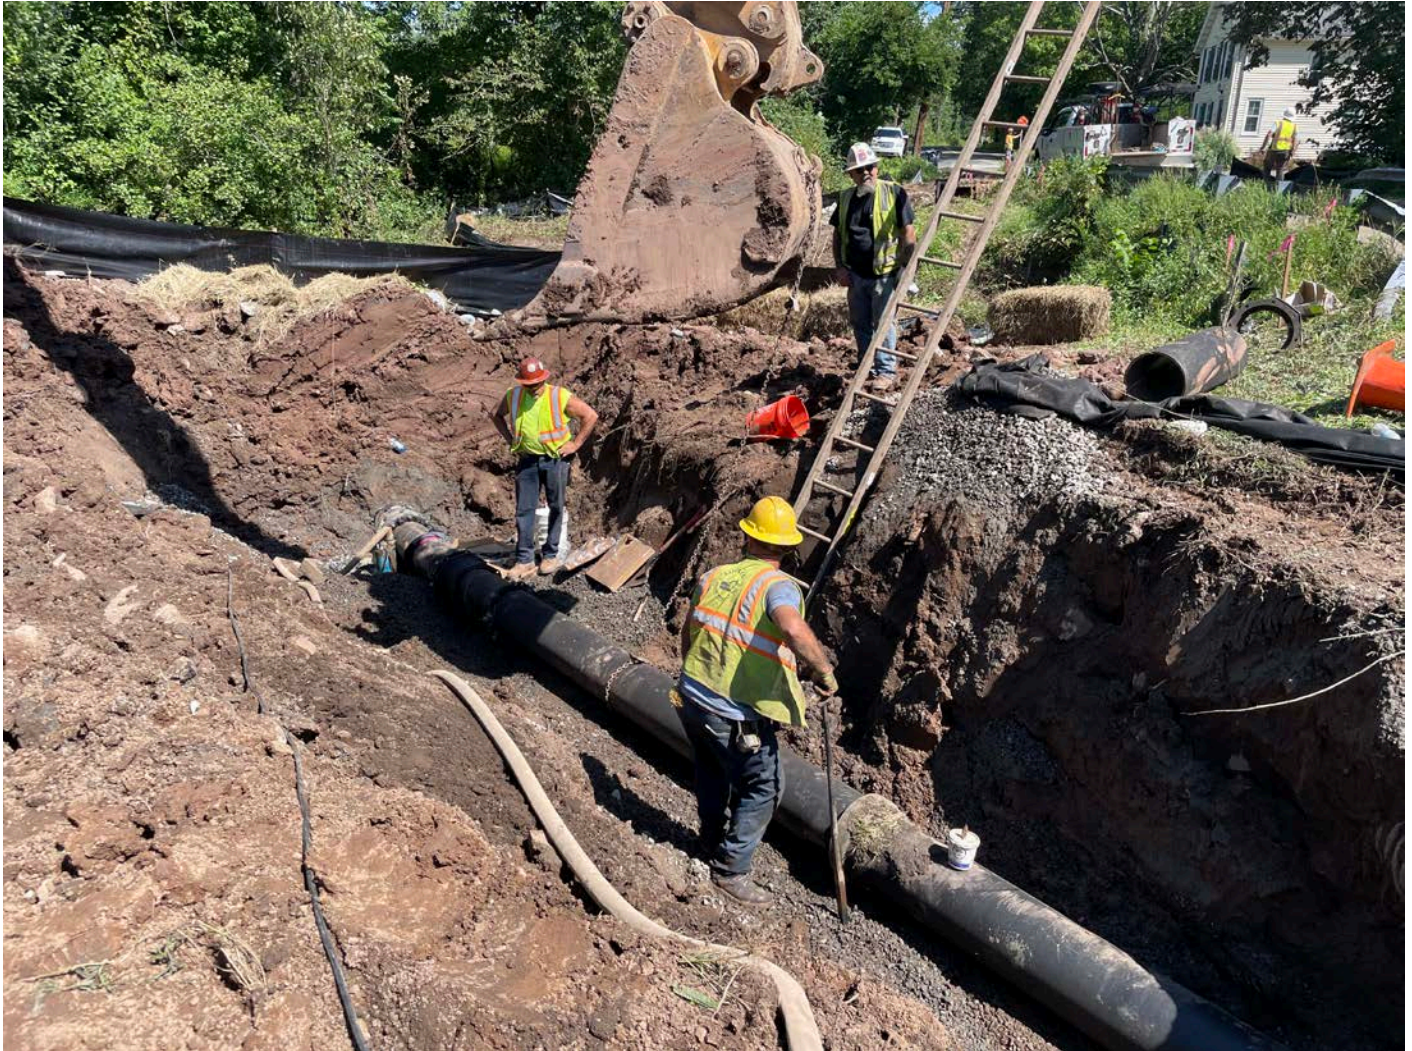
Picture 14: Ludlow placing the final section of 12" DIP on the west side of the Ball Brook stream crossing to complete the connection to 12" DIP that Ludlow installed in Maiden Lane last year. View to the east.

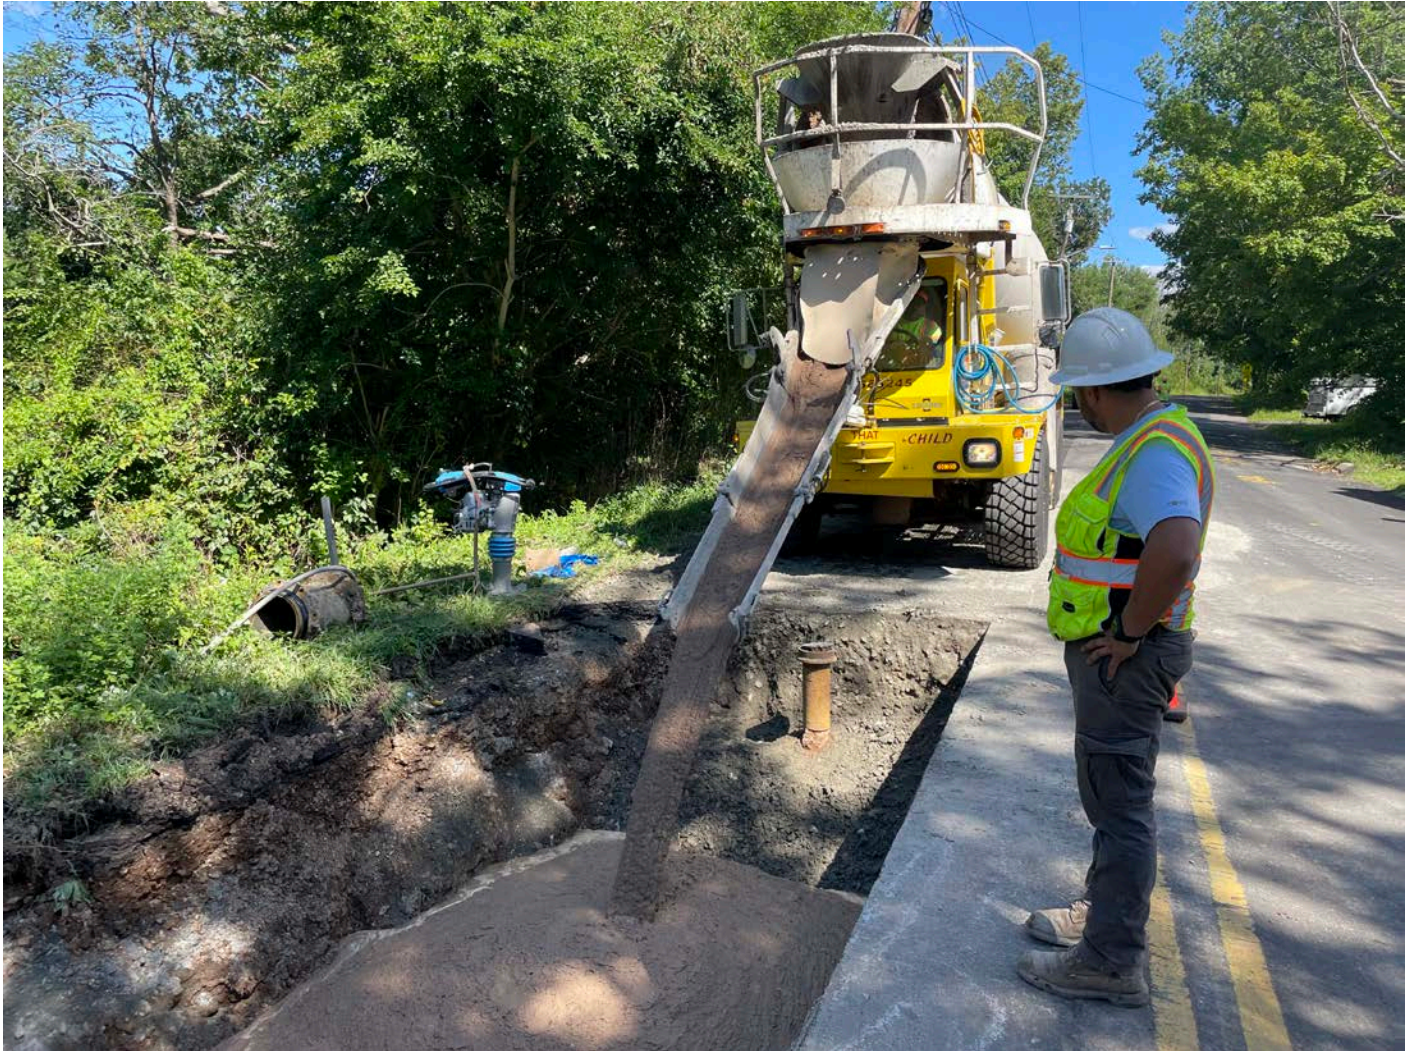
Picture 15: Ludlow overseeing a Tilcon truck placing flowable fill into the excavation at Station 412+20 Maiden Lane. View to the east.
