Daily Report

Project:	Durham Meadows Pipeline Installation	Date:	September 03, 2021
Location:	Maple Avenue and Maiden Lane, Durham	Day of Week:	Friday
Project #:	AECOM: 6061487	Report No:	316
Contractor:	Ludlow Construction	Page:	1 of 15

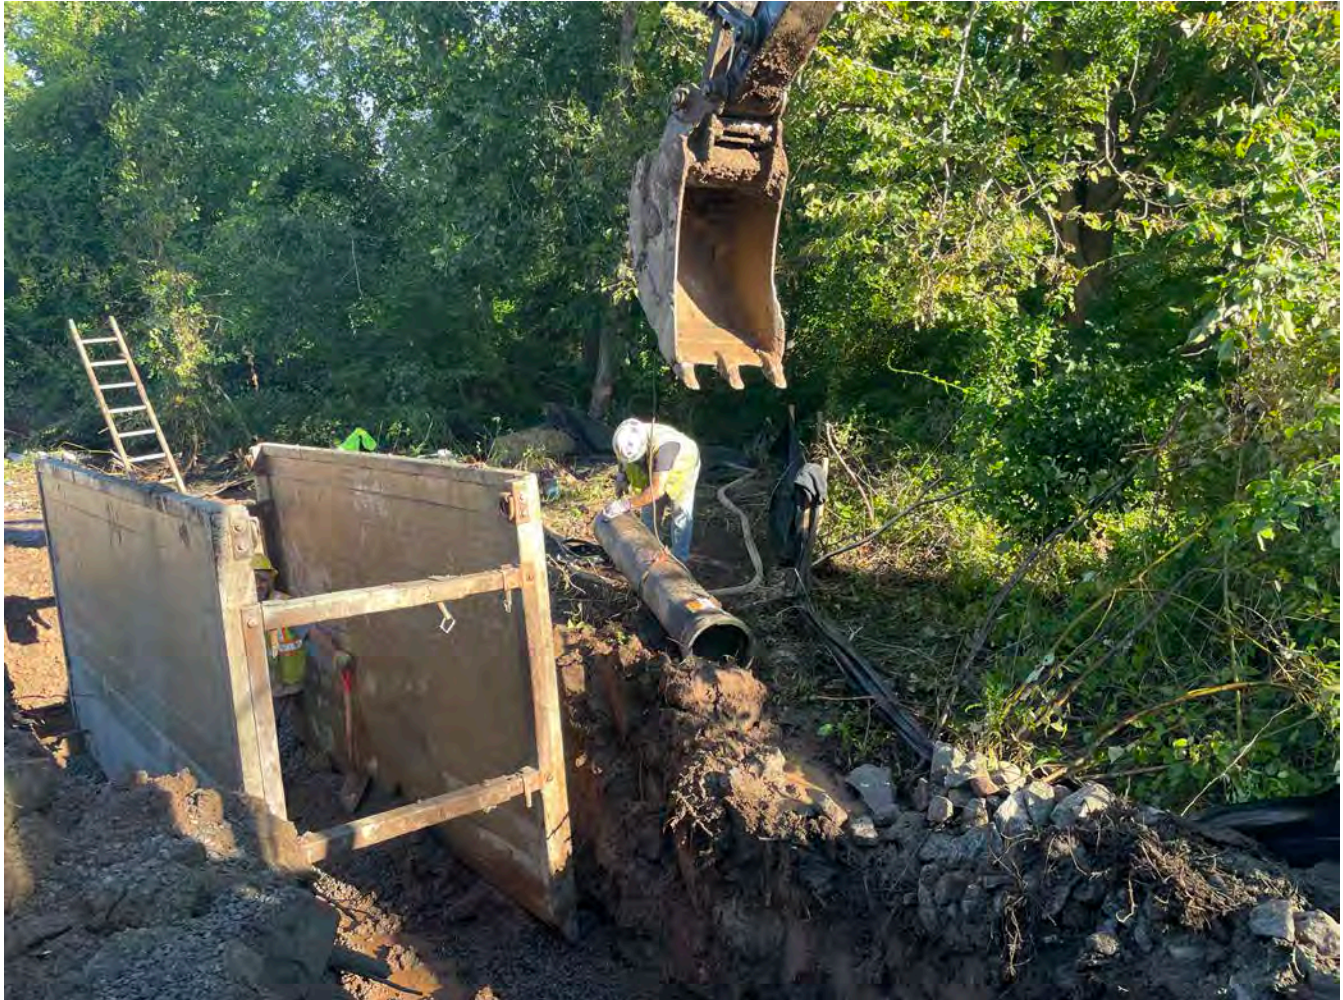
0918: Ludlow continues install 12" DIP to the east of the Maiden Lane stream crossing, working towards Station 412+20. Ludlow has a pump operating in the trench and directing evacuated water into a silt bag.

Picture 1: Ludlow installing 12" DIP to the northwest of Station 412+20. View to the north.

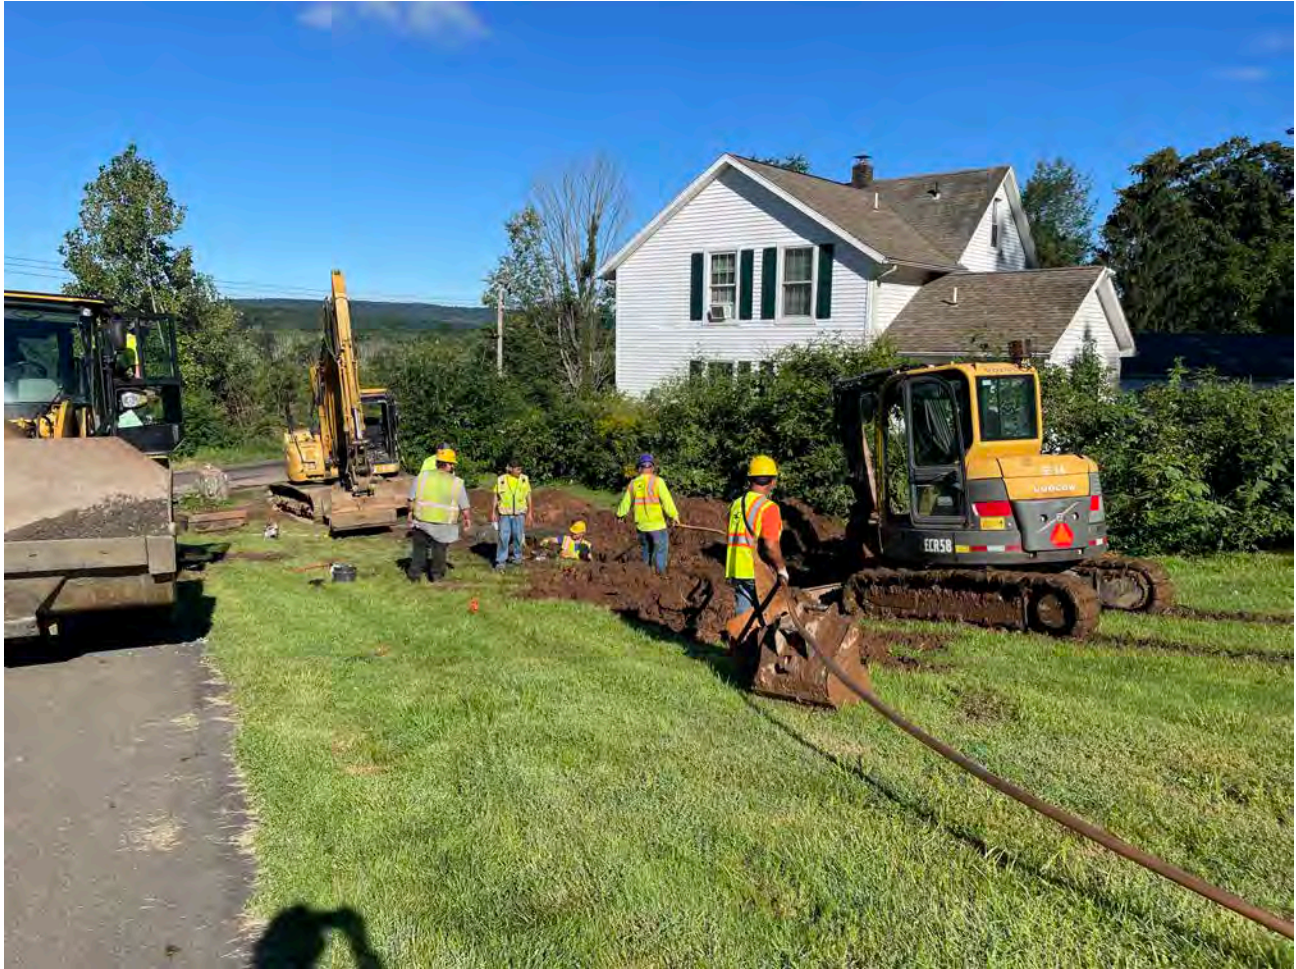
0858: Ludlow continues to excavate at the 129 Maple Avenue property for the installation of a 1.5" copper water service line. Ludlow has been encountering saturated soils while excavating the lower section of the yard. Some water is observed to have pooled up at the bottom of the excavation. The water appears to be seeping out of the sidewalls of the excavation; likely due to the recent storm event two nights ago.

Picture 2: Ludlow installing 1.5" copper water service pipe at the 129 Maple Avenue property. View to the north.

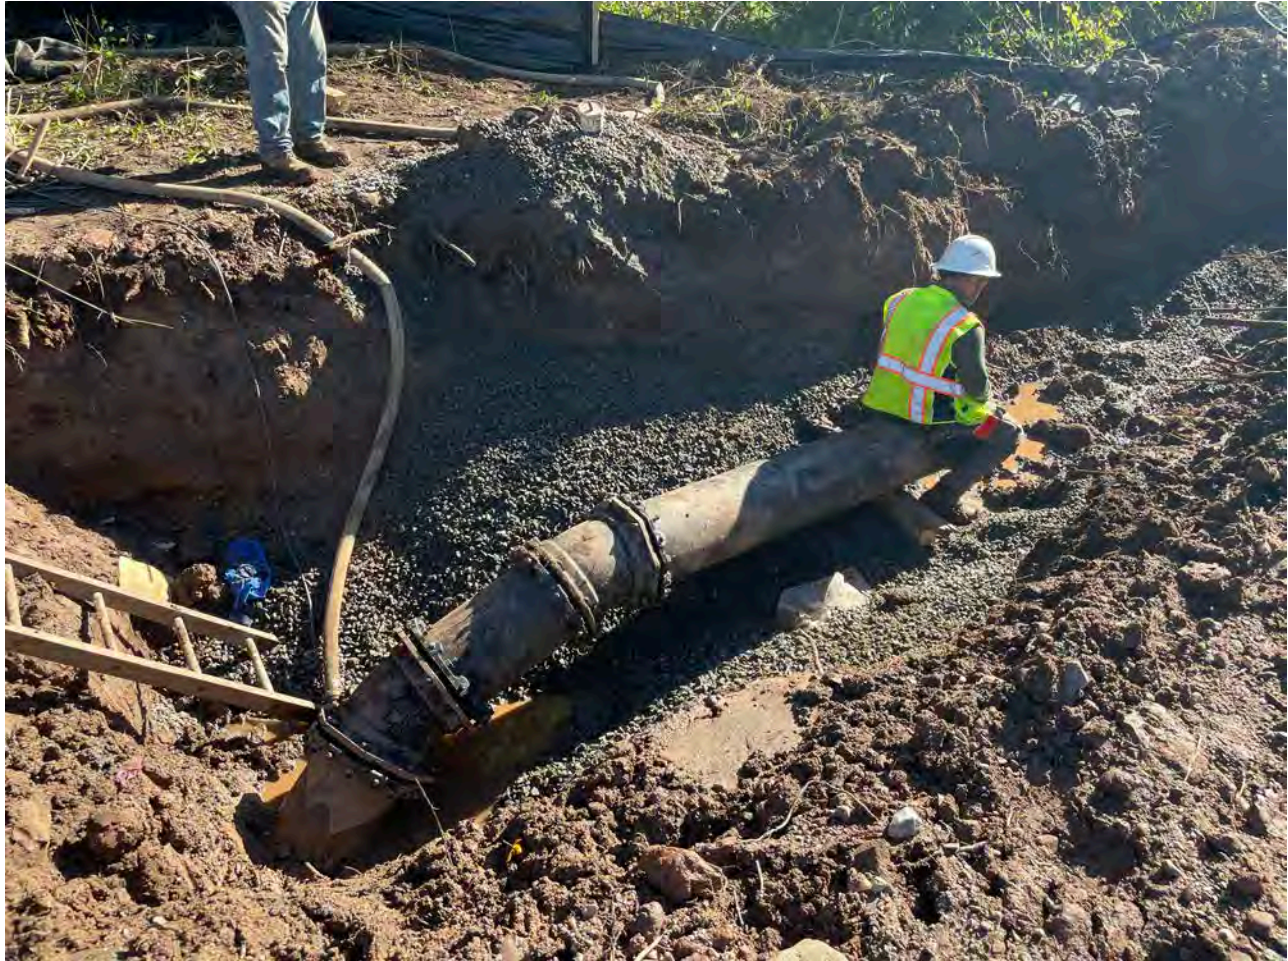
1003: Ludlow has completed the installation of 12" DIP from Station 412+20, heading northwest and connecting to the 12" DIP installed as part of the Maiden Lane stream crossing. Ludlow is currently removing the trench box from the work area.

Picture 3: Section of 12" DIP that Ludlow connected to the 12" DIP coming off the east side of the Maiden Lane Stream crossing. View to the southeast.

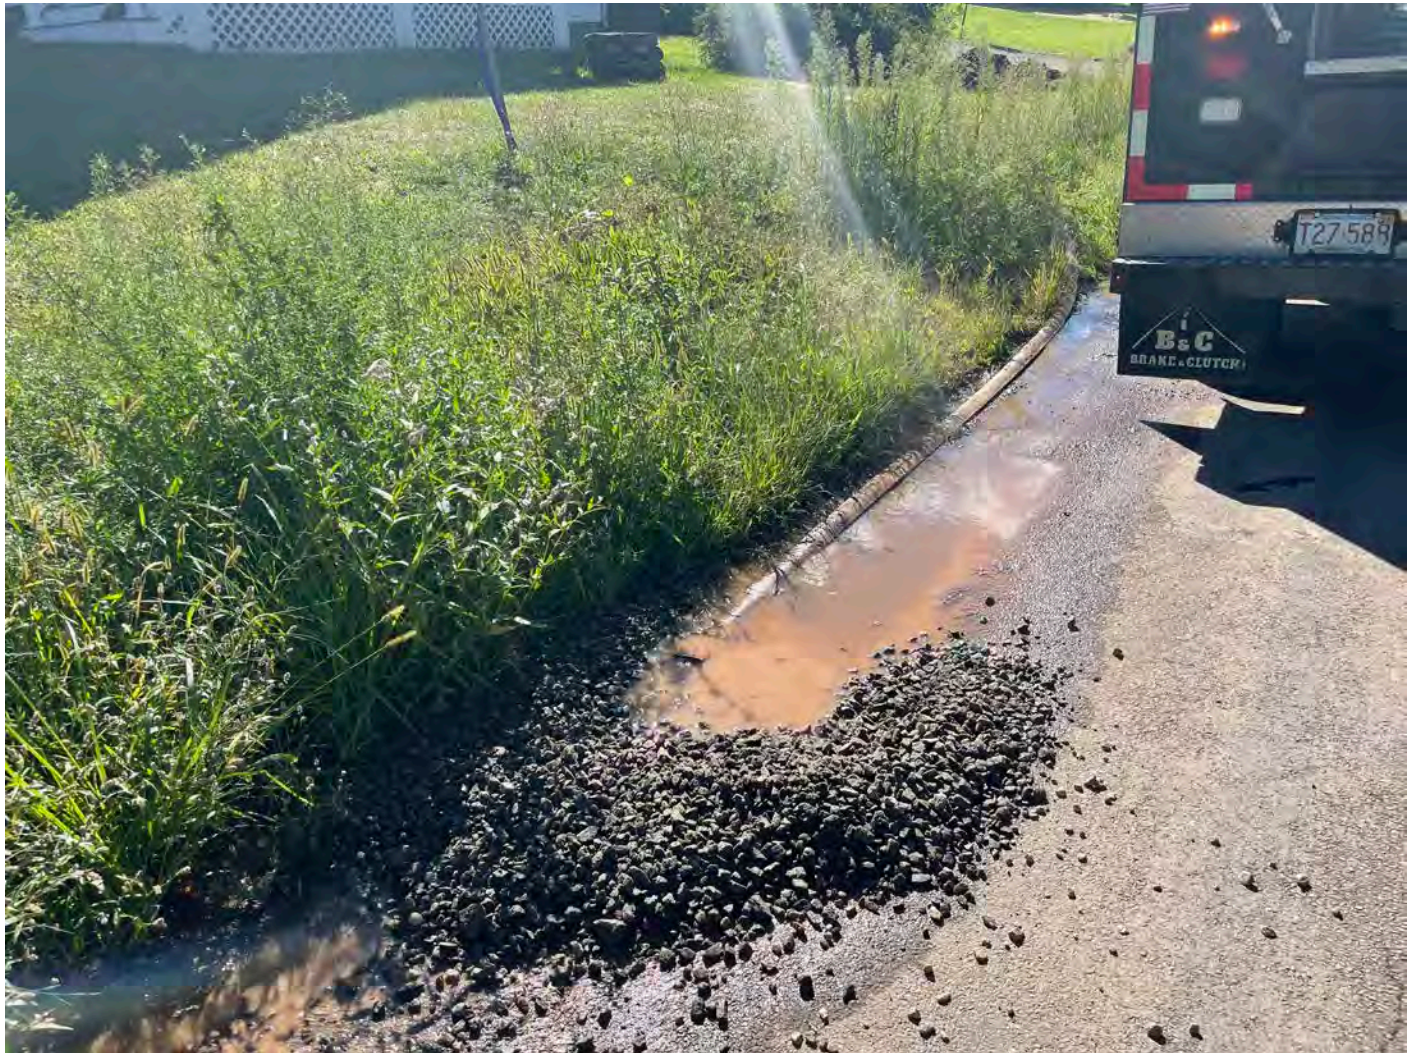
0945: Ludlow continues to place 1.5" copper water service pipe at the 129 Maple Avenue residence. Ludlow is dewatering the trench and pumping the water to the east side of Maple Avenue, where it is running down the east side of the road to a catch basin near the corner of Maple Avenue and Route 68, approximately 50' south of that intersection. No silt bag was observed catch basin.

0949: AECOM informs the USACE field representative about the trench water at 129 Maple Avenue being discharged to a storm drain without a silt bag.

Picture 4: Water being discharged to the east side of Maple Avenue that is being pumped from the excavation at the 129 Maple Avenue, Durham, property. The water was later redirected into a silt bag. View to the southeast.

1124: Ludlow has placed a silt bag on the east side of Maple Avenue in front of 133 Maple Avenue to treat the water being pumped from the trench at the 129 Maple Avenue residence.

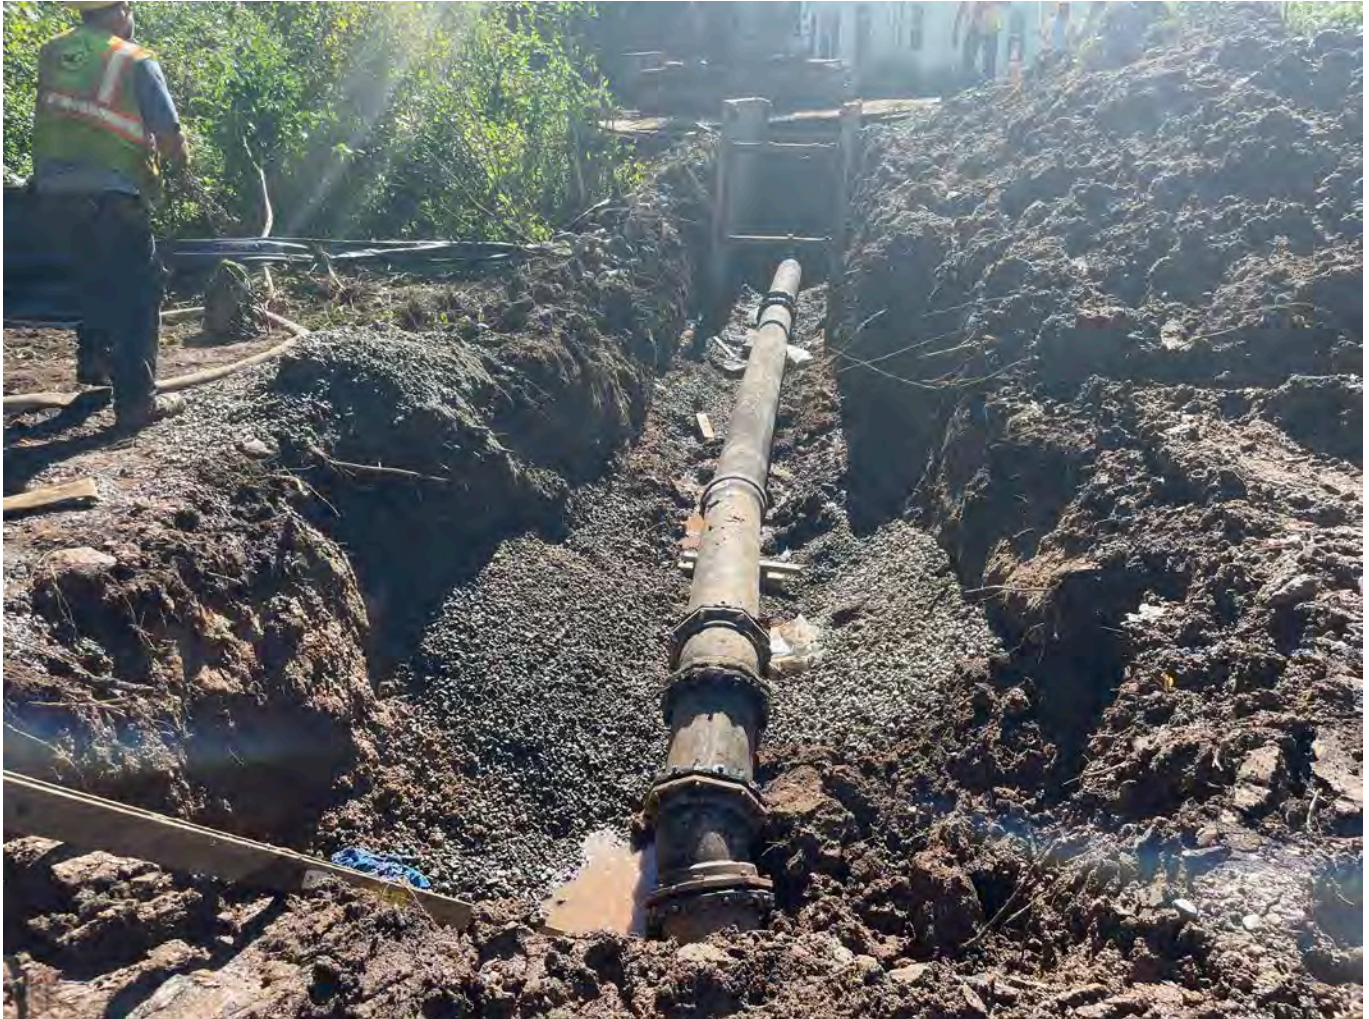
Picture 5: 12" DIP connecting the 12" DIP coming off Station 412+20 to the 12" DIP coming off the east side of the Maiden Lane stream crossing. View to the southeast.

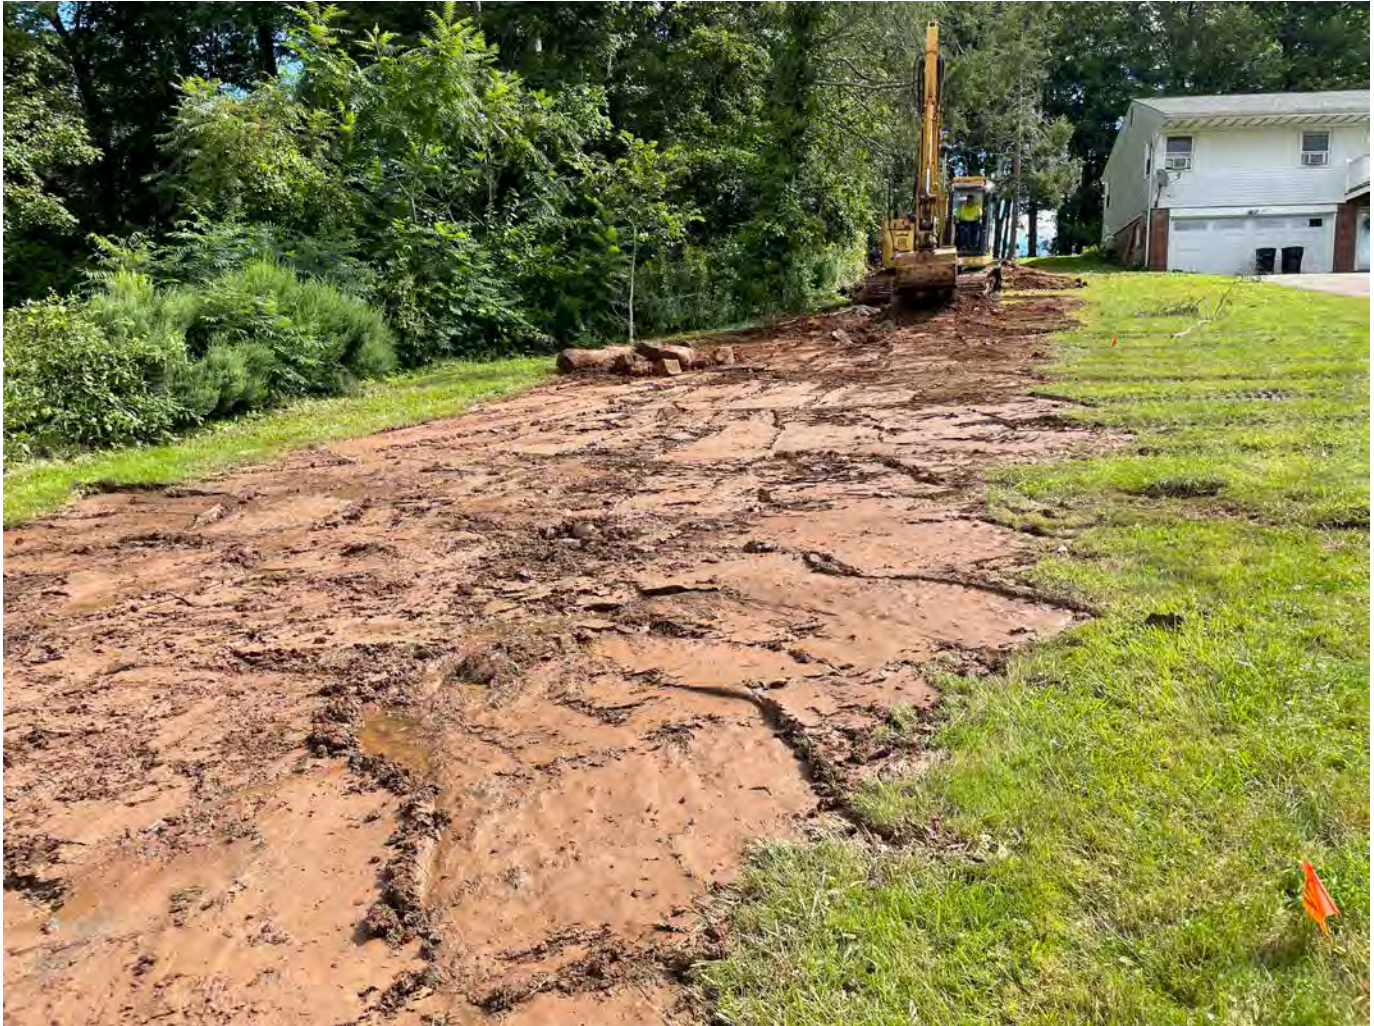
Picture 6: Portion of the lawn at 129 Maple Avenue that was disturbed during the installation of 1.5" copper water service line. View to the east.

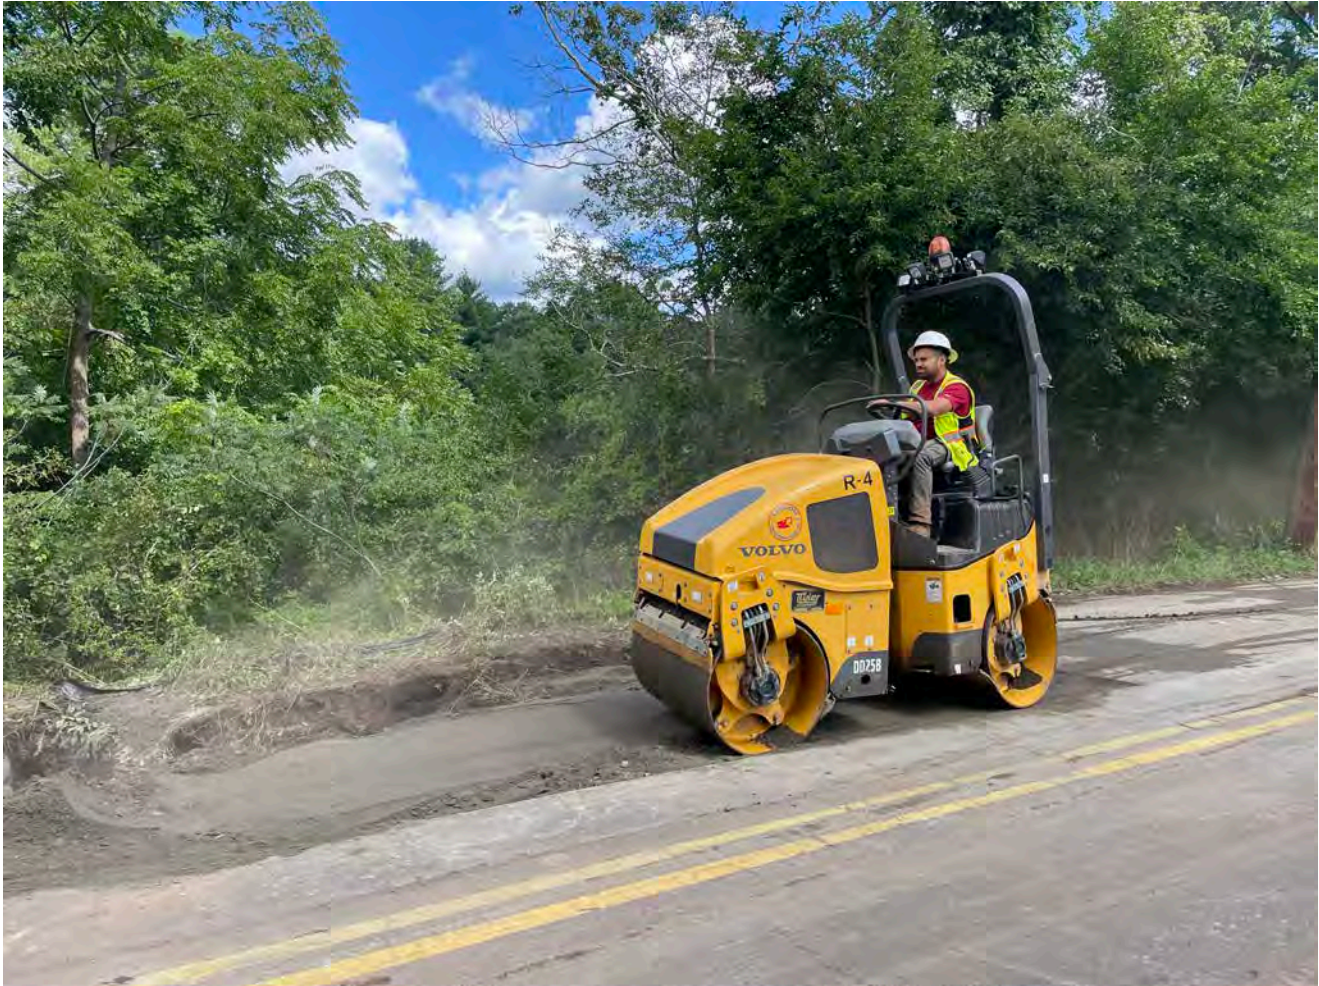
1211: Ludlow is using a rolling compactor on the backfill that was placed in the trench at Station 412+20. Ludlow has restored the work area east bank of Ball Brook at the Maiden Lane stream crossing.

Picture 7: Ludlow using a rolling compactor on the backfilled excavation at Station 412+20. View to the northeast.

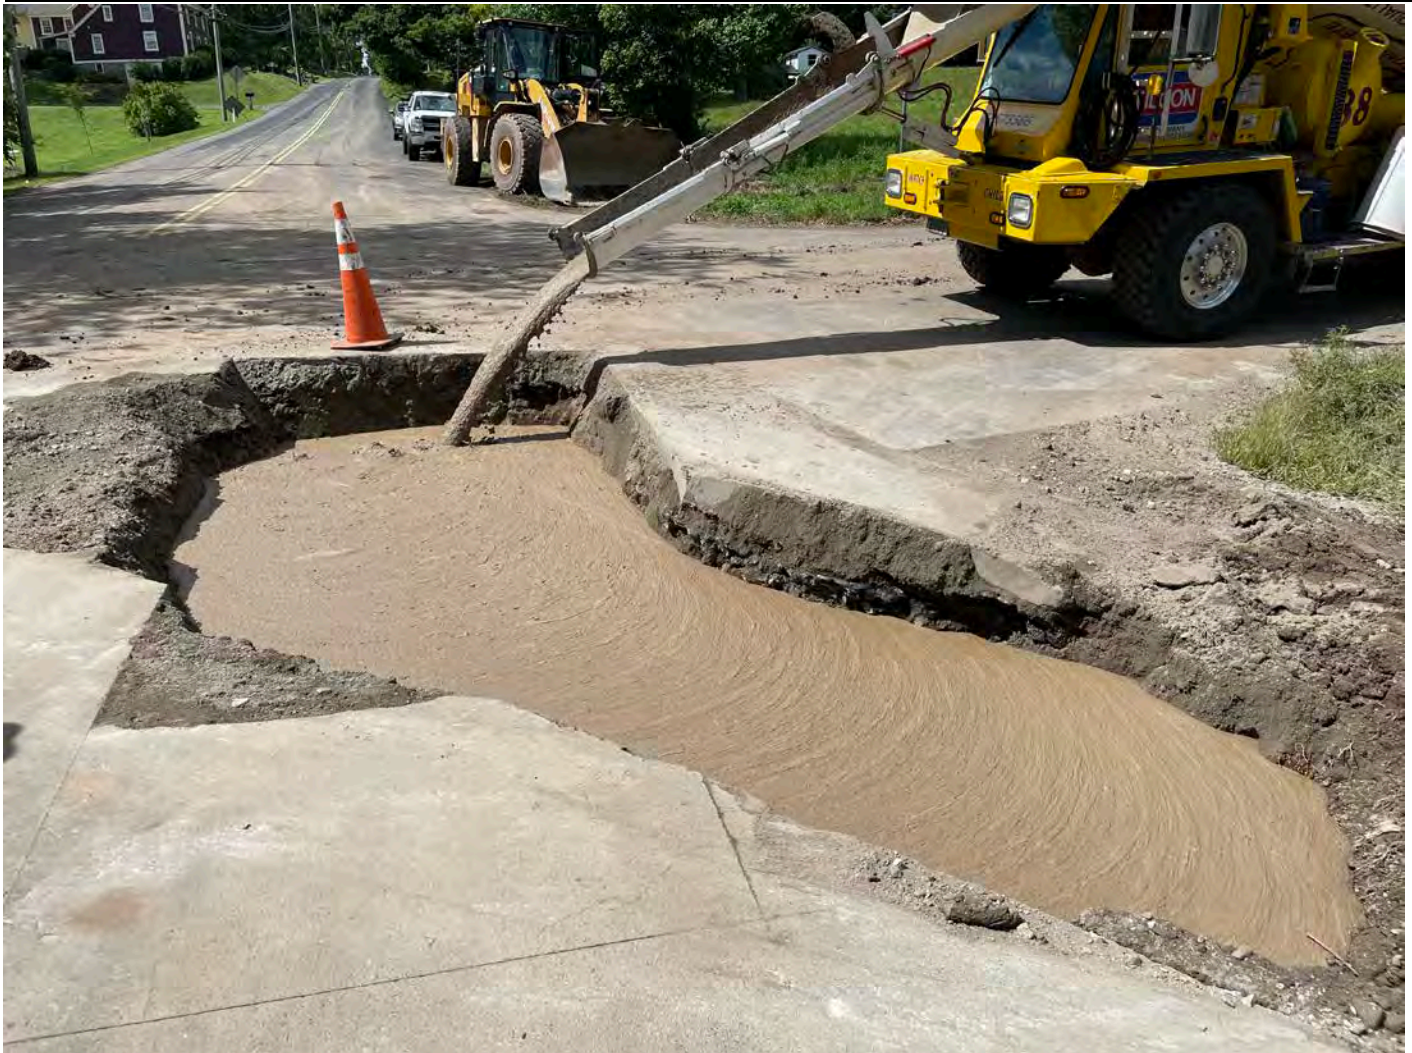
1231: Tilcon begins to place flowable fill at the excavation located at Station 410+47, under the direction of Ludlow.

Picture 8: Tilcon placing flowable fill into the excavation at Station 410+47 under the direction of Ludlow. View to the west.

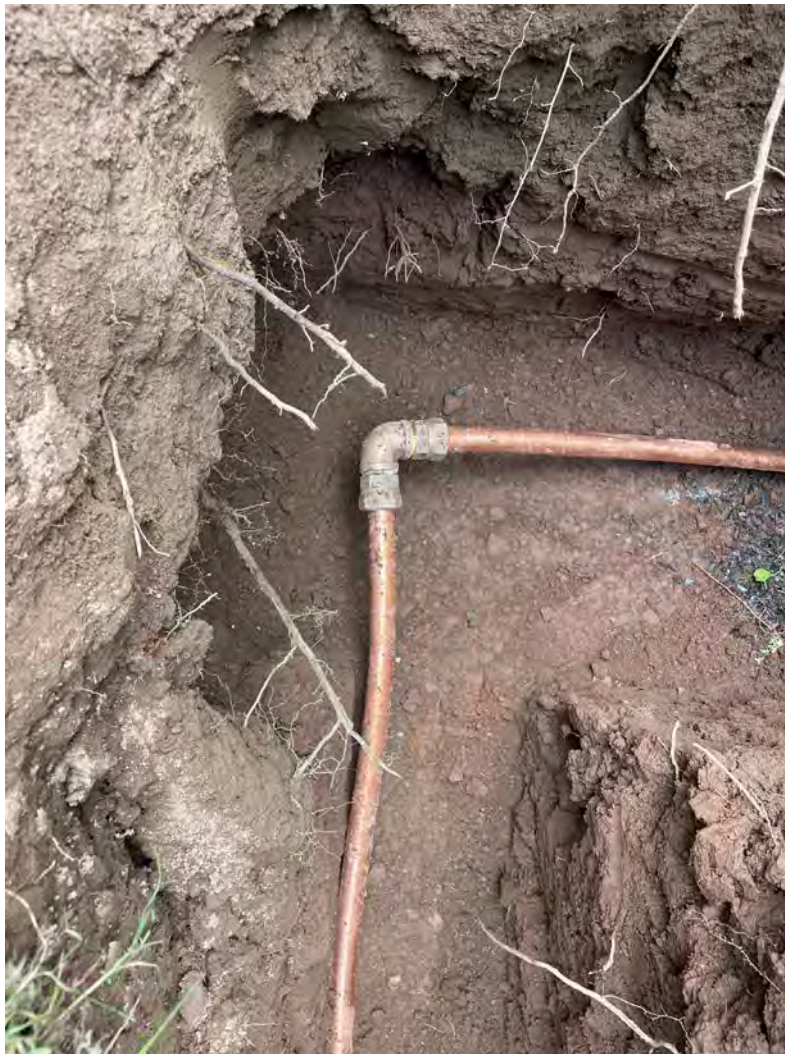
Picture 9: Union between two sections of 1.5" copper water service line that Ludlow installed at the 129 Maple Avenue residence.

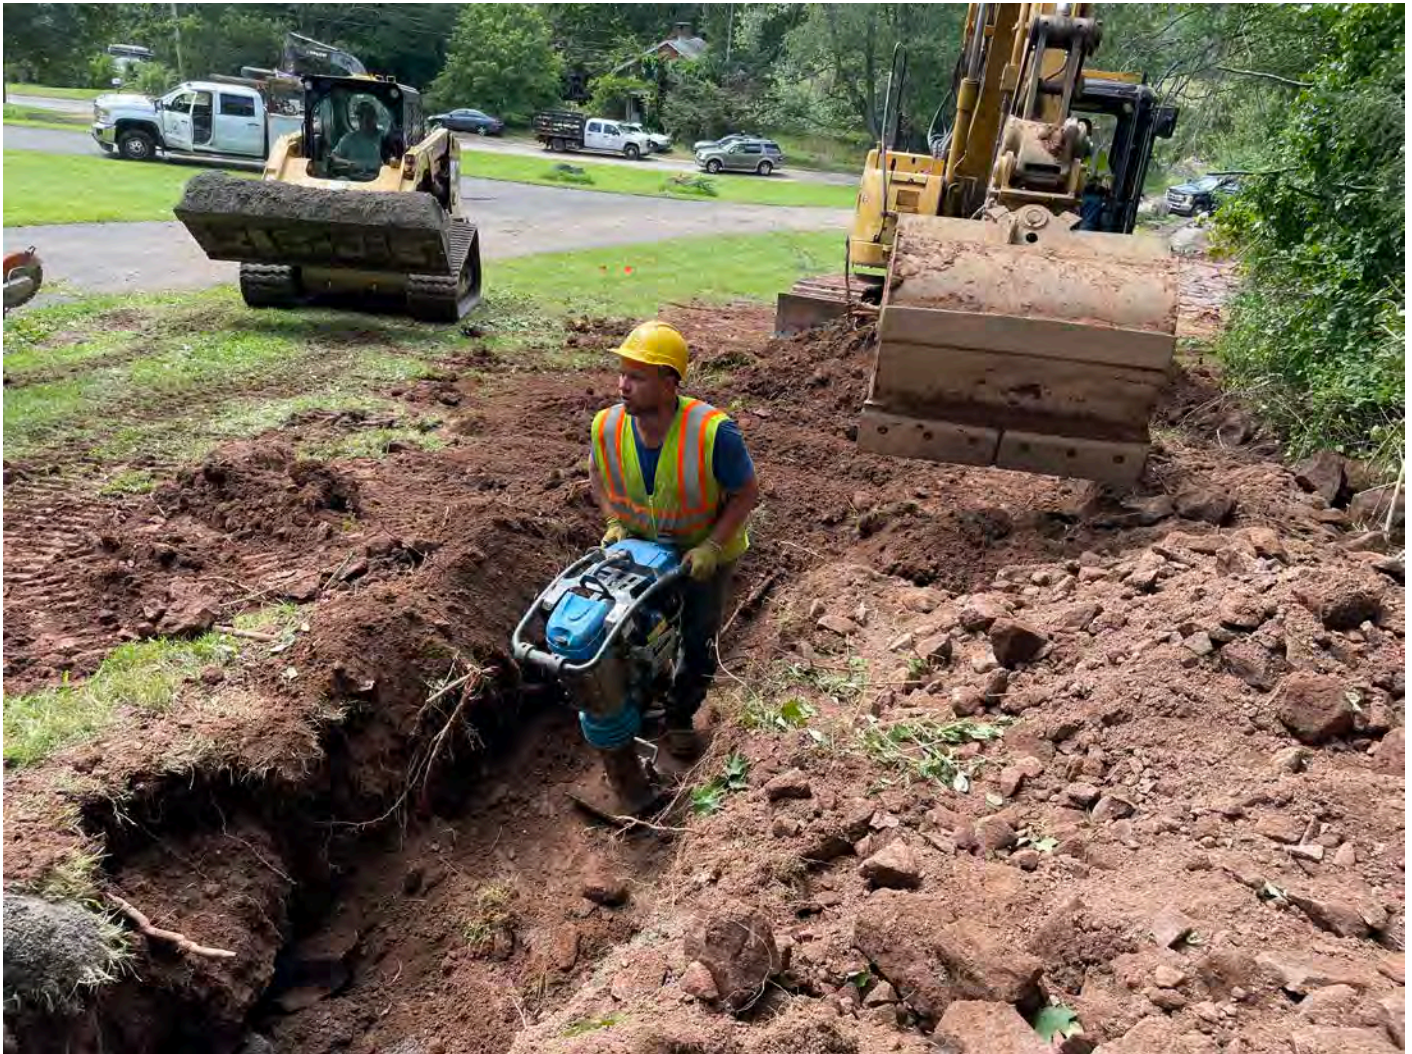
1406: Ludlow is backfilling over the 1.5" copper water service line that they installed at the 129 Maple Avenue property. They are placing 6" of sand over the copper line, followed by caution tape, followed by native fill that is being placed in 1' lifts that Ludlow is compacting with a jumping jack.

Picture 10: Ludlow compacting native fill that has been placed over the 1.5" copper water service line they installed at the 129 Maple Avenue property. View to the west.

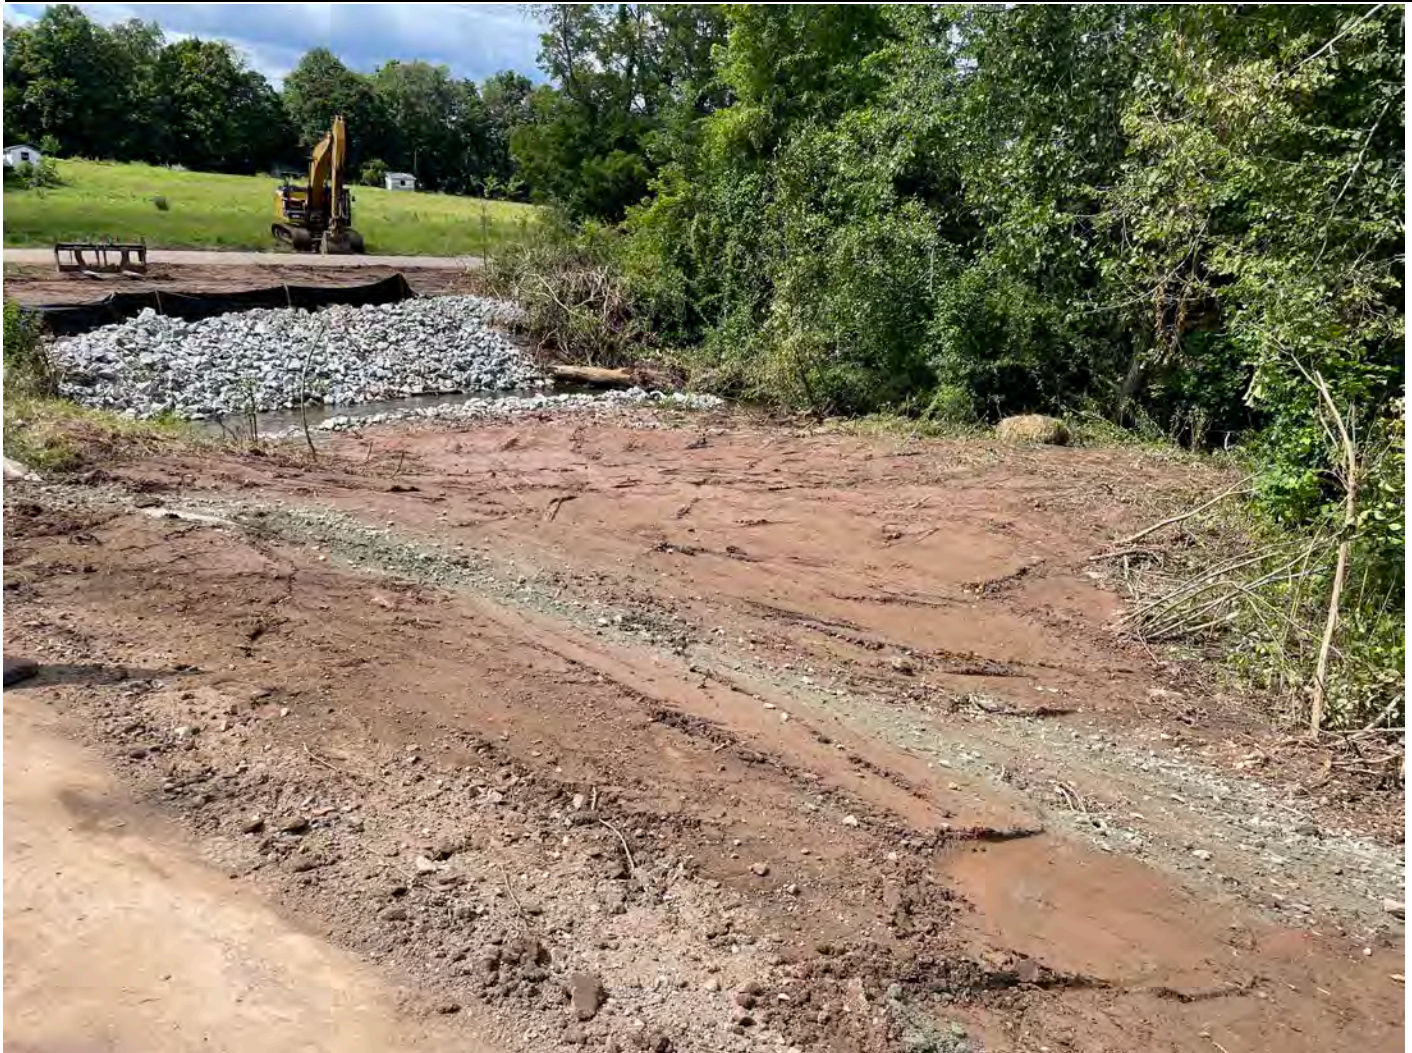
Picture 11: Maiden Lane stream crossing, looking to the northeast from Station 412+20.

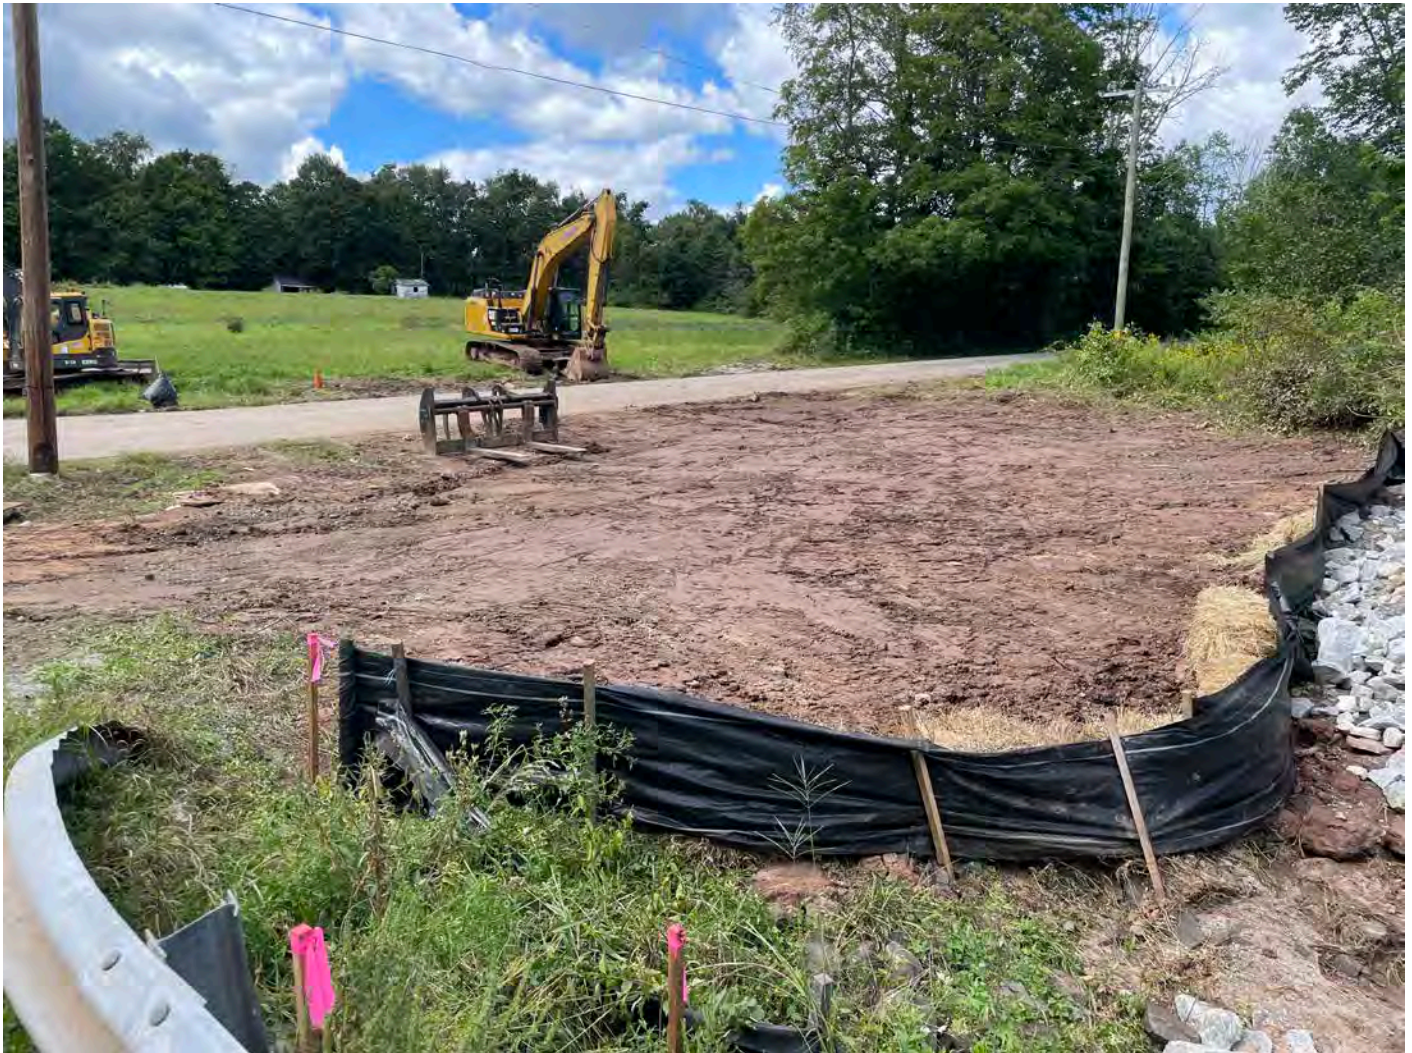
Picture 12: Area located on the west bank of Ball Brook at the Maiden Lane stream crossing. View to the northwest.
