Daily Report

Project:Durham Meadows Pipeline InstallationDate:September 07, 2021

Project #: AECOM: 6061487 **Report No:** 317

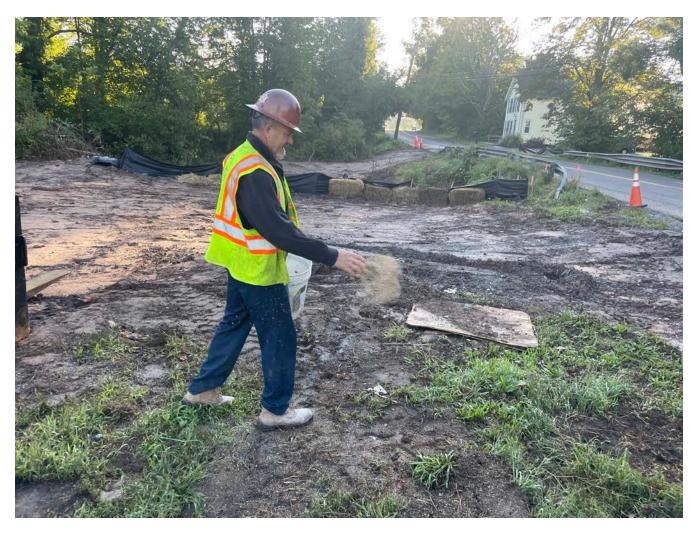
0728: Ludlow is spreading grass seed on the west side of Ball Brook at the Maiden Lane stream crossing.

Picture 1: Ludlow spreading grass seed on the west side of Ball Brook at the Maiden Lane stream crossing in Durham. View to the southeast.

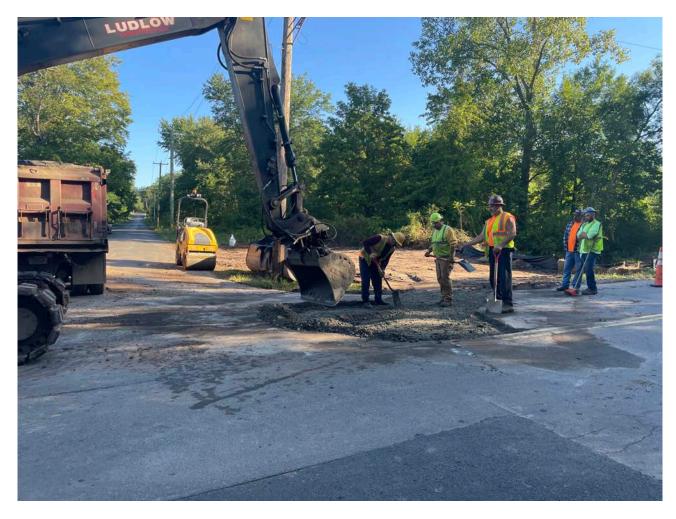
0818: Ludlow has placed 1.5"-minus gravel over the flowable fill that was placed in the excavation at Station 410+47 last week. Ludlow is preparing to place asphalt at this location and the backfilled excavation at Station 412+20 as part of the Maiden Lane stream crossing activities.

Picture 2: Ludlow placing processed stone over the backfilled excavation at Station 410+47 on Maiden Lane, Durham. View to the northeast.

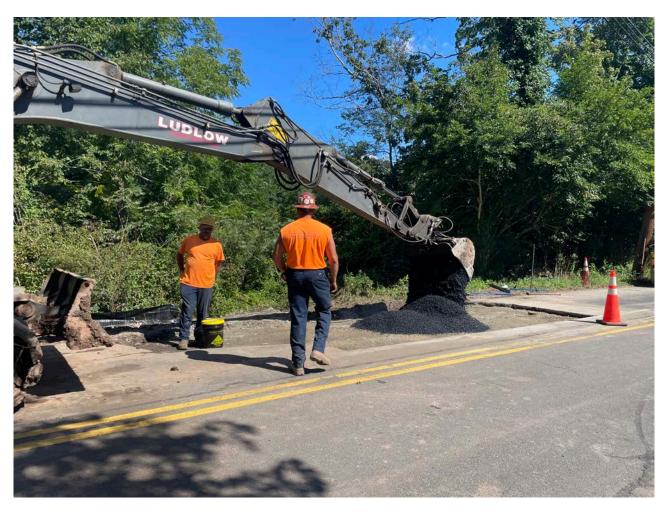
1124: Ludlow is preparing to place asphalt over the excavation at Station 412+20. Ludlow is currently placing tack coating on the cut edges of payment.

1305: Ludlow just finished applying and compacting the second of two lifts of asphalt at the excavations located at Stations 412+20 and 401+47.

Picture 3: Ludlow placing asphalt over the backfilled excavation at Station 412+20 on Maiden Lane, Durham. View to the northeast.

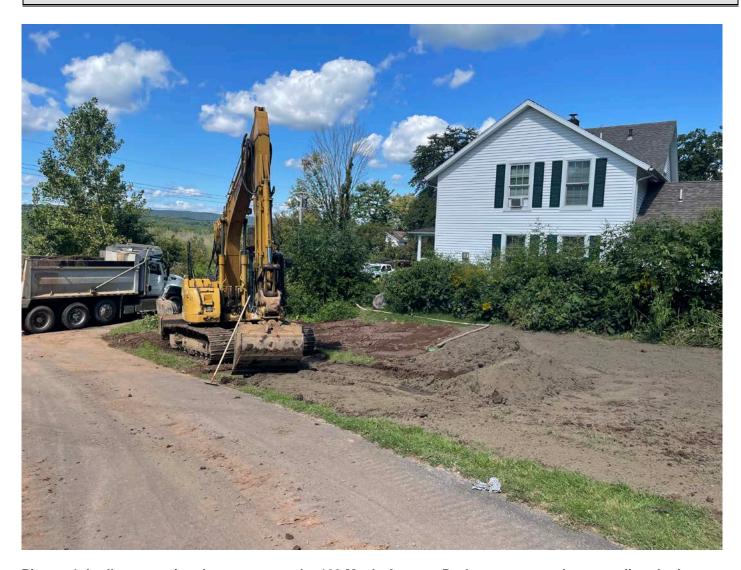
Picture 4: Ludlow restoring those areas on the 129 Maple Avenue, Durham, property that were disturbed during the installation of a 1.5" copper water service line. View to the northwest.

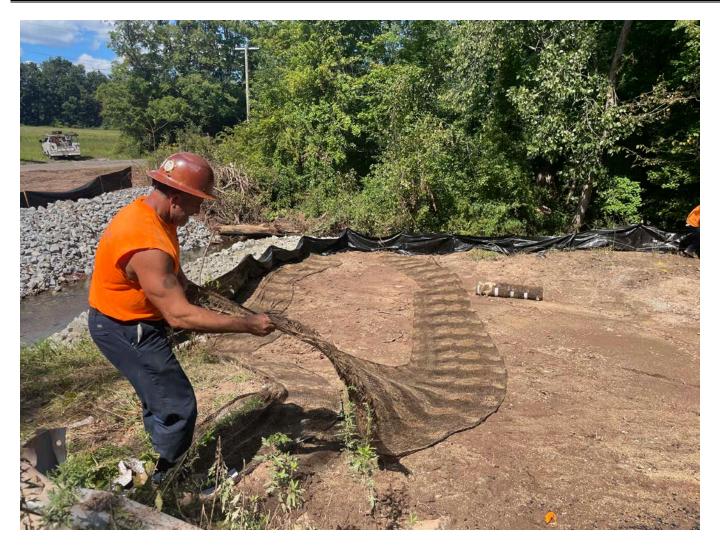
1209: Ludlow begins to place erosion control netting over the area they just restored east of Ball Brook at the Maiden Lane stream crossing.

Picture 5: Ludlow placing erosion control netting over the soils located on the east side of Ball Brook at the Maiden Lane stream crossing. View to the north.

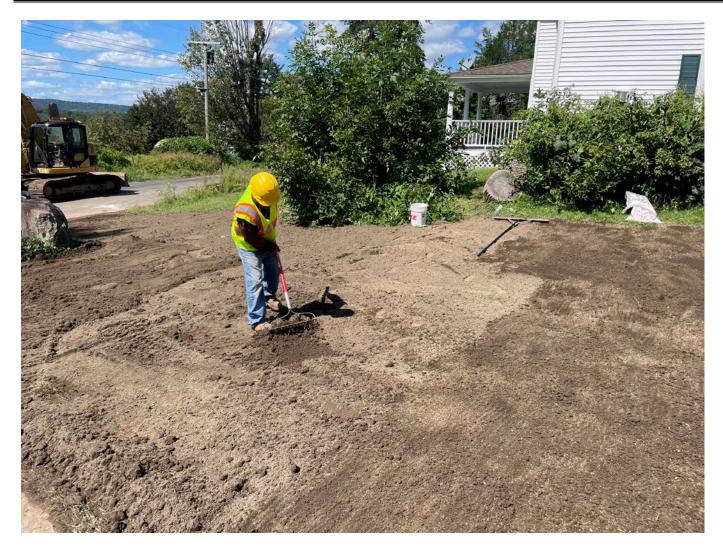
Picture 6: Ludlow raking loam on one of the areas on the 129 Maple Avenue, Durham, property that were disturbed during the installation of a 1.5" copper water service line. View to the northwest.

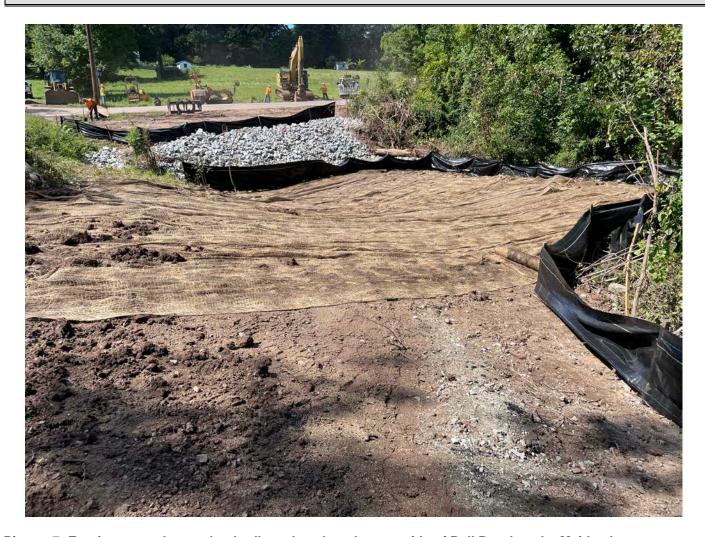
Picture 7: Erosion control mats that Ludlow placed on the east side of Ball Brook at the Maiden Lane stream crossing. View to the northwest.

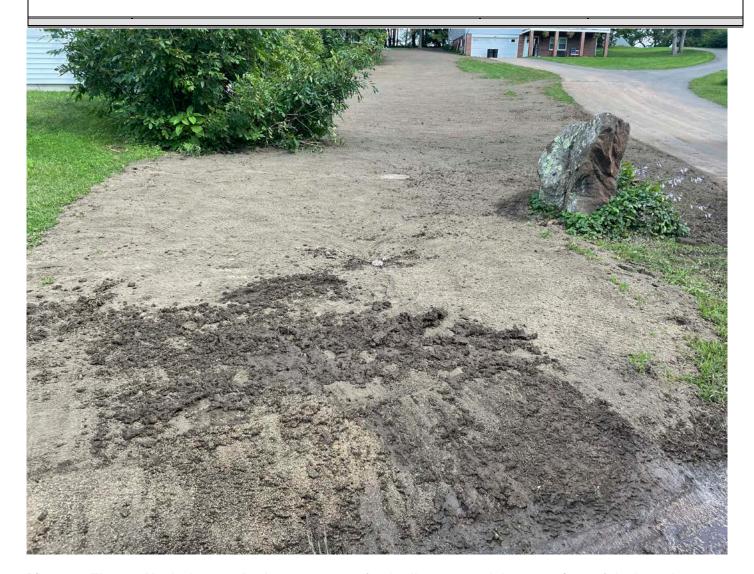
1407: Ludlow has finished lawn restoration activities at the 129 Maple Avenue, Durham, property.

Picture 8: The 129 Maple Avenue, Durham, property after Ludlow restored those sections of the lawn that were disturbed during the installation of a 1.5" copper water service line. View to the east.

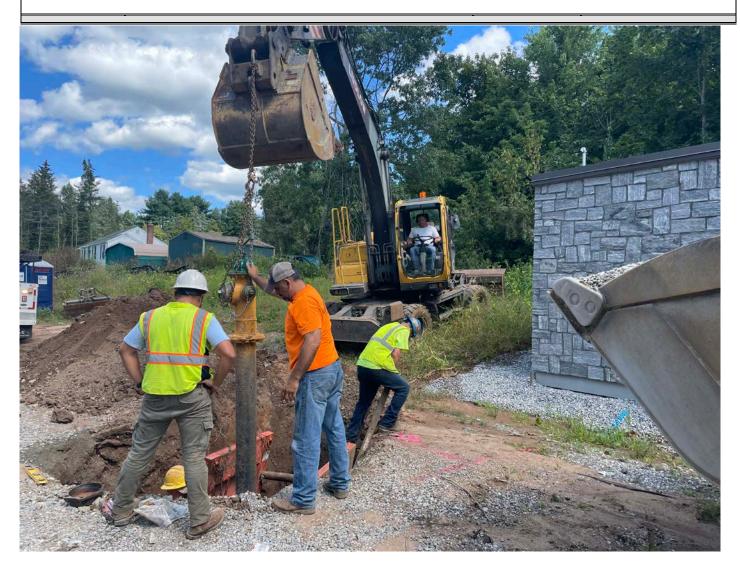
1358: Ludlow begins to install a hydrant at the water meter building located at Station ~124+80.

Picture 9: Ludlow maneuvering a hydrant into place for reinstallation at Station 124+65 on S. Main Street in Middletown. View to the northeast.

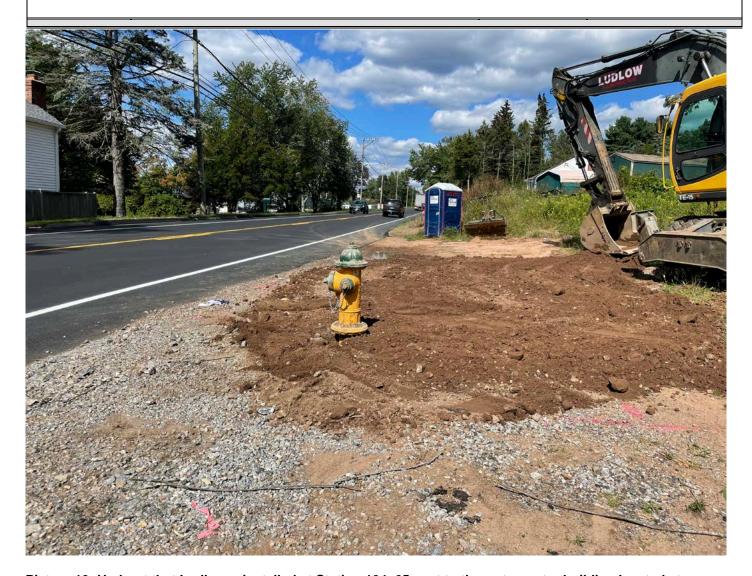
1435: Ludlow has finished the reinstallation of a fire hydrant at Station 124+65.

Picture 10: Hydrant that Ludlow reinstalled at Station 124+65 next to the water meter building located at Station ~124+80. View to the north.
