#### **Daily Report**

Project:Durham Meadows Pipeline InstallationDate:September 10, 2021Leasting Welliam for all Power Project:Day of Week:Friday

Location: Wallingford Road, Durham

Project #:
 AECOM: 6061487
 Report No:
 320

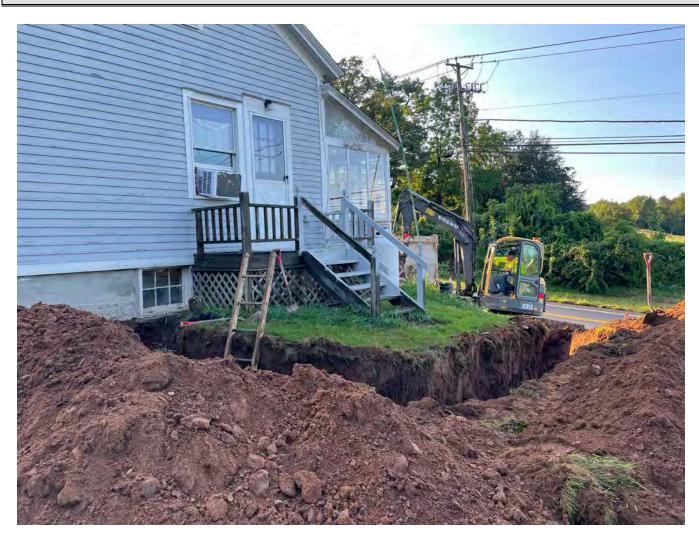
Picture 1: Ludlow excavating on the west side of the 47 Wallingford Road, Durham, residence for the installation of a 1" copper water service line. View to the south.

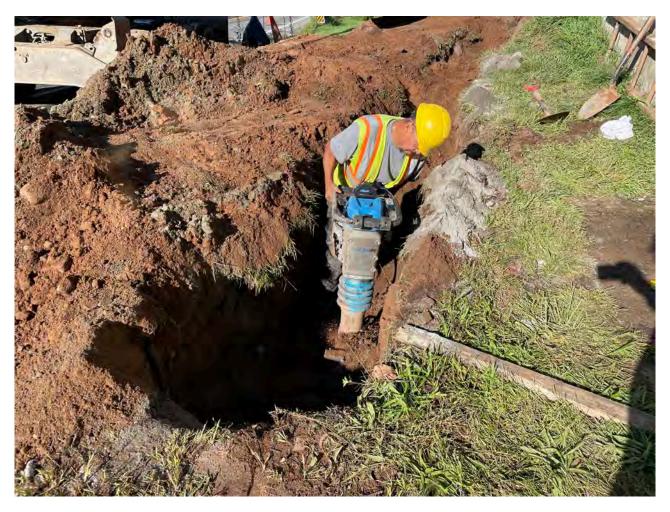
Picture 3: Ludlow compacting backfill with a jumping jack as part of the water service installation activities at the 47 Wallingford Road residence. View to the west.

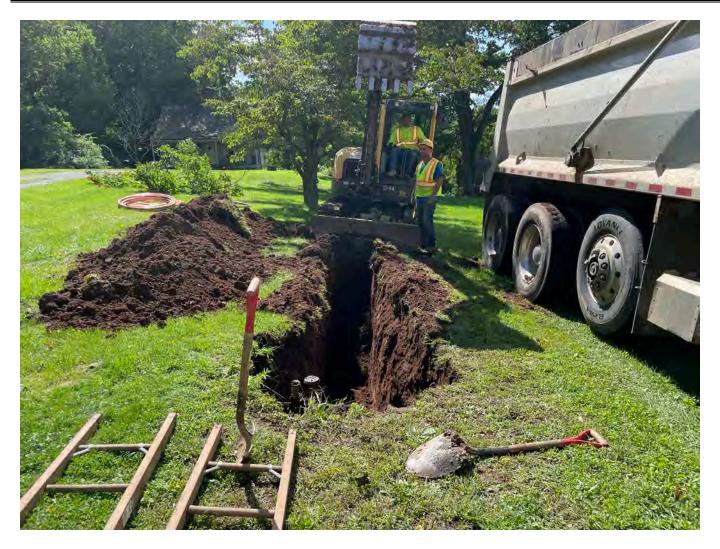
Picture 5: Ludlow excavating south of the curb stop for the installation of a 1.5" copper water service line at the 22 Wallingford Road property in Durham. View to the south.

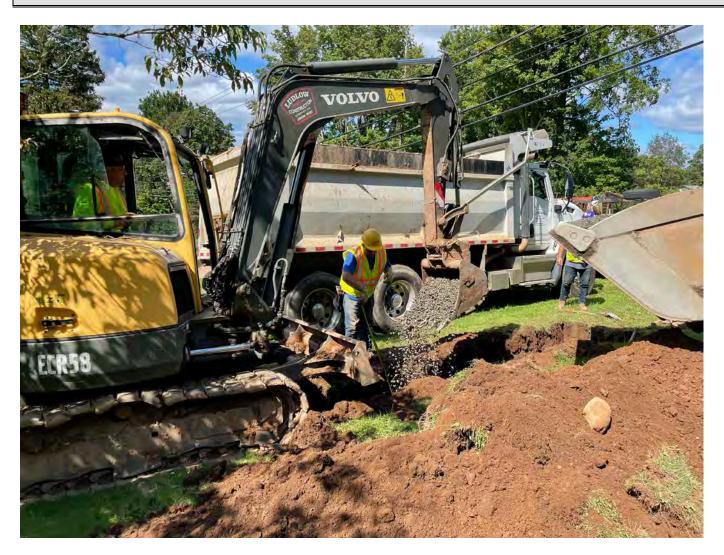
1204: Ludlow is placing ¾" stone at the bottom of the trench at the 22 Wallingford Road property as bedding where a meter pit will be installed.

Picture 6: Ludlow placing a bed of gravel for the placement of a meter pit at the 22 Wallingford Road property. View to the west.

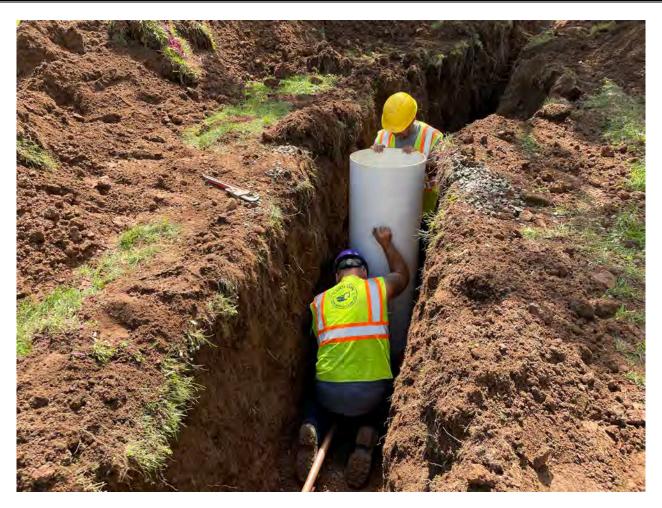
Picture 7: Ludlow installing a meter pit at the 22 Wallingford Road property as part of the installation of a 1.5" copper water service line. View to the south.

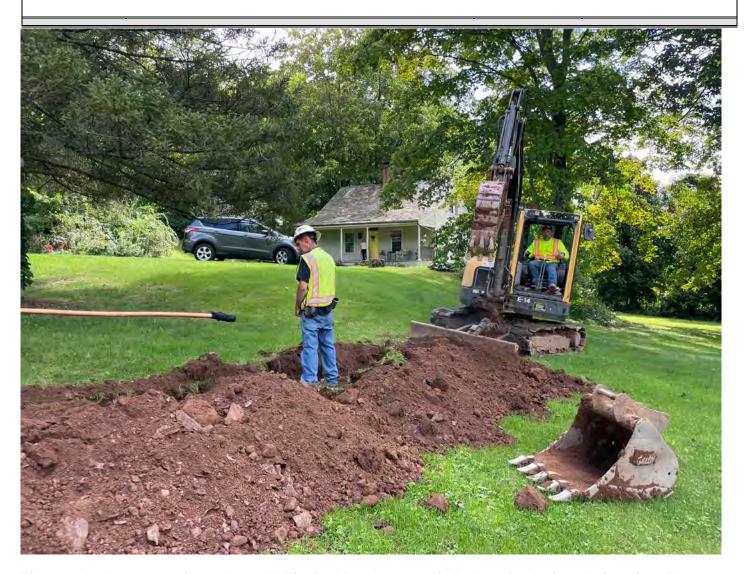
Picture 8: Ludlow excavating at the 22 Wallingford Road property in Durham for the installation of a 1.5" copper water service line. View to the south.

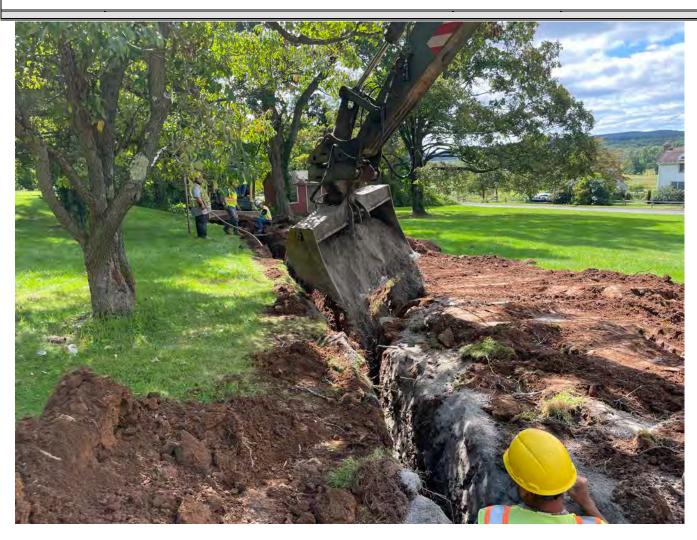
Picture 9: Ludlow placing sand over 1.5" copper water service line at the 22 Wallingford Road property. View to the southwest.

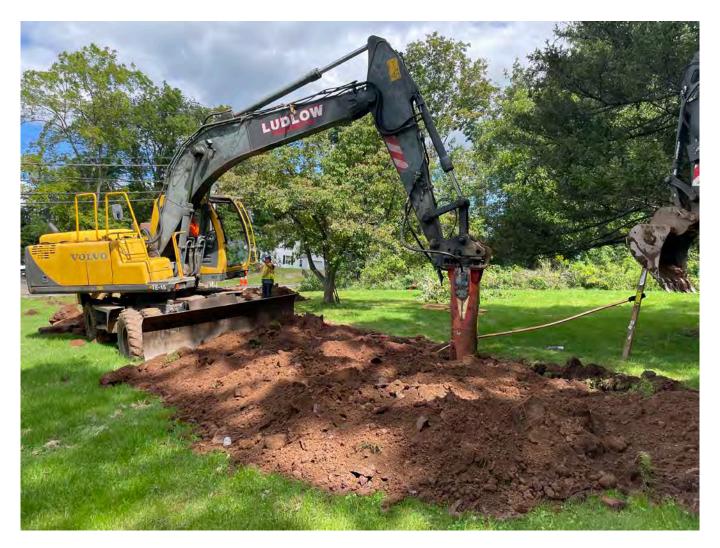
Picture 10: Ludlow hammering rock at the 22 Wallingford Road property for the installation of a 1.5" copper water service line. View to the northeast.

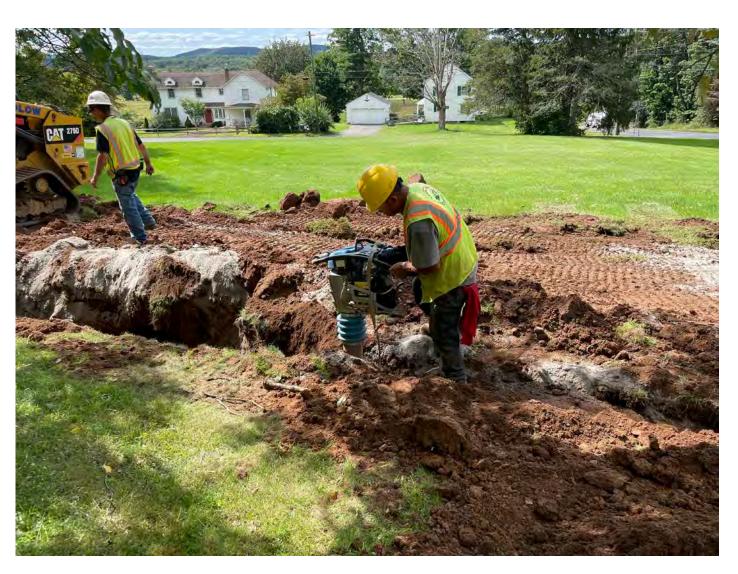
Picture 11: Ludlow compacting backfill with a jumping jack as part of the water service installation activities at the 22 Wallingford Road residence. View to the southwest.

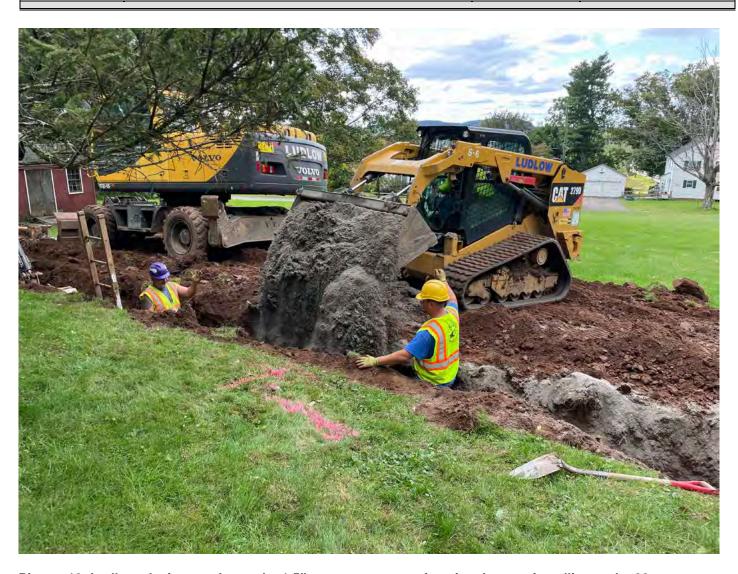
Picture 12: Ludlow placing sand over the 1.5" copper water service pipe they are installing at the 22 Wallingford Road property. View to the southwest.
