Project:	Durham Mea	dow	s Pipeline Installation	-			Date: Septem	ber 14, 2021
Location:	Wallingford F	Road	and Maple Avenue, Durham	ı			Day of Week:	Tuesday

Daily Activities - Installation of water lines, Wallingford Road and Maple Avenue, Durham

Project:	Durham Meadows Pipeline Installation	Date:	September 14, 2021
Location:	Wallingford Road and Maple Avenue, Durham	Day of Week:	Tuesday
Project #:	AECOM: 6061487	Report No:	322
Contractor:	Ludlow Construction	Page:	3 of 16

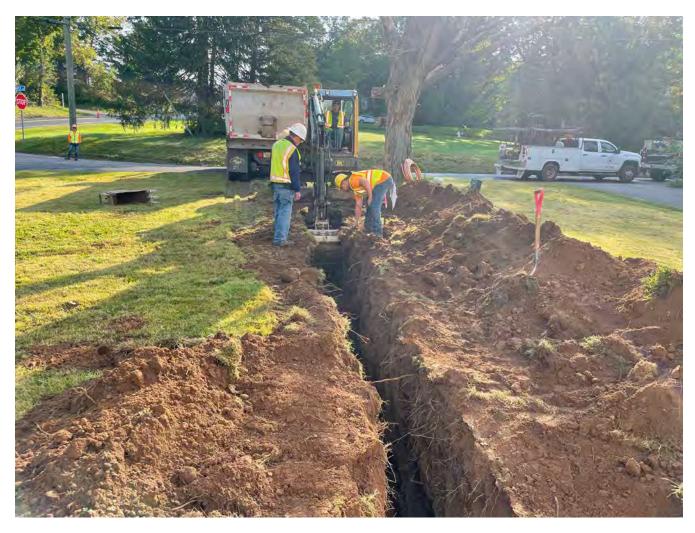
0846: Ludlow continues excavating at the 148 Maple Avenue property for the installation of a 1" copper waterline. Ludlow has daylighted the poured concrete foundation on the east side of the residence.

Picture 1: Ludlow excavating a trench at the 148 Maple Avenue property for the installation of a 1" copper water service line. View to the east.

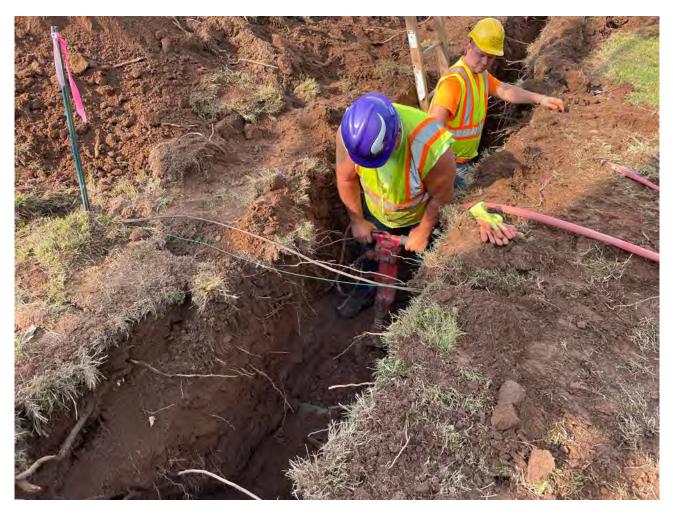
0931: Ludlow continues to excavate on the east side of the 148 Maple Avenue residence forte installation of a 1" copper water service line. Ludlow is currently jackhammering rock they have encountered at the bottom of the trench, located approximately 25' west of the curb stop.

0946: Ludlow continues to jackhammer rock in the trench they are excavating on the east side of 148 Maple Avenue residence.

Picture 2: Ludlow jackhammering rock they encountered while excavating a trench at the 148 Maple Avenue property in Durham. View to the west.

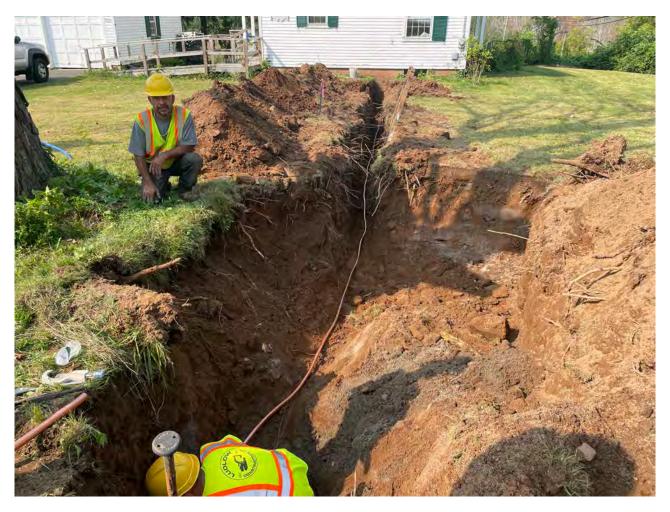
Picture 3: Ludlow placing 1" copper water service line in the trench they excavated at the 148 Maple Avenue property in Durham. View to the west.

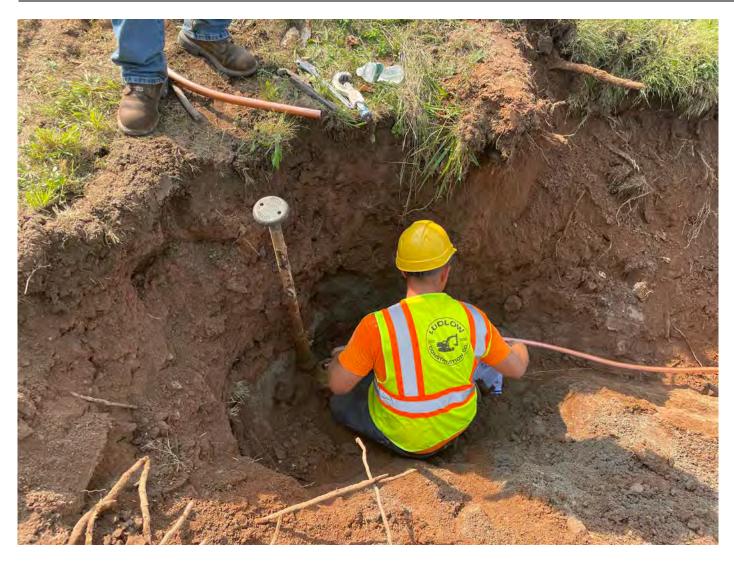
Picture 4: Ludlow connecting 1" copper water service line to the curb stop for the 148 Maple Avenue to property in Durham. View to the south.

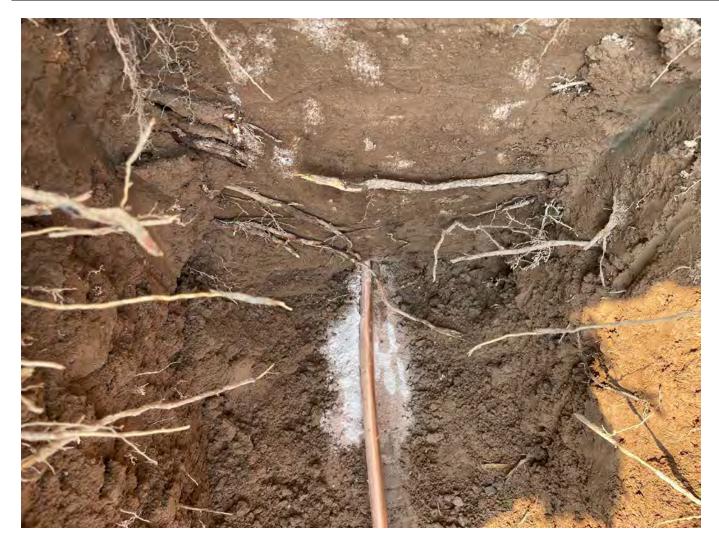
1046: Ludlow has drilled through the eastern foundation of the 148 Maple Avenue residence with a rotary hammer. The penetration point is located 9.5' south of the northeast corner of the house. Ludlow is preparing to place non-shrink grout where the 1" copper pipe passes through the east side of the home's foundation.

Picture 5: 1" copper water service line that Ludlow has inserted through the foundation for the 148 Maple Avenue residence, prior to securing it in place with non-shrink grout. View to the west.

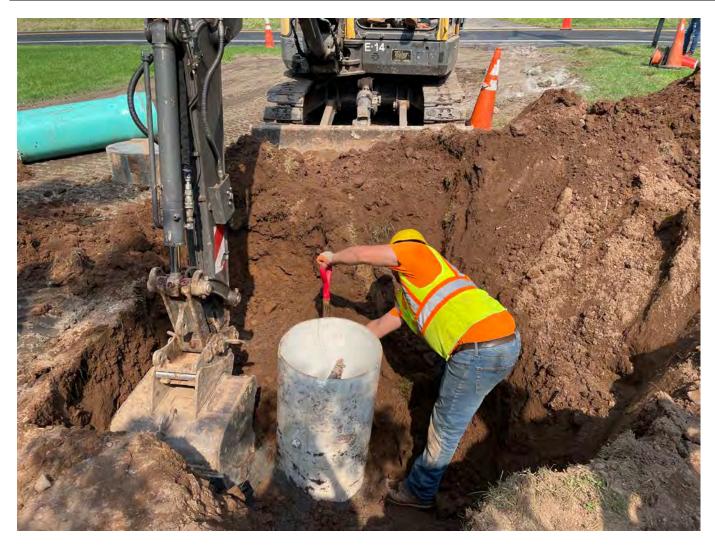
0700: Ludlow returns to the 22 Wallingford Road, Durham, property to continue restoration activities on the portions of the property that were disturbed during the installation of a 1.5" copper water service line. Ludlow is also assessing how they plan to repair the meter pit that they damaged yesterday at the 22 Wallingford Road property.

Picture 6: Ludlow removing the meter pit they damaged yesterday at 22 Wallingford Road in Durham as they prepare to replace it. View to the north.

1141: Ludlow is working on replacing the meter pit they damaged yesterday at 22 Wallingford Road, Durham, property.

1221: Ludlow has finished installing a new meter pit at the 22 Wallingford Road property. Ludlow is currently backfilling around the meter pit with native fill and compacting it with a jumping jack.

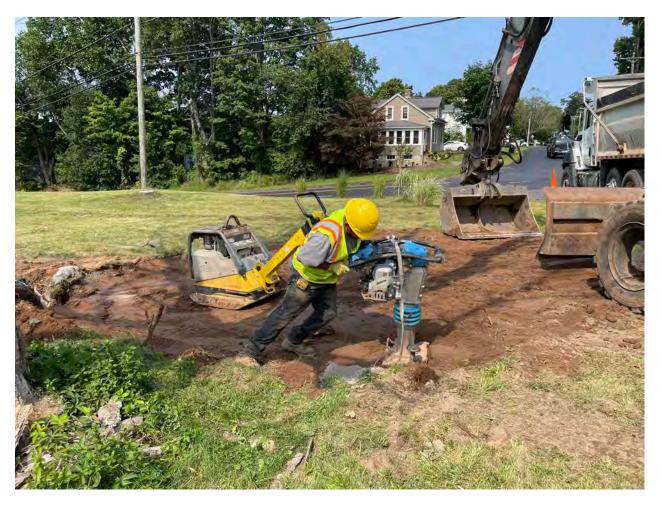
Picture 7: Ludlow compacting native fill that they backfilled into the trench at the 148 Maple Avenue residence in 1' lifts. View to the north.

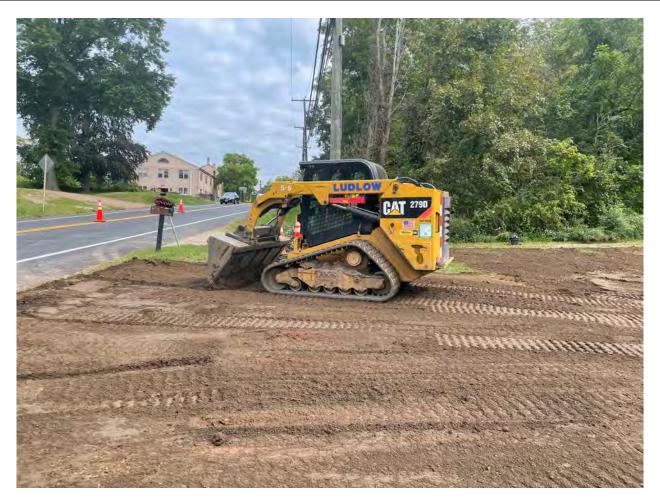
Picture 8: Ludlow grading loam they placed on the 22 Wallingford Road property to restore those areas of the lawn that were disturbed during the installation of a 1.5" copper water service line. View to the east.

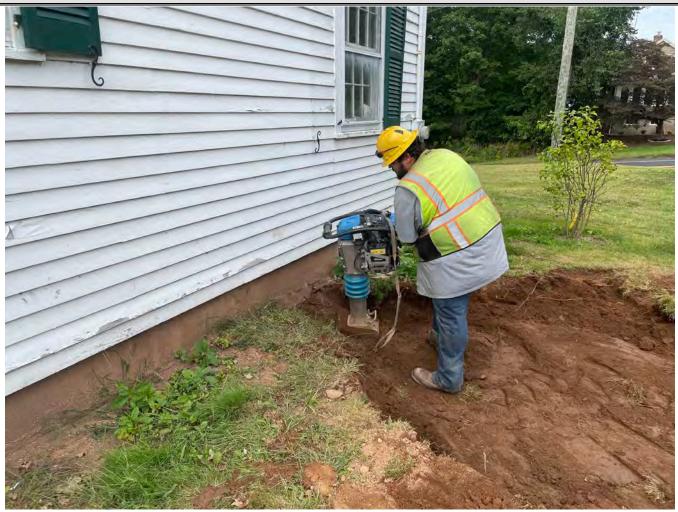
Picture 9: Ludlow compacting fill against the eastern foundation of the 148 Maple Avenue residence after installing a 1" copper water service line at the residence. View to the northwest.

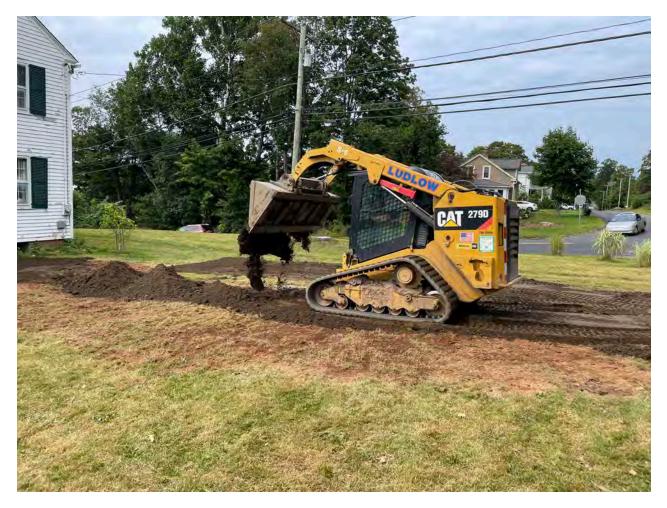
Picture 10: Ludlow placing loam on the areas of the 148 Maple Avenue property that were disturbed during the installation of a 1" copper water service line. View to the north.

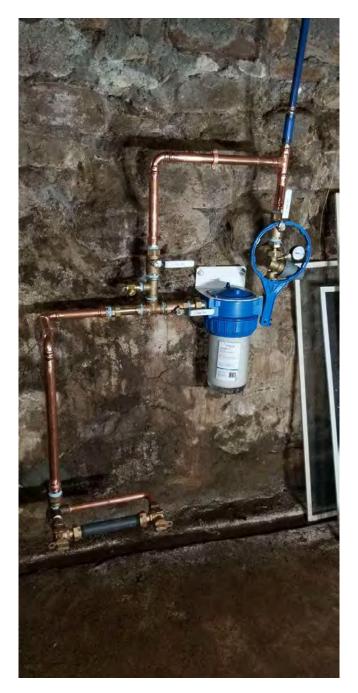
Picture 11: Final water service components that Fazzino Plumbing installed today at the residence located at 133 Maple Avenue, Durham.

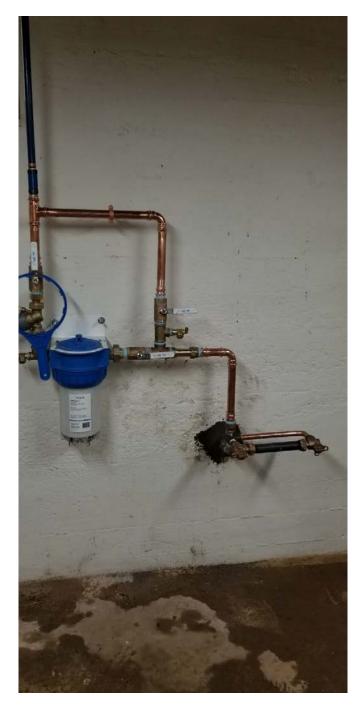
Picture 12: Final water service components that Fazzino Plumbing installed today at the residence located at 148 Maple Avenue, Durham.

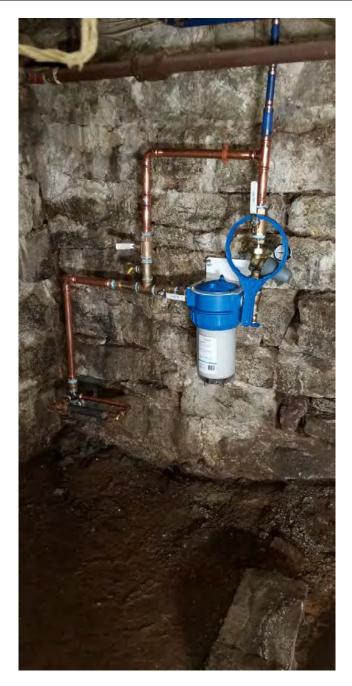
Picture 13: Final water service components that Fazzino Plumbing installed today at the residence located at 146 Maple Avenue, Durham.
