Daily Report

Project:	Durham Meadows Pipeline Installation	Date:	September 30, 2021
Location:	Maple Avenue, Durham; Shared Access Driveway, Middletown	Day of Week:	Thursday
Project #:	AECOM: 6061487	Report No:	333
Contractor:	Ludlow Construction	Page:	1 of 14

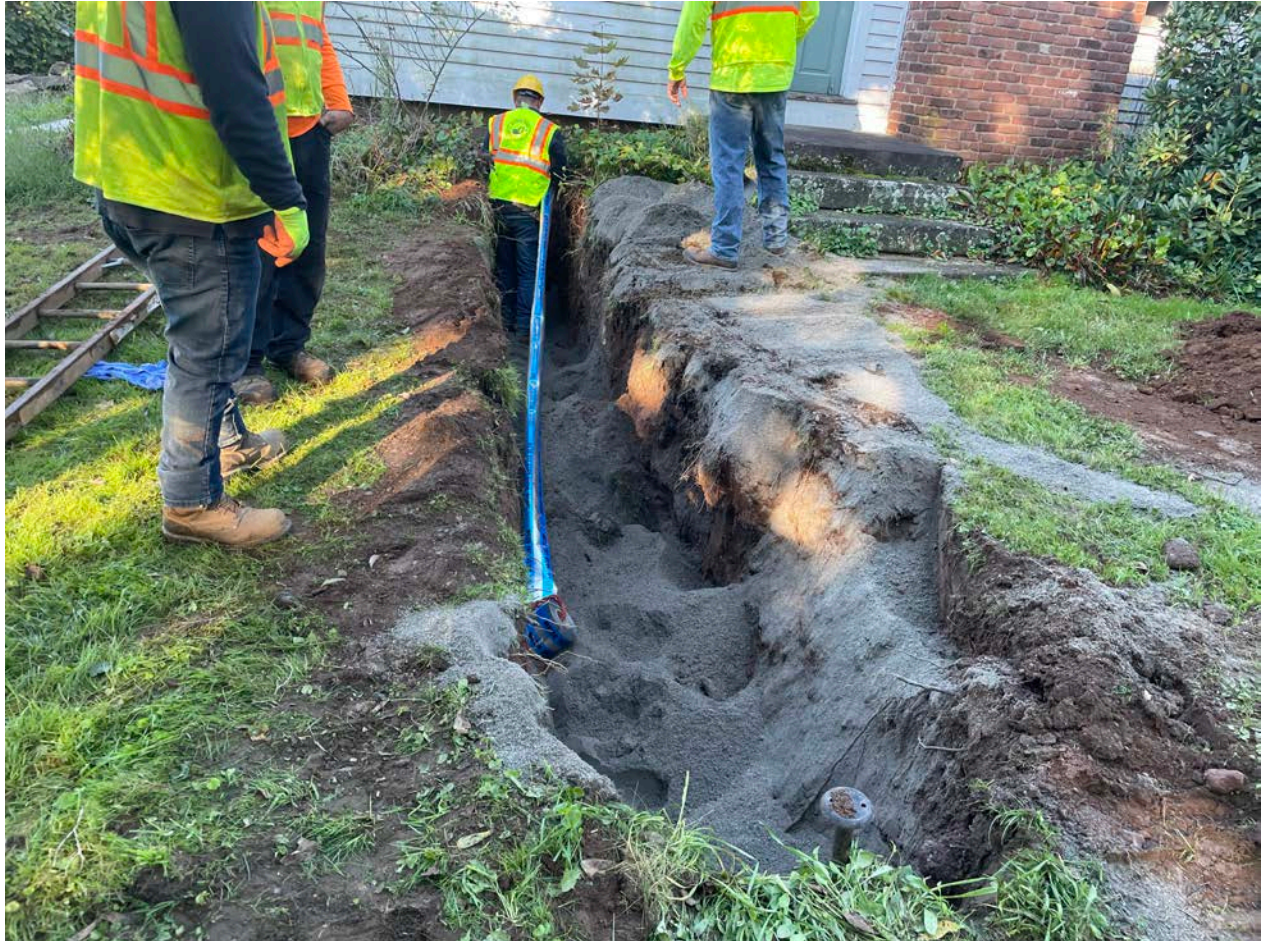
0836: Ludlow placing sand over the 1" copper line they just installed at the 110 Maple Avenue property. Ludlow penetrated the fieldstone foundation with a rotary hammer 5' 3" north of the home's southeast corner.

Picture 1: Ludlow placing caution tape over sand that was placed on top of 1" copper water service line at the 110 Maple Avenue residence in Durham. View to the west.

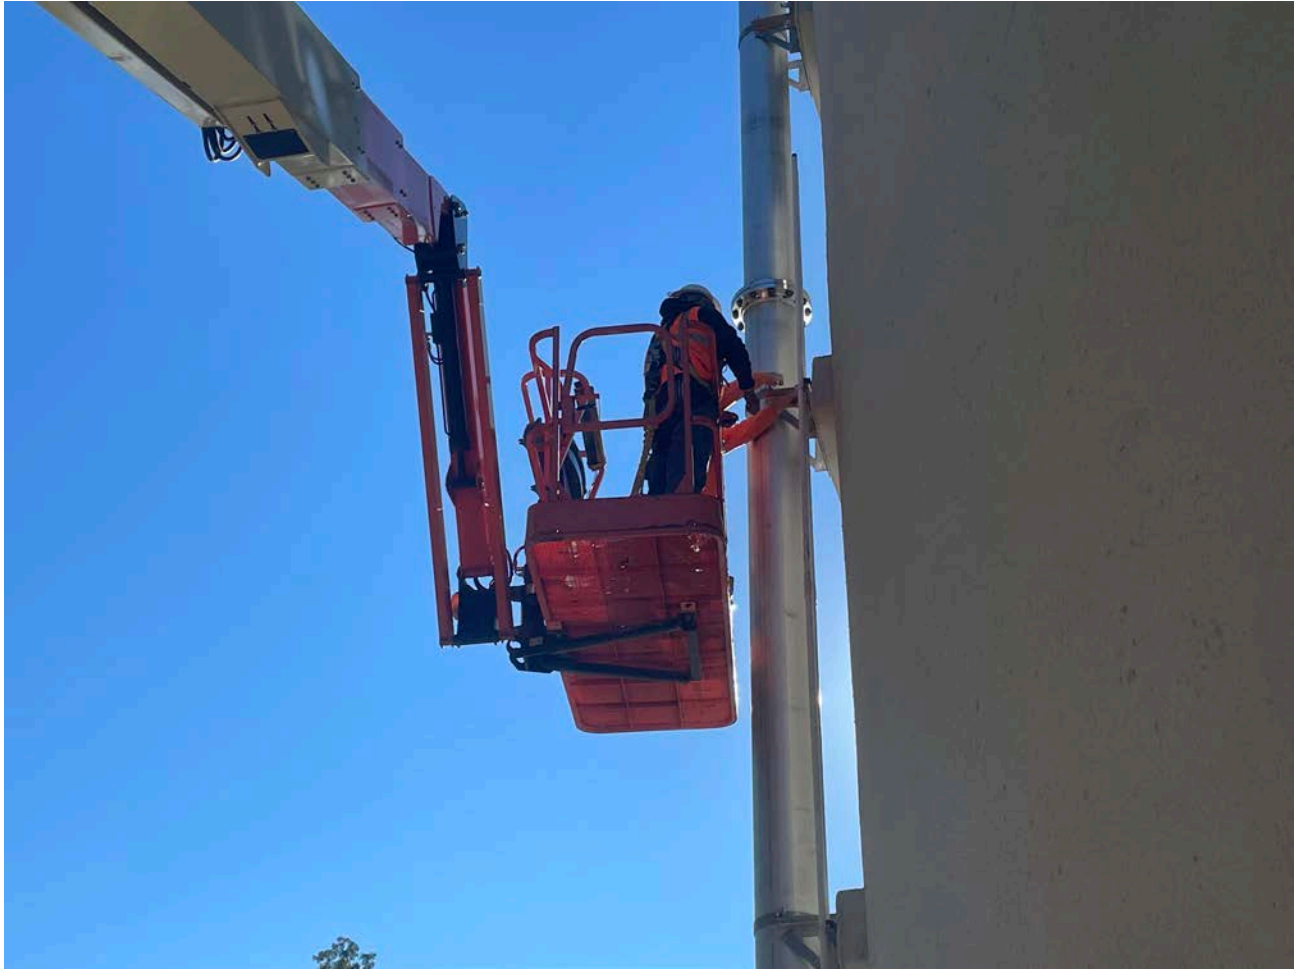
0819: DN Tanks continues to work on the 12" stainless steel air ducts they installed yesterday on the northeast side of the water tank. A DN Tanks safety officer has arrived at the water tank work zone.

Picture 2: DN Tanks working on 12" air duct they installed on the northeast side of the water tank located east of the Shared Access Driveway in Middletown. View to the southeast.

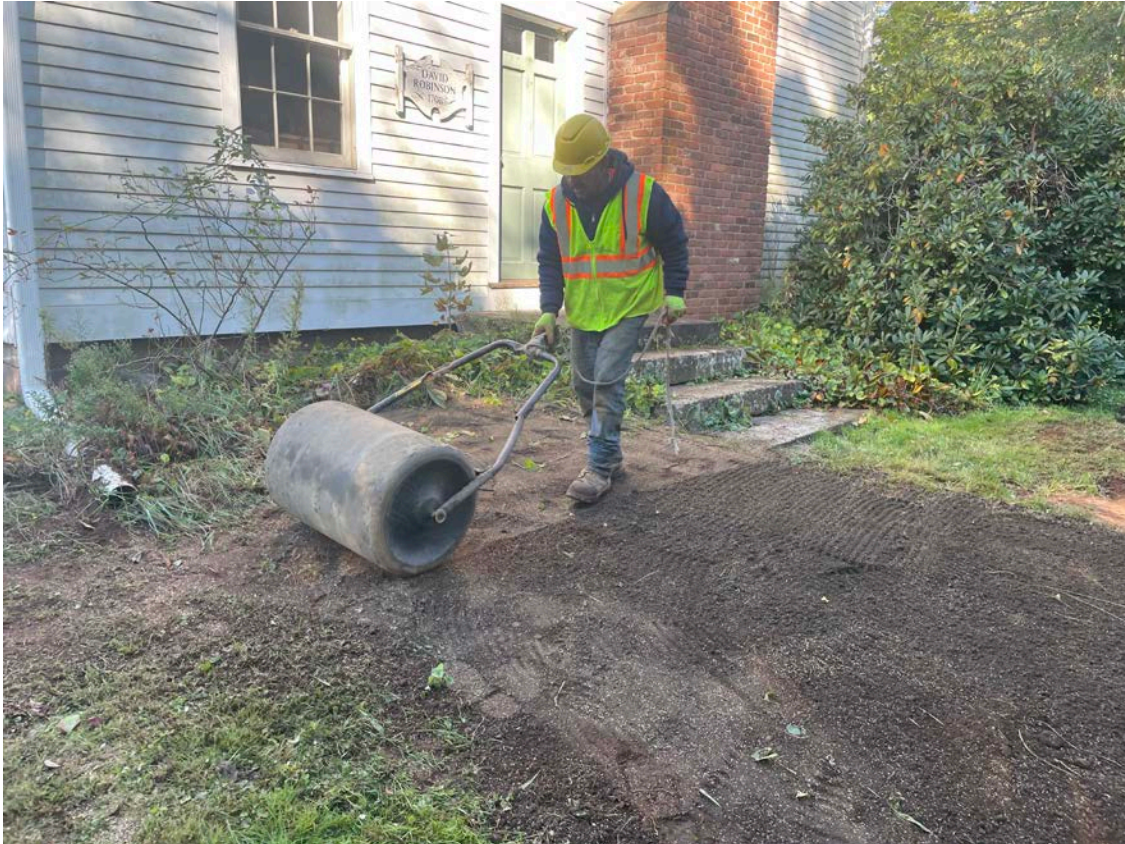
0936: Ludlow has finished the installation of a 1" copper water service line at the 110 Maple Avenue residence. Ludlow is currently rolling the loam and seed they placed over the backfilled water line trench.

Picture 3: Ludlow rolling loam they just placed and seeded at the 110 Maple Avenue residence in Durham. View to the northwest.

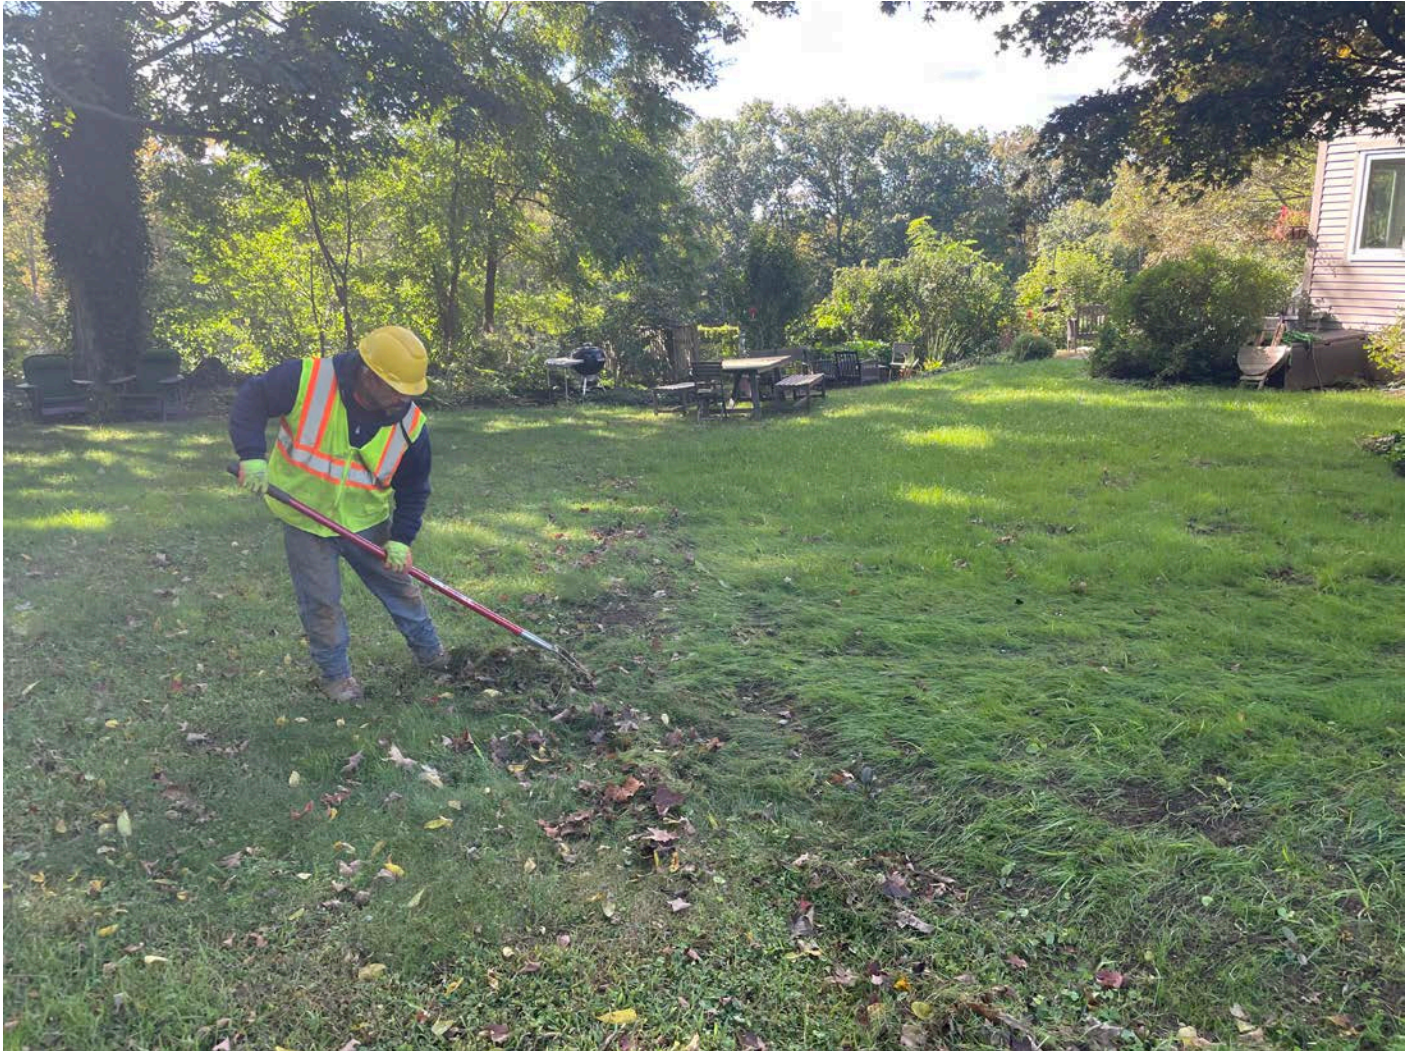
1005: Ludlow is repairing rills on portions of the lawn at the 95R Maple Avenue residence that have eroded since the installation of a copper water service line. Ludlow is also building a short wooden retention wall on the east side of the driveway turnout.

Picture 4: Ludlow repairing a section of the lawn at the 95R residence that was disturbed several weeks ago during the installation of a copper water service line. View to the south.

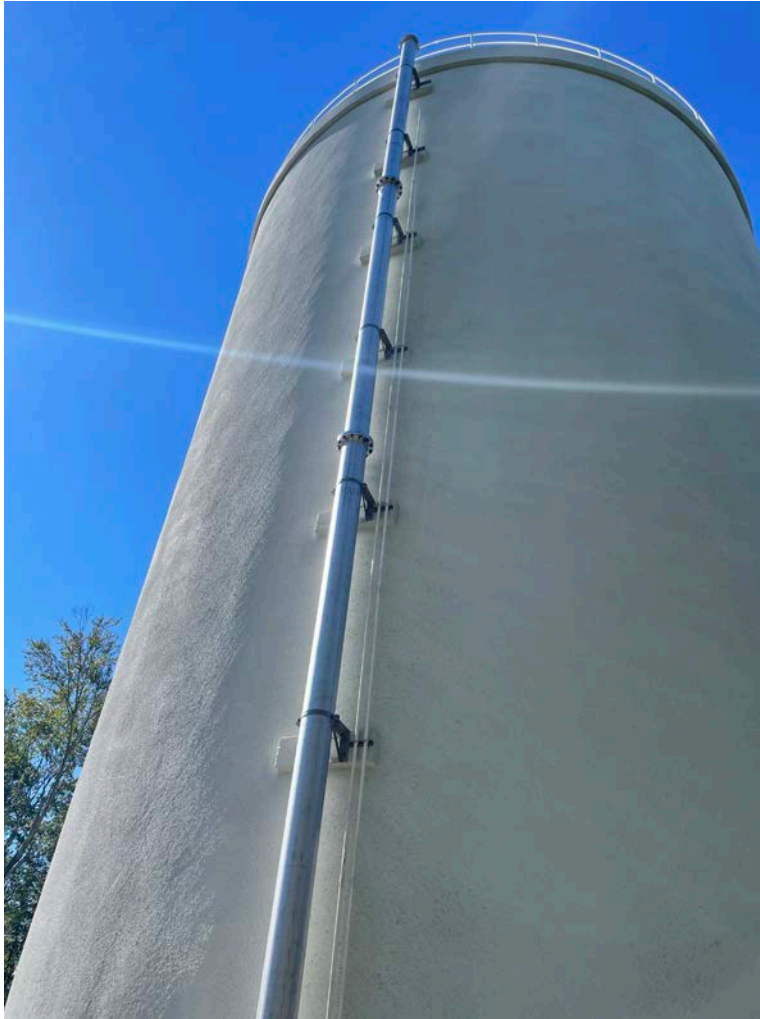
0923: DN Tanks is installing 1" steel conduit on the northeast side of the water tank located east of the Shared Access Driveway in Middletown. DN Tanks has installed approximately 30 feet of the conduit so far. A&R Electrical is working on the west side of the water tank making some minor adjustments to the 2" conduit that emerges from the ground and runs about 30" up the side of the tank. DN Tanks will be adding additional conduit to this 30" section later in the day.

Picture 5: 1" conduit that DN Tanks installed on the west side of the 12" stainless steel air duct on the northeast side of the water tank located east of the Shared Access Driveway in Middletown. View to the south.

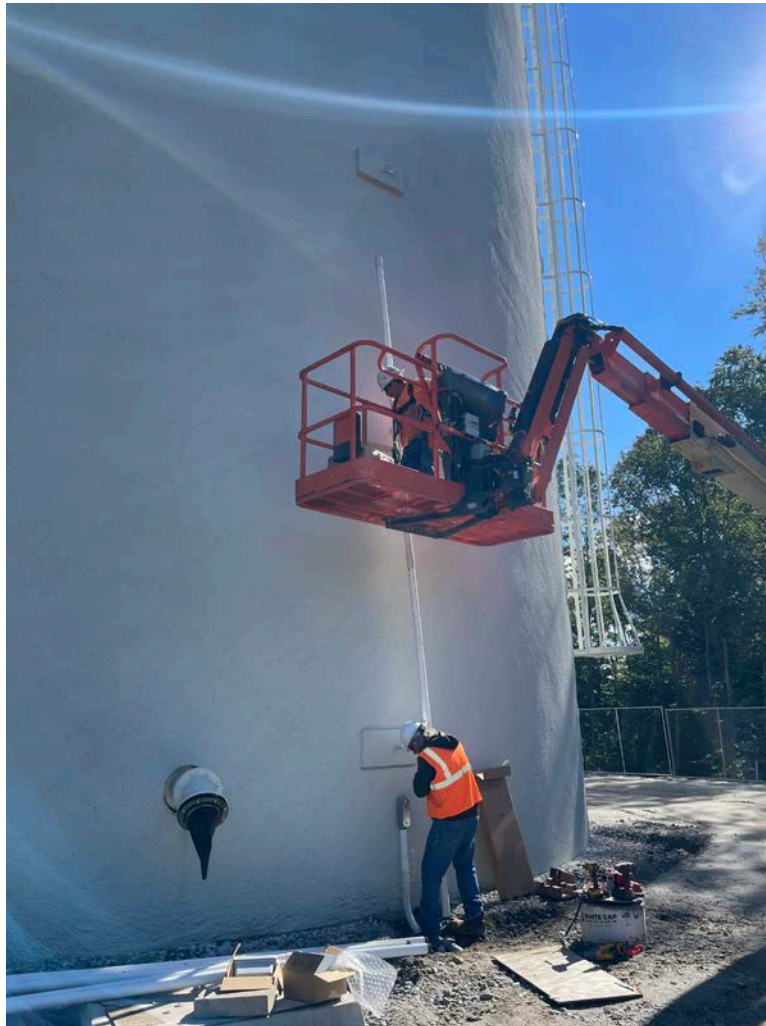
1146: DN Tanks continues to install 2" steel conduit on the west side of the water tank located east of the Shared Access Driveway in Middletown.

Picture 6: DN Tanks installing 2" conduit on the west side of the water tank located east of the Shared Access Driveway. View to the southeast.

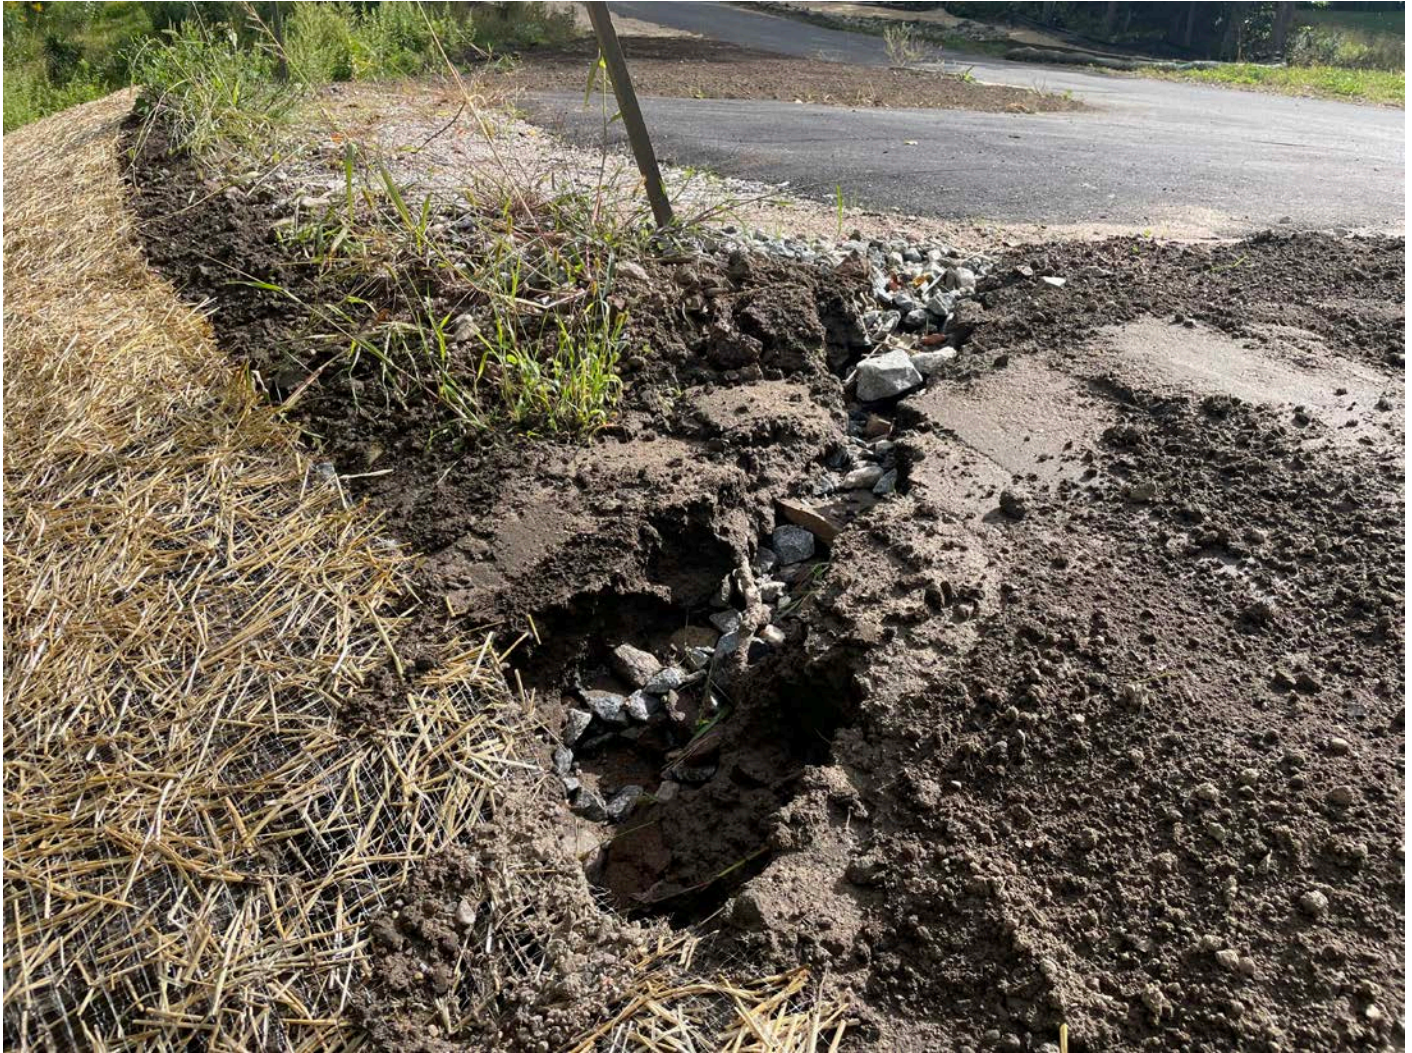
Picture 7: Erosion observed on the northwest corner of the turnout located at Station 14+00. View to the east.

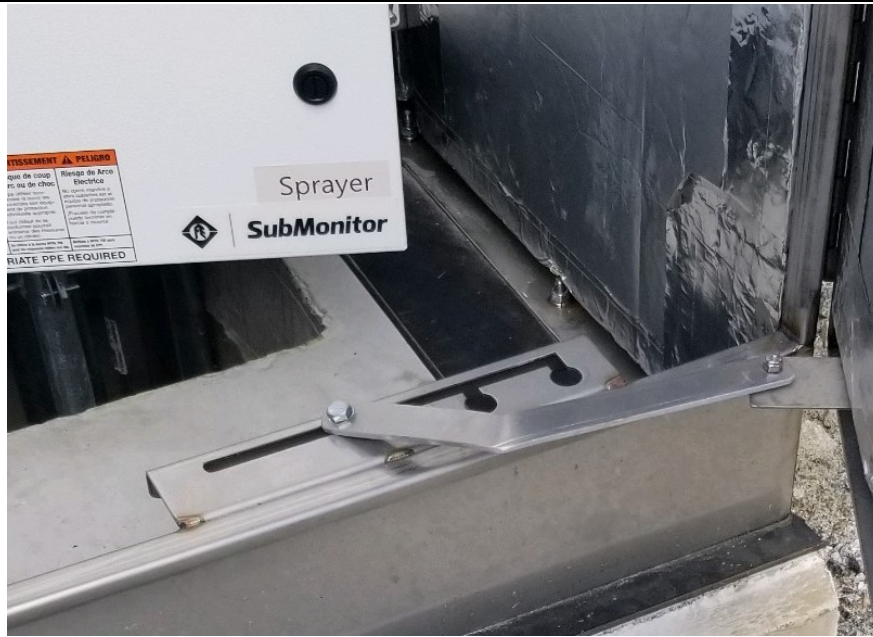
Picture 8: Bent arm observed on the electrical enclosure located north of the altitude vault. View to the northeast.

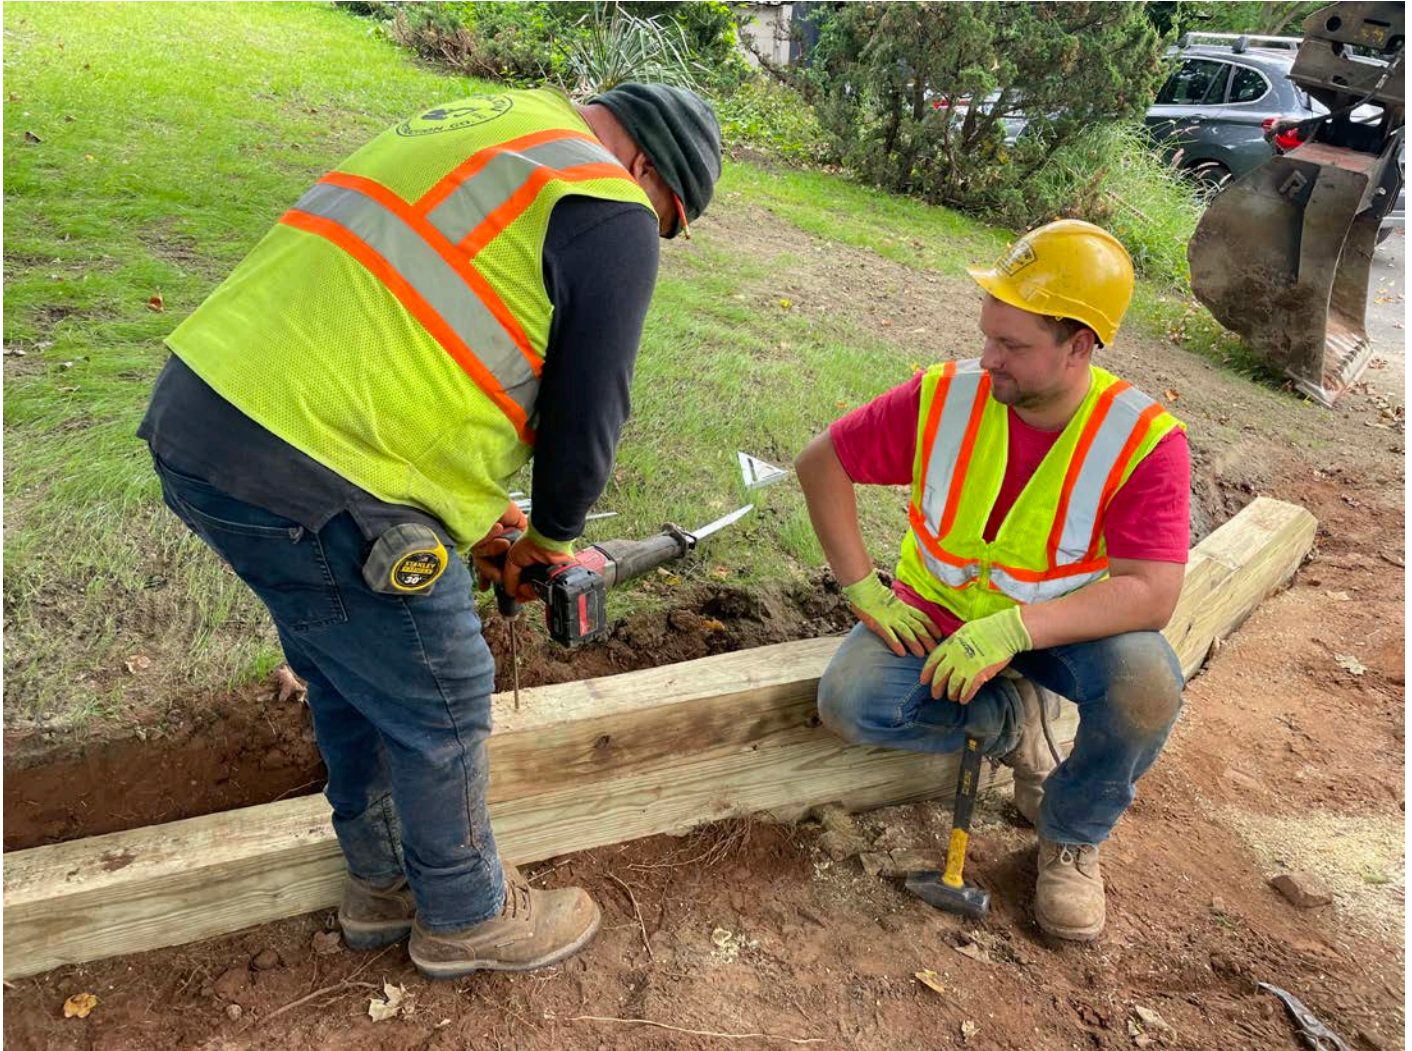
1219: Ludlow continues to construct a short retaining wall on the east side of the driveway turnout at the 95R Maple Avenue property.

Picture 9: Ludlow building a short wooden retention wall on the east side of the driveway turnout at the 95R Maple Avenue property. View to the east.

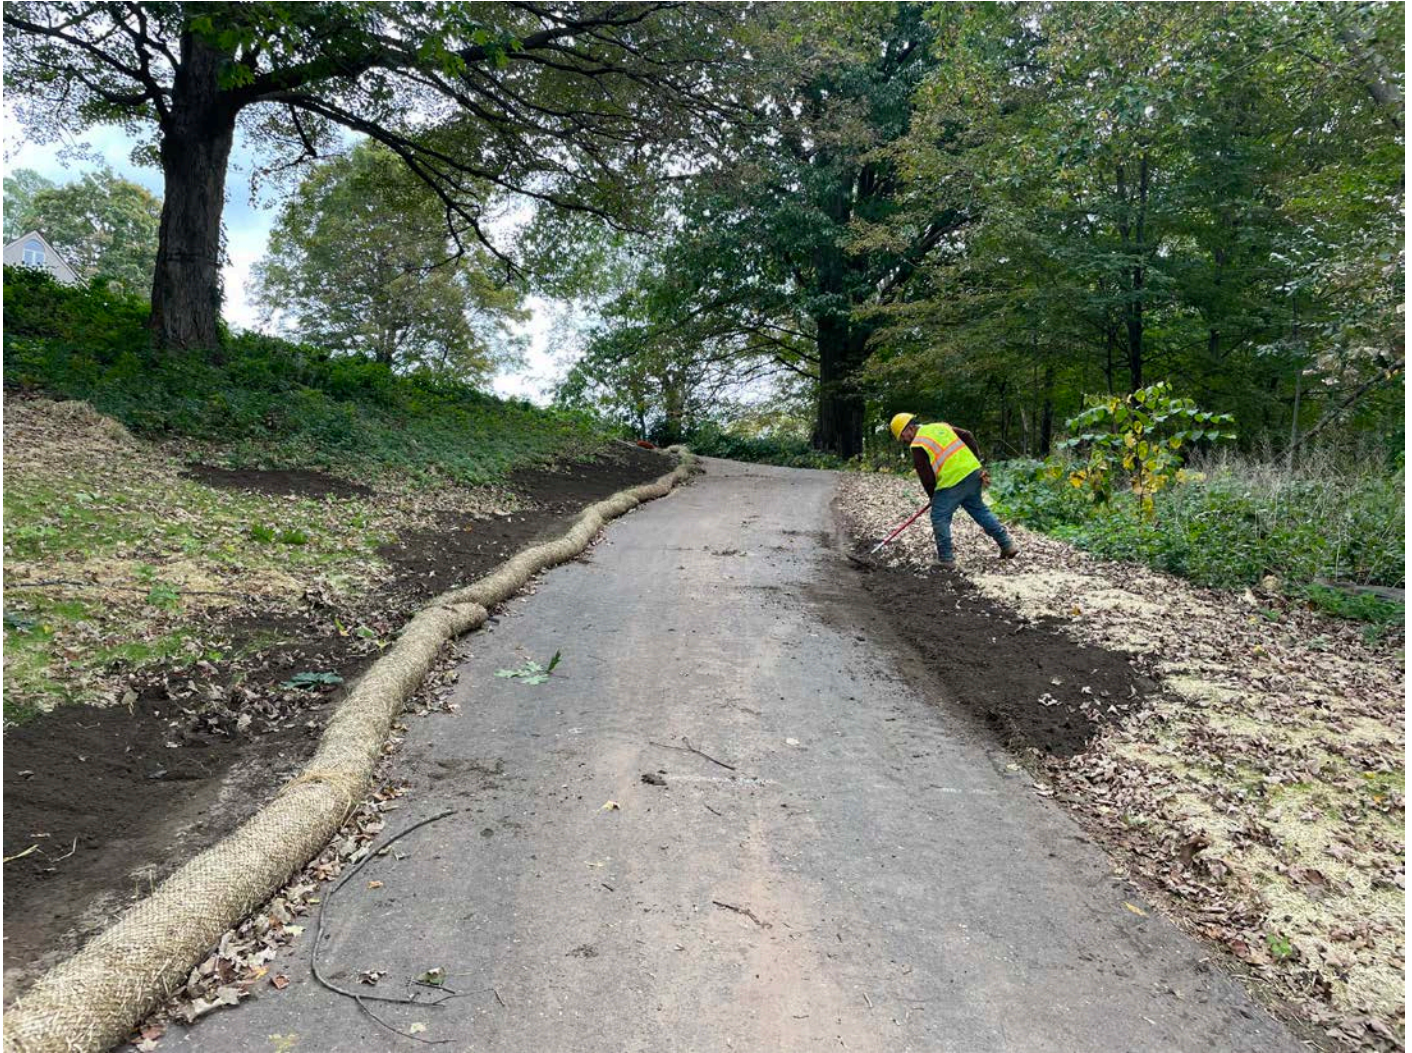
Picture 10: Ludlow raking out loam that they placed on the south side of the driveway for the residence located at 95R Maple Avenue in Durham. View to the east.

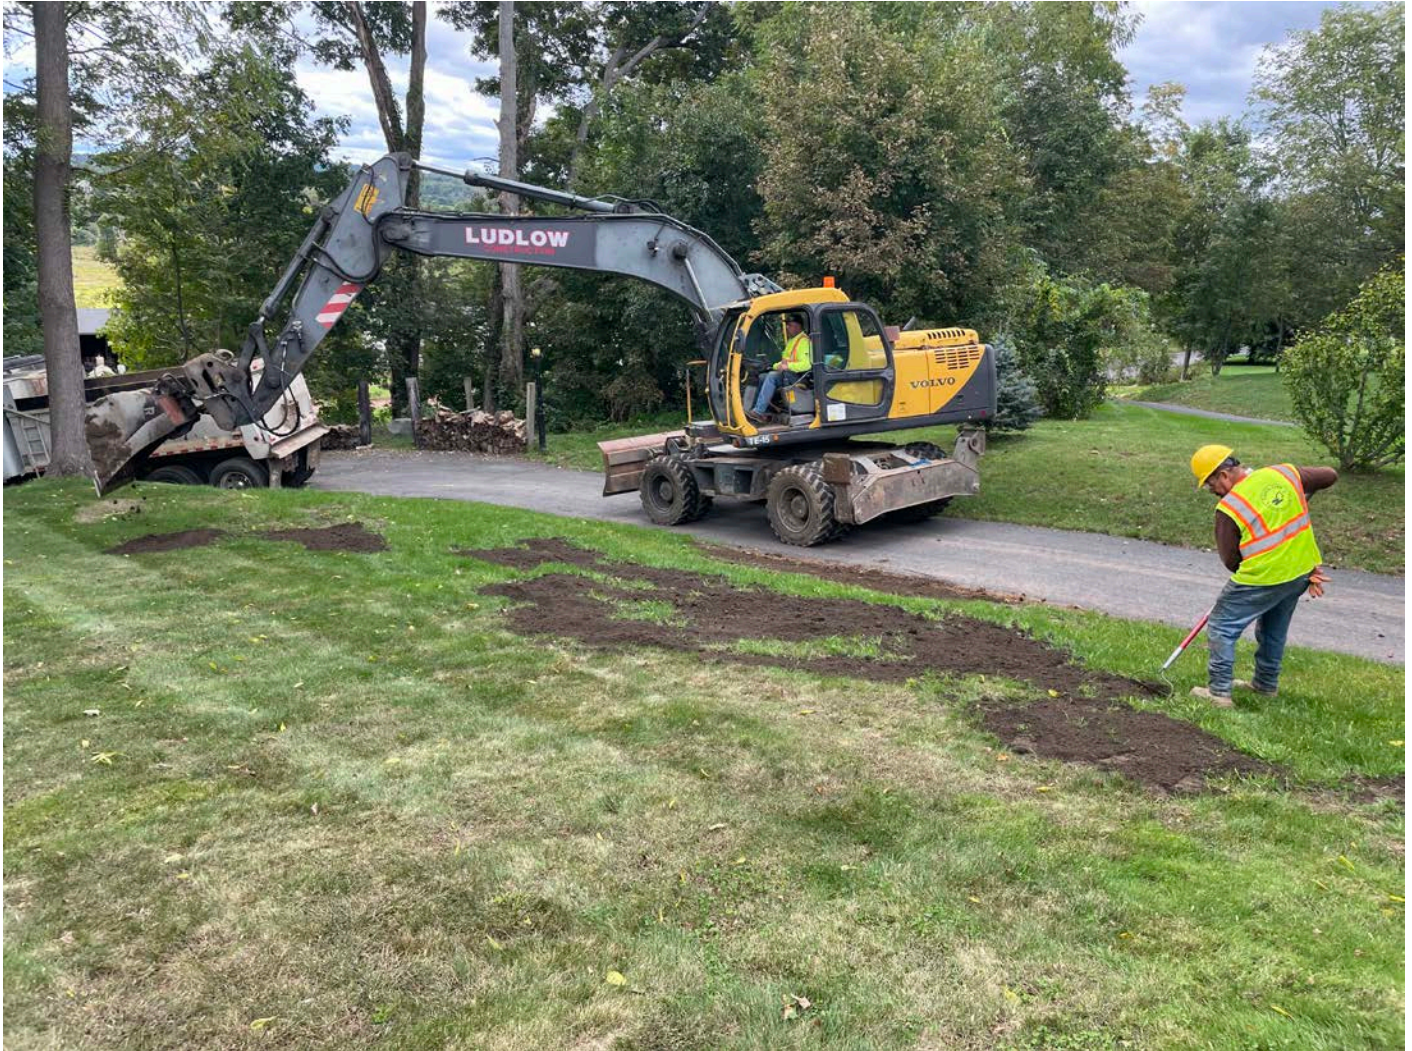
1411: Ludlow has mobilized to the 97 Maple Avenue property to repair portions of the lawn that have eroded since the installation of a copper water service line.

Picture 11: Ludlow placing and raking out loam they placed on the south side of the driveway for the residence located at 97 Maple Avenue in Durham. View to the northwest.
