## Daily Report

<b>Project:</b>	Durham Meadows Pipeline Installation	<b>Date:</b>	October 13, 2021
<b>Location:</b>	Shared Access Road, Middletown	<b>Day of Week:</b>	Wednesday
<b>Project #:</b>	AECOM: 6061487	<b>Report No:</b>	342
<b>Contractor:</b>	Ludlow Construction	<b>Page:</b>	1 of 13

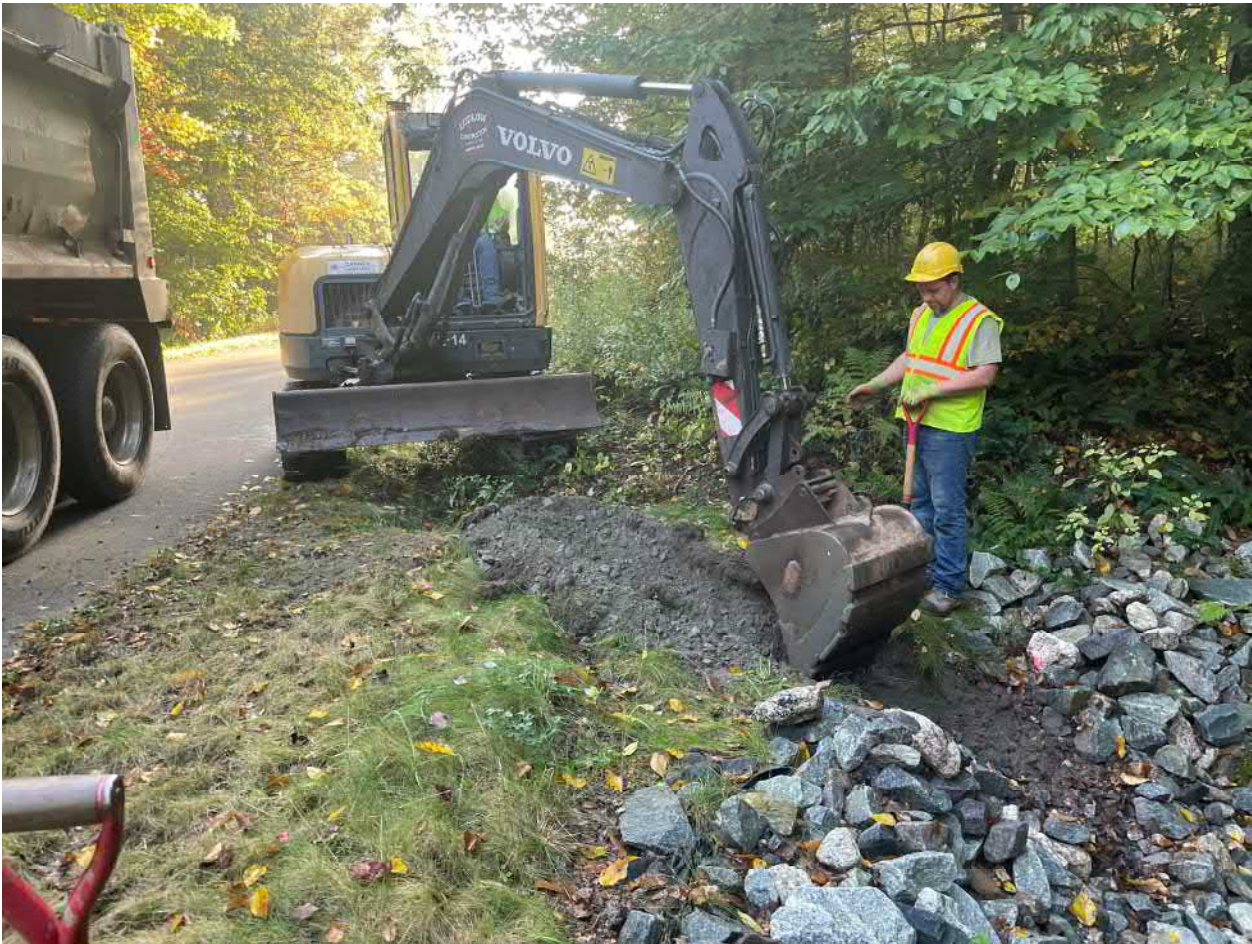
Picture 1: Ludlow beginning excavation at Station 19+75 along the south edge of the Shared Access Road and the east side of a plunge bowl, working east. View to northeast.

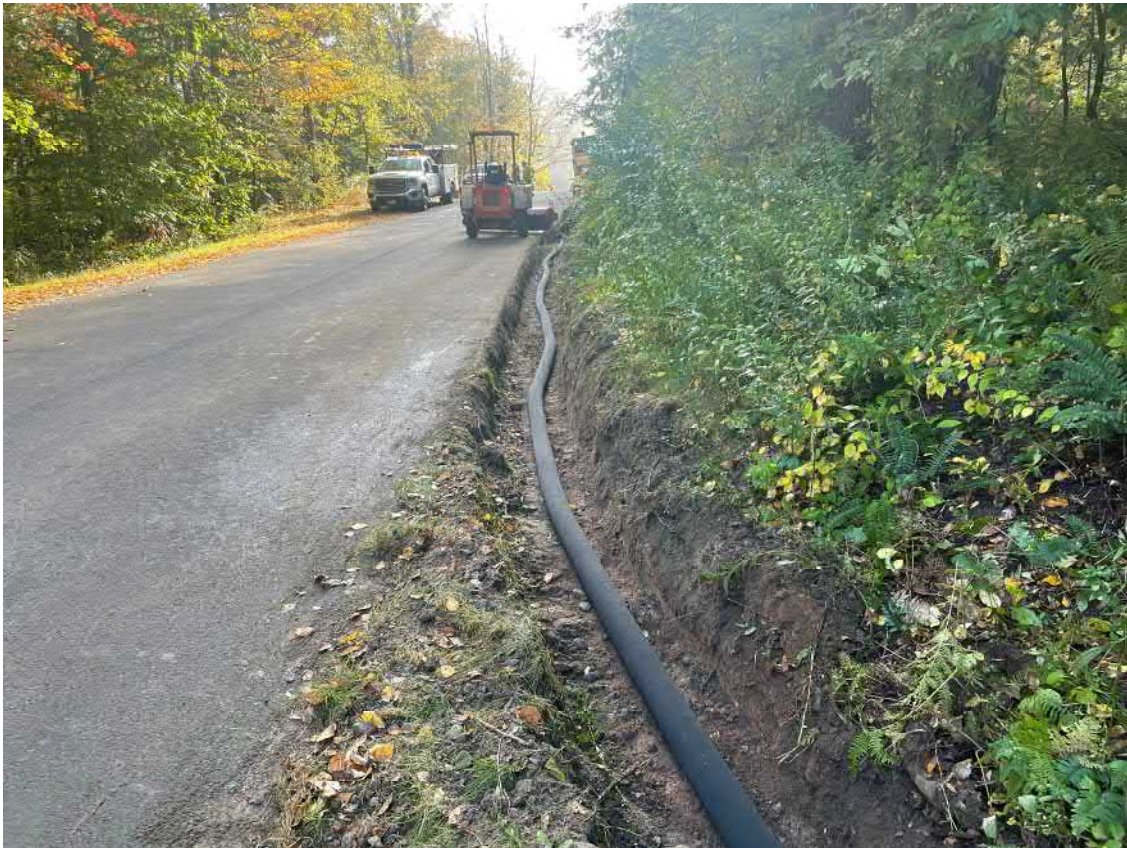
Picture 2: 4" corrugated, perforated, plastic pipe that Ludlow has placed on the south edge of the Shared Access Road between Stations 18+15 and 19+75. View to east.

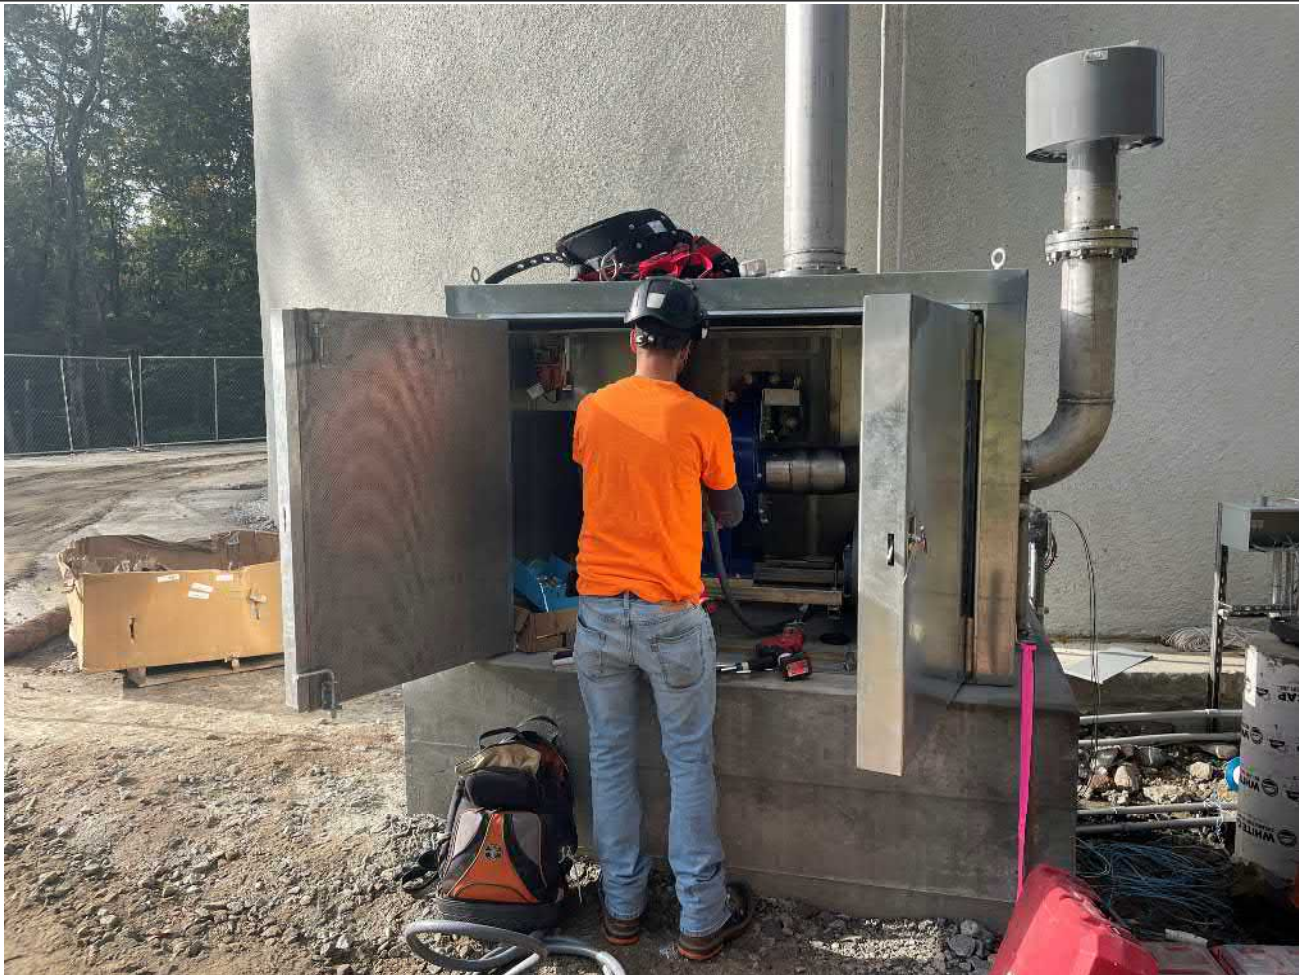
Picture 3: A&R Electrical working on wiring the blower located on the northeast side of the water tank. View to the southwest.

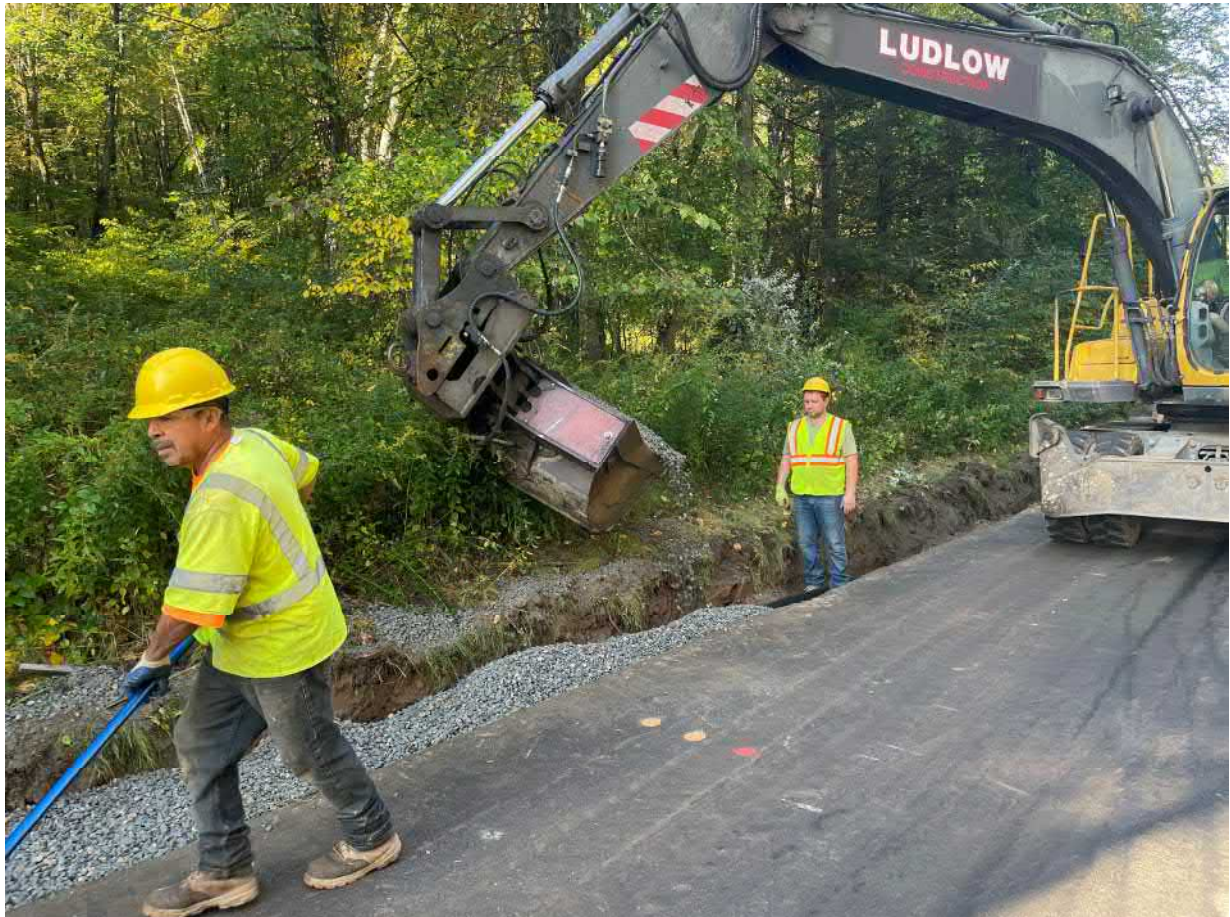
Picture 4: Ludlow placing  $\frac{3}{4}$ " stone over the 4" corrugated, perforated, plastic pipe they just placed along the south edge of the Shared Access Road. View to the southwest.

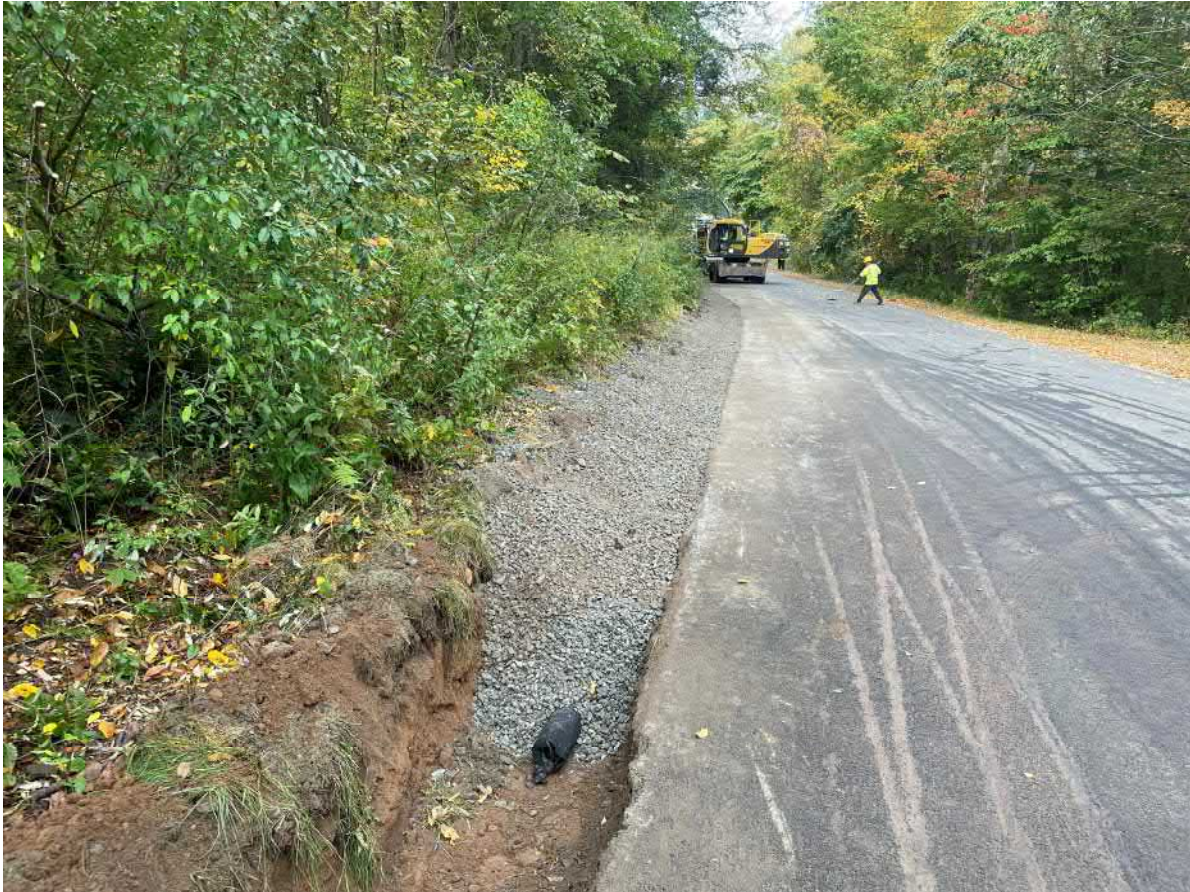
Picture 5: 4" corrugated, perforated, plastic pipe that Ludlow has covered with ¾" stone on the south edge of the Shared Access Road between Stations 18+15 and 19+75. View to west.

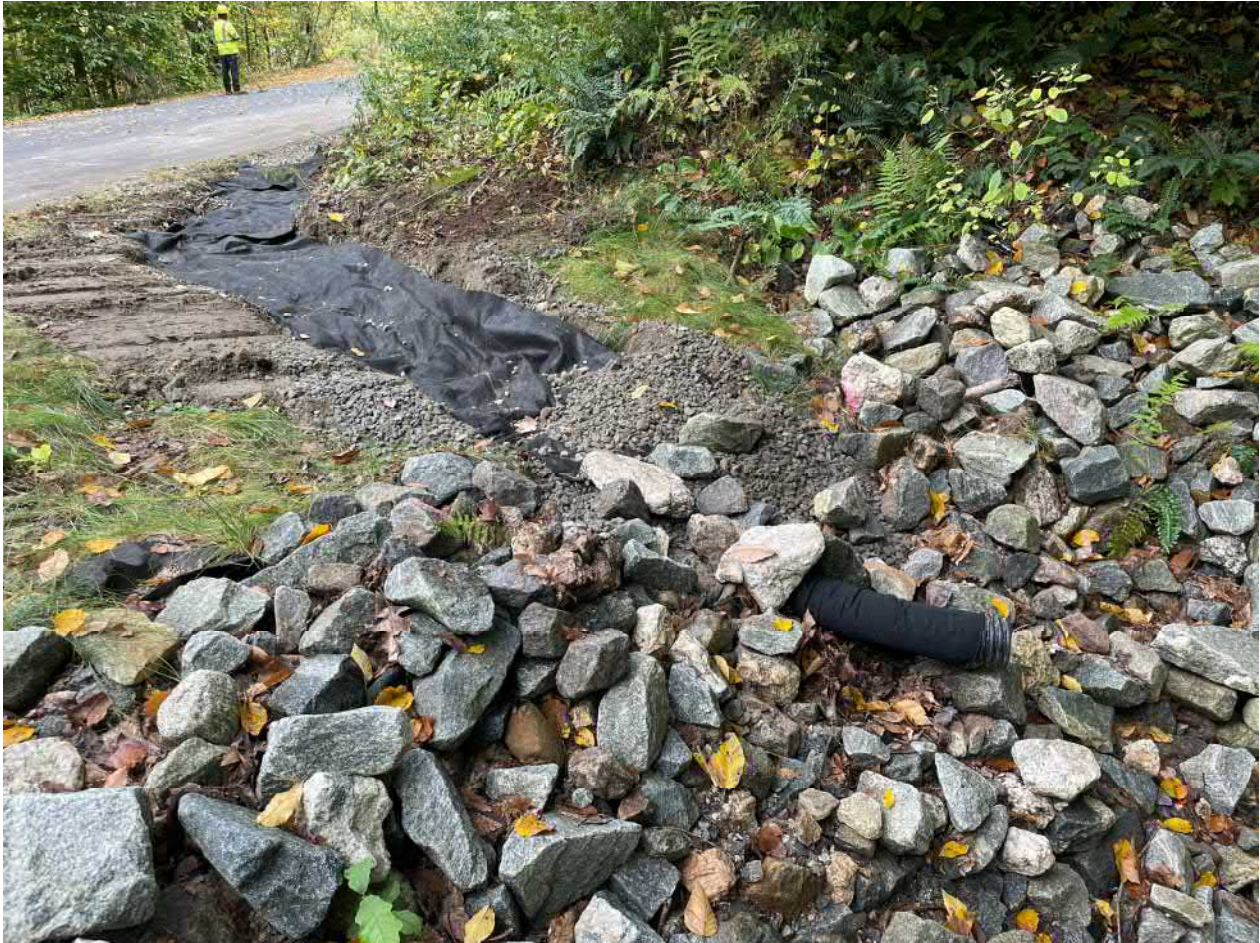
Picture 6: 4" corrugated, perforated, plastic pipe daylighting into the plunge bowl located at Station ~19+85. Ludlow later covered the black filter fabric with loam. View to the northeast.

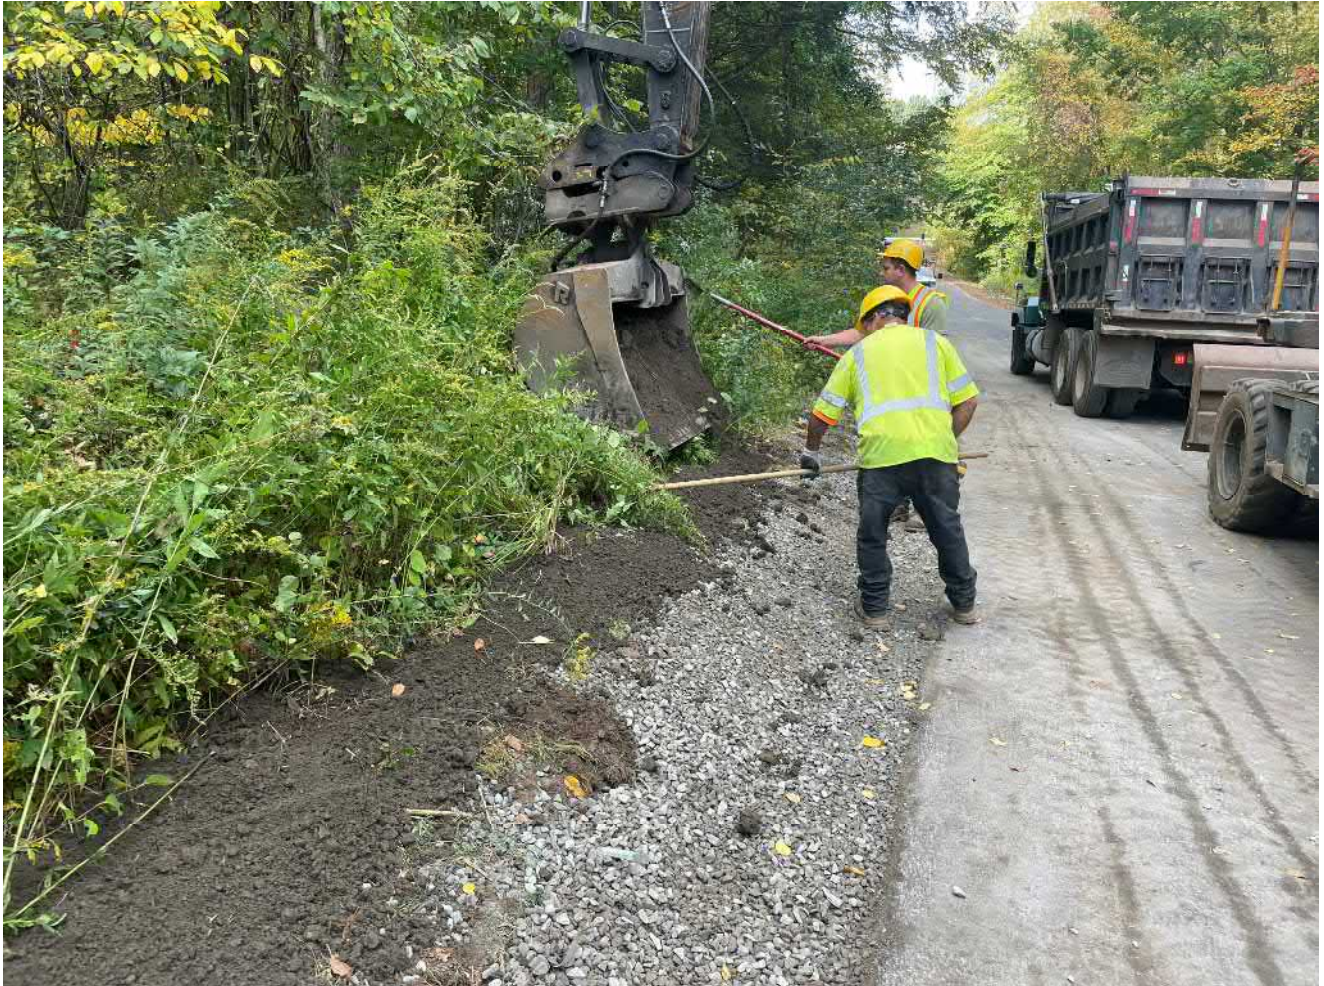
Picture 7: Ludlow placing loam on the south edge of the  $\frac{3}{4}$ " stone they placed over 4" plastic drain pipe on the south edge of the Shared Access Road. View to the west.

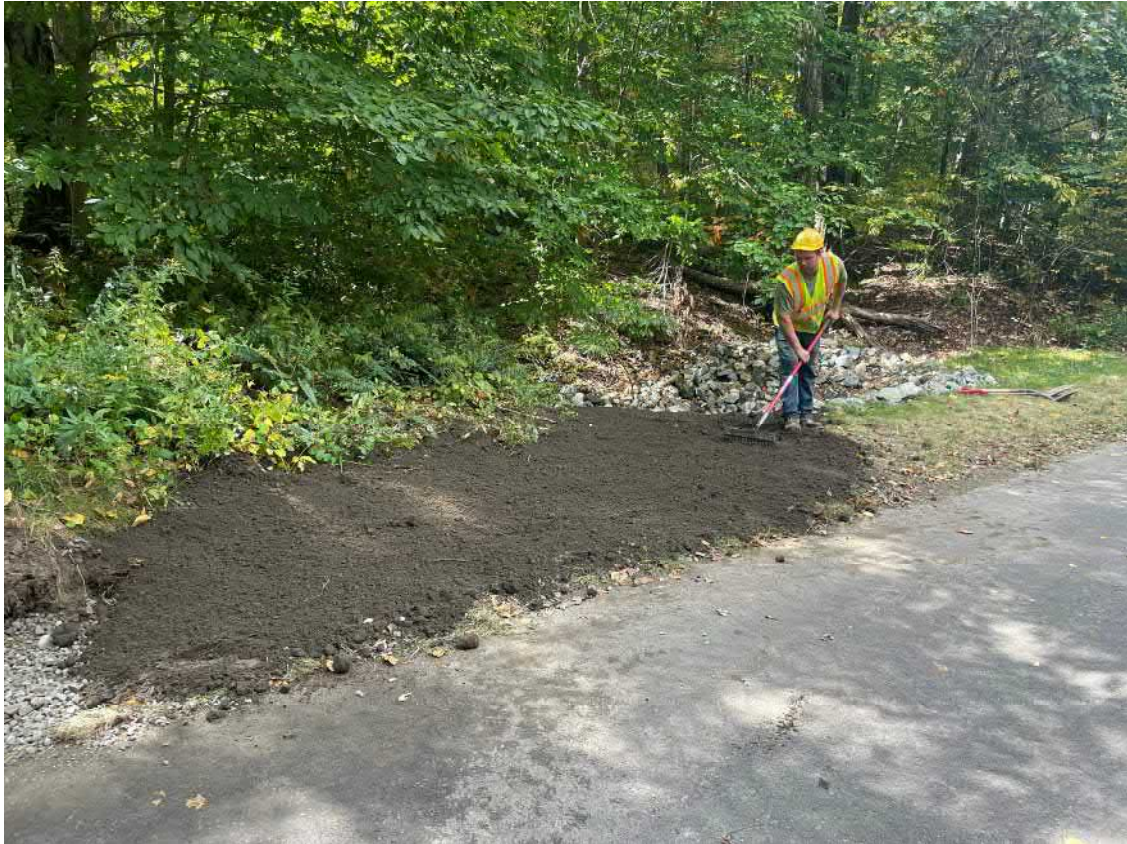
Picture 8: Ludlow raking loam that they placed over filter fabric that was placed on top of the  $\frac{3}{4}$ " stone Ludlow used to cover the 4" plastic drain pipe they just installed on the south edge of the Shared Access Road. Approximately Stations 19+60 to 19+75. View to southwest.

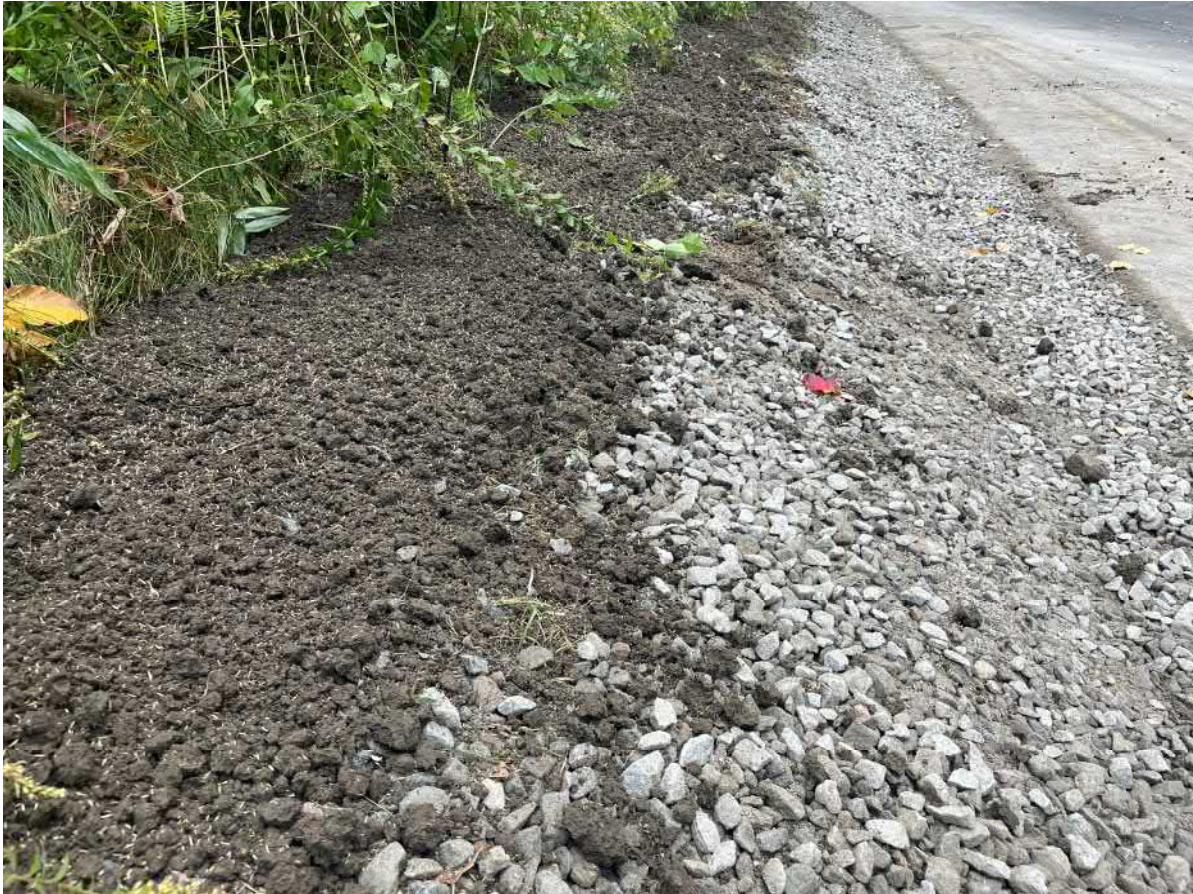
Picture 9: Seeded loam that was placed on the south edge of the 3/4" stone that Ludlow used to cover the 4" plastic drain pipe they just installed on the south edge of the Shared Access Road. View to the west.

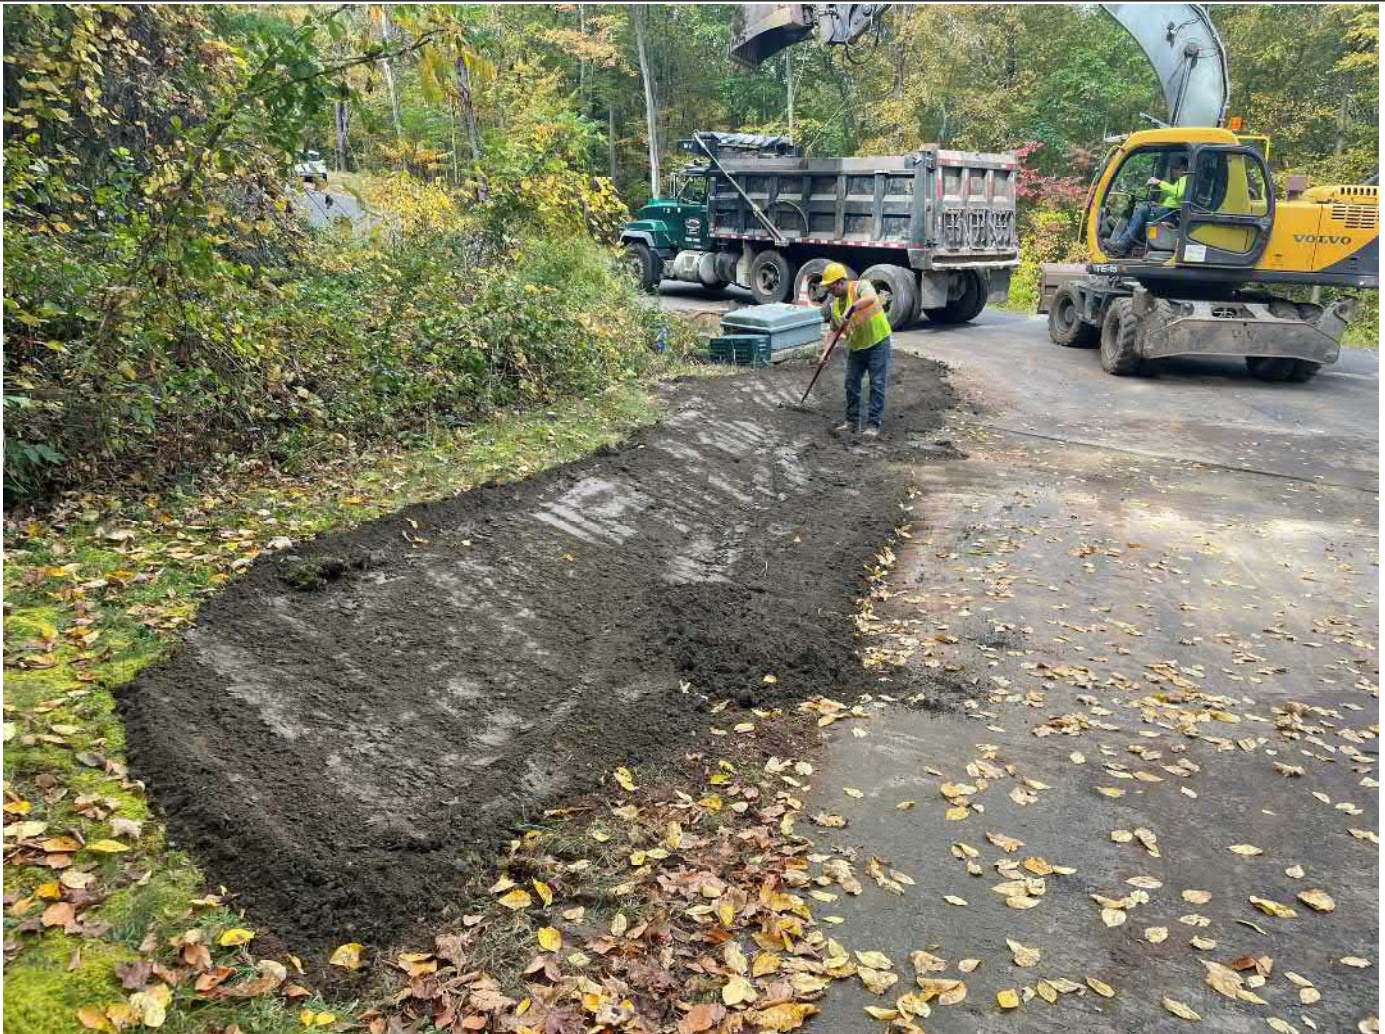
Picture 10: Ludlow raking out loam they placed on the west side of the driveway for the 224 Talcott Ridge Drive property after reshaping the soils to better direct overland flow into the catch basin located at the northwest corner of the driveway. View to the north.

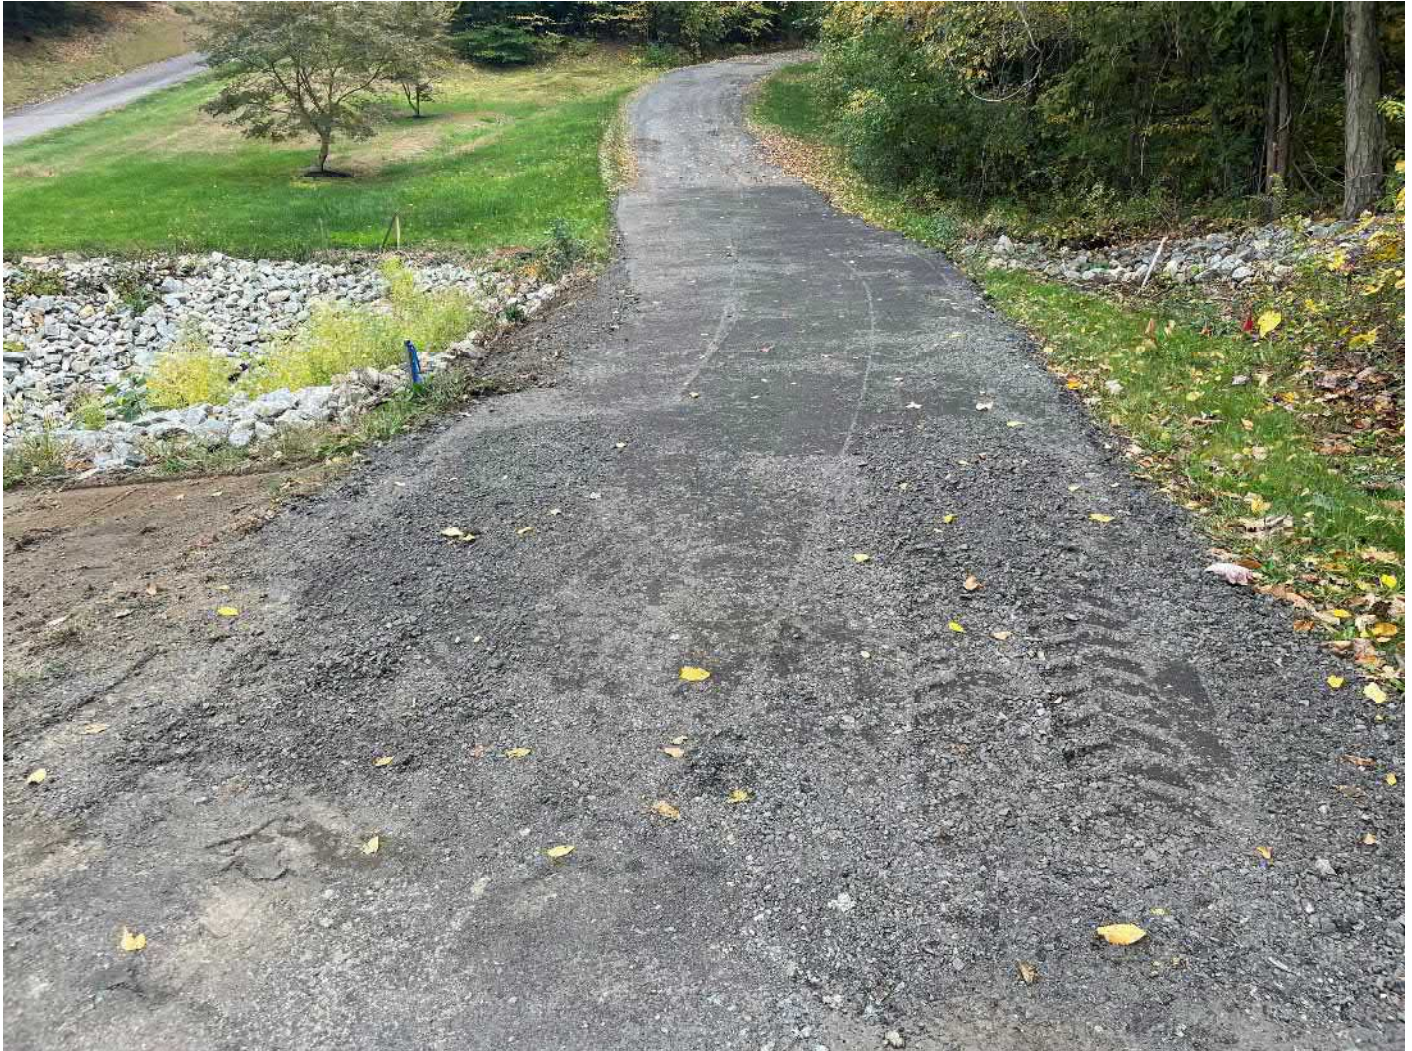
0717: Ludlow is performing some minor grading on the southwest side of the plunge bowl located on the southeast side of the driveway for 216 Talcott Ridge Drive in order to correct some minor drainage issues. Ludlow is grading the slope of the road to drain towards the plunge bowl. Ludlow has placed asphalt millings to fill a slight depression on the portion of the driveway, resulting in the driveway pitching towards the plunge bowl.

Picture 11: Driveway for the 216 Talcott Ridge Drive property that Ludlow reworked today in order to direct overland flow into the plunge bowl located on the northeast side of the driveway. View to the southeast.
