## Daily Report

| Project: | Durham Meadows Pipeline Installation | Date: | October 14, 2021 |
| Location: | S. Main Street and the Shared Access Road, Middletown | Day of Week: | Thursday |
| Project #: | AECOM: 6061487 | Report No: | 343 |

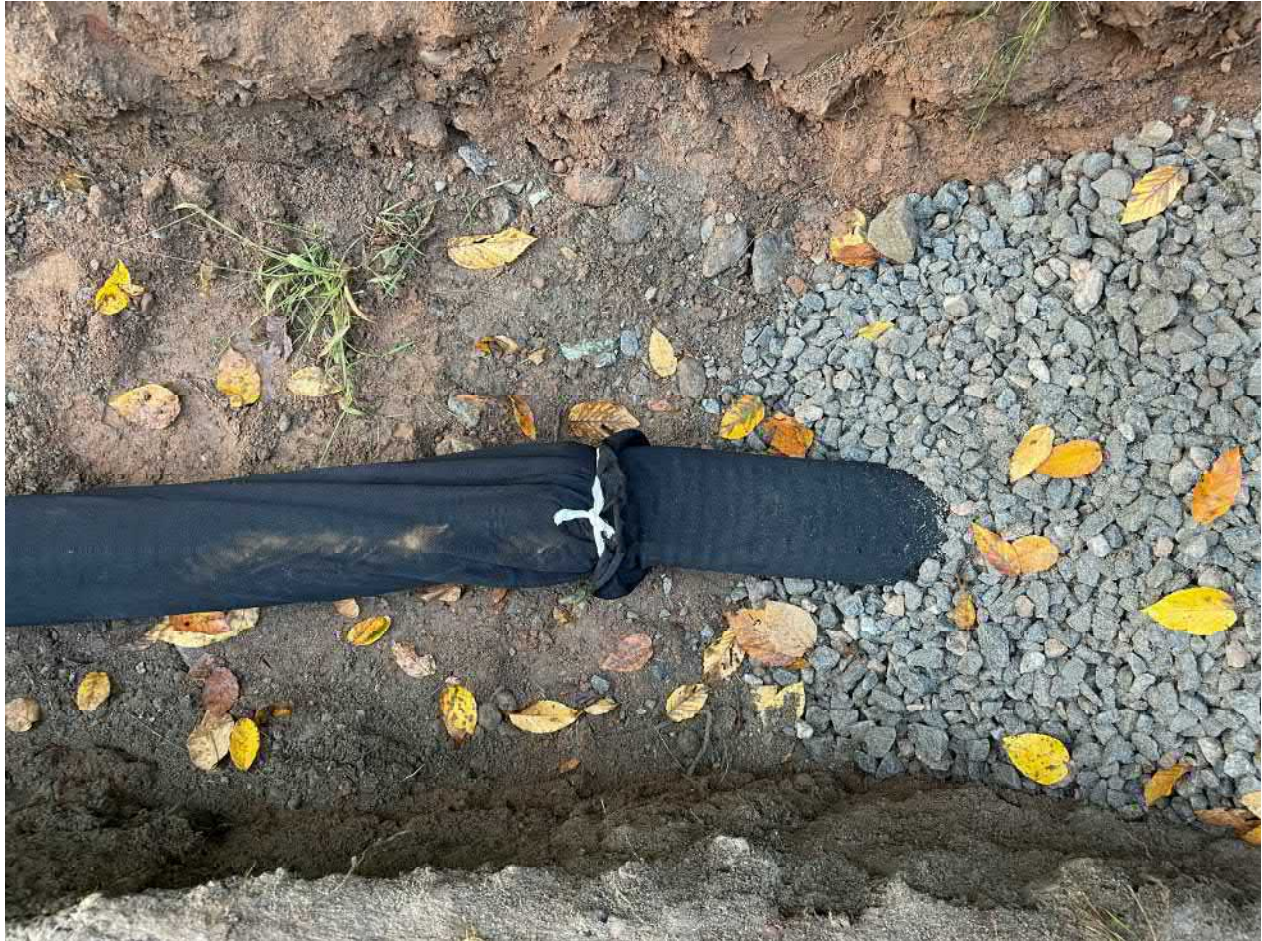
Picture 1: Union of two sections of 4" plastic drainage pipe that were joined together at Station 18+15 on the Shared Access Road.

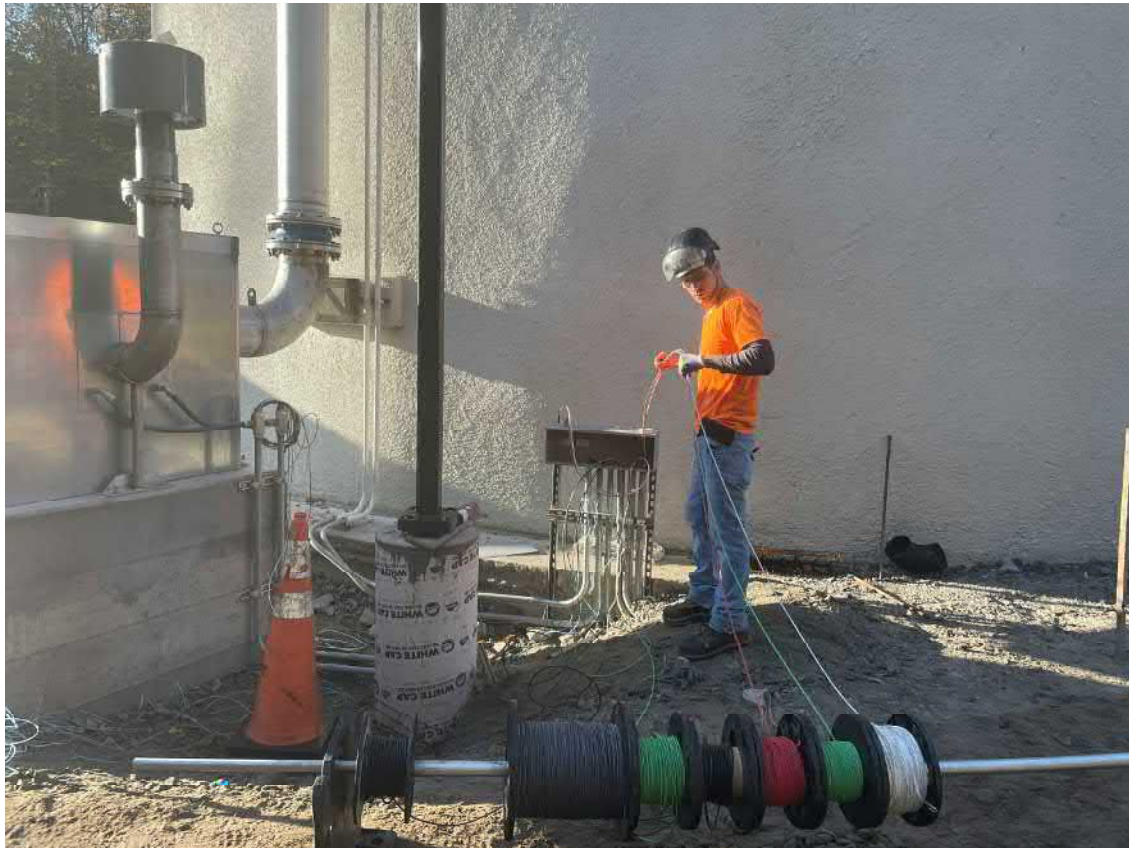
Picture 2: A&R Electrical pulling wire on the northeast side of the water tank located east of the Shared Access Road. View to south.

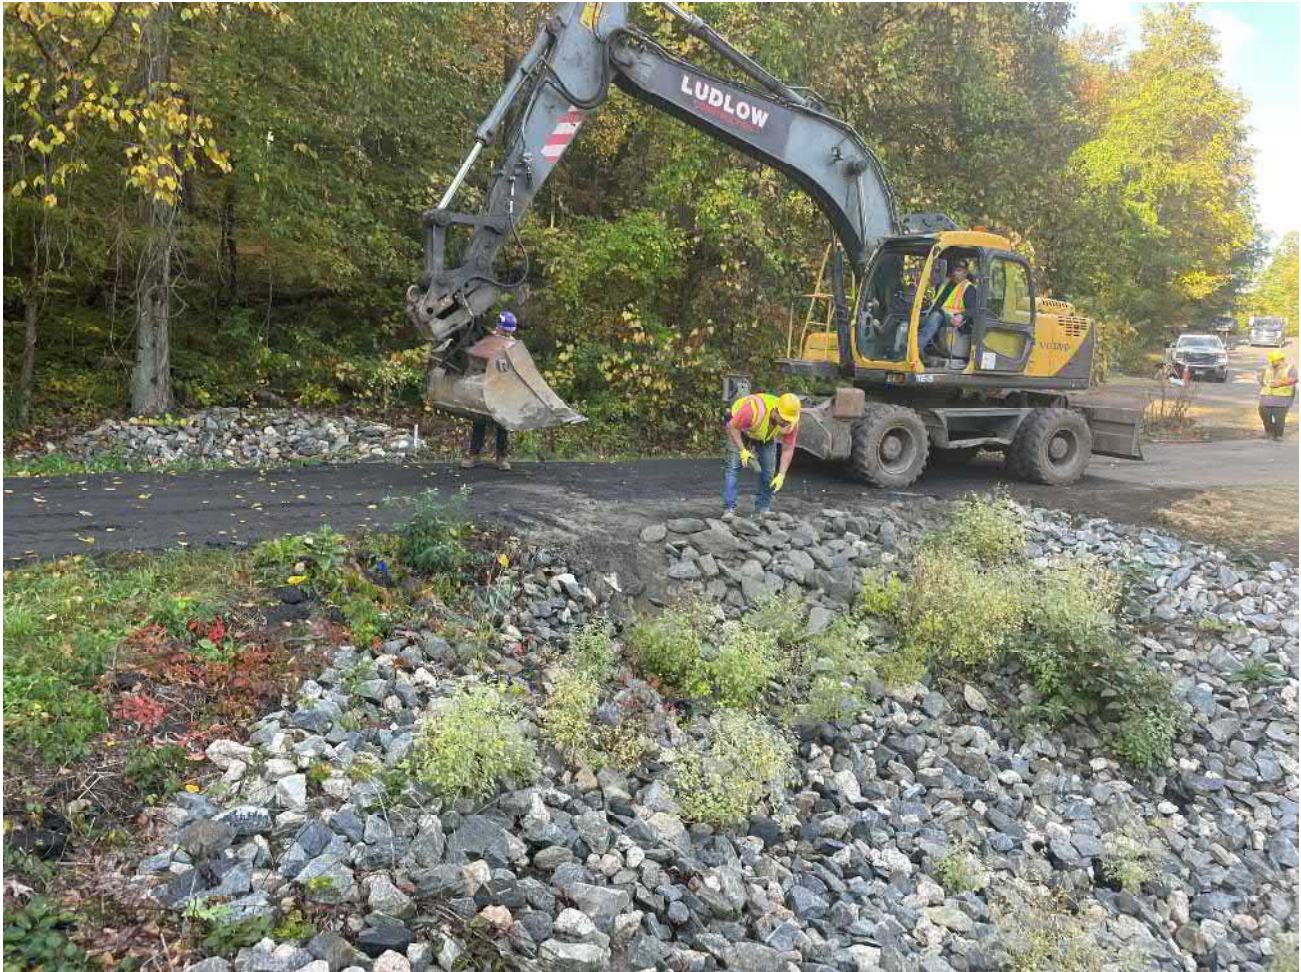
Picture 3: Ludlow placing rock on the plunge bowl located on the northeast side of the driveway for the 216 Talcott Ridge Drive property. View to the southwest.

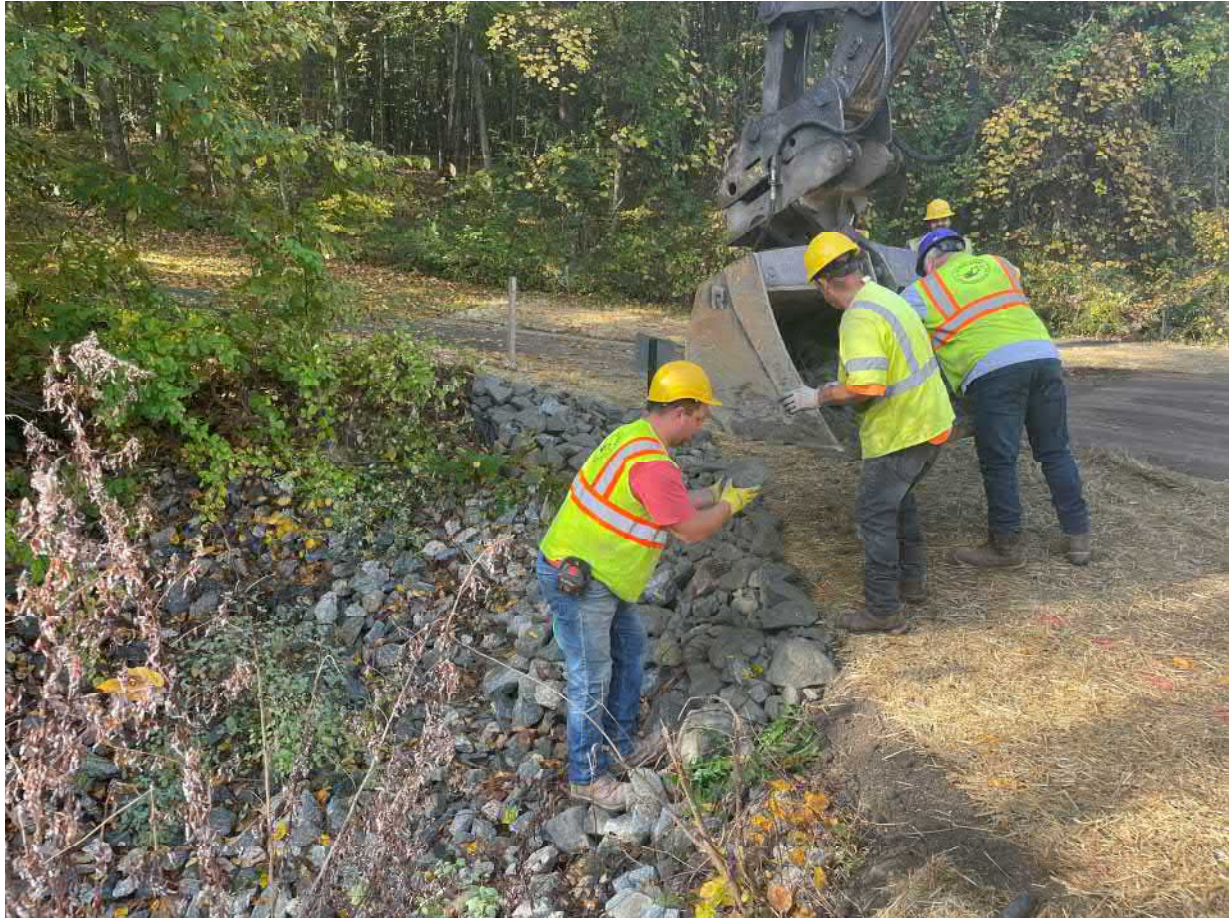
Picture 4: Ludlow placing rock on the plunge bowl located on the east side of the driveway for the 224 Talcott Ridge Drive property. View to the southwest.

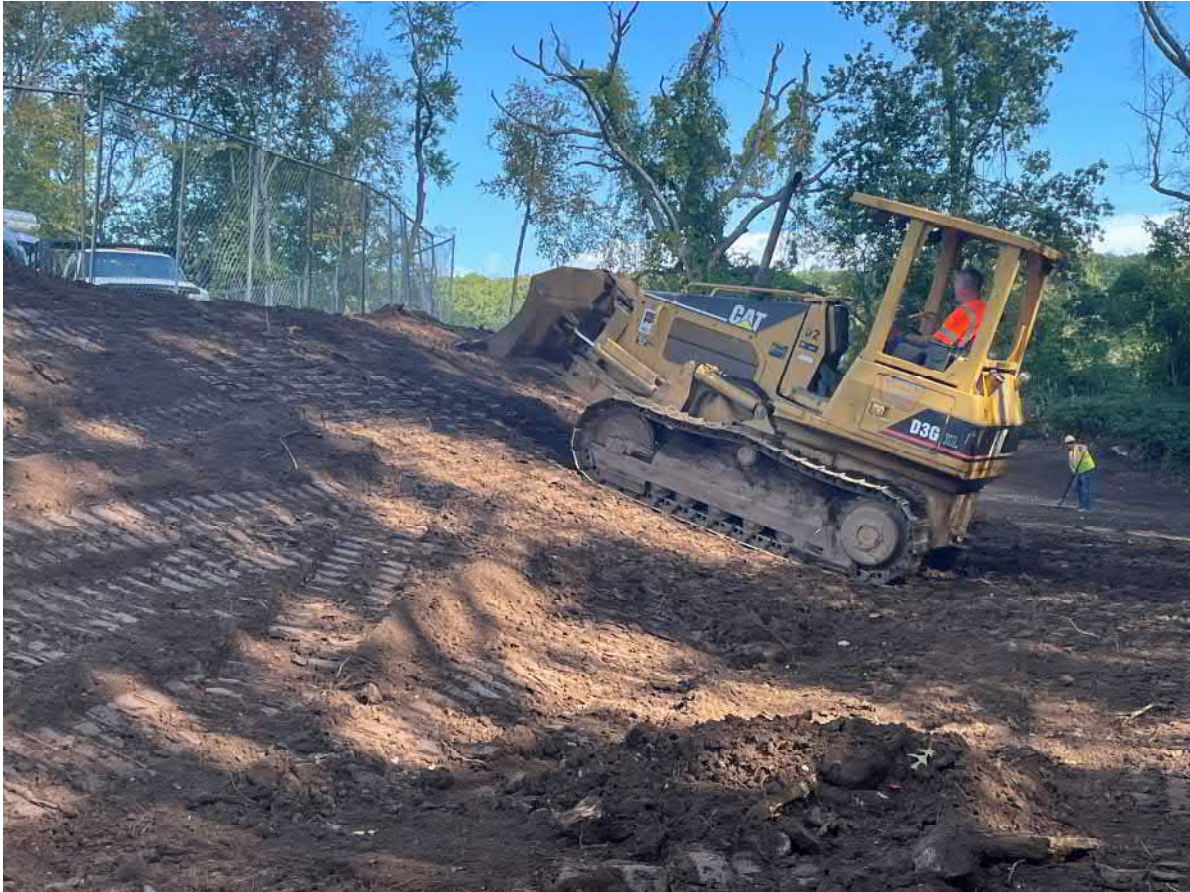
Picture 5: Ludlow grading loam on the slope located to the south of the water tank located to the east of the Shared Access Road. View to east.

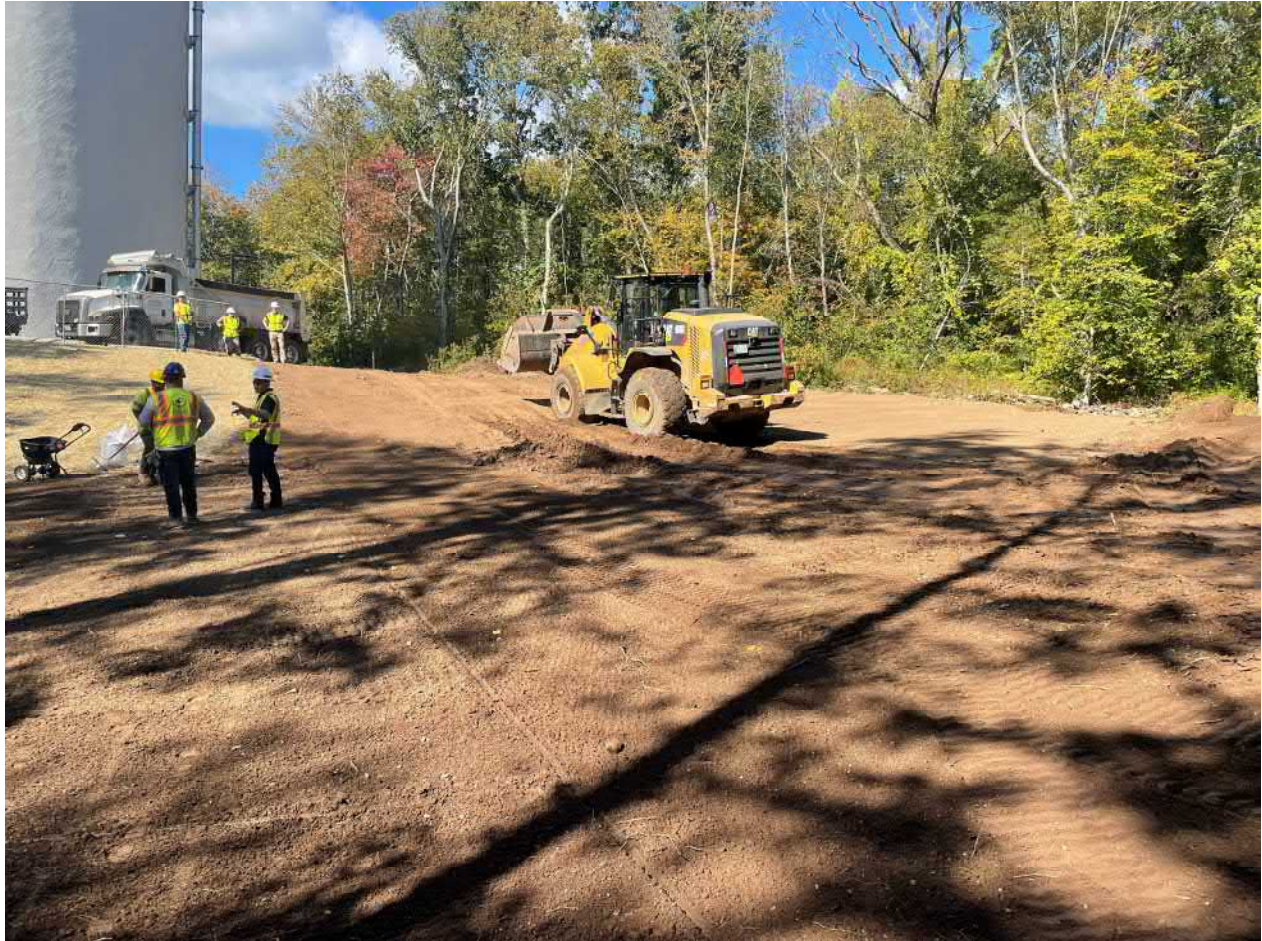
Picture 6: Ludlow grading loam on the slope located to the east of the water tank located to the east of the Shared Access Road. View to northwest.

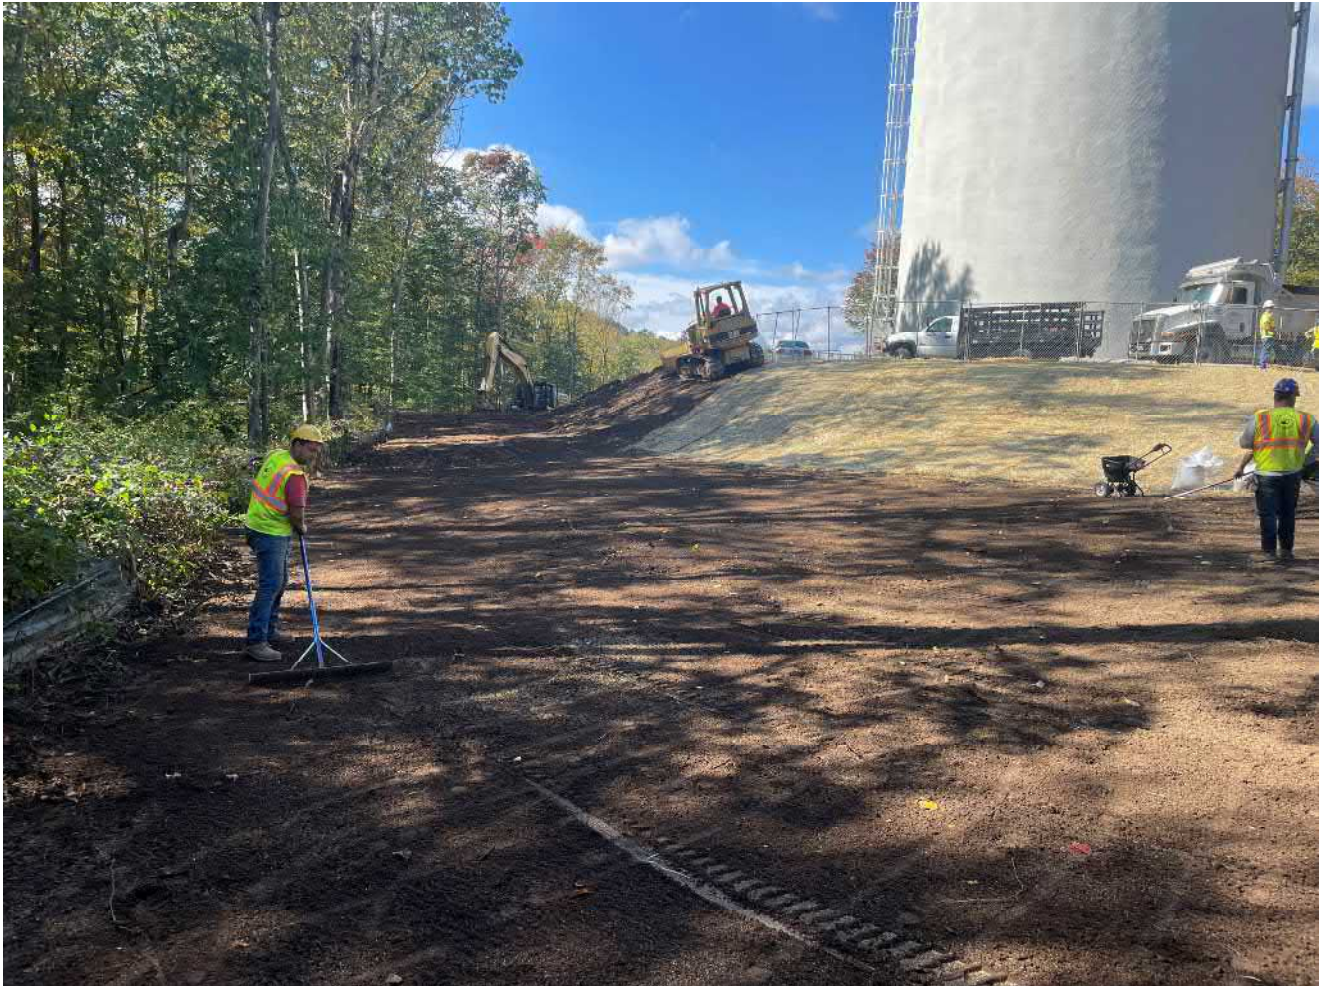
Picture 7: Ludlow raking and seeding loam southeast of the water tank located to the east of the Shared Access Road. View to west.

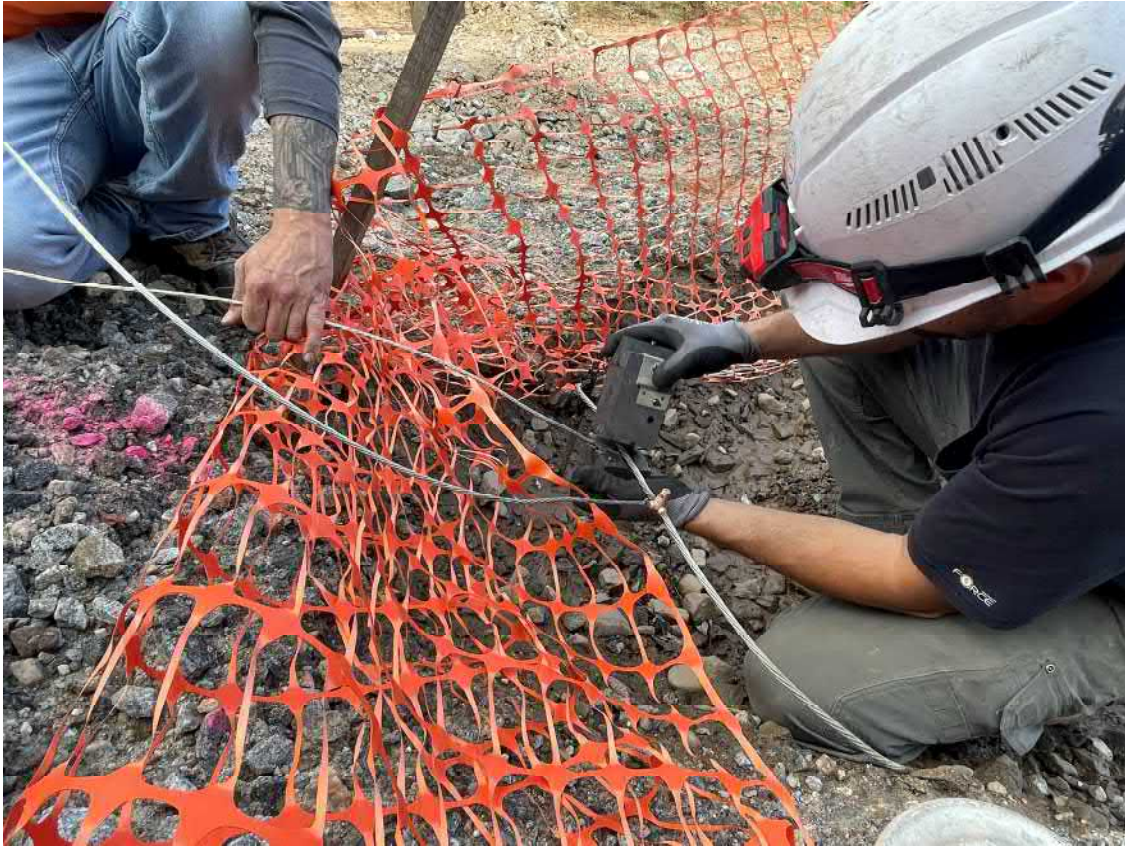
Picture 8: A&R Electrical preparing to cadweld ground wires at the booster station located at Station 750+63.

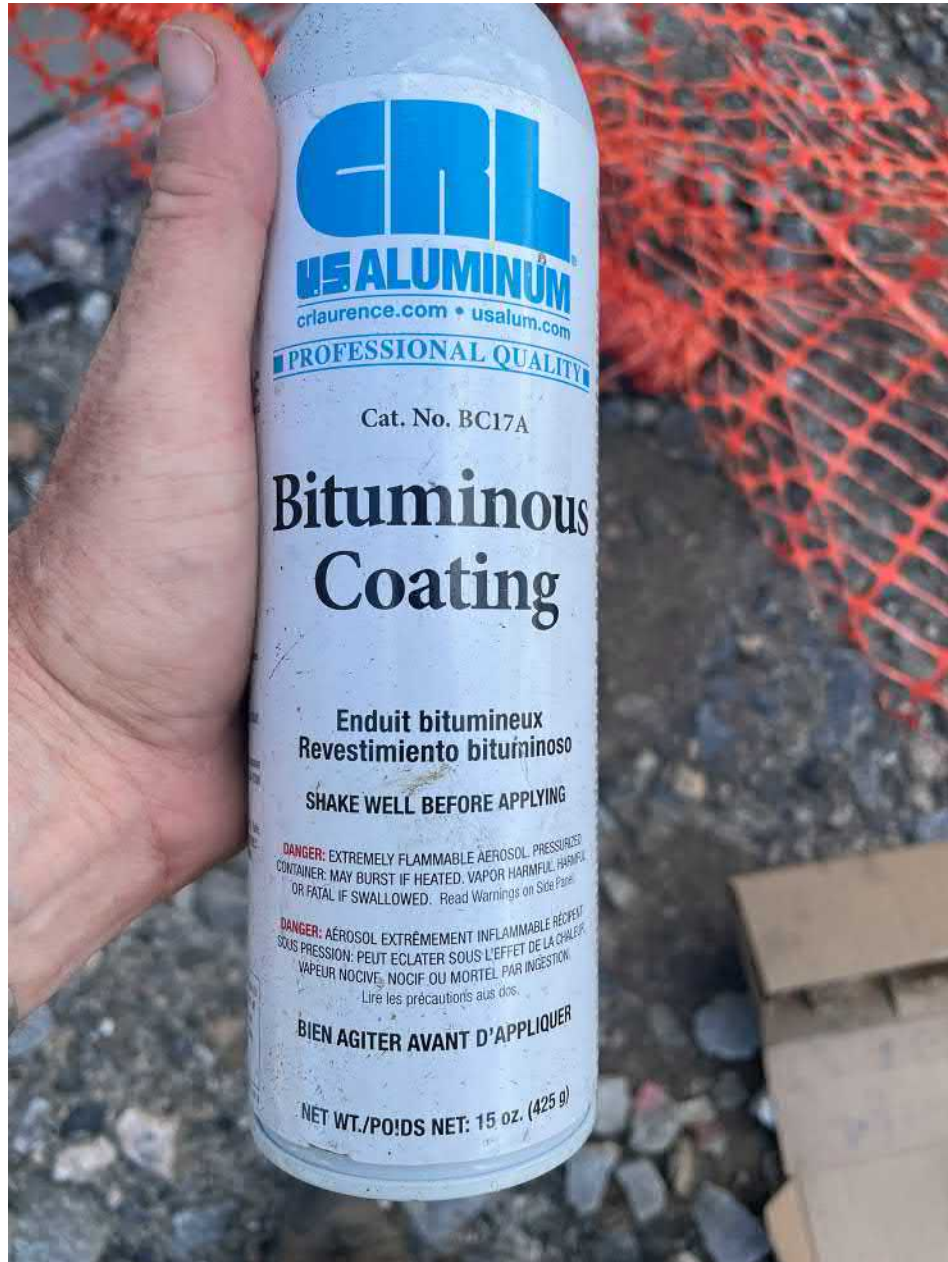
Picture 9: Bituminous coating that A&R Electrical applied to the cadwelded union of grounding wires at the booster station.

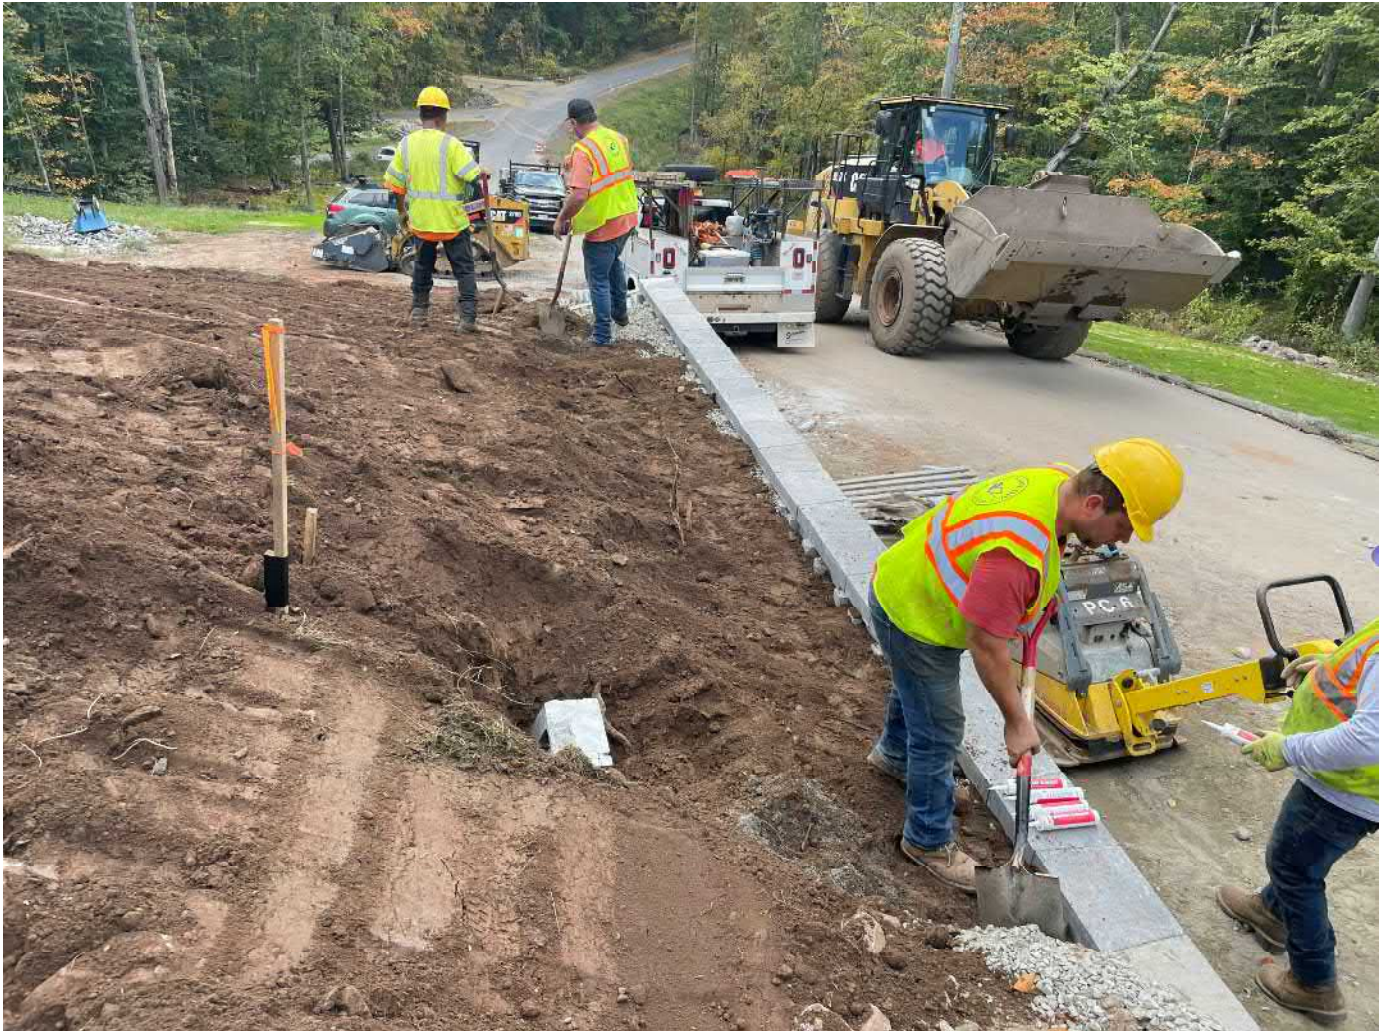
Picture 10: Ludlow placing fill over the ¾" stone that they placed on the south side of the retaining wall located between Stations 10+83 and 11+34. View to the west.
