Daily Report

Project: October 15, 2021 **Durham Meadows Pipeline Installation** Date: Friday Day of Week: Location: S. Main Street and the Shared Access Driveway, Middletown **Report No:** 344 Project #: AECOM: 6061487 Page: 1 of 14 **Contractor: Ludlow Construction**

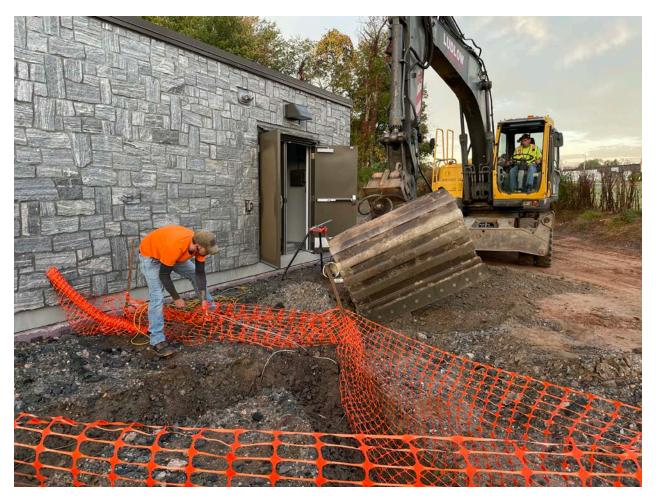
0712: Ludlow and A&R Electrical are at the booster station located at Station 750+63 to bury grounding wires that A&R Electrical recently installed.

Picture 1: Ludlow assisting A&R Electrical in burying newly installed grounding wires on the north side of the booster station located at Station 750+63 on S. Main Street, Middletown. View to the west.

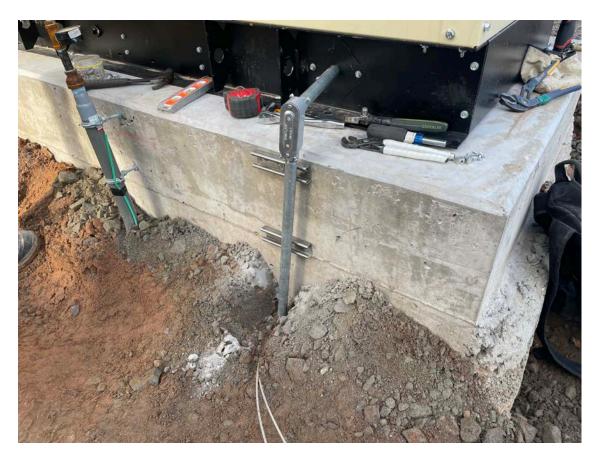
0744: A&R Electrical is installing conduit on the east side of the generator at the booster station. The conduit will house the grounding wire they installed between the generator and the loop of grounding wires previously-installed on the north side of the booster station.

Picture 2: east side of the generator located at the southwest corner of the booster station where A&R Electrical installed conduit for the grounding wires they recently installed. View to west.

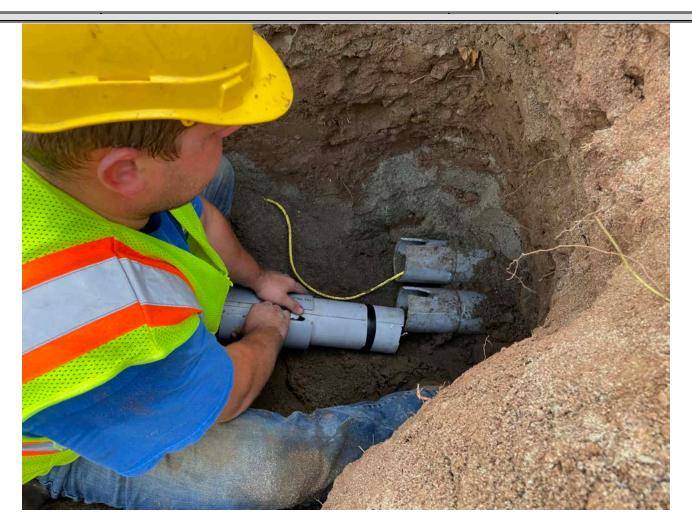
0812: Ludlow is repairing a section of 4" PVC utility conduit located at Station ~10+90 to the south of the retaining wall that they previously damaged, using 4" PVC and several PVC collars.

Picture 3: Ludlow repairing a 4" PVC utility conduit they previously damaged at Station ~10+90 on the Shared Access Driveway. View to the south.

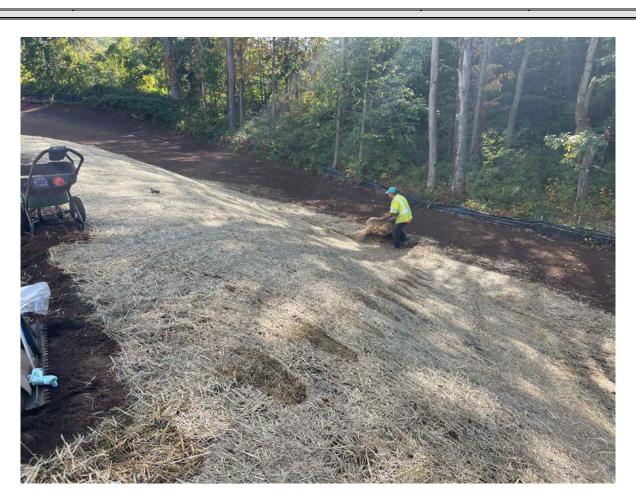
- 0936: Ludlow is excavating along the south edge of the Shared Access Driveway between Stations 11+43 and 11+78 for the construction of a pull-off.
- 0947: Ludlow is placing straw mats on the slope located south of the water tank on top of freshly-seeded loam.

Picture 5: Ludlow placing grass mats for erosion control on the slope to the south of the water tank that is located east of the Shared Access Driveway. View to southeast.

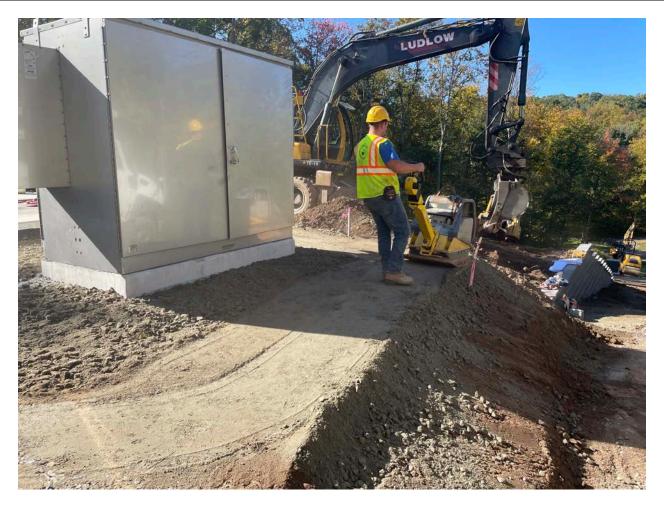
- 1035: Ludlow is using a plate compactor on 1.5"-minus gravel that was placed around the perimeter of the electrical enclosure located on the north of the altitude vault. Ludlow is grading the slope located west of the altitude valve vault with the CAT D3G XL dozer. Ludlow is also using an excavator to grade fill at the top of the slope immediately west of the altitude valve vault.

Picture 6: Ludlow using a plate compactor on 1.5"-minus gravel that was placed around the perimeter of the electrical enclosure located on the north side of the altitude valve vault at the water tank work zone. View to west.

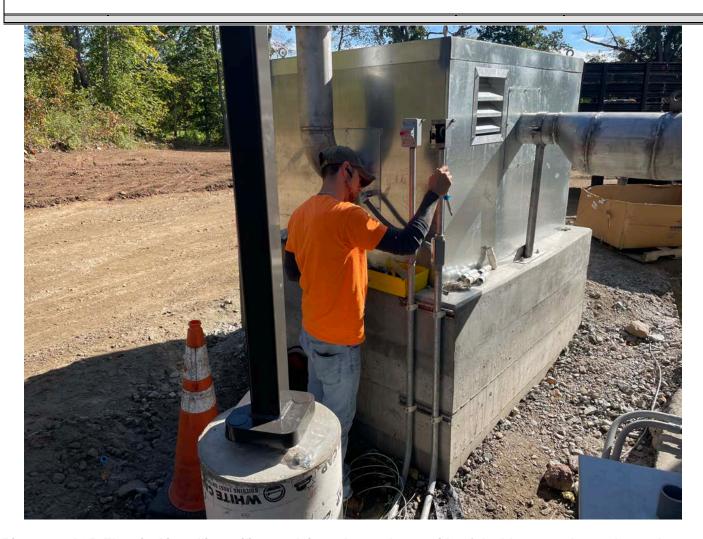
- 1205: Ludlow is using Versa-LOK concrete adhesive to glue cap stones on top of the retaining wall located between Stations 10+83 and 11+34.
- 1209: A&R Electrical continues to work on the northwest side of the blower located to the northeast of the water tank. A&R Electrical is currently attaching 1" steel conduits to the northwest side of the blower pad.

Picture 7: A&R Electrical installing utility conduit on the northwest side of the blower enclosure located on the northeast side of the water tank. View to southeast.

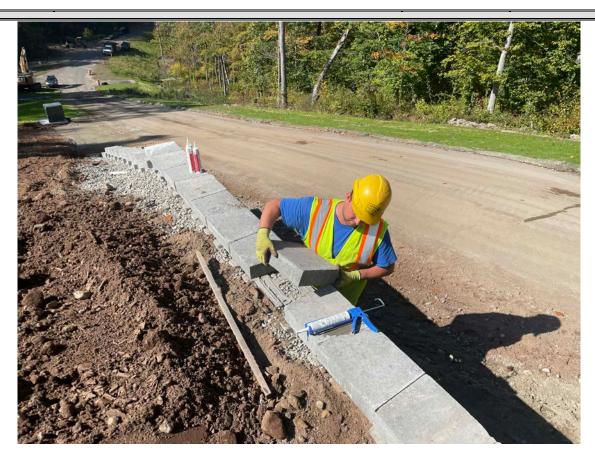
Picture 8: Ludlow securing capstones on the retaining wall located between Stations 10+83 and 11+34 with concrete adhesive. View to the west.

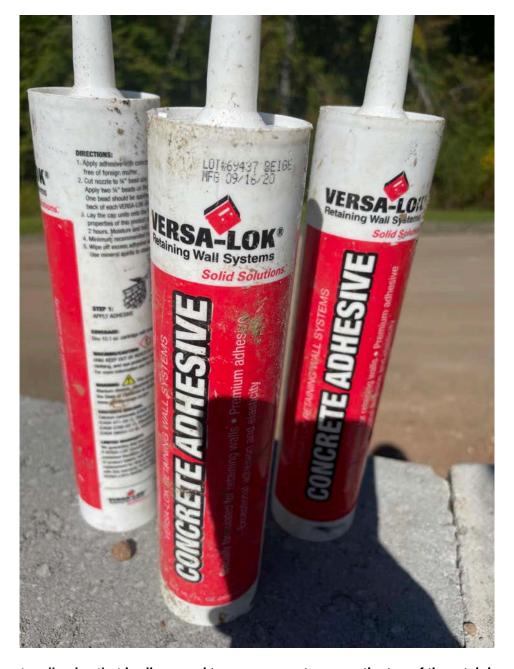
Picture 9: Concrete adhesive that Ludlow used to secure capstones on the top of the retaining wall located between Stations 10+83 and 11+34.

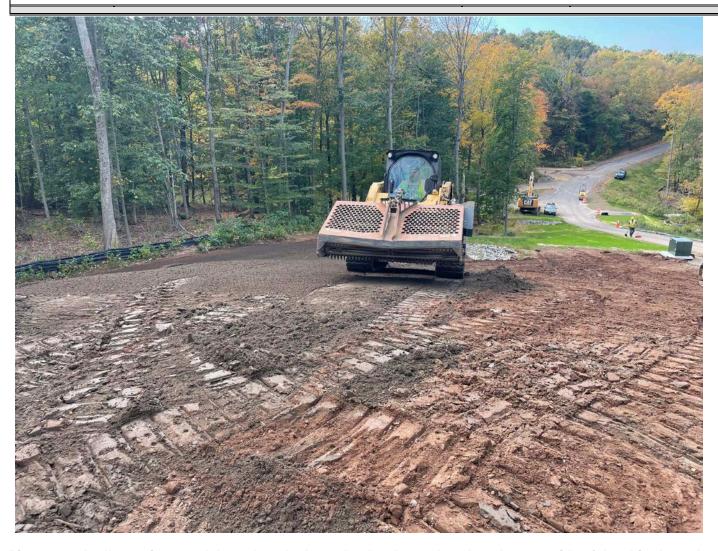
Picture 10: Ludlow using a rock hound on the loam that has been placed on the west side of the altitude vault. View to the west.

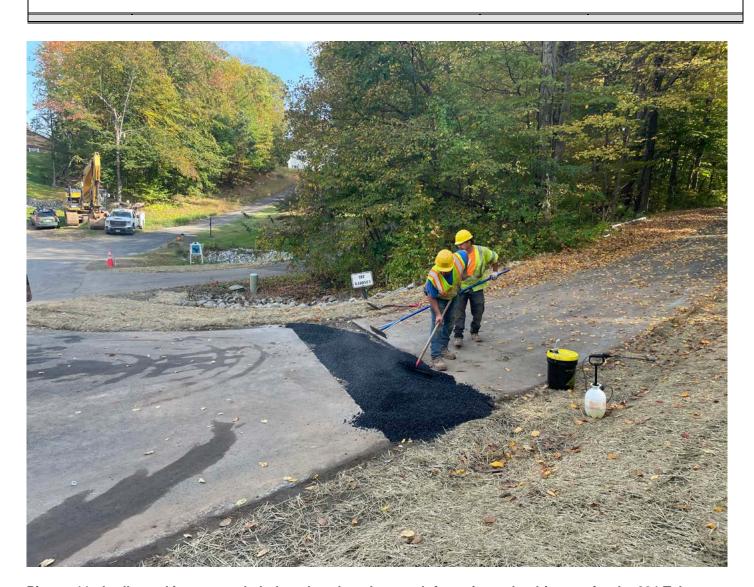
1436: Ludlow begins to place asphalt on the trench footprint at the driveway for the 224 Talcott Ridge Drive property.

Picture 11: Ludlow raking out asphalt that placed on the trench footprint at the driveway for the 224 Talcott Ridge Drive residence. View to the east.
