Daily Report

Project:	Durham Meadows Pipeline Installation	Date:	October 27, 2021
Location:	Main Street, Durham, Shared Access Driveway, Middletown	Day of Week:	Wednesday
Project #:	AECOM: 6061487	Report No:	351
Contractor:	Ludlow Construction	Page:	1 of 14

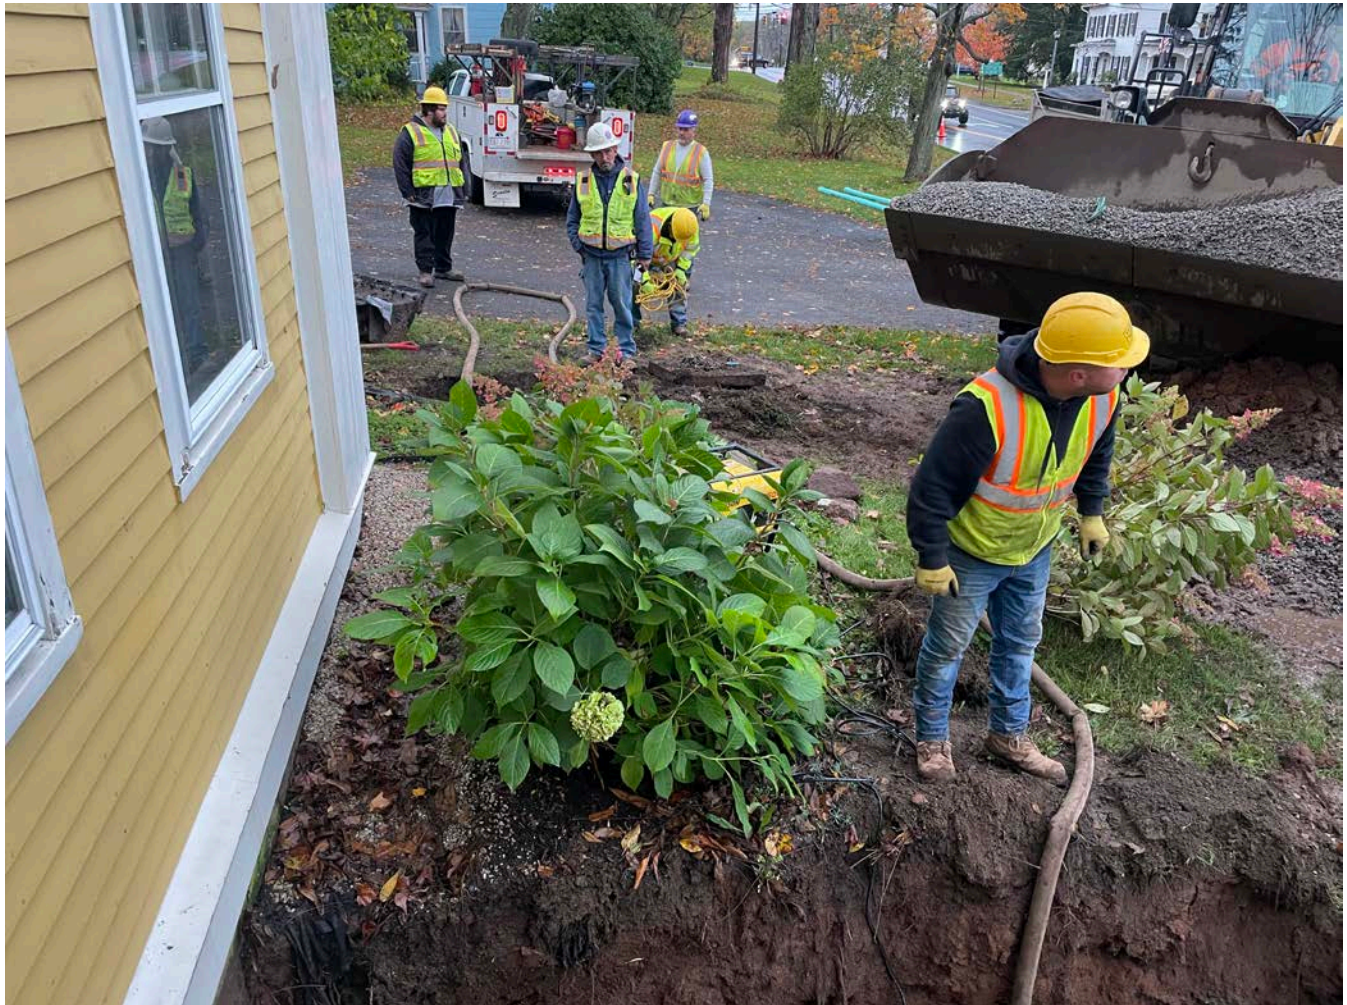
0751: Ludlow is setting a pump surrounded by ¾" stone in the trench they are excavating on the east side of the 202 Main Street residence. The discharge end of the hose has been directed into the septic tank opening located on the northeast corner of the house.

Picture 1: Ludlow pumping water from the excavation they made on the east side of the 202 Main Street, Durham, residence into the septic tank located on the northeast corner of the house. View to the north.

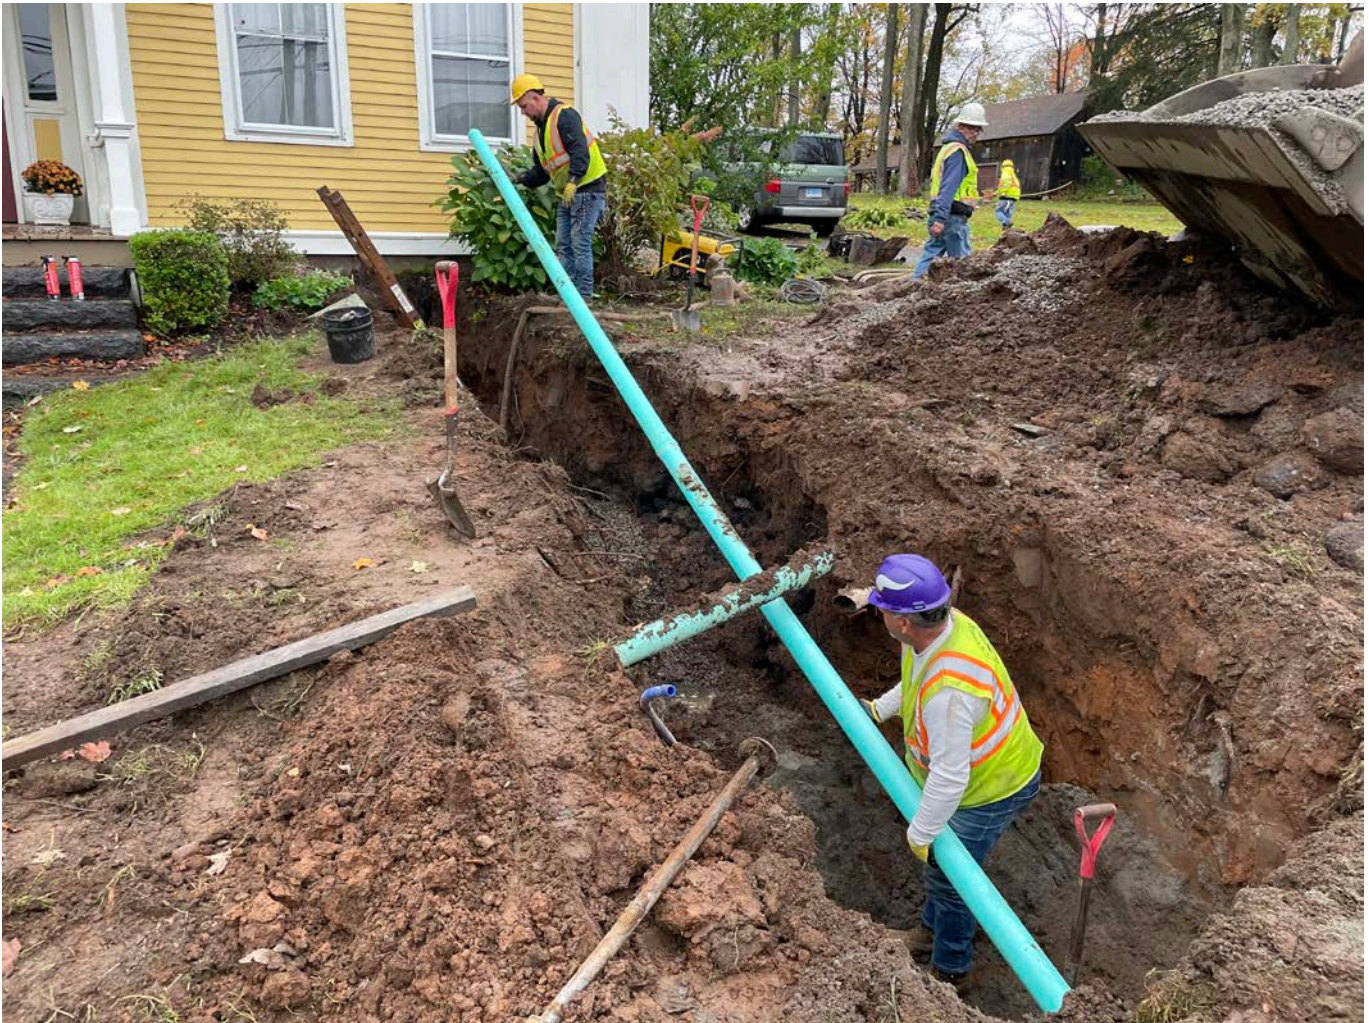
0831: Ludlow has placed a sleeve of 4" PVC SDR35 sewer pipe around the 1" copper water service pipe that they are installing on the east side of the 202 Main Street residence. Ludlow is preparing to seal both ends of the 4" PVC around the 1" copper water service line with polyurethane foam sealant.

Picture 2: Ludlow placing 4" PVC sewer pipe over the 1" copper water service line they are installing on the east side of the 202 Main Street residence. View to the west.

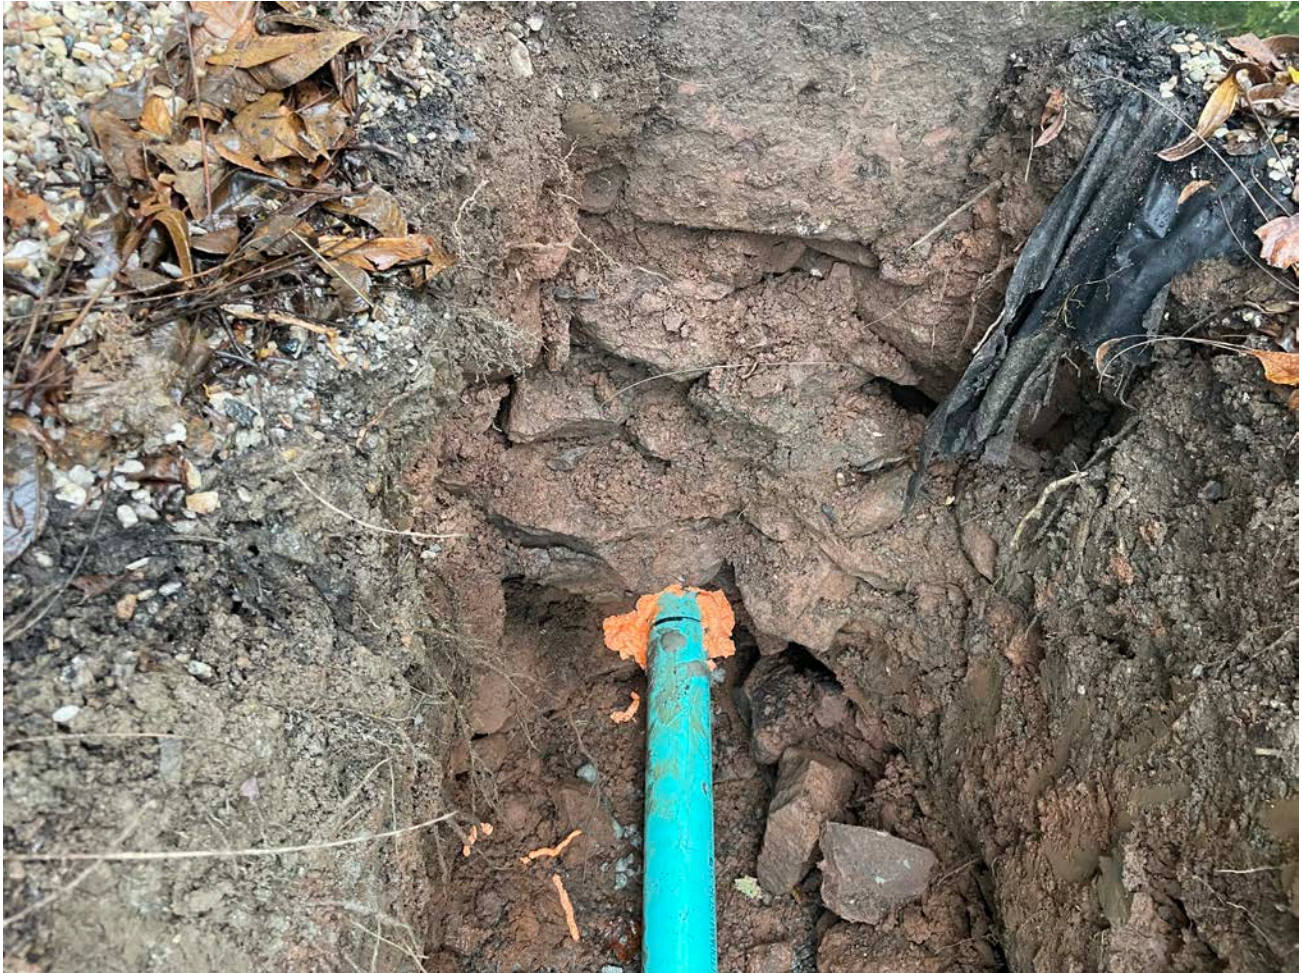
0854: Ludlow has secured 1" copper water service line into the fieldstone foundation of the 202 Main Street residence with non-shrink grout. Ludlow is currently applying polyurethane foam sealant around the 1" copper pipe that Ludlow placed inside of the 4" PVC sewer pipe where the PVC pipe comes in contact with the home's fieldstone foundation.

Picture 3: 4" PVC sewer pipe that Ludlow placed over the 1" copper water service line they are installing on the east side of the 202 Main Street residence. Ludlow has placed polyurethane foam sealant between the 4" PVC and the 1" copper line. View to the west.

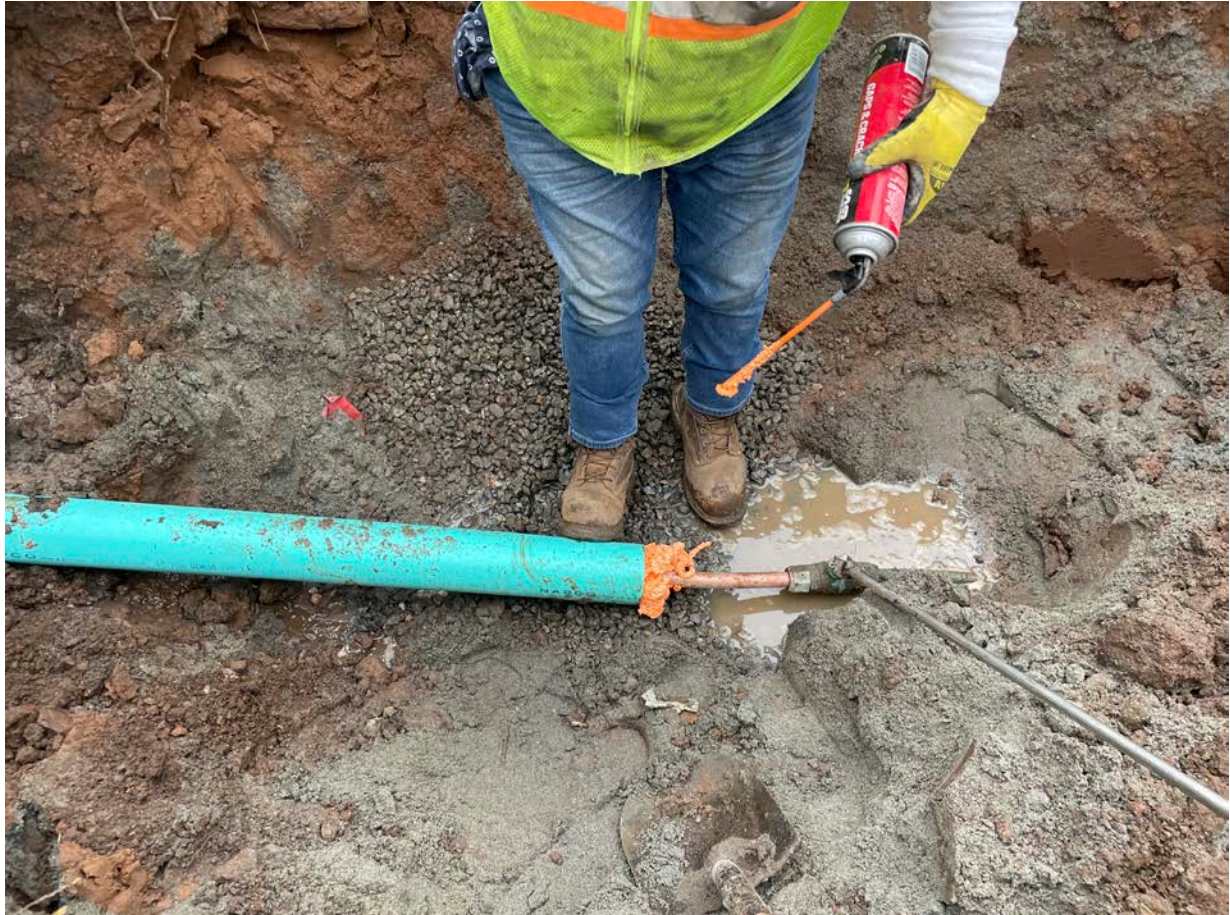
0908: Ludlow is currently applying polyurethane foam sealant around the east end of the 4" PVC sewer pipe around the 1" copper water service line.

Picture 4: Ludlow has just placed polyurethane foam sealant between the 4" PVC and the 1" copper water service line they are installing on the east side of the 202 Main Street residence. View is of the east side of the 1" copper water line where it connects to the curb stop for the 202 Main Street property. View to the north.

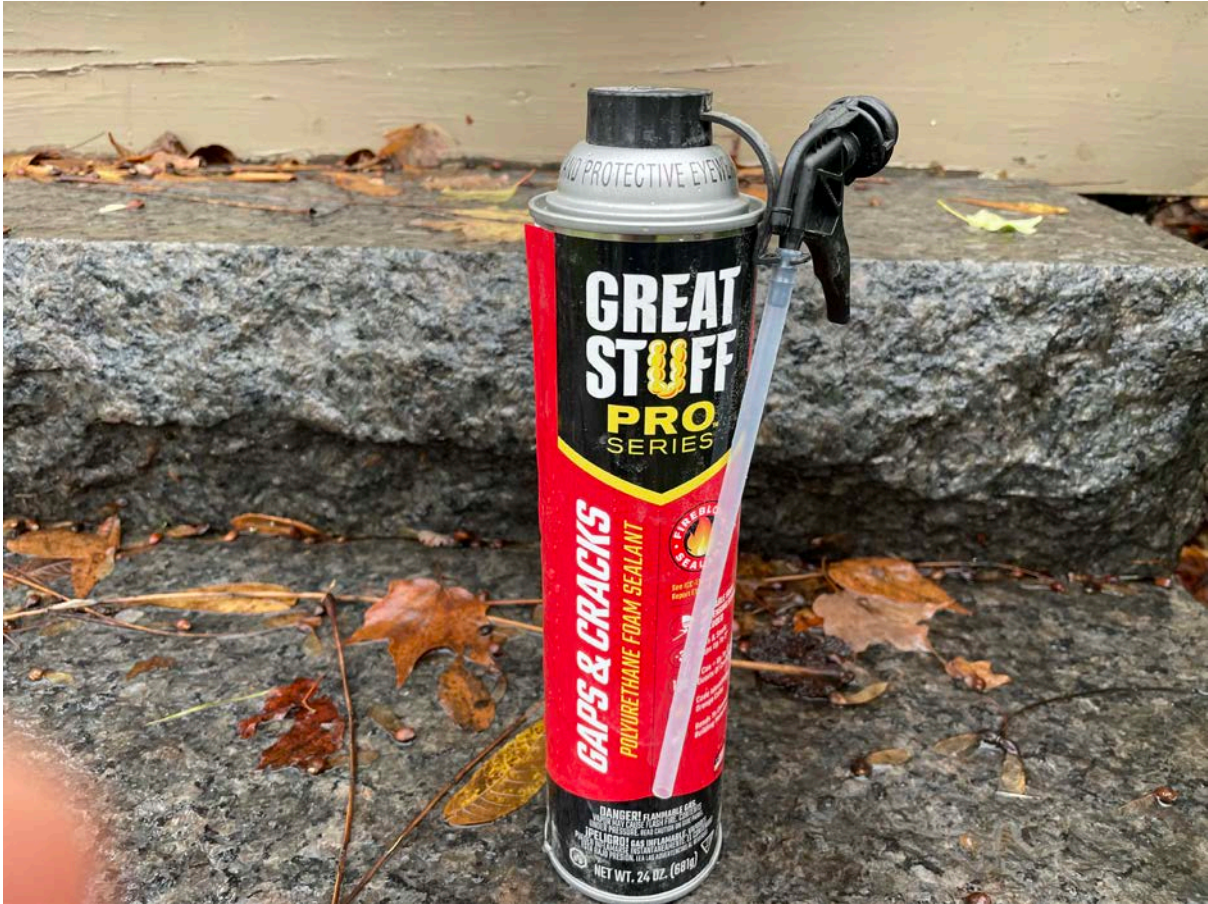
Picture 5: Polyurethane foam sealant that Ludlow used as a seal between the 4" PVC sewer pipe and the 1" copper water service line they are installing on the east side of the 202 Main Street residence.

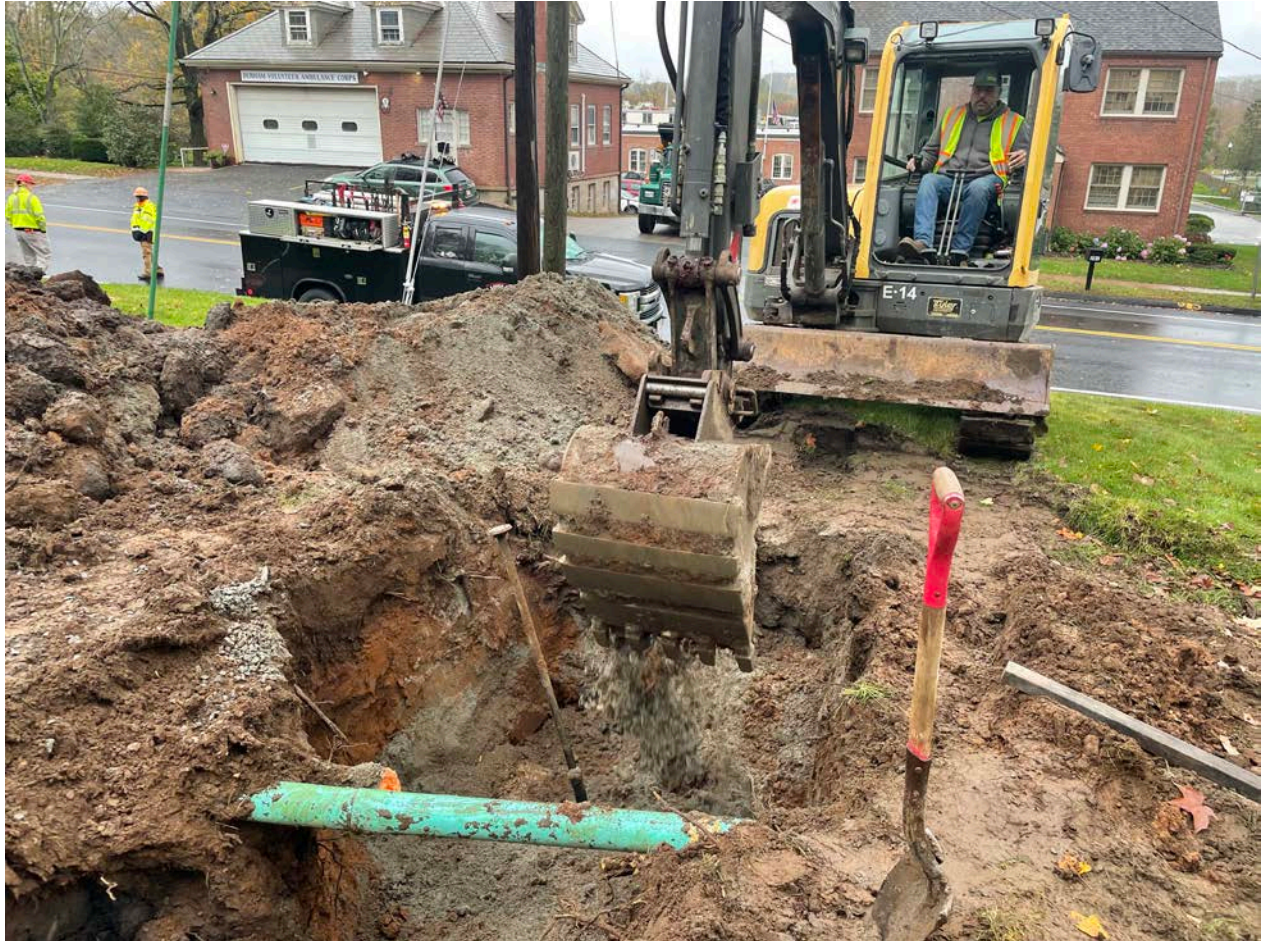
Picture 6: Ludlow placing sand over the 4" PVC sewer pipe that was placed as a sleeve over the 1" copper water service line they installed on the east side of the 202 Main Street residence. View to the west.

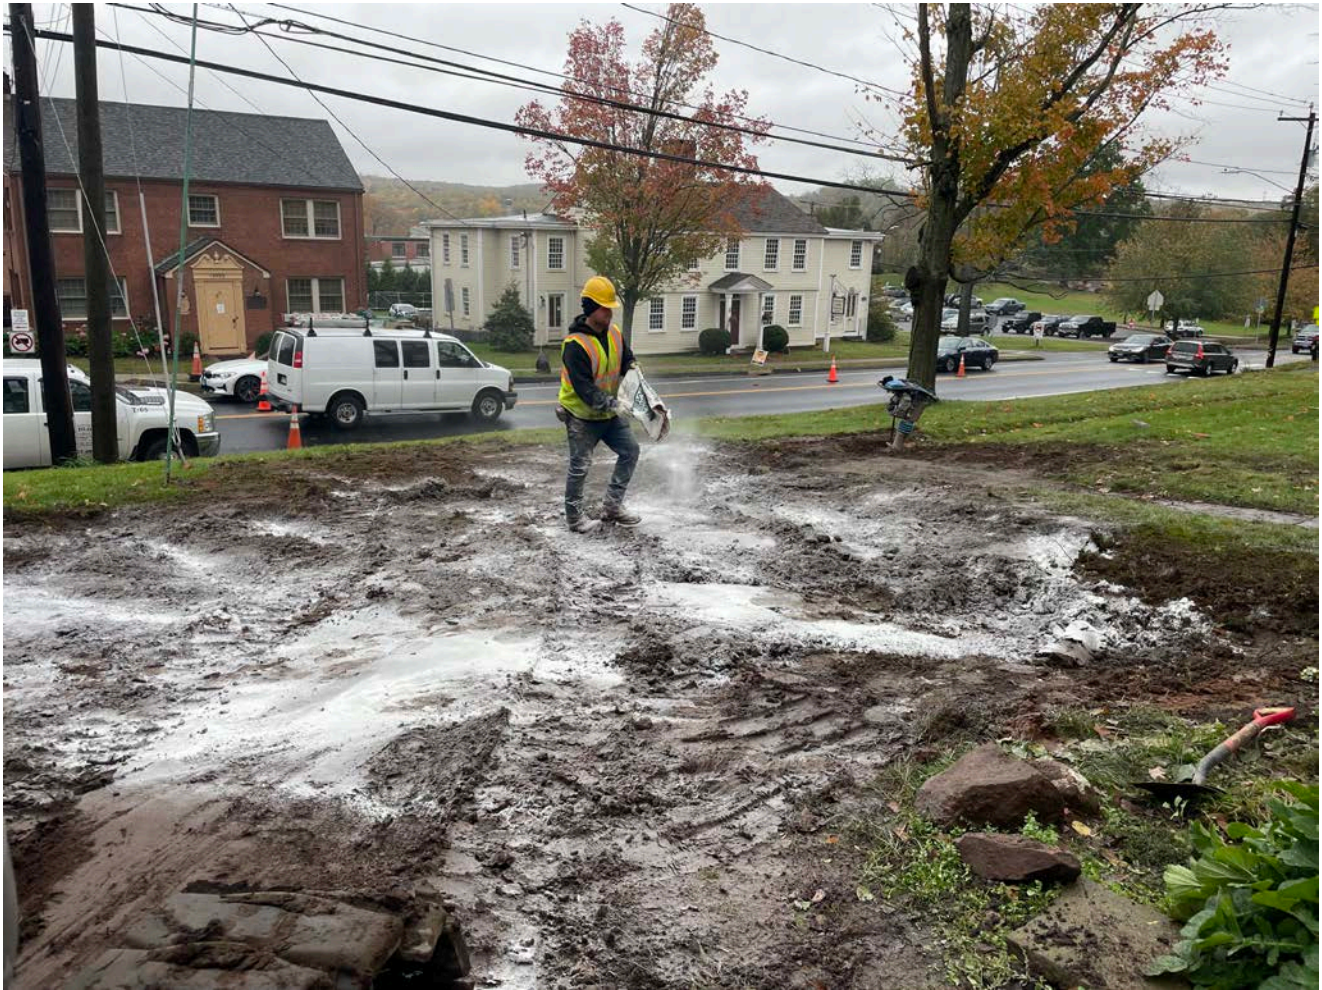
1029: Ludlow is spreading lime on top of the fill they used to backfill the trench and to repair the sections of the lawn that were disturbed during the installation of a 1" copper water service line at the 202 Main Street property.

Picture 7: Ludlow is spreading lime on top of the fill they used to backfill the trench and to repair the sections of the lawn that were disturbed during the installation of a 1" copper water service line at the 202 Main Street property. View to the southeast.

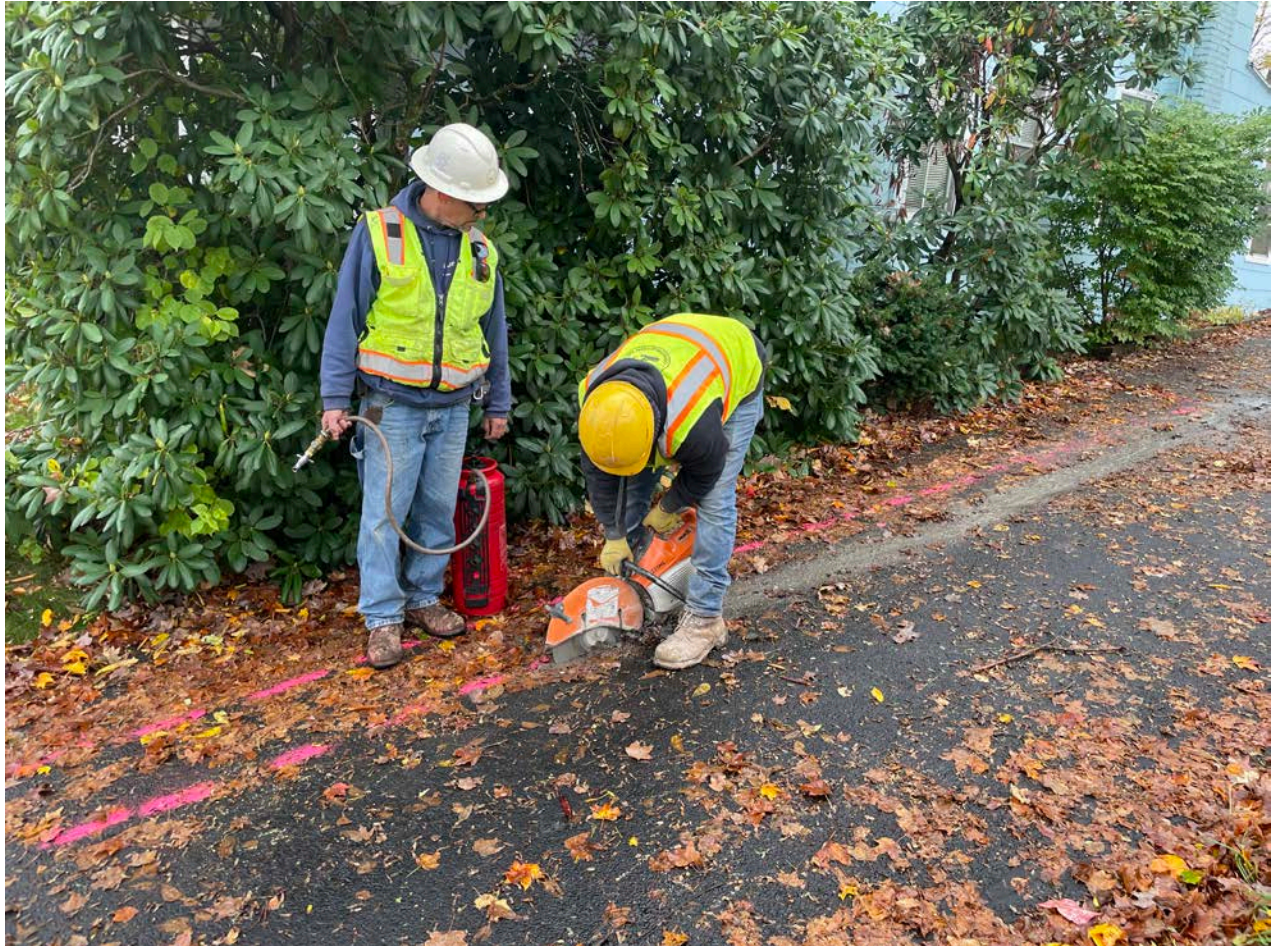
1154: Ludlow is using a cutoff saw to cut the outline of a trench on the asphalt driveway of the 208 Main Street property.

Picture 8: Ludlow saw cutting a footprint for the trench they will excavate on the asphalt driveway of the 208 Main street residence for the installation of a 1" copper water service line. View to the southwest.

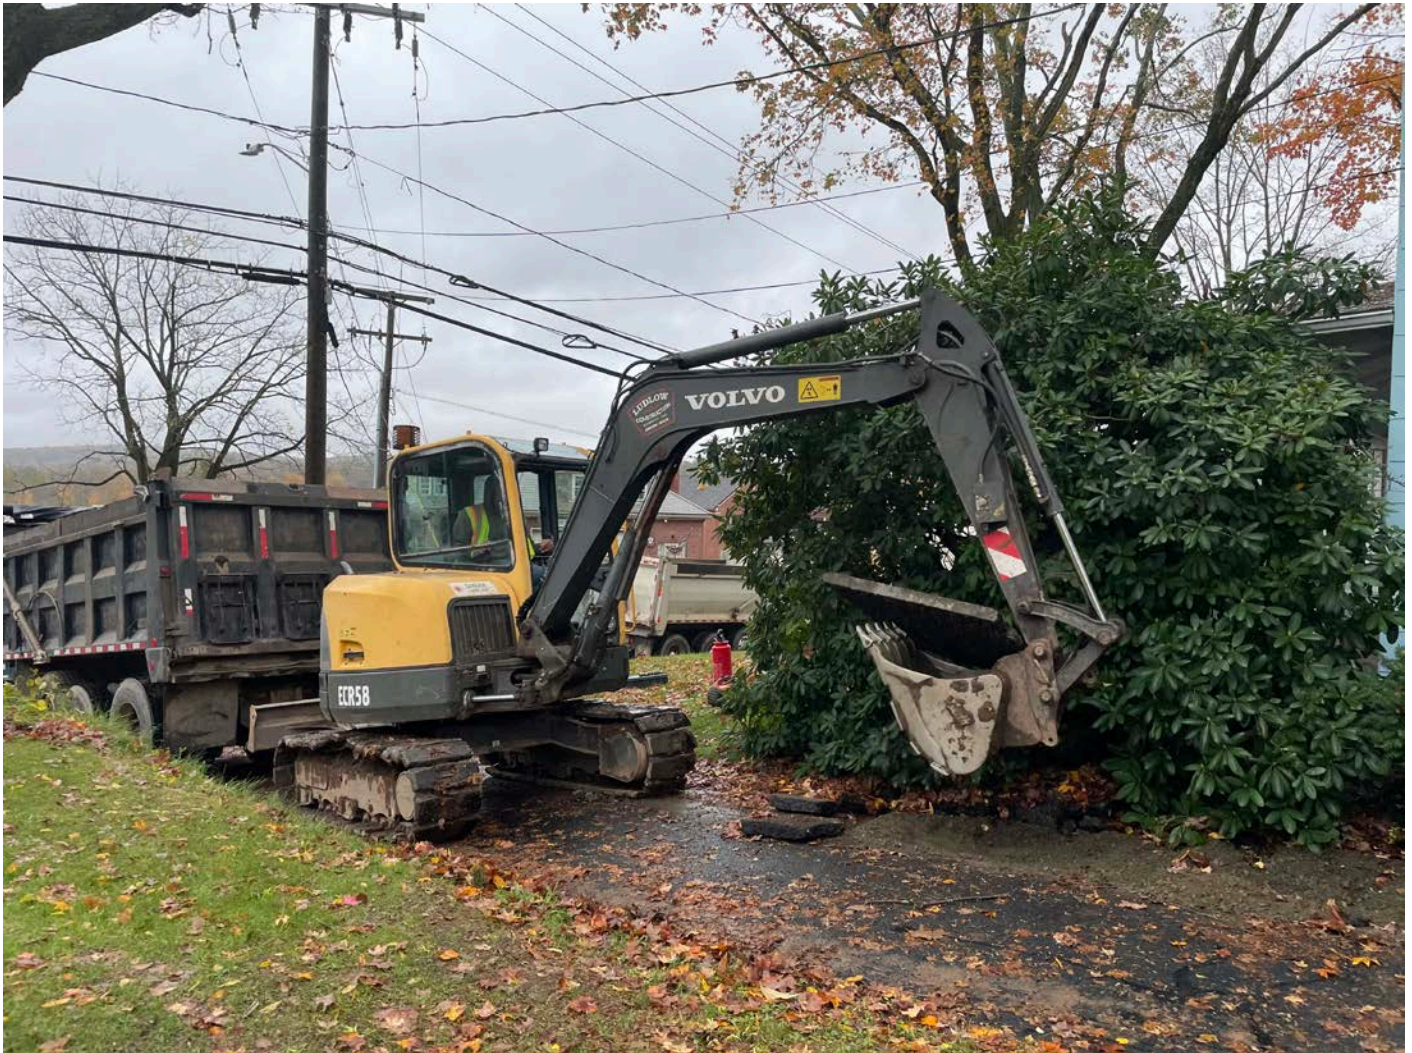
1216: Ludlow begins to remove asphalt from the footprint of the trench they will excavate for the installation of a 1" copper water service line at the 208 Main Street residence.

Picture 9: Ludlow removing asphalt from the driveway of the 208 Main Street residence as part of the installation of a 1" copper water service line. View to the southeast.

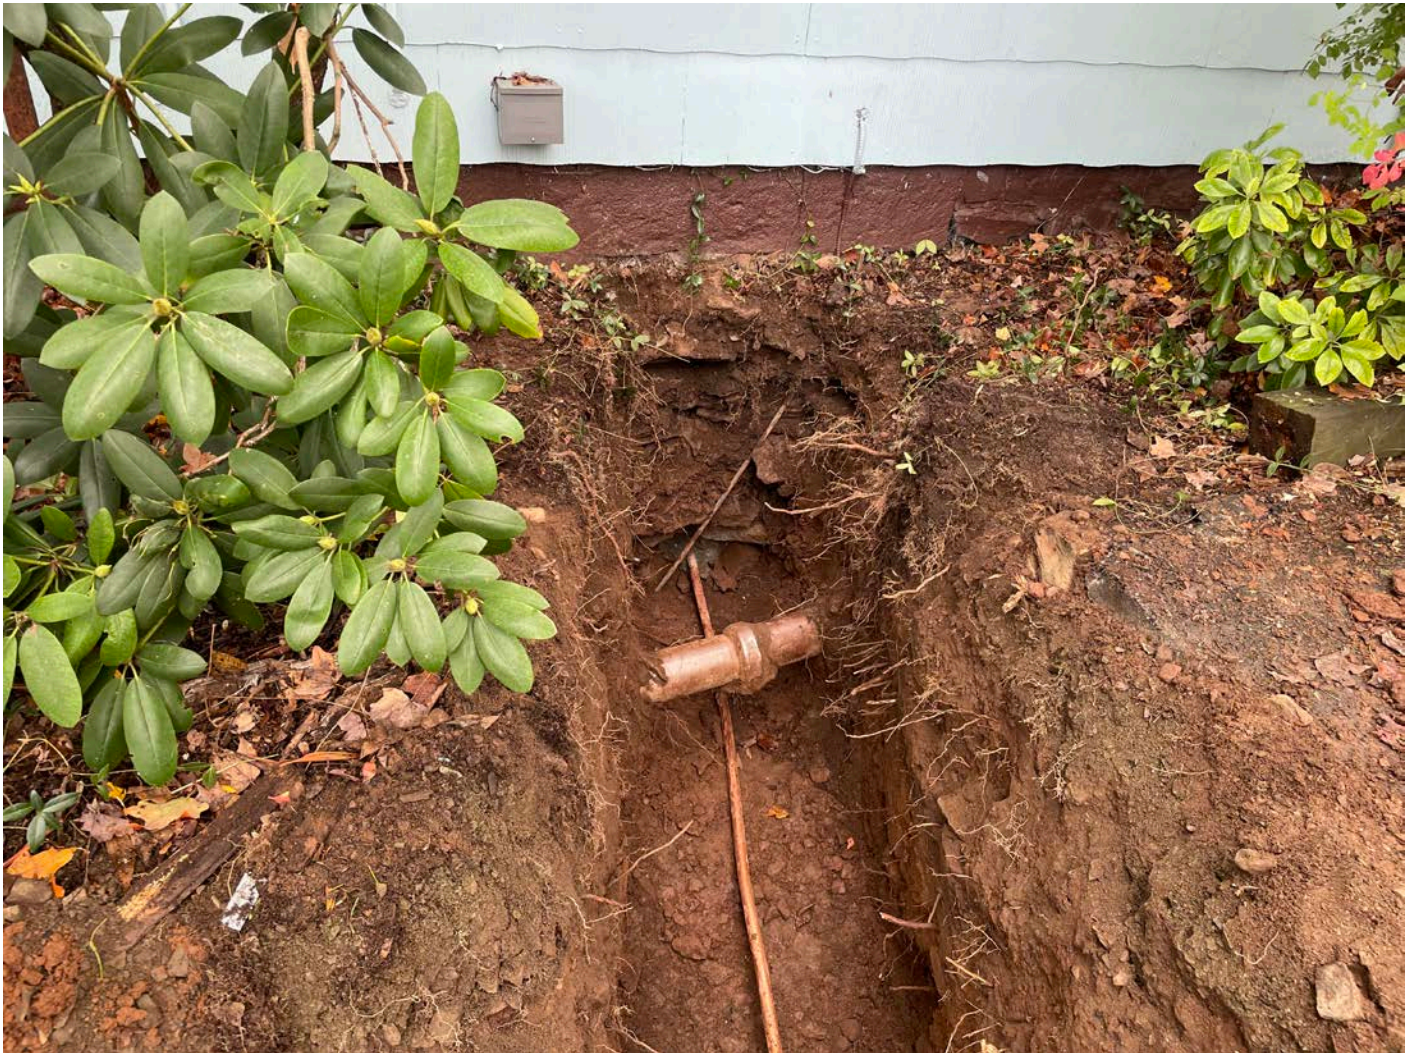
1350: Ludlow has inserted 1" copper water line through the field stone foundation of the 208 Main Street residence. The copper water service pipe penetrates the north foundation of the house 32.5' east of the homes north west corner.

Picture 10: 1" copper water service line that Ludlow has inserted through the northern foundation of the 208 Main Street residence. View to the south.

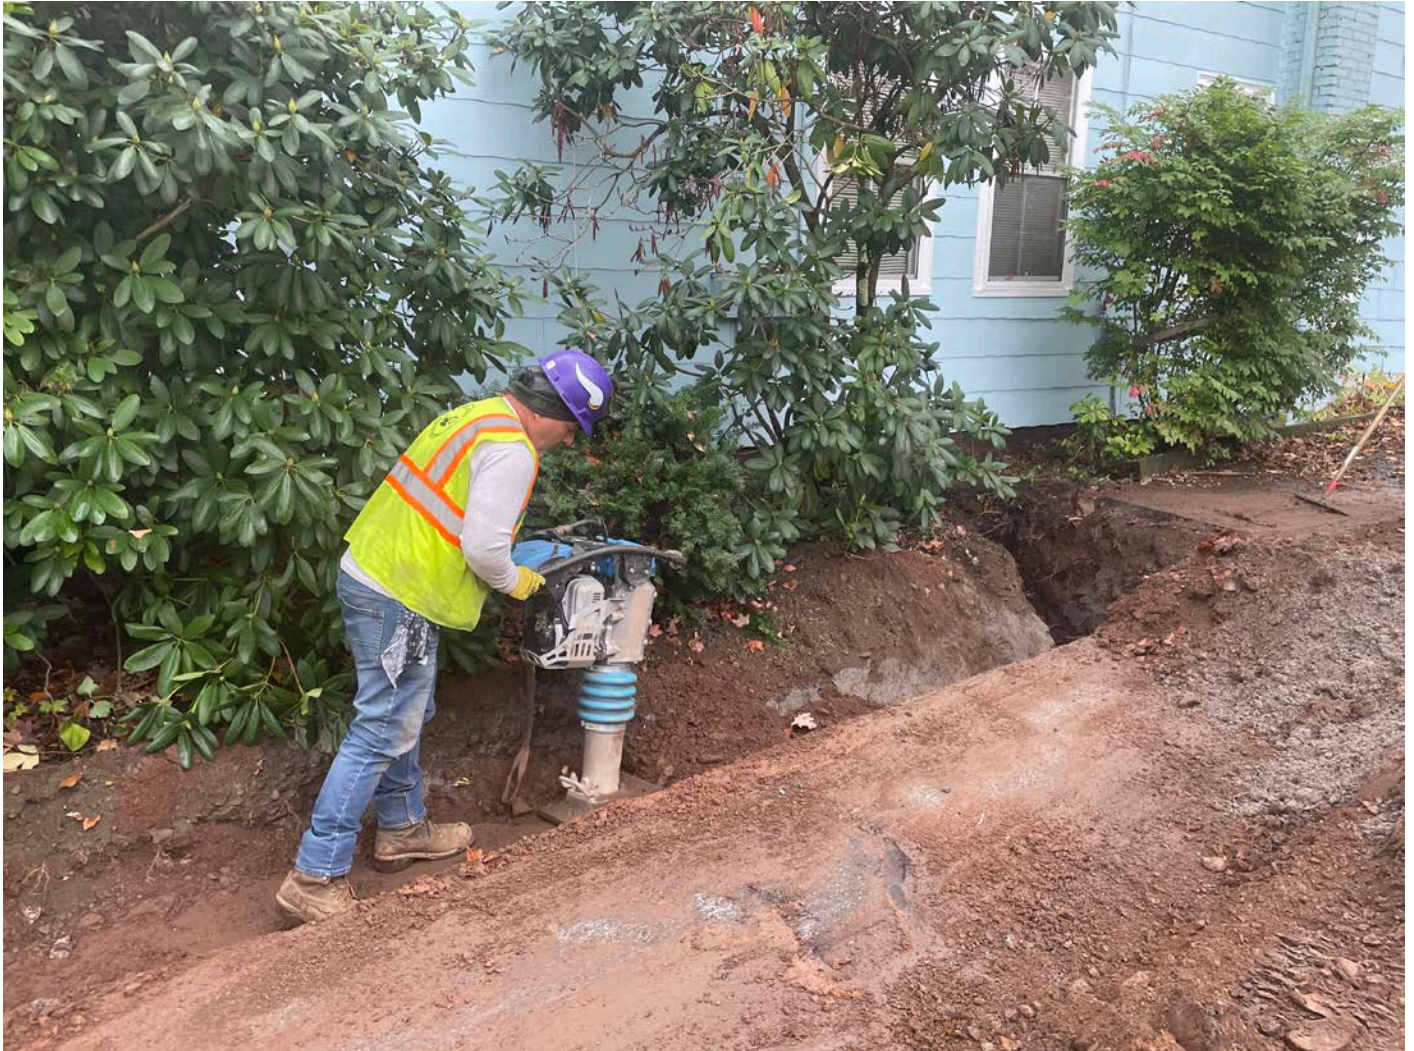
1445: Ludlow is compacting fill with a jumping jack that they backfilled into the trench they excavated on the driveway of the 208 Main Street property.

Picture 11: Ludlow compacting fill over sand and caution tape that was placed over the 1" copper water service line they installed at the 208 Main Street residence. View to the southwest.
