Daily Report

Project:	Durham Meadows Pipeline Installation	Date:	October 28, 2021
Location:	Main Street and Maple Avenue, Durham; Shared Access Driveway, Middletown	Day of Week:	Thursday
Project #:	AECOM: 6061487	Report No:	352
Contractor:	Ludlow Construction	Page:	1 of 11

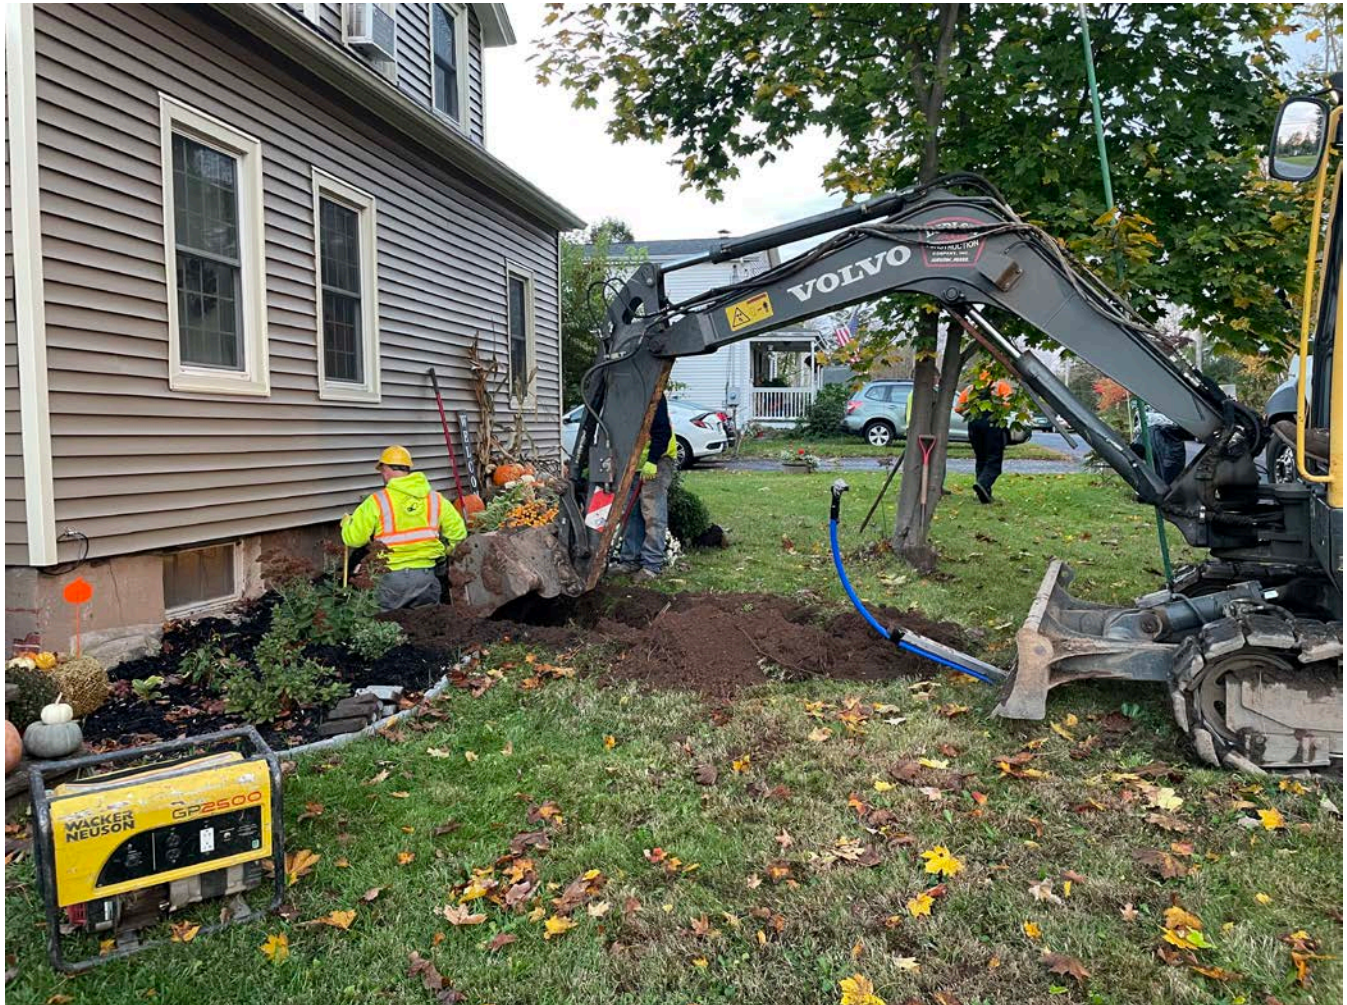
0709: Ludlow begins excavating on the east side of the 158 Maple Avenue, Durham, residence for installation of a 1" copper water service line.

Picture 1: Ludlow excavating on the east side of the 158 Maple Avenue, Durham, residence for the installation of a 1" copper water service line. View to the north.

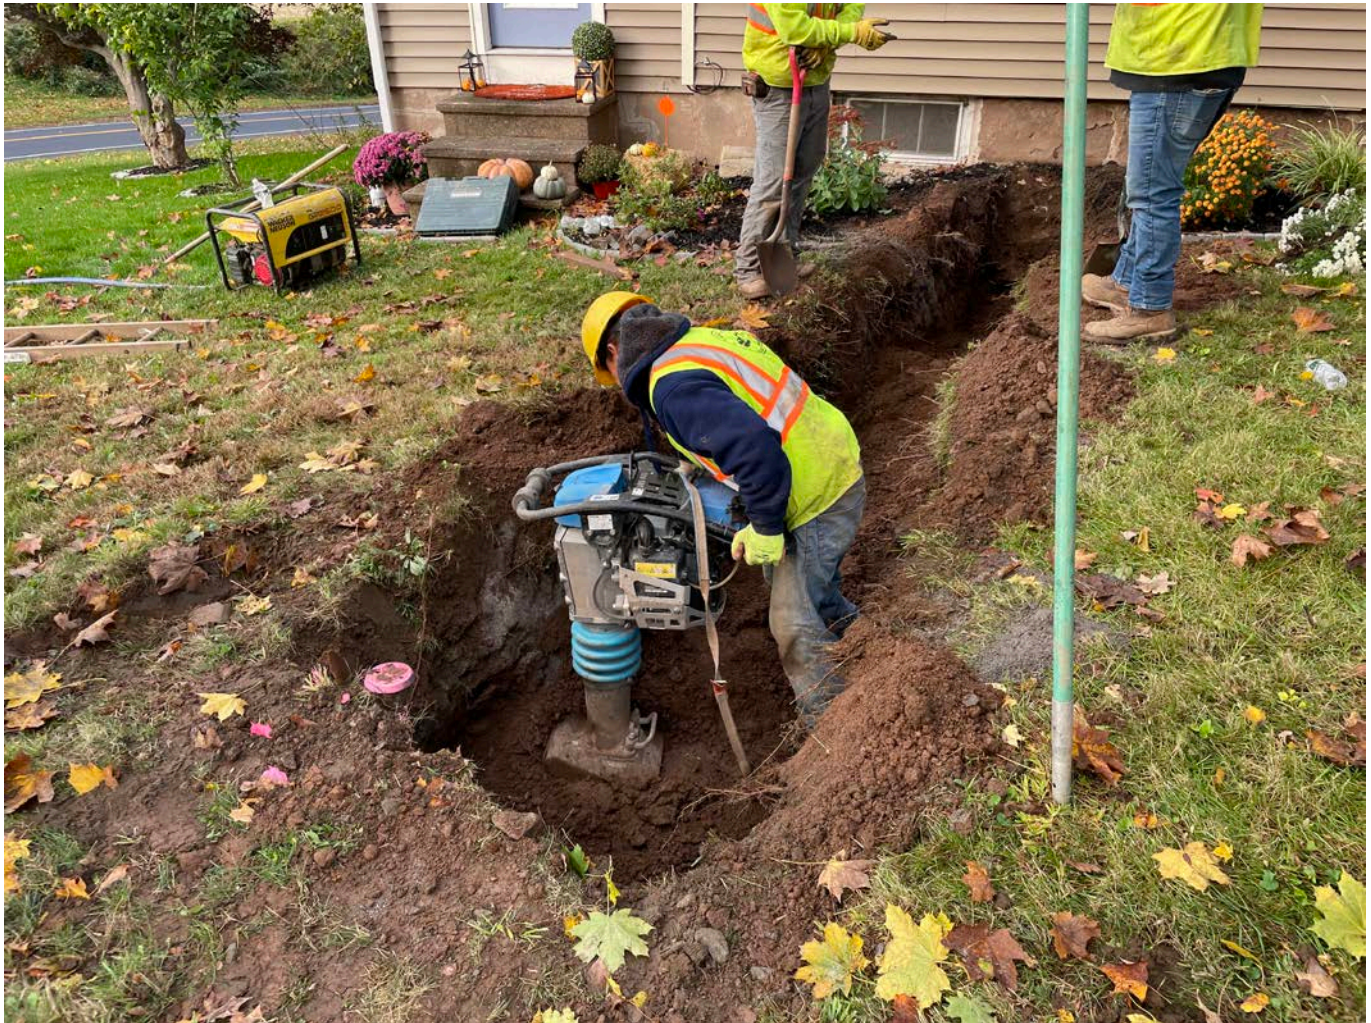
0824: Ludlow is backfilling native fill into the trench they excavated at the 158 Main Street residence during the installation of a 1" copper water service line. The fill is being placed in 1' lifts and being compacted with a jumping jack.

Picture 2: Ludlow compacting fill that was placed over caution tape and sand that was placed over the 1" copper water service line they installed on the east side of the 158 Maple Avenue residence. View to the southwest.

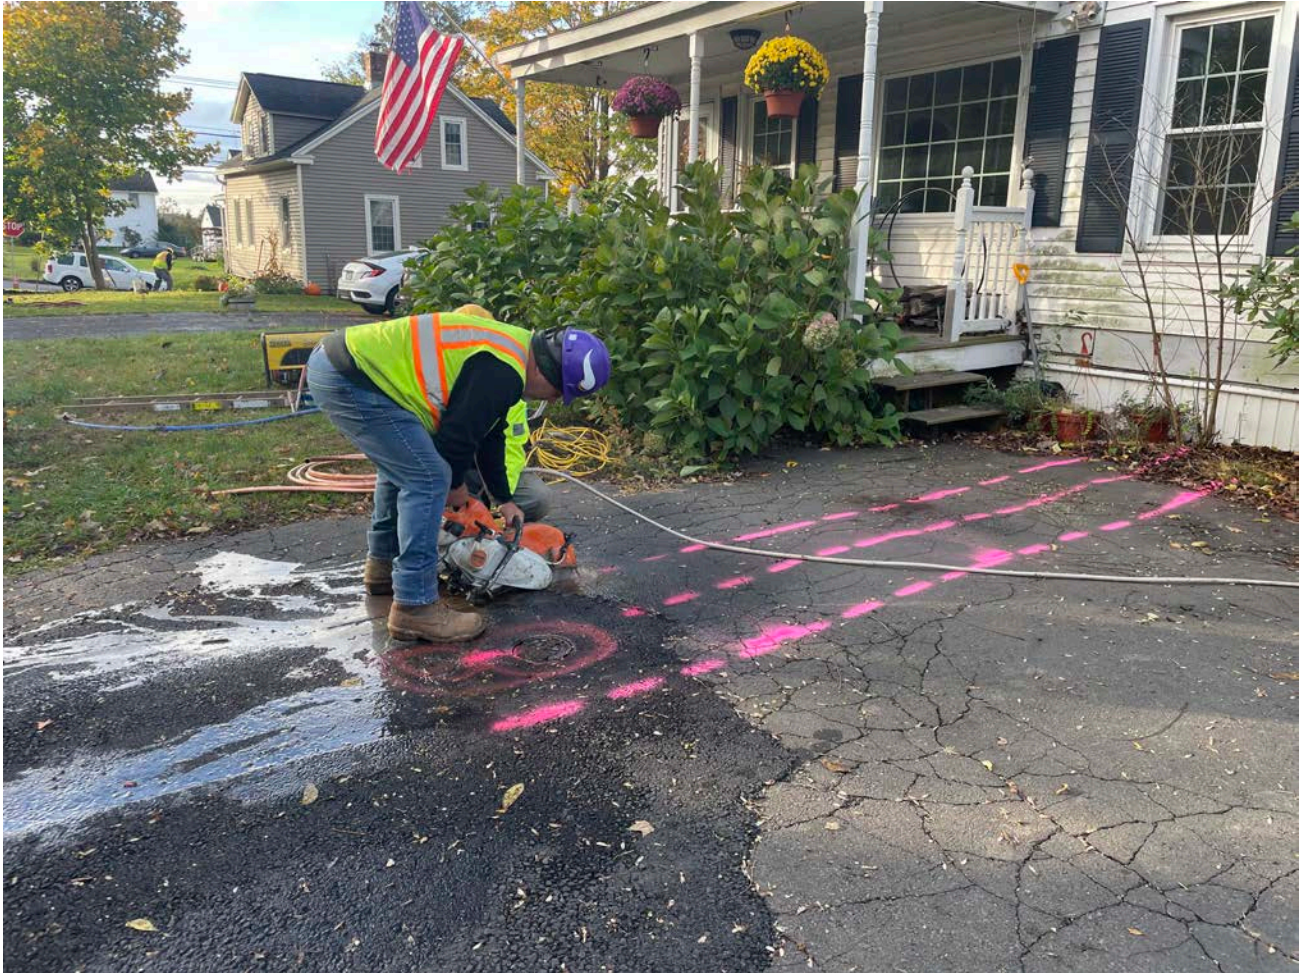
0906: Ludlow is saw cutting a footprint of the trench they plan to excavate on the asphalt driveway of the 162 Maple Avenue residence.

Picture 3: Ludlow saw cutting a footprint for the trench they will excavate on the asphalt driveway of the 162 Maple Avenue, Durham, residence for the installation of a 1" copper water service line. View to the southwest.

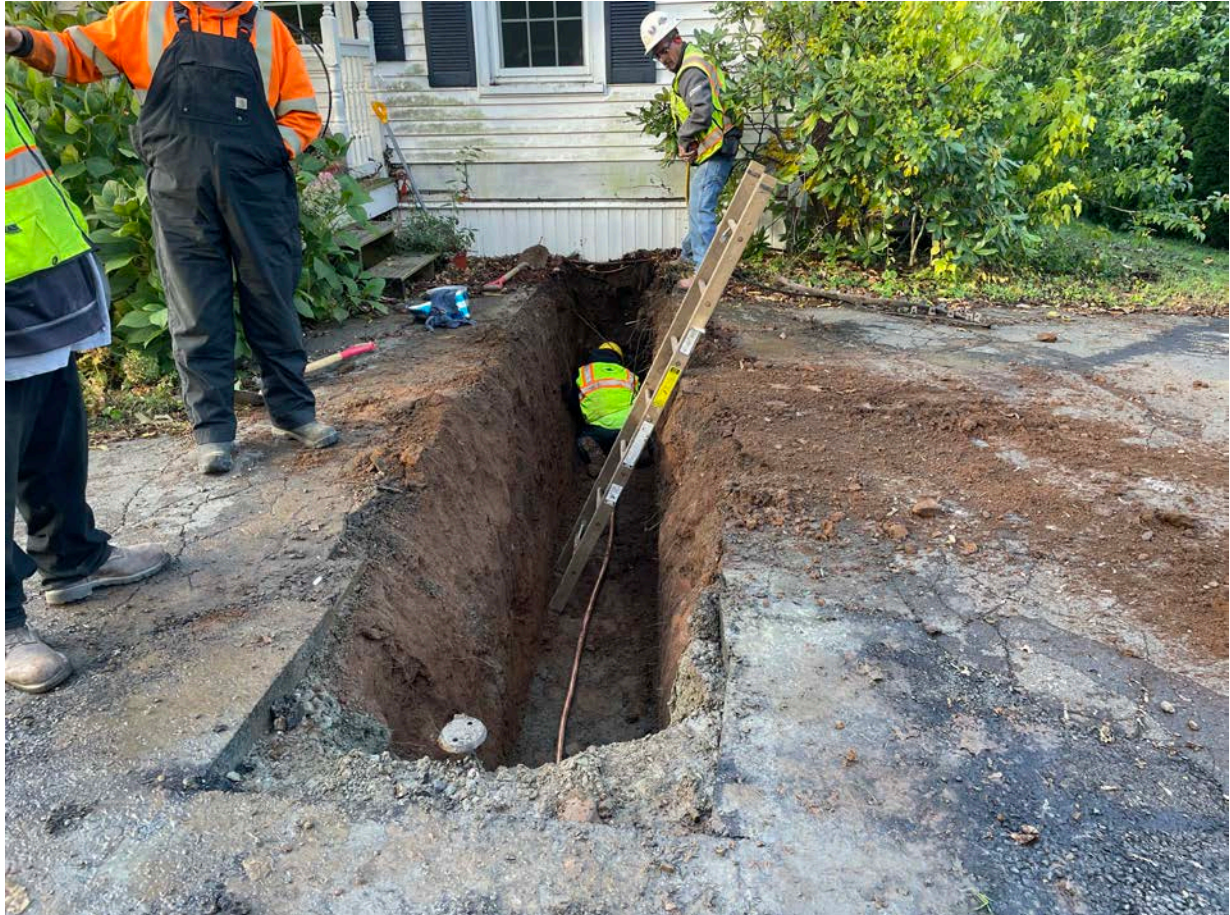
Picture 4: Ludlow placing a 1" copper water service line in the trench they excavated on the east side of the 162 Maple Avenue residence. View to the west.

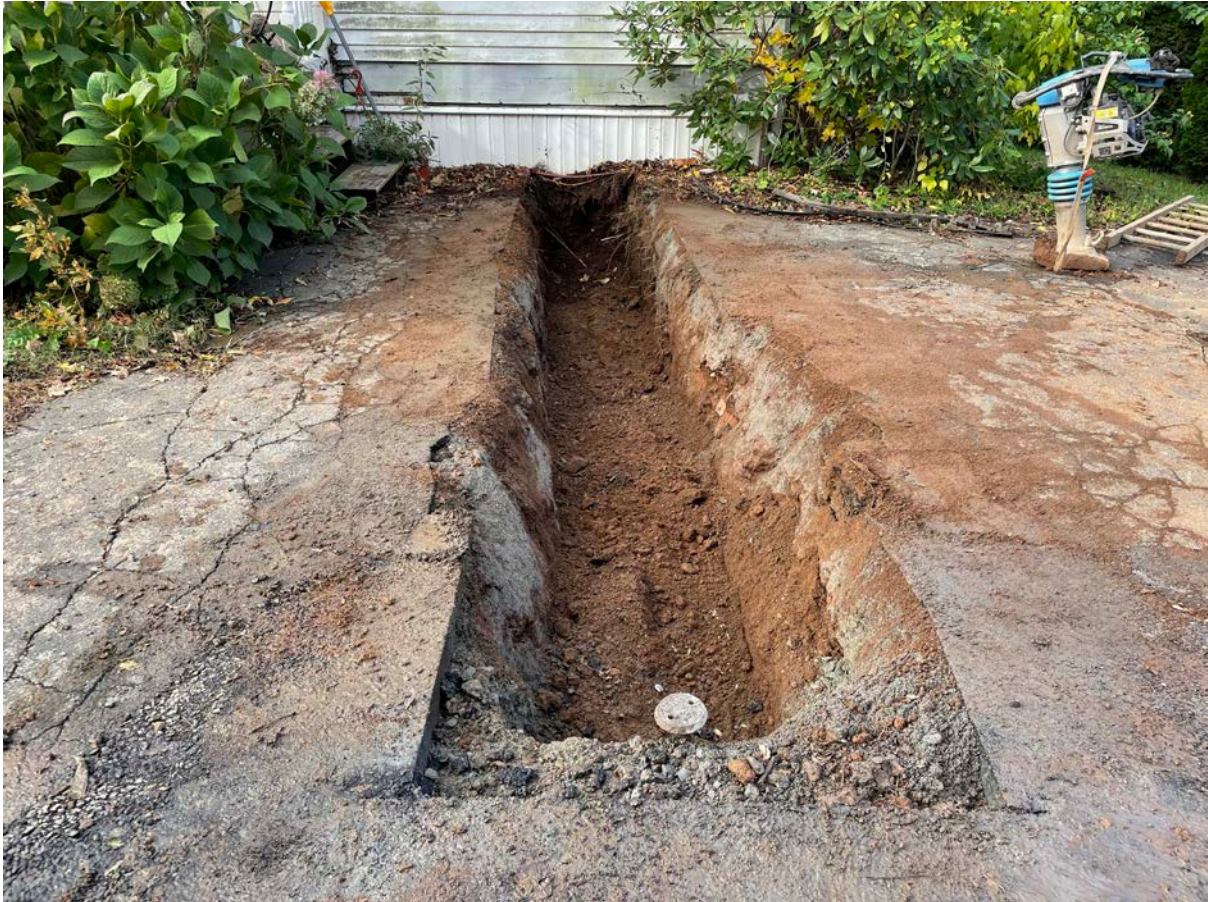
1016: Ludlow continues to backfill the trench on the east side of the 162 Maple Avenue residence after having installed a 1" copper water service line. The top two feet of backfill in the trench that Ludlow excavated for the installation of a 1" copper water service line is comprised of 1.25"-minus gravel that Ludlow is placing and compacting in 1' lifts.

Picture 5: Trench that Ludlow excavated on the east side of the 162 Maple Avenue residence, prior to the placement and compaction of 1.25"-minus gravel. View to the west.

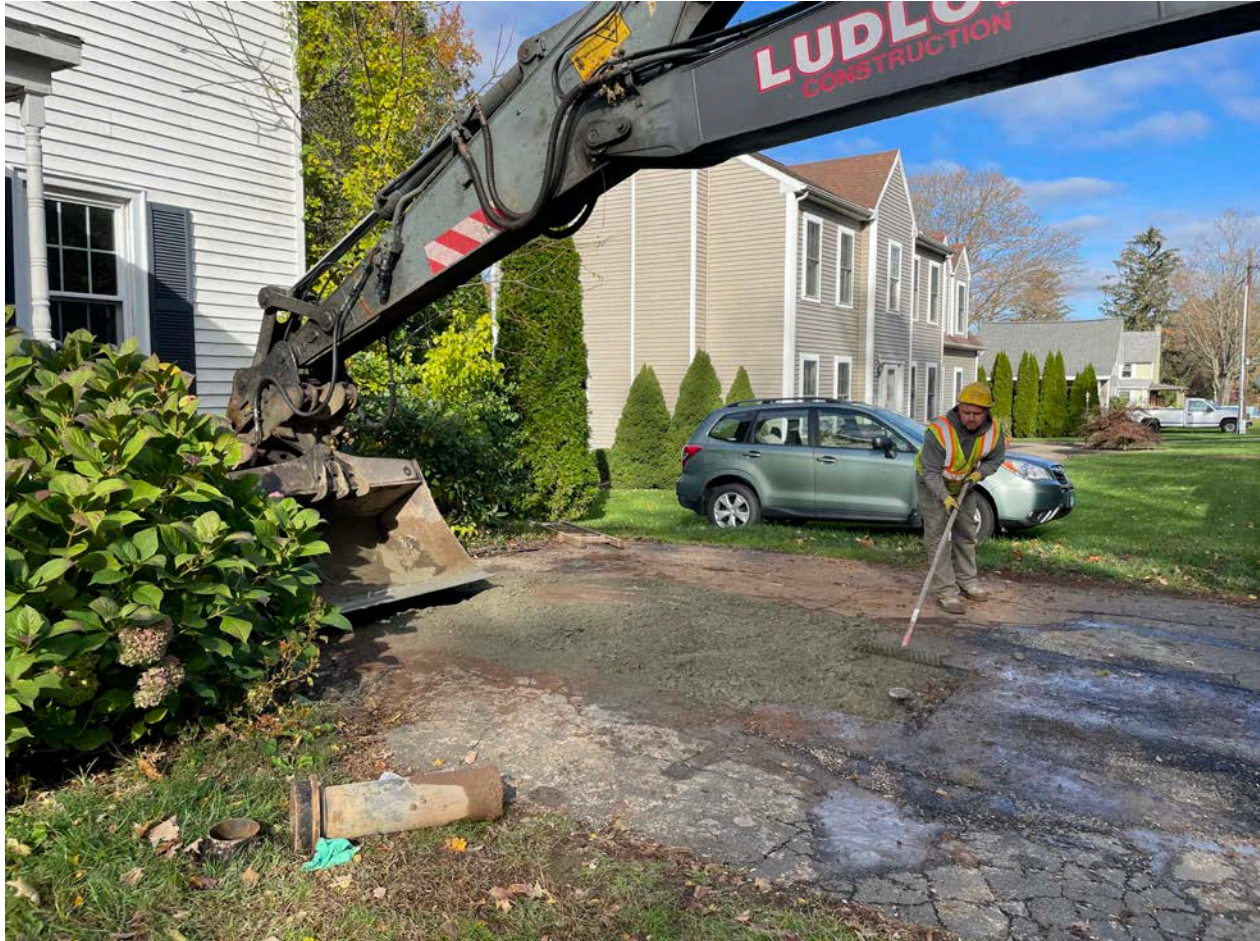
Picture 6: Ludlow grading 1.25"-minus gravel in the trench that Ludlow excavated on the east side of the 162 Maple Avenue residence. View to the north.

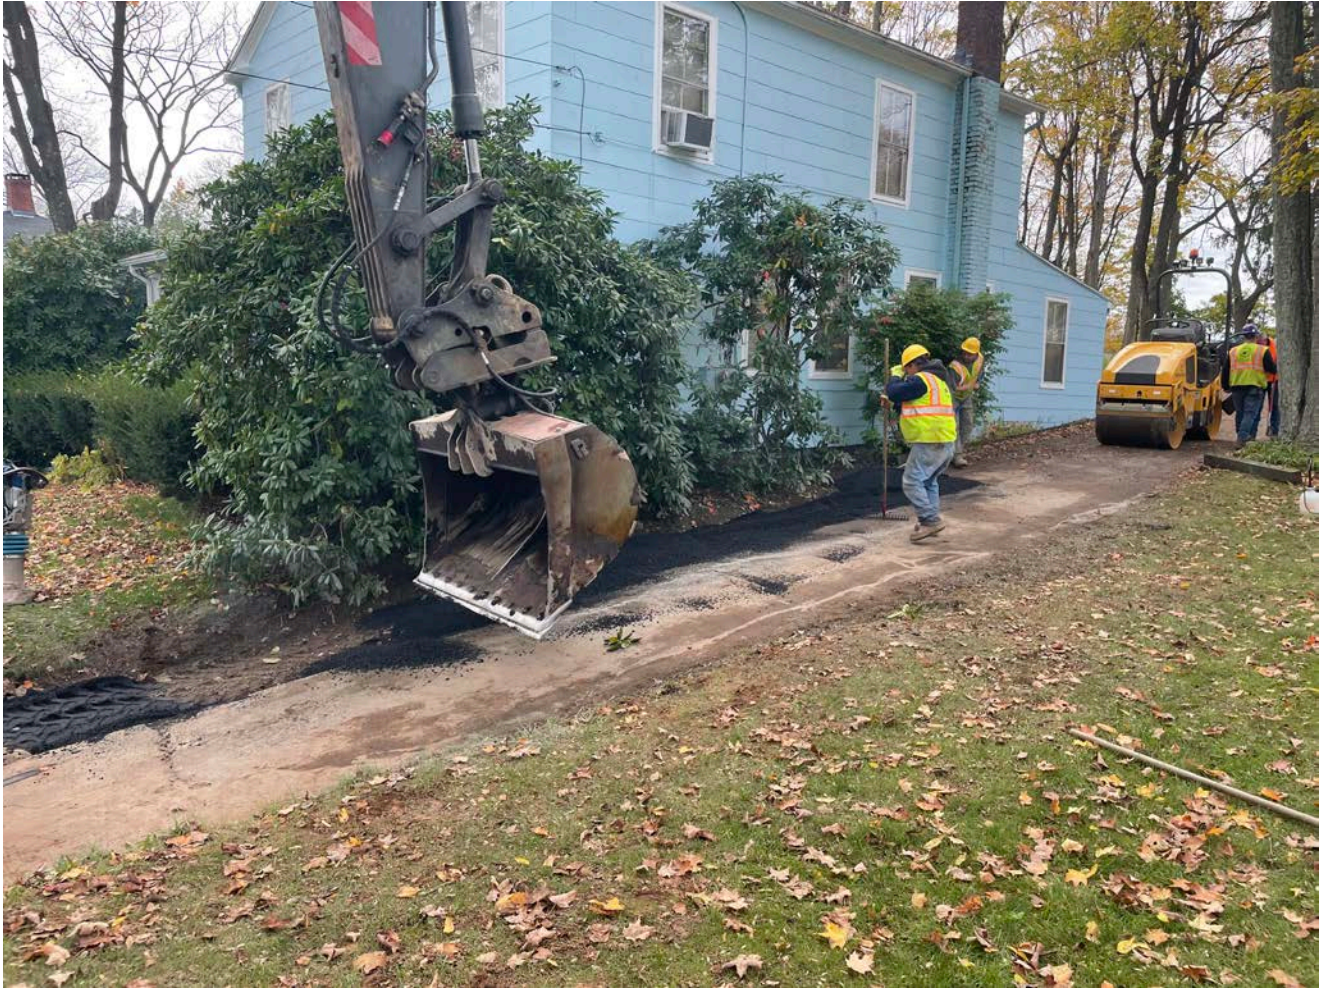
1329: Ludlow is placing asphalt on the trench at the driveway of the 208 Main Street residence.

Picture 7: Ludlow placing asphalt on the trench footprint on the driveway of the 208 Main Street, Durham, property. View to the southwest.

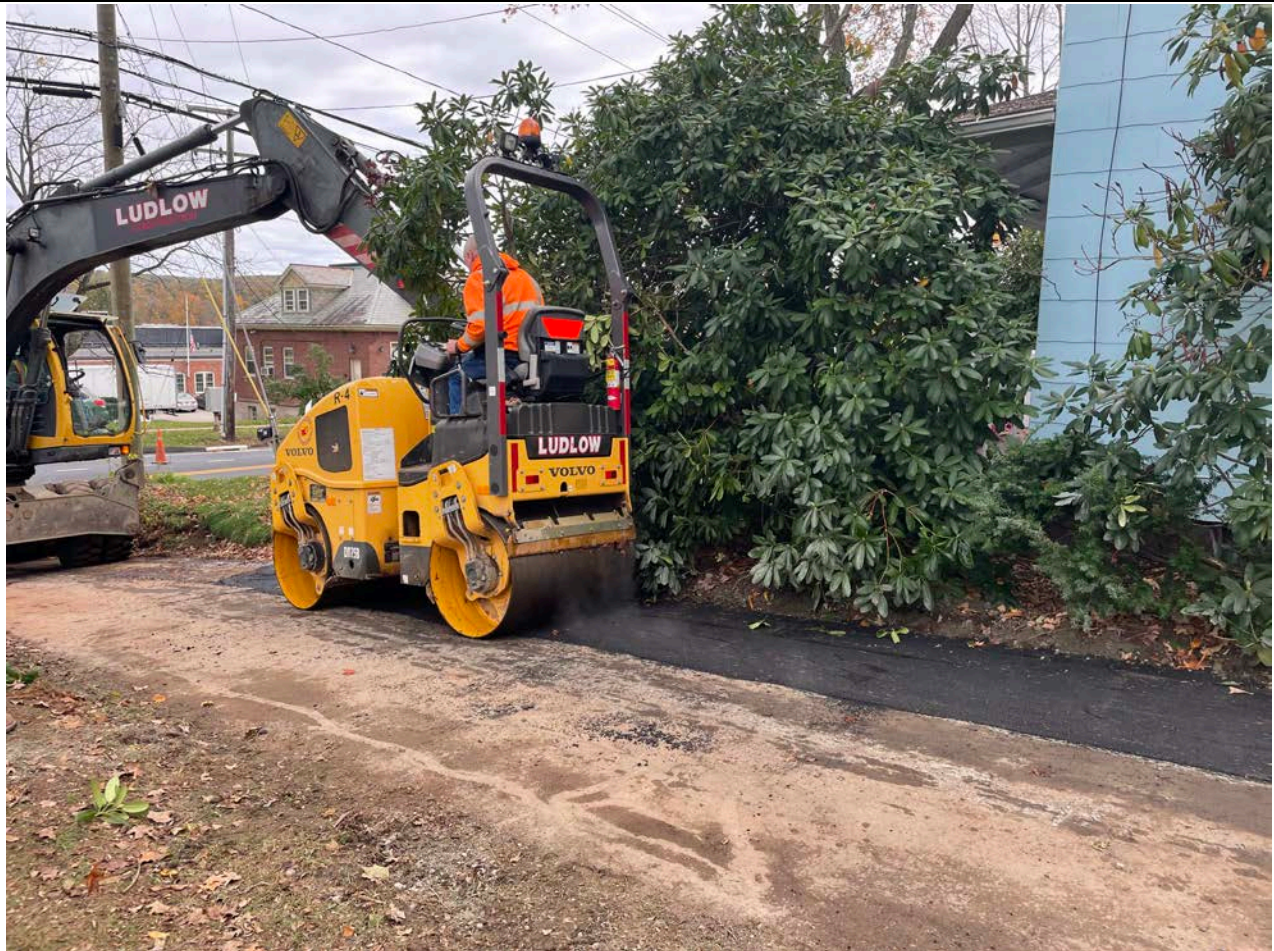
Picture 8: Ludlow compacting asphalt that they just placed on the trench footprint on the driveway of the 208 Main Street, Durham, property. View to the southeast.
