Daily Report

Project:	Durham Meadows Pipeline Installation	Date:	October 29, 2021
Location:	Main Street, Durham; S. Main Street, Middletown	Day of Week:	Friday
Project #:	AECOM: 6061487	Report No:	353
Contractor:	Ludlow Construction	Page:	1 of 16

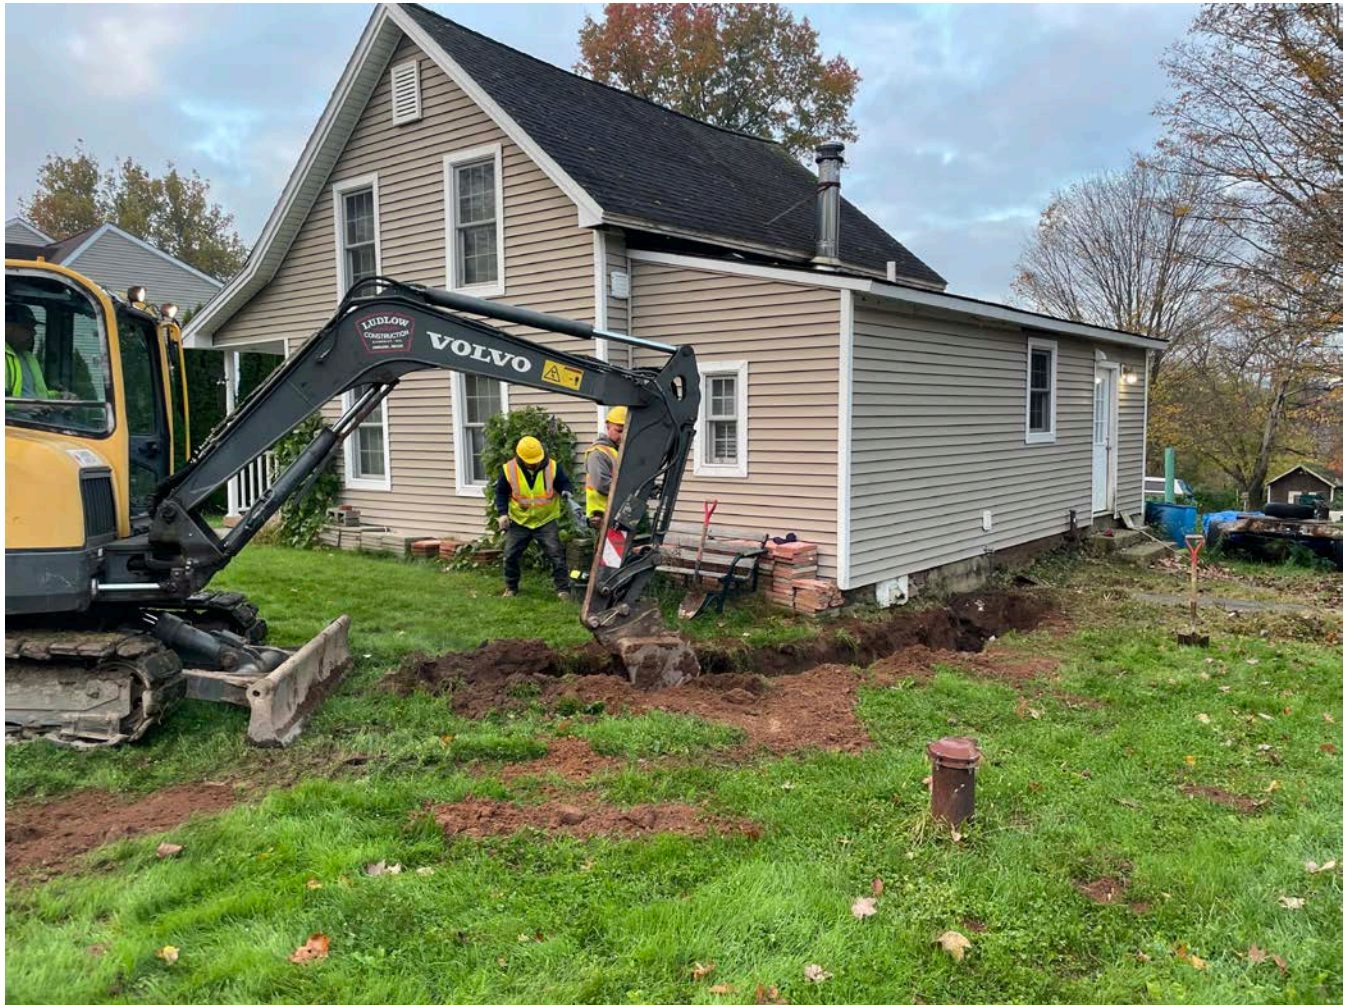
Picture 1: Ludlow excavating on the north and east sides of the 172 Maple Avenue, Durham, residence for the installation of a 1" copper water service line. View to the southwest.

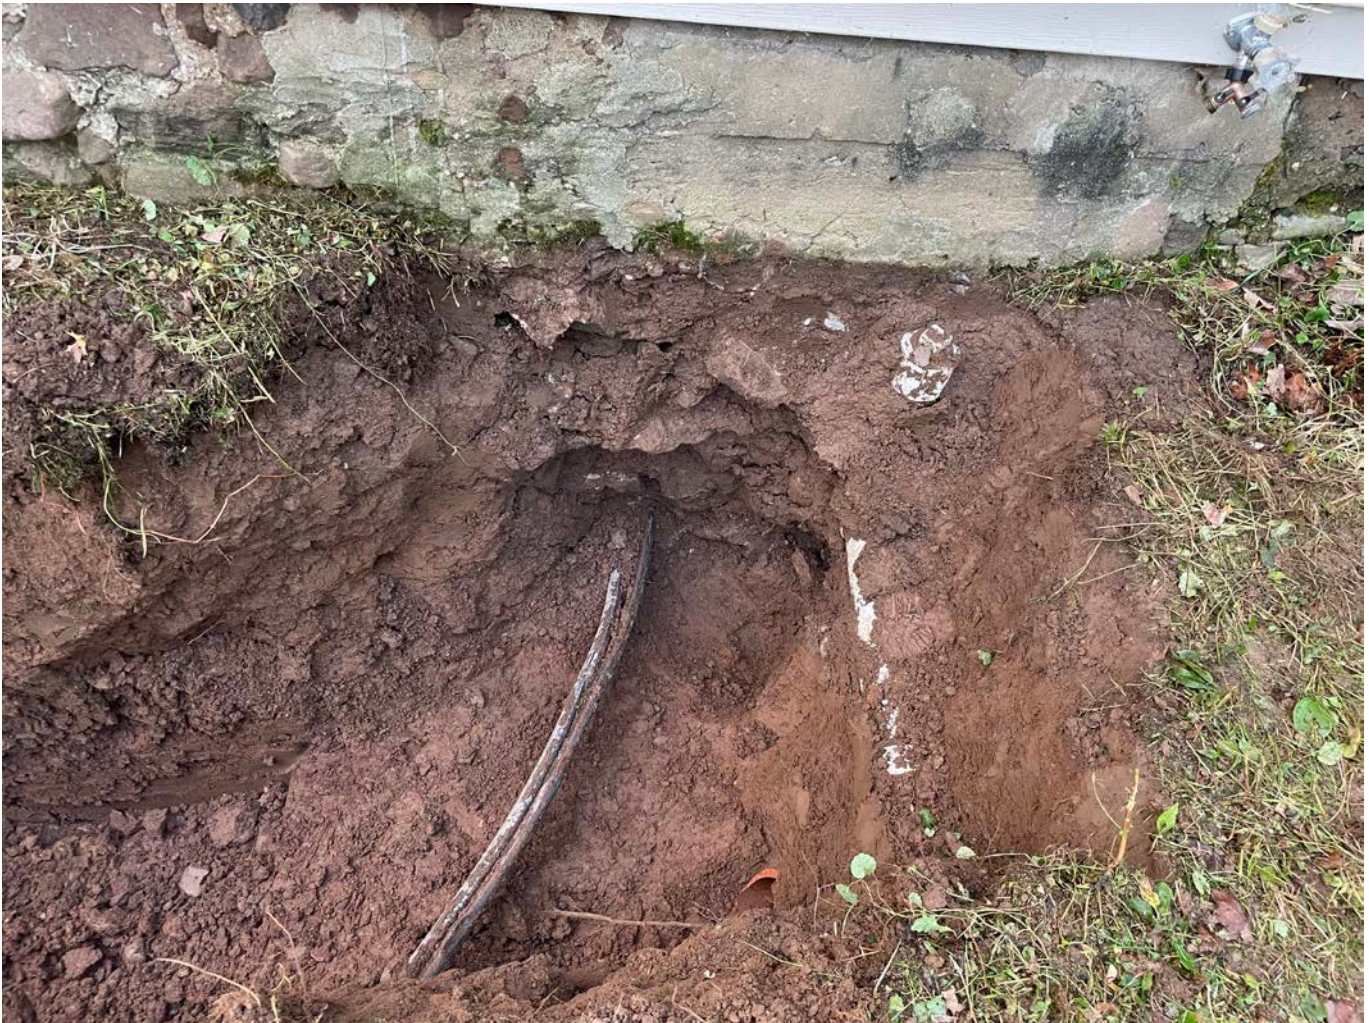
0743: Ludlow continues to excavate at the 172 Maple Avenue property, moving in an eastwards direction towards the curb stop. Ludlow has daylighted the waterline, septic tank line, and the field stone foundation on the north side of the residence.

Picture 2: North side of the 172 Maple Avenue residence where Ludlow has daylighted the field stone foundation of the residence along with the well water supply line and a 4" PVC line that runs to the home's septic system. View to the south.

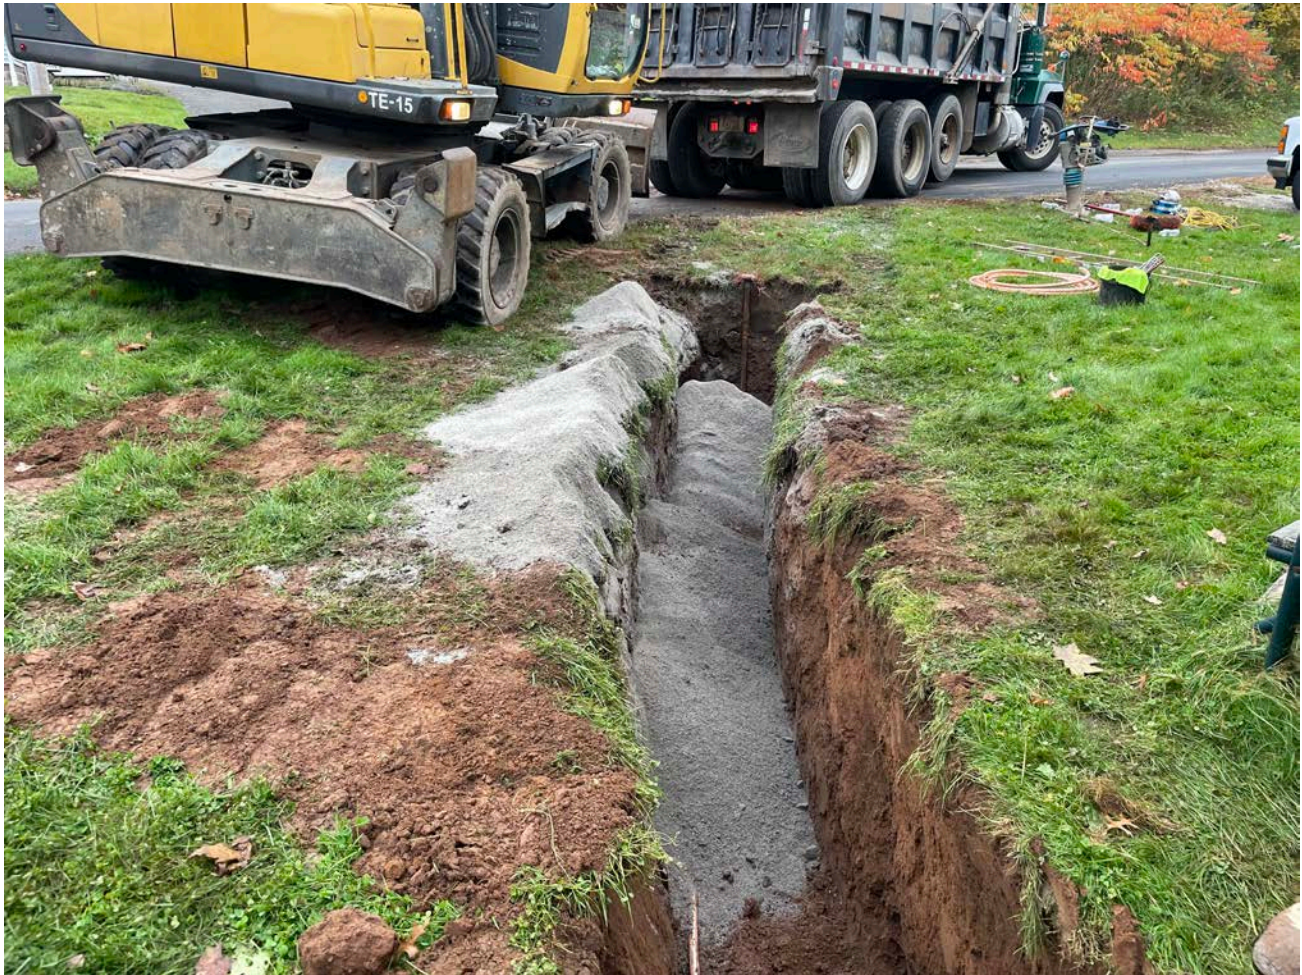
Picture 3: Ludlow saw backfilling over the 1" copper water service line they just installed at the 172 Maple Avenue, Durham, residence. View to the southeast.

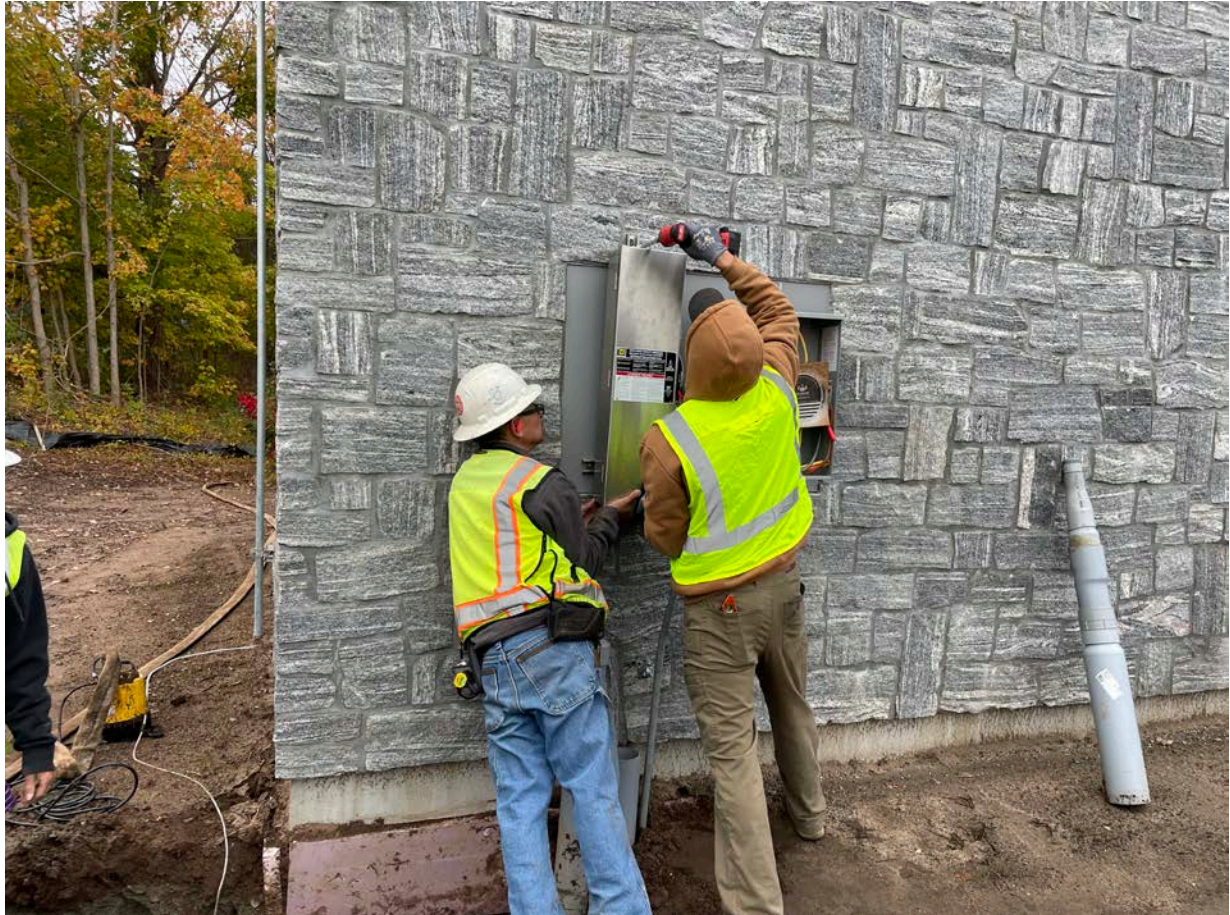
0900: Ludlow is excavating at the northeast corner of the booster station located at Station 750+63 as A&R Electrical begins to move one of the four" PVC conduits to the east as part of changing out the electrical disconnect at the booster station.

Picture 4: A&R Electrical replacing the electrical disconnect on the northeast corner of the booster station located at Station 750+63 on S. Main Street, Middletown. View to the south.

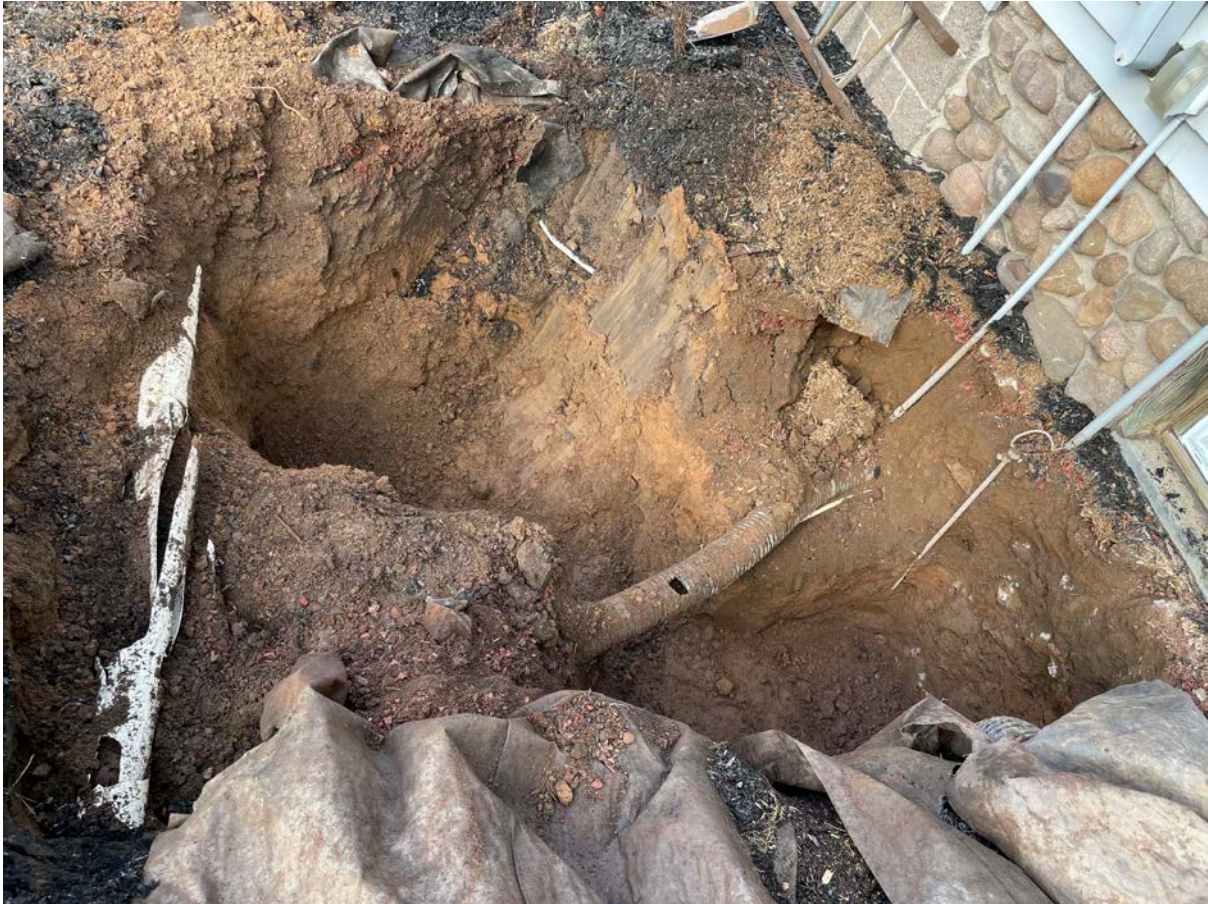
0946: Ludlow begins to excavate at the 173 Maple Avenue, Durham, property for the installation of a 1" copper water service line. Ludlow broke a 4" PVC drain line located approximately 2' north of the northern edge of the driveway. Ludlow also punctured a 4" black corrugated plastic drain line that runs from the south edge of the home's foundation.

Picture 5: Portion of the trench that Ludlow excavated on the south side of the 173 Maple Avenue residence, showing broken PVC and plastic drain lines that were later repaired prior to backfilling. View to the northwest.

1253: Ludlow is repairing the 4" PVC drain line that runs along the north side of the driveway for the 173 Maple Avenue residence using 4" PVC and Fernco boots. Ludlow is placing fill over the sand they placed over the 1" copper pipe on the south side of the foundation for 173 Main Maple Avenue residence.

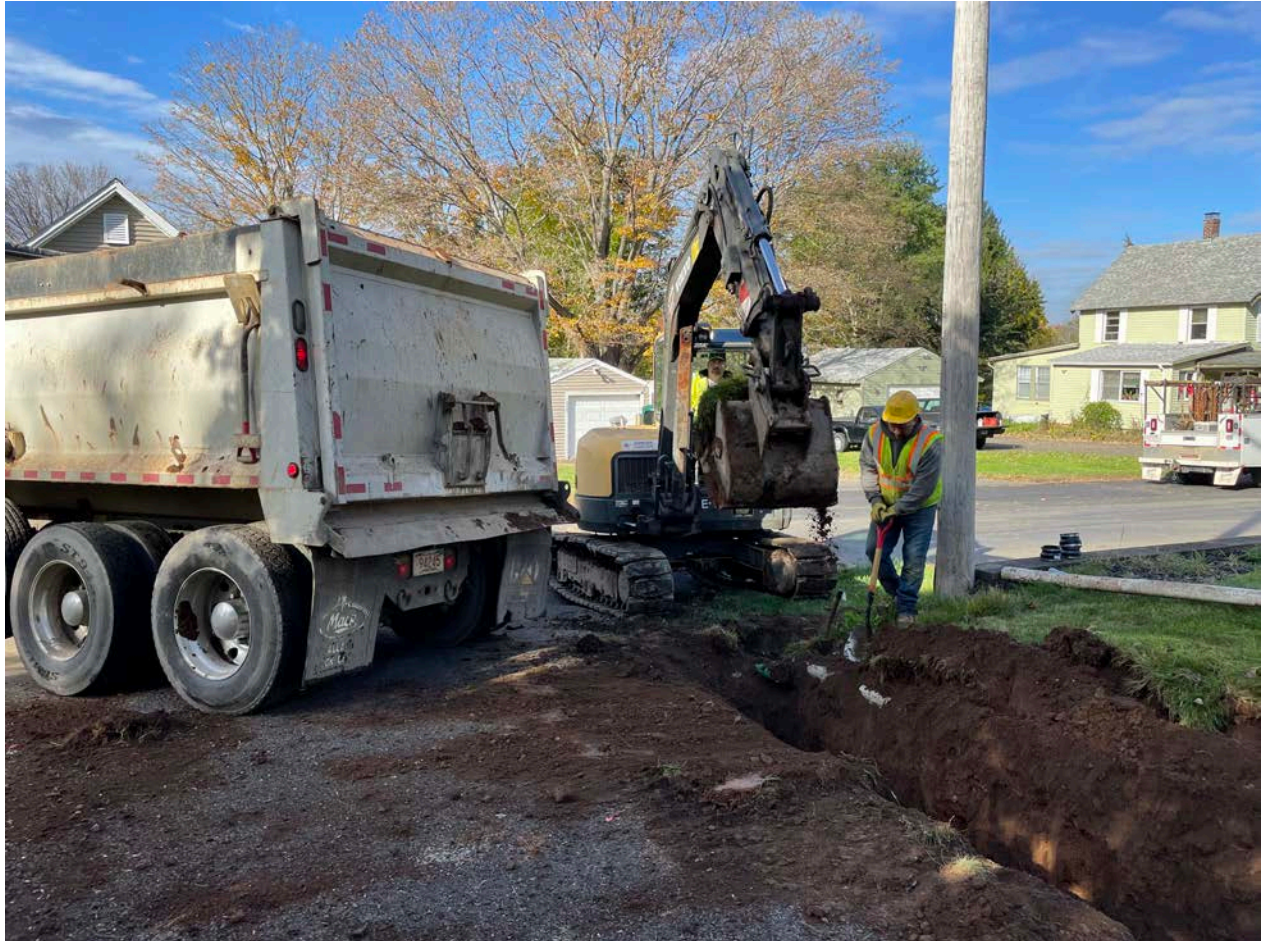
Picture 6: Ludlow excavating on the north side of the driveway for the 173 Maple Avenue residence. View to the northwest.

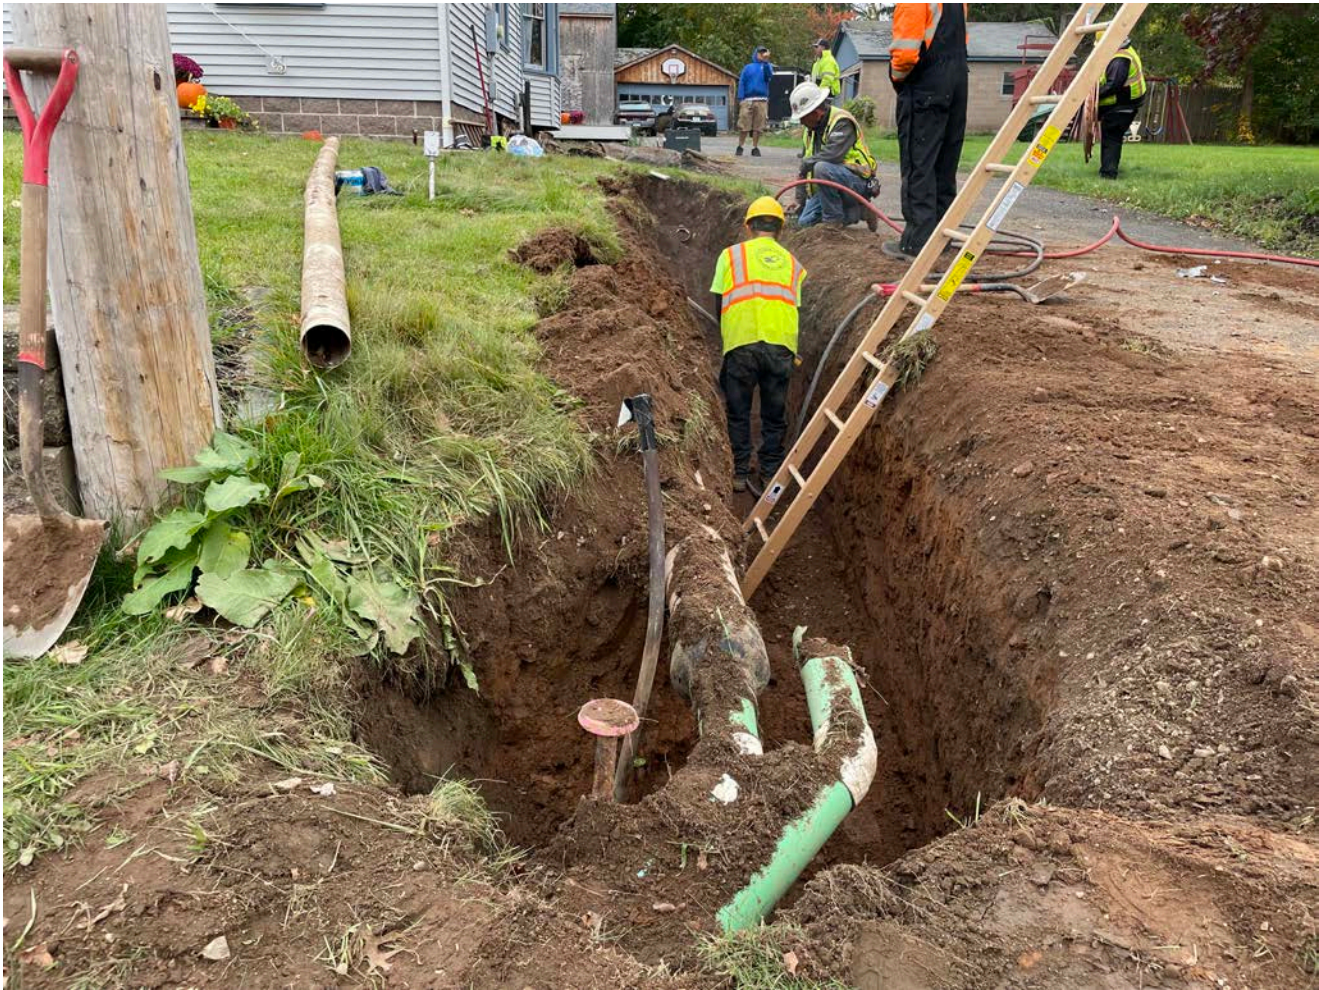
Picture 7: View of the trench that Ludlow is excavating on the north side of the driveway for the 173 Maple Avenue residence. View to the east.

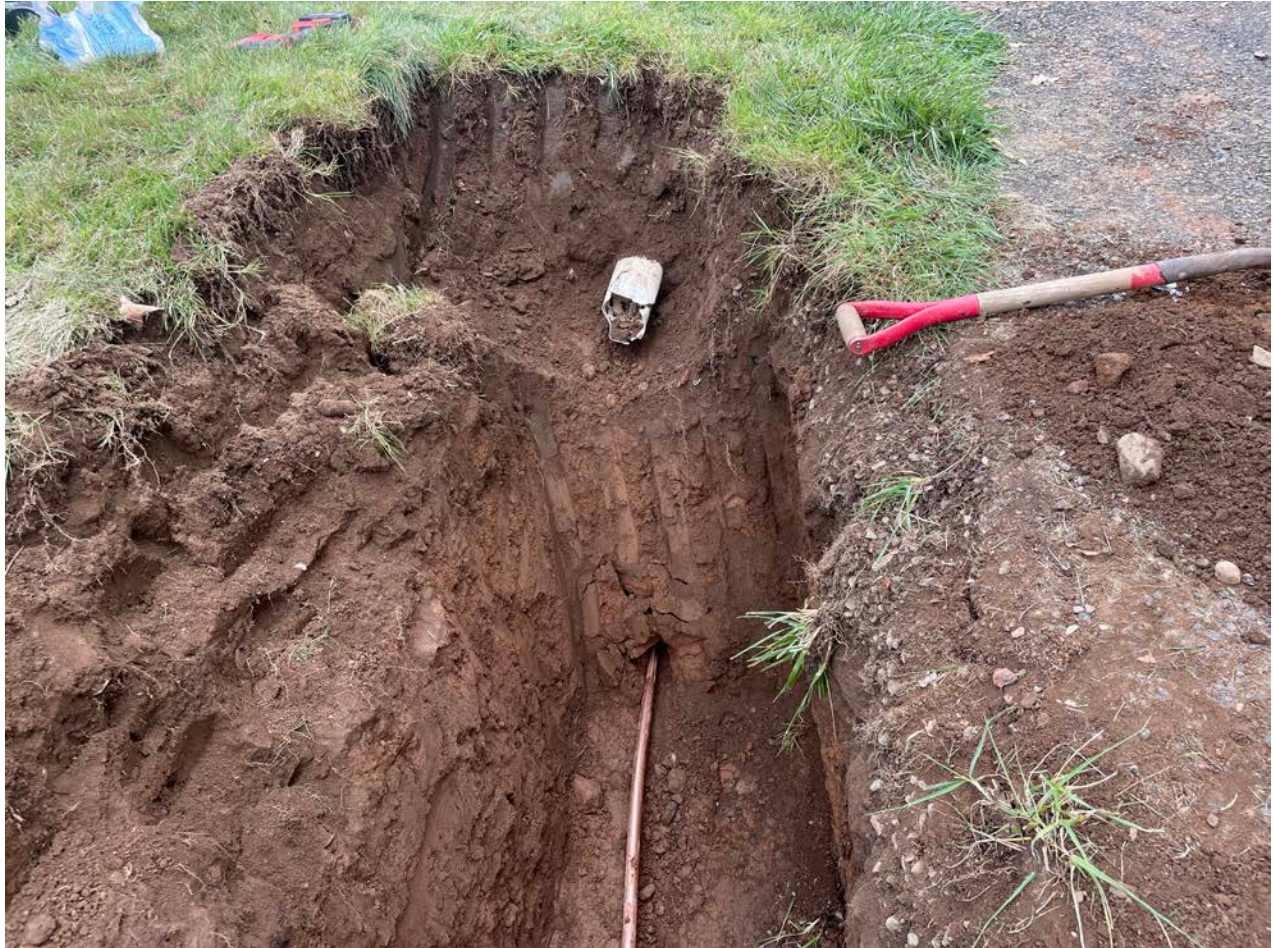
Picture 8: View of the 1" copper water service line that Ludlow ran through a hole that they made with a pneumatic mole on the north side of the driveway for the 173 Maple Avenue residence. View to the east.

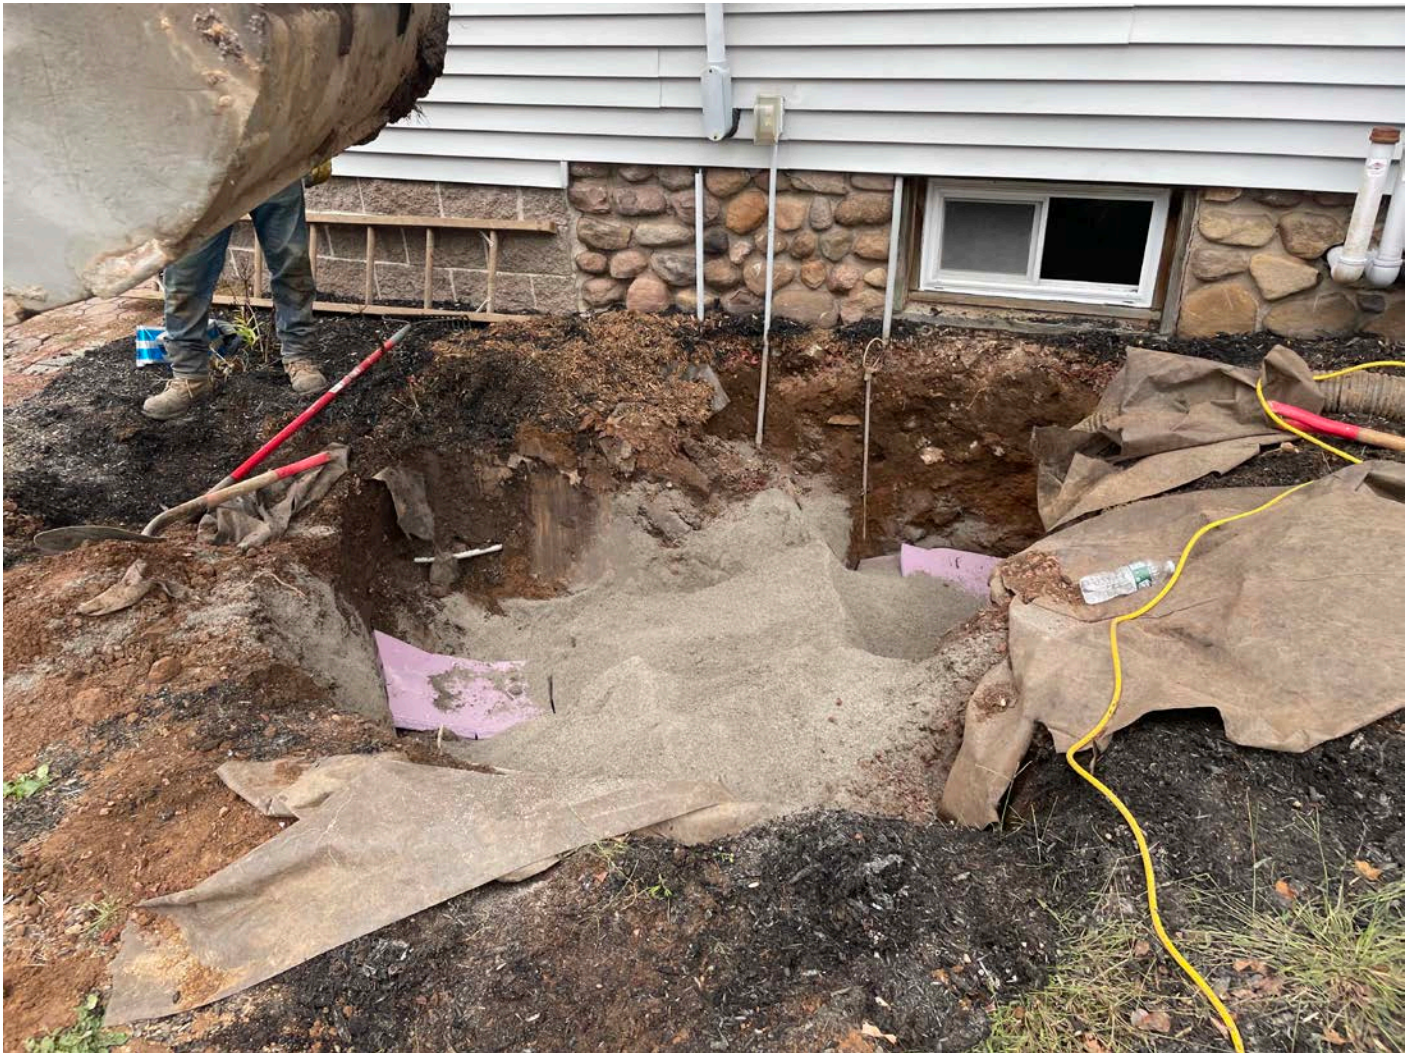
1228: Ludlow is placing sand over the 1" copper water service line they just installed on the south side of the 173 Maple Avenue residence. Ludlow placed 2" foam insulation over the section of the 1" copper pipe (which is 2.5'-3' BSG) that is located to the south of the 173 Maple Avenue residence.

Picture 9: Sand that Ludlow has placed over sections of 2" foam insulation board that was placed over the 1" copper water service line on the south side of the foundation for the 173 Maple Avenue residence. View to the northwest.

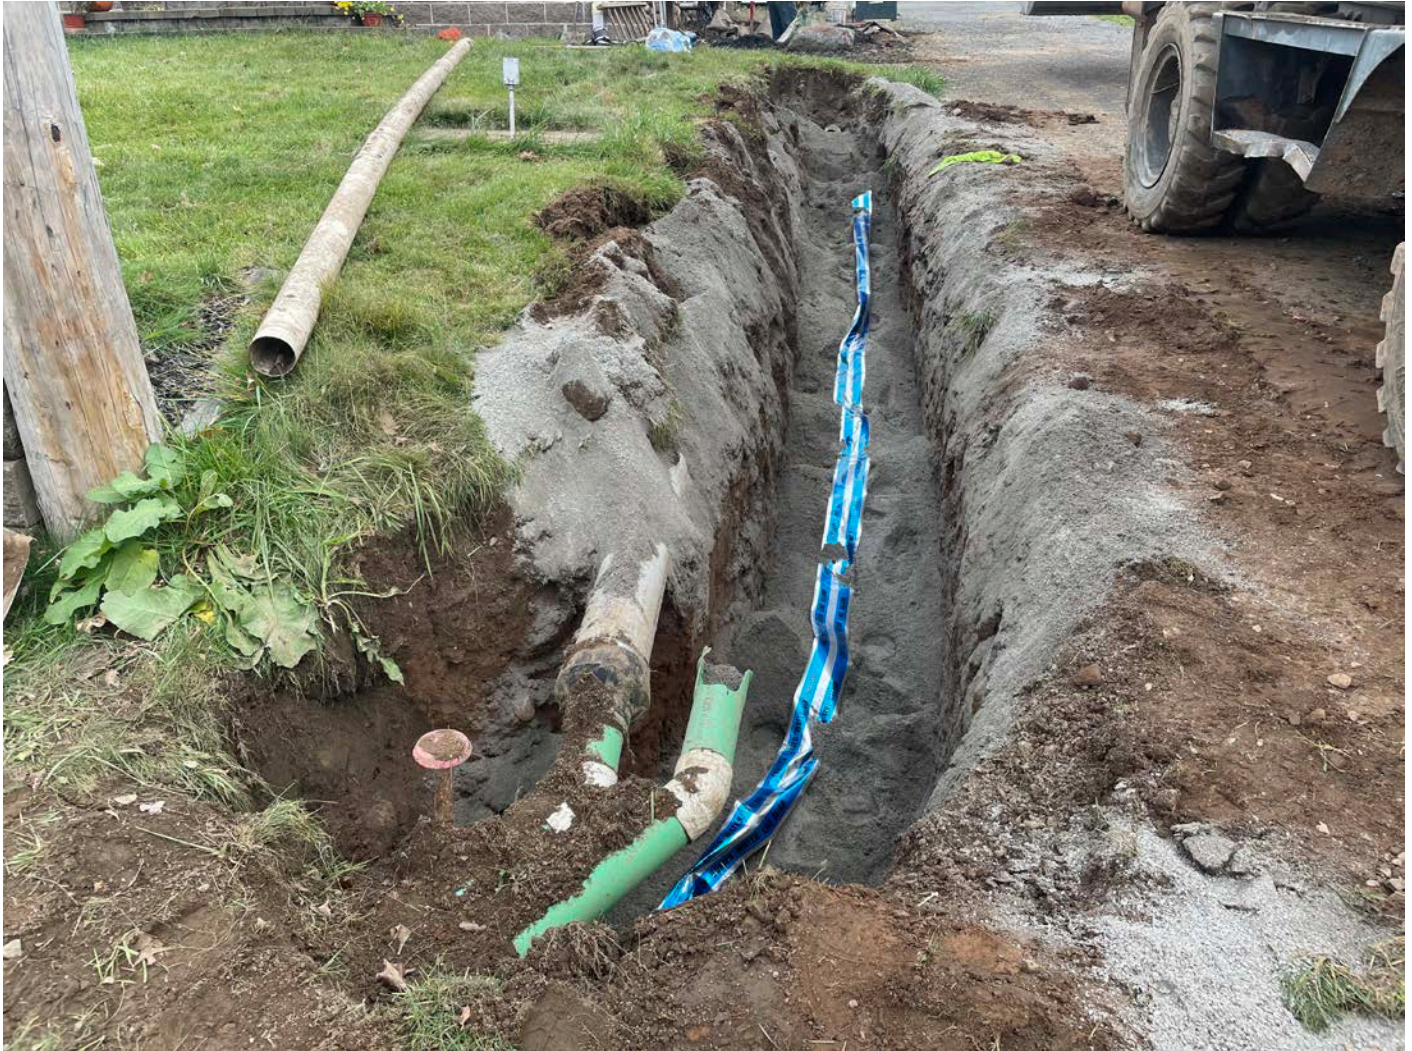
Picture 10: View of the trench that Ludlow excavated on the north side of the driveway for the 173 Maple Avenue residence, where they have placed sand and caution tape over the 1" copper water service line they just installed. View to the east.

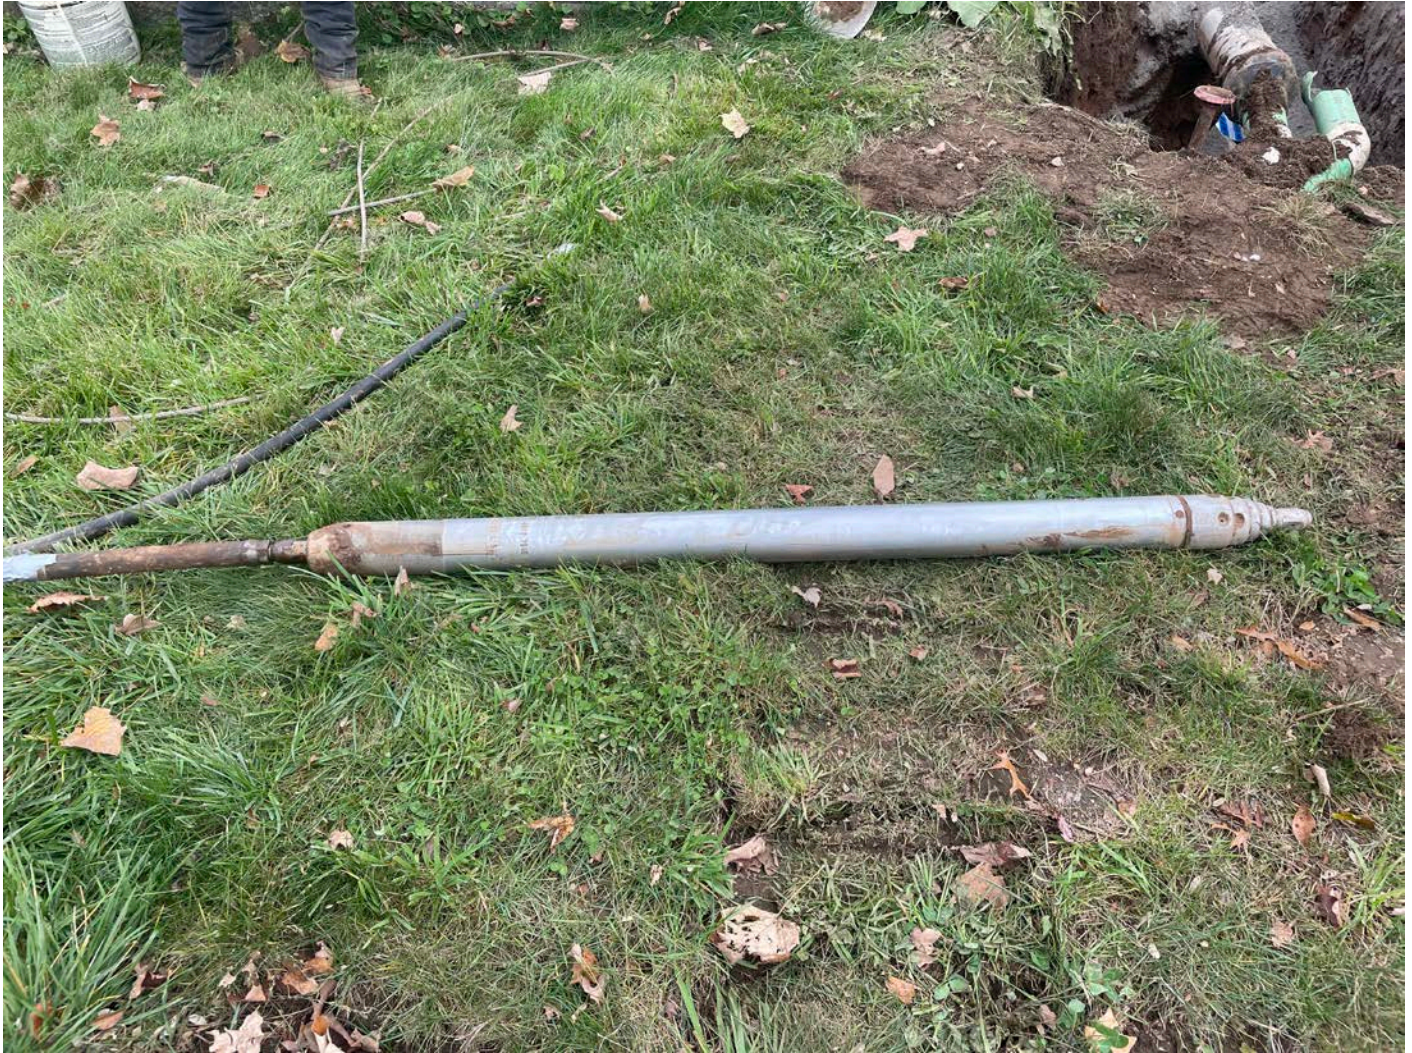
Picture 11: Pneumatic mole that Ludlow used to punch a hole beneath a sidewalk at the 173 Maple Avenue property for the installation of a 1" copper water service line. View to the southeast.

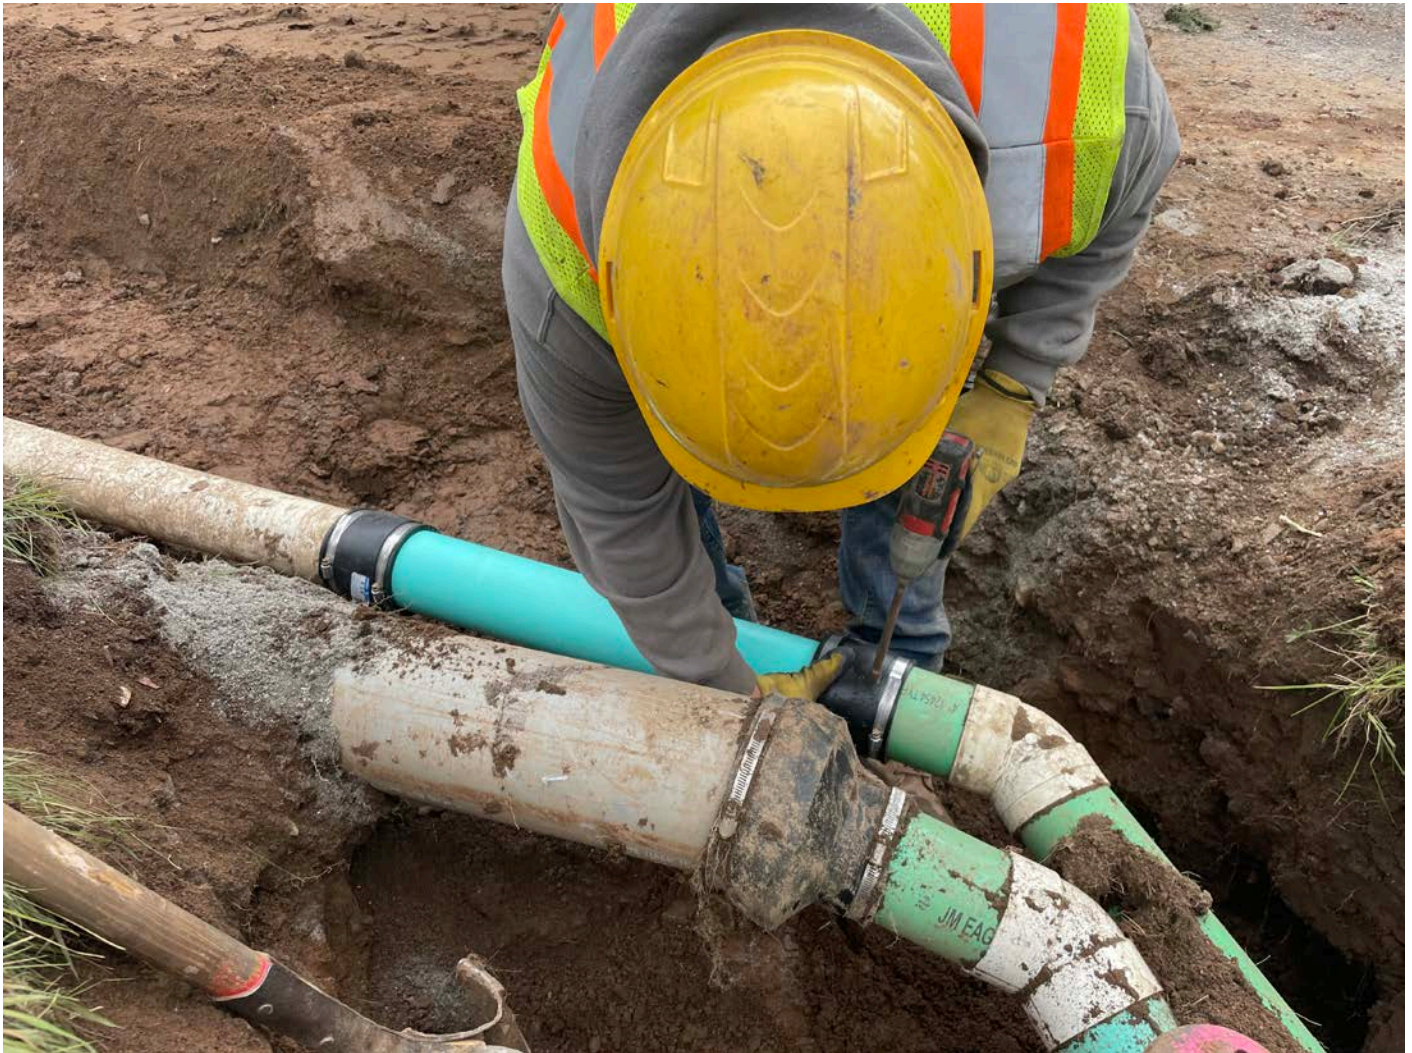
Picture 12: Ludlow repairing a 4" PVC drain line at the 173 Maple Avenue property with 4" PVC pipe and Fernco boots. View to the southeast.

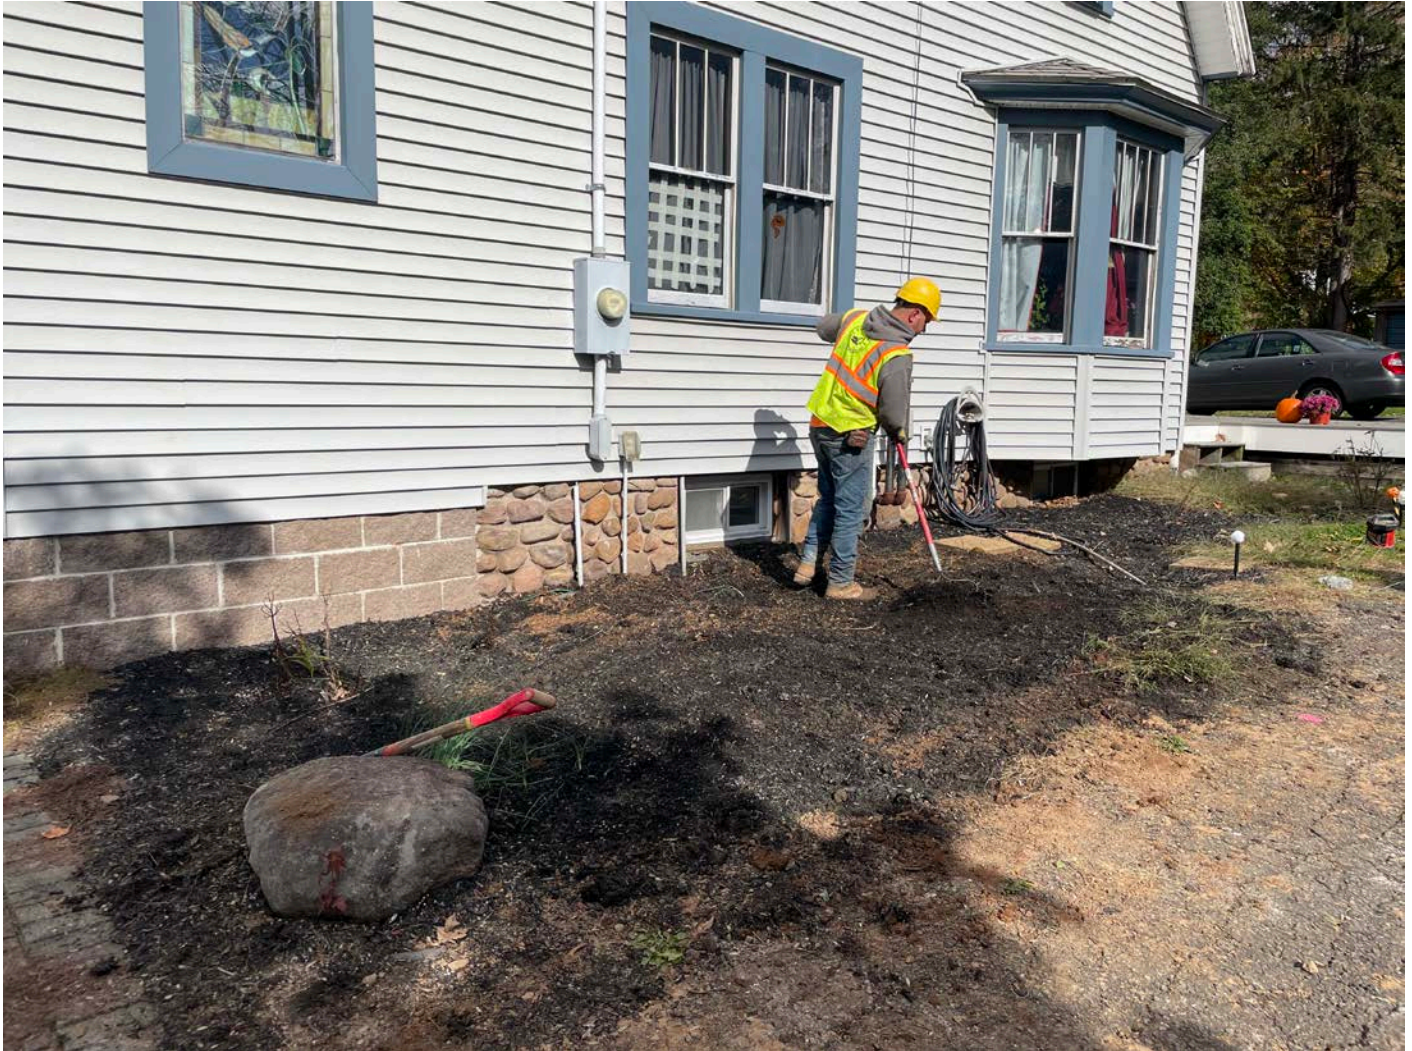
Picture 13: Ludlow raking out loam on a section of the garden on the south side of the 173 Maple Avenue residence that was disturbed by the installation of a 1" copper water service line. View to the east.
