Daily Report

Project:	Durham Meadows Pipeline Installation	Date:	November 02, 2021
Location:	Main Street and Maple Avenue, Durham	Day of Week:	Tuesday
Project #:	AECOM: 6061487	Report No:	355
Contractor:	Ludlow Construction	Page:	1 of 11

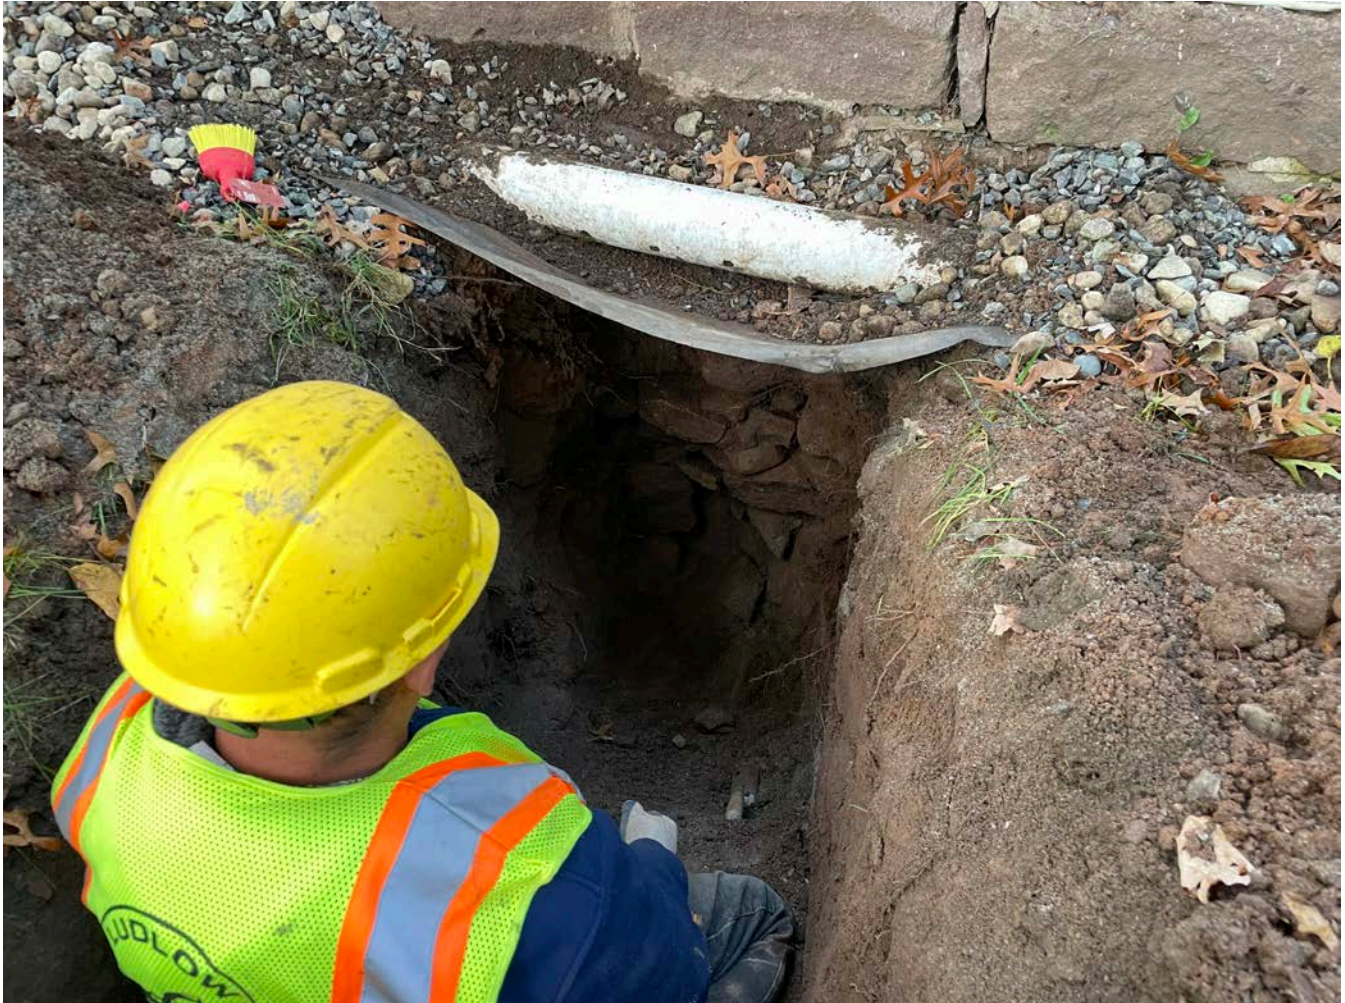
Ludlow began the repair of the eastern foundation of the residence located at 248 Main Street, Durham.

Picture 1: Ludlow placing non-shrink grout on a section of the eastern foundation of the 248 Main Street residence. View to the west.

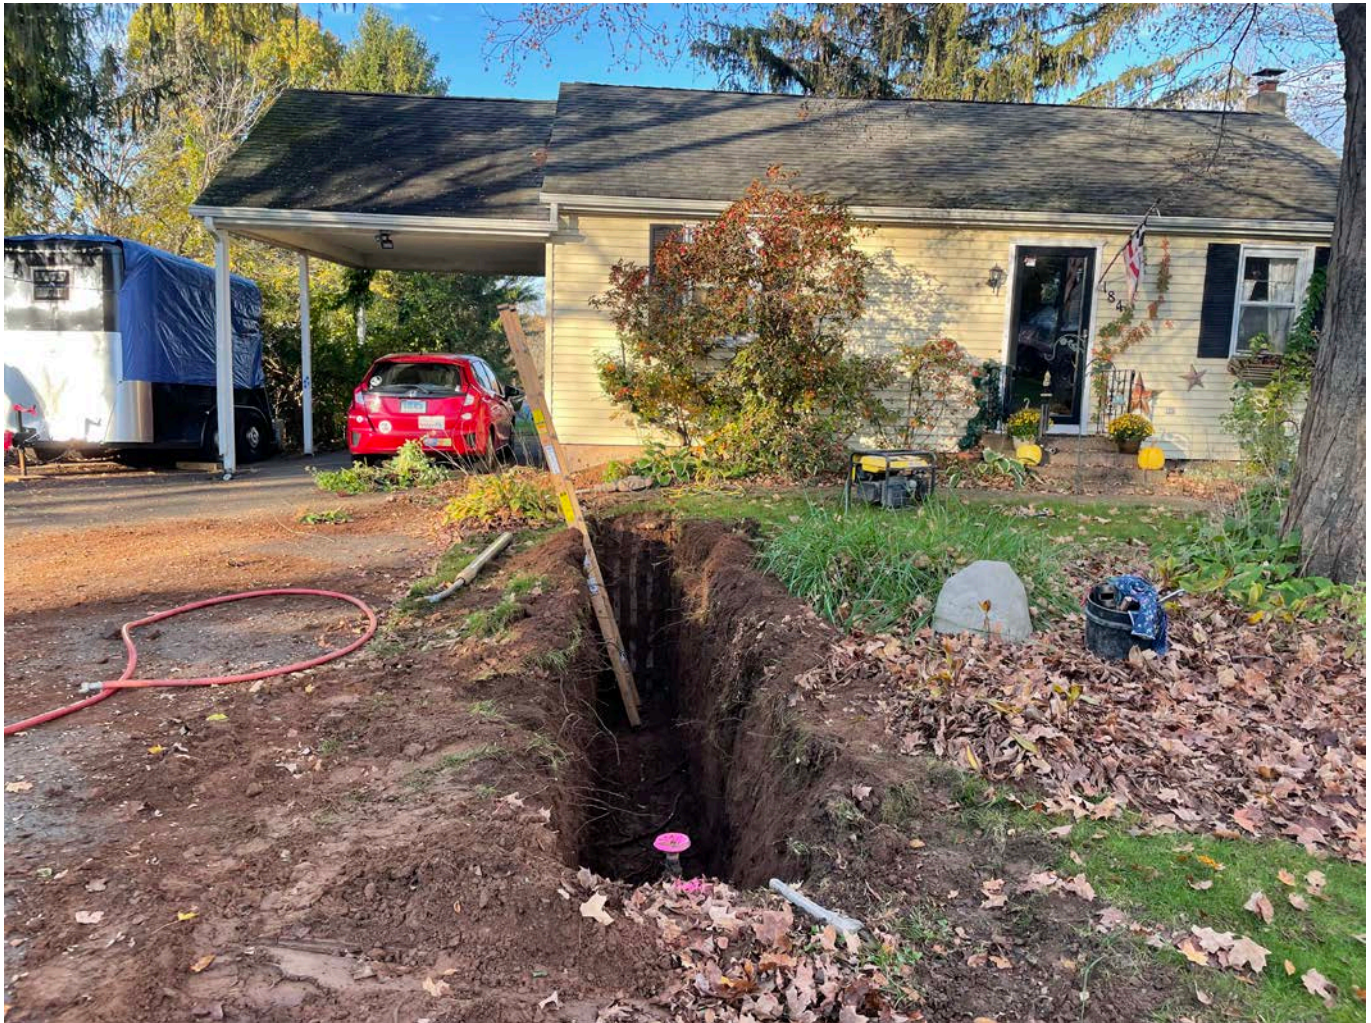
0854: Ludlow has a trench excavated between the eastern foundation of the 184 Maple Avenue residence and its associated curb stop, with the exception of a section of a brick sidewalk that Ludlow will run a pneumatic mole beneath in order to install a 1" copper water service line.

Picture 2: Trench that Ludlow has excavated at the 184 Maple Avenue residence for the installation of a 1" copper water service line. View to the west.

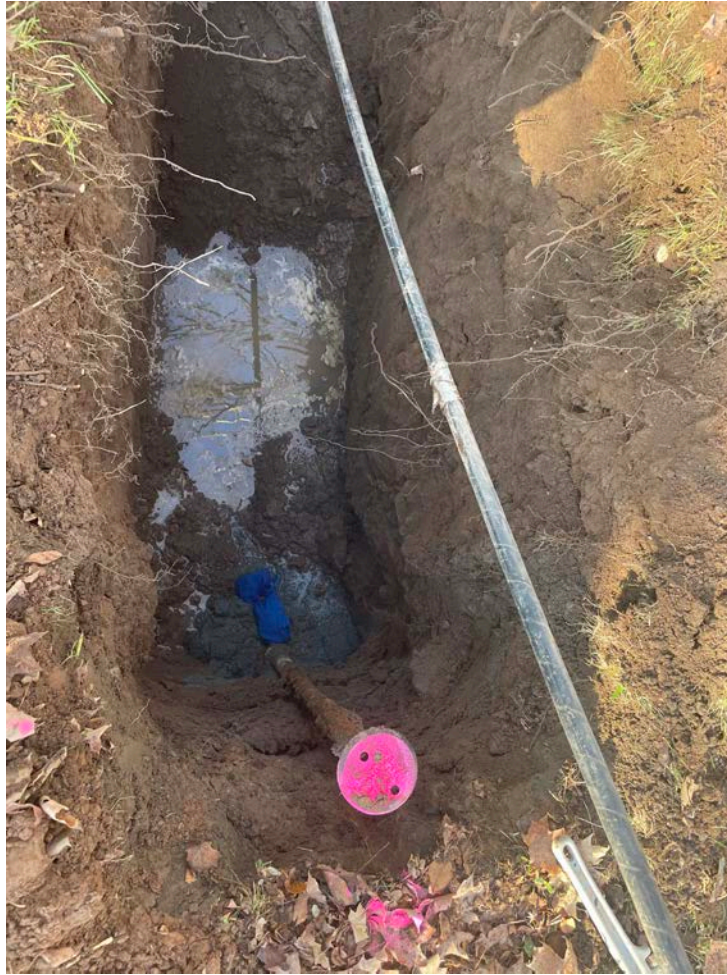
0921: Ludlow is running a pneumatic mole beneath the brick sidewalk at the 184 Maple Avenue residence. A small amount of water has shown up in the trench, immediately proximal to the curb stop.

Picture 3: Water observed pooling at the east end of the trench that Ludlow has excavated at the 184 Maple Avenue residence for the installation of a 1" copper water service line.

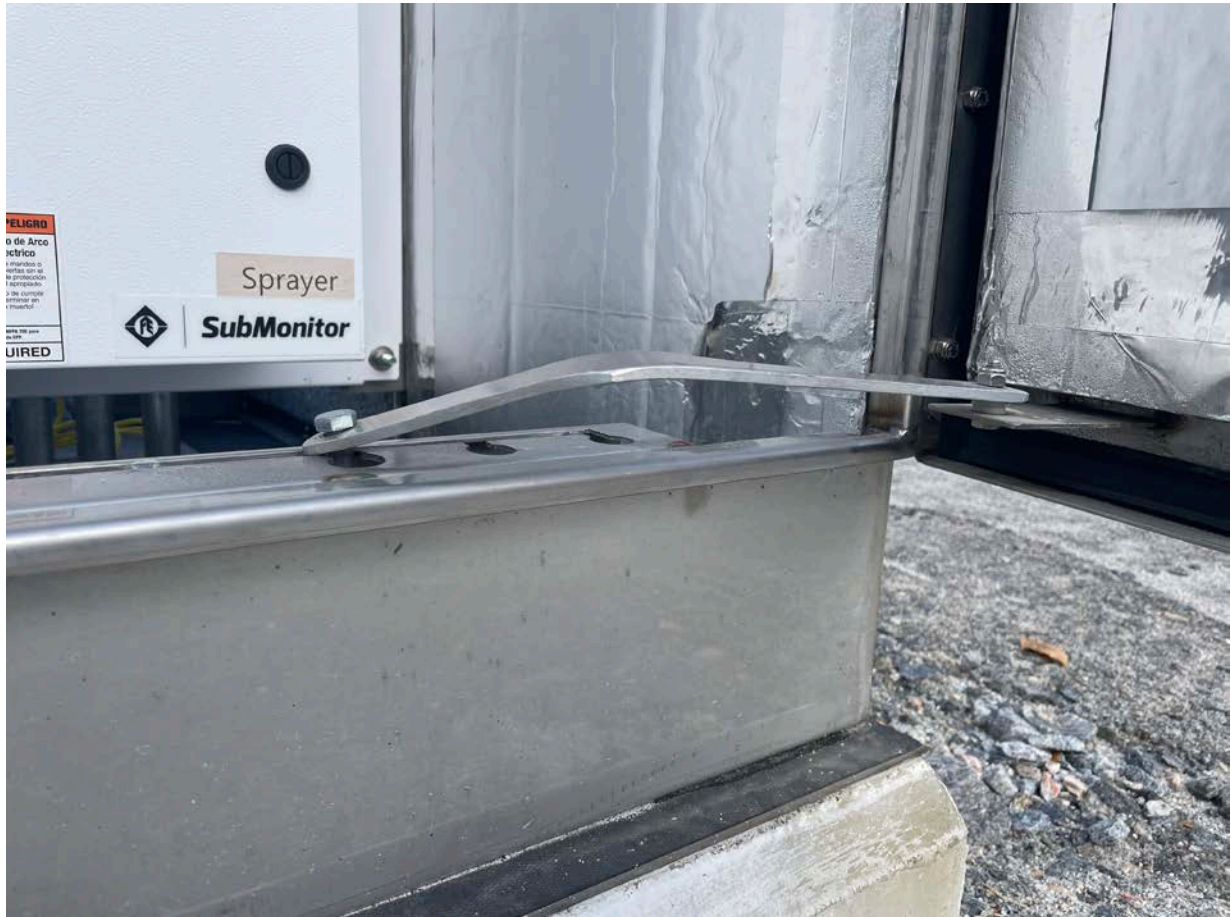
Picture 4: Bent support arm on one of the south-facing doors of the electrical cabinet located north of the altitude vault at the water tank work zone. View to the northeast.

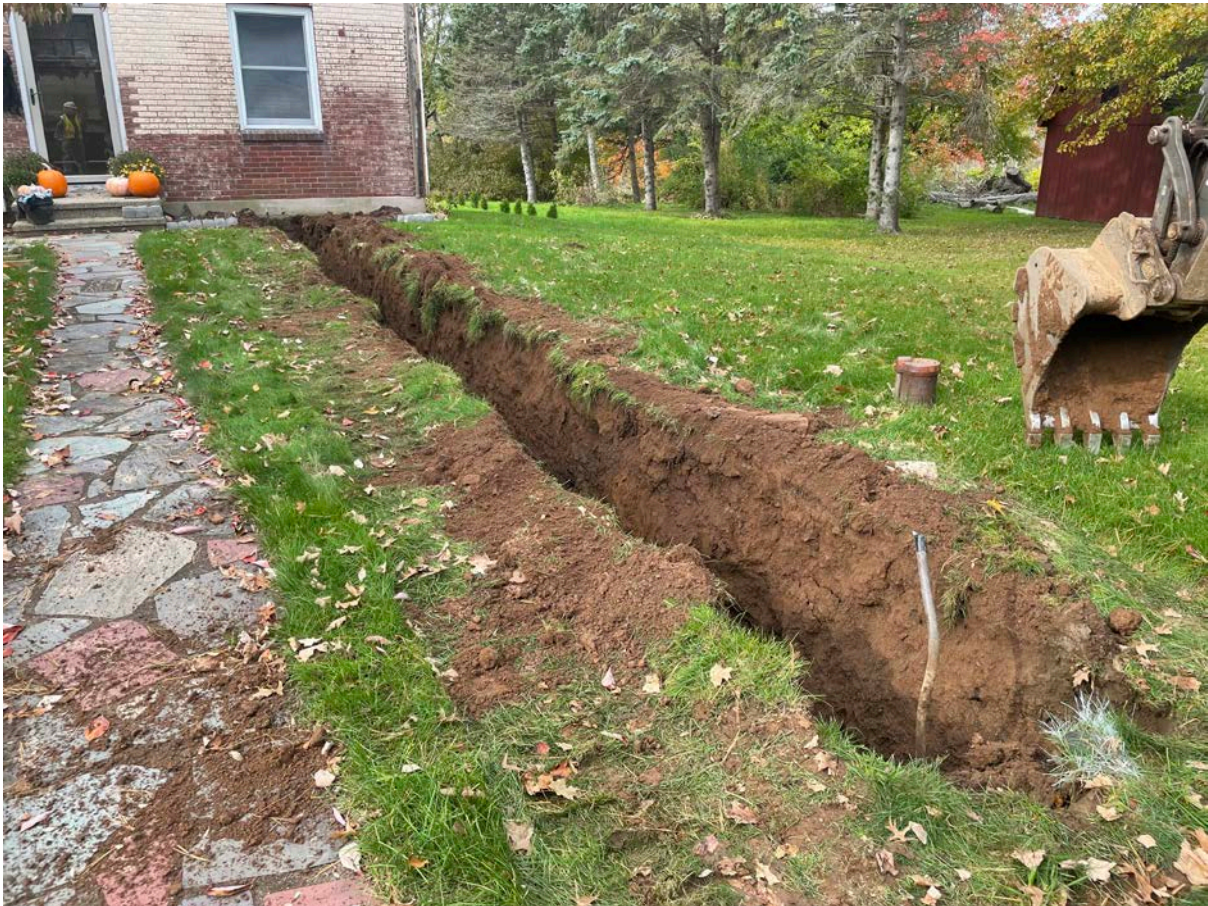
1210: Ludlow is currently excavating a trench for the installation of a 1" copper water service line at the 188 Maple Avenue residence.

Picture 5: Trench that Ludlow has excavated at the 188 Maple Avenue residence for the installation of a 1" copper water service line. View to the west.

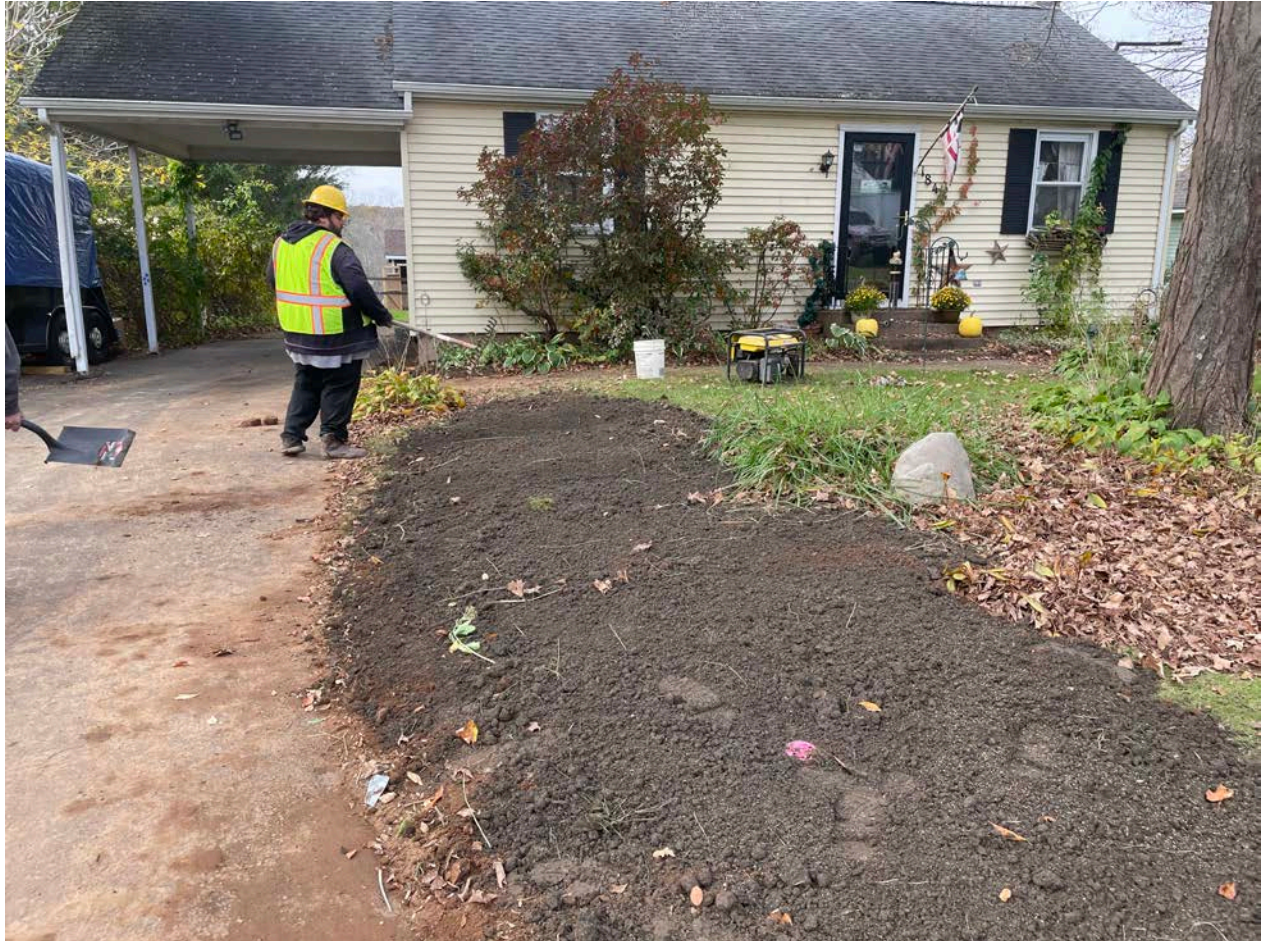
1207: Ludlow has finished the installation of a 1" copper water service line at the 184 Maple Avenue residence. Ludlow is currently raking out loam and placing grass seed to restore those sections of the lawn that were disturbed during the water line installation. Ludlow penetrated the foundation of the 184 Maple Avenue residence with a rotary hammer 16" north of the home's southeast corner.

Picture 6: Ludlow raking out loam that they placed on the portions of the 184 Maple Avenue property that were disturbed during the installation of a 1" copper water service line. View to the west.

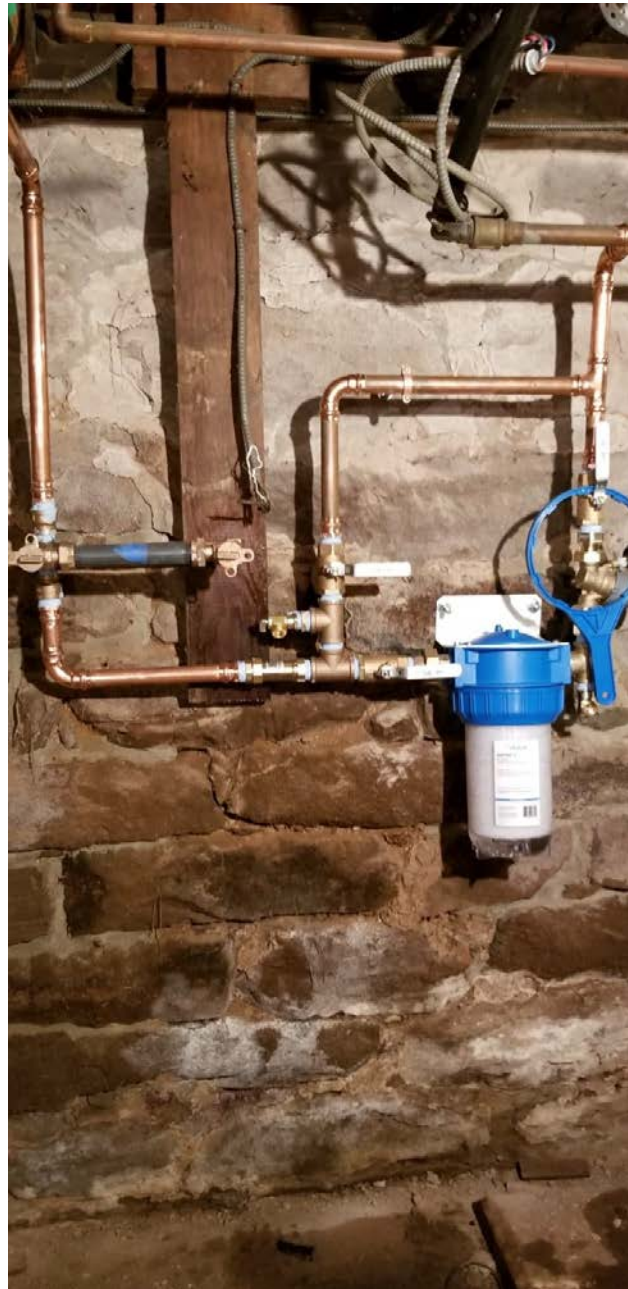
1304: Fazzino is working at the 110 Maple Avenue, Durham, residence, installing final water service components.

Picture 7: Final water service components that Fazzino Plumbing installed at the 110 Maple Avenue, Durham, residence.

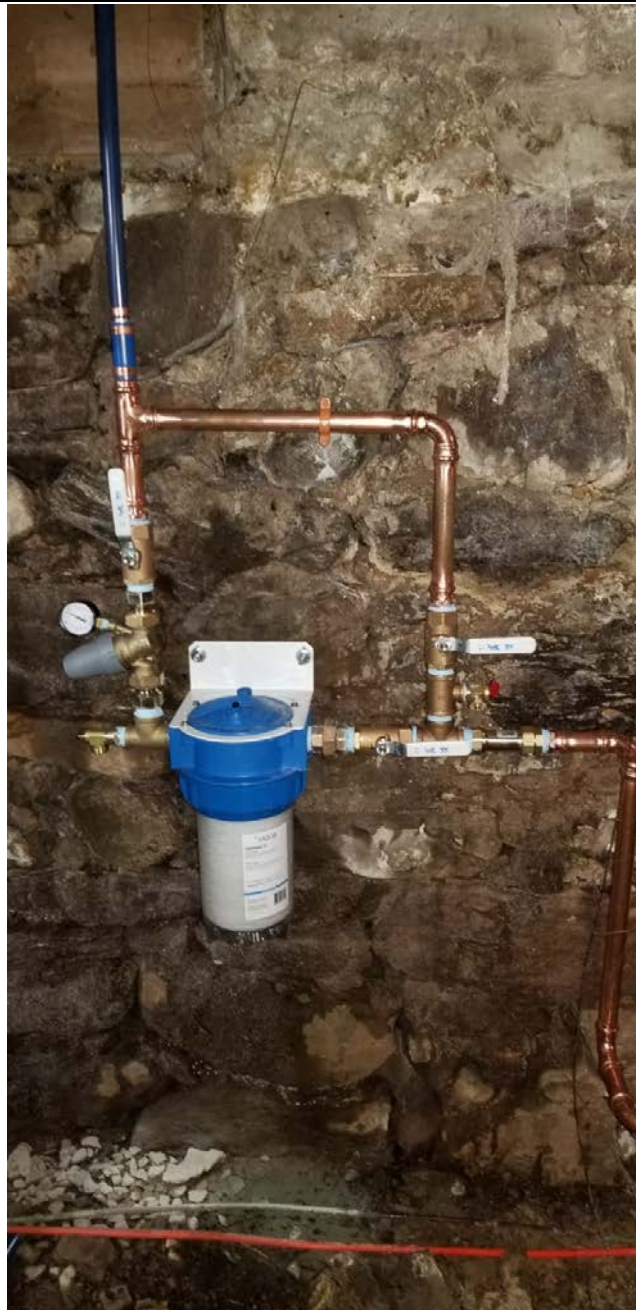
1223: Fazzino Plumbing is working at the 208 Main Street, Durham, residence installing final water service components.

Picture 8: Final water service components that Fazzino Plumbing installed at the 208 Main Street, Durham, residence.
