## Daily Report

<b>Project:</b>	Durham Meadows Pipeline Installation	<b>Date:</b>	November 03, 2021
<b>Location:</b>	Main Street and Maple Avenue, Durham	<b>Day of Week:</b>	Wednesday
<b>Project #:</b>	AECOM: 6061487	<b>Report No:</b>	356
<b>Contractor:</b>	Ludlow Construction	<b>Page:</b>	1 of 10

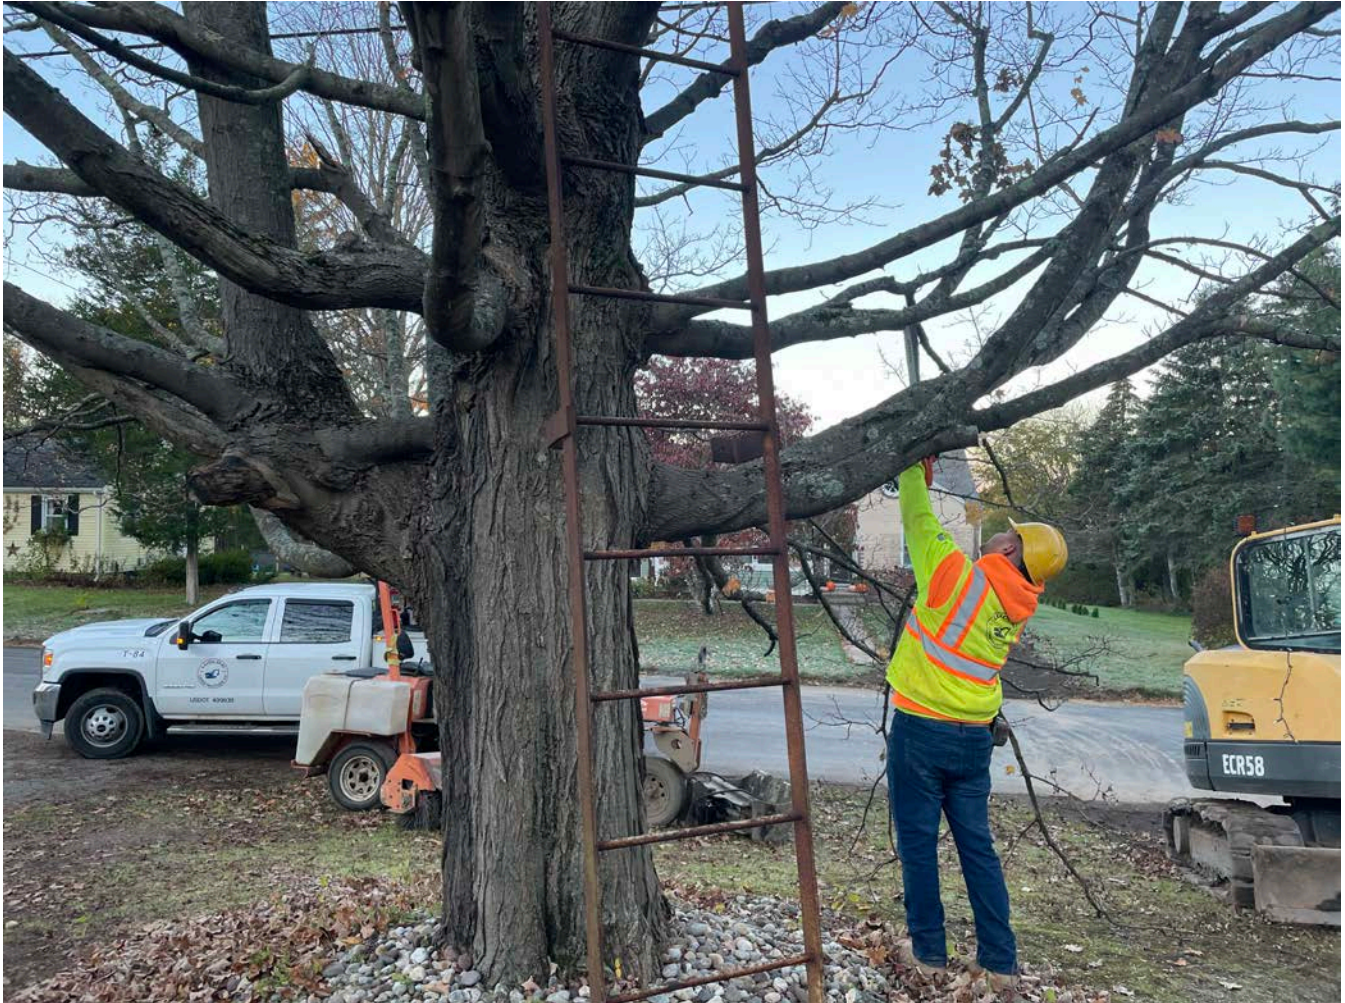
Picture 1: Ludlow is using a chainsaw to trim some branches off a tree that's in the path of the 1" copper water service line they installed at the 187 Maple Avenue residence today. View to the west.

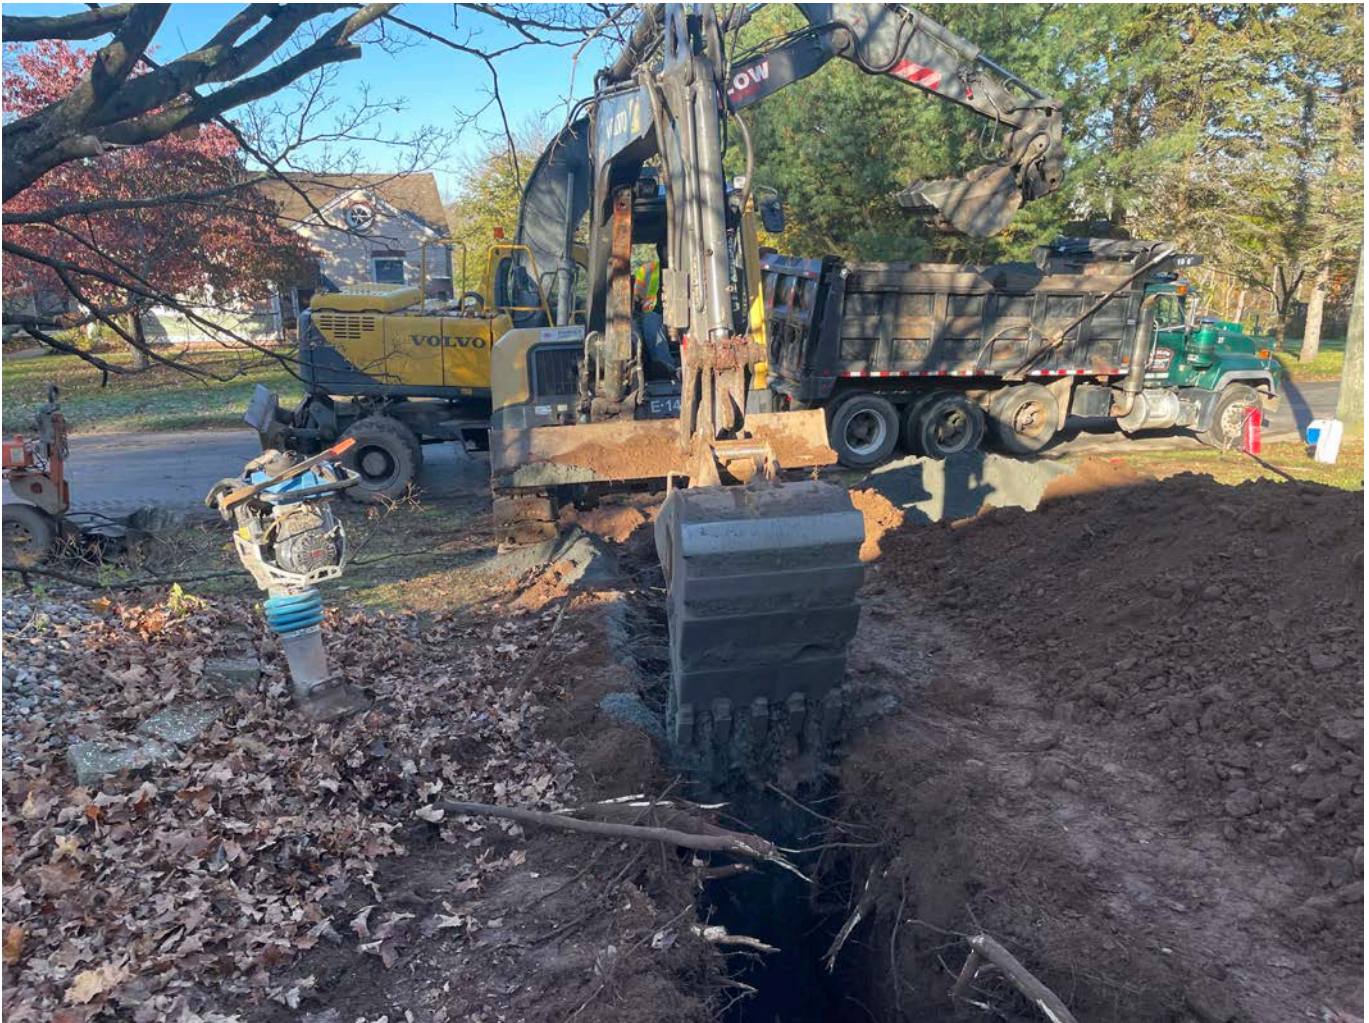
**Picture 2: Trench that Ludlow is excavating at the 187 Maple Avenue residence for the installation of a 1” copper water service line. View to the northwest.**

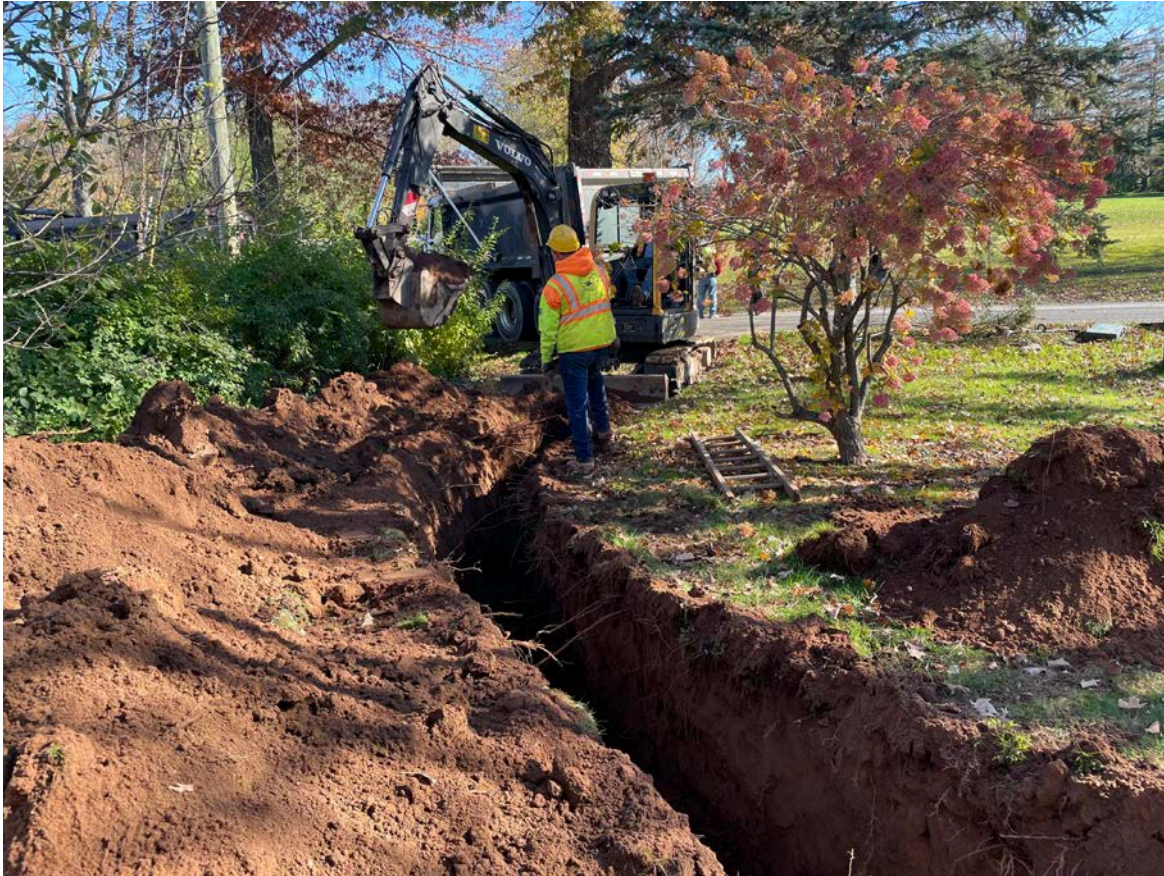
Picture 3: Ludlow excavating a trench at the 200 Maple Avenue residence for the installation of a 1" copper water service line. View to the east.

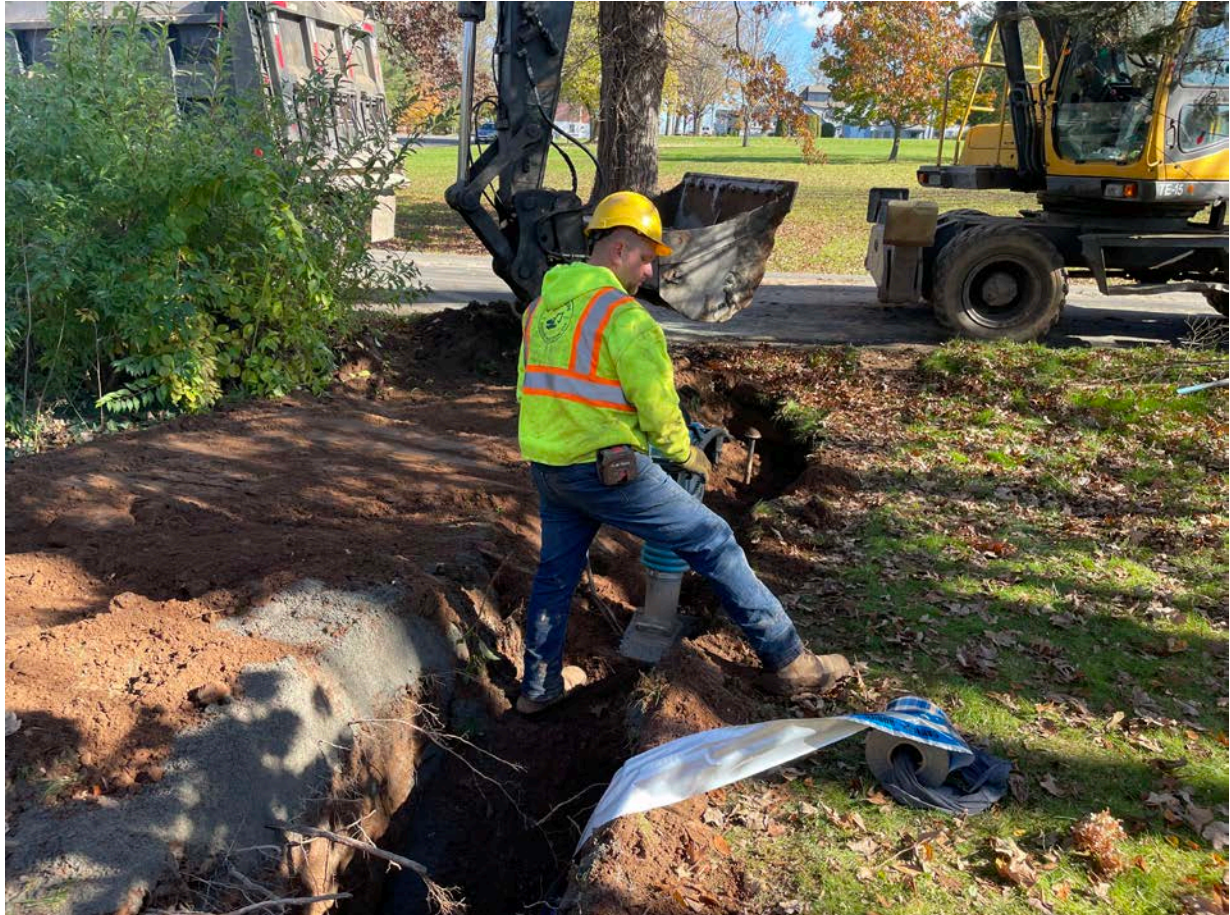
Picture 4: Ludlow compacting fill in the trench they excavated at the 200 Maple Avenue residence during the installation of a 1" copper water service line. View to the east.

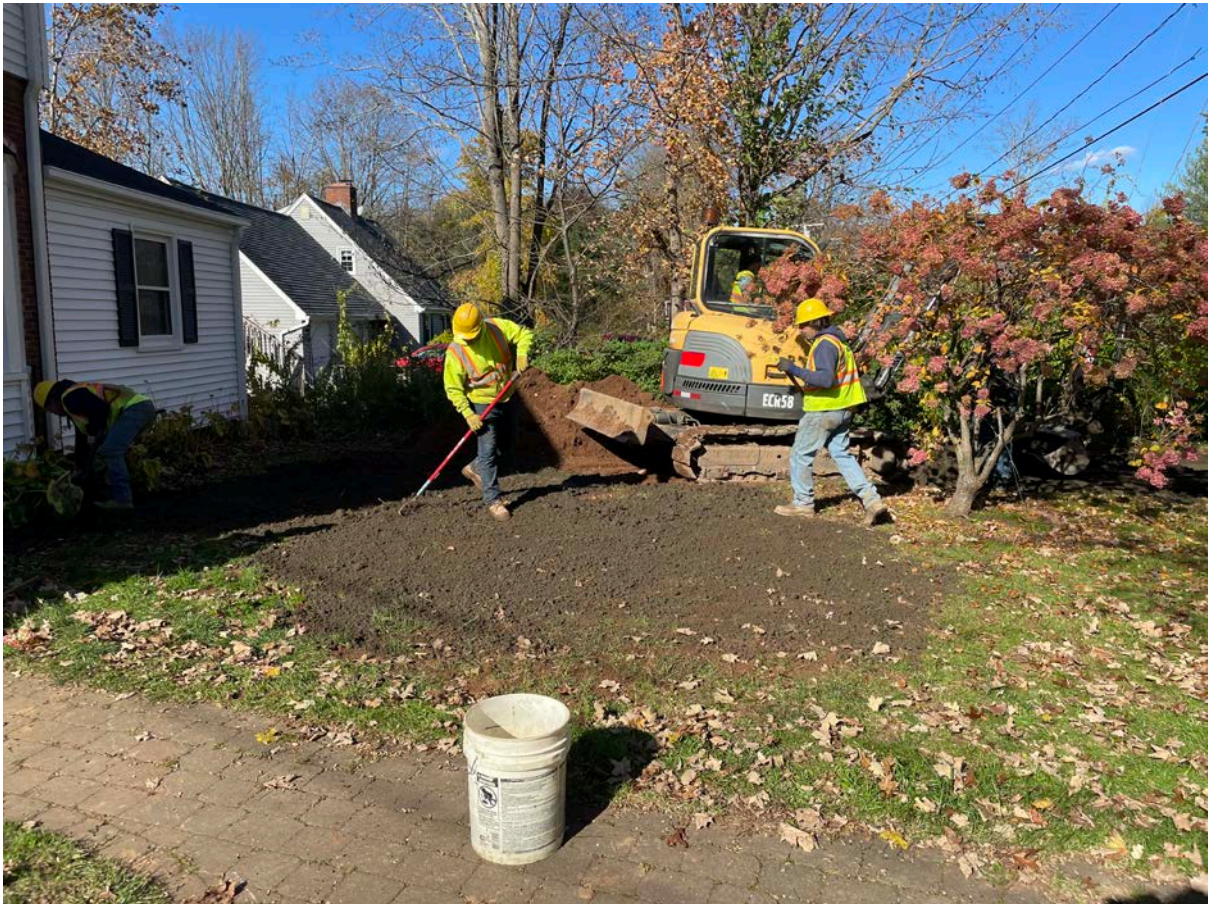
Picture 5: Ludlow placing and raking out loam at the 200 Maple Avenue residence after the installation of a 1" copper water service line. View to the north.

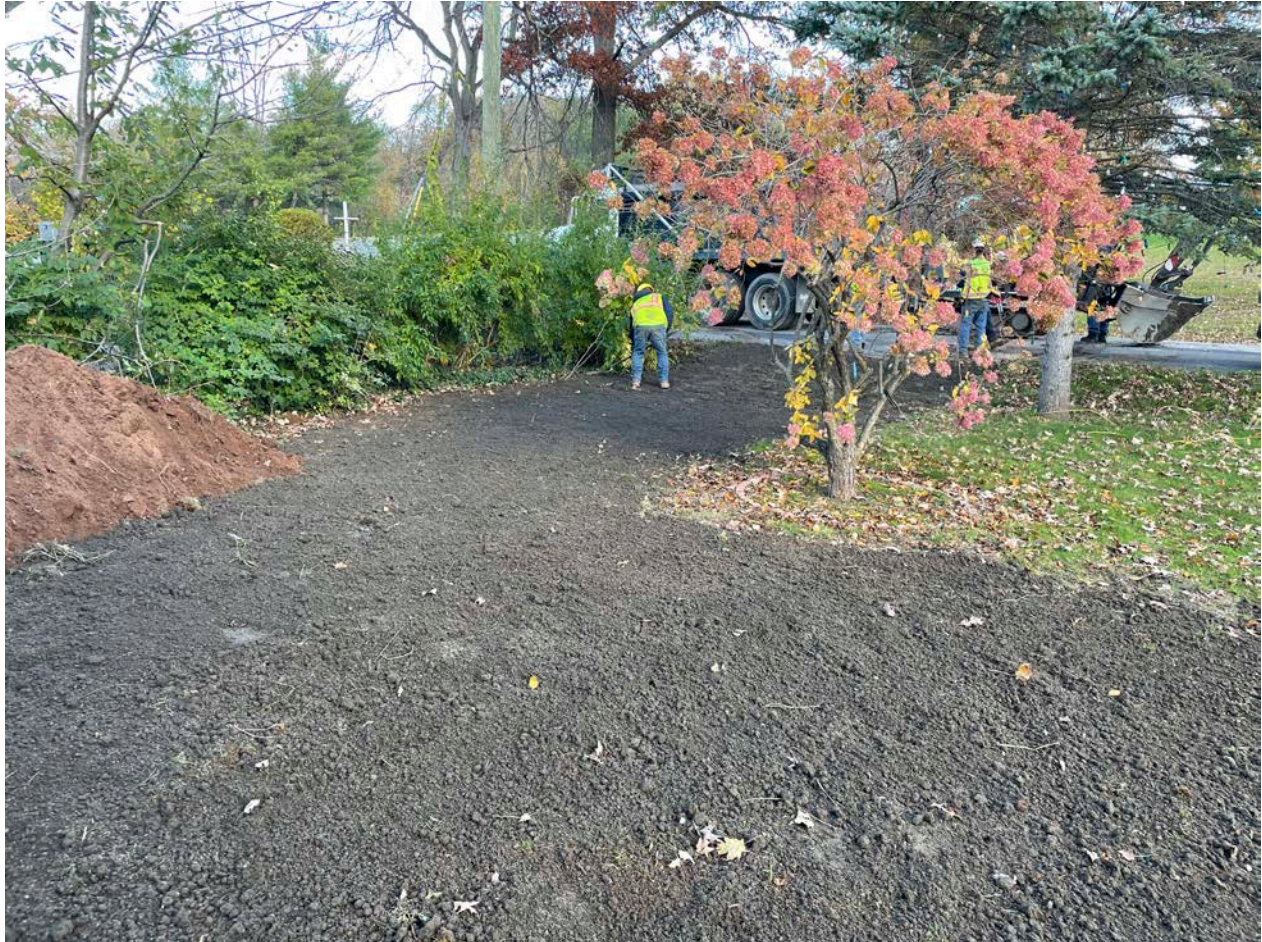
Picture 6: Ludlow raking out loam at the 200 Maple Avenue residence after the installation of a 1" copper water service line. View to the east.

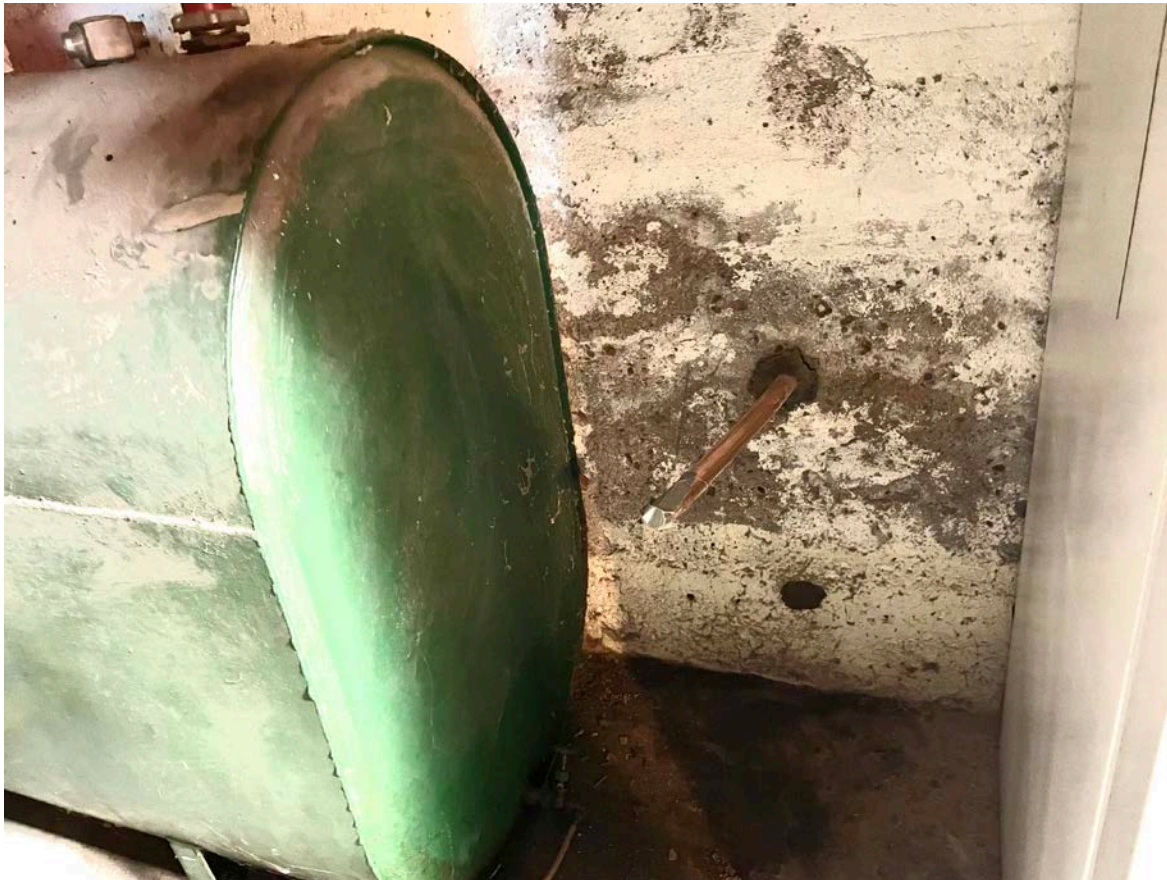
1113: Ludlow is preparing to penetrate the eastern wall of the 200 Maple Avenue residence foundation with a rotary hammer. The foundation on the east side of the house is comprised of concrete block. Ludlow has moved the insertion point of the 1" copper service line further south than was indicated in the Appendix B plans to work around the location of the residence's oil tank.

1211: Ludlow has inserted 1" copper water service line through the concrete block foundation on the east side of the 200 Maple Avenue residence and is preparing to secure it into place with non-shrink grout.

Picture 7: Copper pipe penetrating the eastern wall of the 200 Maple Avenue foundation. View to the east.
