Daily Report

Project:	Durham Meadows Pipeline Installation	Date:	November 04, 2021
Location:	Main Street and Maple Avenue, Durham	Day of Week:	Thursday
Project #:	AECOM: 6061487	Report No:	357
Contractor:	Ludlow Construction	Page:	1 of 14

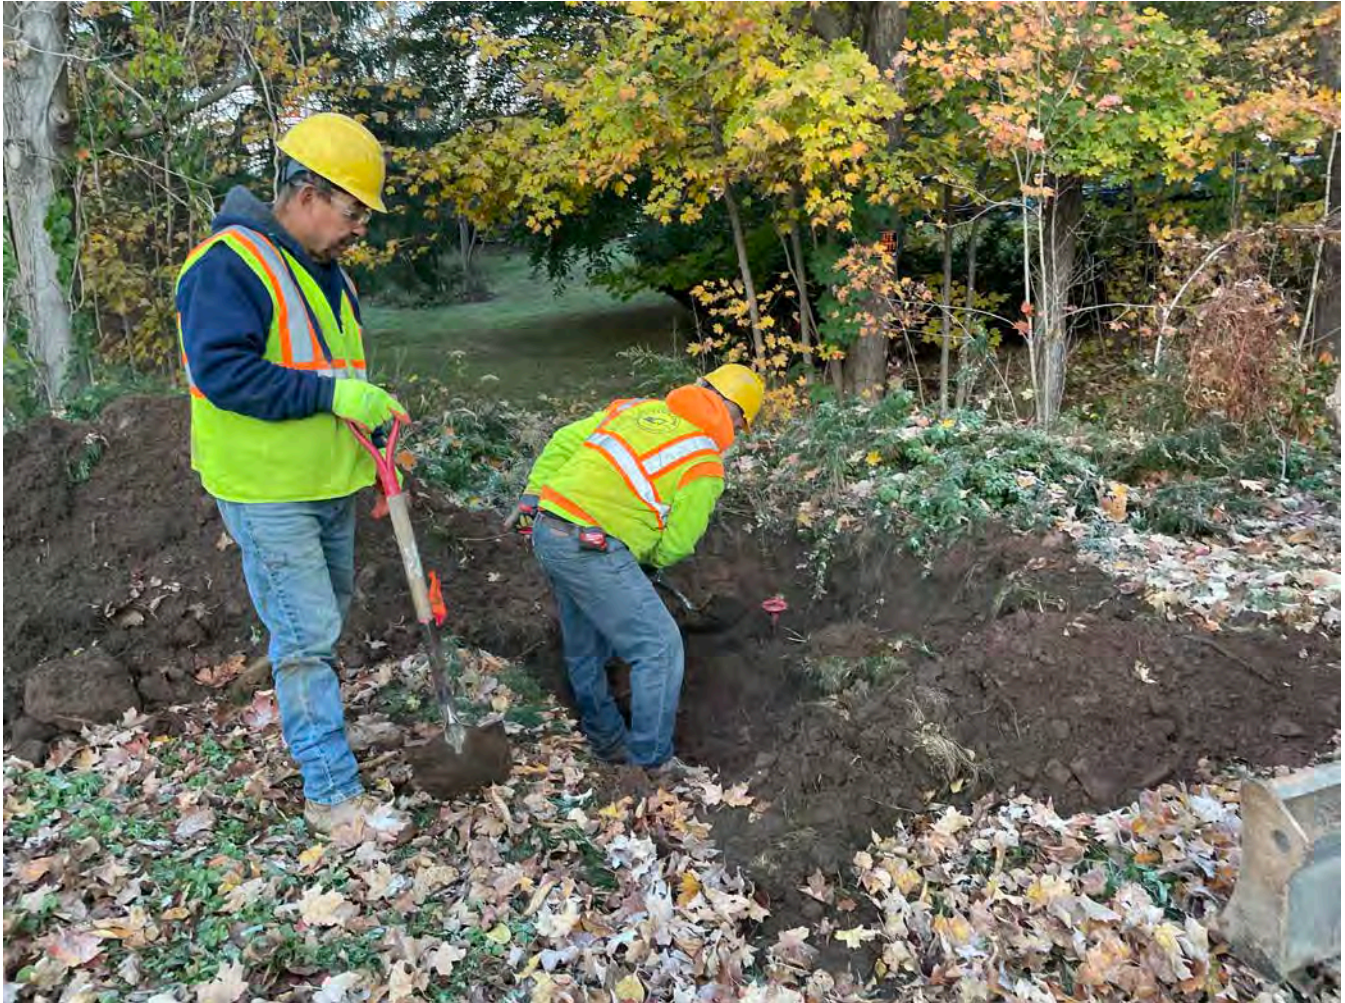
Picture 1: Ludlow preparing to remove the curb stop for the 212R Maple Avenue property, to be reinstalled later today south of this location. View to the west.

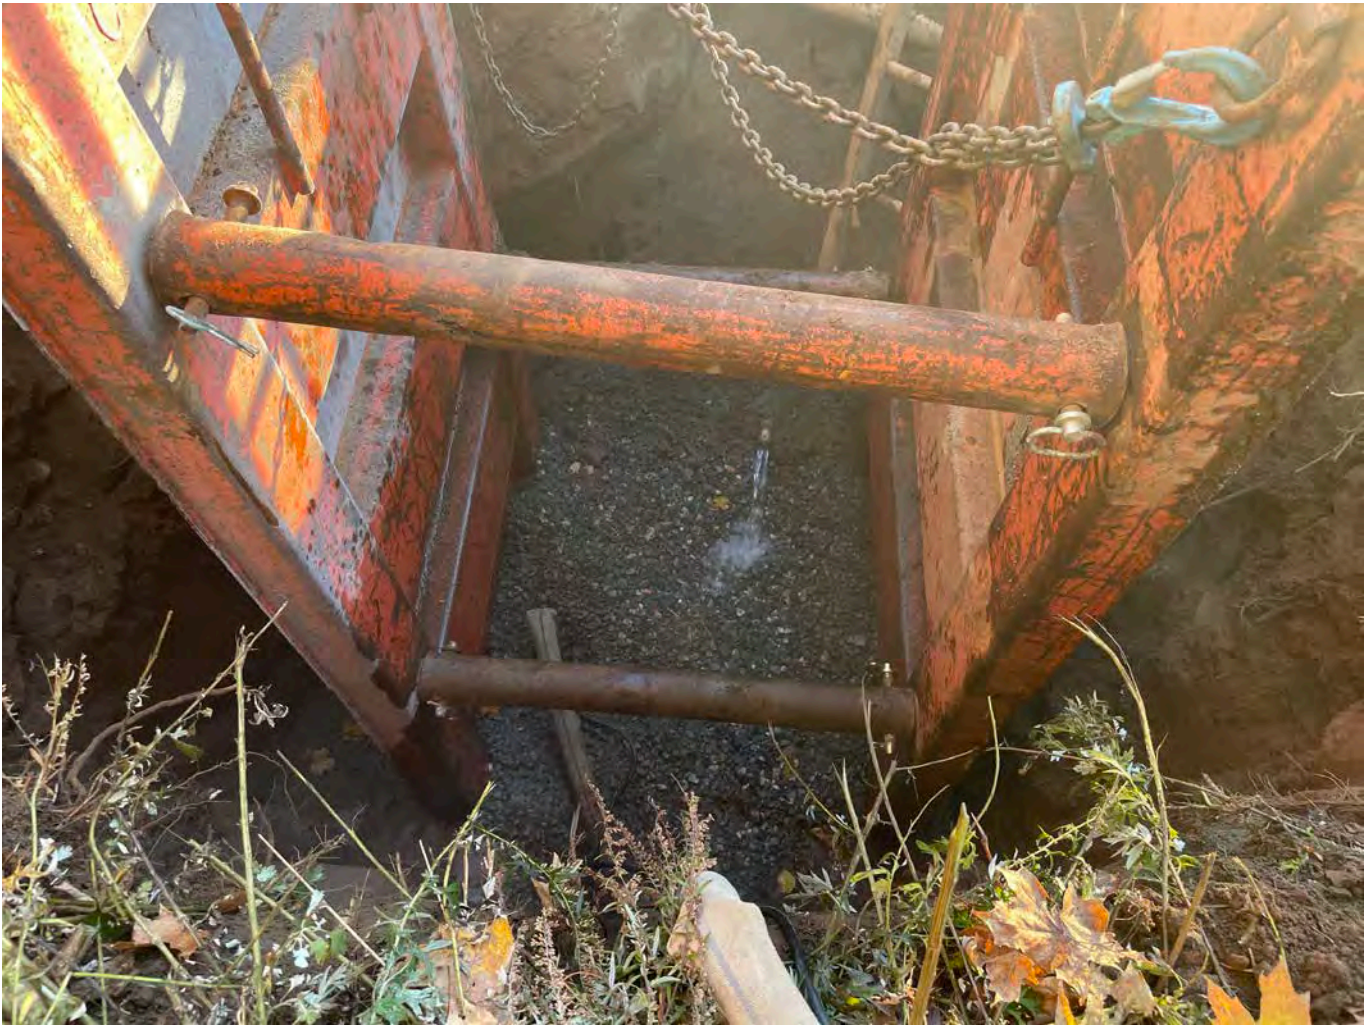
water line. This water is draining the water line between Talcott Lane and 200 Maple Avenue, where Ludlow has turned off gate valves at these locations.

Picture 2: Water from a section of the Maple Avenue water line that is draining into the excavation where Ludlow removed the curb stop for the 212R Maple Avenue property. The water is being removed from the excavation via a pump that is set in the ¾" rock that is visible on the bottom of the excavation. View to the east.

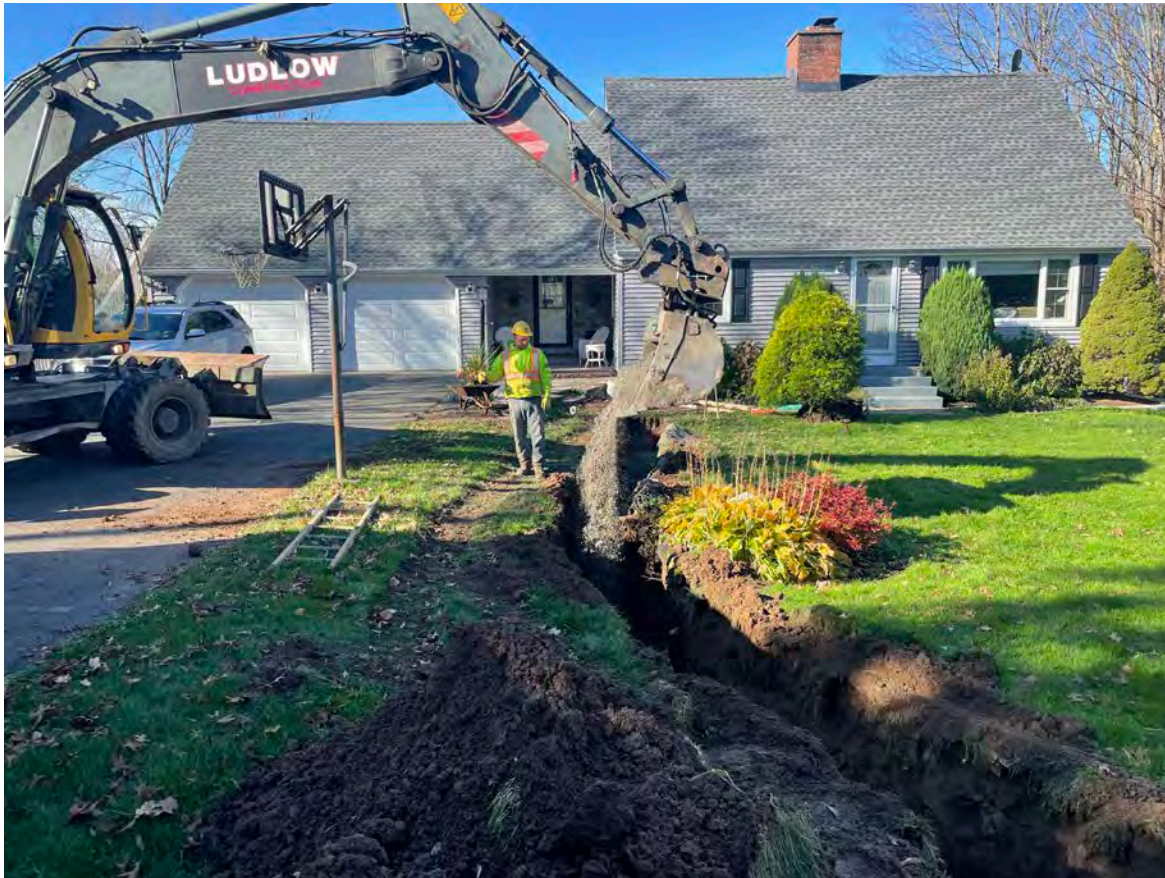
1048: Ludlow is placing sand over the 1" copper water service line that they've installed between the curb stop and the foundation of the 206 Maple Avenue residence. Ludlow is currently using non-shrink grout to secure the 1" copper pipe in place where it penetrates the poured concrete foundation.

Picture 3: Ludlow placing sand over 1” copper water service line that they just installed on the east side of the 206 Maple Avenue residence. View to the west.

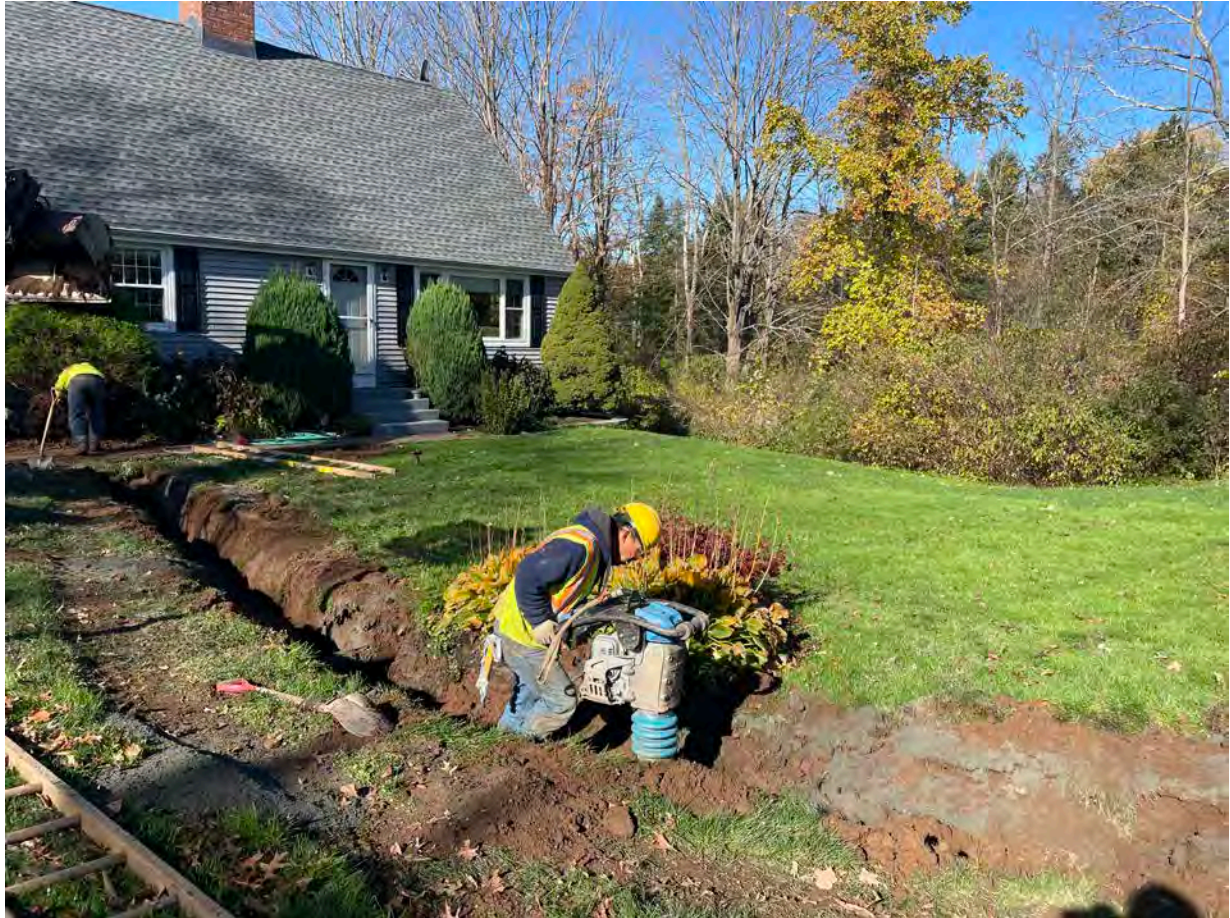
1121: Ludlow is placing fill in 1' lifts over the sand and caution tape they placed over the 1" copper water service line they just installed at the 206 Maple Avenue property. Ludlow is compacting each lift of fill with a jumping jack.

Picture 4: Ludlow compacting fill that has been placed over the sand and caution tape that was placed over the 1" copper water service line that they just installed on the east side of the 206 Maple Avenue residence. View to the northwest.

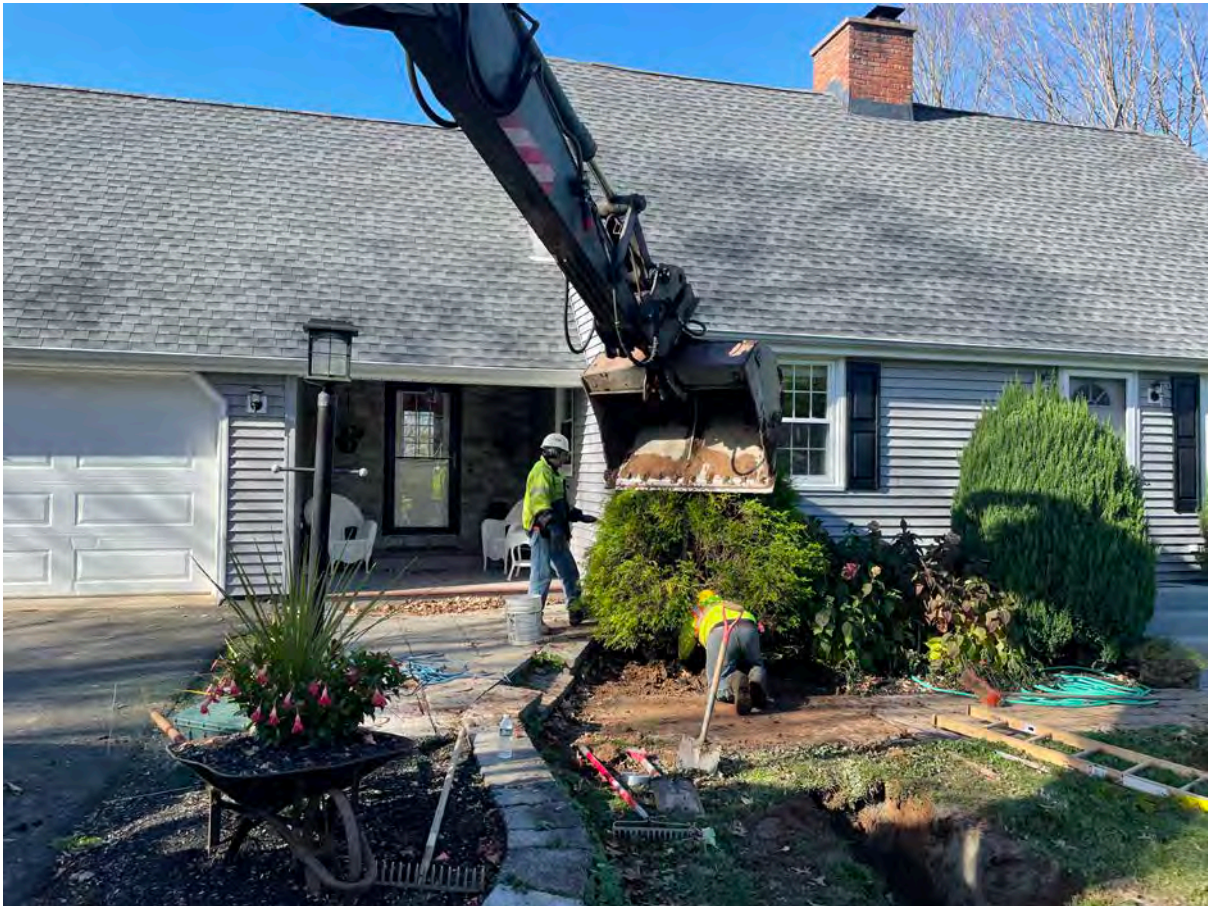
Picture 5: Ludlow setting a shrub back in place on the east side of the 206 Maple Avenue residence after they installed a 1" copper water service line. View to the west.

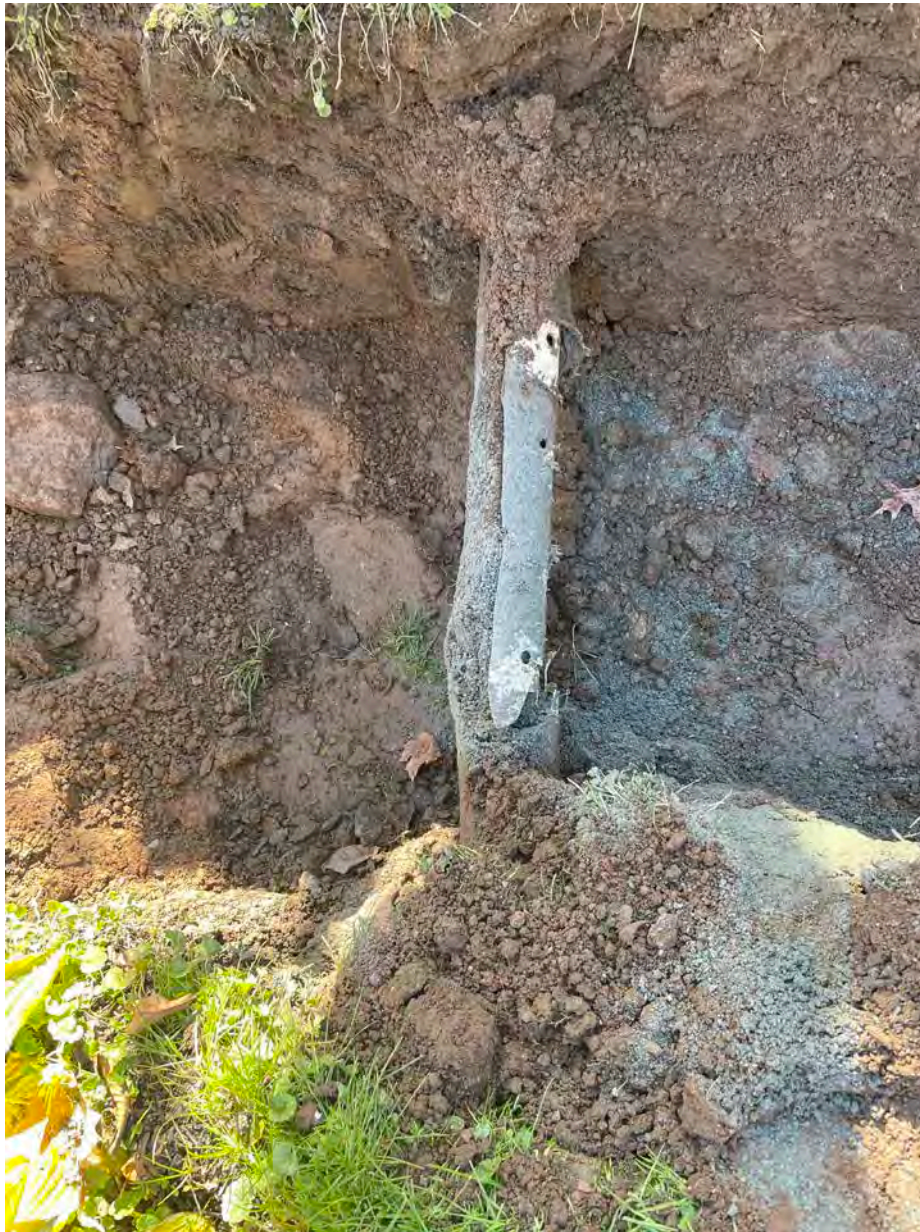
1113: Ludlow is preparing to repair a section of corrugated, perforated 4" PVC drain pipe located approximately 40' east of the 206 Maple Avenue residence.

Picture 6: 4" PVC drain line that Ludlow damaged during the installation of a 1" copper water service line at the 206 Maple Avenue residence. View to the south.

1128: Ludlow has repaired the damaged drainage pipe located approximately 40' east of the 206 Maple Avenue residence with a new section of corrugated, perforated PVC and has covered the repaired section with filter fabric.

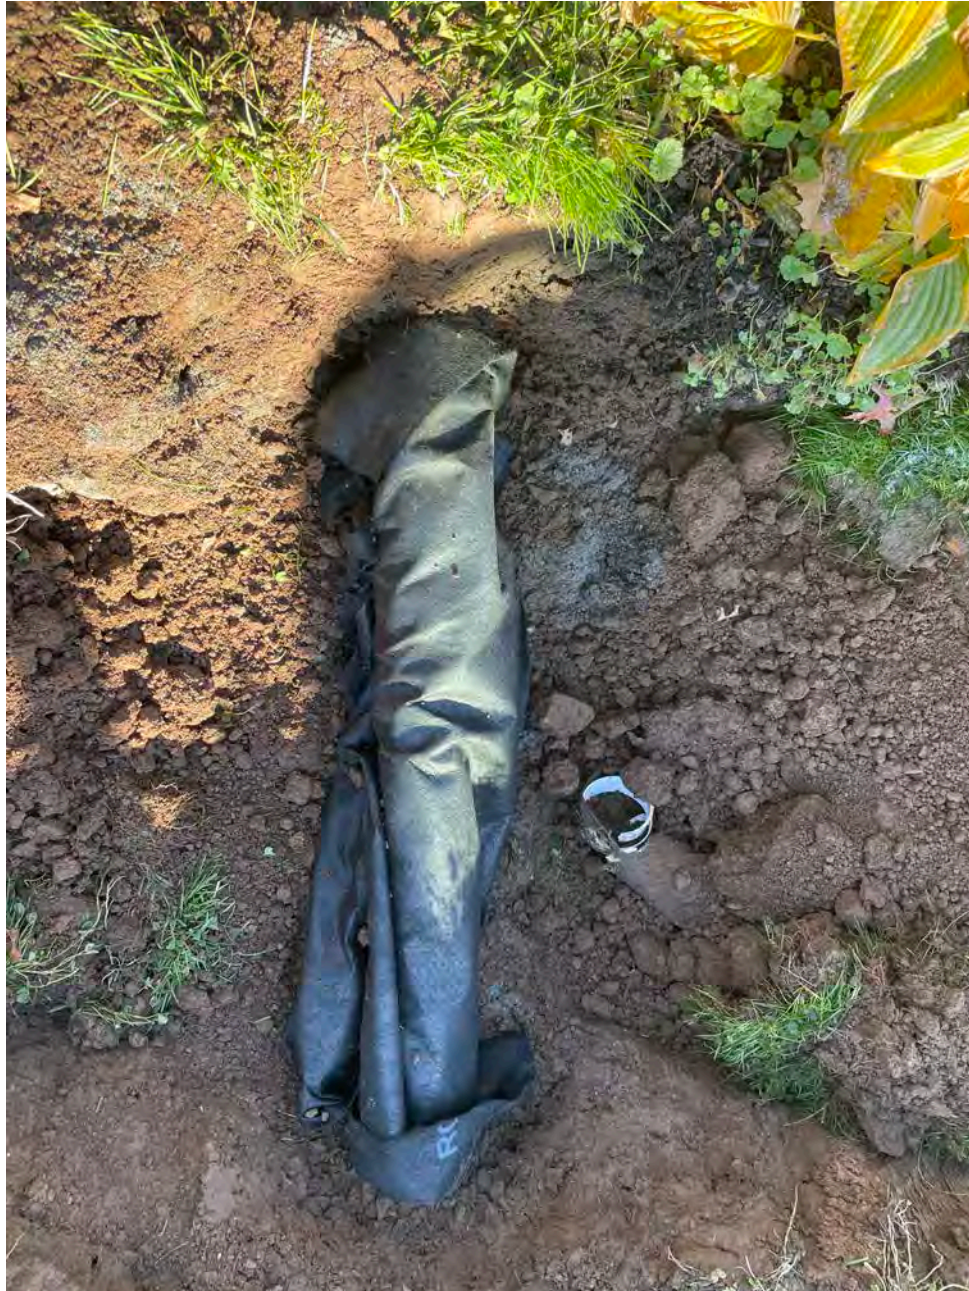
Picture 7: 4" PVC drain line that Ludlow repaired after damaging it during the installation of a 1" copper water service line at the 206 Maple Avenue residence. View to the south.

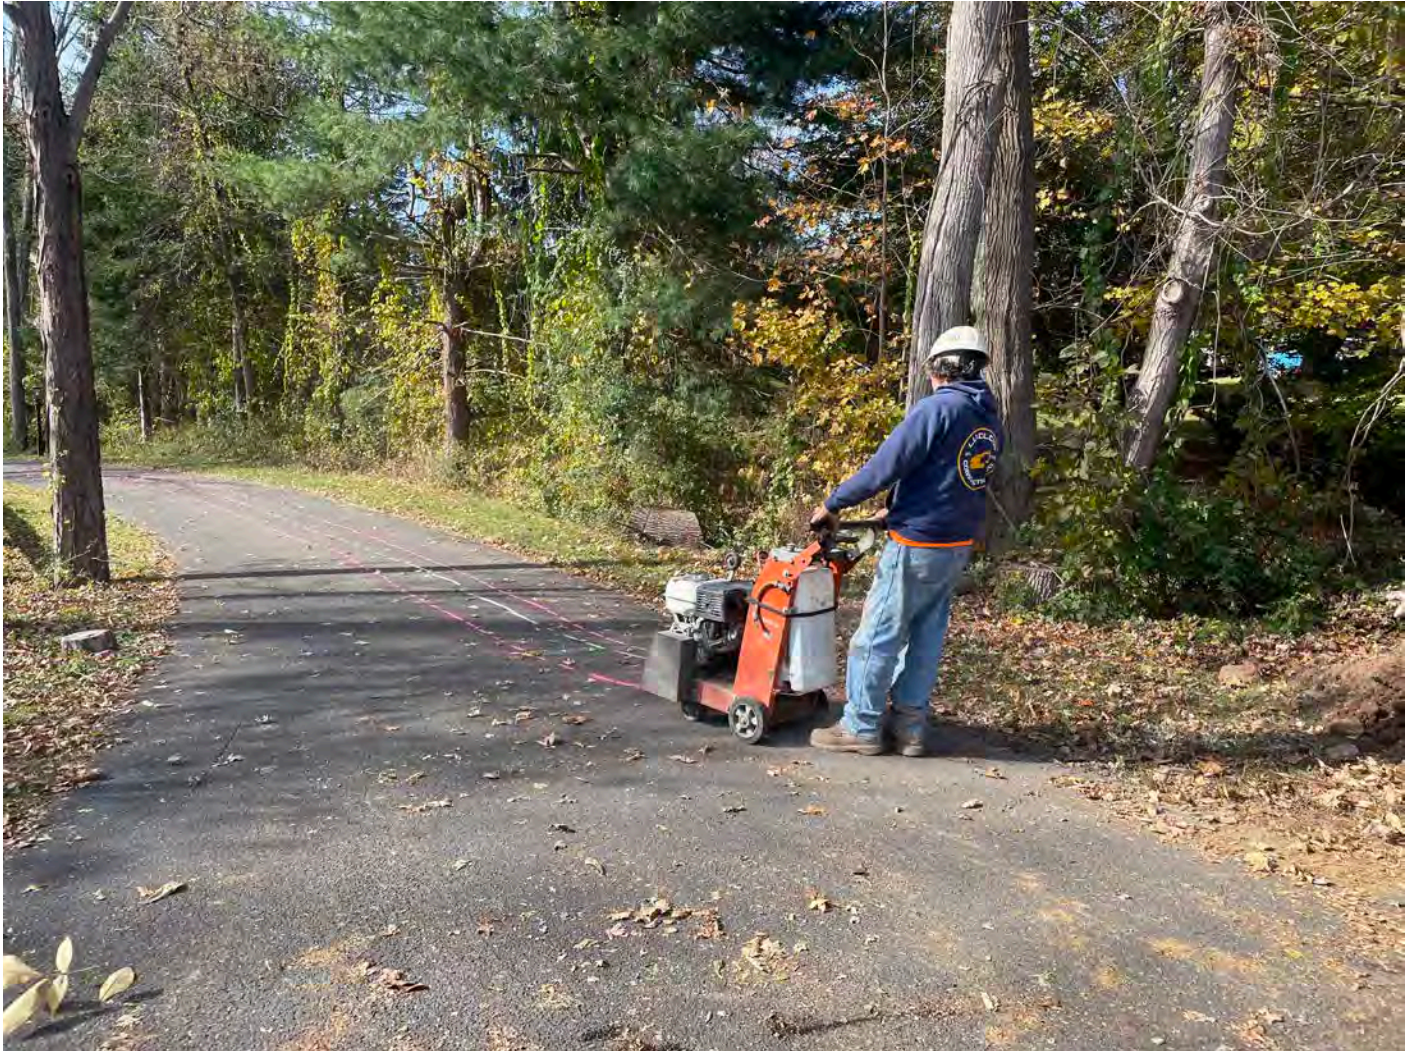
1256: Ludlow begins to saw cut the footprint of a trench on the 212R Maple Avenue driveway. Ludlow is also excavating a trench running from the west side of Maple Avenue (where a 1.5" copper water service line comes off of the main water line to service the 212R Maple Avenue property) to the north side of the driveway for the 212R Maple Avenue property where they will place a curb stop and a meter pit.

Picture 8: Ludlow saw-cutting the footprint of a trench on the 212R Maple Avenue driveway for the installation of a 1.5" copper water service line. View to the west.

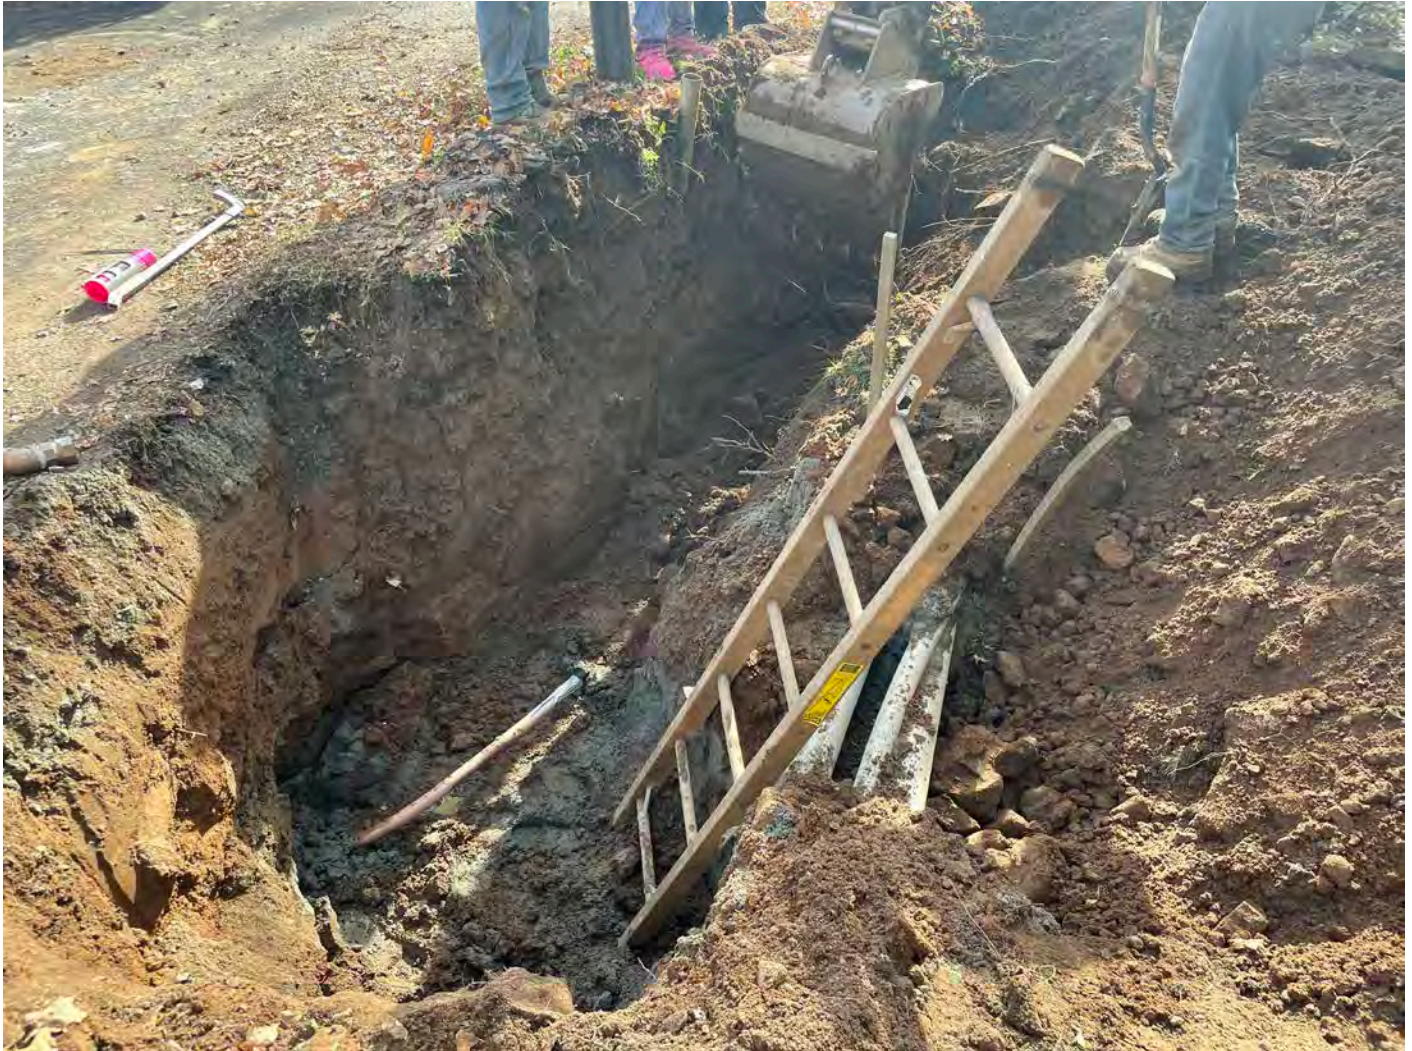
Picture 9: Ludlow excavating a trench for the reinstatement of a curb stop and the installation of a meter pit and 1.5" copper water service line for the 212R Maple Avenue property. View to the south.

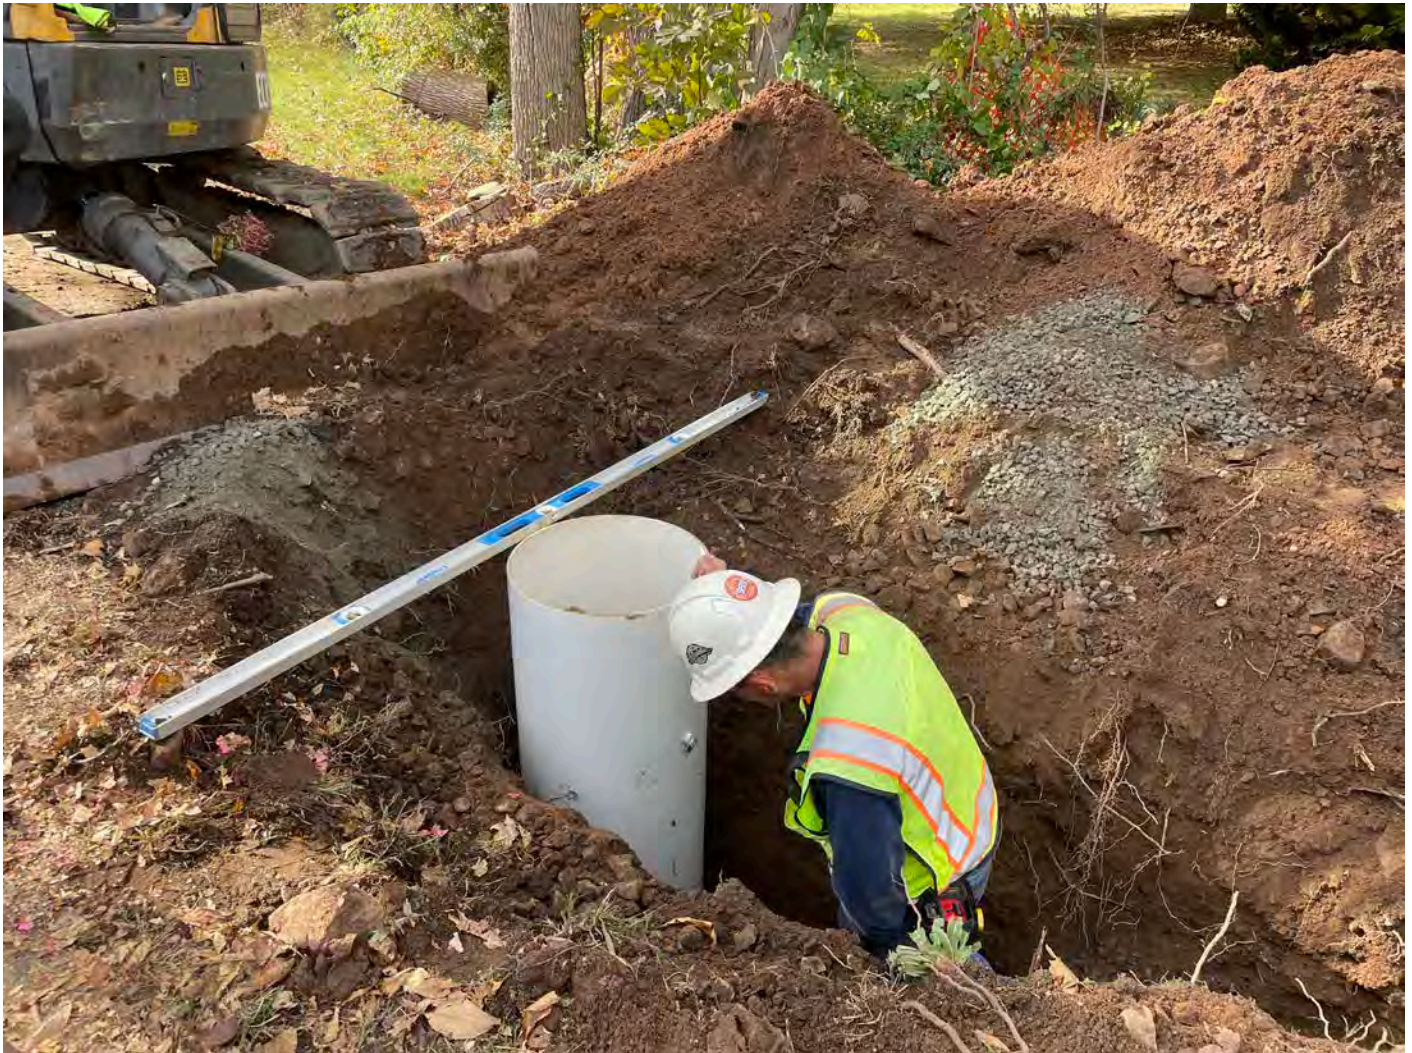
1446: Ludlow continues saw cutting the 212R Maple Avenue property driveway. Ludlow has installed a meter pit and has moved the curb stop for the 212R Maple Avenue property at the north edge of the property's driveway.

Picture 10: Ludlow leveling the meter pit that they are in the process of installing on the north edge of the 212R Maple Avenue driveway. View to the southwest.

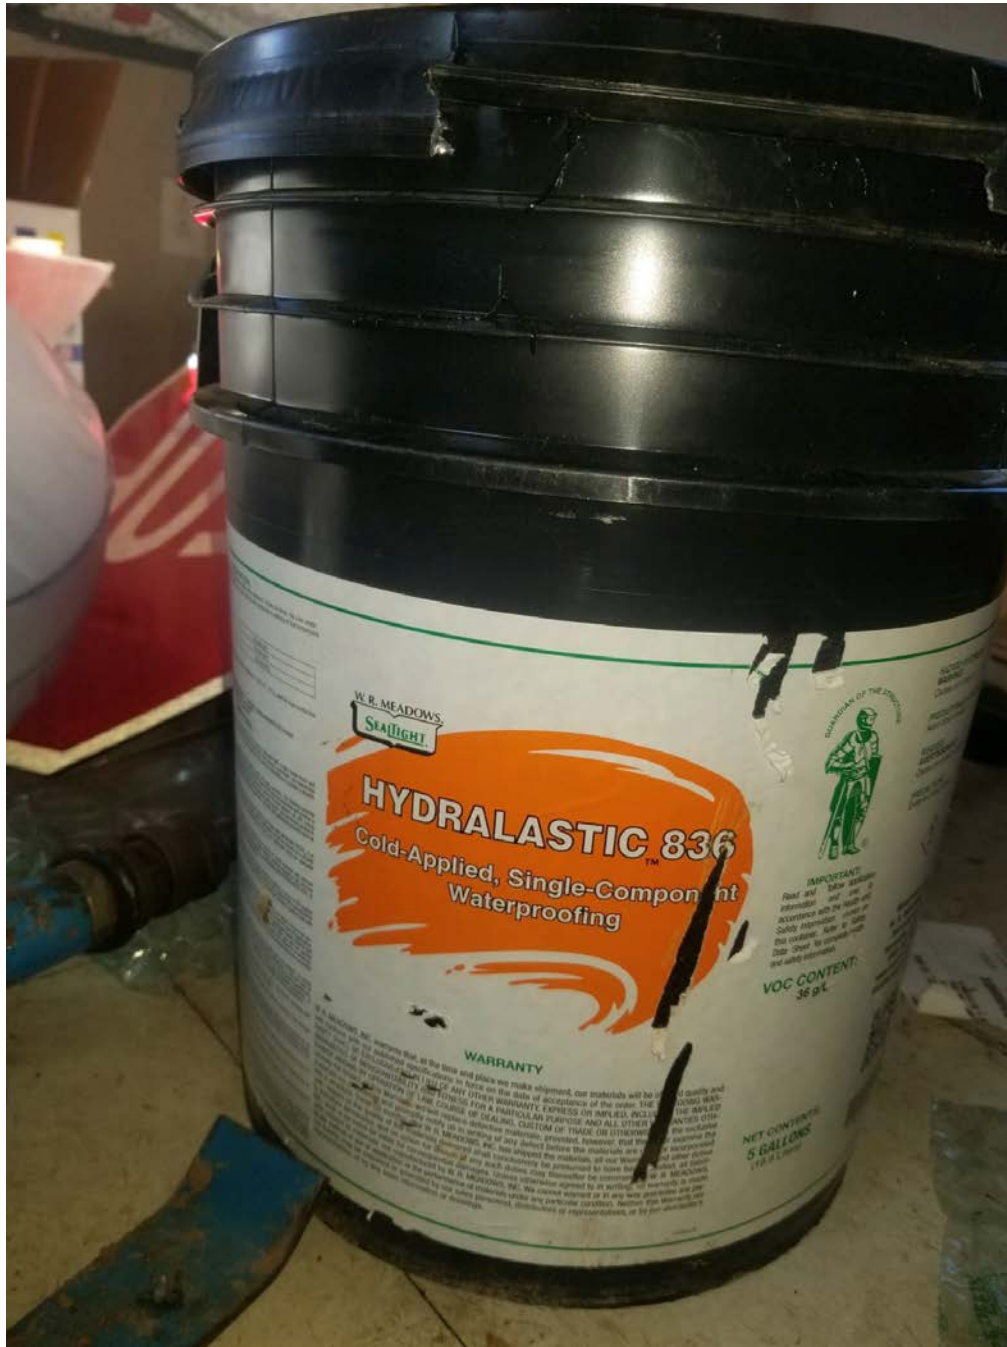
Picture 11: Sealant that Ludlow applied to the portion of the exterior of the 248 Main Street residence foundation after the non-shrink grout they applied to the area had set up.

1002: Ludlow continues work on the eastern foundation of the 248 Main Street residence. Ludlow is preparing to apply foundation coating over the non-shrink grout that they applied to the exterior of the dry-set fieldstone foundation earlier in the week.

1141: Ludlow is finishing up applying foundation coating over the non-shrink grout that they applied to east side of the dry-set fieldstone foundation of the 248 Main Street residence.
