**Daily Report** Project: November 11, 2021 **Durham Meadows Pipeline Installation** Date: Day of Week: Thursday Location: Maple Avenue, Durham **Report No:** 362 Project #: AECOM: 6061487 Page: 1 of 12 Contractor: **Ludlow Construction** Weather Conditions Conditions: Daylight hours: Clear. Wind's variable 0-2 mph. Temperature (°F): High 60°F Low Contractors & Subcontractors Workforce Equipment in Use # X hrs # x hrs Trade # x hrs Trade Type Concrete/Asphalt Road Saw USACE udlow Construction 1 x 8 Field Engineer 1 x 8 Superintendent Dump truck 1 x 8 Χ 8 Safety Officer 1 Χ 8 Excavator – Large 0 x 8 Χ Excavator - Mid-Size 1 x 8 oreman 8 Dump truck Operator 1 Χ 8 Excavator - Rubber Wheeled 1 x 8 Skid Steer / Bucket Loader Excavator Operator 1 Χ 8 1 x 8 Skid Steer/Bucket Loader 1 X 8 Rolling Compactor 1 x 8 0 x 8 aborers 4 X 8 Plate Compactor United Concrete 0 X 8 Note that some persons Jumping Jack Compactor 1 x 8 Fazzino Plumbing 0 x 8 Multiple pieces Street Sweeper (Broce Broom) 8 x 0 A&R Electrical 0 x 8 Material Hopper 0 x 8

#### Daily Activities – Installation of Water Lines, Wallingford Road and Maple Avenue, Durham

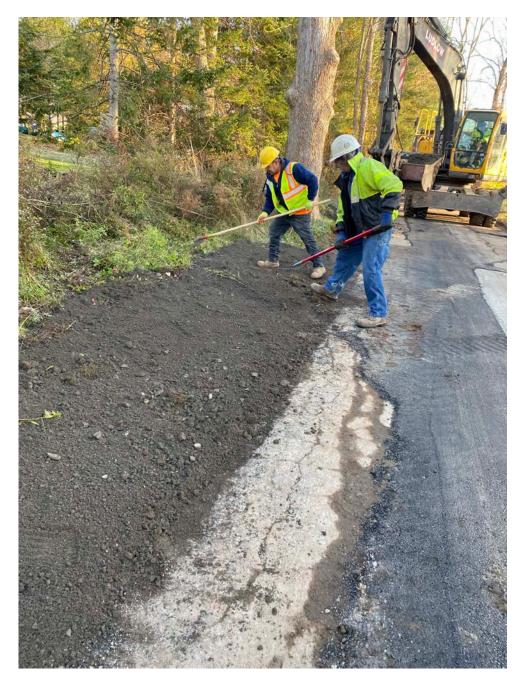
Picture 1: Ludlow loaming and seeding the disturbed area surrounding the driveway of the 212R Maple Ave residence. Looking West.

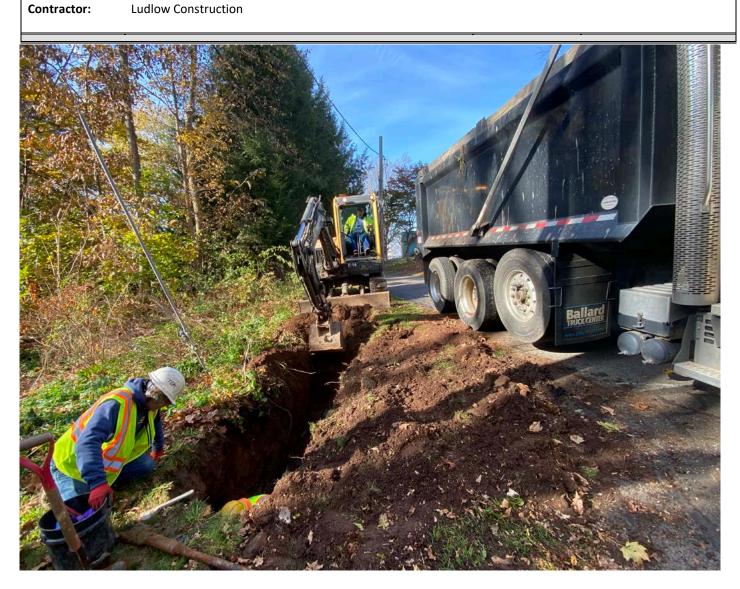
Picture 2: Ludlow excavating the trench for the installation of a meter pit just south of the driveway of the 228R Maple Ave residence. Looking west.

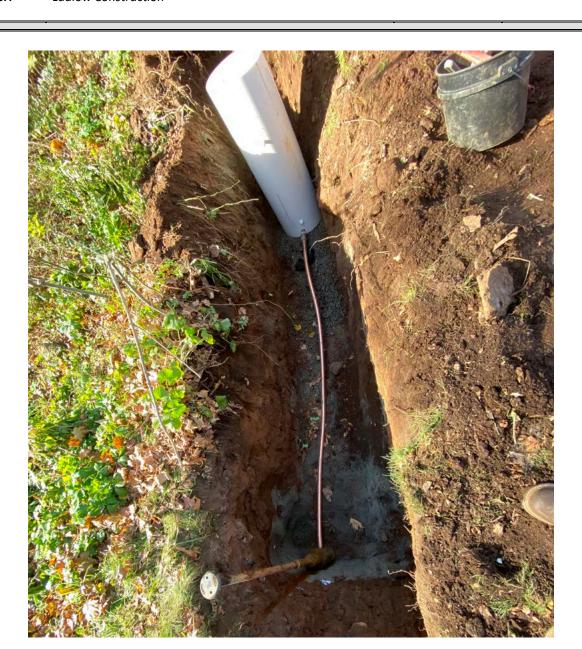
Picture 4: Ludlow connects the new meter pit to the curb stop at the 228R Maple Ave residence. Looking west.

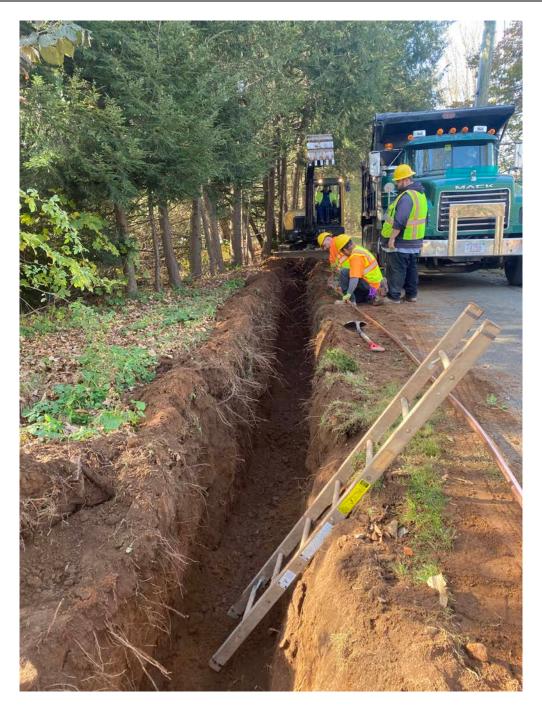
Picture 5: Ludlow excavates a trench at the 228R Maple Ave property for the placement of a 1.5" copper service line. Looking west.

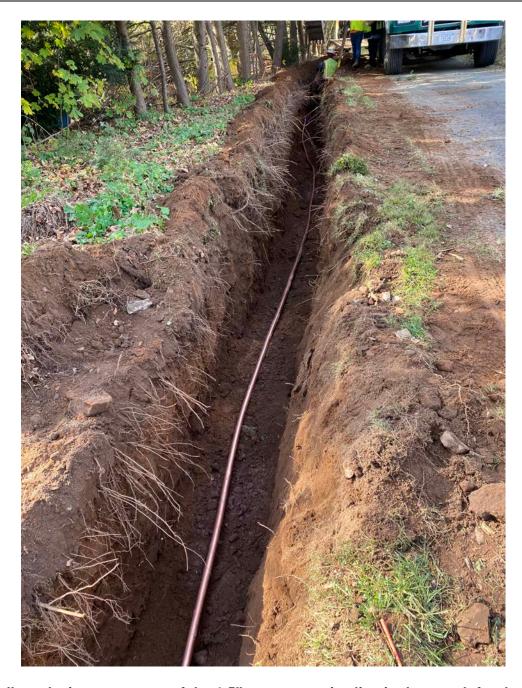
Picture 6: Ludlow placing a segment of the 1.5" copper service line in the trench for the 228R Maple Ave. residence property in Durham. Looking west.

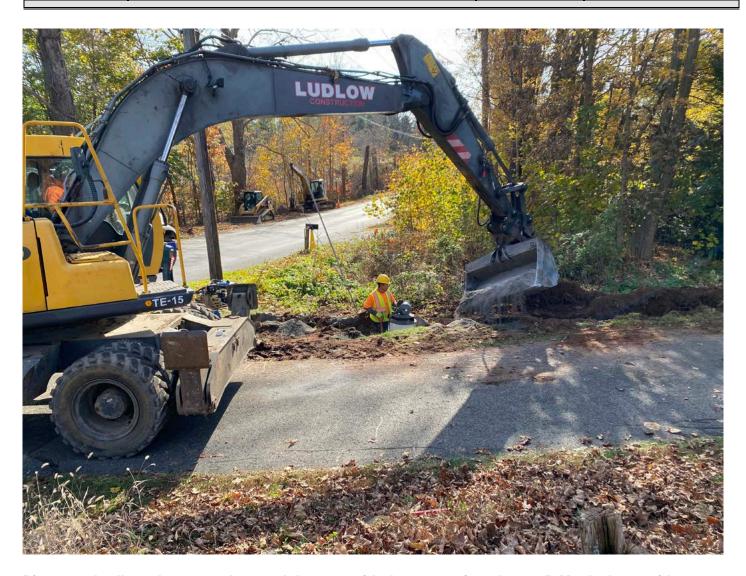
Picture 7: Ludlow places sand around the area with the meter pit at the 228R Maple Ave residence. Looking south.

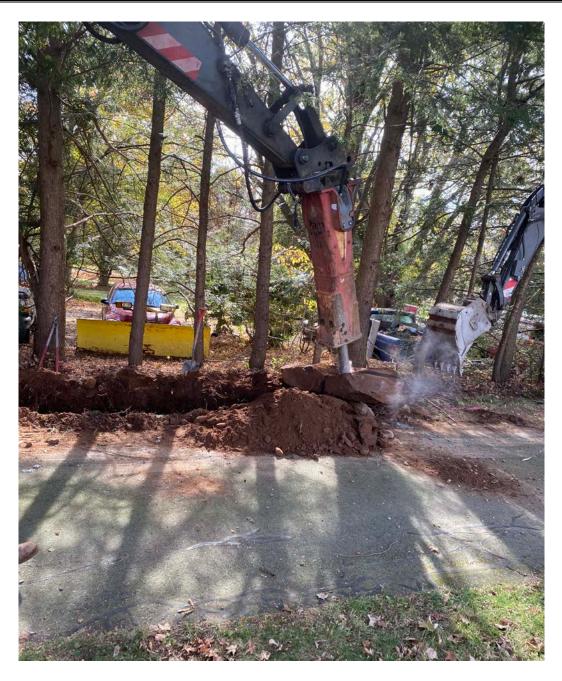
Picture 8: Ludlow uses the jack hammer to break a small section of rock in the trench. Looking south.

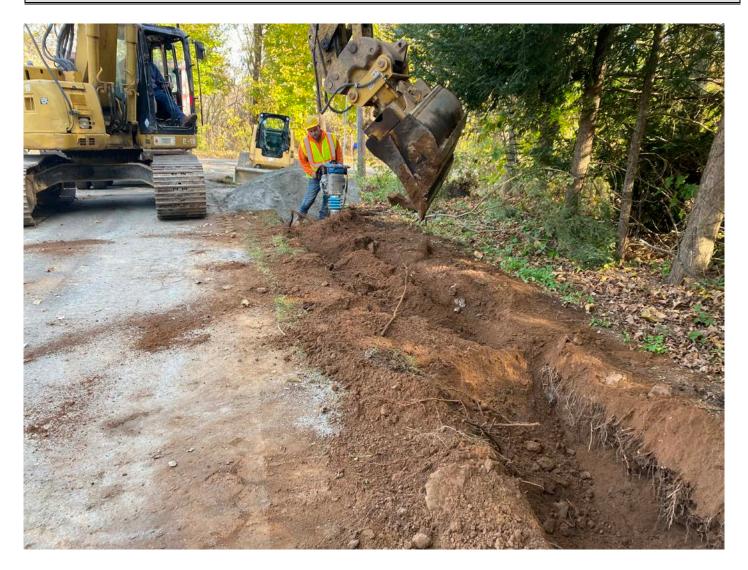
Picture 9: Ludlow backfills the trench of the 1.5" copper water service line to 228R Maple Ave. residence with native fill. Looking east.

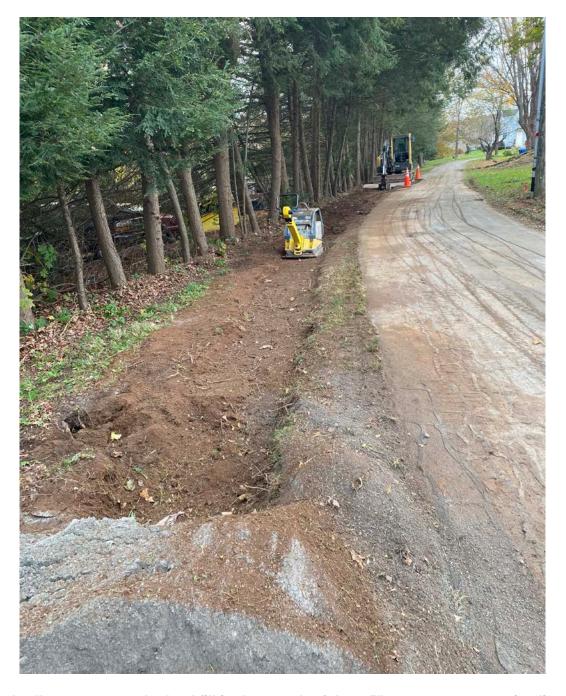
Picture 10: Ludlow compacts the backfill in the trench of the 1.5" copper water service line to 212R Maple Ave. residence with a plate compactor. Looking west.
