Daily Report

Project:	Durham Meado	vs Pipeline Installation				Date: Novemb	er 17, 2021
Location:	•	Durham; Shared Access Drive	way,			Day of Week:	Wednesday
	Middletown						
Project #:	AECOM: 606148	7				Report No:	365
						Page:	1 of 9
Contractor:	Ludlow Construc	tion

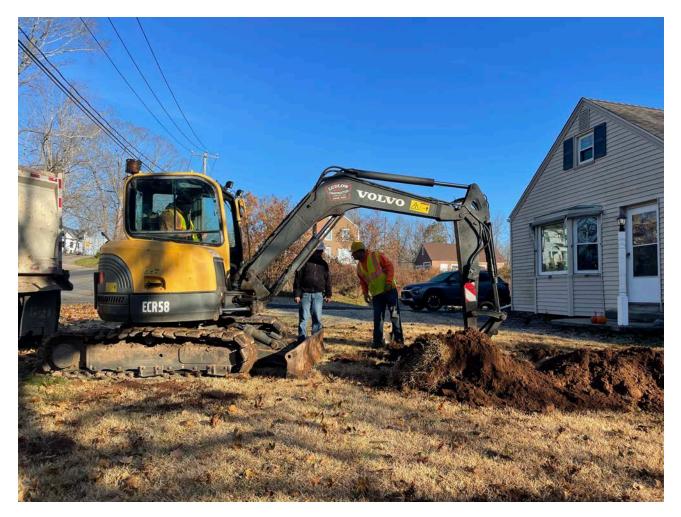
0829: Ludlow begins to excavate on the west side of the 235 Maple Avenue property for the installation of a 1" copper water service line. Ludlow started on the west side of home's field stone foundation and is working westwards.

Picture 1: Ludlow excavating on the west side of the 235 Maple Avenue property for the installation of a 1" copper water service line. View to the northeast.

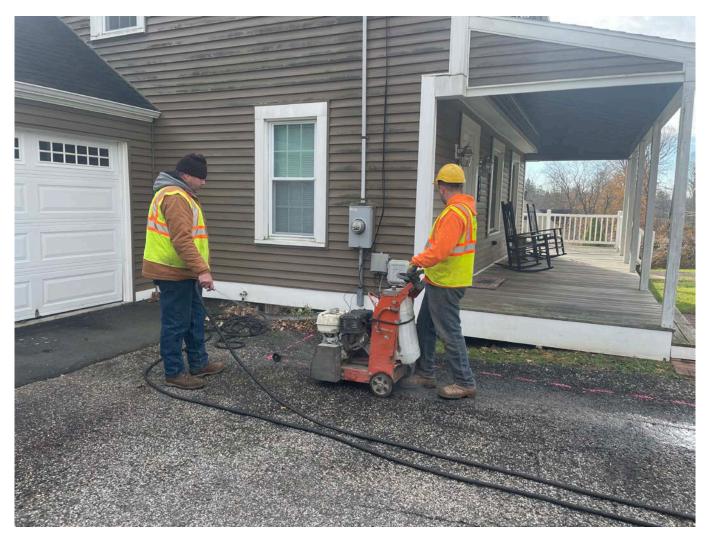
941: Ludlow has begun to saw cut the footprint of a trench on the asphalt driveway of the 245 Maple Avenue property for the installation of a 1" copper water service line.

Picture 2: Ludlow saw cutting asphalt on the driveway of the 245 Maple Avenue property for the installation of a 1" copper water service line. View to the south.

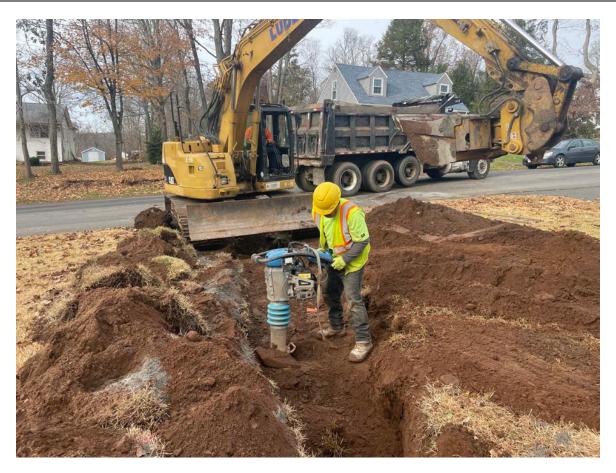
0945: Ludlow has finished installing a 1" copper water service line at the 235 Maple Avenue property. Ludlow is currently backfilling over the copper pipe with 12" of sand, followed by caution tape, followed by native fill placed in 1' lifts. The fill is being compacted with a jumping jack. The fieldstone foundation of the residence was penetrated with a rotary hammer and the 1" copper water service line was secured in place through the foundation with non-shrink grout. The penetration point for the 1" copper line is located 80" north of the residence's southwest corner.

Picture 3: Ludlow compacting a 1' lift of native fill after having installed a 1" copper water line at the 235 Maple Avenue property. View to the west.

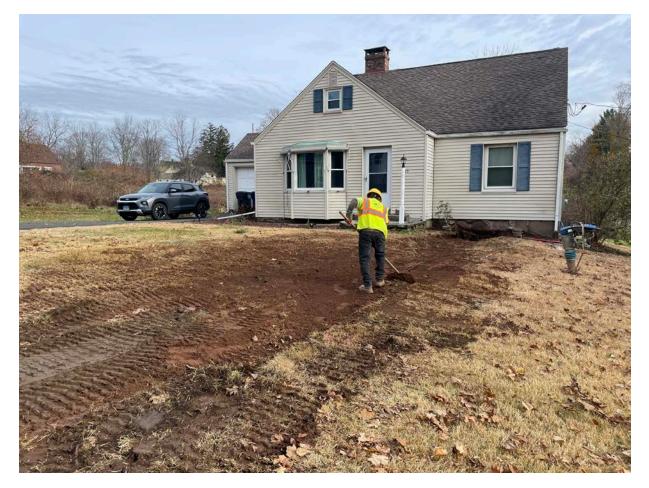
1143: Ludlow continues to place and rake out loam at the 235 Maple Avenue property to restore the portions of the yard that were disturbed during the installation of a 1" copper water service line.

Picture 4: Ludlow raking out loam that they placed at the 235 Maple Avenue property to restore those areas of the lawn that were disturbed during the installation of a 1" copper water service line. View to the east.

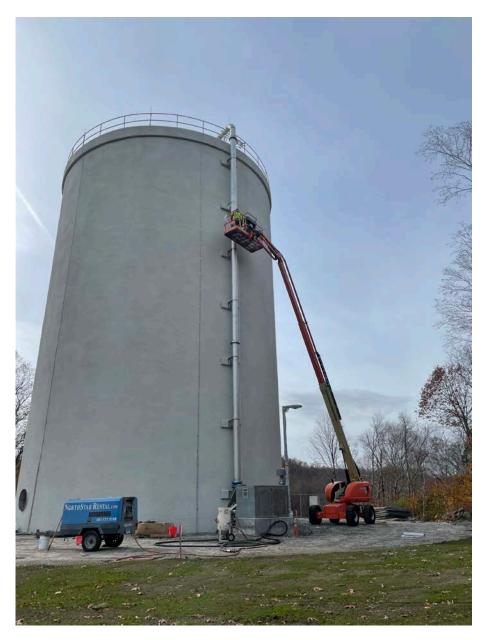
1239: Keltic Painting begins to paint the stainless steel air duct on the northeast side of the water tank located east of the Shared Access Driveway.

Picture 5: Keltic Painting in the process of painting the 12" air duct located on the northeast side of the water tank located east of the Shared Access Driveway in Middletown. View to the west.

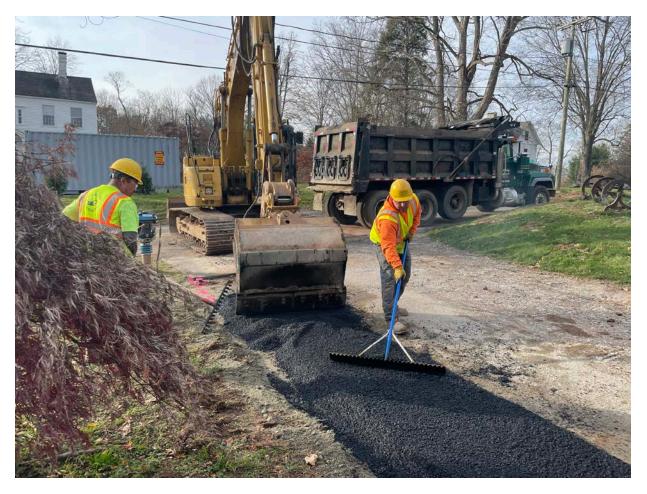
1410: Ludlow begins placing asphalt on the trench footprint at the 245 Maple Avenue property.

Picture 6: Ludlow placing asphalt over the trench footprint at the 245 Maple Avenue property. View to the west.
