Daily Report

Project:	Durham Meadows Pipeline Installation	Date:	November 18, 2021
Location:	Maple Avenue, Durham; Shared Access Driveway, Middletown	Day of Week:	Thursday
Project #:	AECOM: 6061487	Report No:	366
Contractor:	Ludlow Construction	Page:	1 of 10

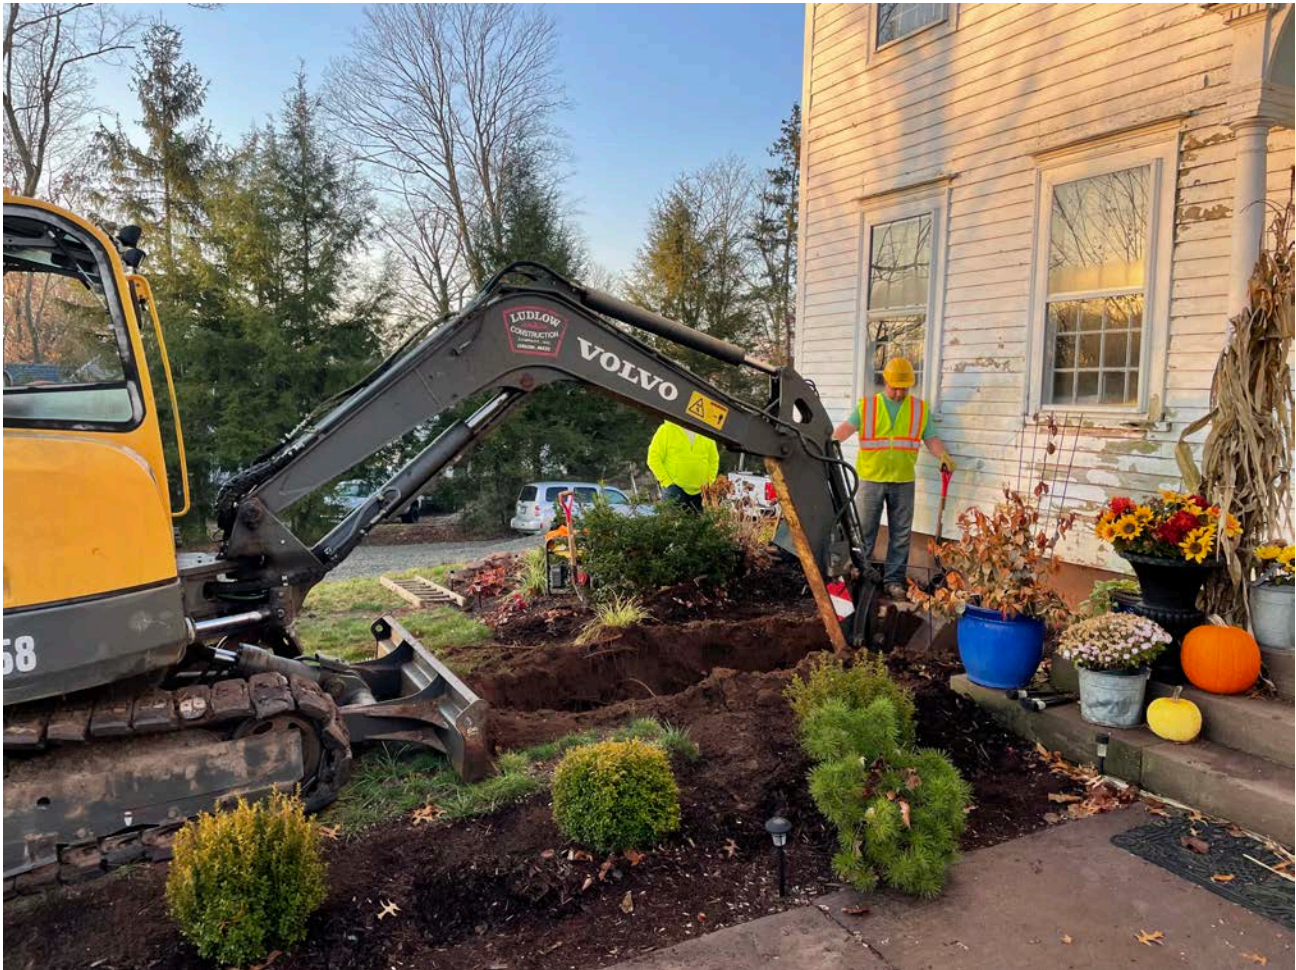
0709: Ludlow begins to excavate a trench for the installation of a 1" copper water service line at the 244 Maple Avenue property. The excavation has begun on the east side of the residence's field stone foundation.

Picture 1: Ludlow excavating on the east side of the 244 Maple Avenue property for the installation of a 1" copper water service line. View to the southwest.

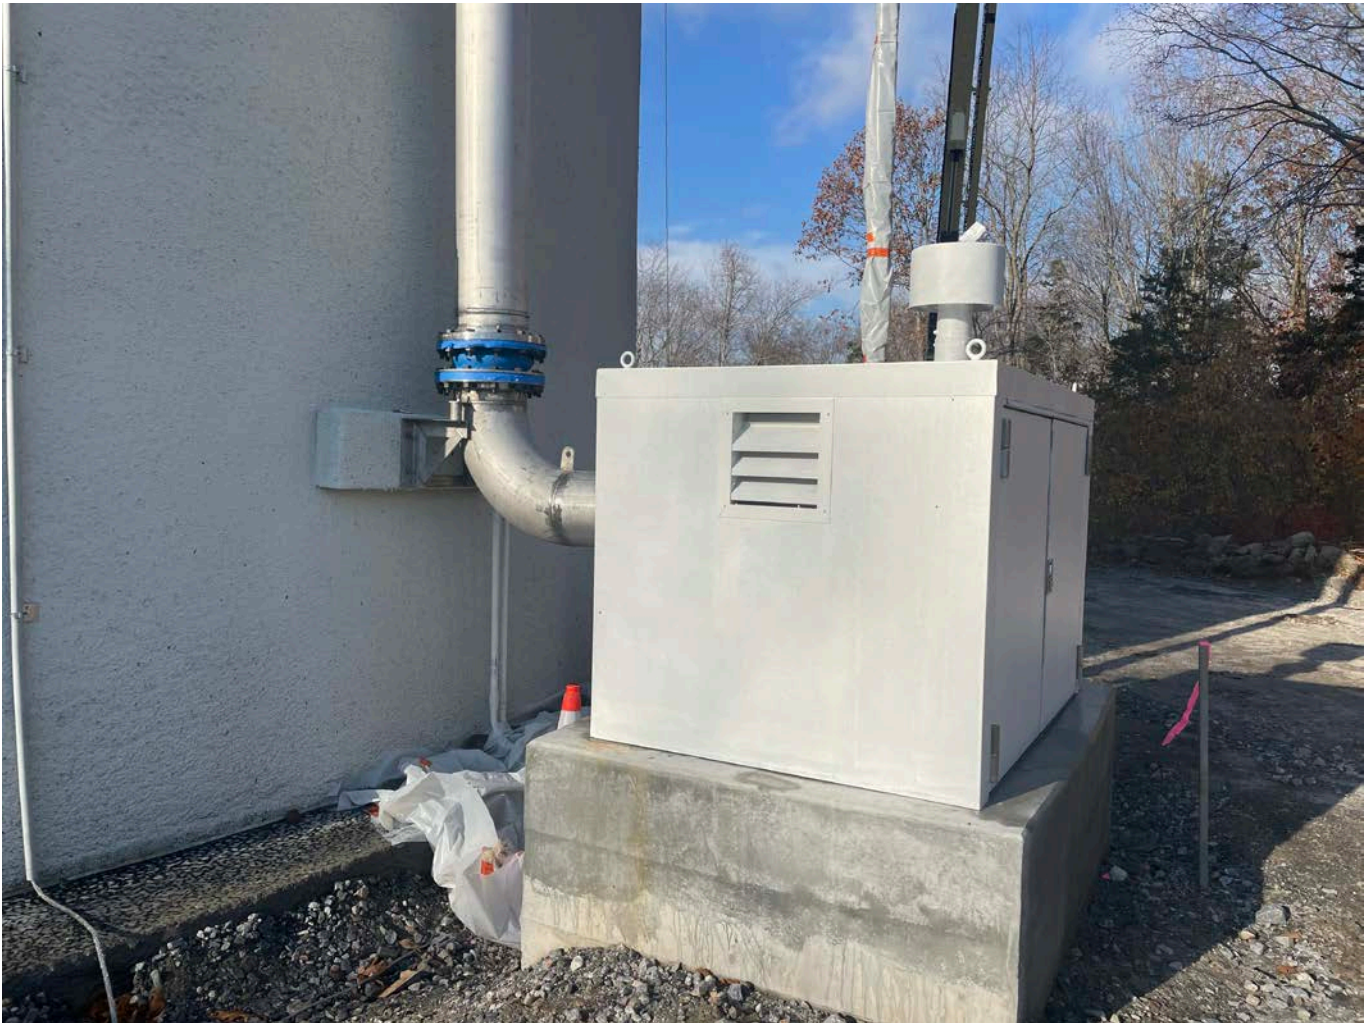
Picture 2: Blower enclosure that Keltic Painting has applied the first of two coats of paint. Water tank work zone located east of the Shared Access Driveway, Middletown. View to the northwest.

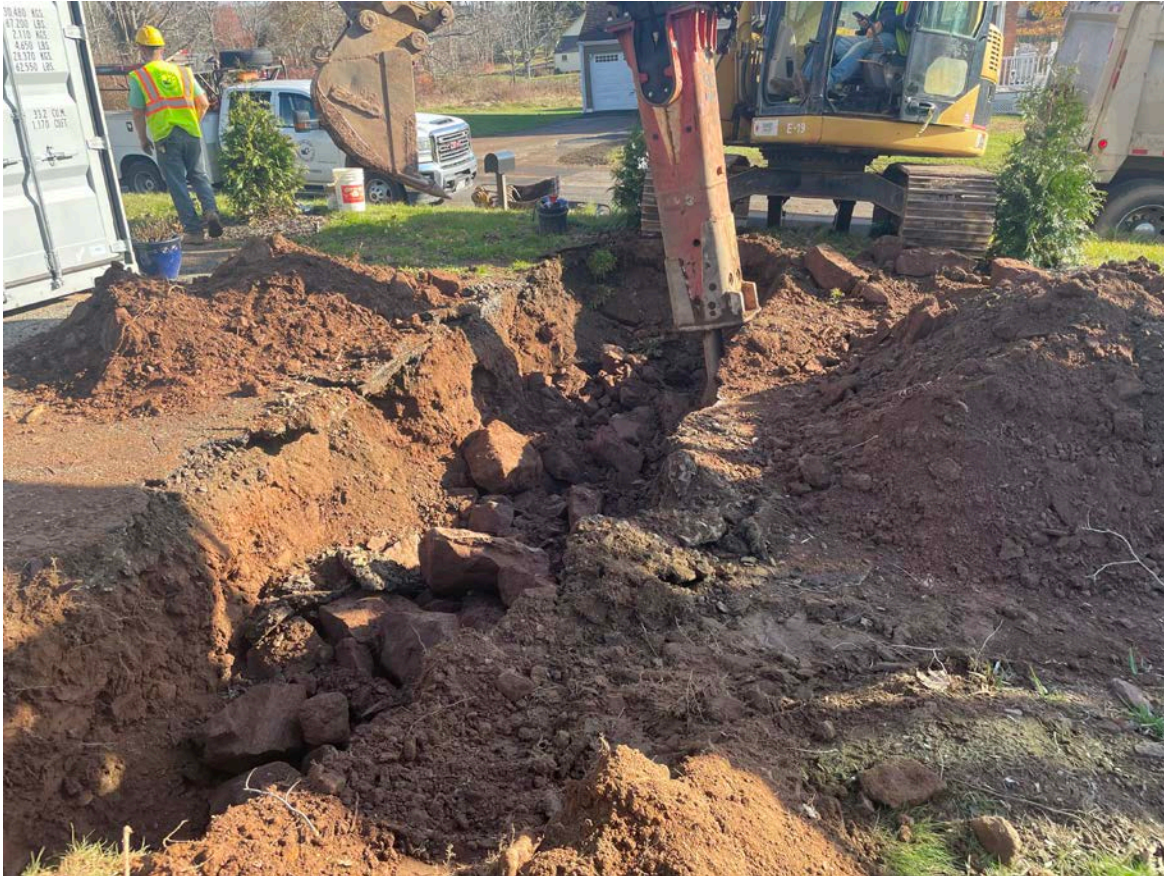
0755: Ludlow is using a large excavator with a hammer attachment to break up rock they are encountering in the trench they are excavating at the 244 Maple Avenue property.

Picture 3: Ludlow hammering rock in the trench they are excavating at the 244 Maple Avenue property. View to the east.

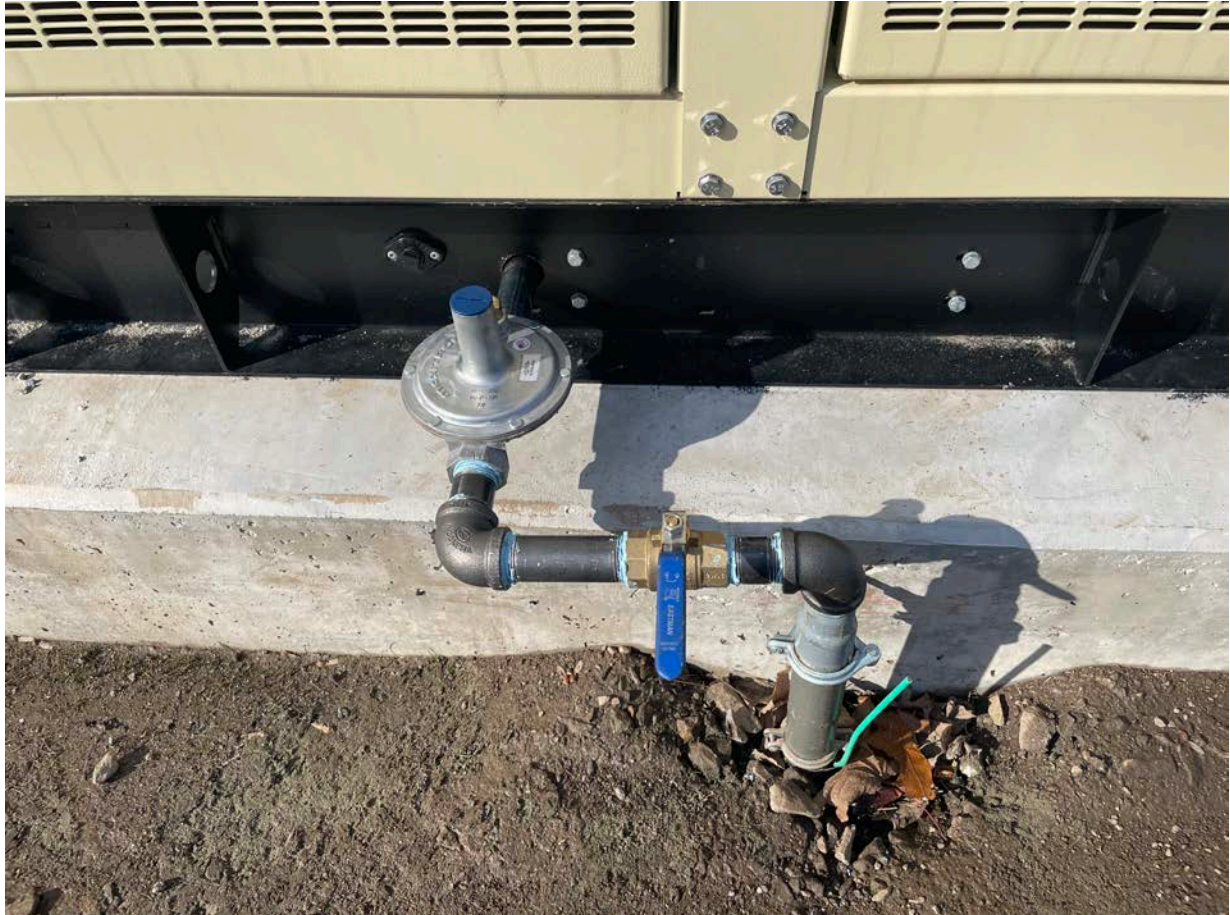
1223: Fazzino Plumbing has finished installing a gas line and regulator on the generator located on the west side of the booster station at Station 750+63.

Picture 4: Natural gas line and regulator that Fazzino Plumbing installed on the east side of the generator at the booster station. View to the west.

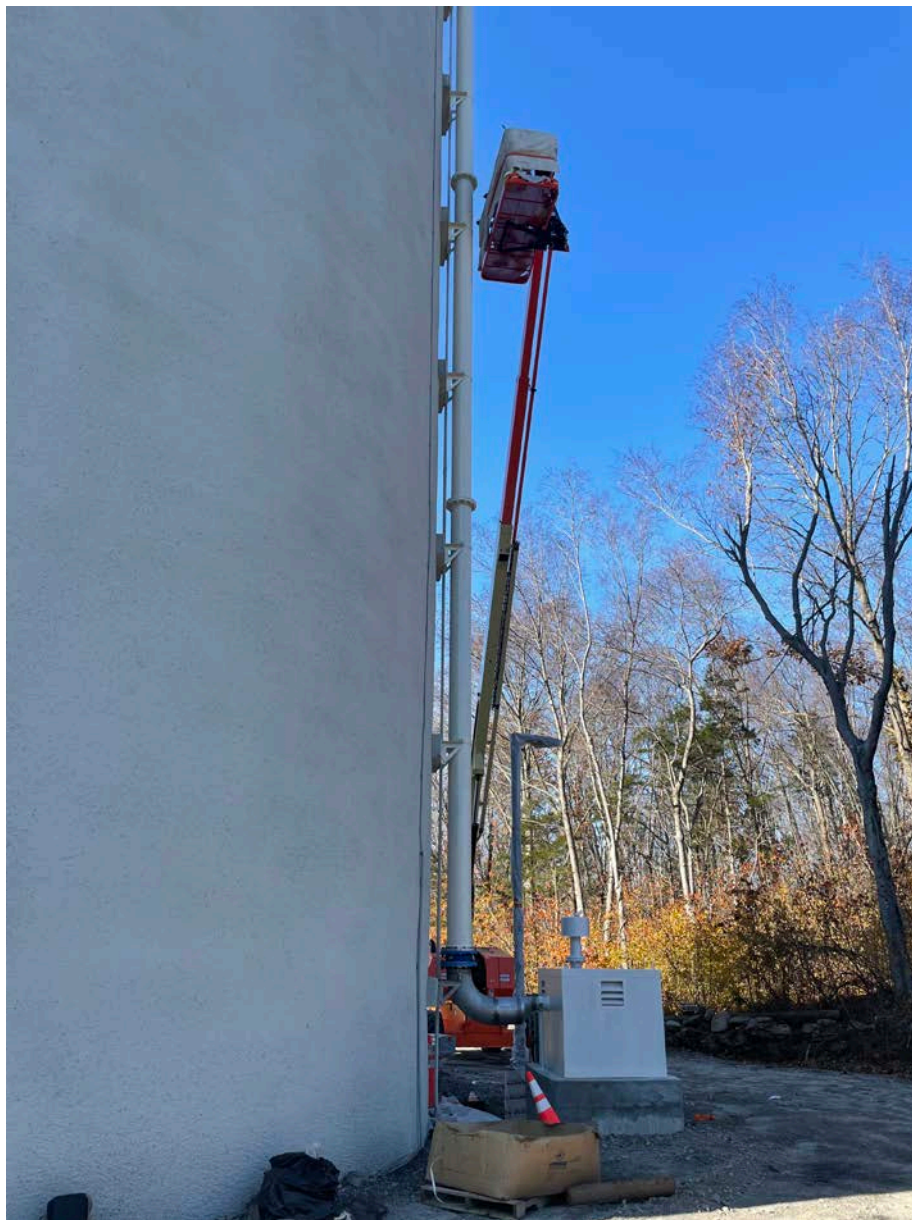
1129: Keltic Painting is painting the 12" stainless steel air duct located on the northeast side of the water tank.

Picture 5: Keltic Painting in the process of painting the 12" air duct located on the northeast side of the water tank located east of the Shared Access Driveway in Middletown. View to the northwest.

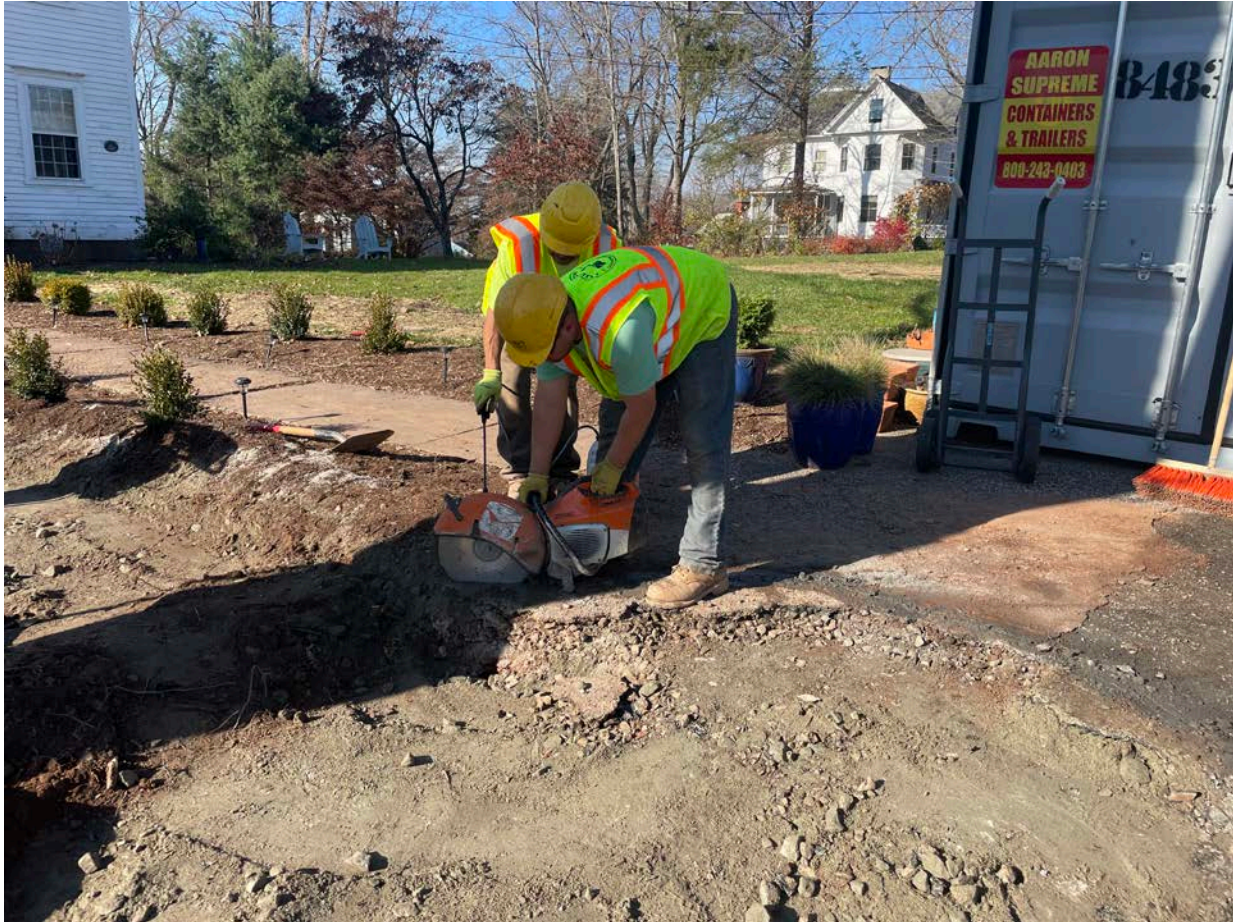
1256: Ludlow is saw cutting the edges of the asphalt where the trench they are excavating crosses the asphalt driveway located east of the 244 Maple Avenue residence.

Picture 6: Ludlow saw cutting the edge of the asphalt driveway that they excavated a trench across in the process of installing a 1" copper water service line at the 244 Maple Avenue property. View to the northwest.

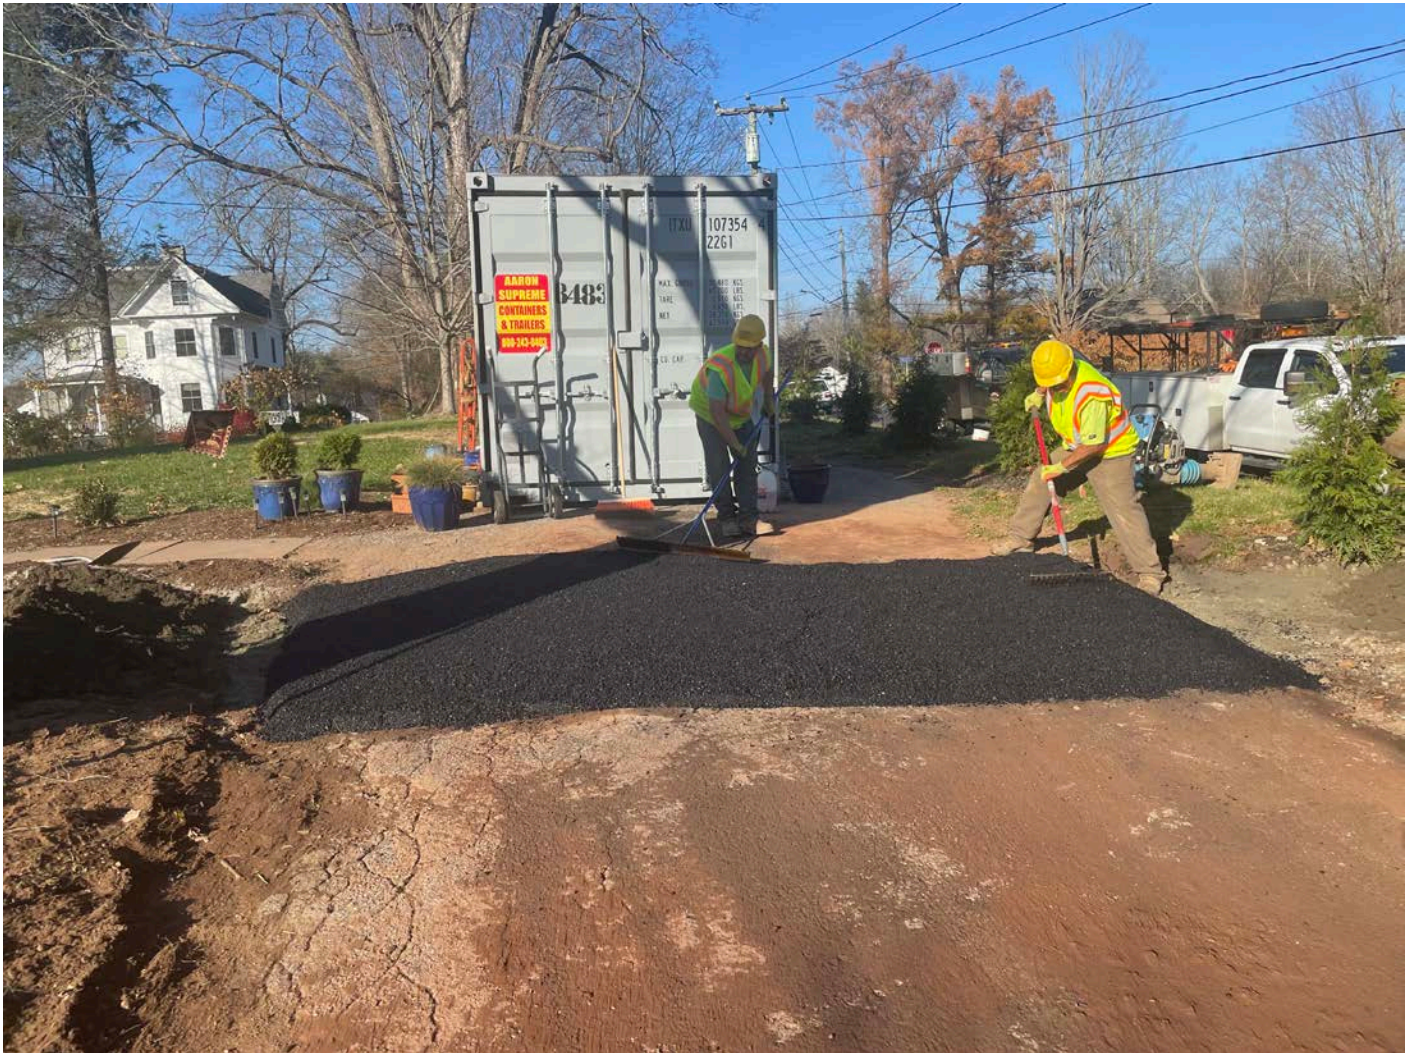
1404: Ludlow is placing asphalt over the trench footprint that crosses the driveway located east of the 244 Maple Avenue residence.

Picture 7: Ludlow placing asphalt over the trench footprint at the 244 Maple Avenue property. View to the north.
