Daily Report

Project:	Durham Meadows Pipeline Installation	Date:	November 29, 2021
Location:	Talcott Lane, Durham; S. Main Street and the Shared Access Driveway, Middletown	Day of Week:	Monday
Project #:	AECOM: 6061487	Report No:	371
Contractor:	Ludlow Construction	Page:	1 of 15

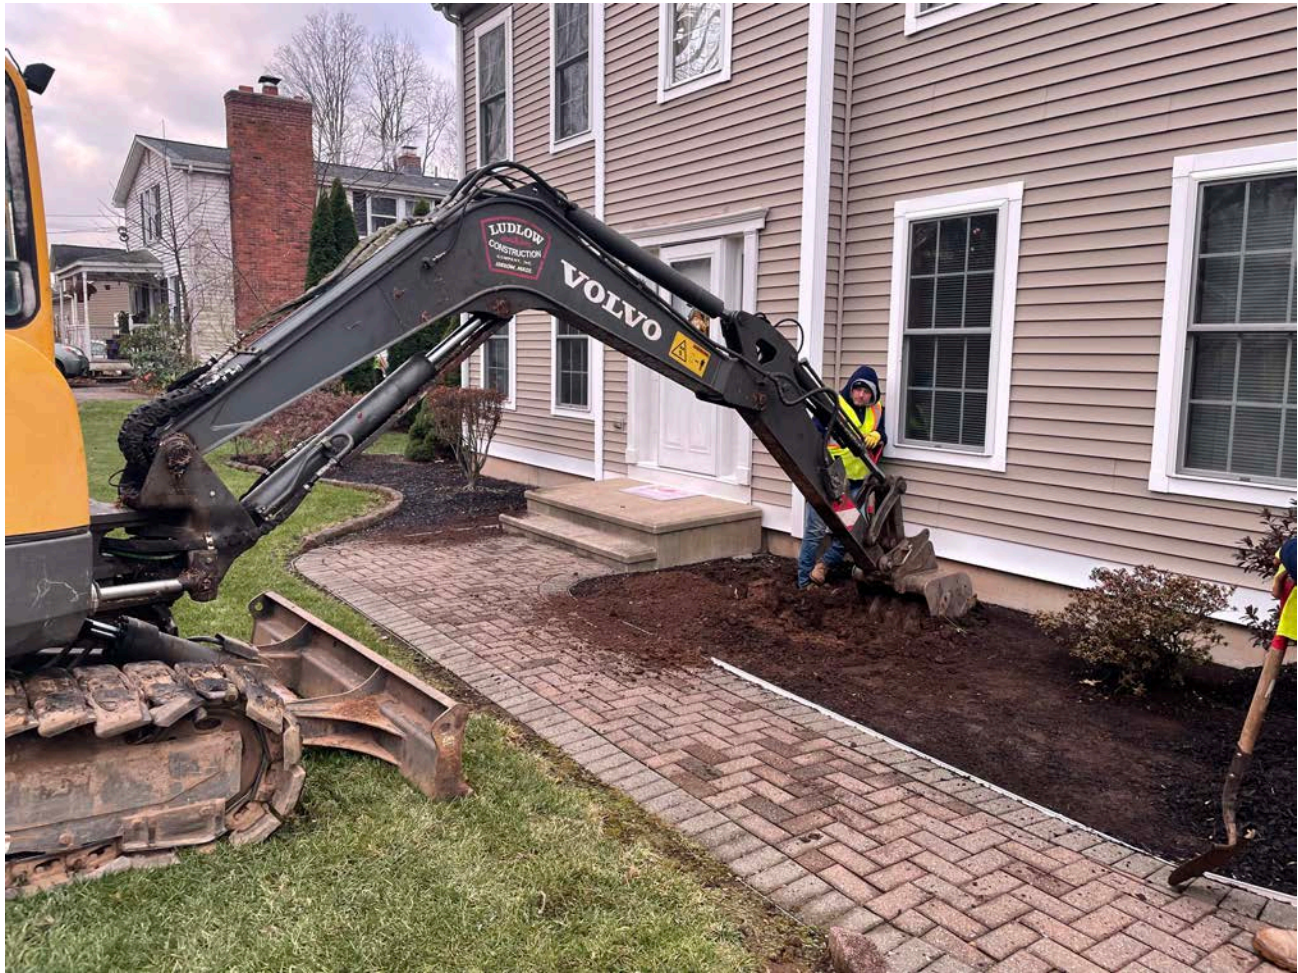
Picture 1: Ludlow excavating on the east side of the 166 Maple Avenue residence for the installation of a 1” copper water service line. View to the southwest.

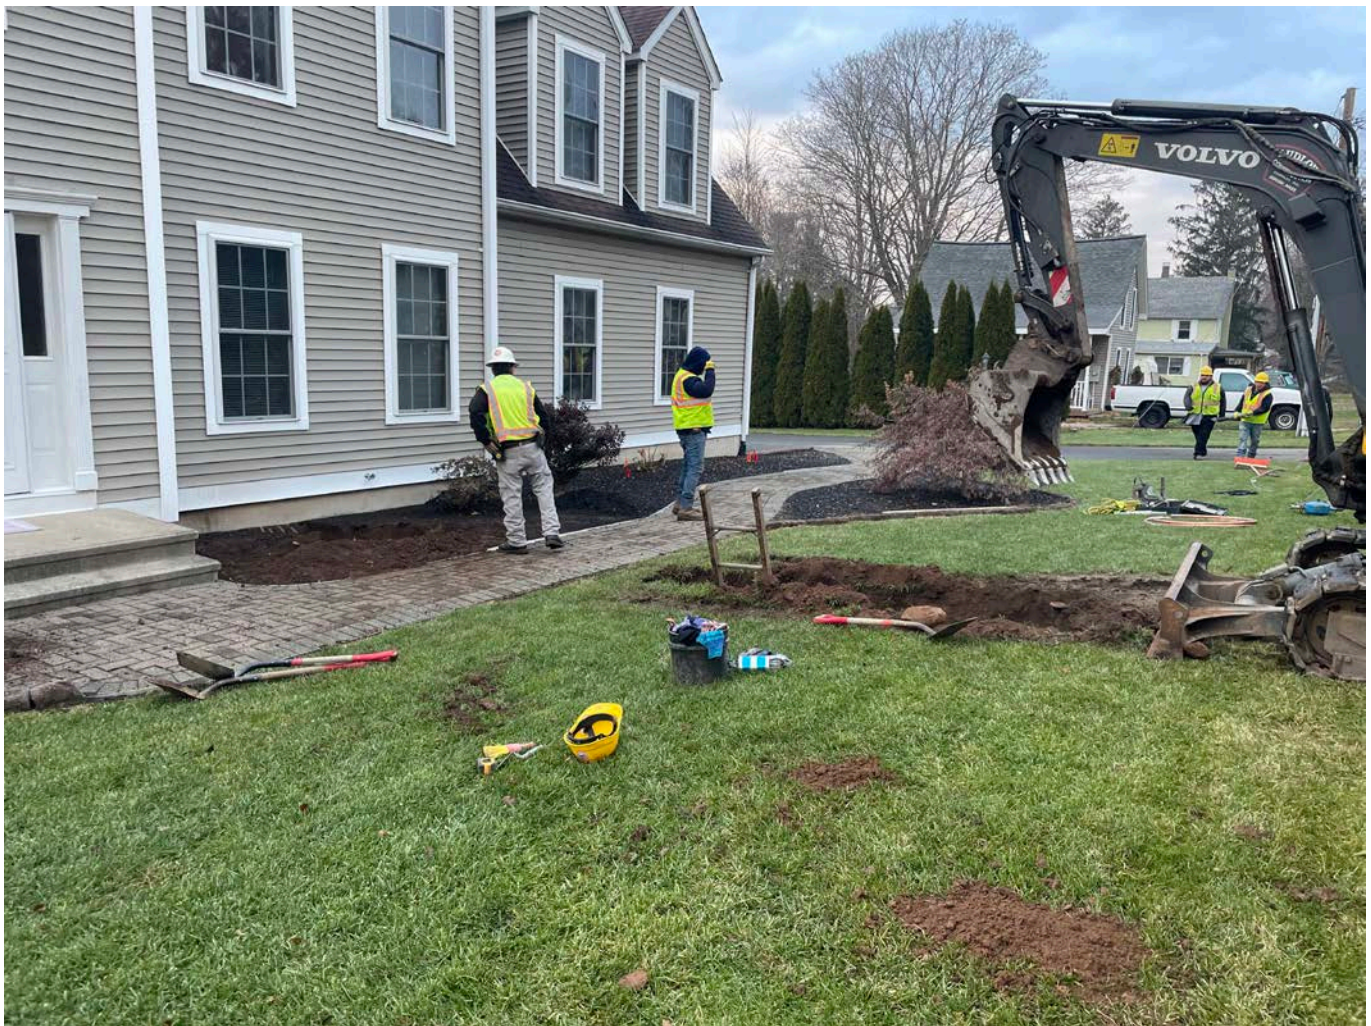
Picture 2: Ludlow excavating at the 166 Maple Avenue property for the installation of a 1" copper water service line. View to the northwest.

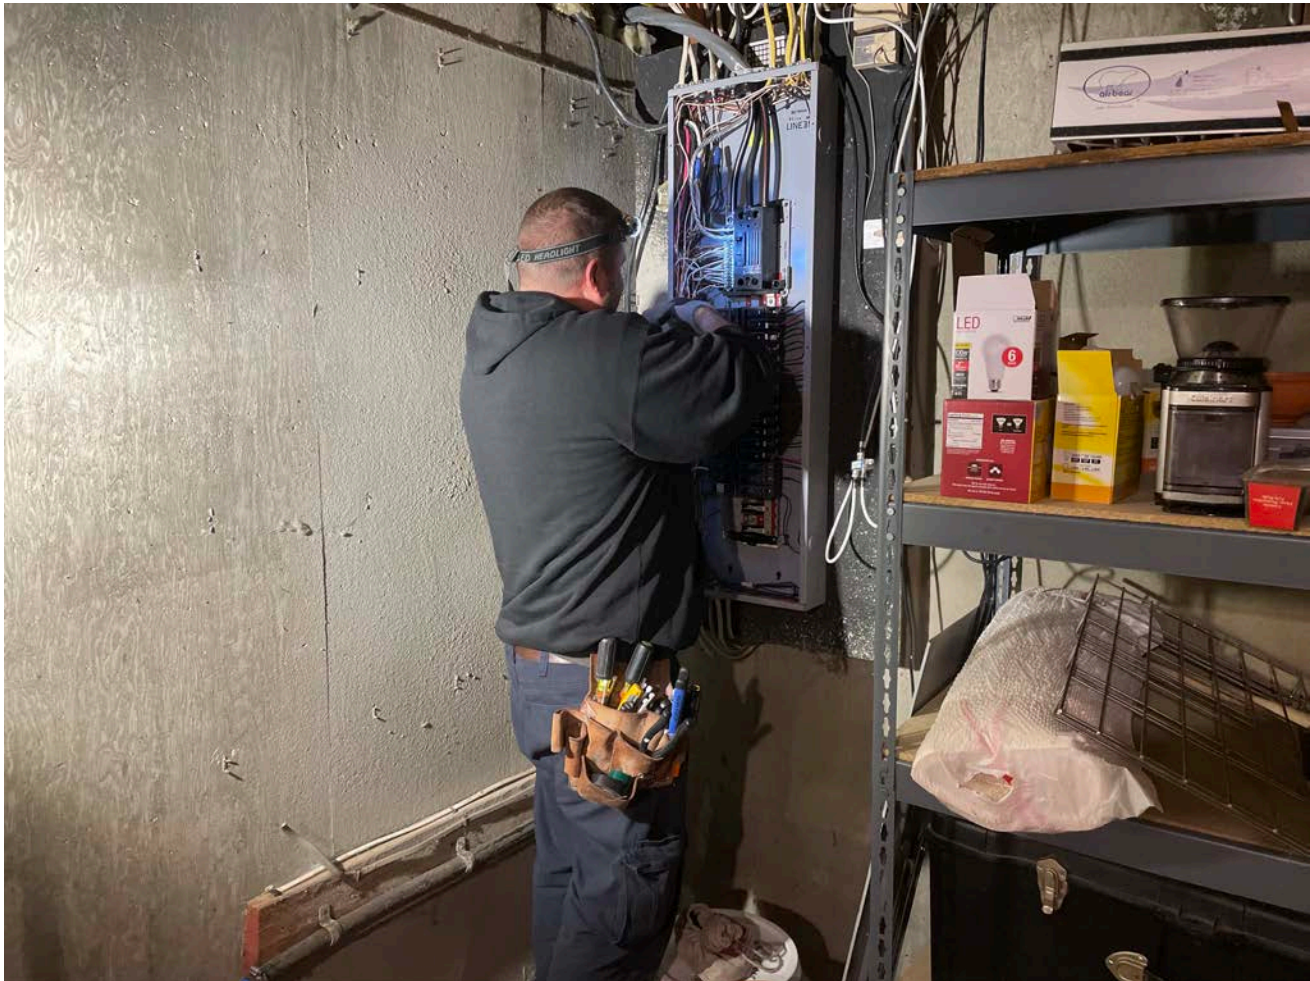
Picture 3: Apuzzo Electric working at the 95R Maple Avenue property installing bonding lines to the newly installed water system components.

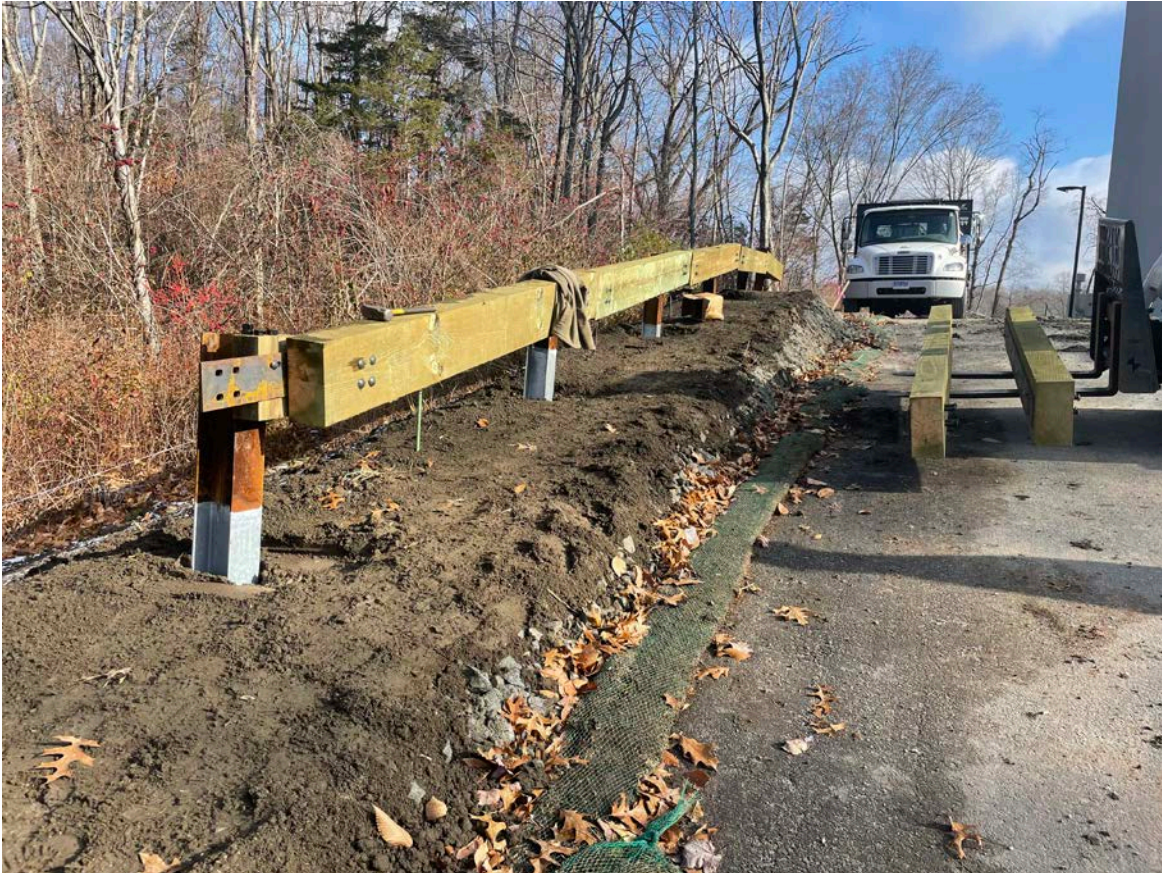
Picture 4: Eagle Fence and Guardrail installing a guard rail on the north side of the Shared Access Driveway in Middletown at Station ~11+00. View to the east.

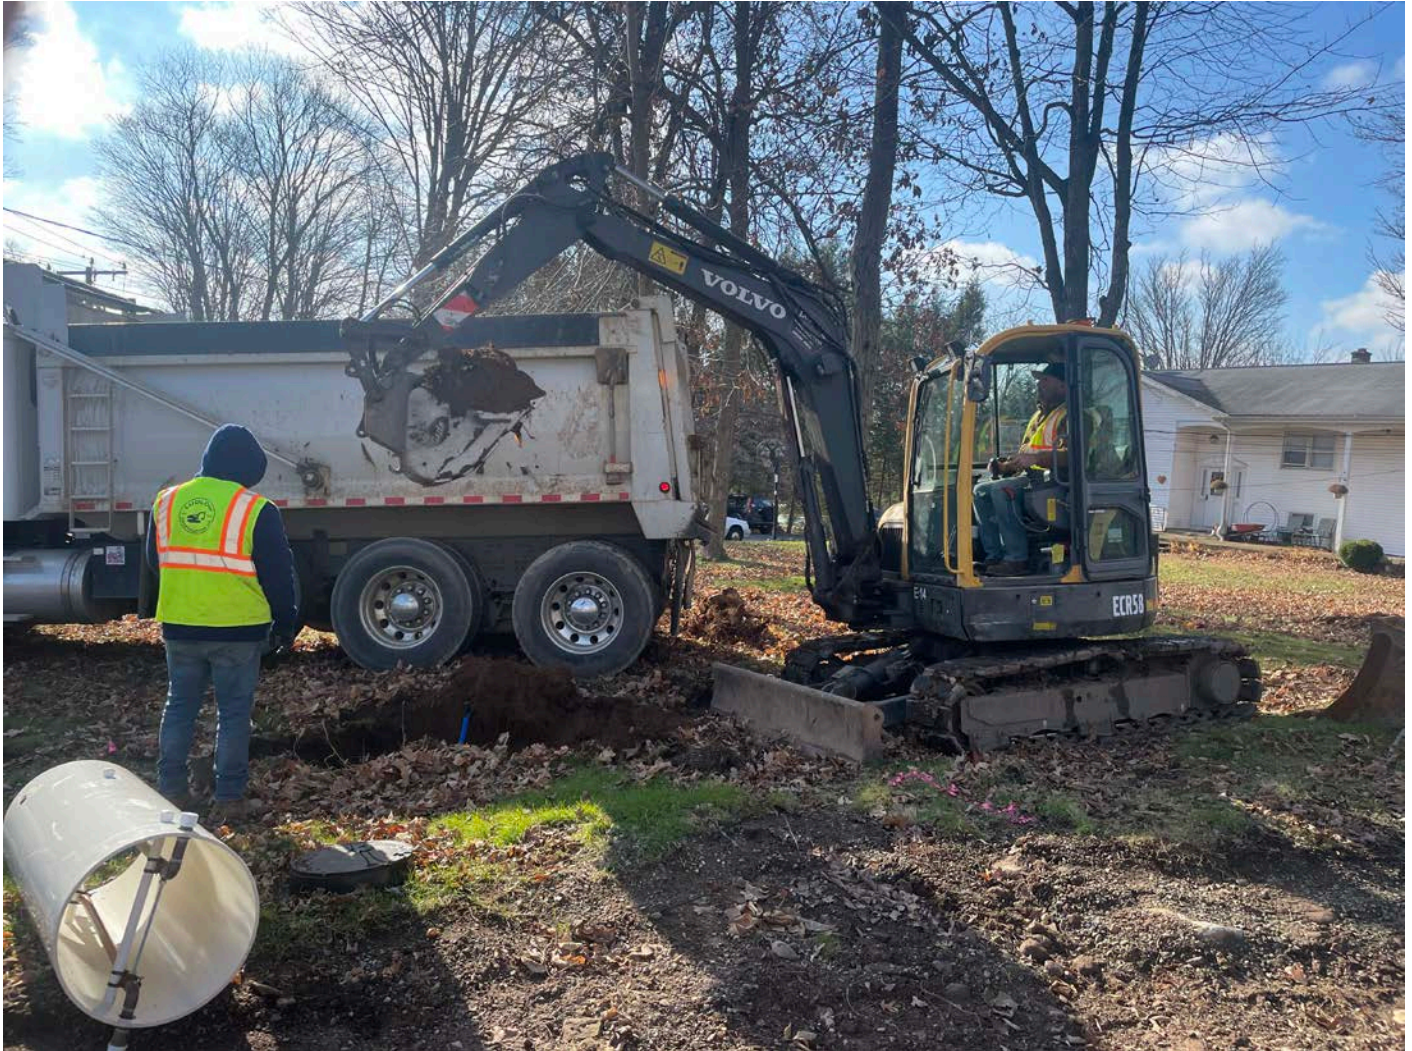
Picture 5: Ludlow excavating a trench at the 230 Maple Avenue property for the installation of a 1" copper water service line. View to the southwest.

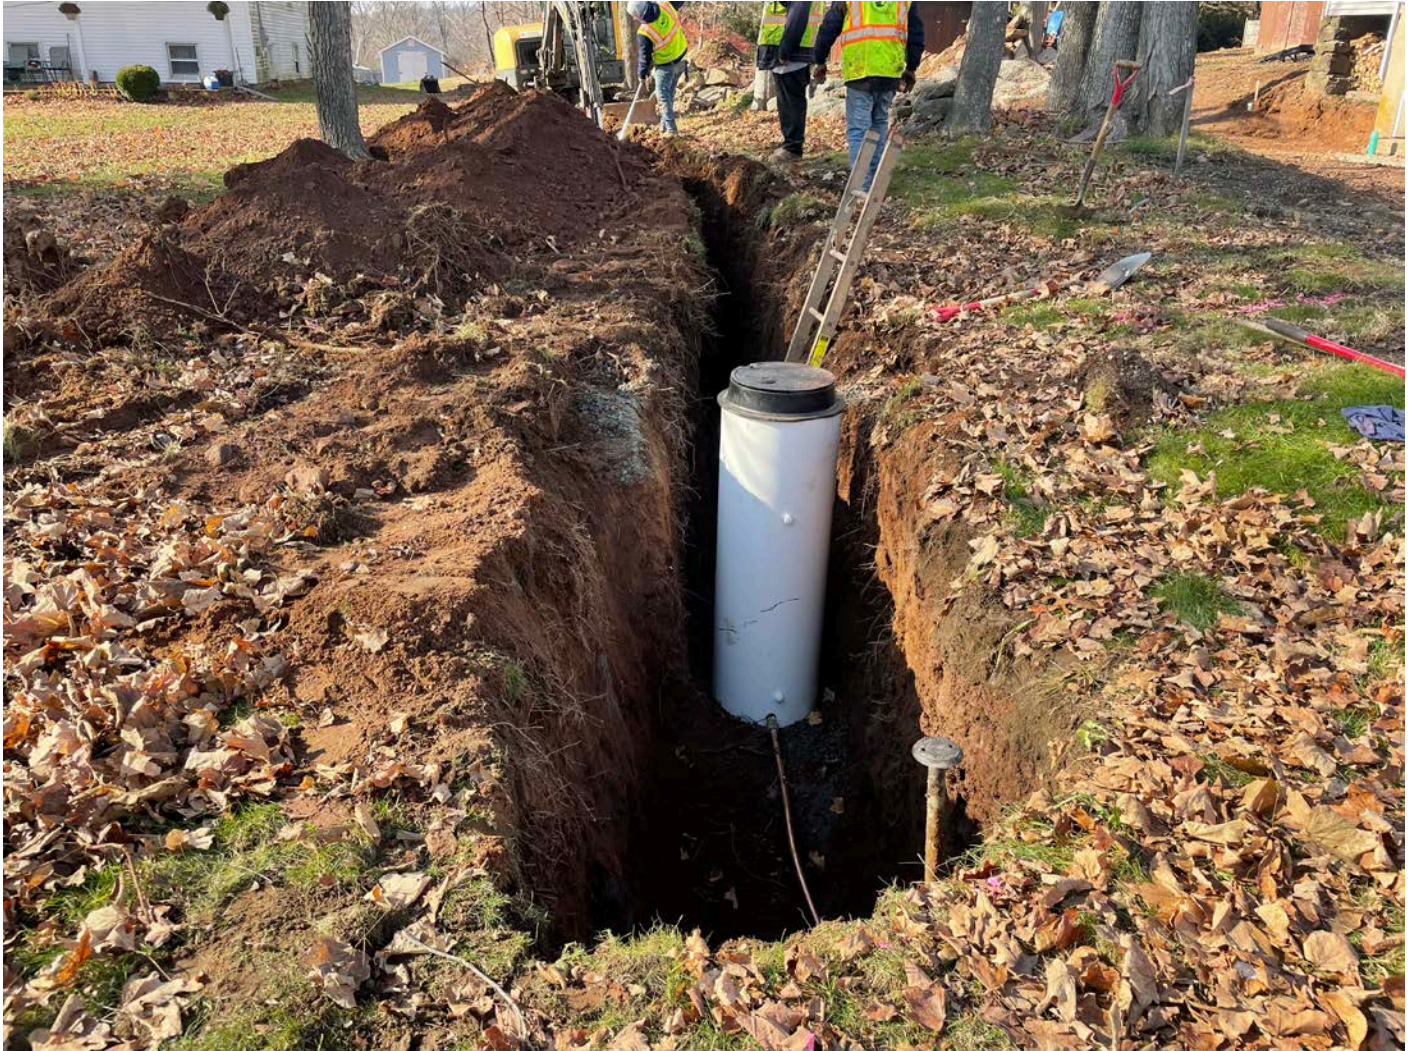
Picture 6: Meter pit that Ludlow installed approximately 8' west of the curbstop for the 230 Maple Avenue property. View to the west.

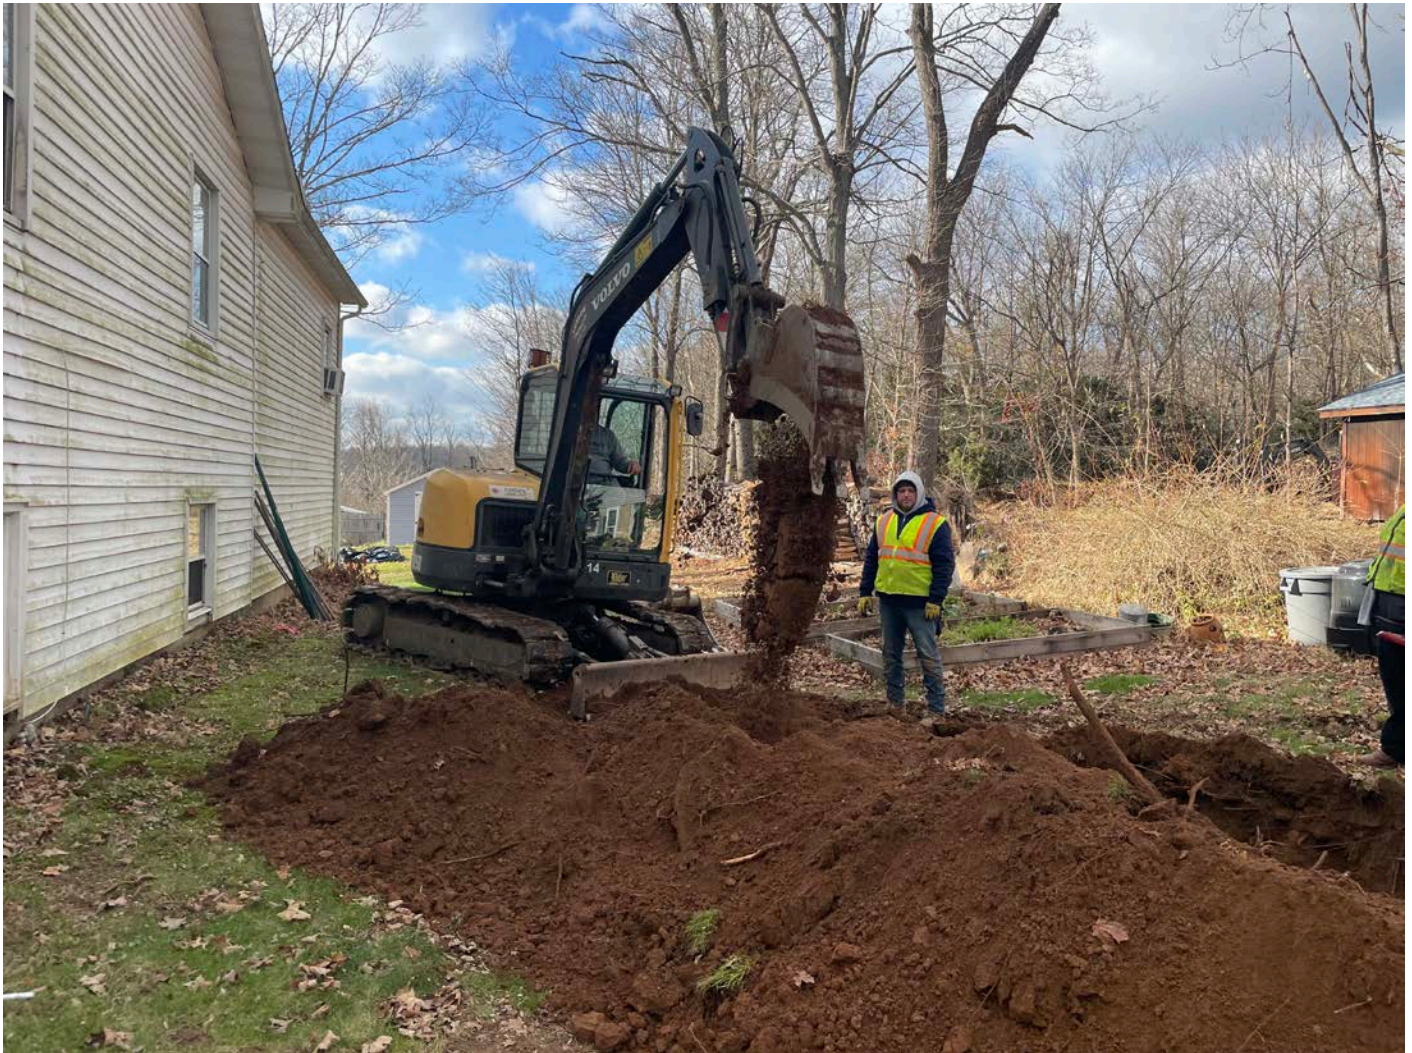
Picture 7: Ludlow excavating a trench for the 1" copper water service at 230 Maple Avenue. View to the west.

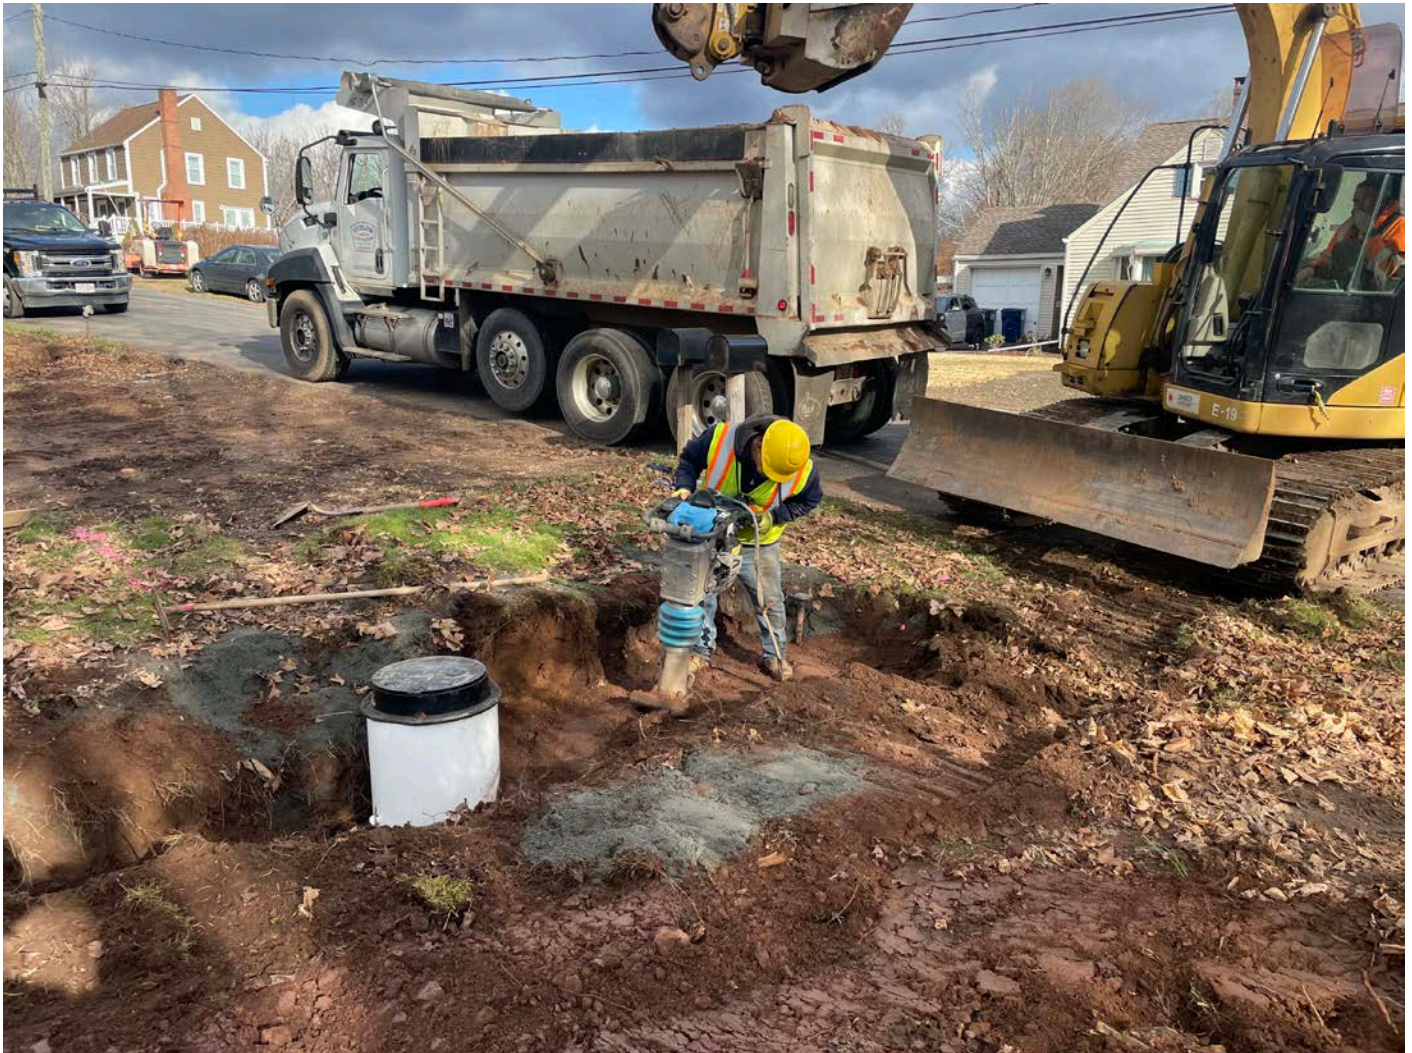
Picture 8: Ludlow compacting native fill that has been backfilled over the 1" copper water service line that they installed at the 230 Maple Avenue property. View to the east.

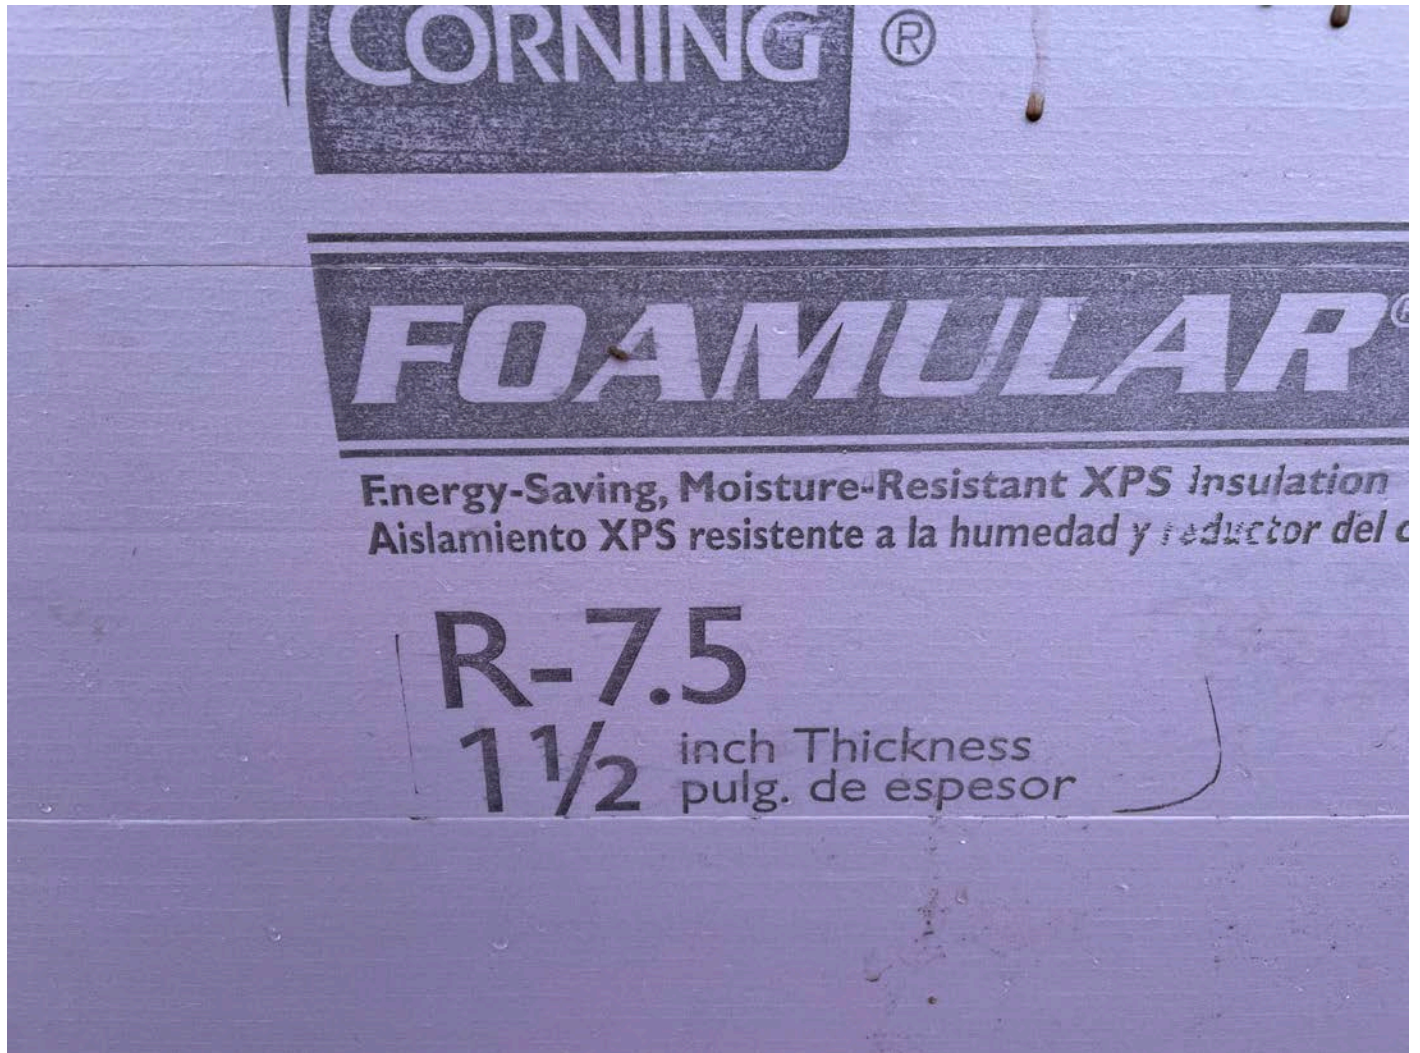
Picture 9: Foam board that Ludlow placed over ~10' of the 1" copper pipe located on the north side of the 230 Maple Avenue residence.

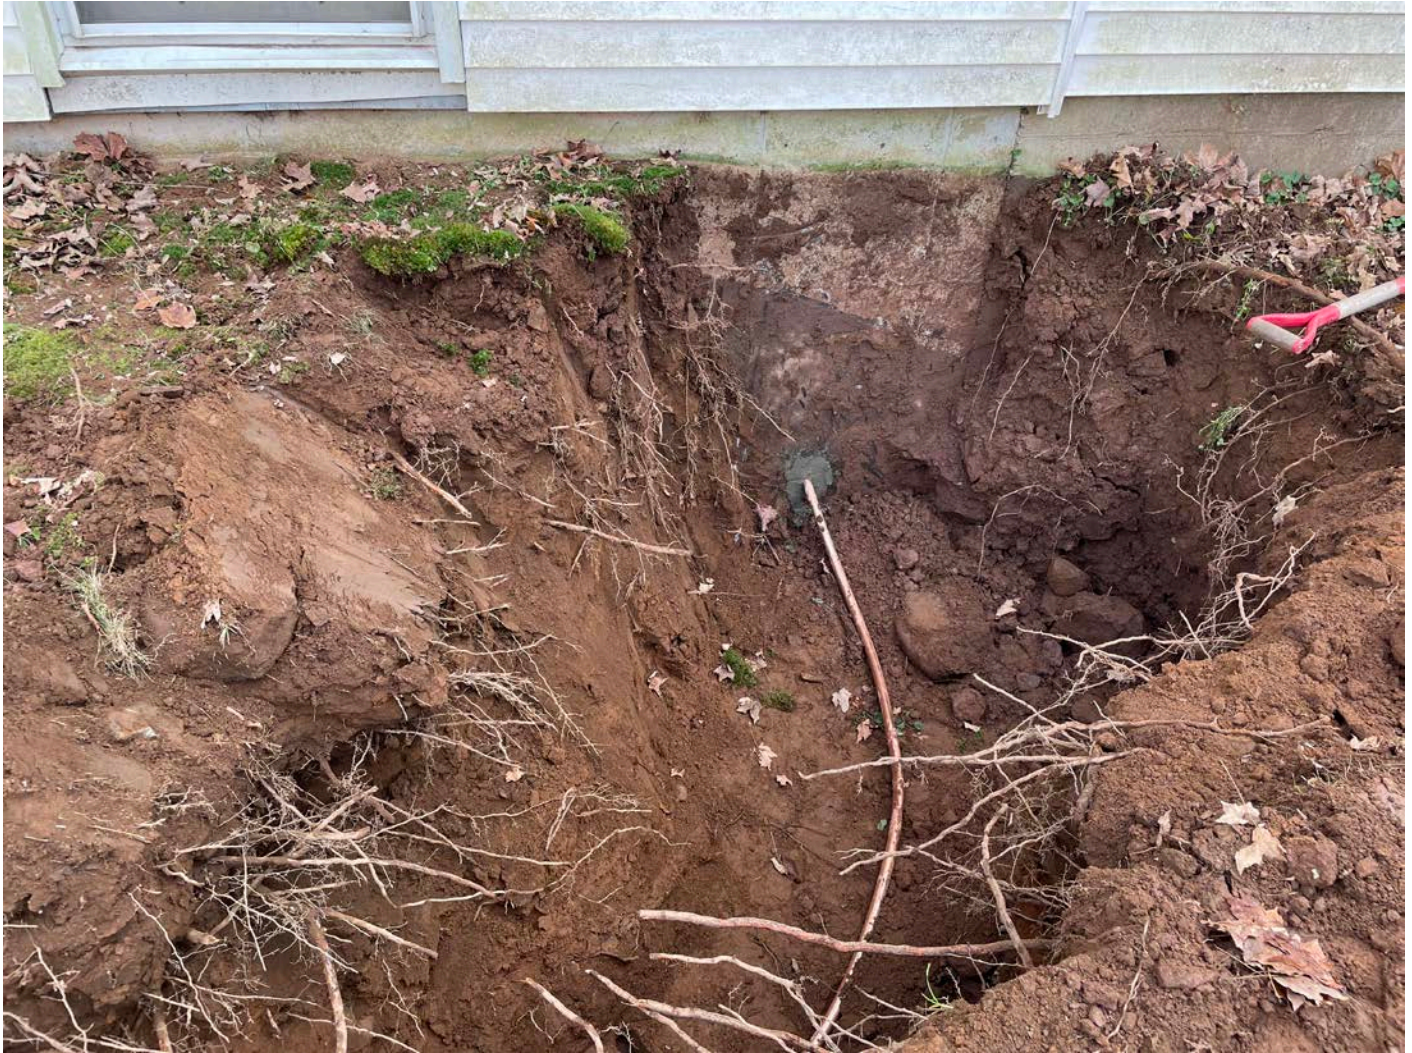
Picture 10: 1" copper water service line that Ludlow inserted through the poured-concrete foundation of the 230 Maple Avenue home and secured in place with non-shrink grout. View to the south.

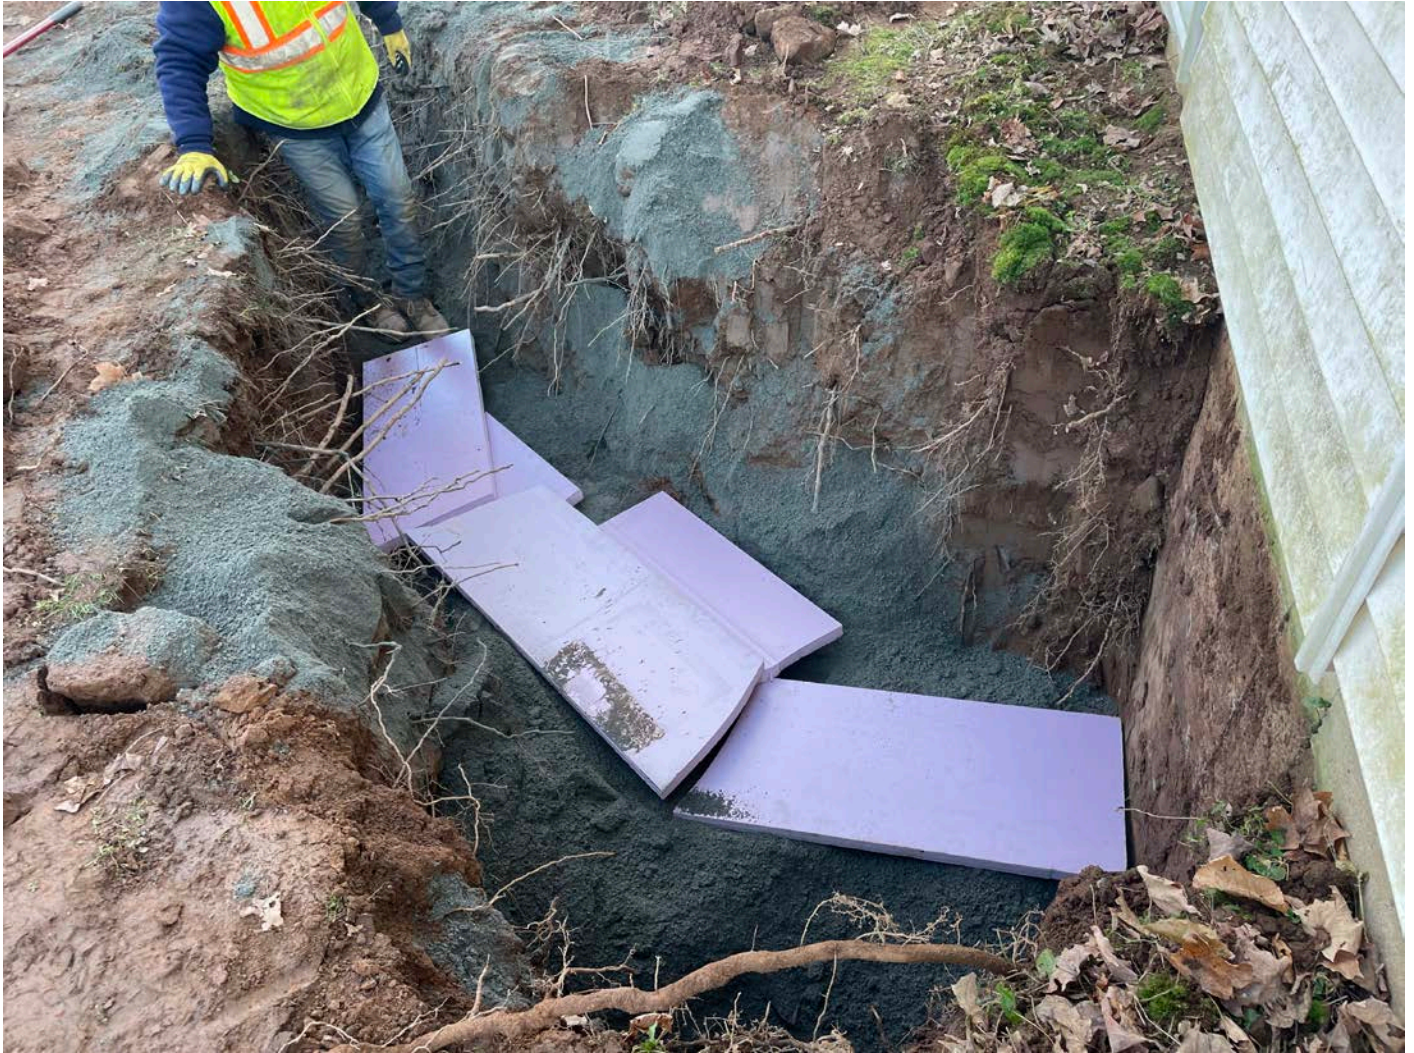
Picture 11: Foam board that Ludlow placed over 1" copper water service line just north of where it penetrates the north foundation of the 230 Maple Avenue residence. View to the east.
