## Daily Report

<b>Project:</b>	Durham Meadows Pipeline Installation	<b>Date:</b>	November 30, 2021
<b>Location:</b>	Talcott Lane and Maple Avenue, Durham; S. Main Street and the Shared Access Driveway, Middletown	<b>Day of Week:</b>	Tuesday
<b>Project #:</b>	AECOM: 6061487	<b>Report No:</b>	372
<b>Contractor:</b>	Ludlow Construction	<b>Page:</b>	1 of 11

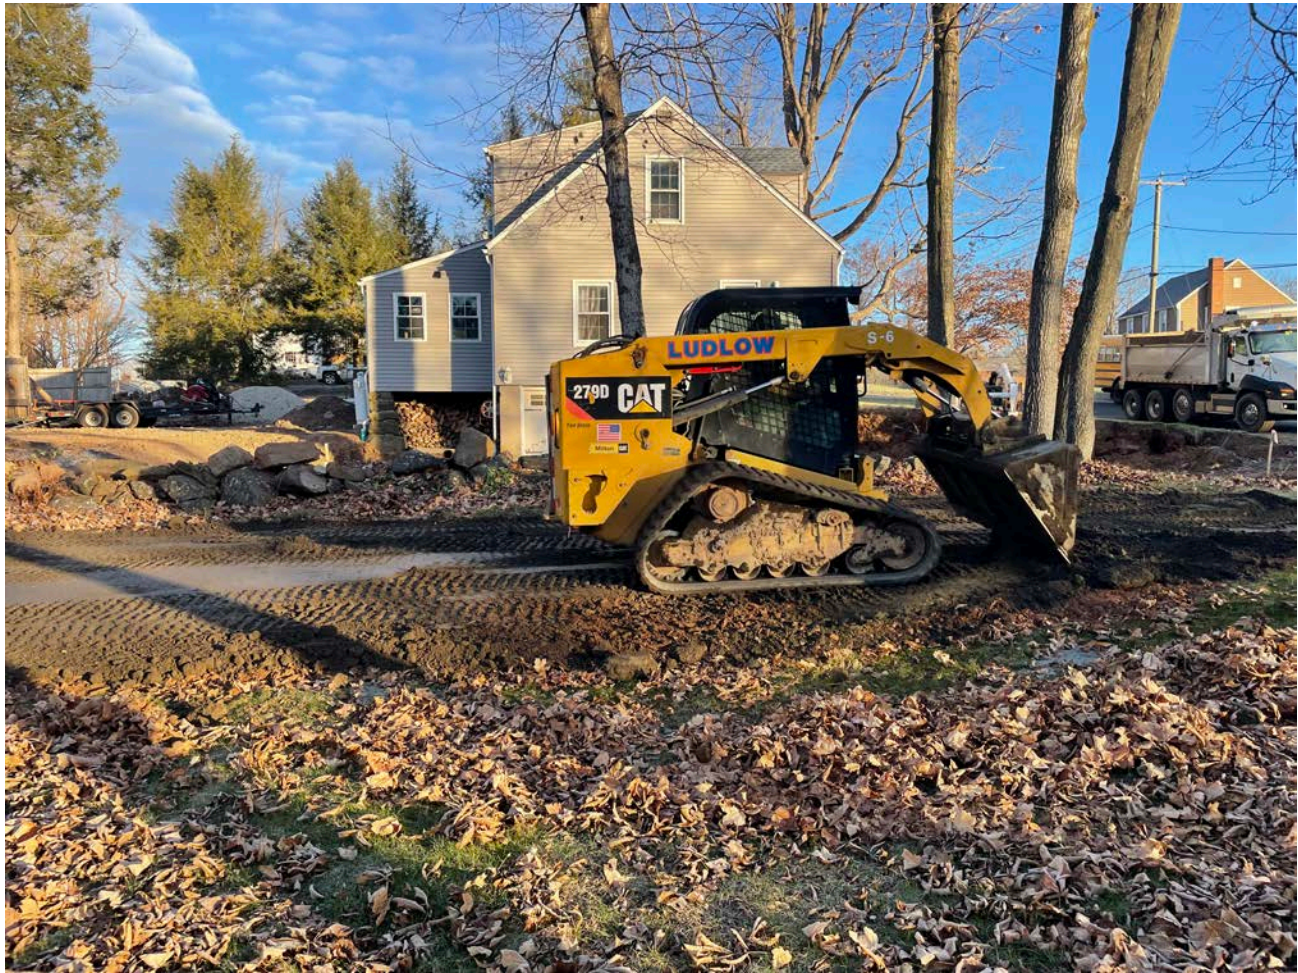
0753: Ludlow continues to place, grade, and rake out loam to restore those areas of the 230 Maple Avenue property that were disturbed during the installation of a 1" copper water service line.

Picture 1: Ludlow grading loam that they placed at the 230 Maple Avenue property to restore those areas that were disturbed during the installation of a 1" copper water service line. View to the north.

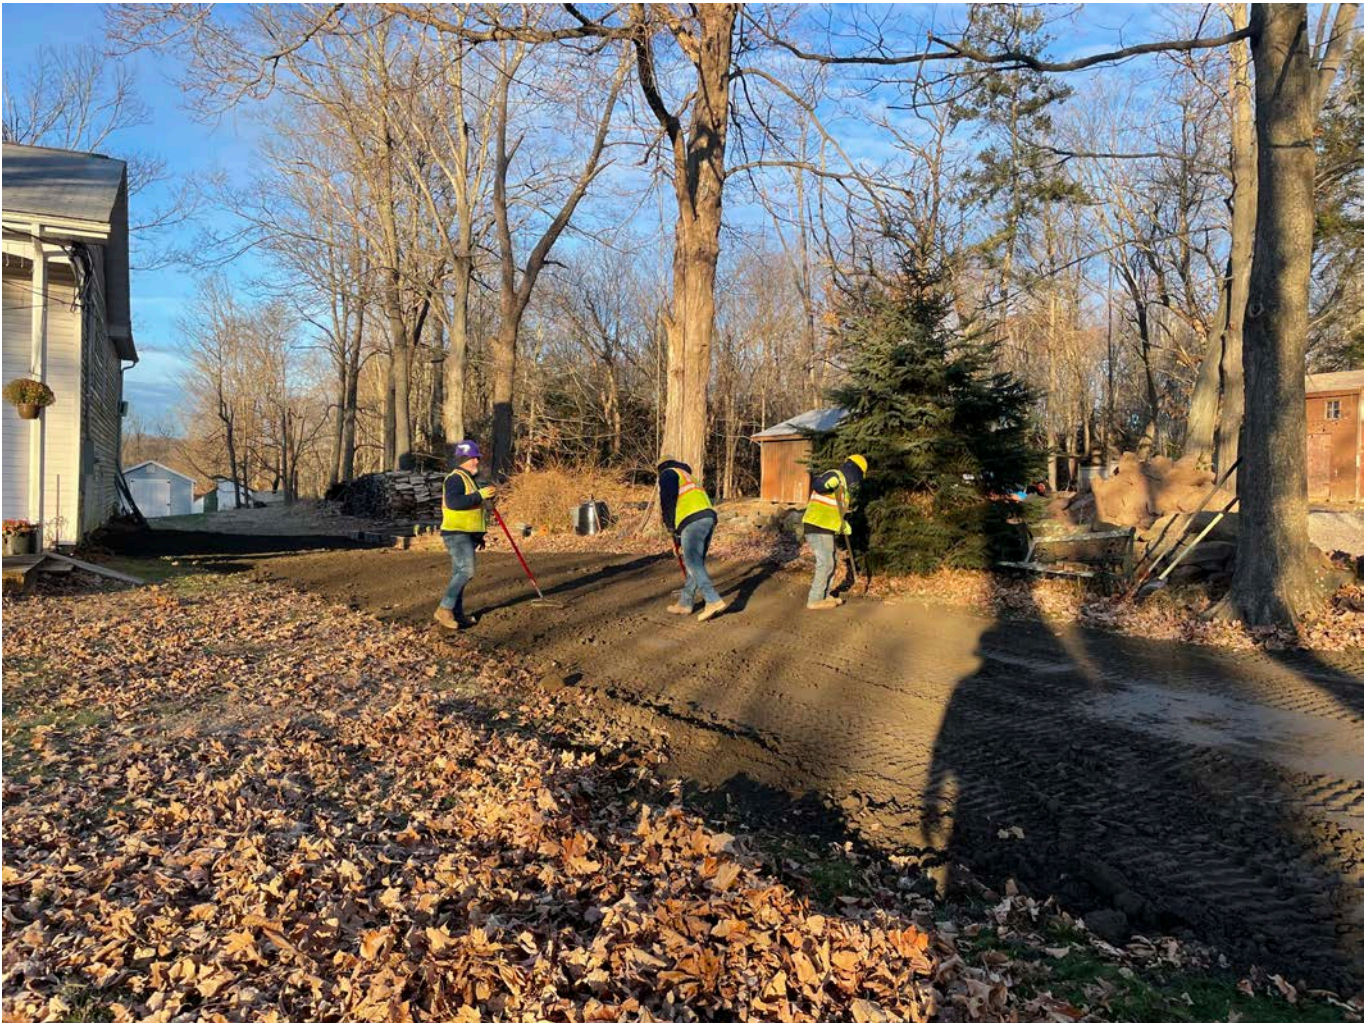
**Picture 2: Ludlow raking out the loam they placed at the 230 Maple Avenue property to restore those areas that were disturbed during the installation of a 1" copper water service line. View to the northwest.**

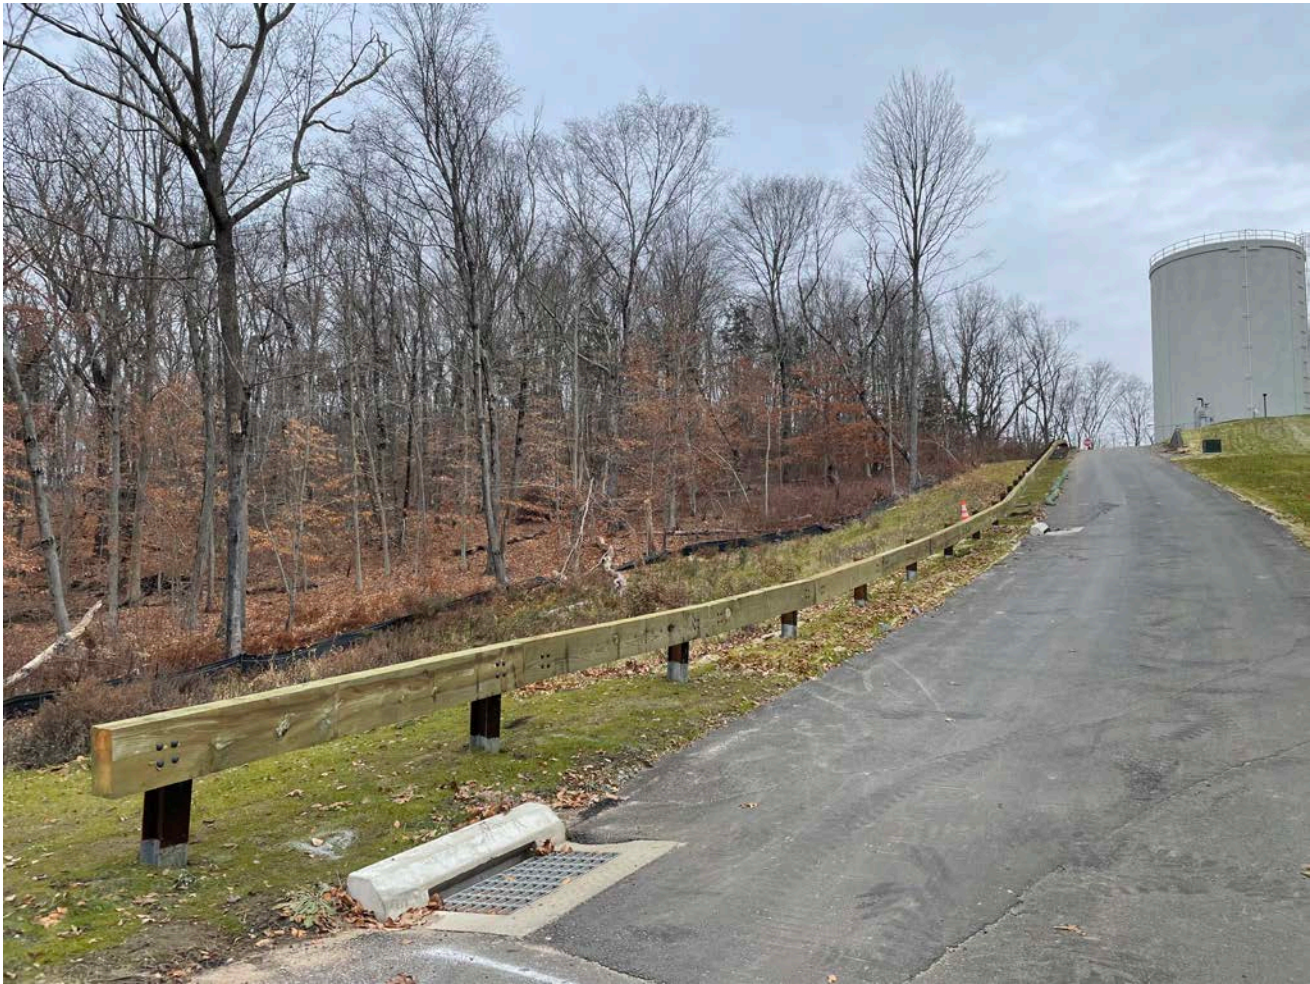
1010: Eagle Fence and Guardrail has finished the installation of a guard rail between stations 10+50 and 13+70 on the north side of the Shared Access Driveway in Middletown and have departed.

**Picture 3: Guardrail that Eagle Fence and Guardrail installed between Stations 10+50 and 13+70 on the north side of the Shared Access Driveway in Middletown.**

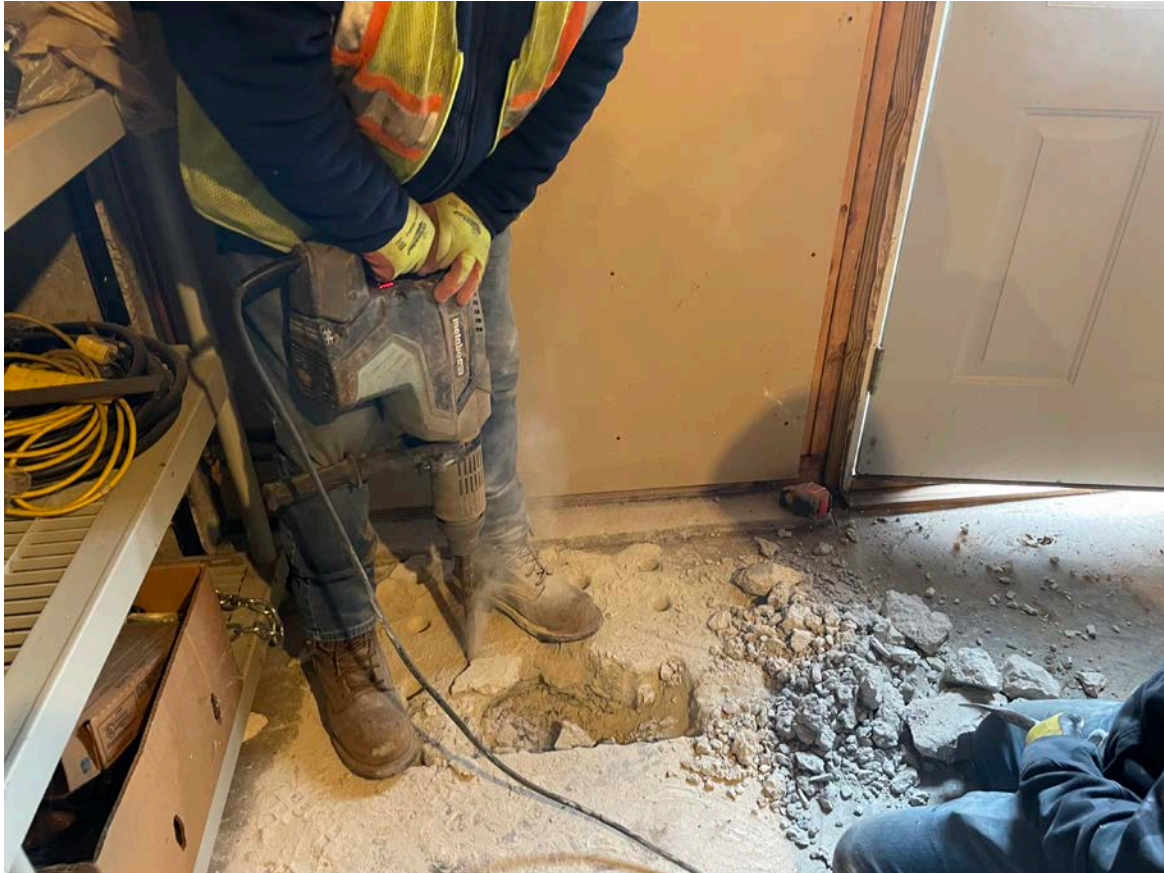
1002: Ludlow has daylighted the poured-concrete foundation of the 14 Talcott Lane residence on the south side of the house. Ludlow is currently using a rotary hammer to penetrate the concrete floor of the residence to bring a 2" copper water service line inside the home. Ludlow has approximately 30' of trench excavated on the south side of the residence so far.

**Picture 4:** Ludlow penetrating the concrete floor of the 14 Talcott Lane residence to bring a 2" copper water service line inside the home. View to the south.

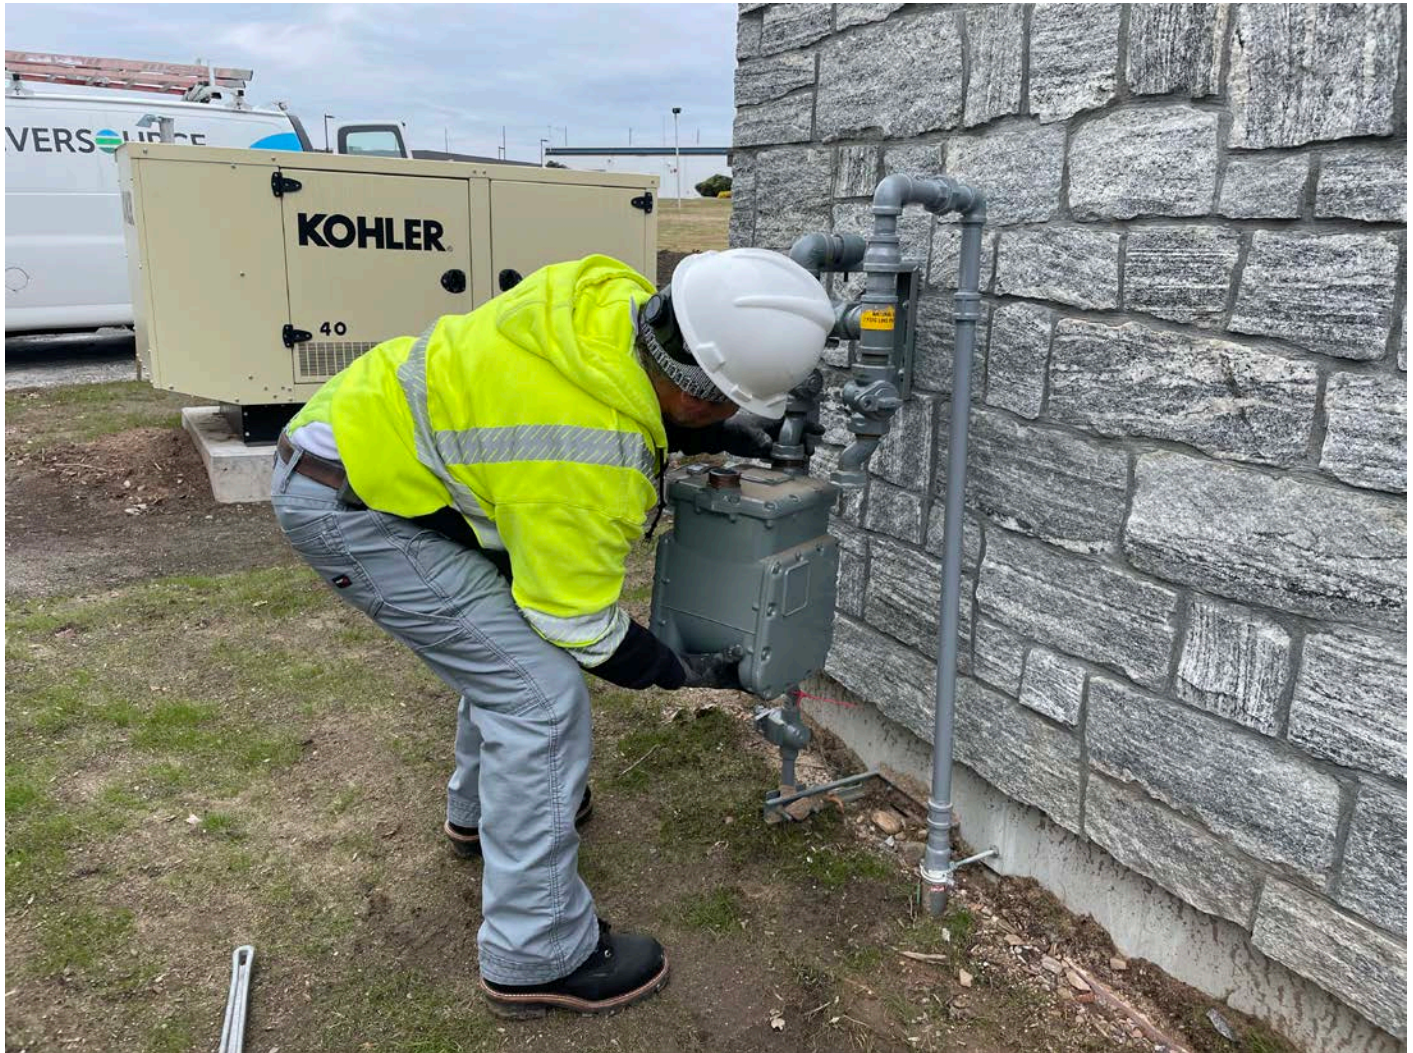
1149: Eversource is working at the booster station installing the meter for the gas line that services the generator. The meter is being installed on the south side of the building next to the southwest corner.

Picture 5: Eversource installing a gas meter on the south side of the booster station next to the southwest corner.

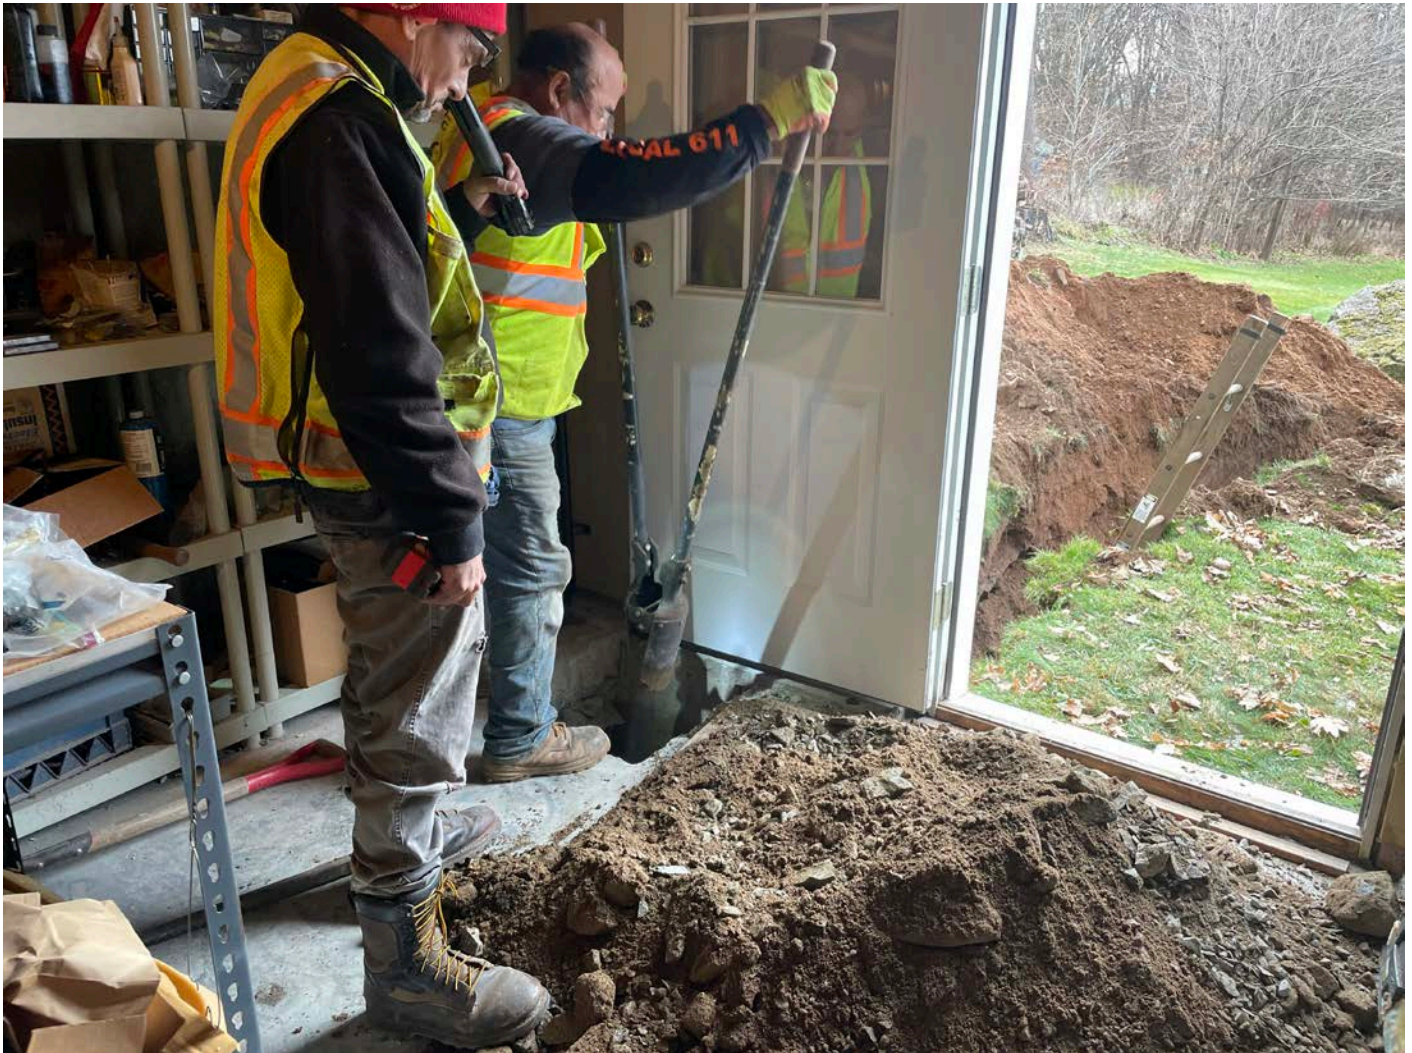
1212: Ludlow has cut a hole in the concrete floor of the 14 Talcott Lane residence and is currently using a post hole digger to remove soil down to where they cored a 2" hole through the southern foundation wall.

Picture 6: Ludlow using a post hole digger to remove soil down to where they cored a 2” hole through the southern foundation wall of the 14 Talcott Lane residence. View to the south.

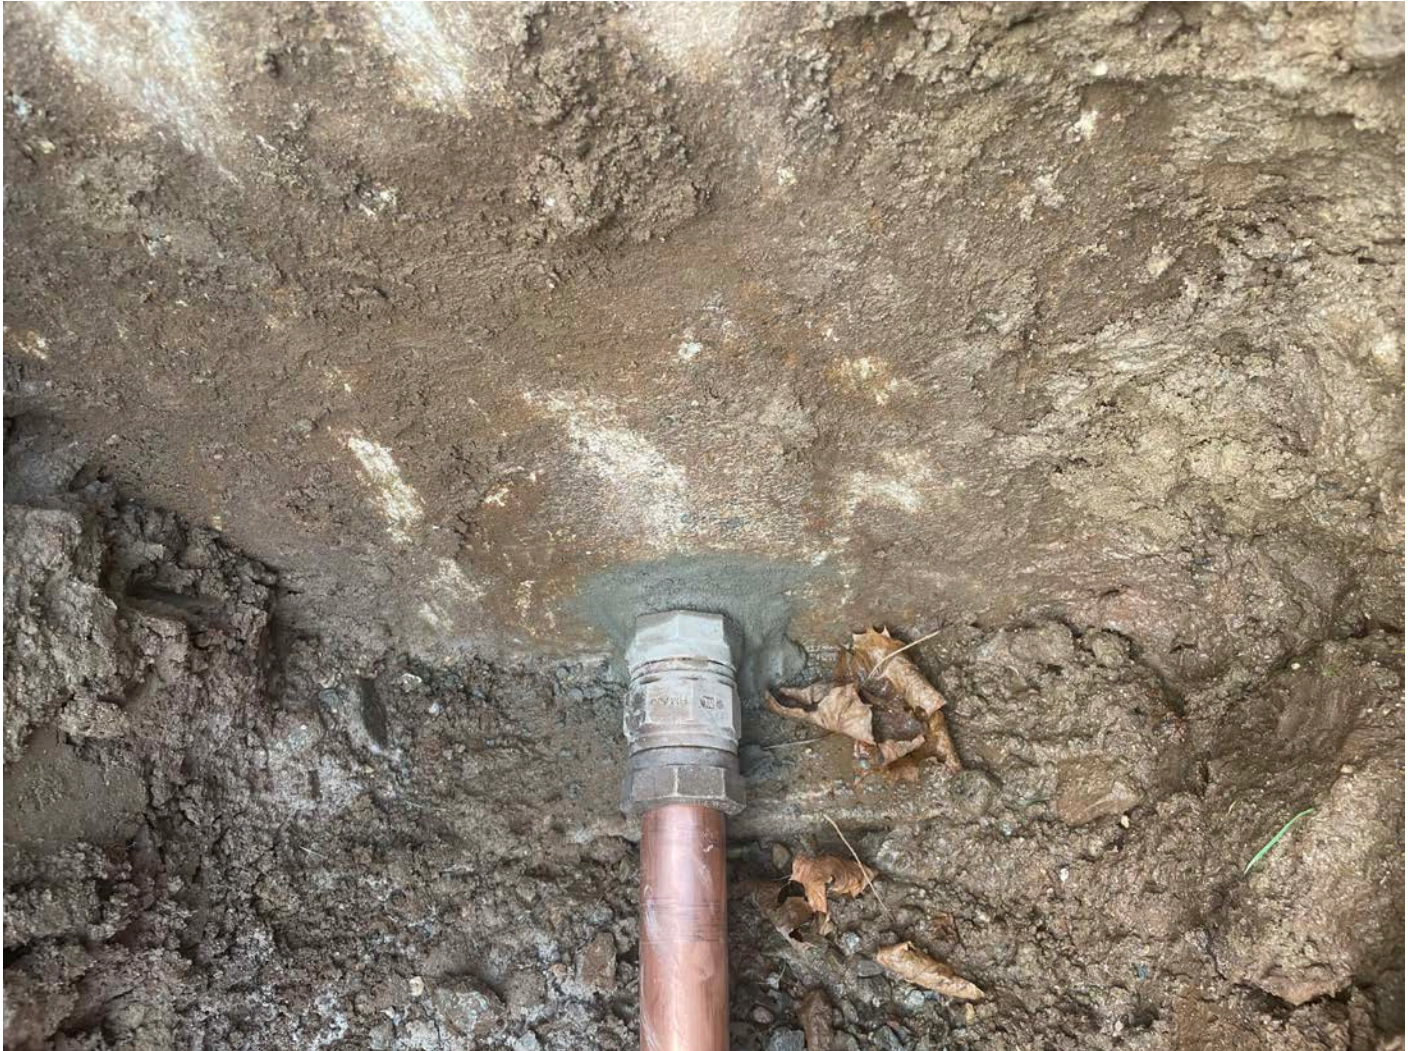
1334: Ludlow has secured a section of 2" copper water service pipe that they inserted through the penetration on the southern foundation for the 14th Talcott Lane residence with non-shrink grout. Ludlow continues to excavate a trench to the west for the installation of a 2" copper water service line. Ludlow has daylighted a black 1" HDPE line that runs from the residence's well to the inside of the house.

Picture 7: 2" copper water service line that Ludlow inserted through the southern foundation of the 14 Talcott Lane residence and secured in place with non-shrink grout. View to the north.

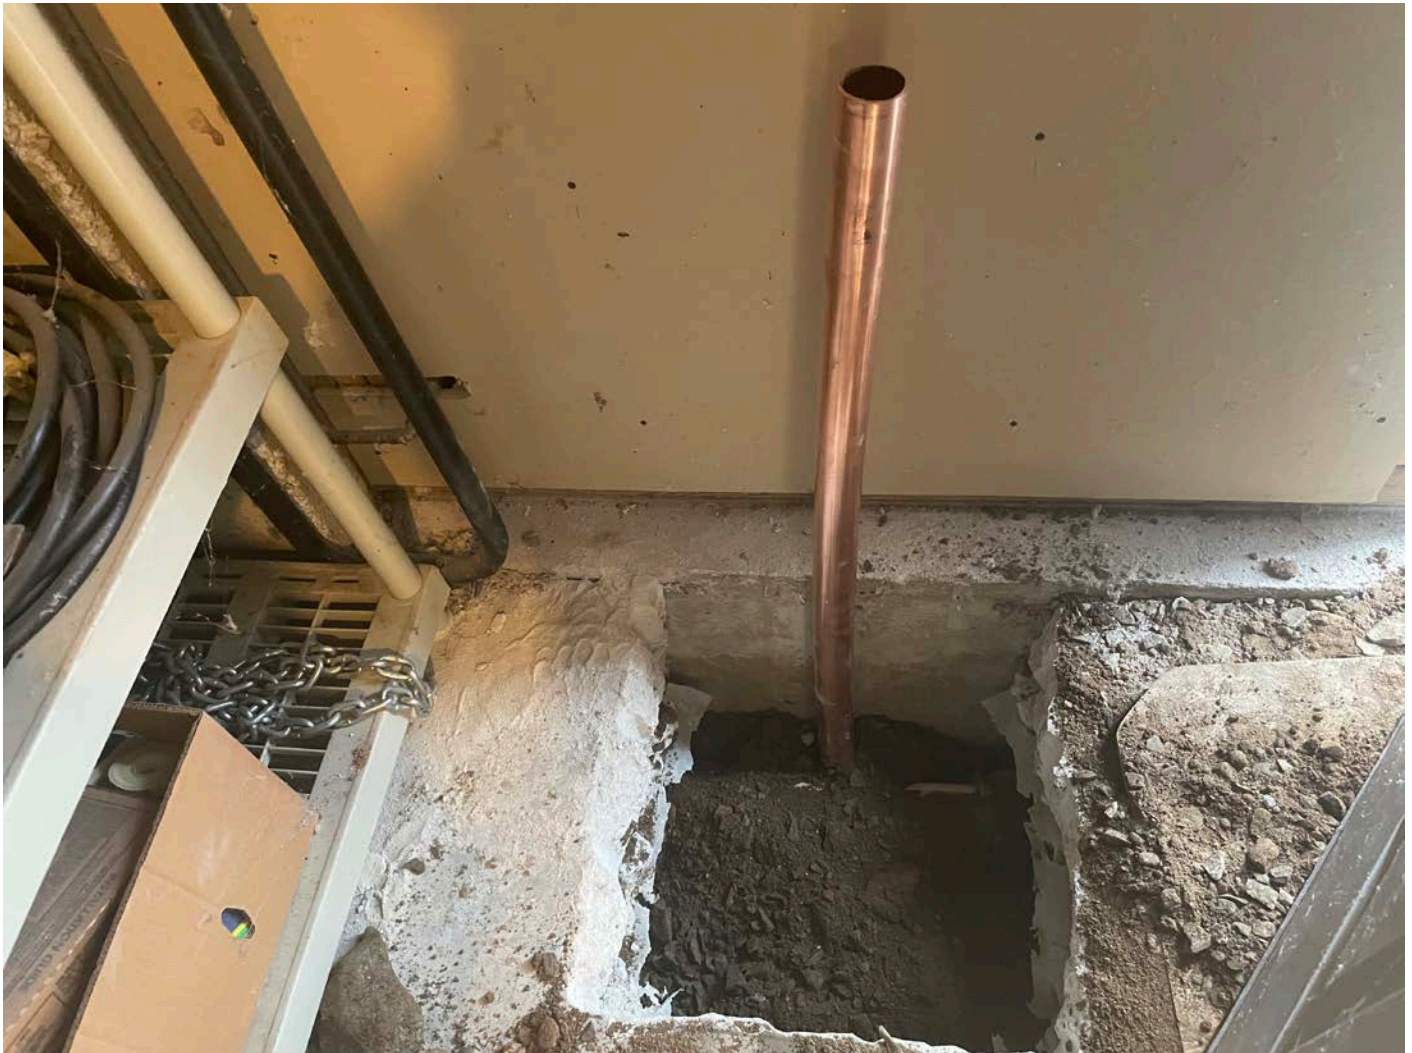
Picture 8: 2" copper water line that Ludlow has brought to the inside of the 14 Talcott Lane residence. View to the south.
