## Daily Report

<b>Project:</b>	Durham Meadows Pipeline Installation	<b>Date:</b>	April 19, 2022
<b>Location:</b>	Maple Avenue and Main Street, Durham	<b>Day of Week:</b>	Tuesday
<b>Project #:</b>	AECOM: 6061487	<b>Report No:</b>	407
<b>Contractor:</b>	Ludlow Construction	<b>Page:</b>	1 of 17

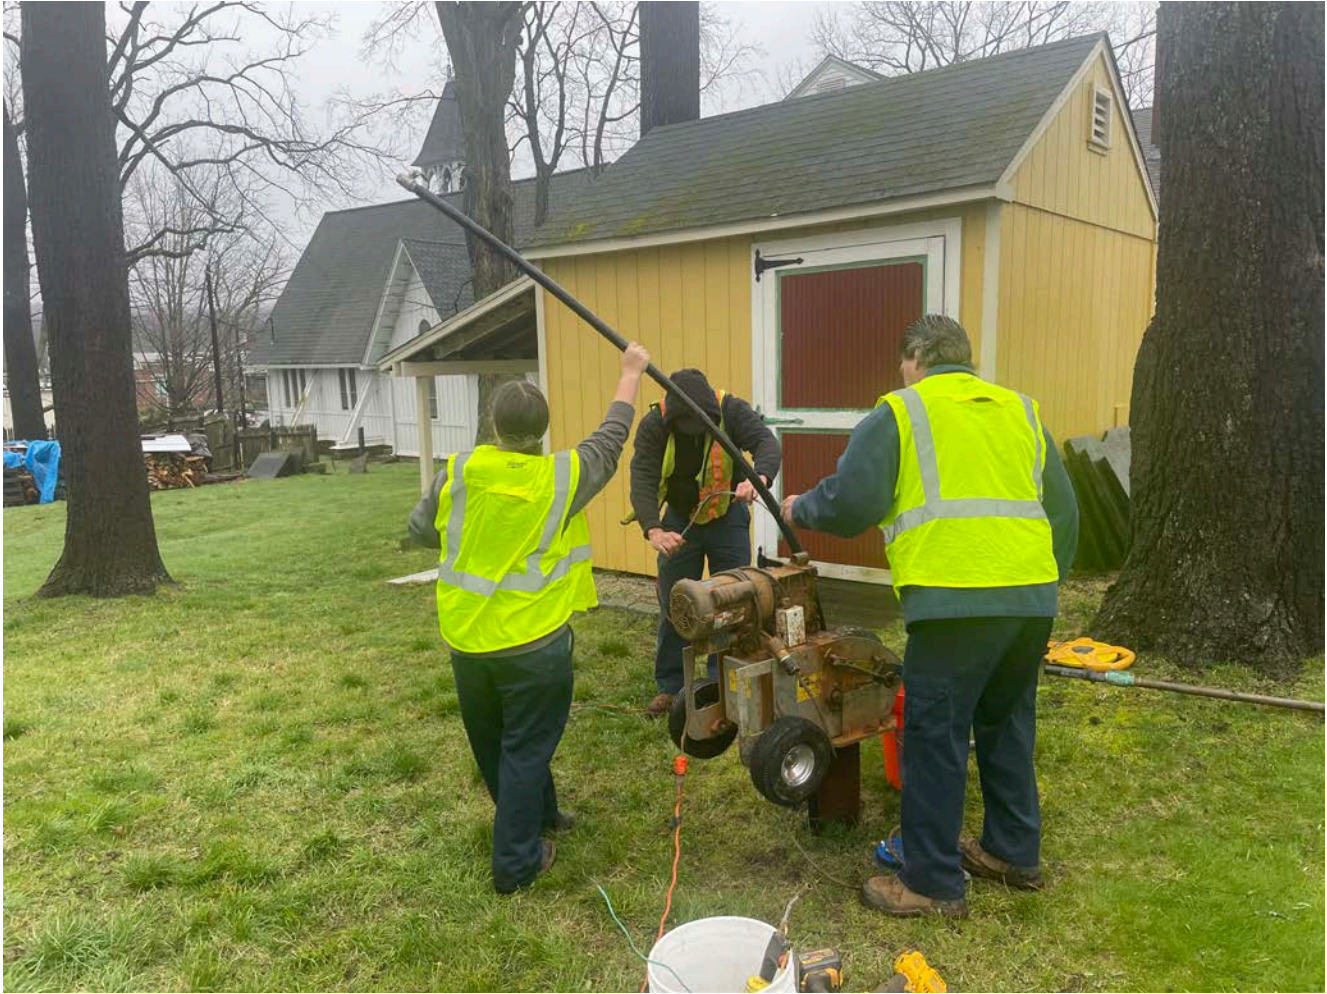
0908: Grela begins to pull the water line and the pump from the well located on the west side of the 202 Main Street, Durham, property.

Picture 1: Grela pulling the well pump from the well located at the 202 Main Street, Durham, residence. View to the southeast.

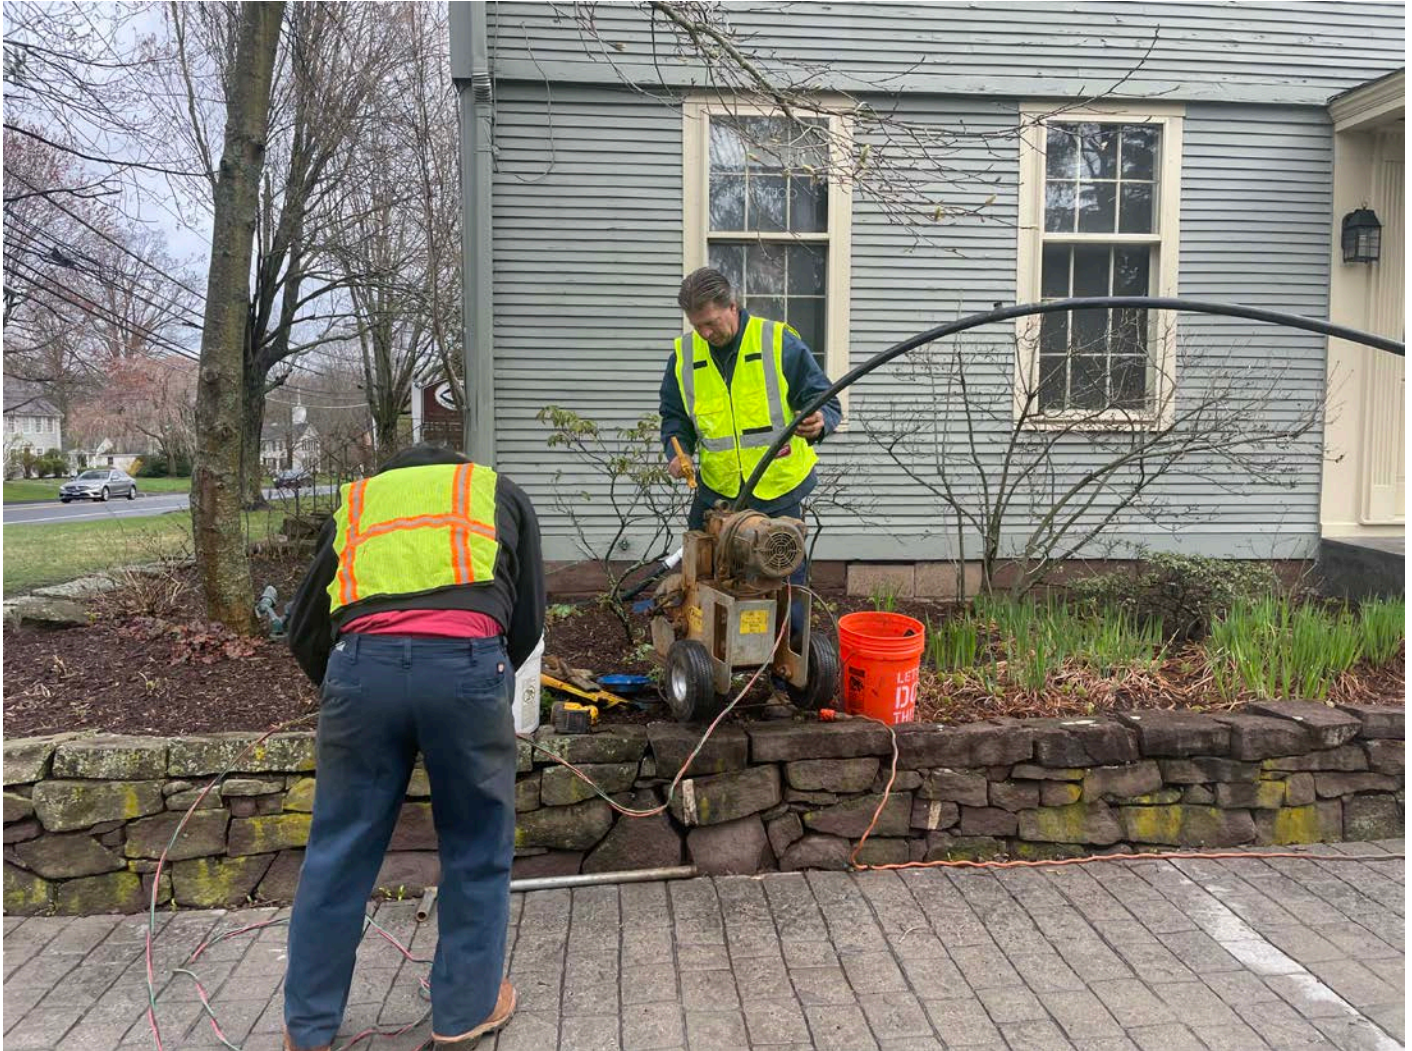
0950: Grela begins to pull the pump from the well located on the south side (Maiden Lane side) of the 243 Main Street building.

**Picture 2: Grela pulling the well line and well pump from the well located at the 243 Main Street, Durham, residence. View to the north.**

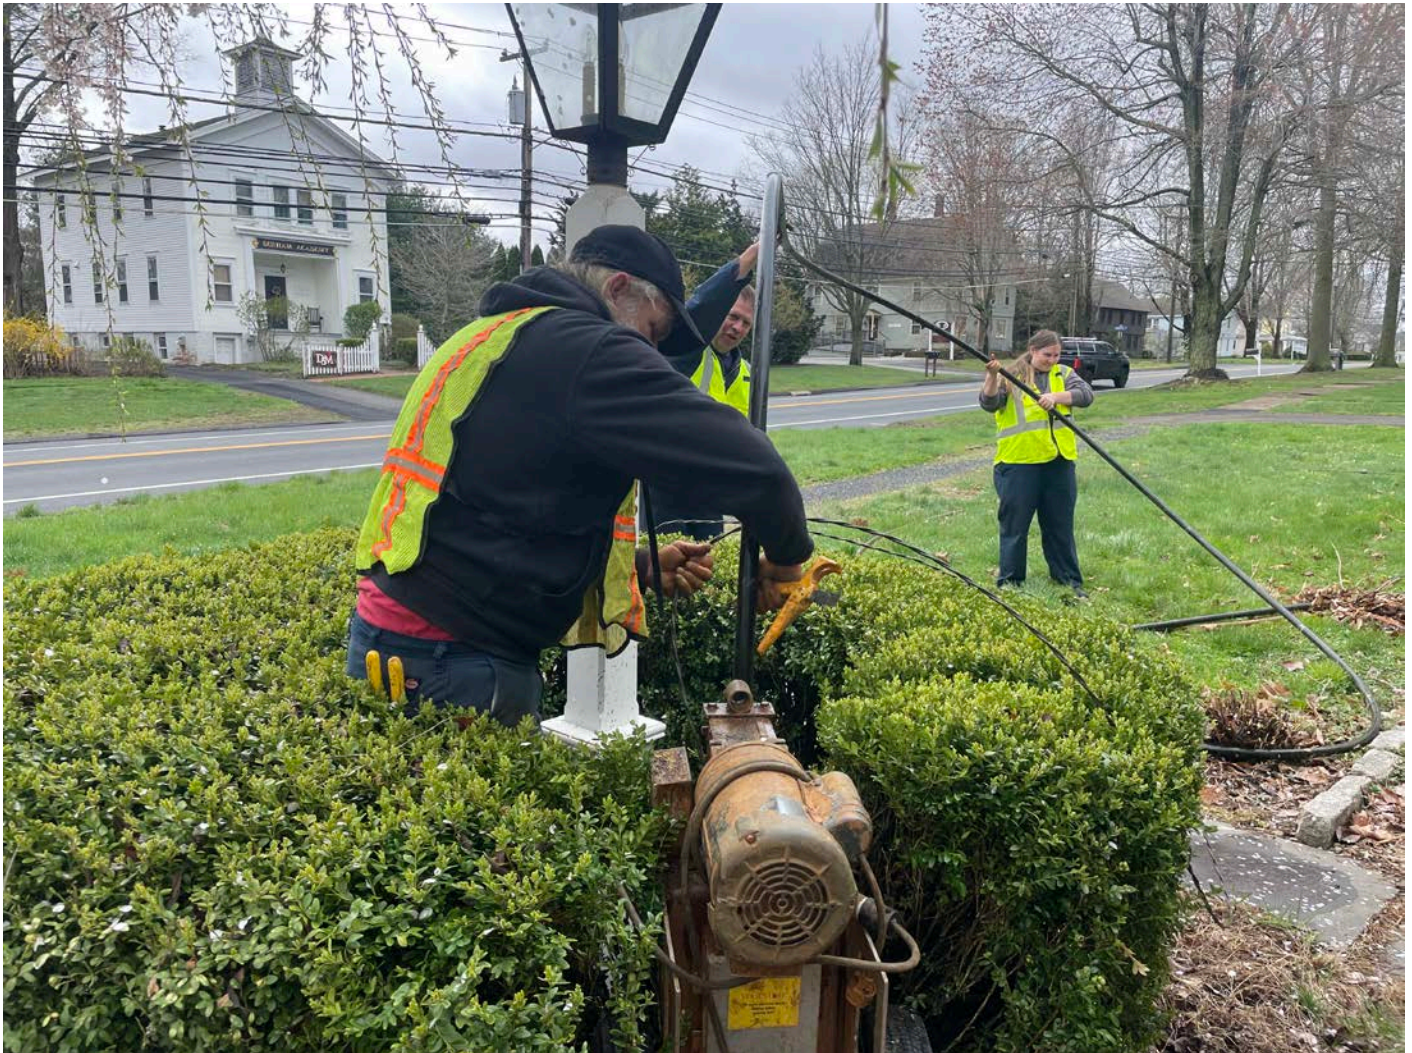
1027: Grela has removed the pump and from the well located at the 256 Main Street property.

Picture 3: Grela pulling the well line and well pump from the well located at the 256 Main Street, Durham, residence. View to the southeast.

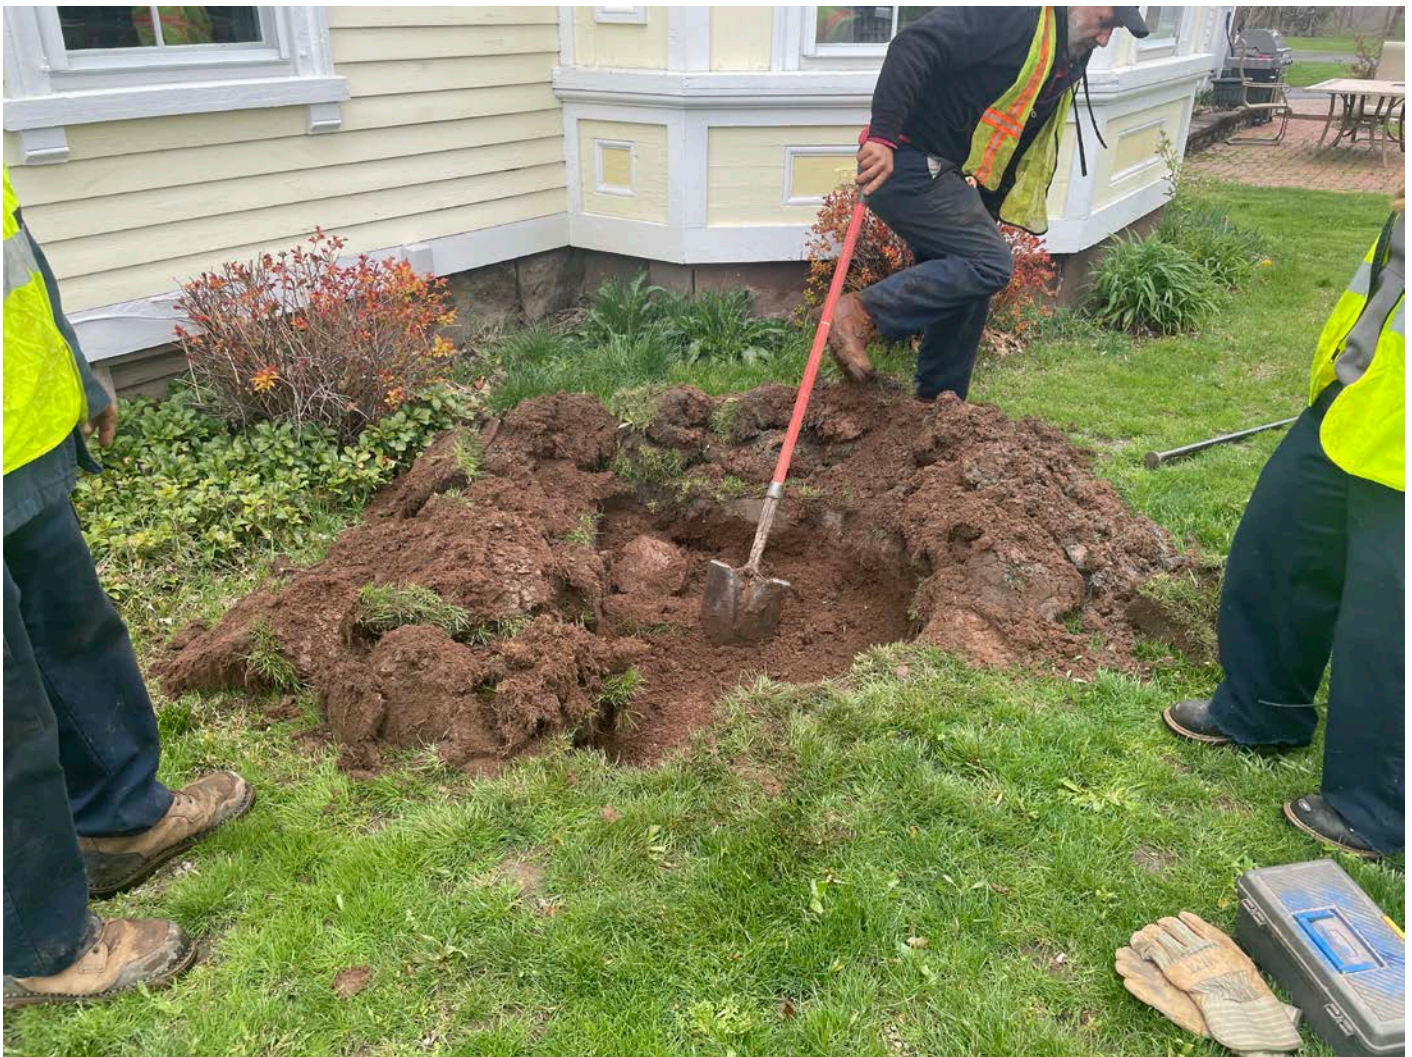
1124: Grela has just mobilized to the 265 Main Street, Durham, residence where they are going to remove the pump from the property's well as part of well decommissioning activities. The wellhead is located ~10" below surface grade.

1143: Grela uses hand tools to daylight a large concrete lid that covers the well at the 265 Main Street property. The lid is too heavy to lift by hand. Grela will have to return at a later date to remove the pump.

**Picture 4: Grela daylighting a cement cover that sits over the well located on the south side of the 265 Main Street, Durham, residence. View to the northeast.**

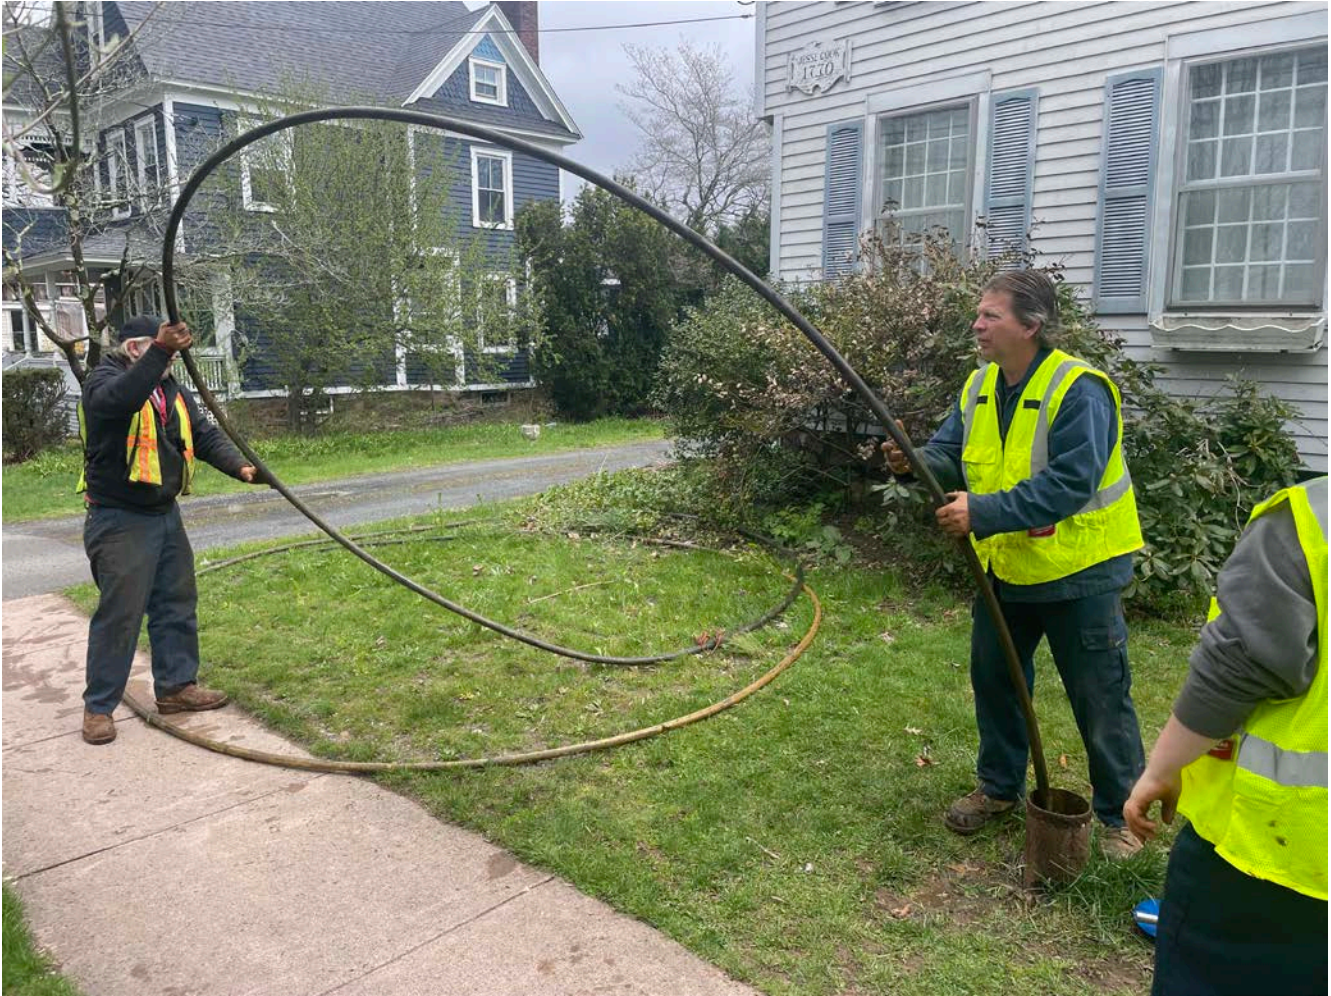
Picture 5: Grela pulling the well pump from the well located at the 267 Main Street, Durham, residence. View to the southeast.

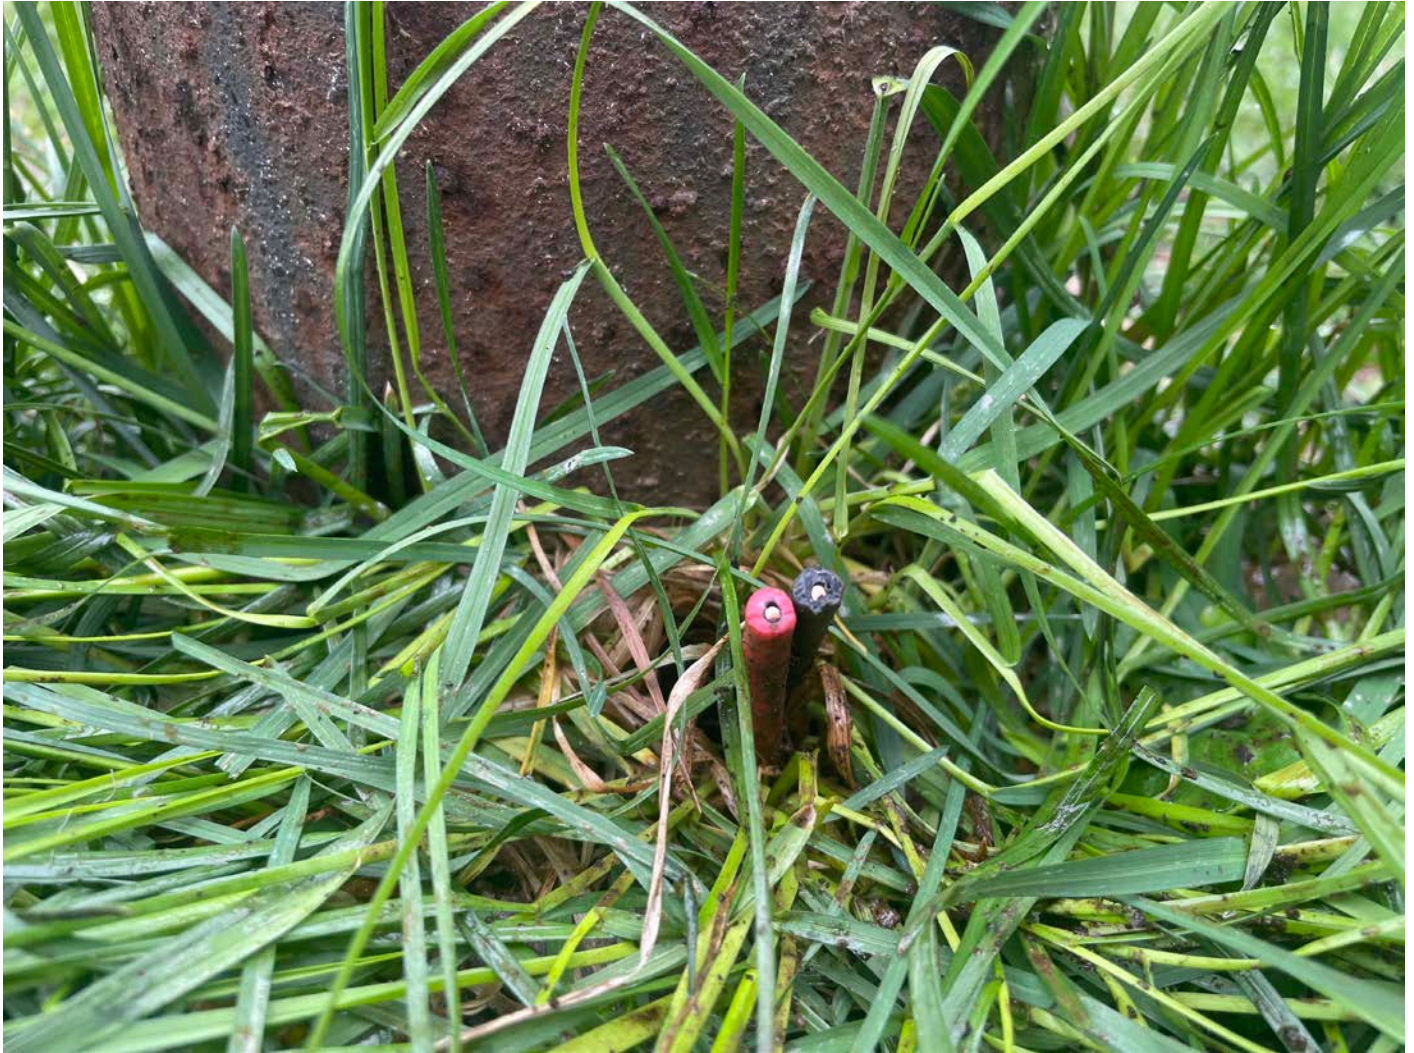
1201: Grela is in the process of pulling the pump from the well located on the west side of the 267 Main Street residence. Grela has just severed the power line well. The power line was observed to not be encased in a conduit.

**Picture 6: Power lines (without a protective exterior conduit surrounding them) that connected to the well pump at 267 Main Street, Durham, residence. View to the northeast.**

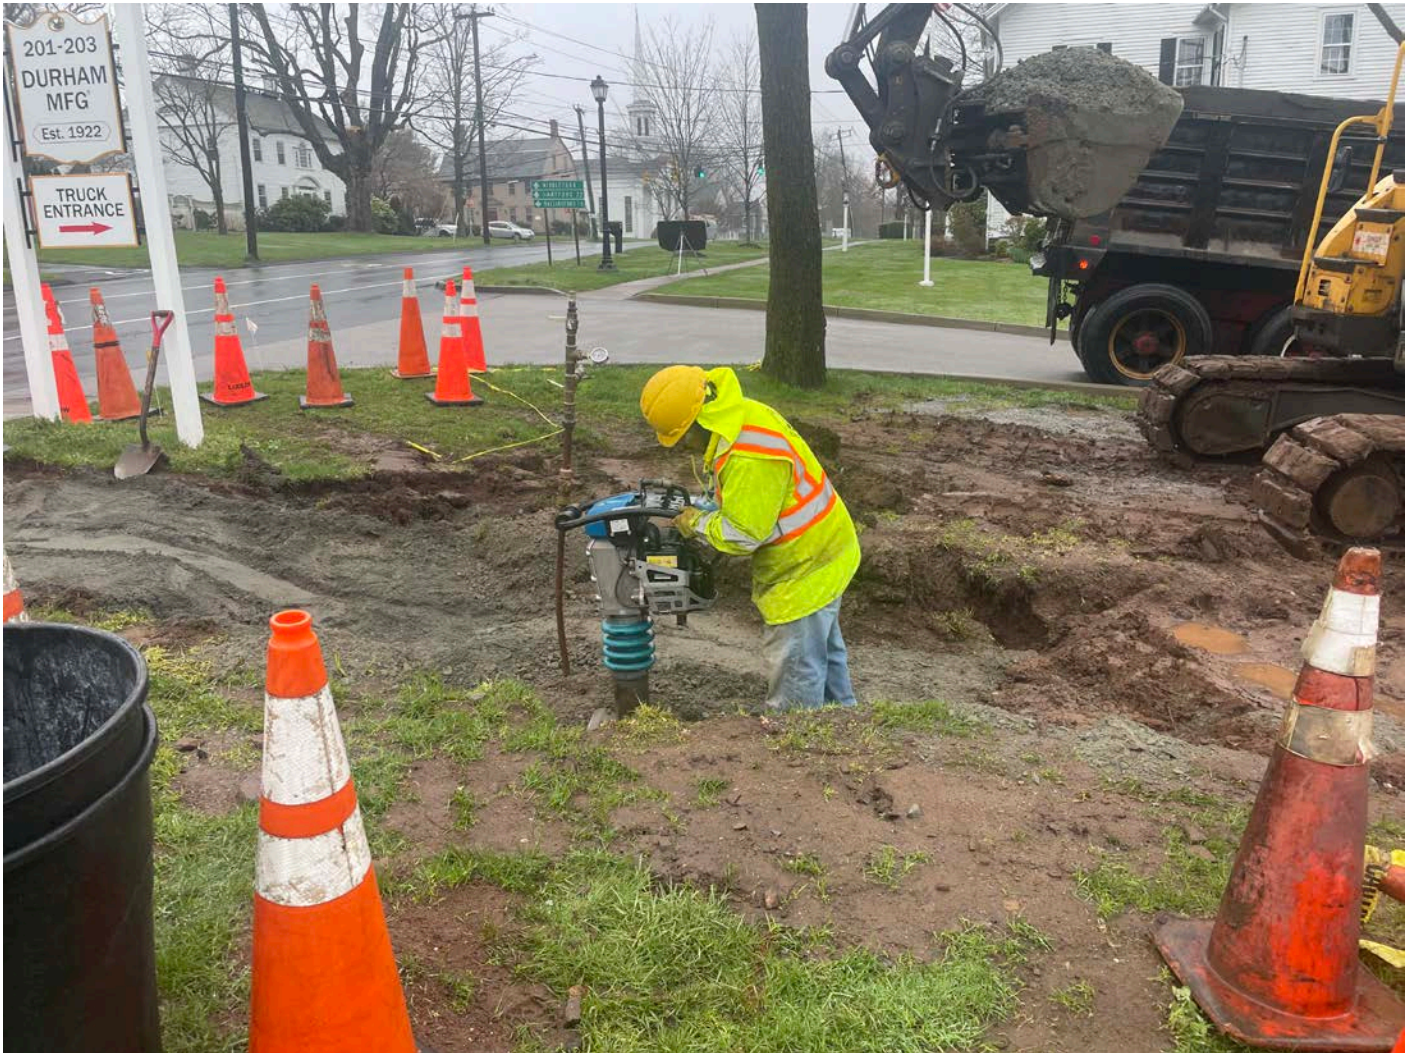
Picture 7: Ludlow compacting fill in 1' lifts as they backfill the trench they excavated on the west side of the meter vault at the Durham Manufacturing property for the installation of a 4" DIP water service line.

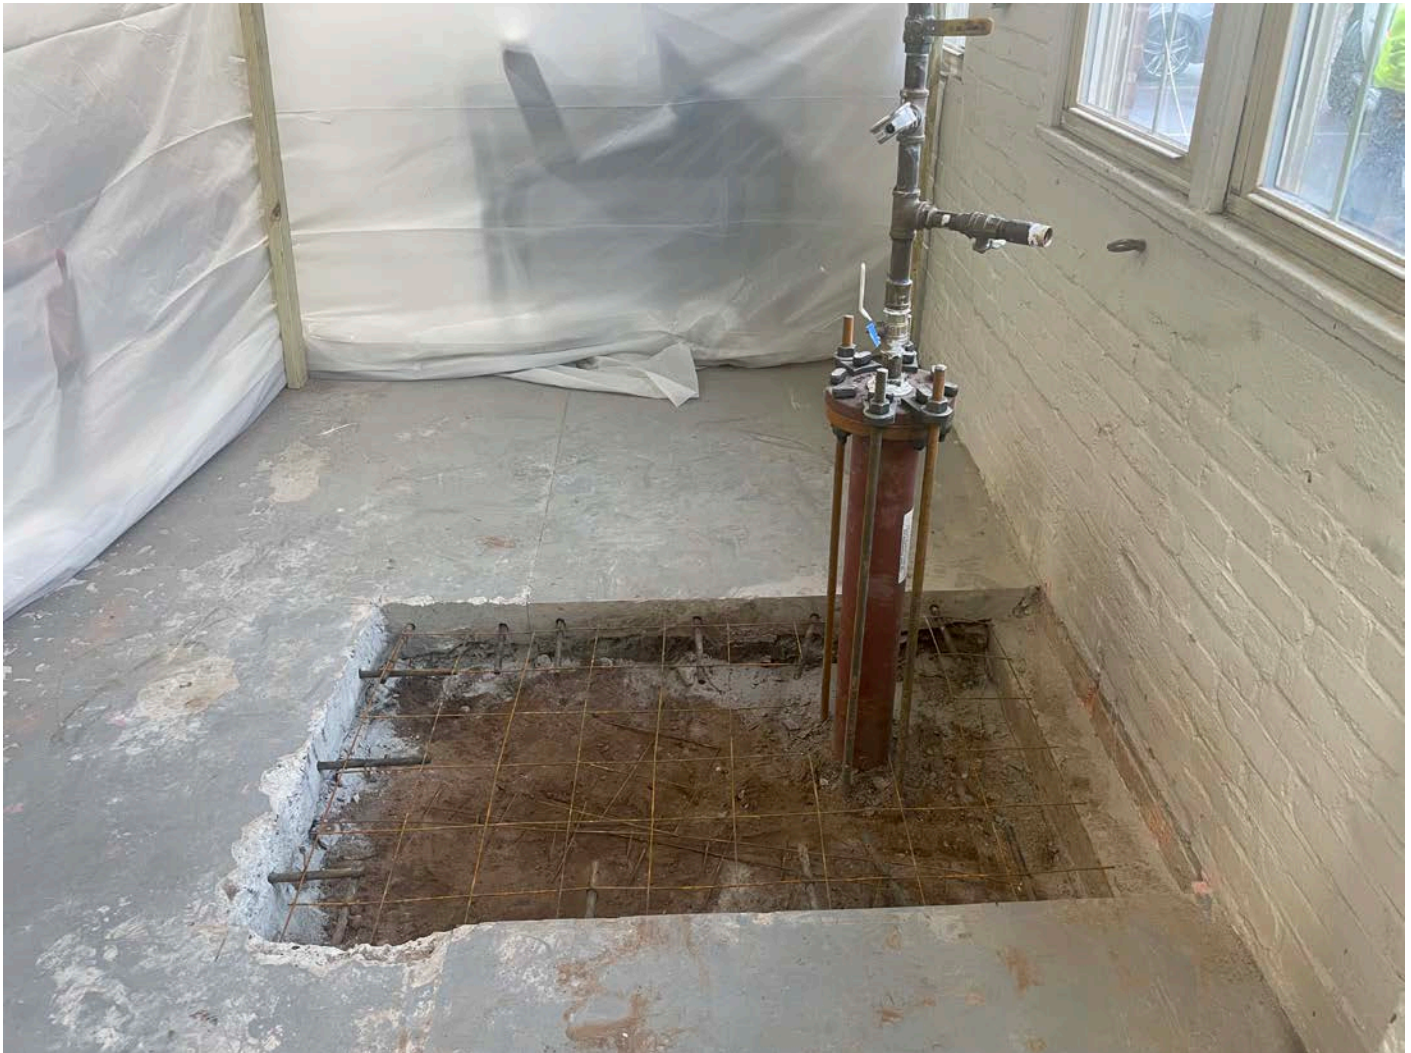
**Picture 8: Hole in the floor of the Durham Manufacturing facility where Ludlow brought in a 4" DIP water service line. View to the south. Ludlow has placed steel screen and sections of rebar set into the sidewalls of the cut concrete as they prepare to fill the hole with concrete. View to the south.**

0916: Ludlow is mixing cement to fill the hole they cut in the floor of the Durham Manufacturing facility when they brought a 4" water service line inside of the building.

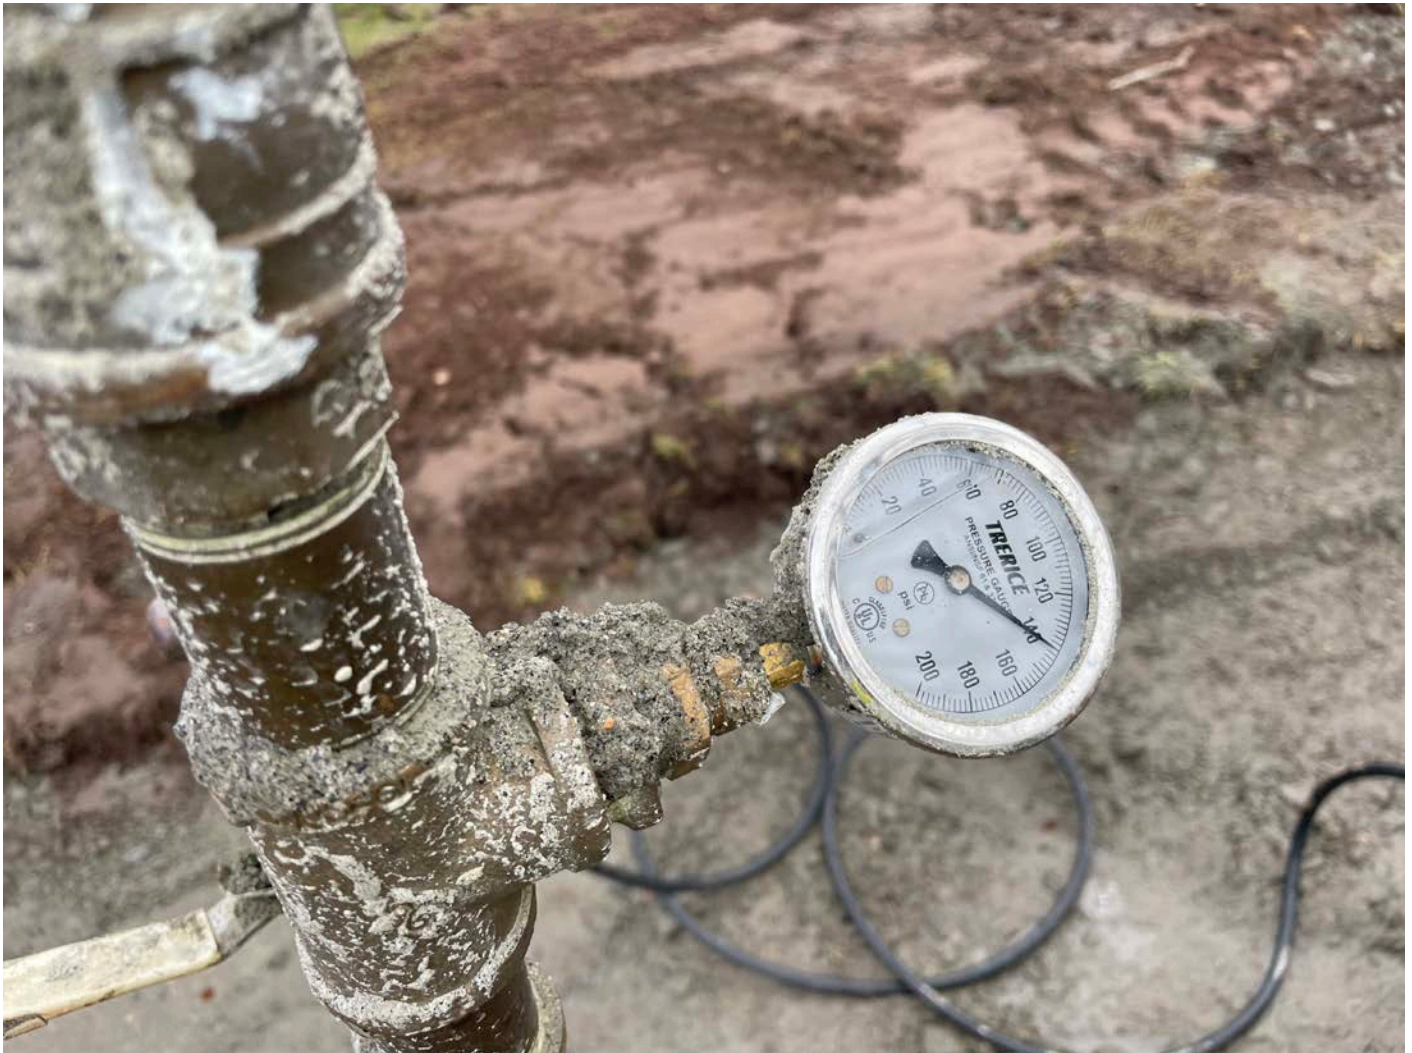
1030: Ludlow has pressurized the 4" inch DIP water service line at the Durham Manufacturing property to 140 PSI to test the line.

Picture 9: Pressure gage showing a pressure of 140 PSI on the 4" DIP water service line they installed at the Durham Manufacturing property.

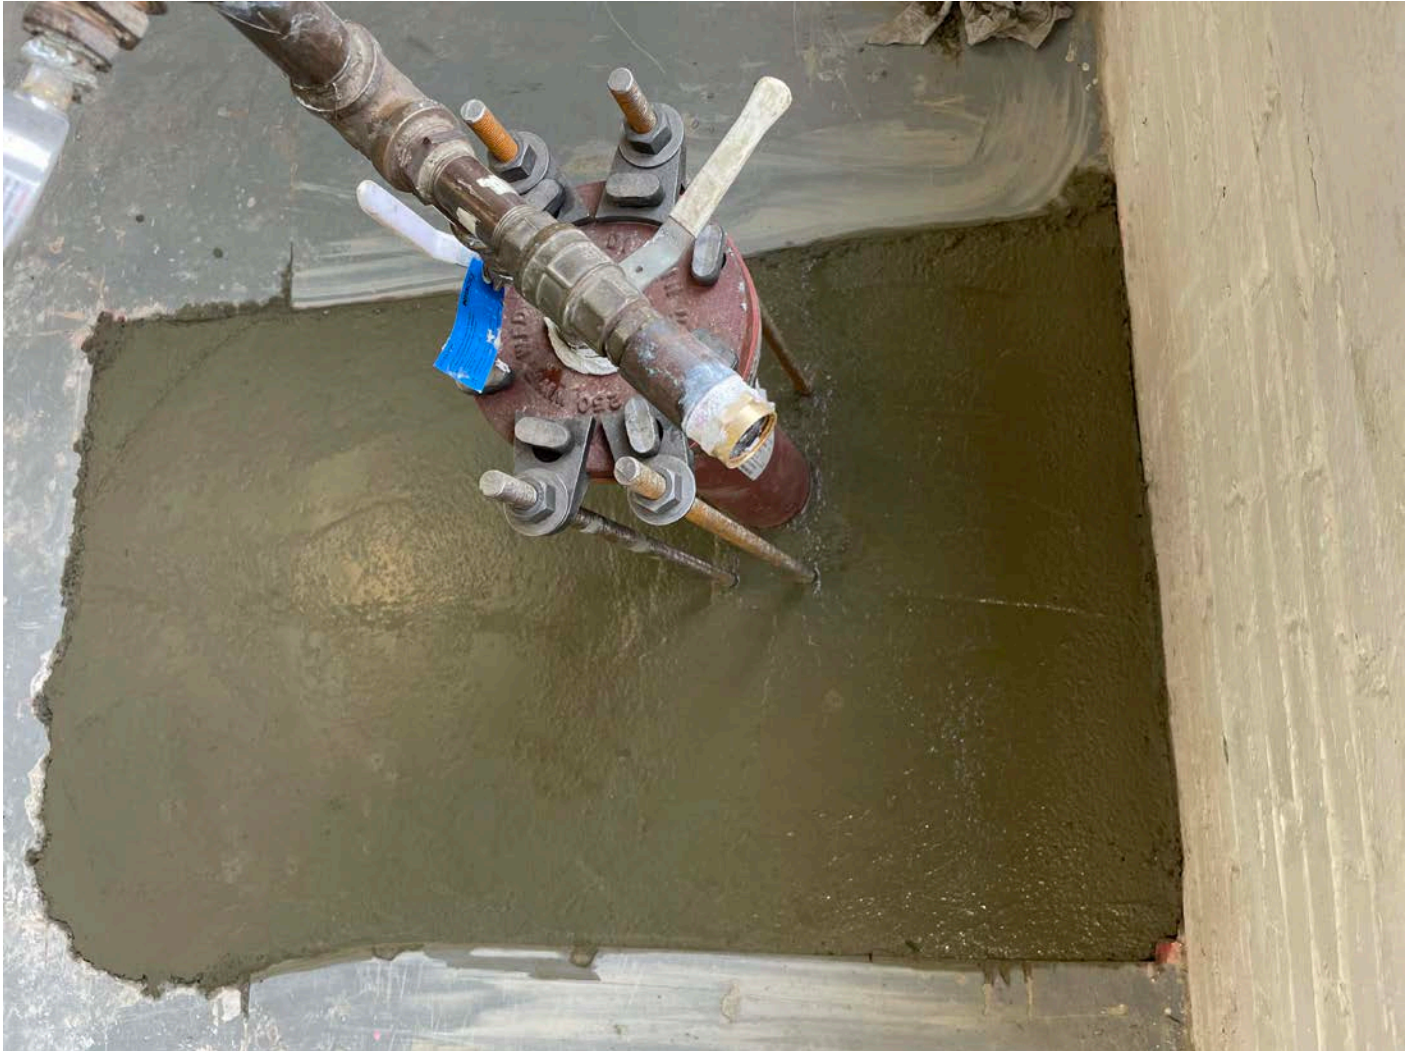
0956: Ludlow is finishing up placing concrete on the inside of the Durham Manufacturing facility where they cut the floor during the installation of a 4" DIP water service line.

**Picture 10: Hole in the floor of the Durham Manufacturing facility where Ludlow brought in a 4" DIP water service line and subsequently patched today with concrete. View to the south.**

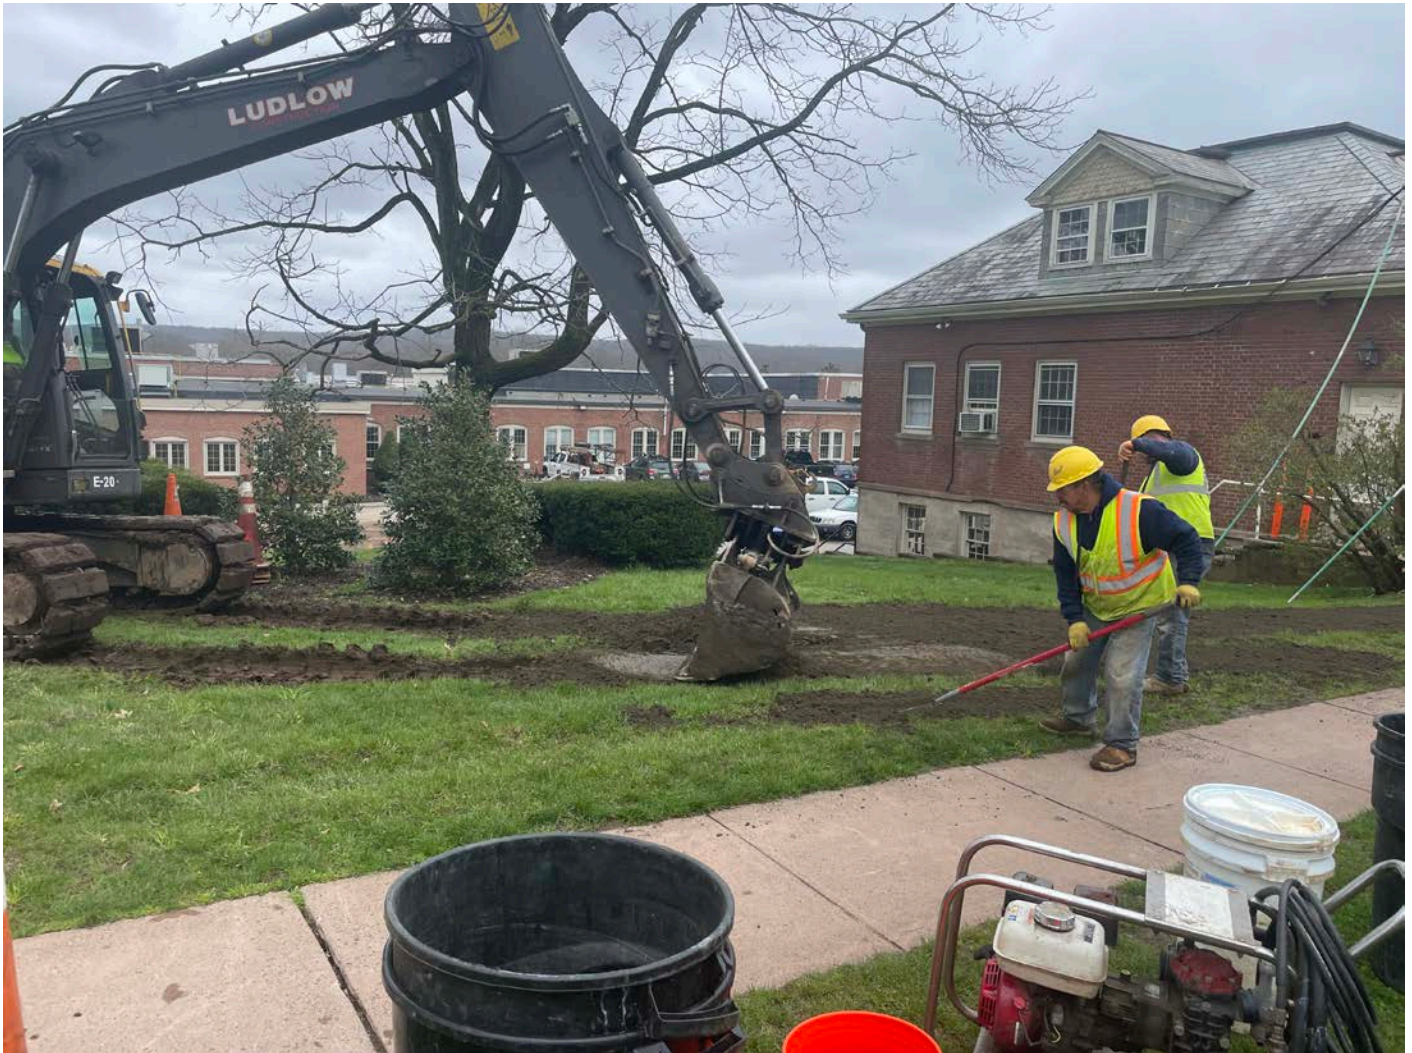
1307: Ludlow continues to restore those portions of the lawn at the Durham Manufacturing property that were disturbed during the installation of a 4" DIP water service line.

**Picture 11: Ludlow placing and raking fill on those portions of the lawn at the Durham Manufacturing property that were disturbed during the installation of a 4" DIP water service line. View to the west.**

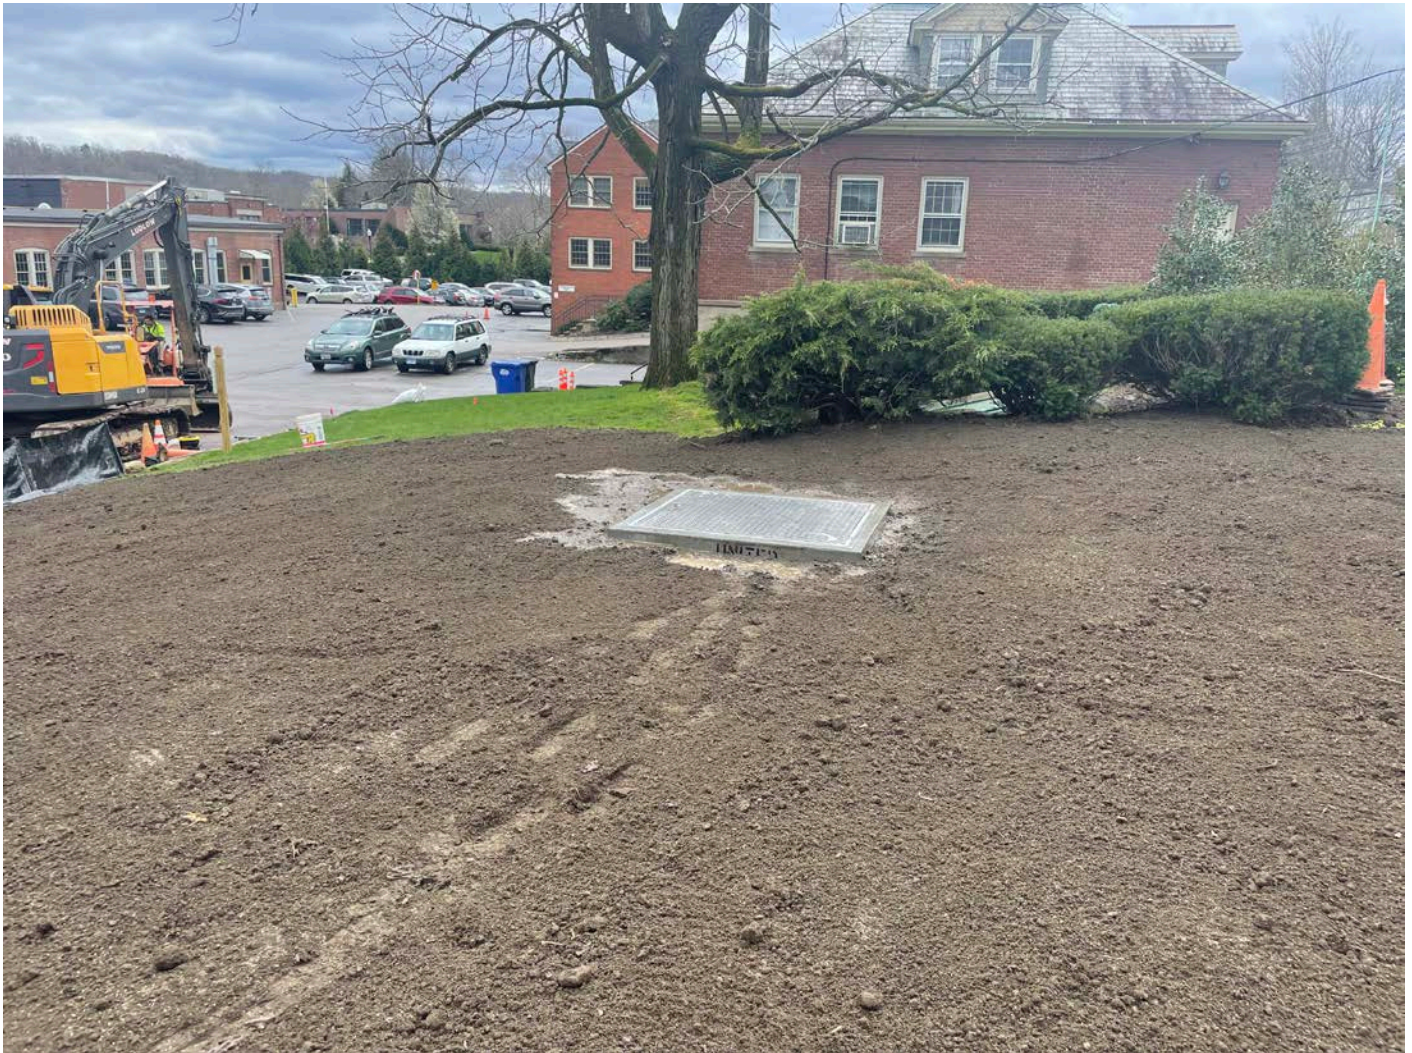
1240: Ludlow is placing loam around the water meter vault they recently installed at the Durham Manufacturing property.

**Picture 12: View of the area surrounding the hatch to the water meter vault that Ludlow installed at the Durham Manufacturing property. View to the southeast.**

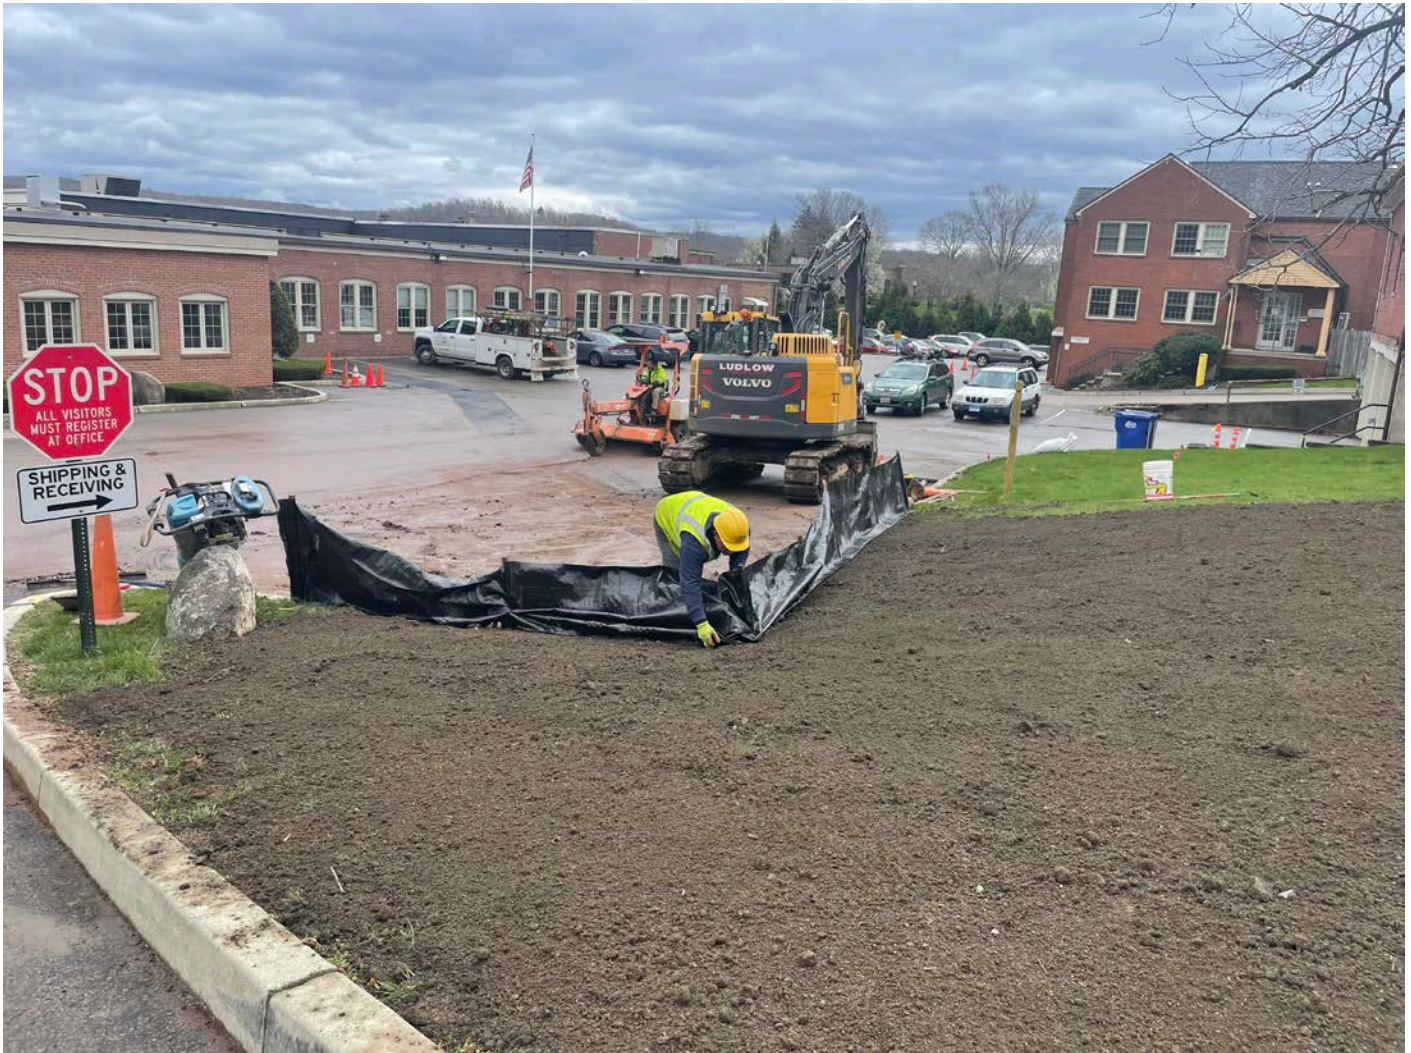
1325: Ludlow is erecting silt fence on the west side of the parking lot of the Durham Manufacturing property.

Picture 13: Ludlow erecting silt fencing at the Durham Manufacturing property, downslope of where they restored and seeded the area that was disturbed during the installation of a 4" DIP water service line. View to the northeast.

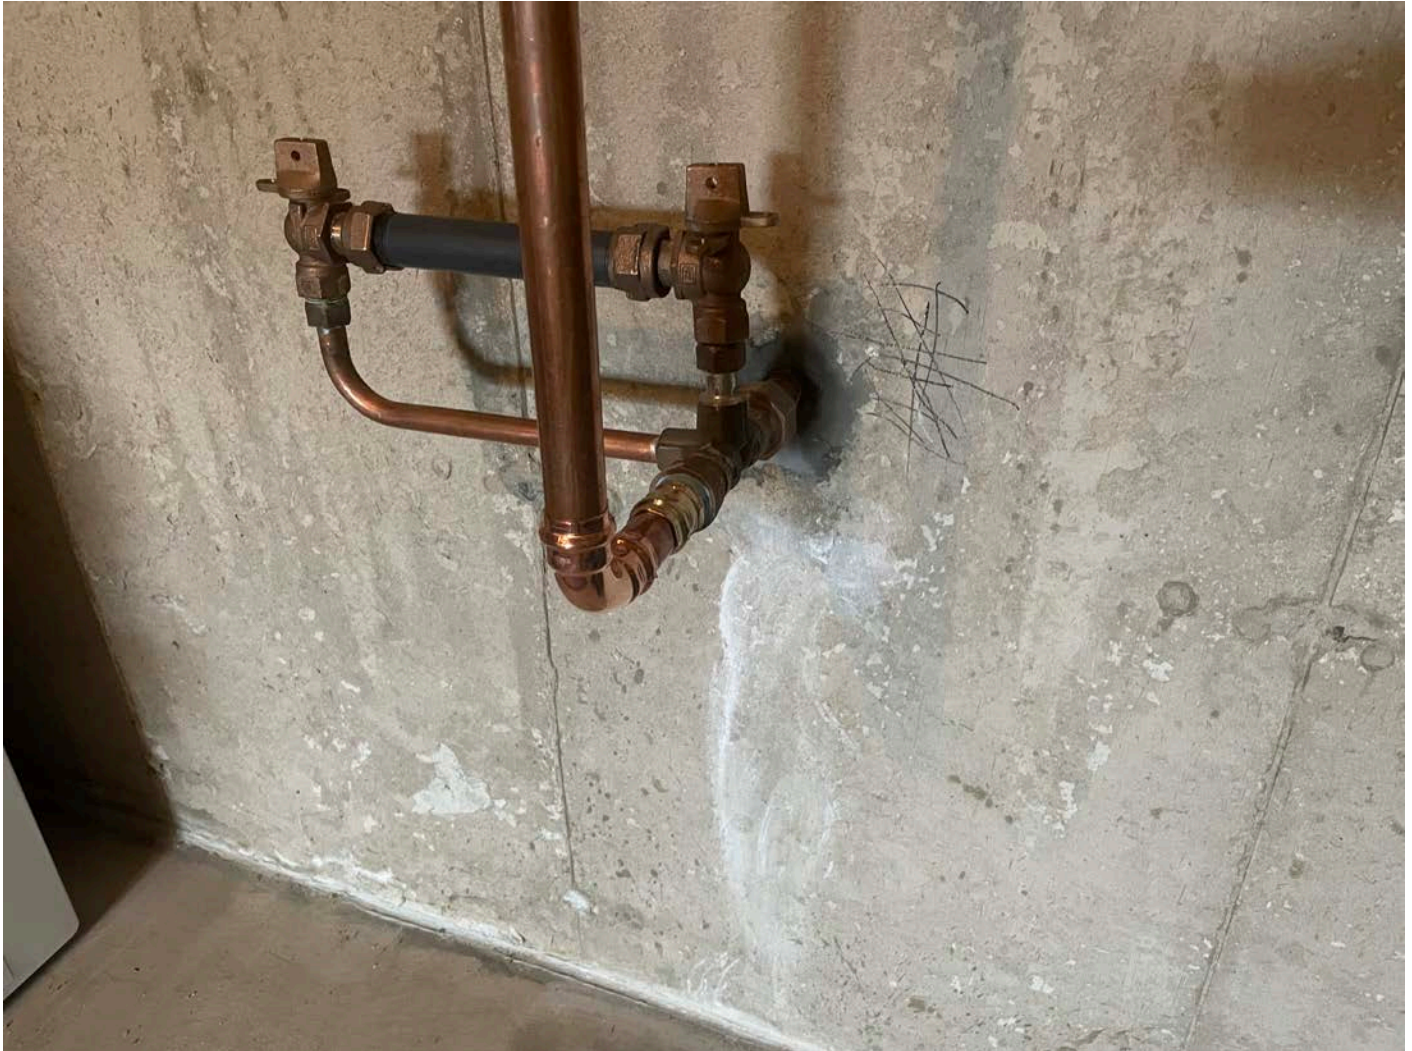
1255: Representatives from Ludlow, the USACE, and AECOM visit the 166 Maple Avenue, Durham, residence to respond to the resident's concerns regarding a leak where the 1" copper water service line penetrates the home's east foundation. Ludlow inspected the area of the reported leak, took pictures, and told the resident that they would get back to her once Ludlow came up with a solution.

**Picture 14: Area of the wall and floor in the basement of the 166 Maple Avenue residence where the resident observed leaking where the 1" copper water service line penetrates the eastern foundation of the home. View to the northeast.**
