## Daily Report

| <b>Project:</b> | Durham Meadows Pipeline Installation | <b>Date:</b> | April 28, 2022 |
| <b>Project #:</b> | AECOM: 6061487 | <b>Report No:</b> | 414 |
| <b>Contractor:</b> | Ludlow Construction | <b>Page:</b> | 1 of 8 |

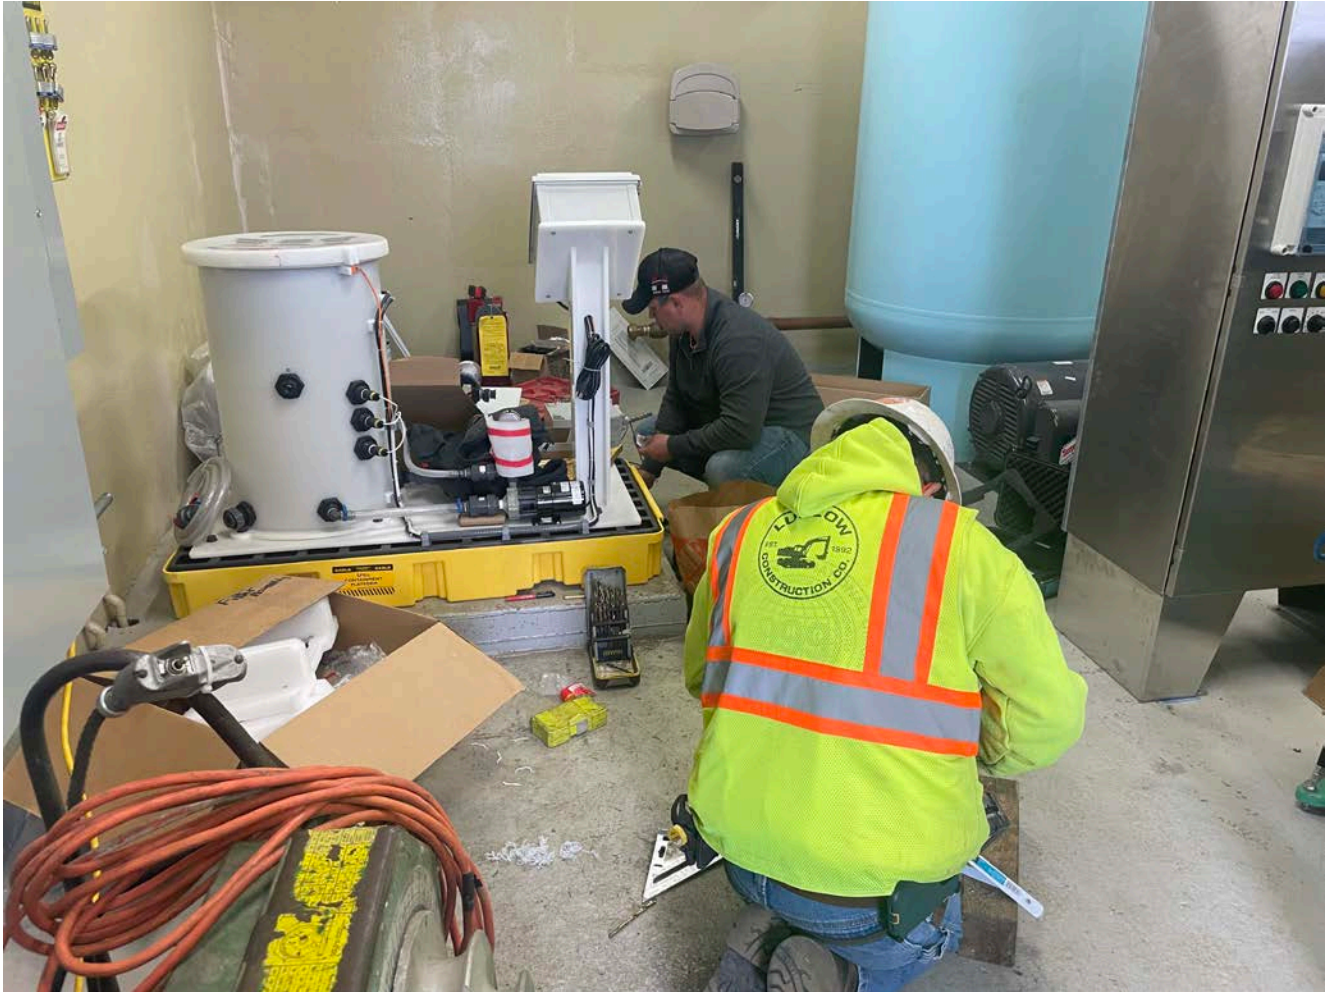
Picture 1: Ludlow continuing work on the installation of a chlorination system at the Long Hill pump station located on Long Hill Road in Middletown. View to the south.

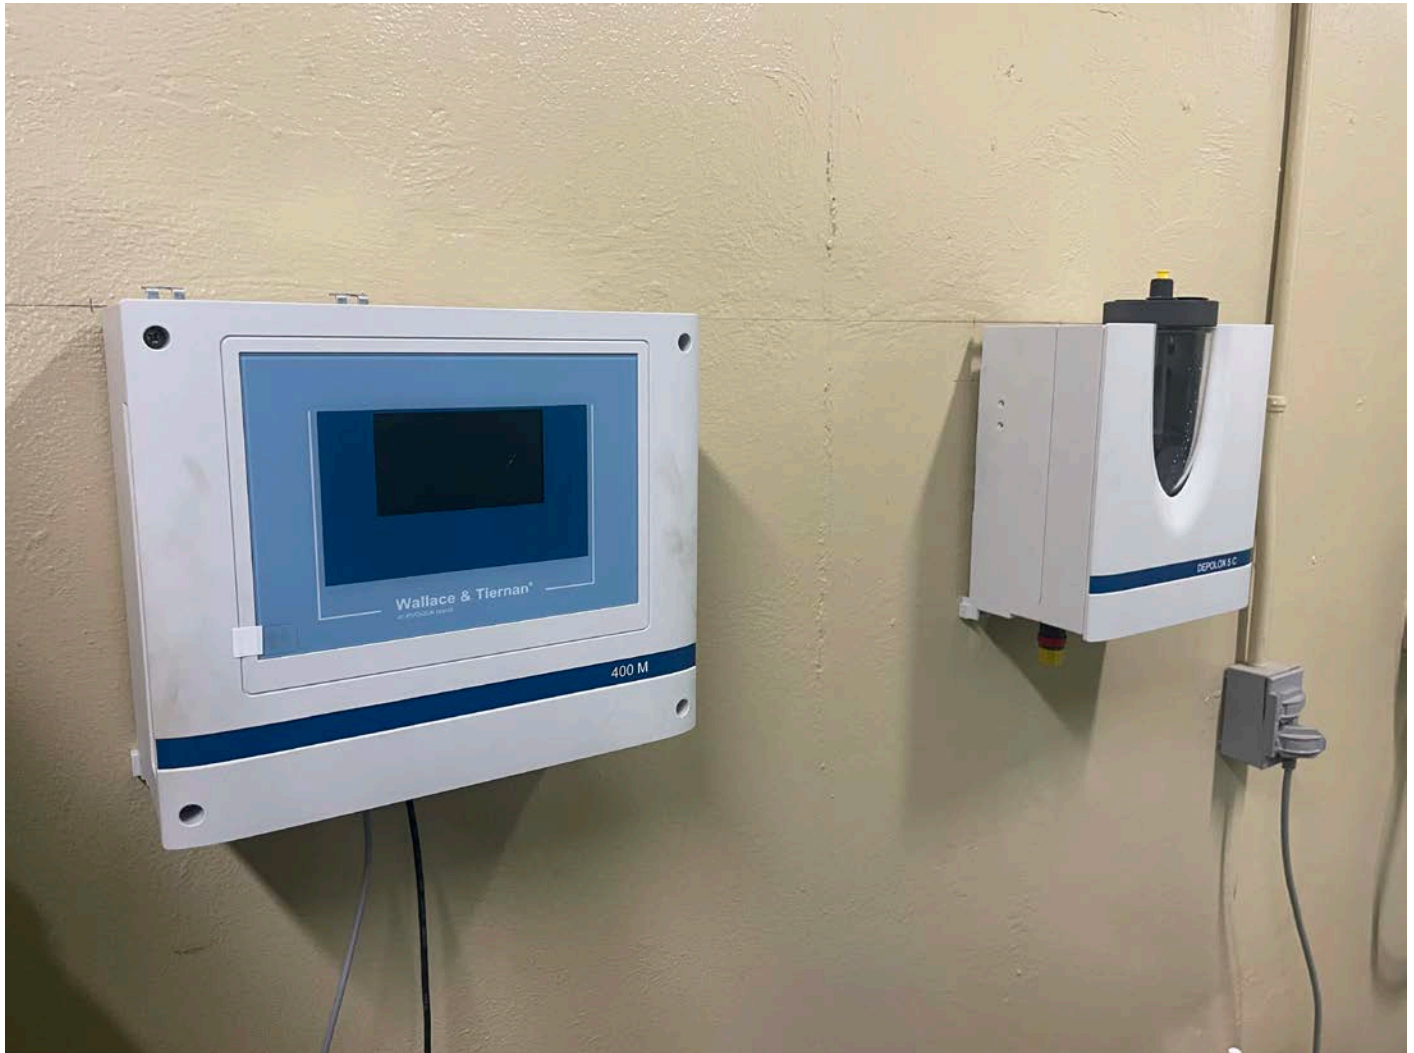
0911: Ludlow has installed a chlorine analyzer (Wallace & Tiernan 400M) and analyzer (Depolox 5 C) installed on the south wall of the Long Hill pump station.

Picture 2: Chlorine monitor (Wallace & Tiernan 400M) and analyzer (Depolox 5 C) that Ludlow installed on the south wall of the Long Hill pump station. View to the southwest.

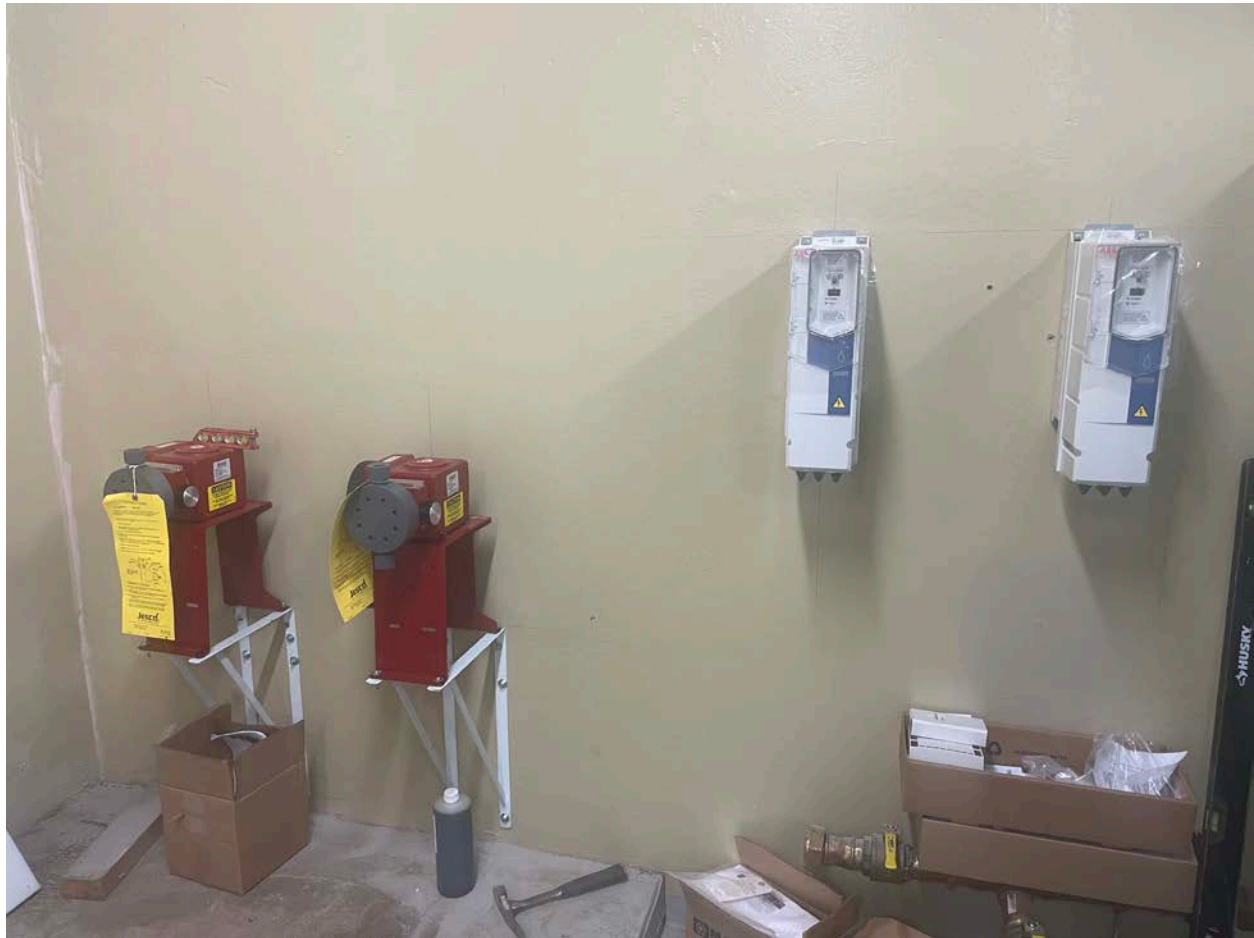
1028: Ludlow has installed two meter pumps and pump VFDs on the south wall of the Long Hill pump station.

**Picture 3: Two metering pumps (on the left) and pump VFDs (on the right) that Ludlow installed on the south wall of the Long Hill pump station. View to the south.**

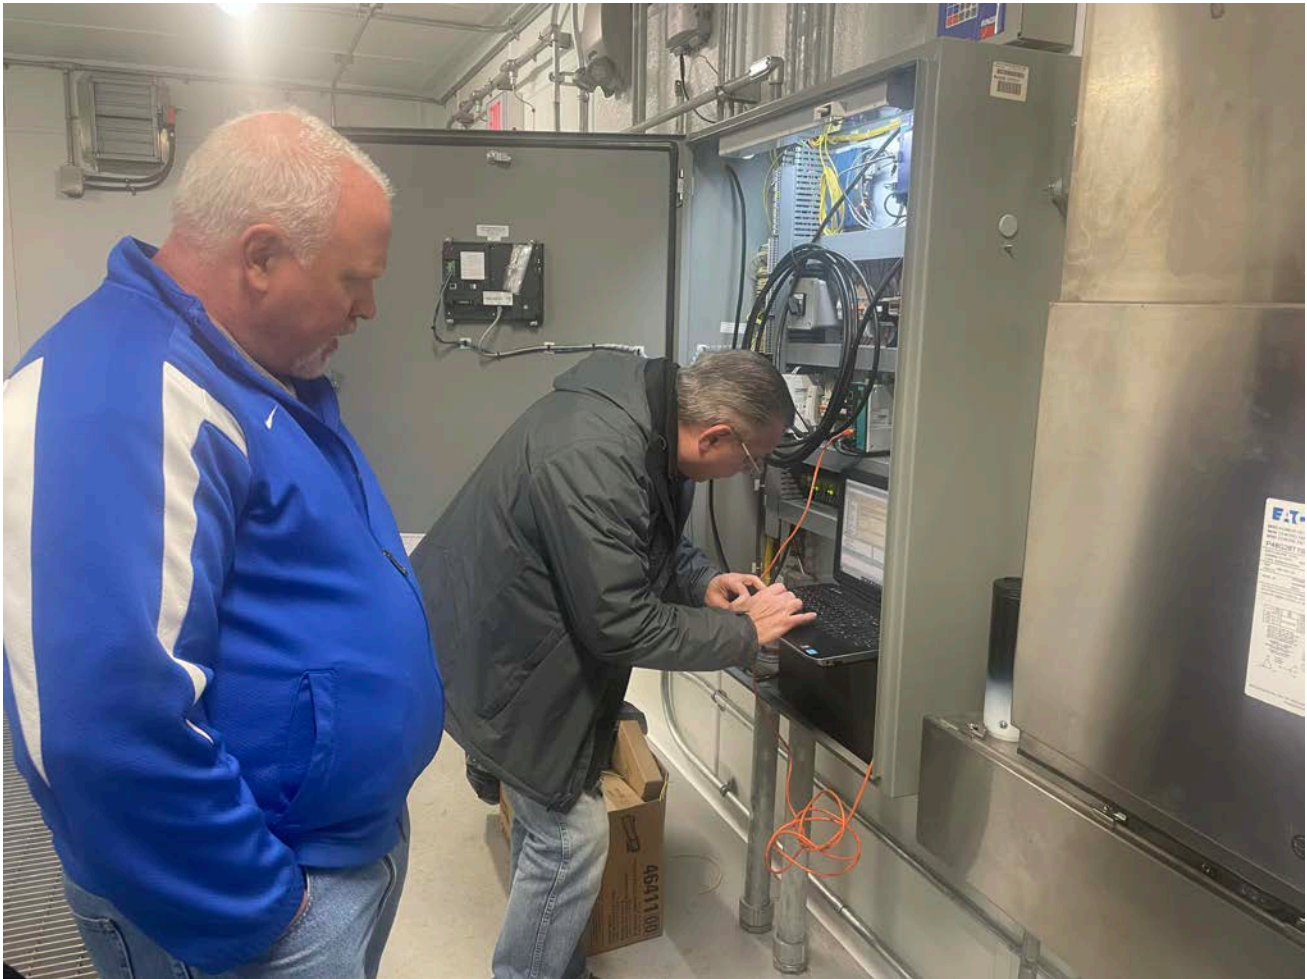
Knapp Engineering worked on the communication system at the booster station located on S. Main Street in Middletown.

**Picture 4: Knapp Engineering working on the communication system at the booster station located on S. Main Street in Middletown. View to the northwest.**

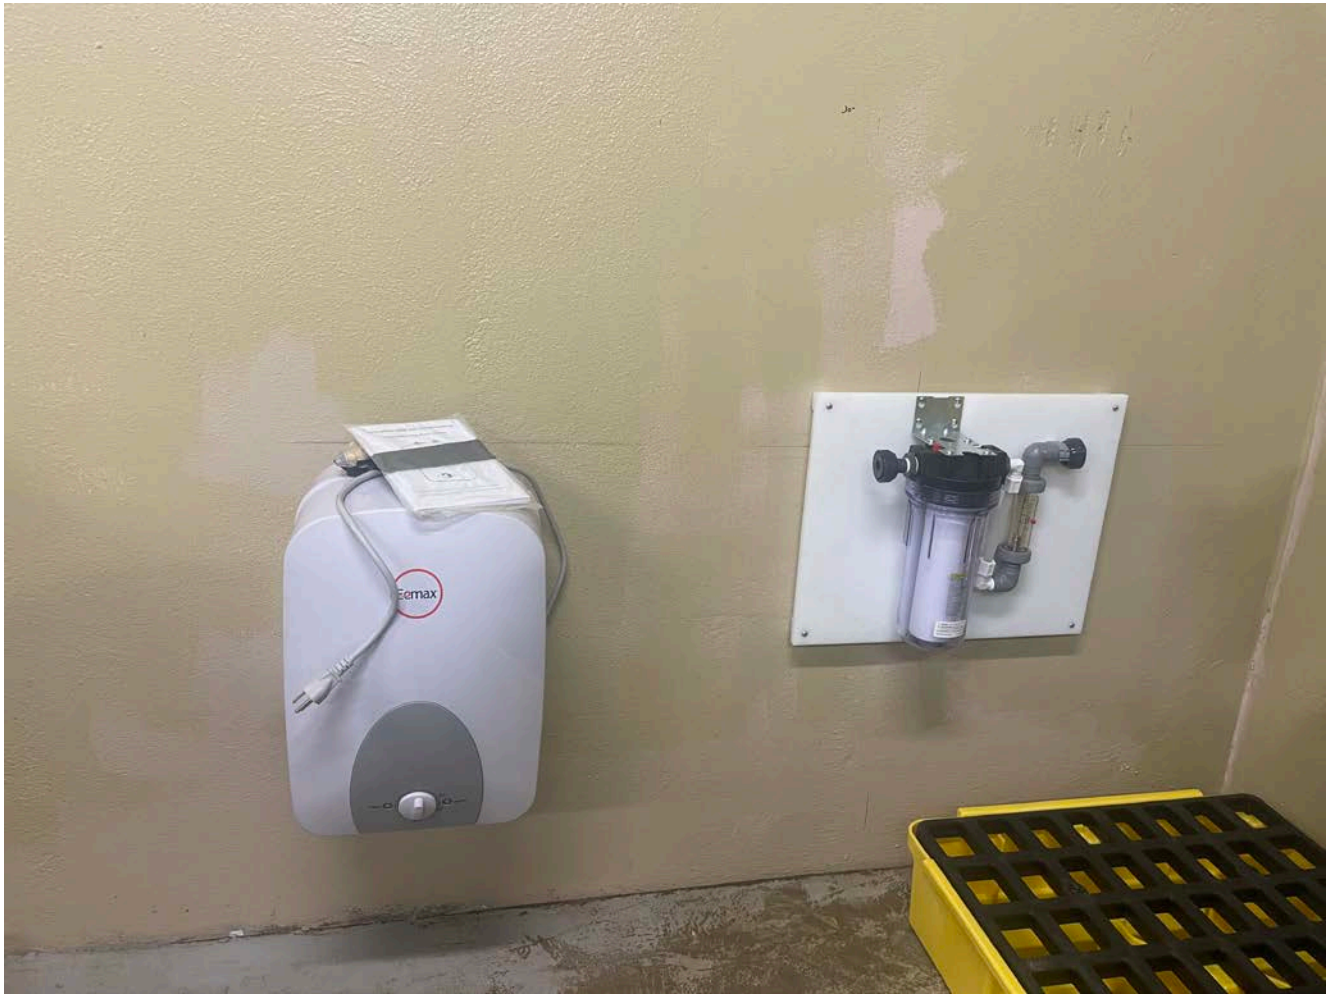
Picture 5: Water heater and filter that Ludlow installed on the east wall of the Long Hill pump station. View to the southeast.

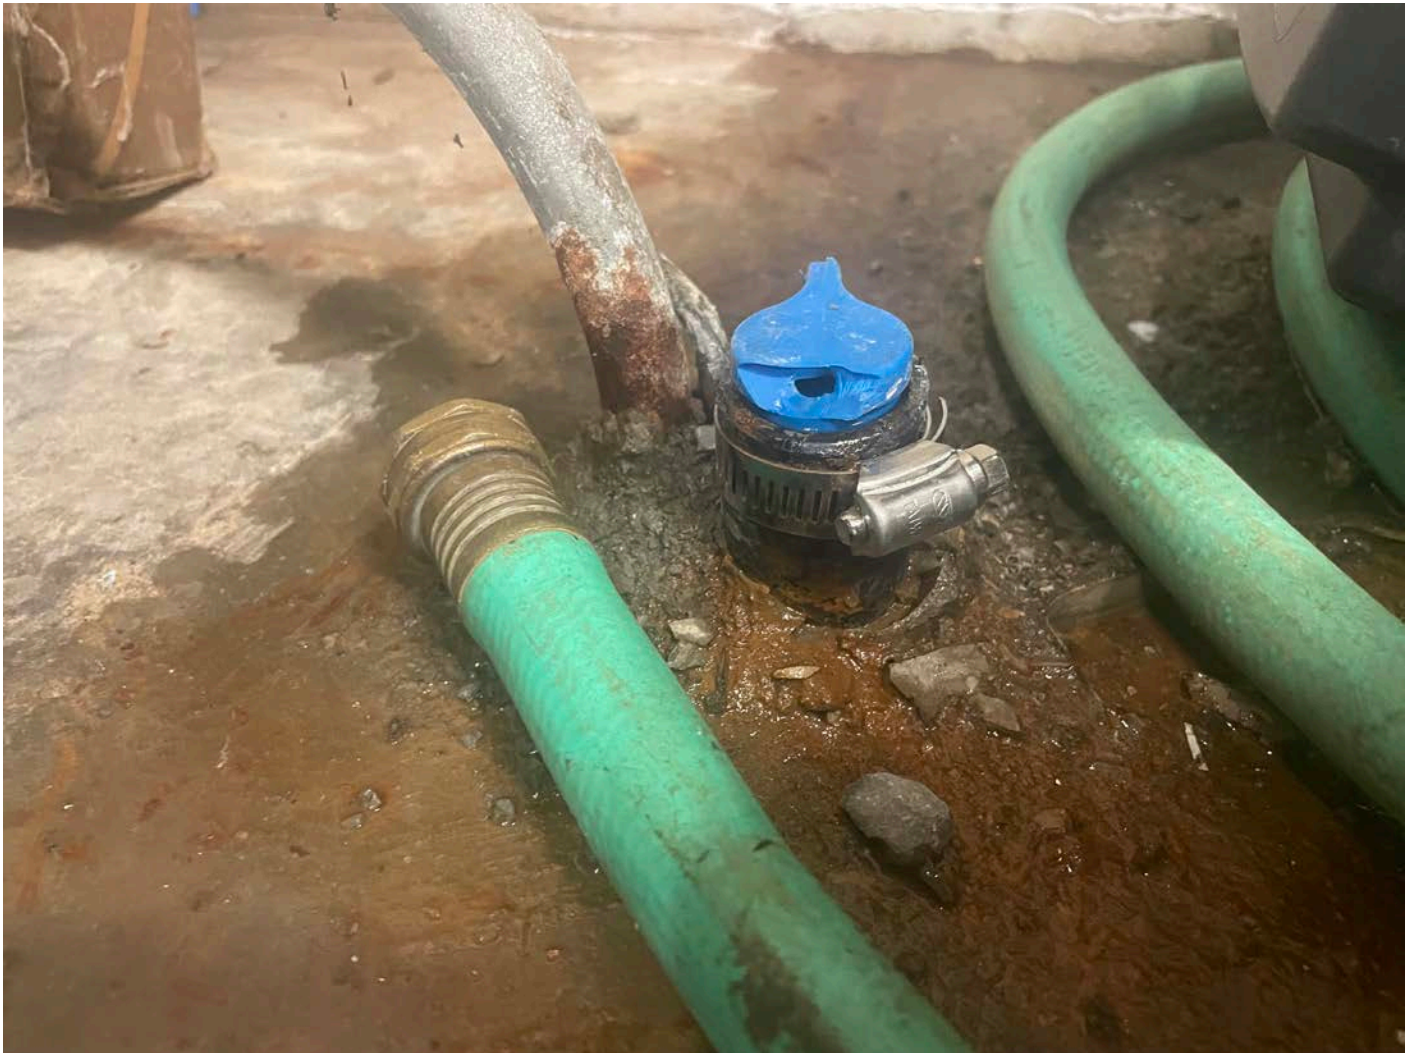
Grela informed AECOM of a leak the 212R Maple Avenue, Durham, residence. A small amount of water was observed on the basement floor of the residence. The leak appeared to come from the well line that enters the basement floor from the outside that was previously cut and capped by Fazzino. The blue plastic cap used to plug the well line was observed to have a piece missing from it that created a hole. The cap appears to have had something dropped on it after installation. Grela replaced the plug and the leak appeared to stop.

Picture 6: Damaged cap located on top of the black plastic well line on the basement floor of the 212R Maple Avenue residence. View to the southwest.
