## Daily Report

<b>Project:</b>	Durham Meadows Pipeline Installation	<b>Date:</b>	April 29, 2022
<b>Location:</b>	Johns Way and Maple Avenue, Durham; Long Hill Road and the Shared Access Driveway, Middletown	<b>Day of Week:</b>	Friday
<b>Project #:</b>	AECOM: 6061487	<b>Report No:</b>	415
<b>Contractor:</b>	Ludlow Construction	<b>Page:</b>	1 of 18

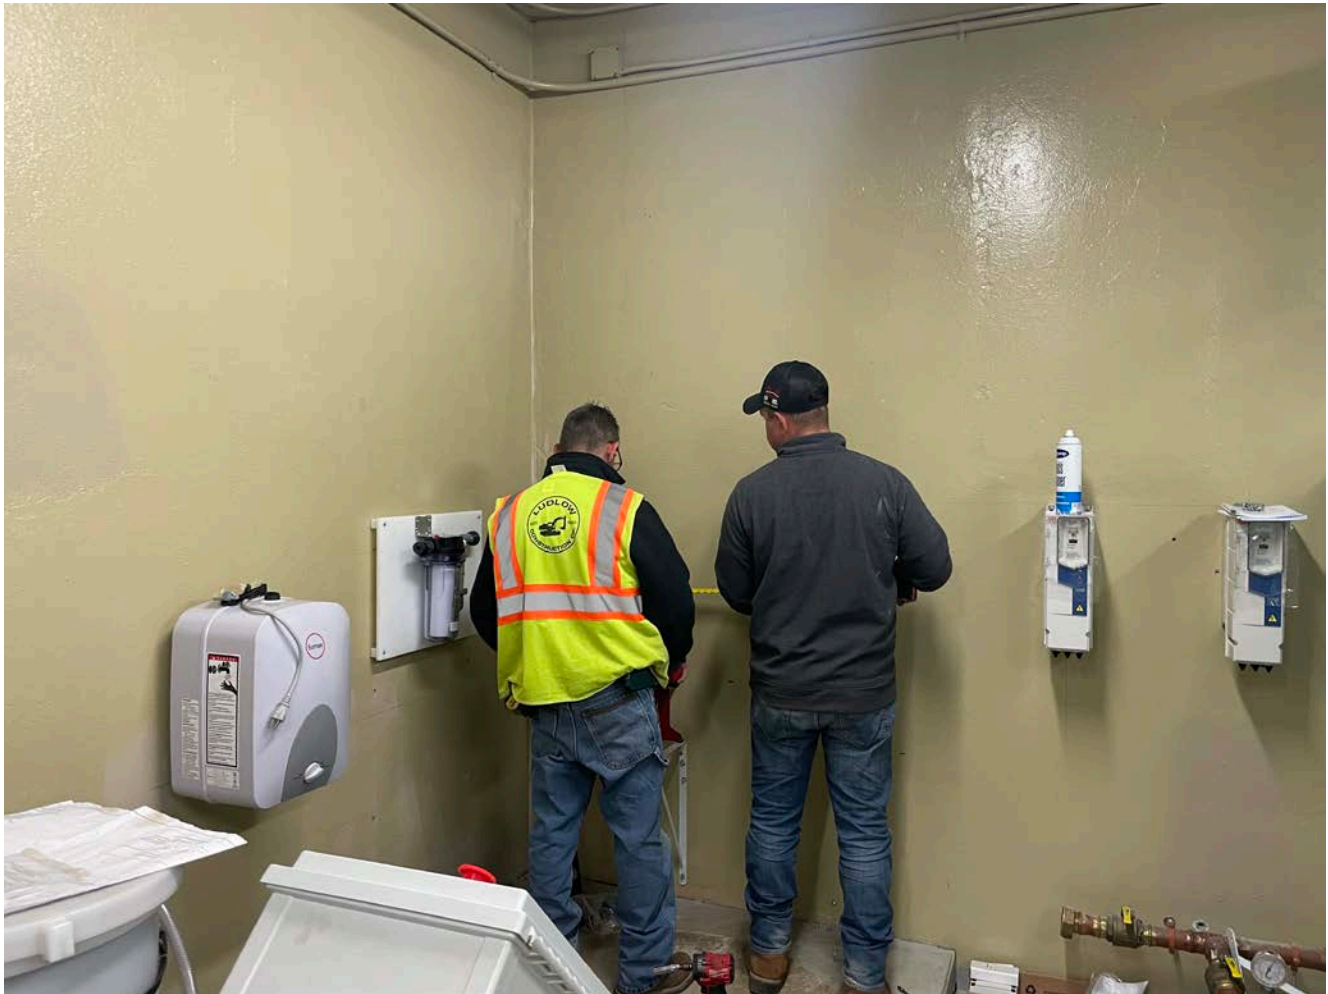
0711: Ludlow is laying out the locations where they will install additional components of the chlorination system at the Long Hill pump station.

Picture 1: Ludlow laying out the location of the chlorination system components they are installing at the Long Hill pump station located on Long Hill Road in Middletown. View to the south.

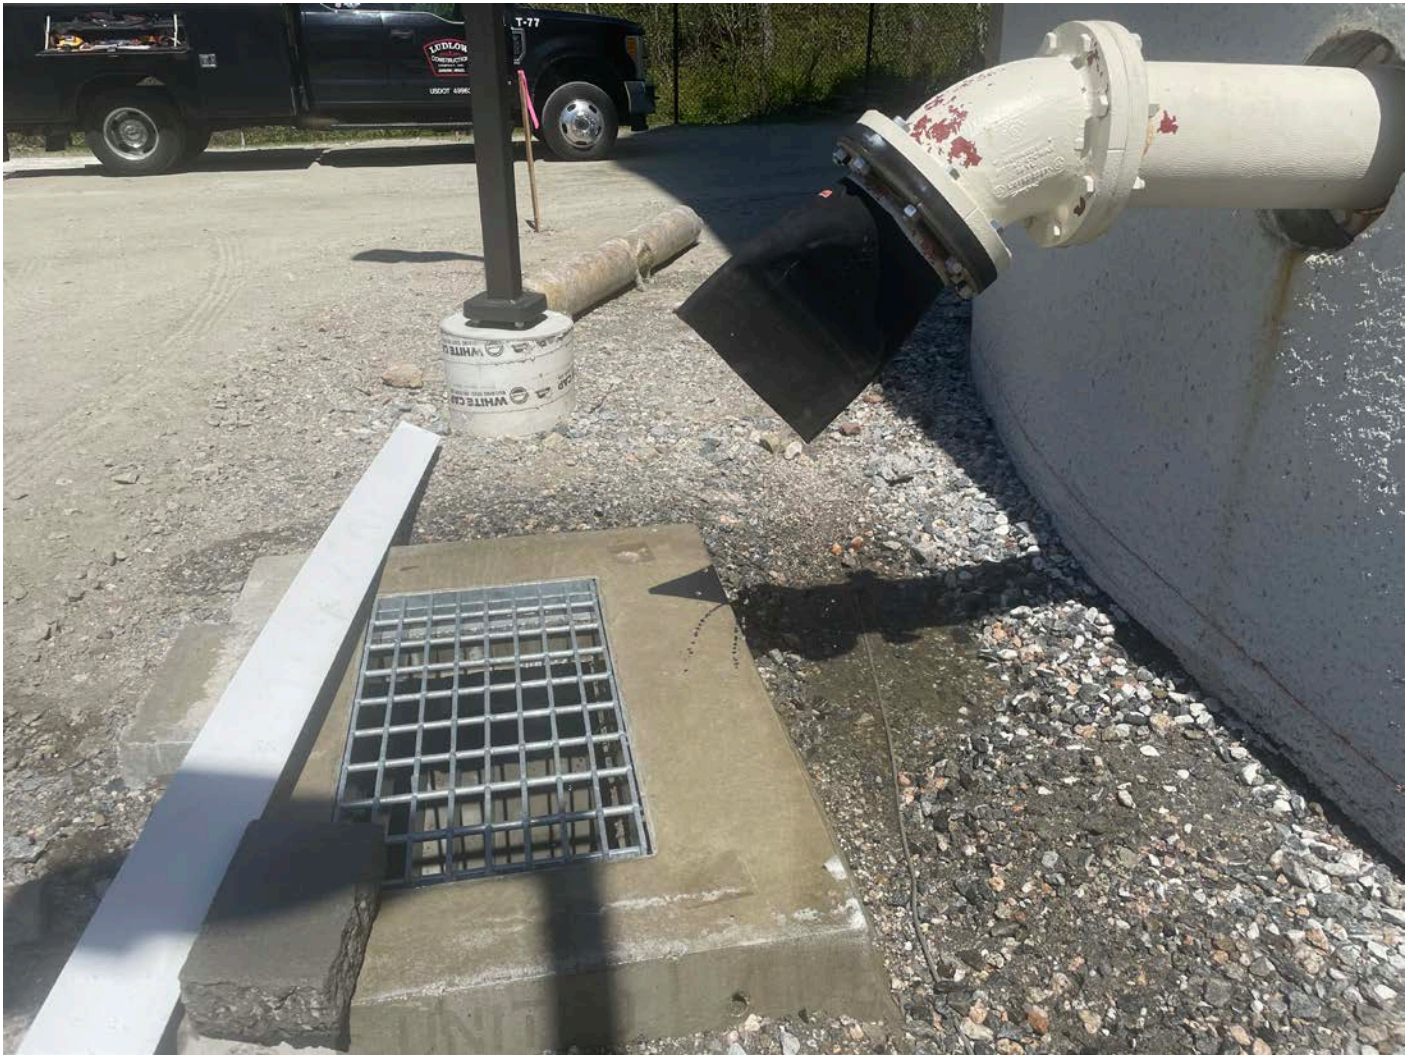
1133: Ludlow has filled the water tank located east of the Shared Access Driveway. The two gauges in the altitude valve vault indicate water levels of 71.69' and 71.80', respectively.

**Picture 2: Water coming out of the tank overflow after Ludlow filled the tank. West side of the water tank located west of the Shared Access Driveway in Middletown. View to the north.**

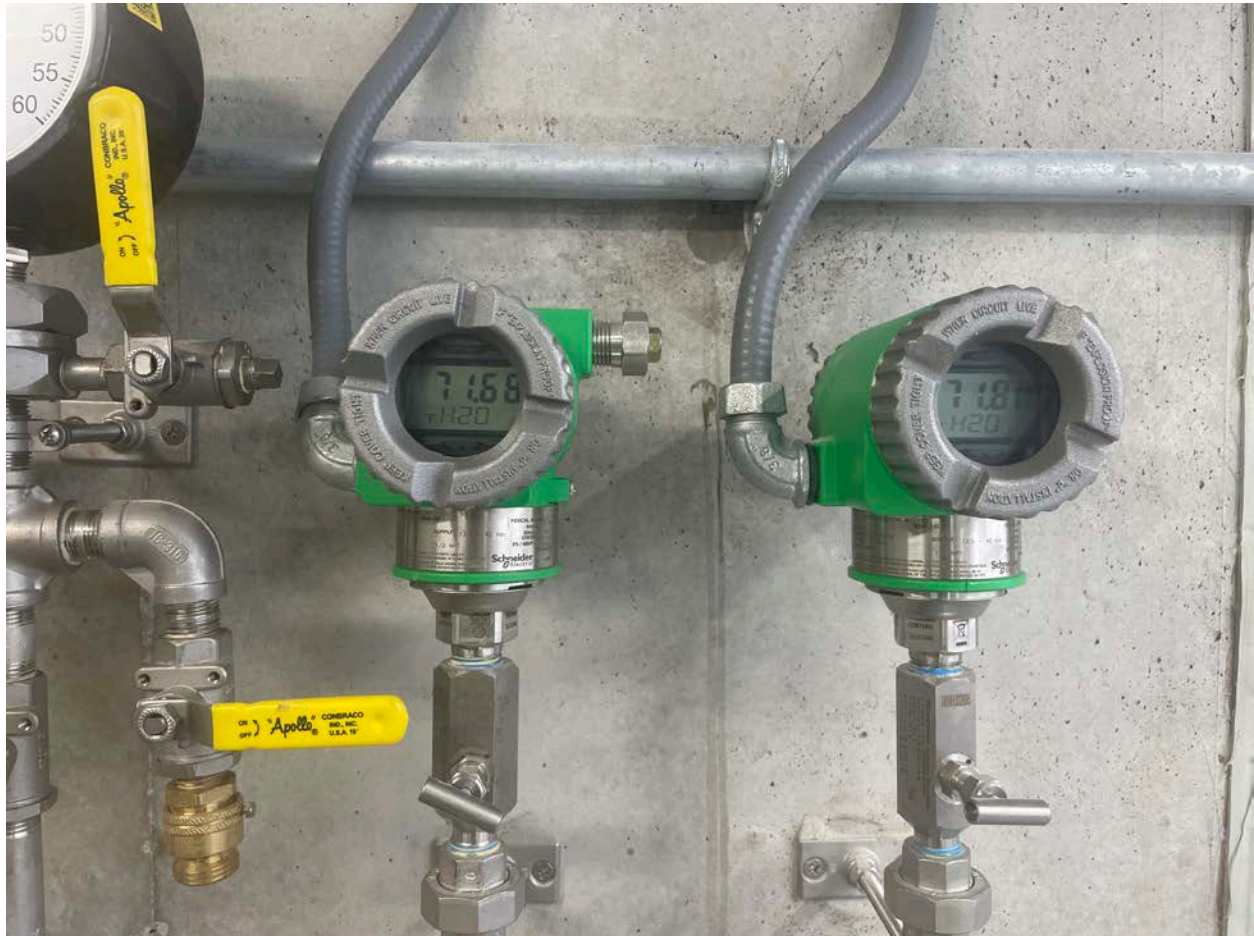
Picture 3: Two gauges in the altitude vault reporting the water level in the water tank after Ludlow filled it. View to the east.

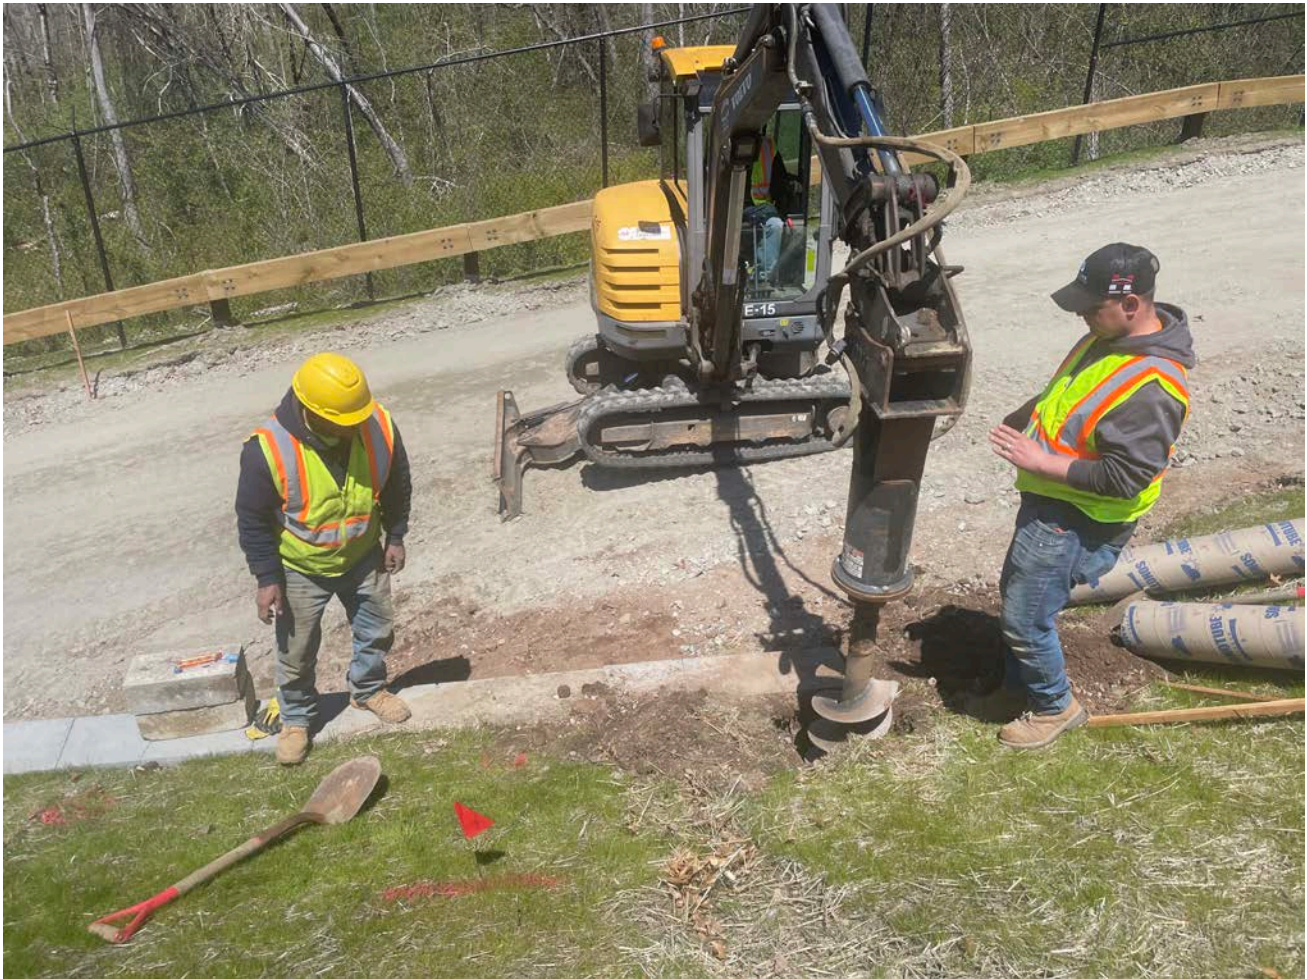
1227: Ludlow continues working on installing a railing on the south side of the retaining wall located between Stations 10+65 and 11+35. They have just finished excavating a hole for the placement of an 8" diameter, 4' long Sonotube and are currently laying out the location of a second Sonotube.

**Picture 4: Ludlow auguring a hole for the placement of a 4' section of 8" diameter Sonotube on the south side of the retaining wall located between Stations 10+65 and 11+35 on the Shared Access Driveway in Middletown. View to the north.**

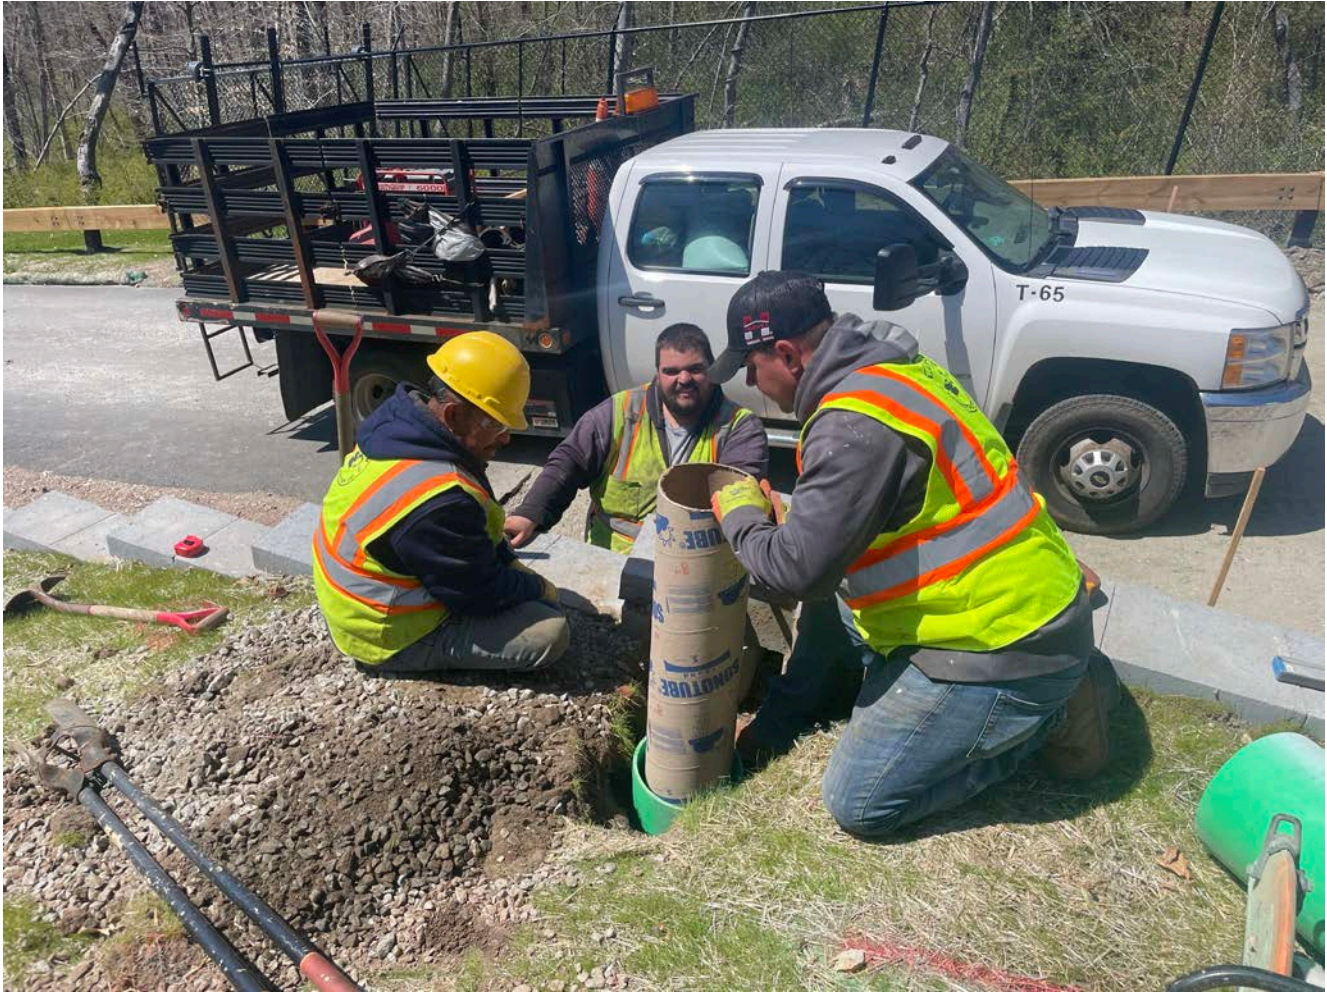
1424: Ludlow continues to work on placing a Sonotube on the south side of the retaining wall for the installation of railing post.

Picture 5: Ludlow installing a 4' section of 8" diameter Sonotube on the south side of the retaining wall located between Stations 10+65 and 11+35 on the Shared Access Driveway in Middletown. View to the northwest.

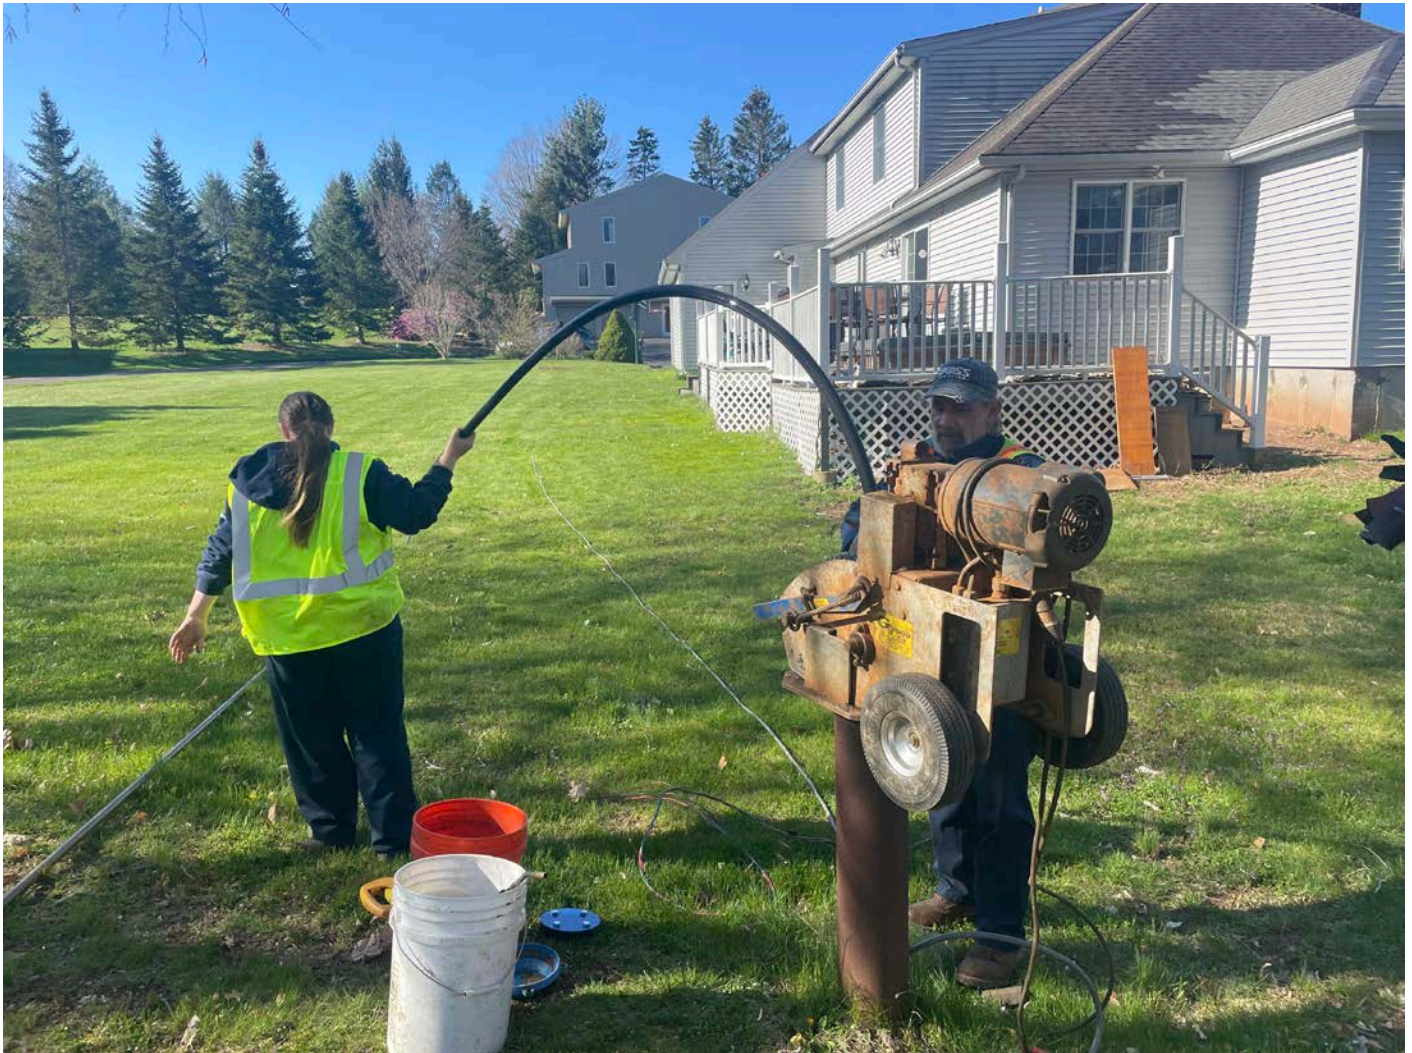
0849: Grela has just removed the pump from the well located at the 10 Johns Way property.

**Picture 6: Grela removing the pump from the well located on the north side of the 10 Johns Way, Durham, property.  
View to the south.**

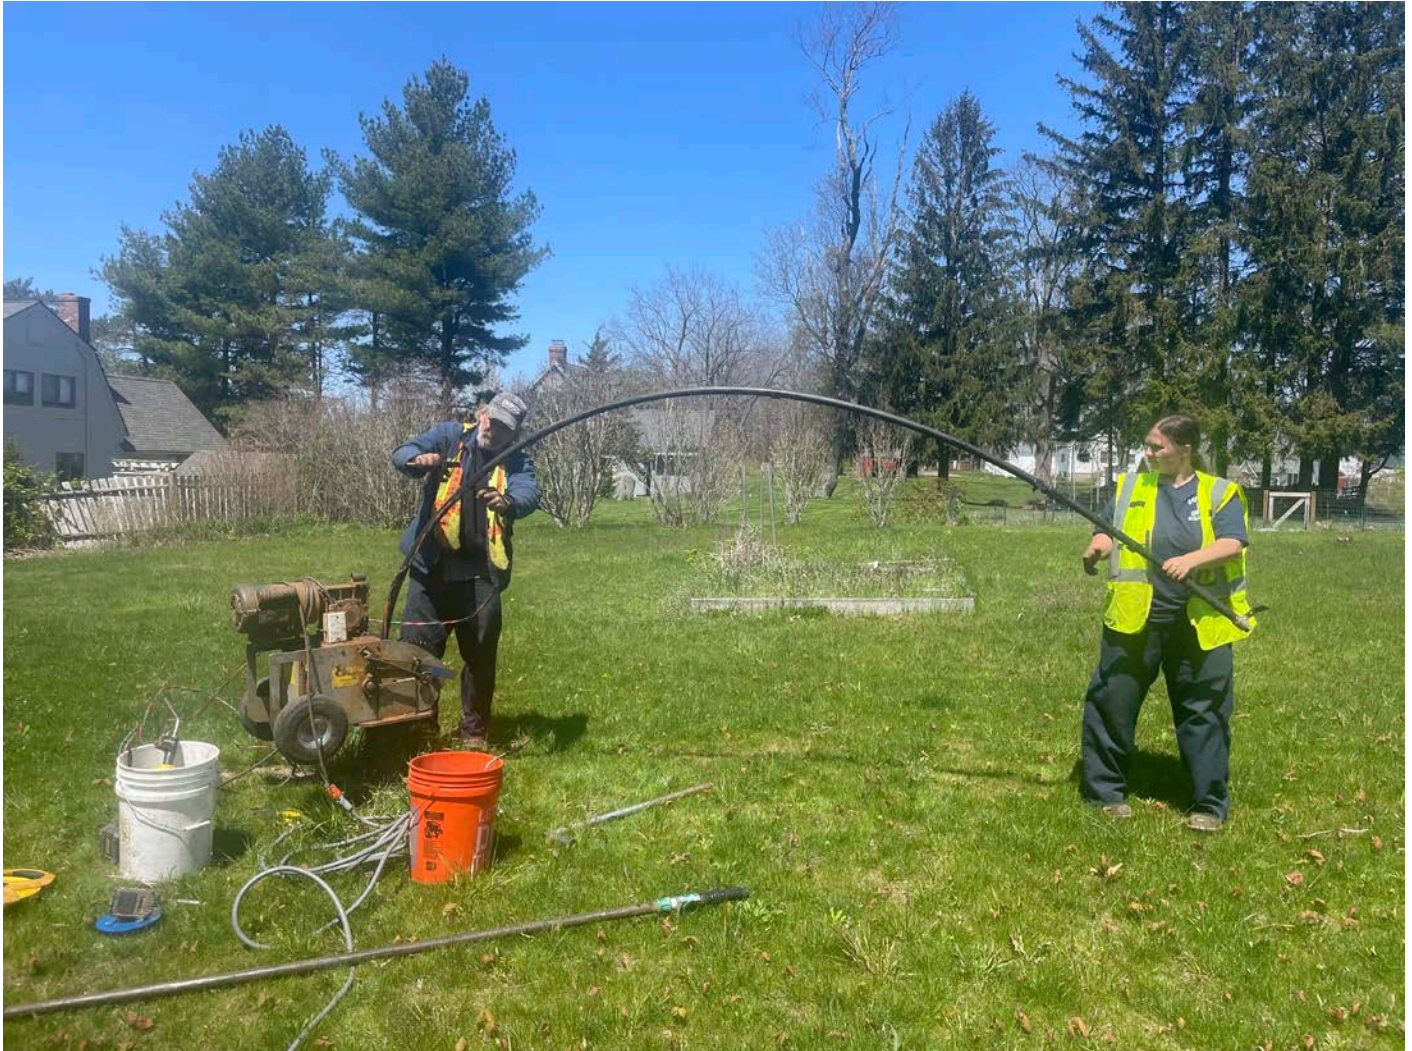
1239: Grela begins to pull the pump from the well located to the northeast of the 95R Maple Avenue residence.

**Picture 7: Grela removing the pump from the well located on the north side of the 95R Maple Avenue, Durham, property. View to the north.**

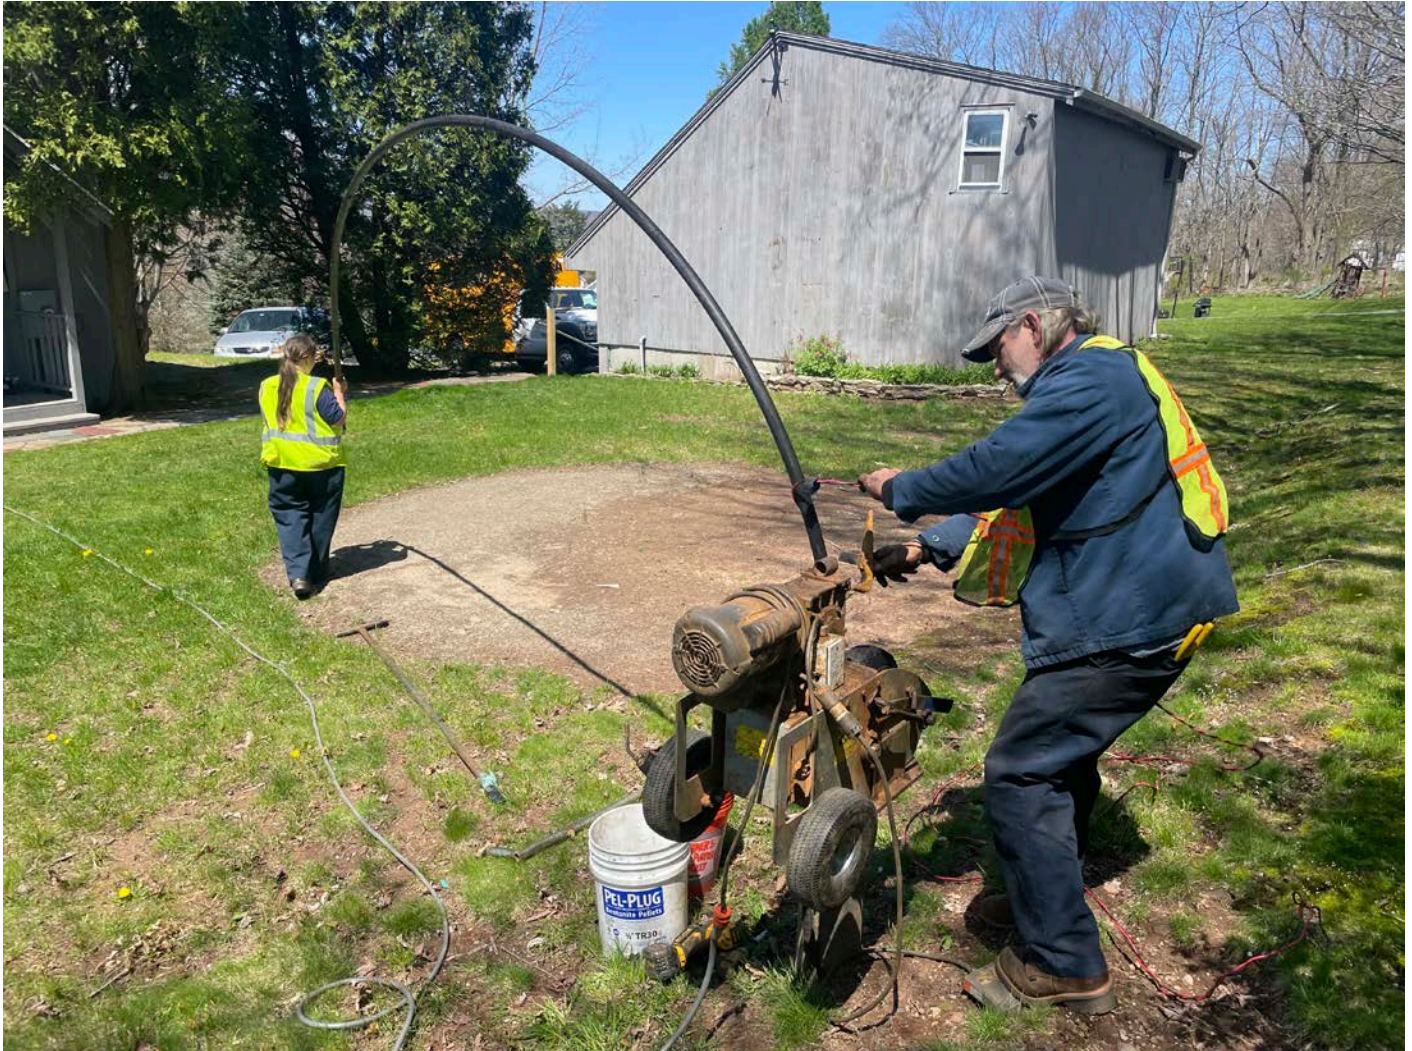
1155: Grela is pulling the pump from the well located on the east side of the 119 Maple Avenue residence.

**Picture 8: Grela removing the pump from the well located on the north side of the 119 Maple Avenue, Durham, property. View to the northwest.**

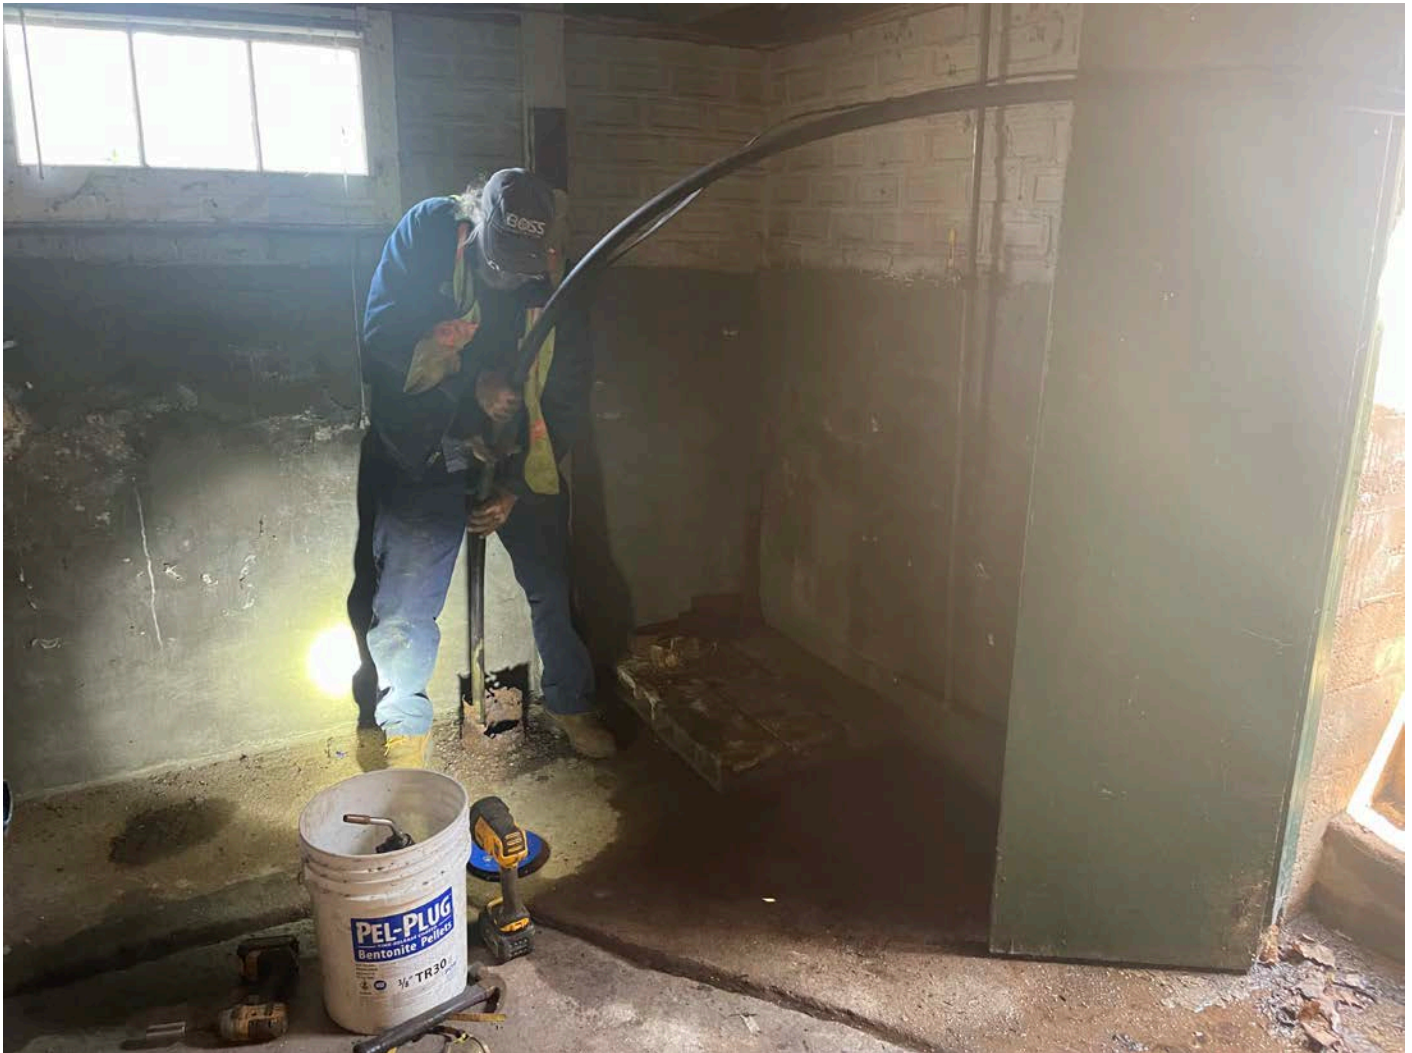
1100: Grela has just removed the pump from the well in the basement of the 175 Maple Avenue residence and is currently sending the black plastic water line back down the well to use later when Grela tremie grouts the well.

Picture 9: Grela removing the pump from the well located inside the basement of the 175 Maple Avenue, Durham, property. View to the northeast.

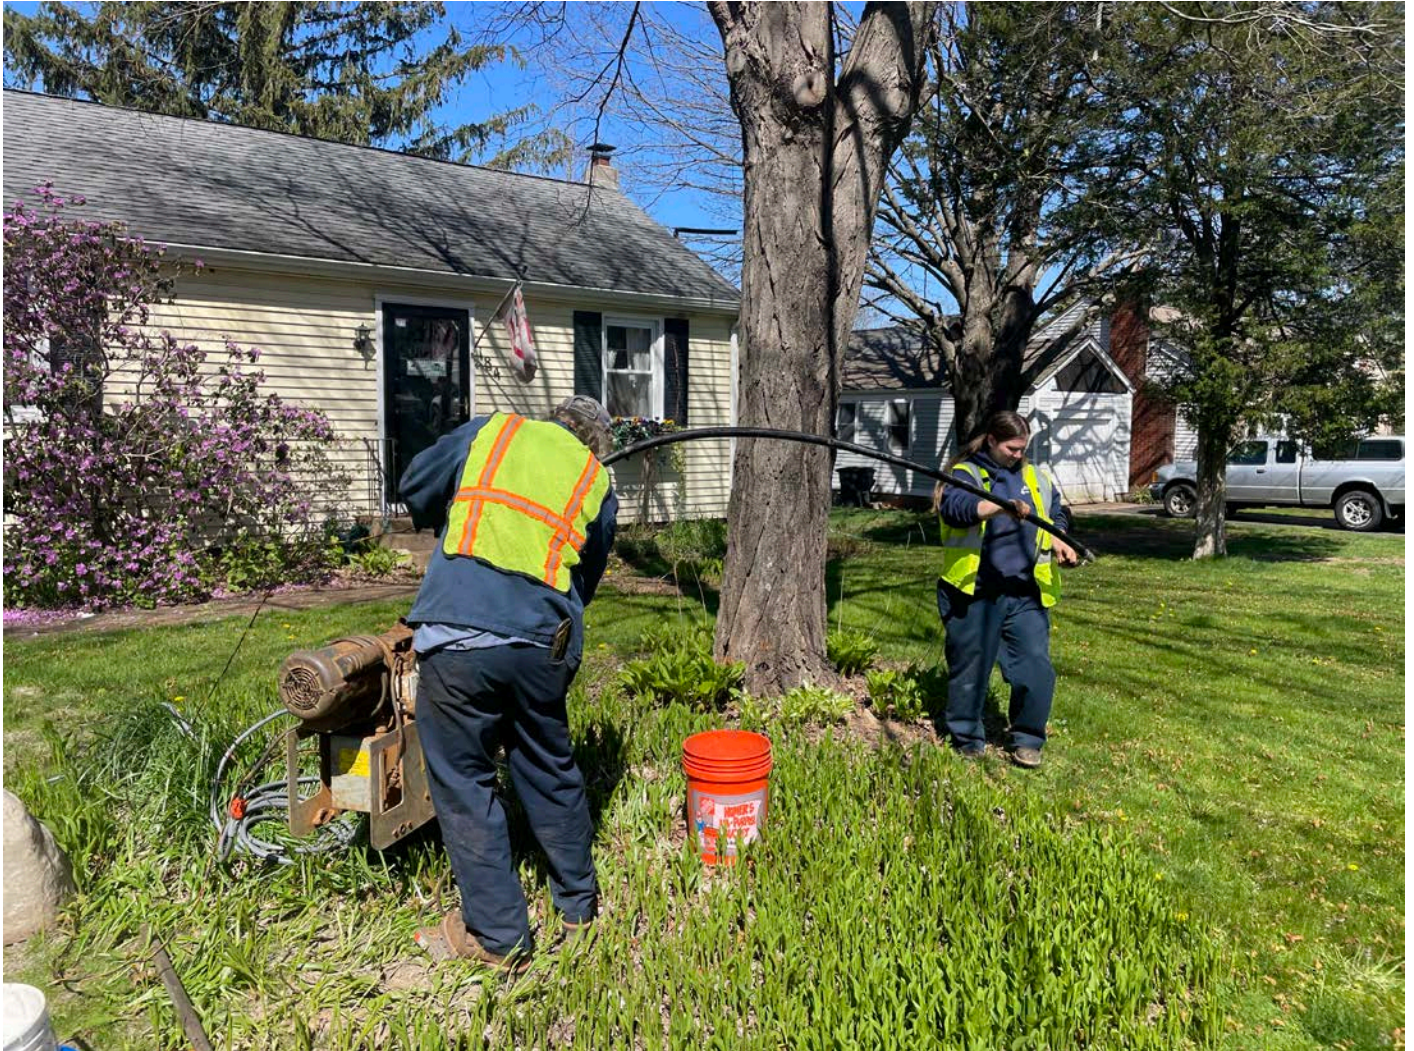
1027: Grela begins to pull the pump from the well located on the east side of the 184 Maple Avenue residence.

1038: Grela has cut the power line to the well and is plugging the power line conduit with a plastic plug.

**Picture 9: Grela removing the pump from the well located on the east side of the 184 Maple Avenue, Durham, property. View to the northwest.**

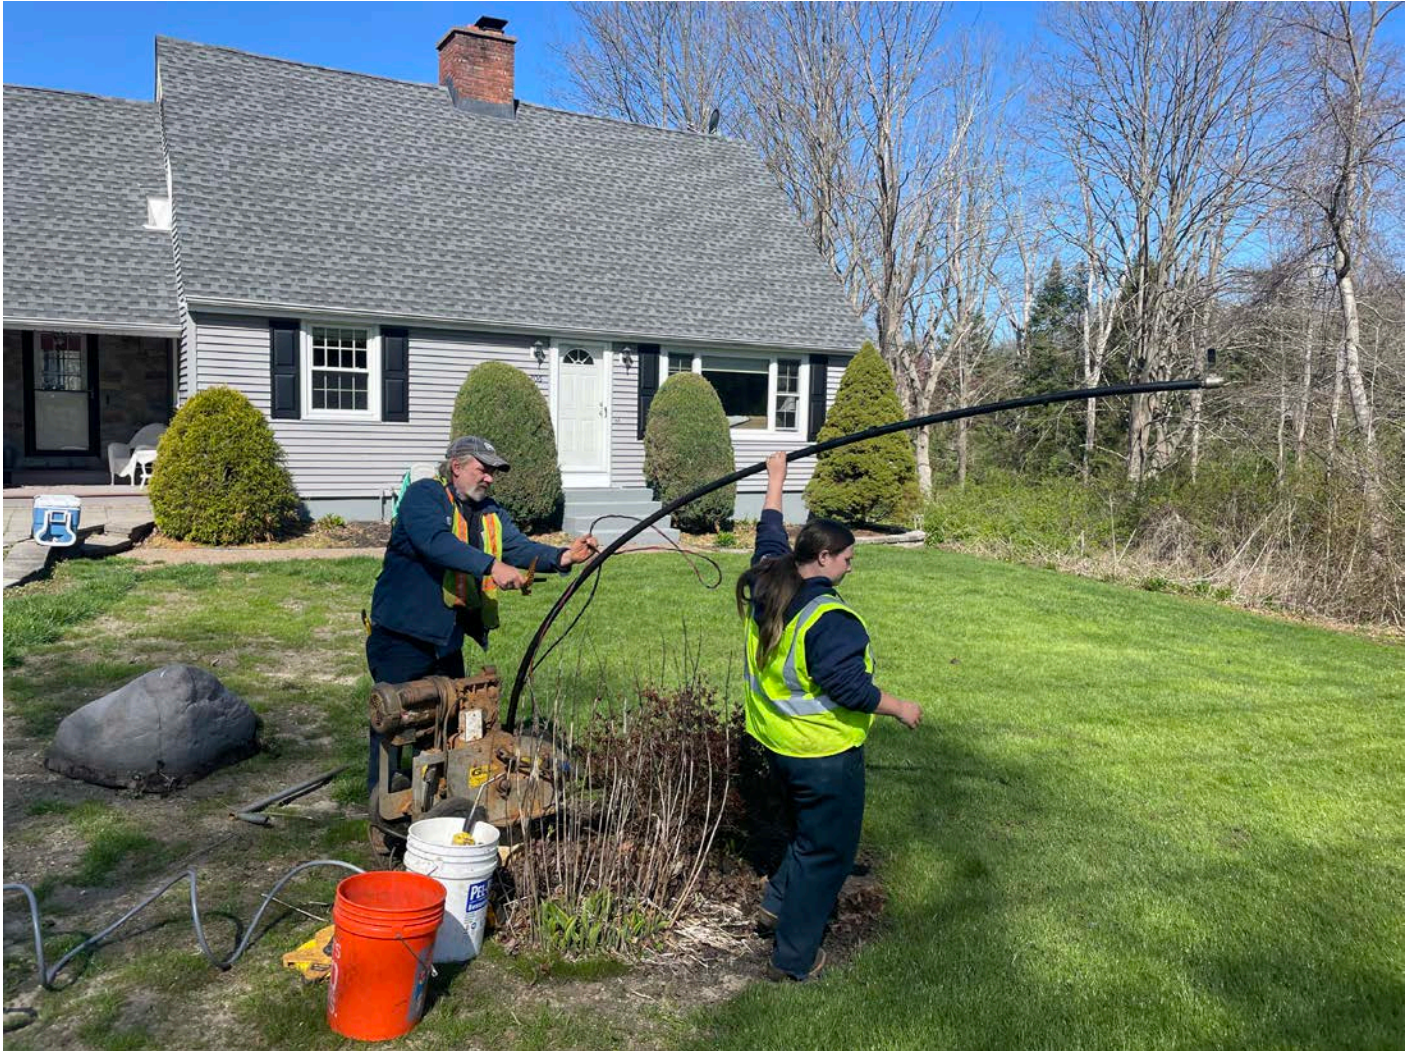
0940: Grela is in the process of removing the pump from the well at the 206 Maple Avenue property.

Picture 10: Grela removing the pump from the well located on the east of the 206 Maple Avenue, Durham, property. View to the northwest.

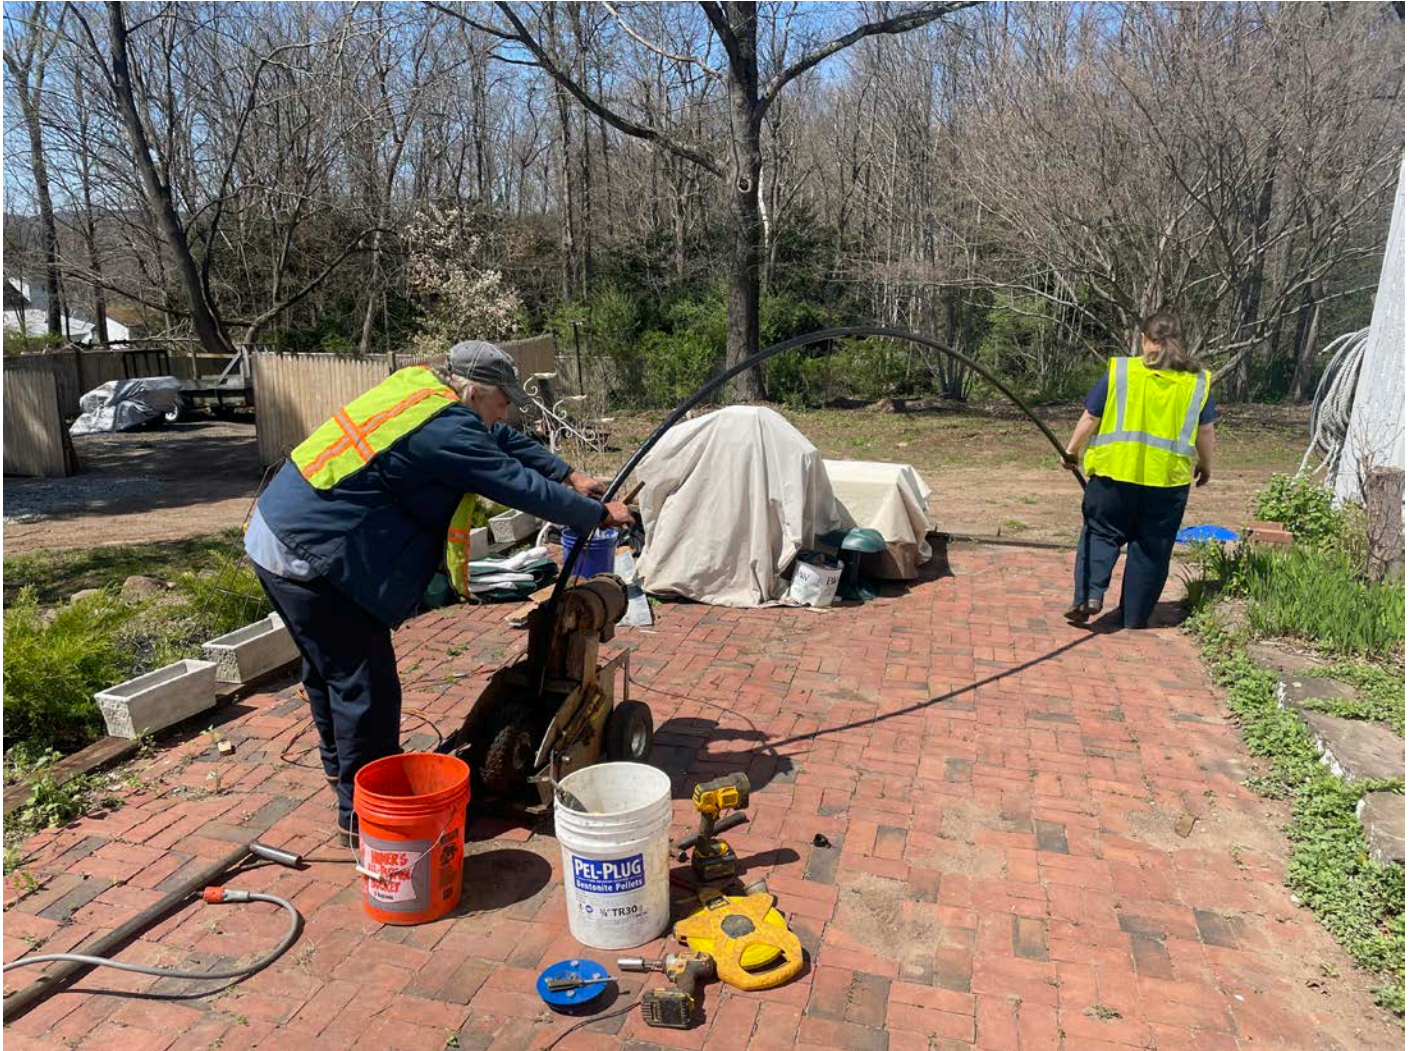
1115: Grela begins to remove the pump from the well located on the east side of the 244 Maple Avenue residence.

Picture 11: Grela removing the pump from the well located on the south side of the 244 Maple Avenue, Durham, property. View to the west.

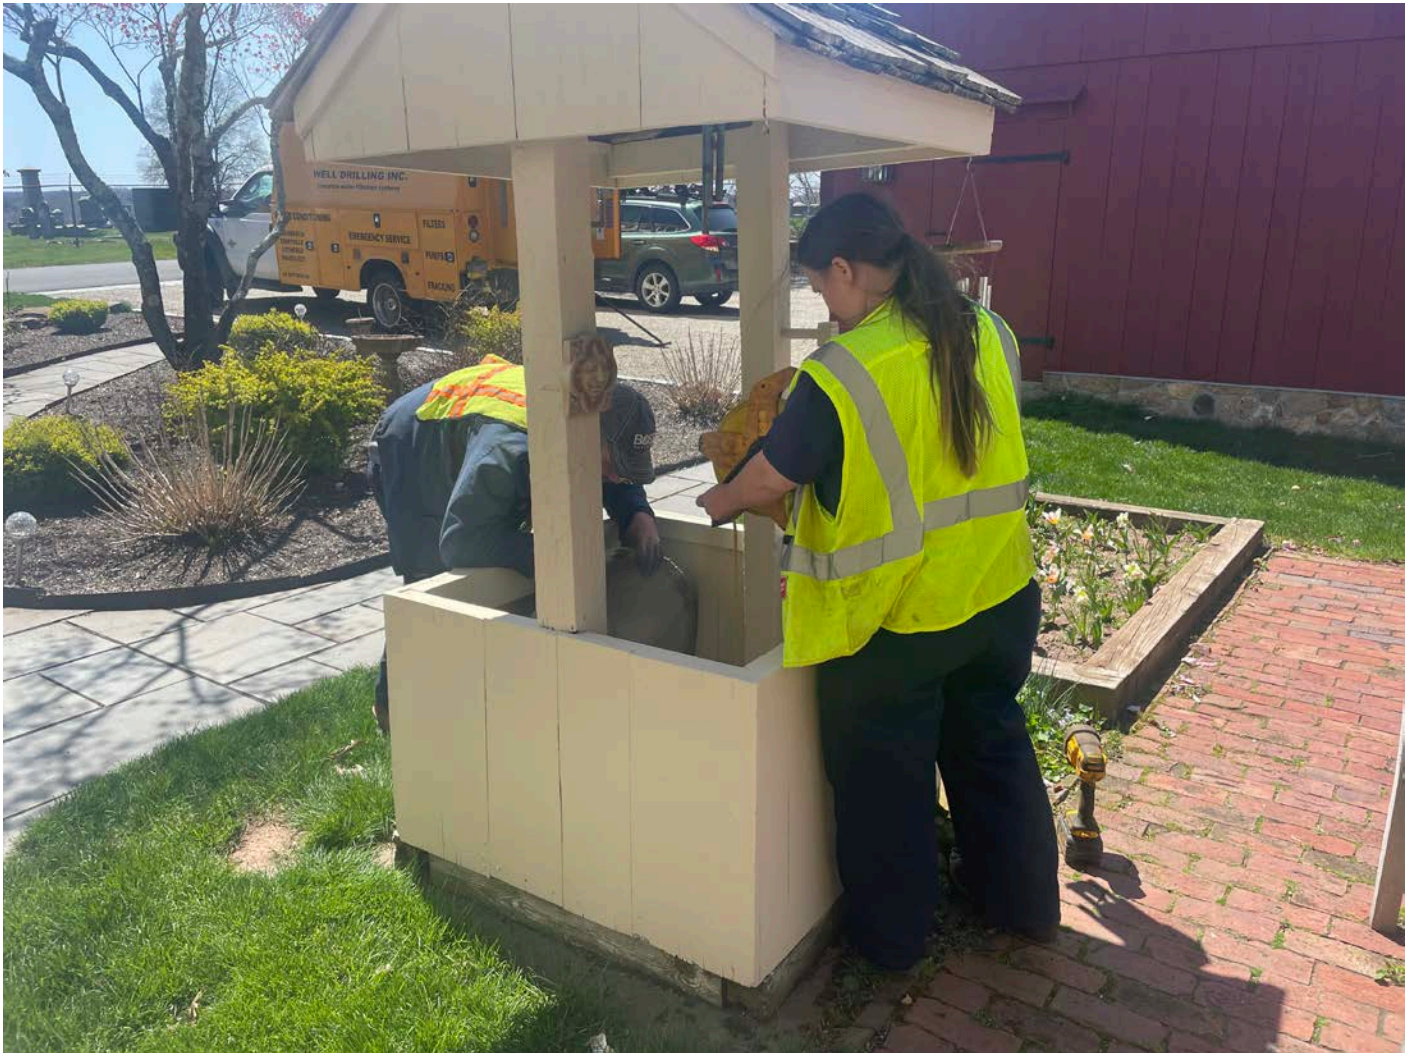
1328: Grela collects well depth data from the dug wells located on the east and west sides of the 13 Maple Avenue residence.

Picture 12: Grela collecting well depth data from the dug well located on the west side of the 13 Maple Avenue, Durham, property. View to the southwest.

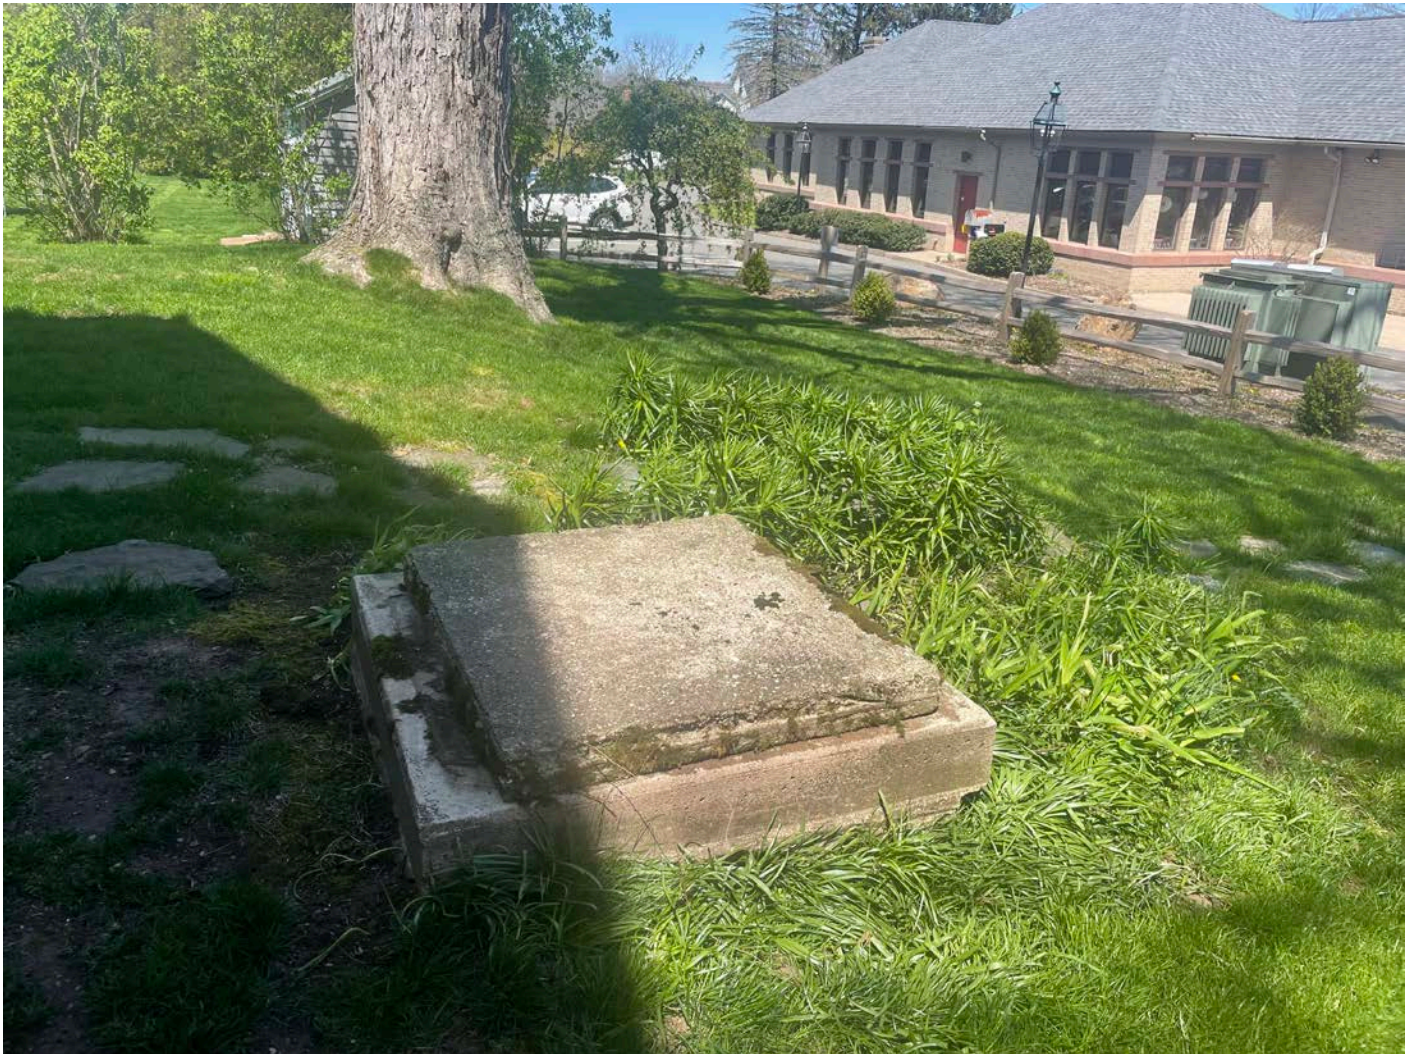
**Picture 13: The dug well located on the east side of the 13 Maple Avenue, Durham, property. View to the north.**
