Daily Report

Project:	Durham Meadows Pipeline Installation	Date:	May 18, 2022
Location:	Main Street, Durham; S. Main Street, Long Hill Road and the Shared Access Driveway, Middletown	Day of Week:	Wednesday
Project #:	AECOM: 6061487	Report No:	428
Contractor:	Ludlow Construction	Page:	1 of 15

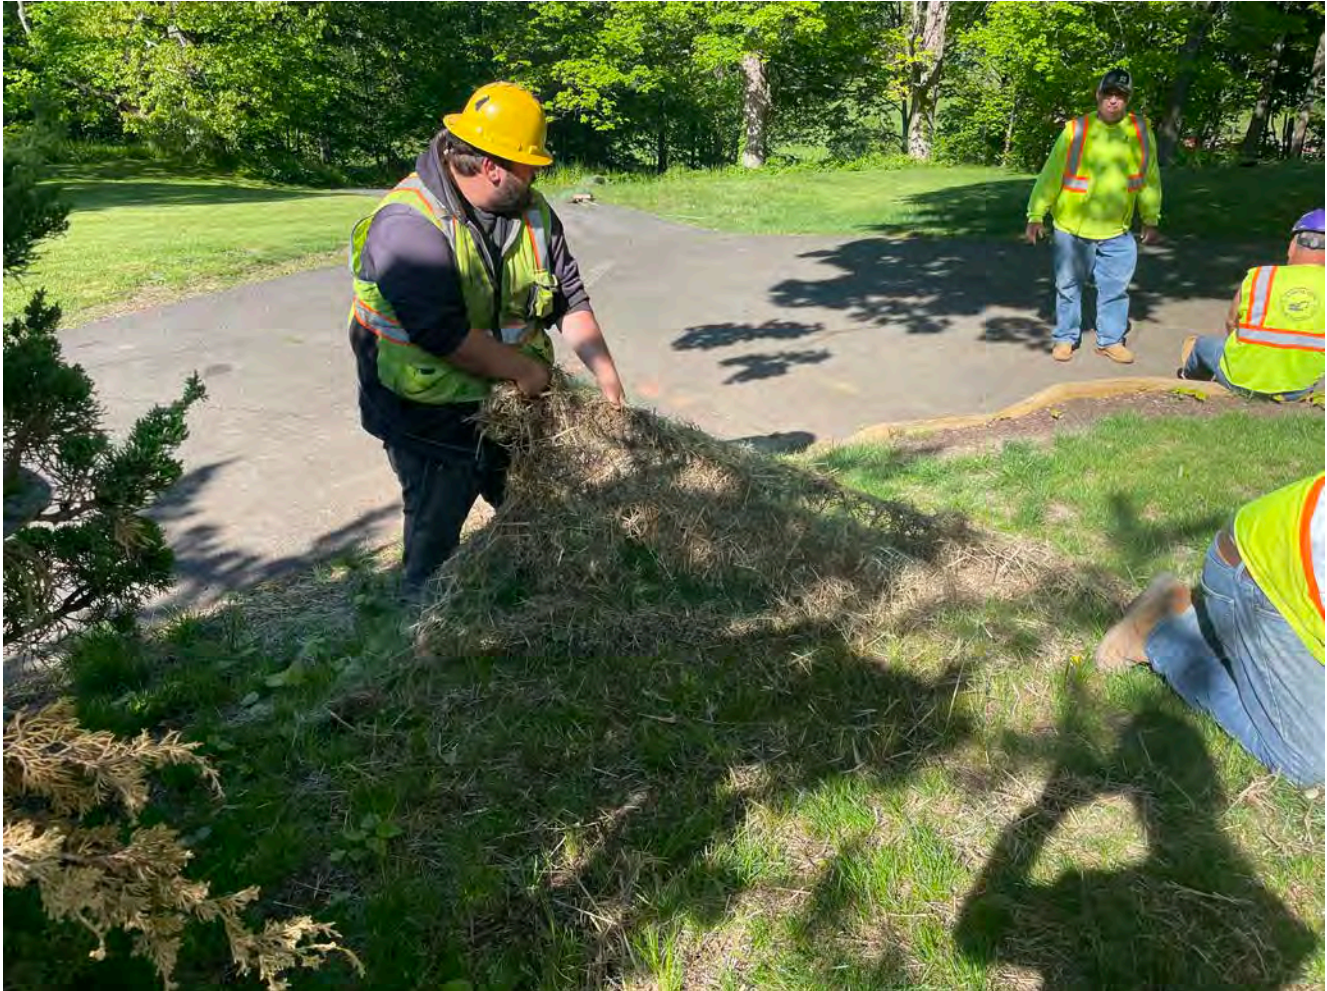
0857: Ludlow has mobilized to the 95R Maple Avenue property to remove the erosion control blankets that they placed last year after they installed a copper water service line.

Picture 1: Ludlow removing erosion control blankets from the 95R Maple Avenue property in Durham. View to the west.

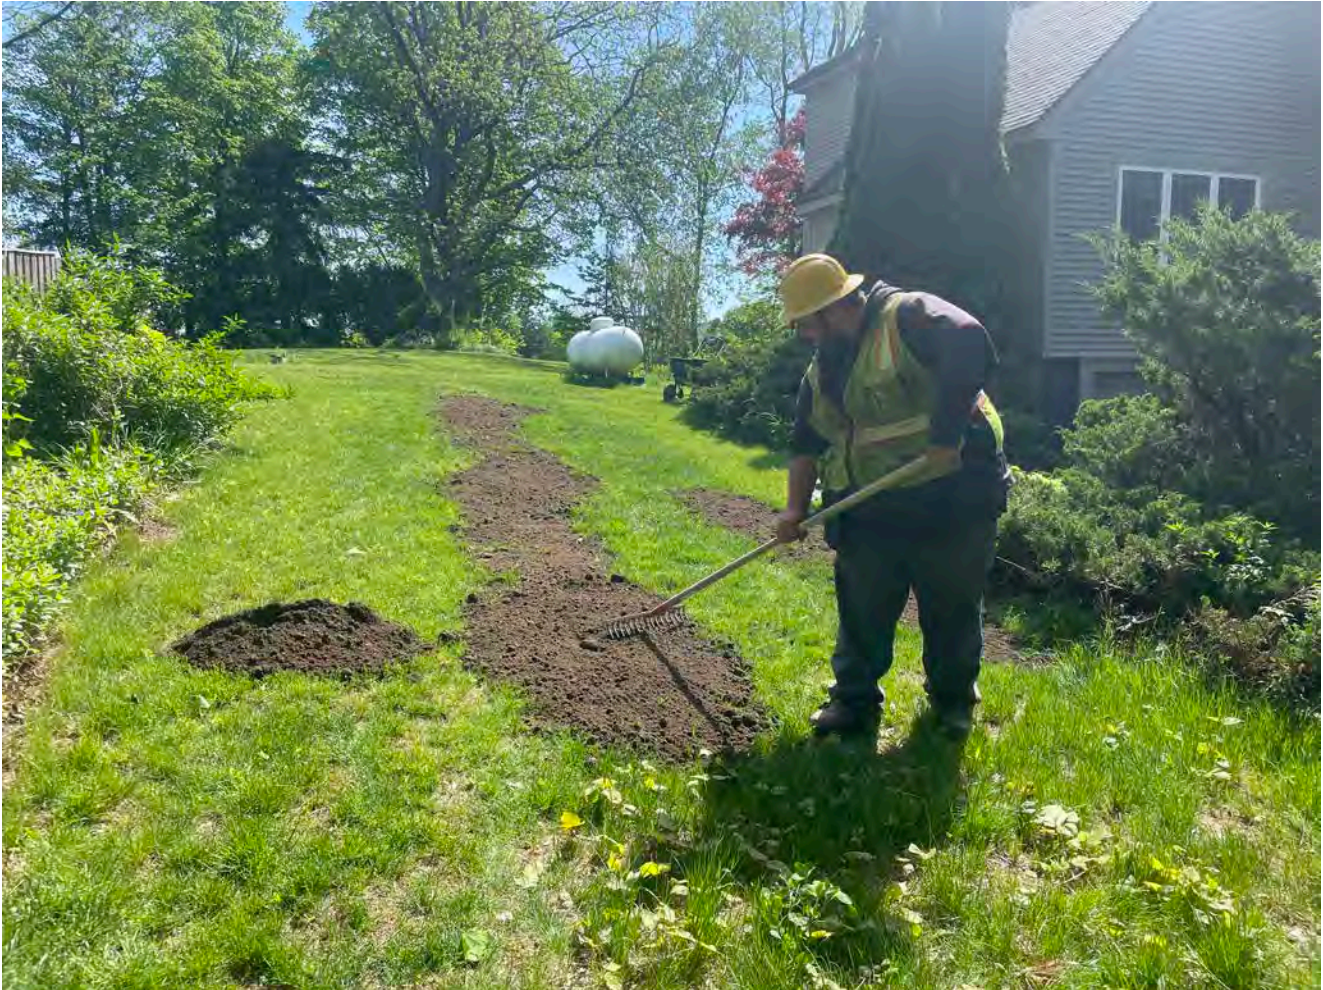
Picture 2: Ludlow grading loam that they just placed on the north side of the 95R Maple Avenue, Durham, property. View to the east.

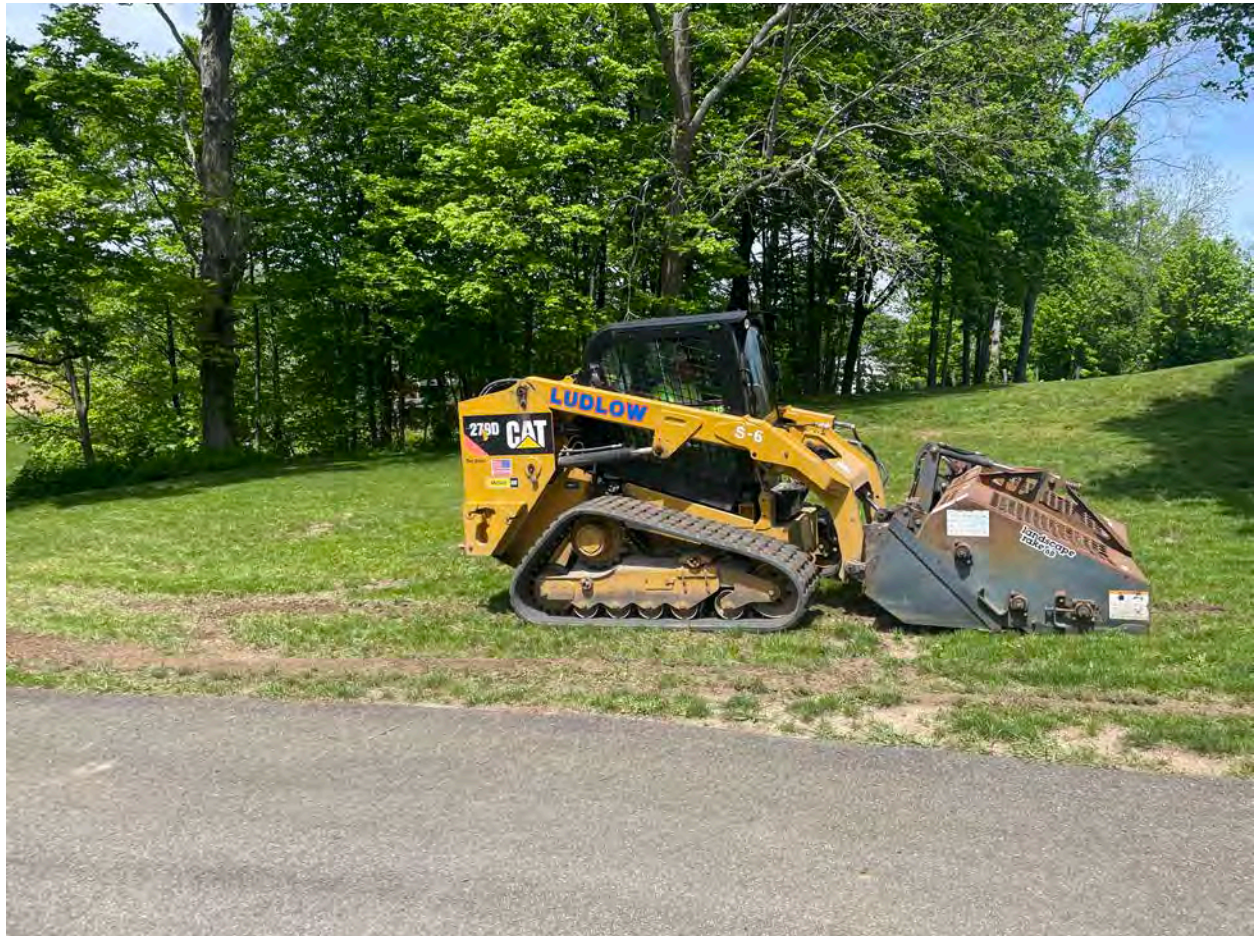
1204: Ludlow is running a Harley Rake over a section of the lawn at the 95R Maple Avenue property.

Picture 3: Ludlow using a Harley Rake to level an area of the lawn at the 95R Maple Avenue property as they work on restoring those areas that were disturbed during the installation of a copper water service line last year. View to the north.

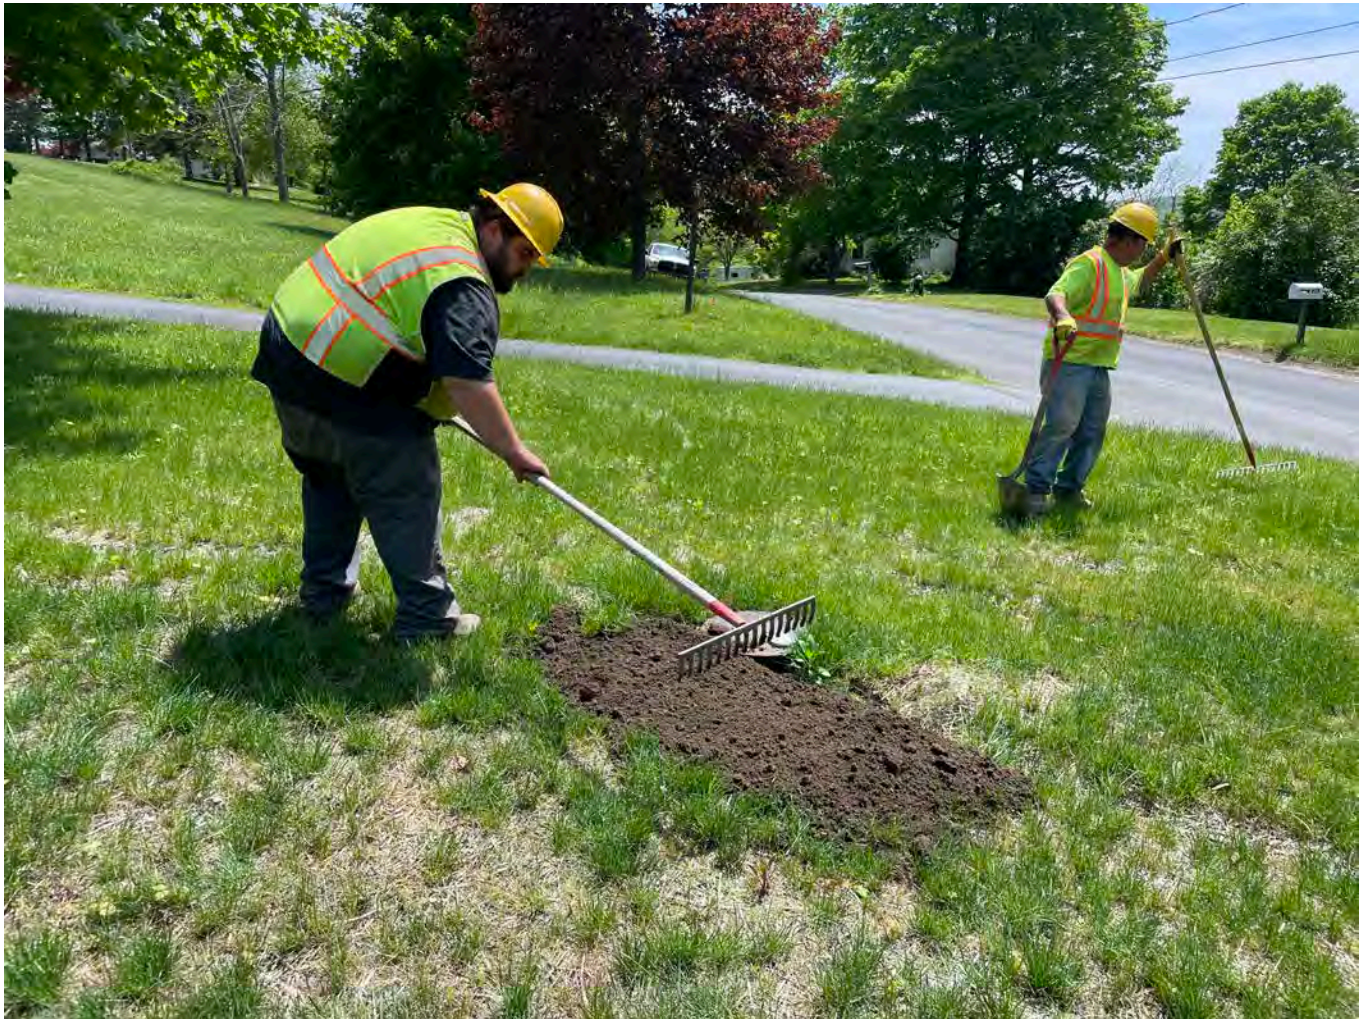
1340: Ludlow has mobilized to the 119 Maple Avenue property where they are placing loam on bare spots of the lawn that were disturbed last year during the installation of a copper water service line.

Picture 4: Ludlow placing loam and grass seed as they restore a portion of the lawn at the 119 Maple Avenue property that was disturbed last year during the installation of a copper water service line. View to the south.

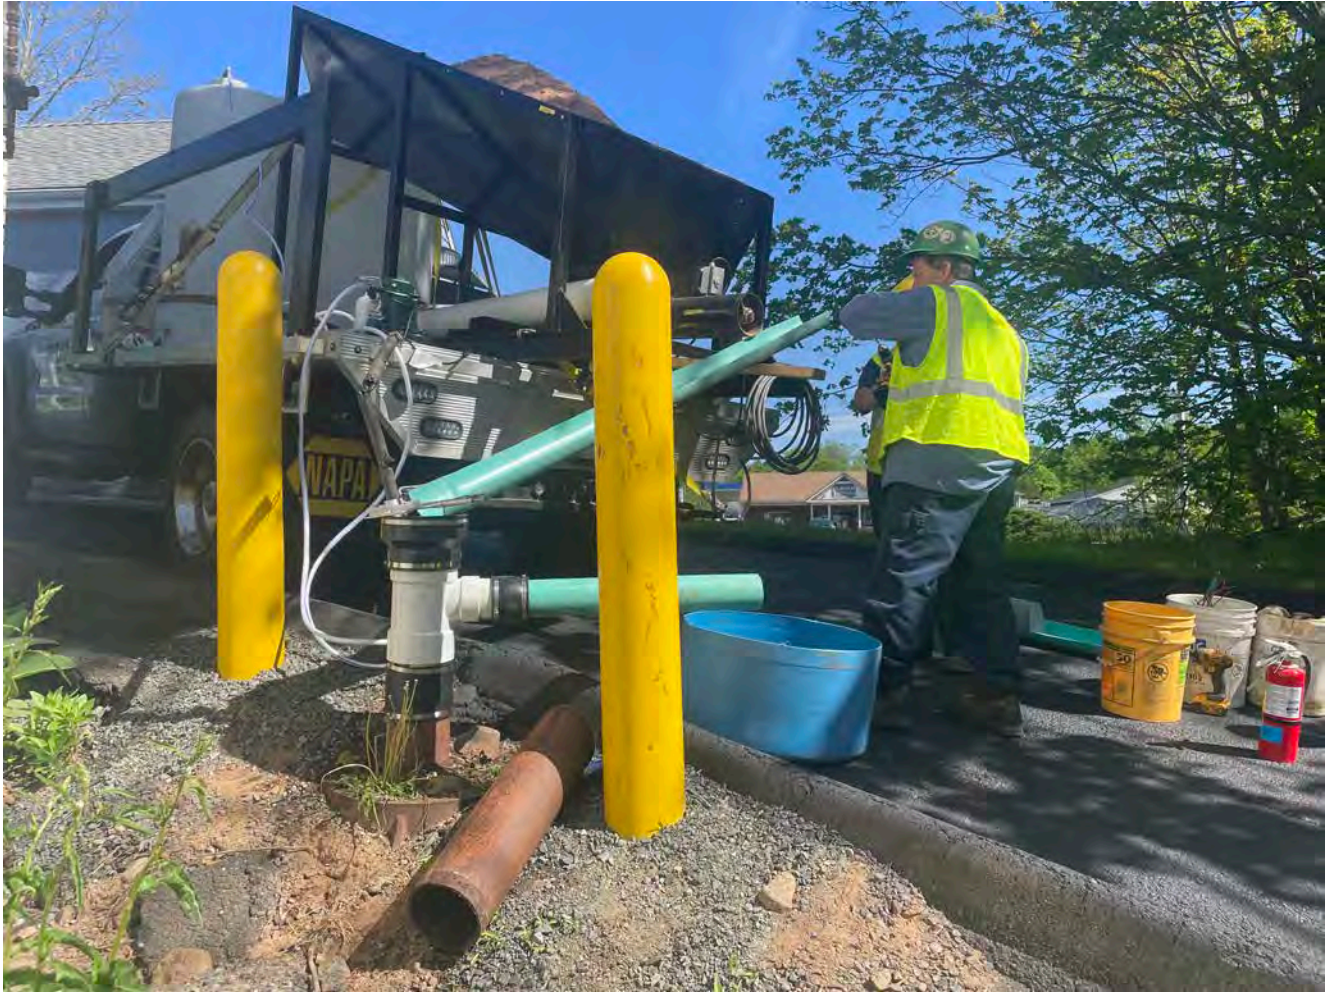
0946: Grela begins placing sand into the well located at the 325 Main Street property as they continue well decommissioning activities.

1036: Grela has completed decommissioning activities on the well that services the 325 Main Street property. Sand was placed into the well up to 38' below surface grade, after which the well was filled to 3' below surface grade with bentonite chips. Grela cut the steel casing 6" above surface grade before decommissioning activities commenced: Grela will return to cut the casing 2' below surface grade and top off the well with bentonite chips once Ludlow has removed 2' of soil from around the well casing. No displaced groundwater was generated during the well decommissioning activities.

Picture 5: Grela placing sand into the well located on the northeast corner of the 325 Main Street building as they work to decommission the well. View to the northwest.

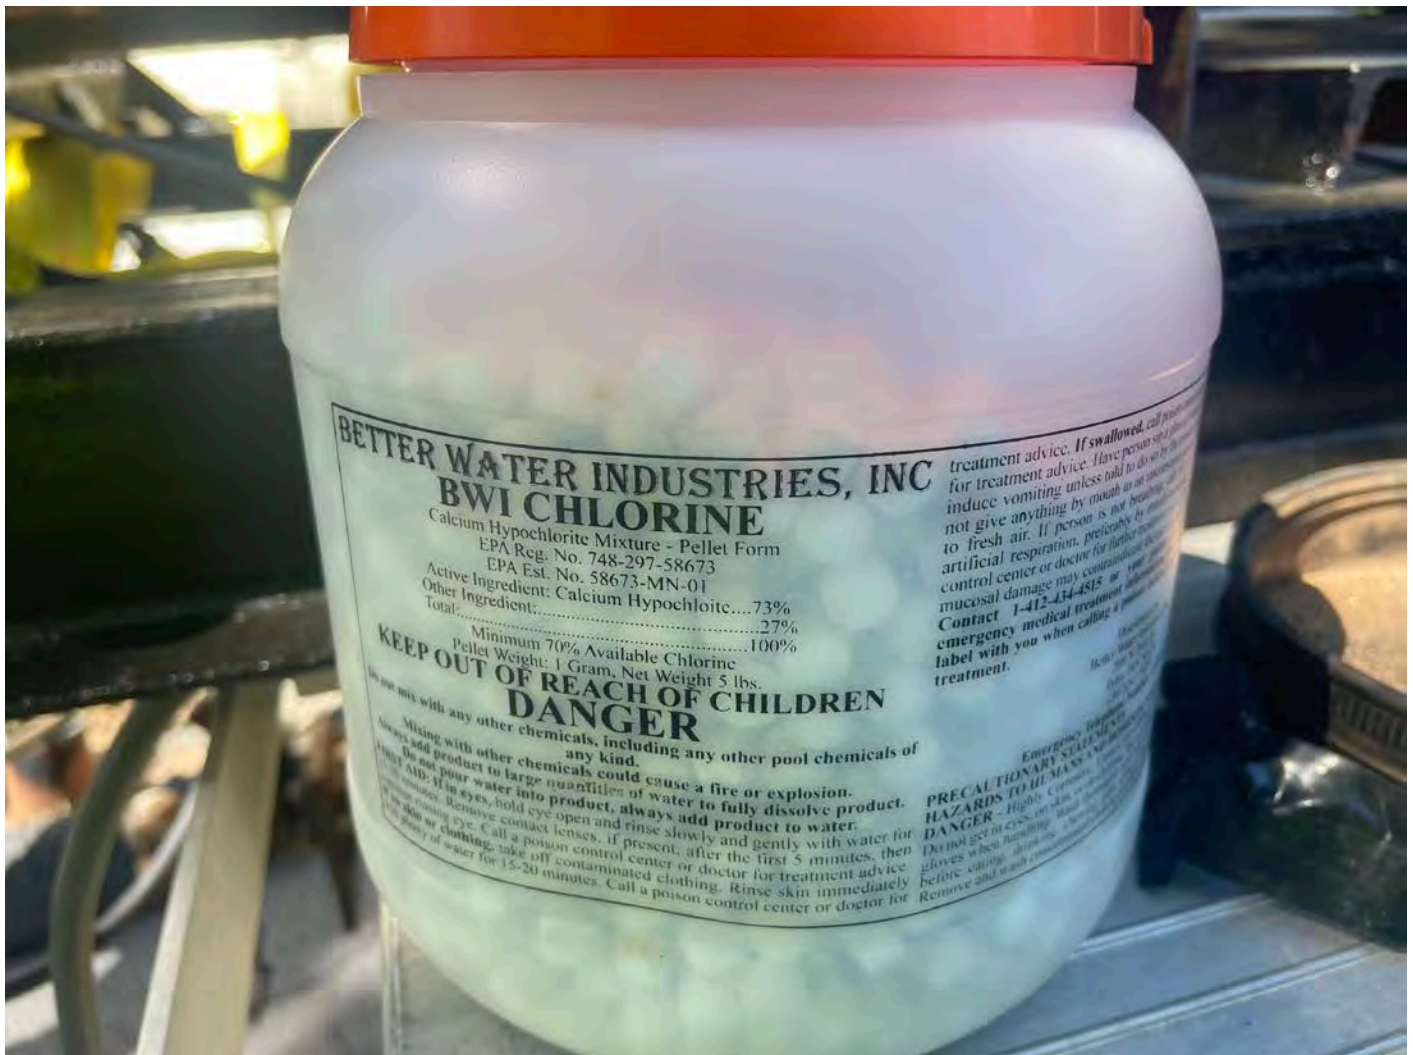
0938: Grela places 35 chlorine pellets (calcium hypochlorite mixture) into the well located at the 325 Main Street property to achieve 50 ppm chlorine in the well water.

Picture 6: Chlorine tablets that Grela is using to chlorinate the water in the wells they are decommissioning.

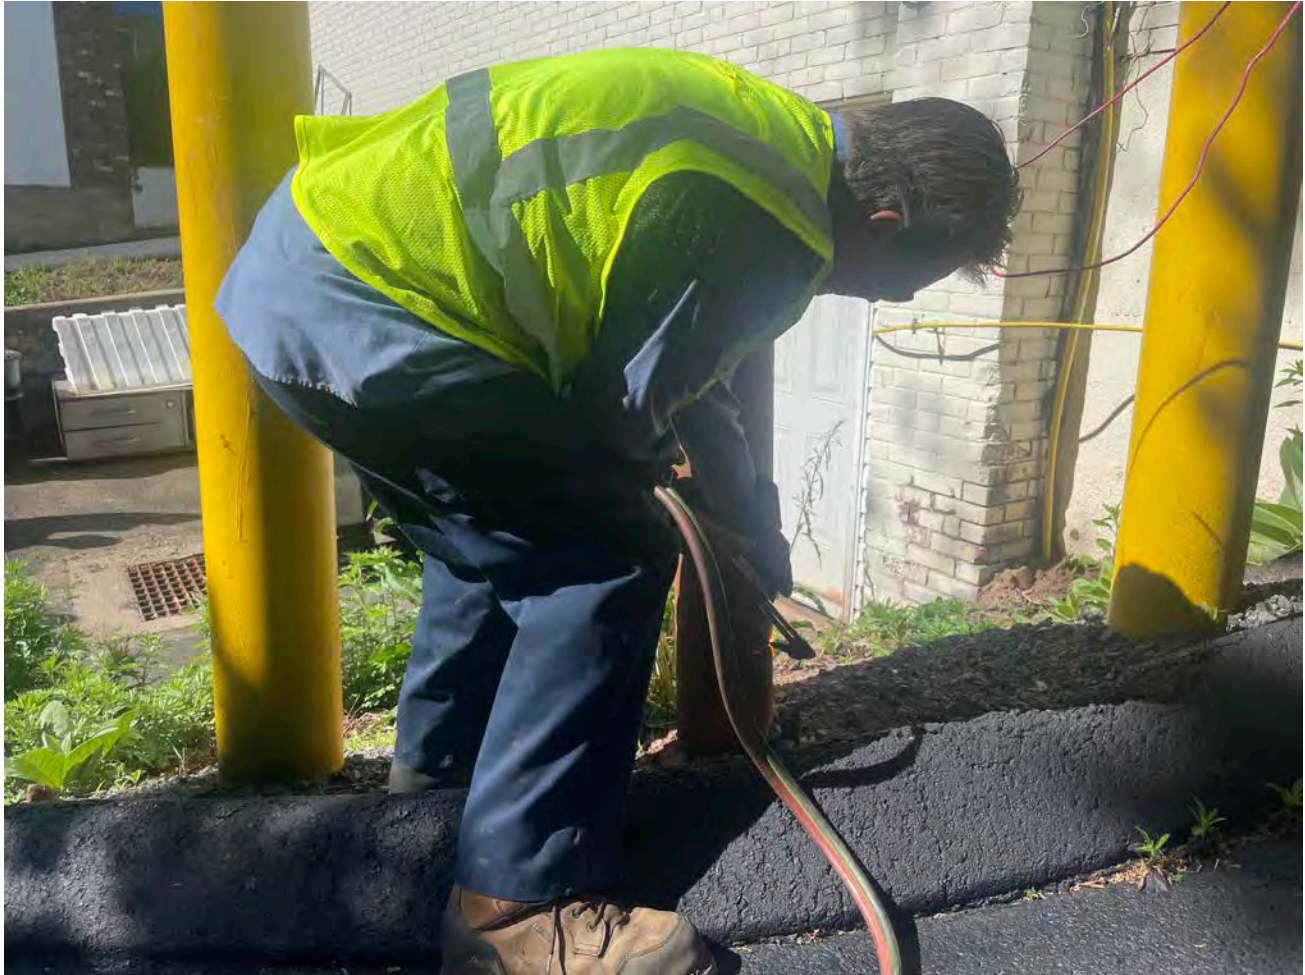
0931: Grela begins to cut the stand pipe located at the northwest corner of the 325 Main Street building. The remaining stub is approximately 6" inches above surface grade. Grela will come back to cut and remove the casing 2' below surface grade once Ludlow removes soil from around the casing.

Picture 7: Grela using a torch to cut the 6" steel riser for the well located at the 325 Main Street property. Grela will return to cut the casing 2' below surface grade once Ludlow has removed the top two feet of soil from around the casing. View to the southwest.

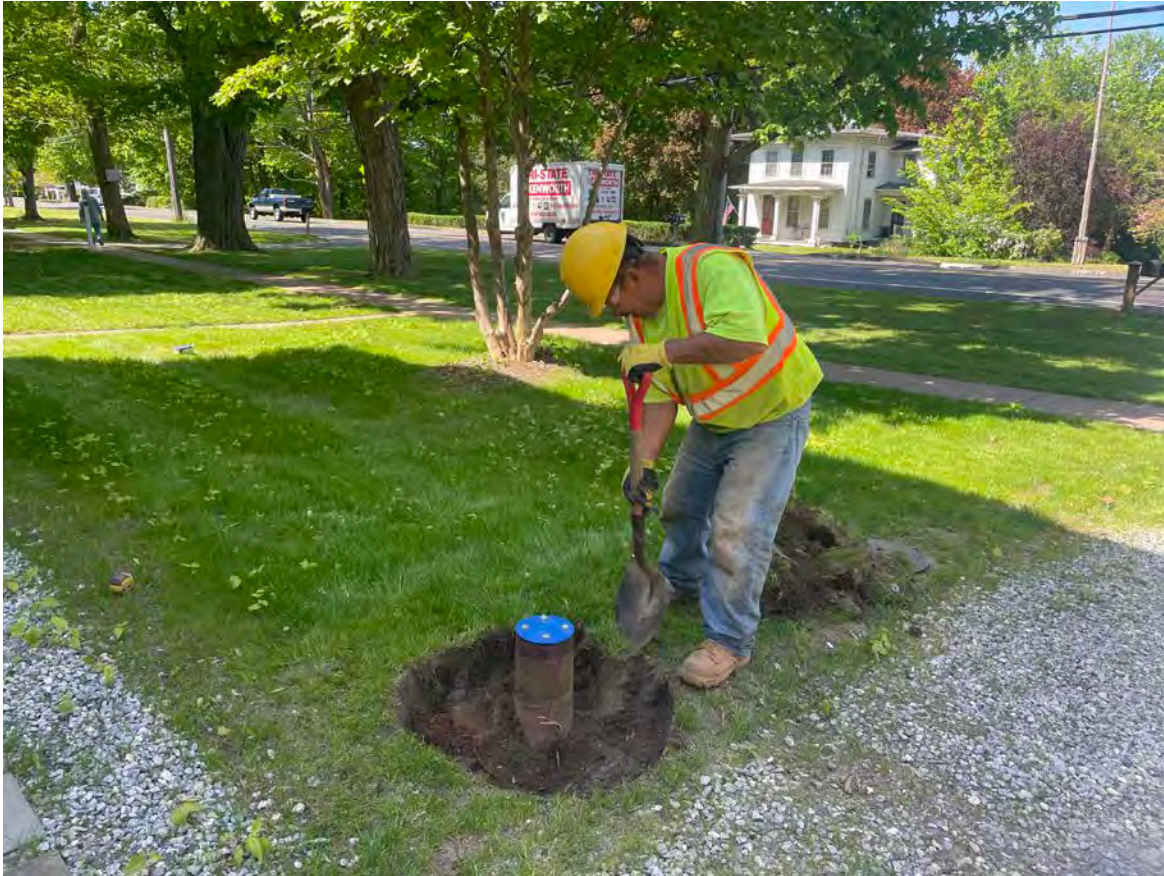
1140: Ludlow has hand-excavated down 2' below surface grade around the well that services the 305 Main Street, Durham, residence. Ludlow is preparing to do the same for the well that services the 303 Main Street residence.

Picture 8: Ludlow hand-excavating around the casing of the well that services the 305 Main Street, Durham, residence. Ludlow is removing soil to 2' below surface grade. View to the southwest.

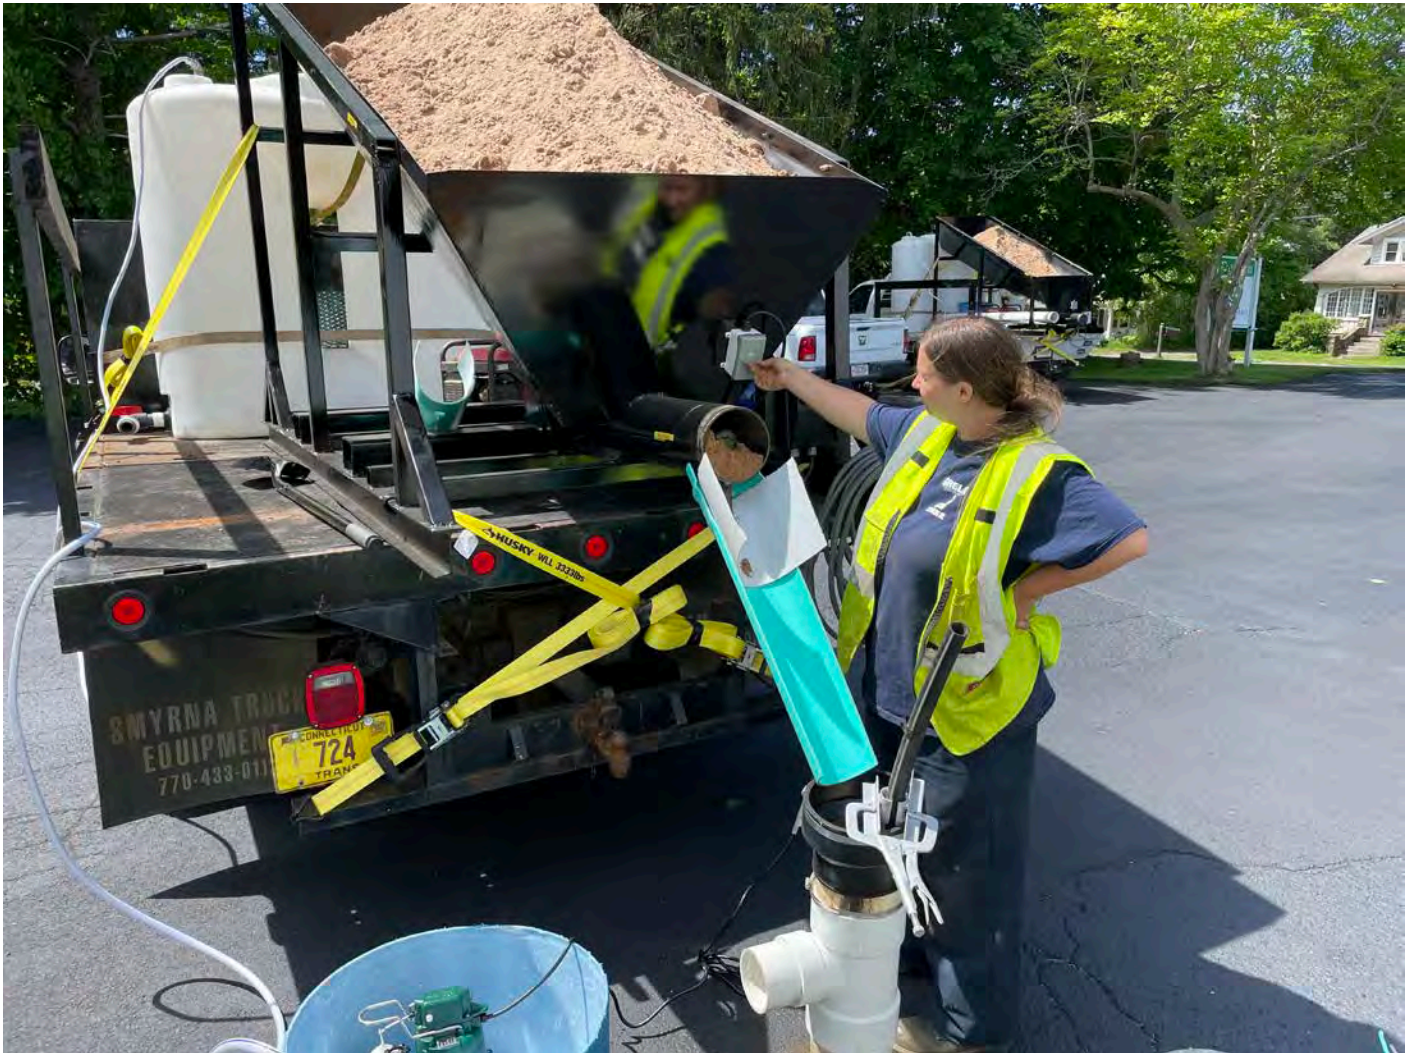
1054: Grela begins to place sand into the well located on the north side of the 321 Main Street building as part of well decommissioning activities.

Picture 9: Ludlow placing sand into the well located on the south side of the 321 Main Street, Durham, building as part of well decommissioning activities. View to the southwest.

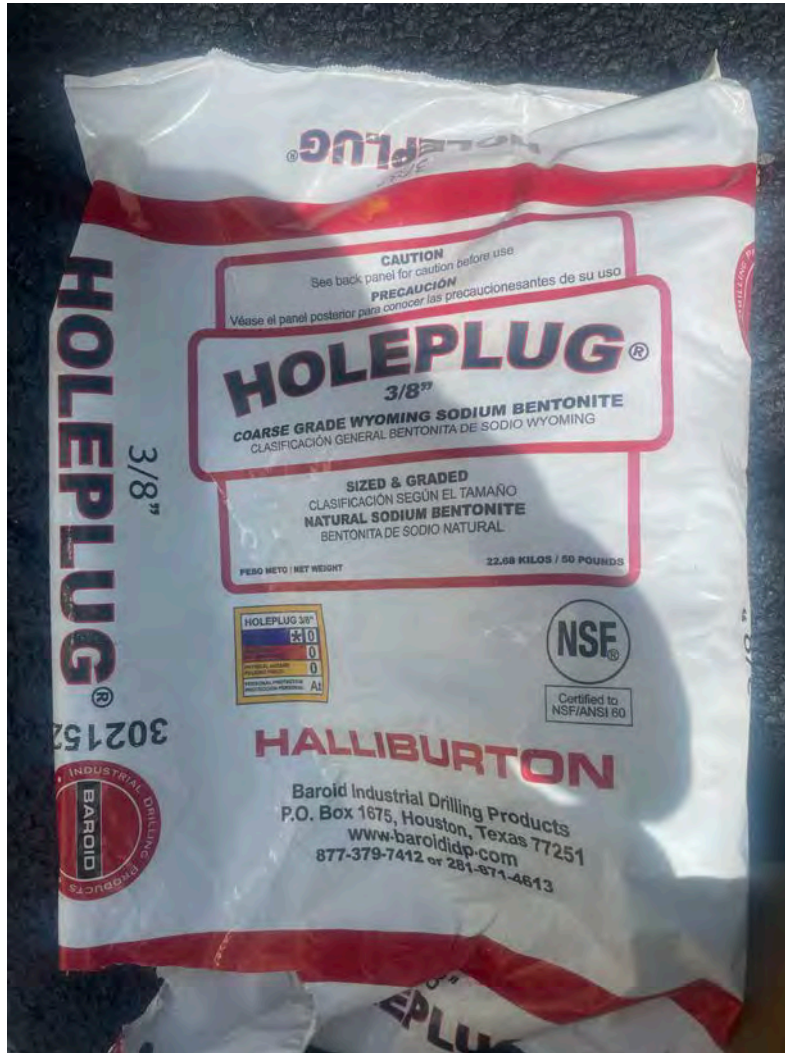
Picture 10: Bentonite chips that Grela is using during well decommissioning activities.

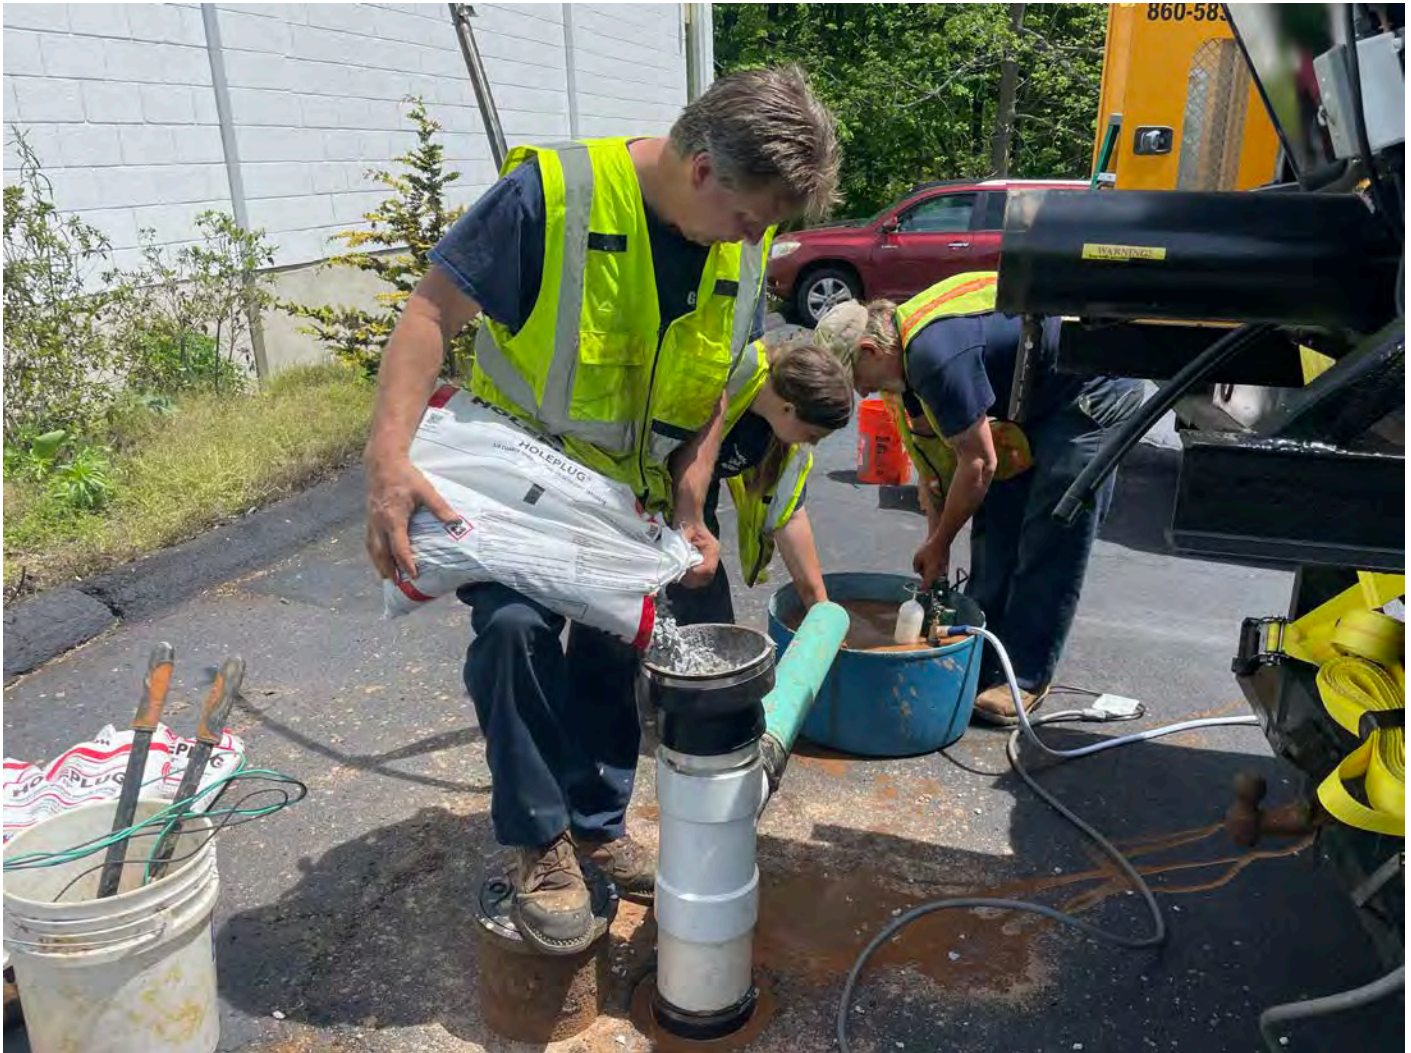
1227: Grela is placing bentonite chips into the wall located on the south side of the 321 Main Street building. Grela generated about 10 gallons of ground water that was displaced from the well while they were adding sand and chips to the well. Grela transferred that water from a collection tub set next to the well into a large poly container in the back of one of the utility trucks.

Picture 11: Ludlow placing bentonite chips into the well located on the south side of the 321 Main Street, Durham, building as part of well decommissioning activities. View to the east.

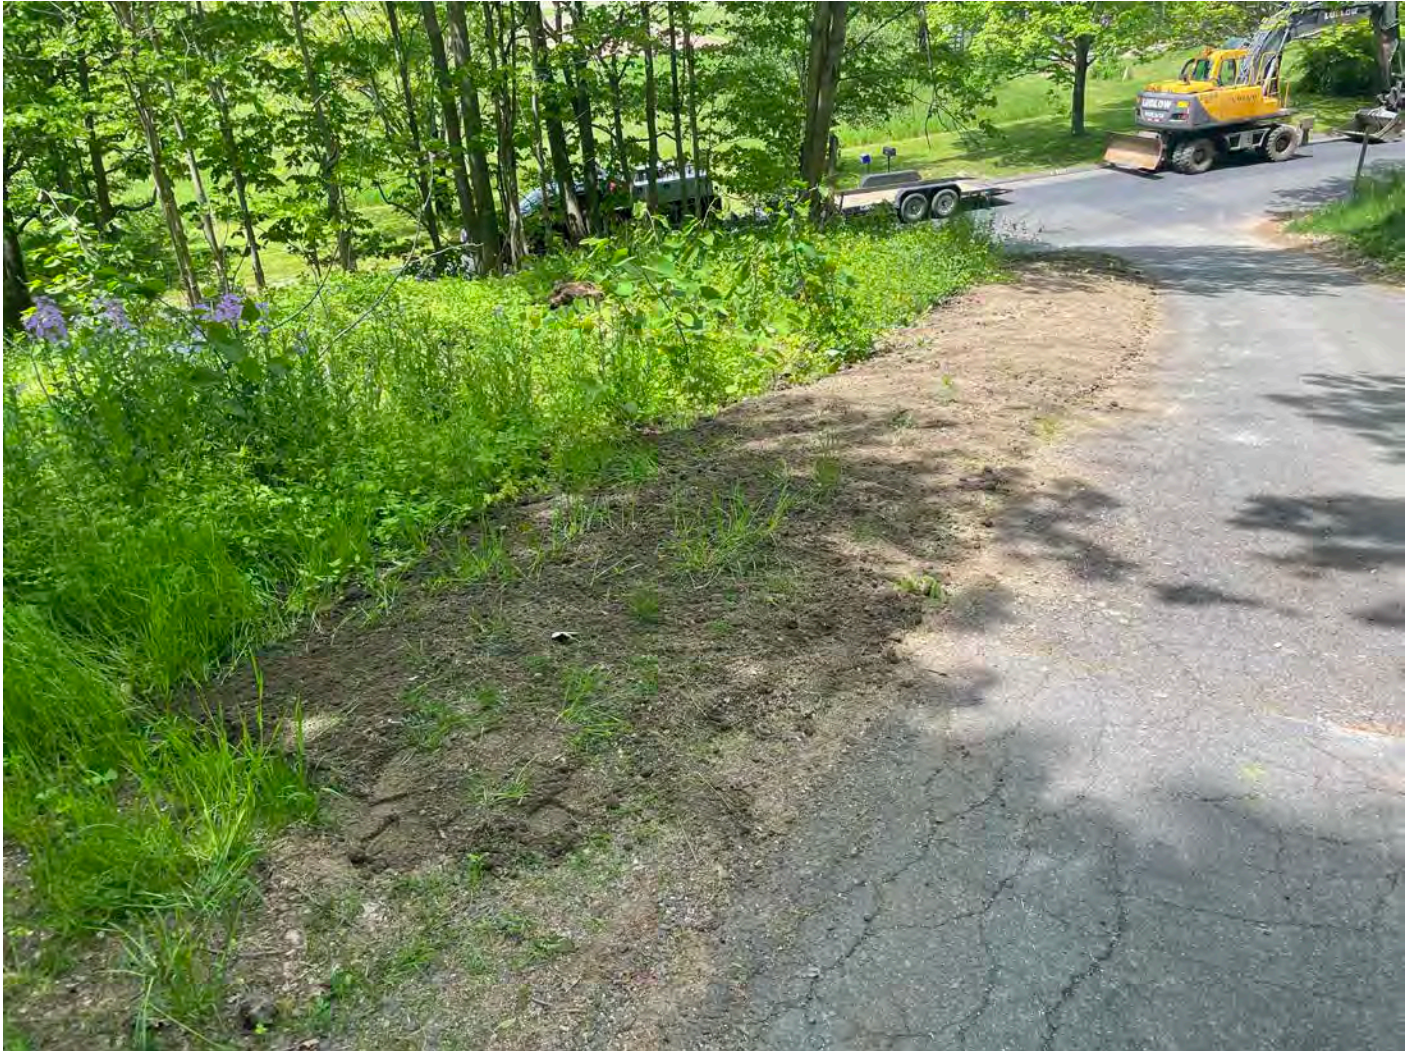
Picture 12: The south side of the driveway for the 95R Maple Avenue, Durham, property where Ludlow placed loam and grass seed. View to the west.
