Daily Report

Project: Durham Meadows Pipeline Installation Date: May 19, 2022

Project #:
 AECOM: 6061487
 Report No:
 429

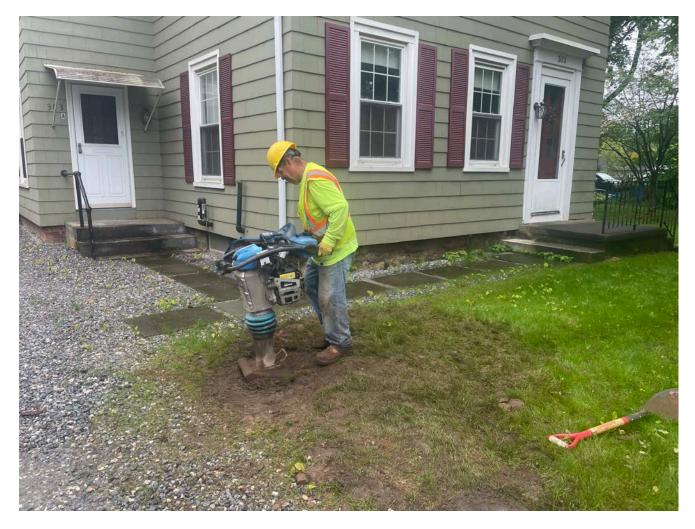
Picture 2: Ludlow compacting fill where the backfilled the location of the well for the 305 Main Street residence that Grela decommissioned yesterday. View to the southeast.

0918: Ludlow is backfilling around the two wells that Grela decommissioned at the 303/305 Main Street, Durham, property. The fill is being placed in 1' lifts and is being compacted with a jumping jack.

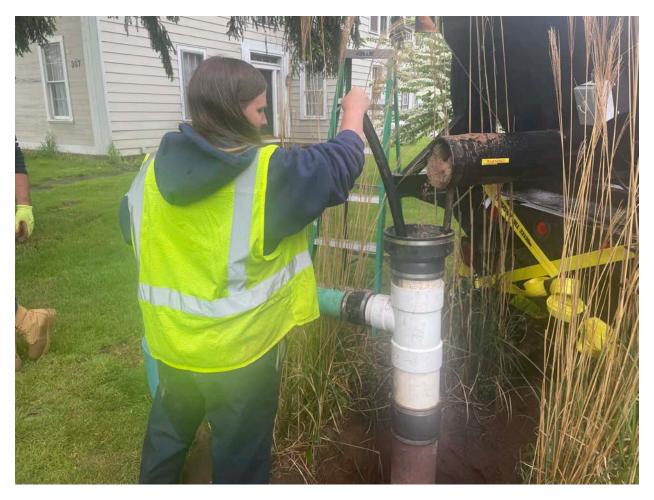
Picture 3: Grela placing sand into the well located on the southwest corner of the 307 Main Street, Durham property as part of well decommissioning activities. View to the northeast.

- 0939: Grela has begun to place sand into the well on the 307 Main Street property as part of well decommissioning activities.
- 0945: Ludlow is placing loam and grass seed on the areas they just backfilled at the 303/305 Main Street property where Grela decommissioned two wells yesterday.

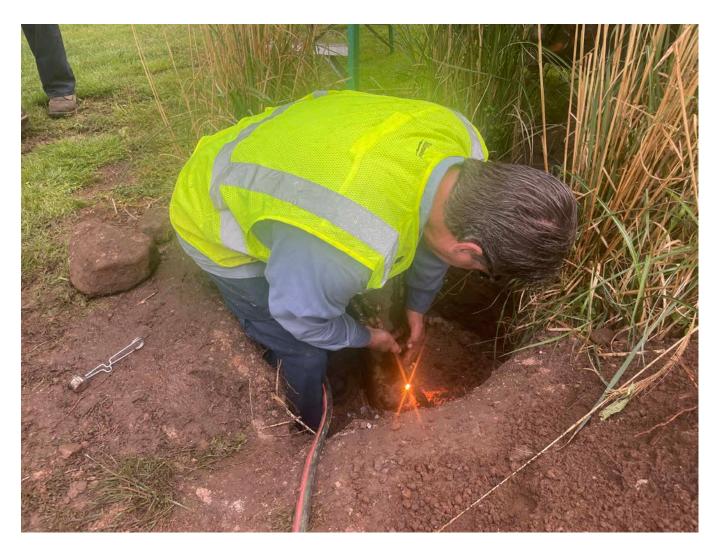
Picture 4: Grela using a torch to cut the steel casing of the well located on the 307 Main Street, Durham property as part of well decommissioning activities. View to the northeast.

- 1052: Grela is using a torch to cut the 6" steel casing of the well located at the 307 Main Street property. Grela is cutting the casing 2' below service grade.

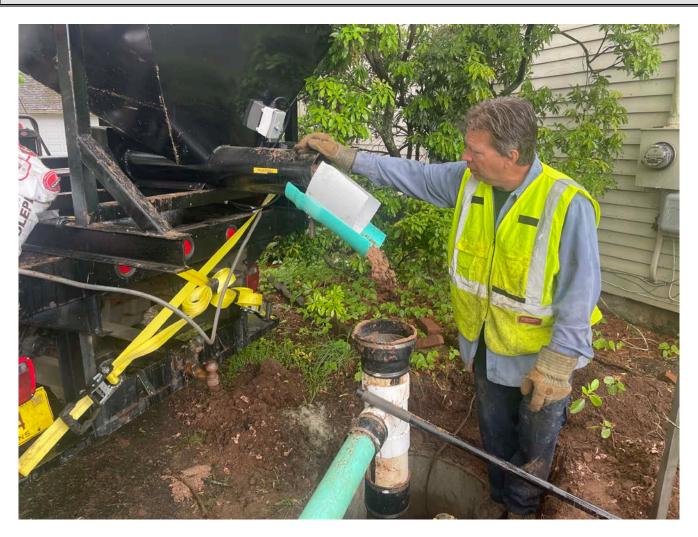
Picture 5: Grela placing sand into the well located on the northwest corner of the 297 Main Street residence as they work to decommission the well. View to the southeast.

- 1240: Grela continues to fill the well at the 297 Main Street property with sand.
- 1254: Grela has placed sand into the well at the 297 Main Street property up to 35' below the surface grade and is starting to place bentonite chips into the well as part of well decommissioning activities.

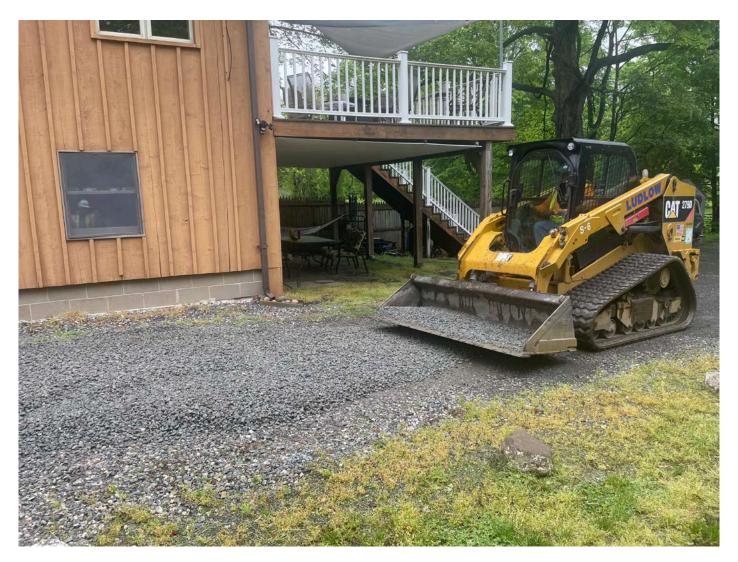
Picture 6: Ludlow grading $\frac{3}{4}$ " gravel they placed on the south side of the 305 Main Street, Durham, residence as they work to restore the driveway. View to the northeast.

1203: Ludlow is backblading the driveway at 305/303 Main Street property with a CAT 279D. Ludlow is currently delivering a load of 3/4" rock to the property and has begun placing it on the south side of the 305 Main Street residence, working westwards.

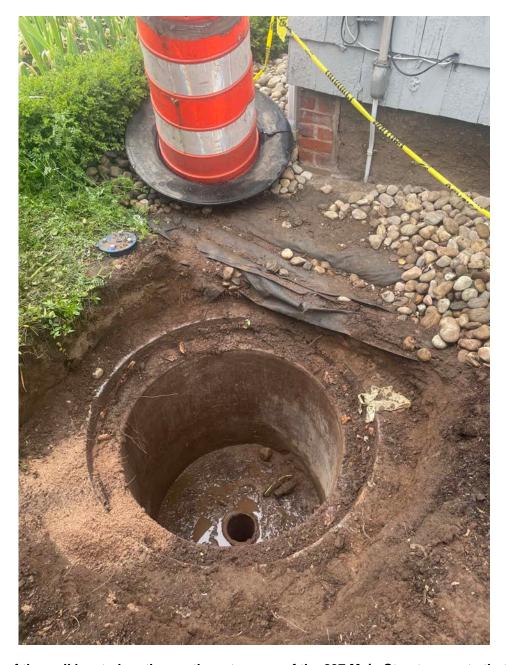
Picture 7: View of the well located on the southwest corner of the 297 Main Street property that Grela is in the process of decommissioning. View to the northwest.

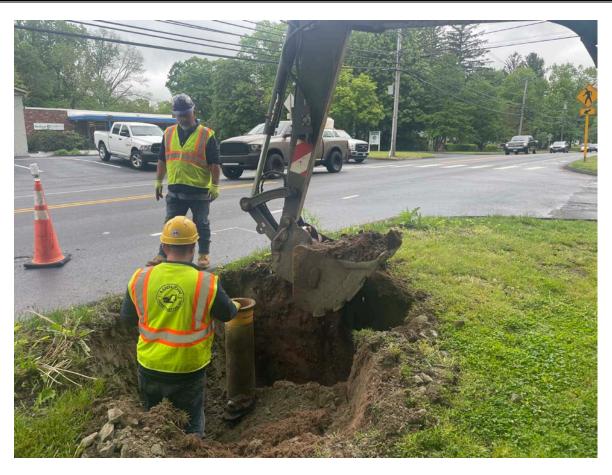
1033: Ludlow is setting up at Station 174+91 (immediately north of the intersection of Talcott Lane and Main Street) to replace a hydrant that was previously damaged by a motor vehicle.

Picture 8: Ludlow excavating around the stem of a damaged hydrant located at Station 174+91 that they are in the process of replacing. View to the southeast.

1259: Ludlow begins to excavate on the west side of Main Street at Station 174+91 as they prepare to replace the hydrant that was previously damaged by a vehicle.

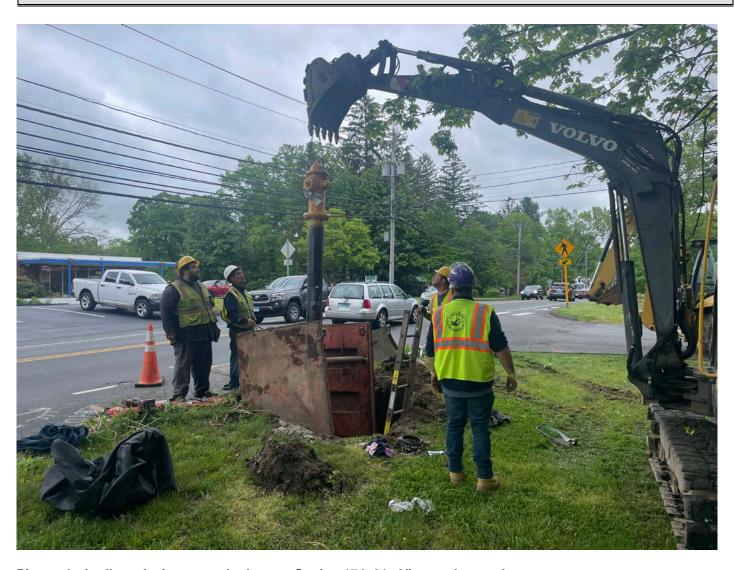
Picture 9: Ludlow placing a new hydrant at Station 174+91. View to the southeast.

1414: Ludlow placing a new hydrant at Station 174+91 on Main Street.

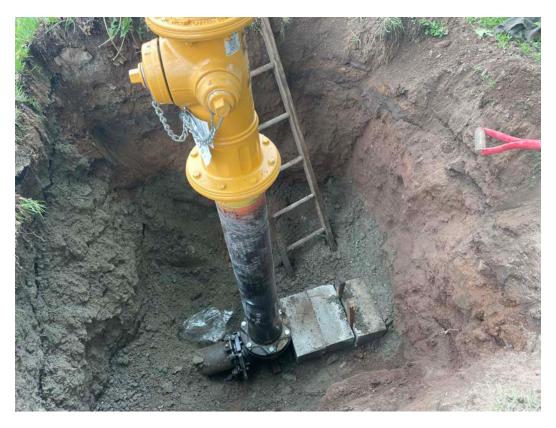
Picture 10: Three cinder blocks that Ludlow placed as thrust blocks on the west side of the hydrant stem at Station 174+91. View to the south.

1443: Ludlow has installed new hydrant at Station 174+91 and is preparing to place thrust blocks (3 cinder blocks placed on the west side of base of the hydrant stem where it connects to the 6" DIP feed line).

1449: Ludlow is in the process of placing 3 cinderblocks on the west side of the hydrant stem located at Station 174+91 for use as thrust blocks.

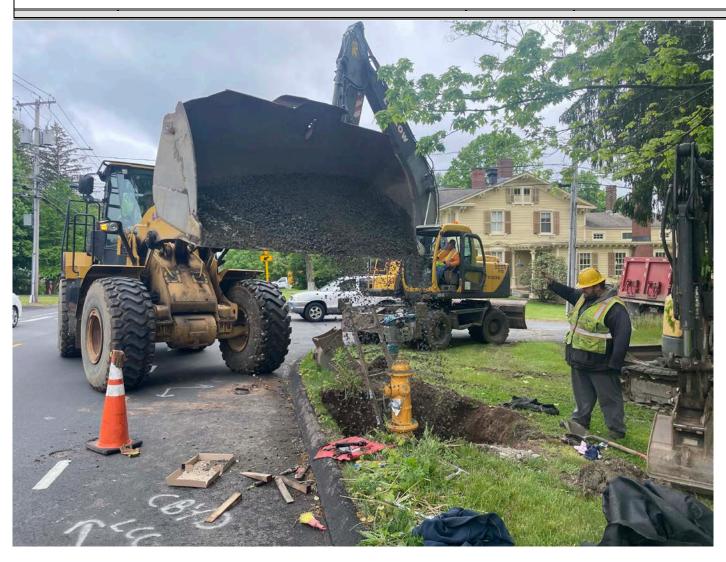
Picture 11: Ludlow backfilling around the new hydrant they installed at Station 174+91. View to the south.

1510: Ludlow is in the process of placing fill in 1' lifts into the excavation they made during the replacement of a hydrant at Station 174+91.

1519: Ludlow is using a jumping jack to compact the fill that is being placed around the stem of the hydrant located at Station 174+91 in 1' lifts.

1526: Ludlow has finished working for the day at Station 174+91. Ludlow needs to return at a later date to add a 1' riser in order to bring the hydrant up to its proper elevation.

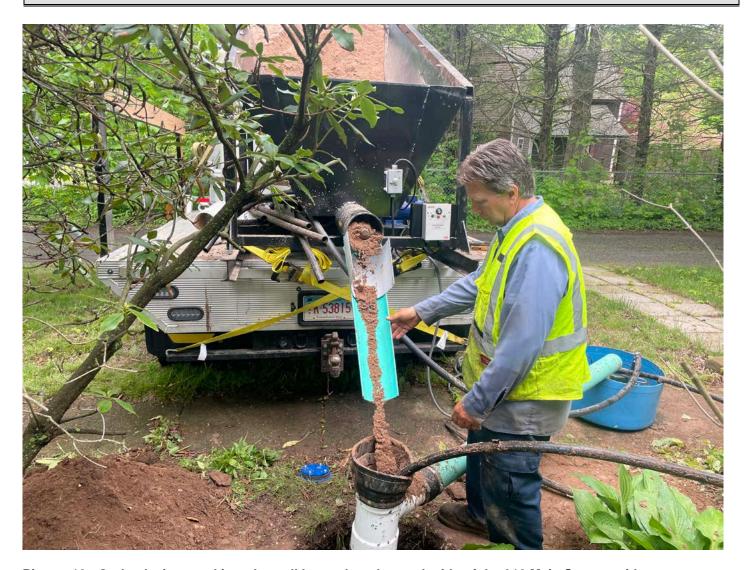
Picture 12: Grela placing sand into the well located on the north side of the 312 Main Street residence as part of well decommissioning activities. View to the south.

1551: Grela has placed sand to within 40' below surface grade in the well located at the 312 Main Street property. Grela is preparing to add bentonite chips on top of the sand.

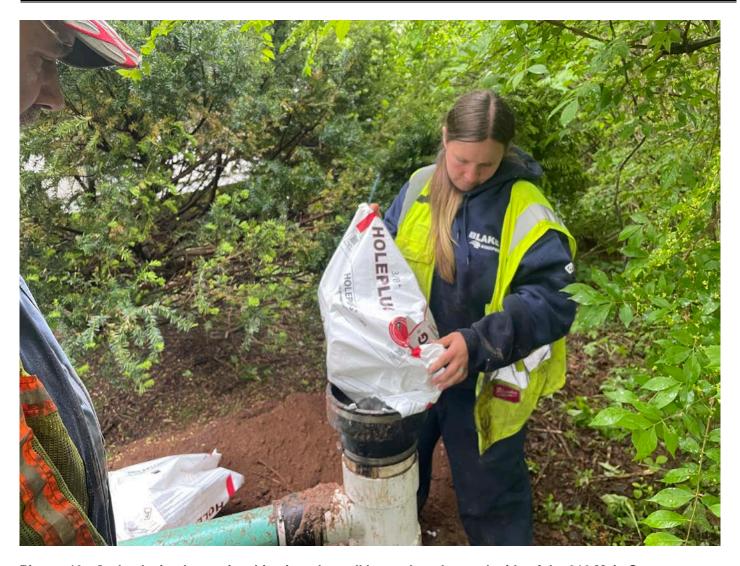
Picture 13: Grela placing bentonite chips into the well located on the north side of the 316 Main Street residence as part of well decommissioning activities. View to the west.

1507: Grela continues to place sand in the well located at the 312 Main Street property. Grela is in the process of placing bentonite chips into the well located at the 316 Main Street property.

1531: Grela continues to add bentonite chips to the well located on the 316 Main Street property. Grela has generated approximately 10 gallons of displaced ground water during the decommissioning process.
