## Daily Report

<b>Project:</b>	Durham Meadows Pipeline Installation	<b>Date:</b>	June 2, 2022
<b>Location:</b>	Maple Avenue, Durham; Shared Access Driveway and Watch Hill Drive, Middletown	<b>Day of Week:</b>	Thursday
<b>Project #:</b>	AECOM: 6061487	<b>Report No:</b>	438
<b>Contractor:</b>	Ludlow Construction	<b>Page:</b>	1 of 15

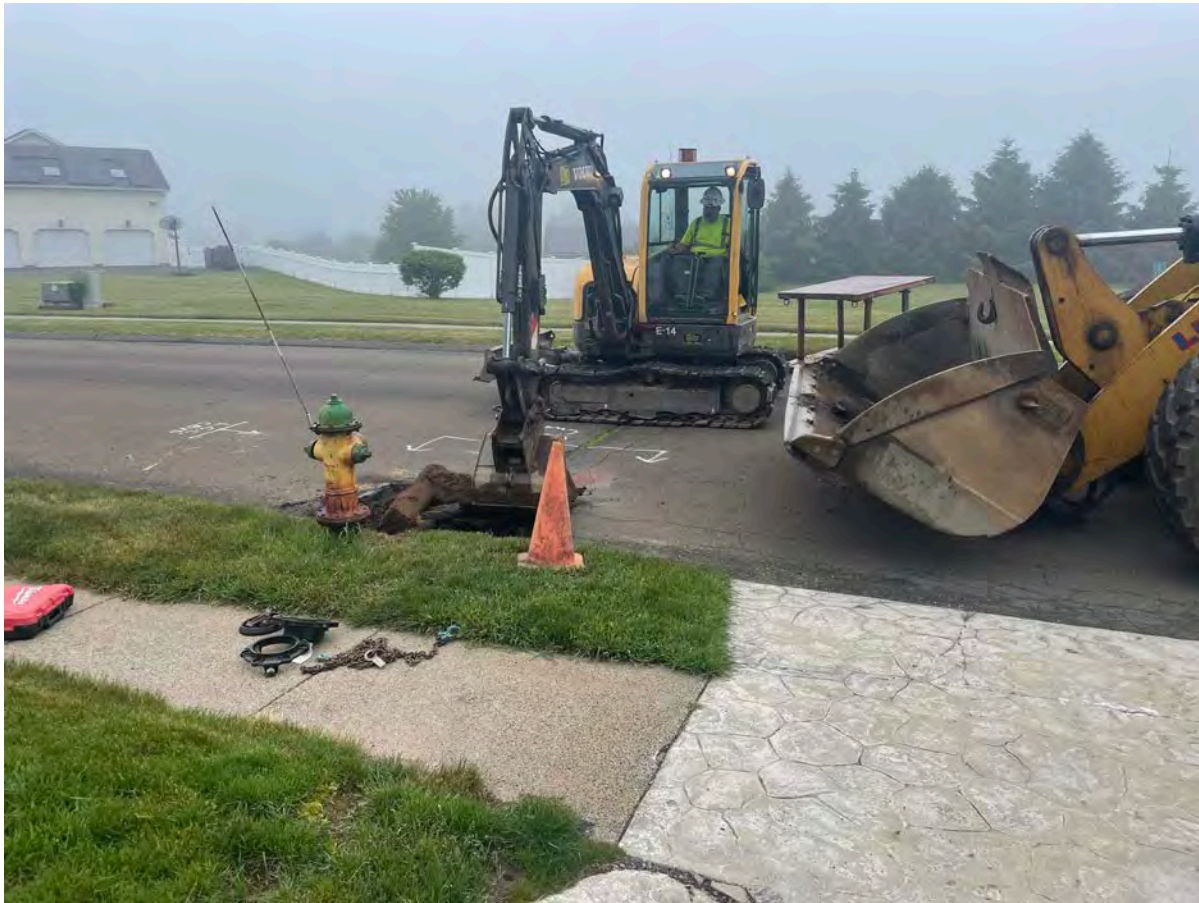
0759: Ludlow has begun to excavate around the hydrant located at Station 604+31.

0821: Ludlow has set a trench box into the excavation at Station 604+31. They are currently excavating to daylight the 6" DIP water line that fed the hydrant they will remove at Station 604+31.

Picture 1: Ludlow excavating to remove the old hydrant located on the south of Watch Hill Drive at Station 604+31. View to the north.

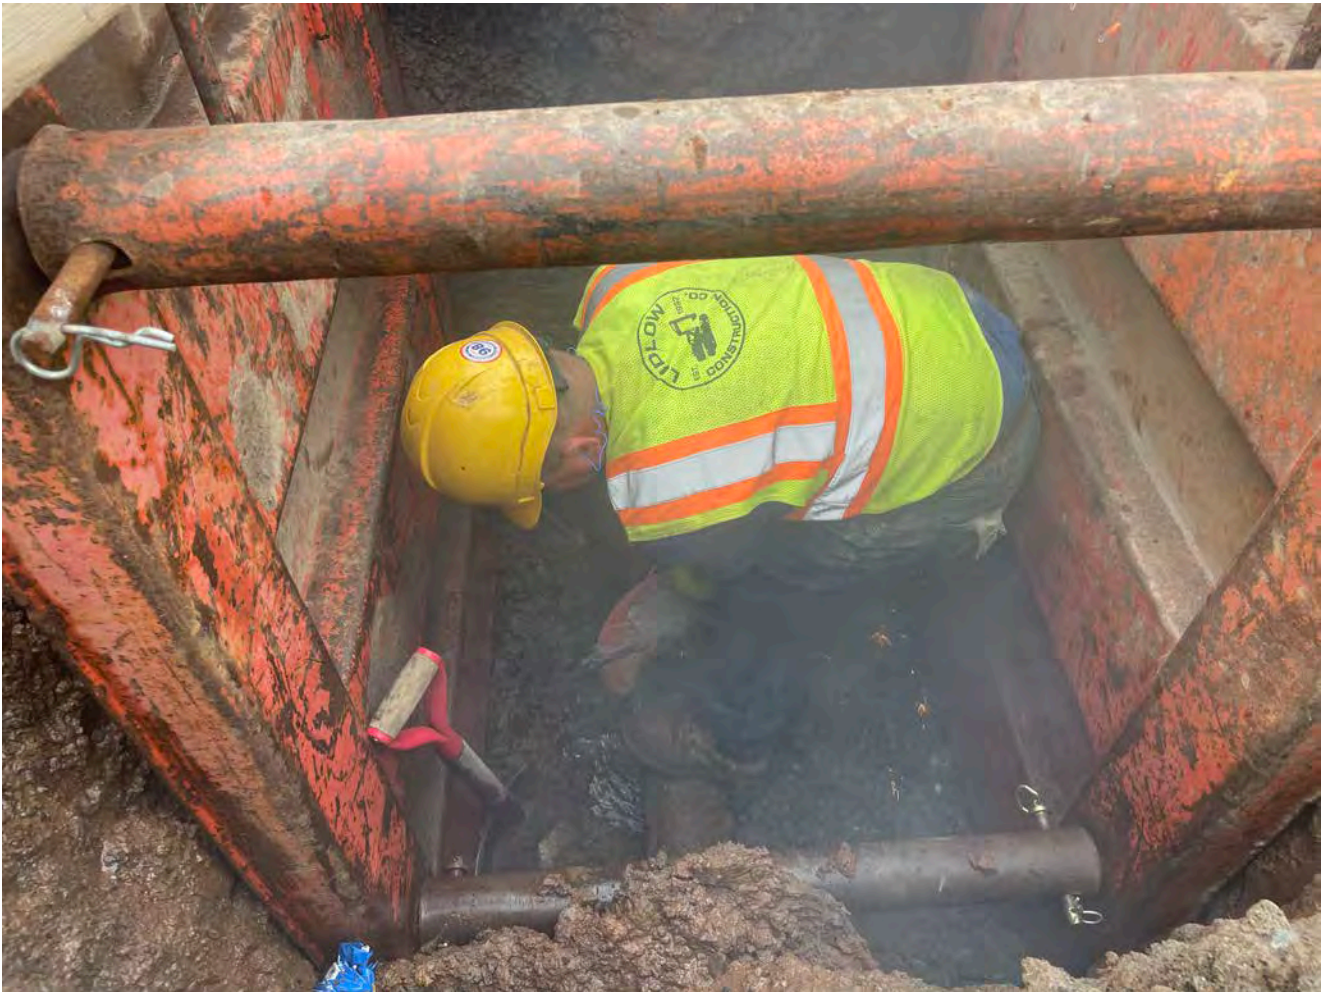
0840: Ludlow is cutting the 6" DIP water line to the old hydrant at Station 604+31 with a cut-off saw.

**Picture 2: Ludlow using a cutoff saw to remove the 6” DIP water line that fed the hydrant they are removing at Station 604+31 on the south of Watch Hill Drive.**

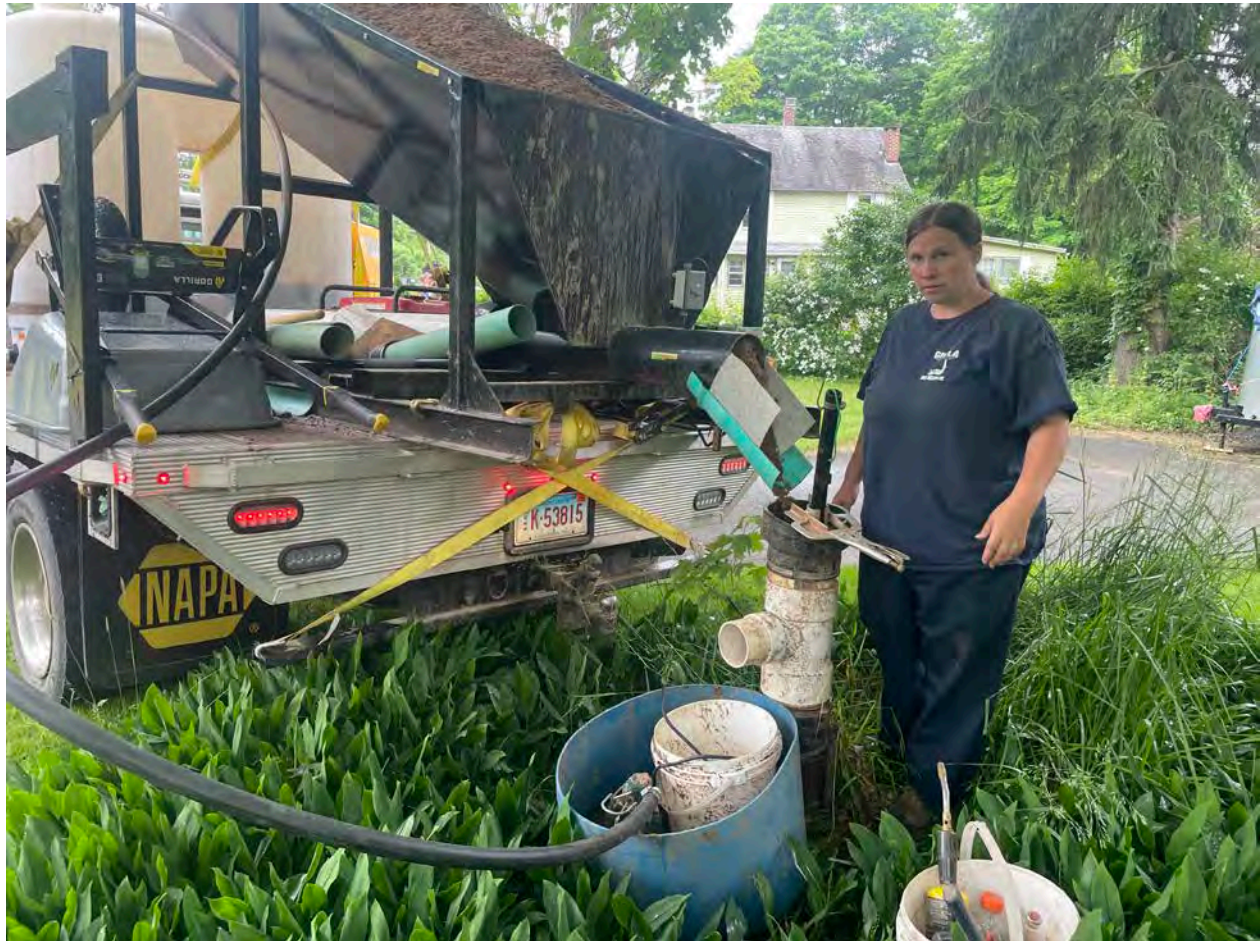
1011: Grela continues to place sand into the well located on the east side of the 184 Maple Avenue residence as part of well decommissioning activities. Grela has mobilized to the 176 Maple Avenue, Durham, property and has begun placing sand into the dug well located on the south side of the residence.

Picture 3: Grela placing sand into the well located on the east side of the 184 Maple Avenue property as part of well decommissioning activities. View to the southwest.

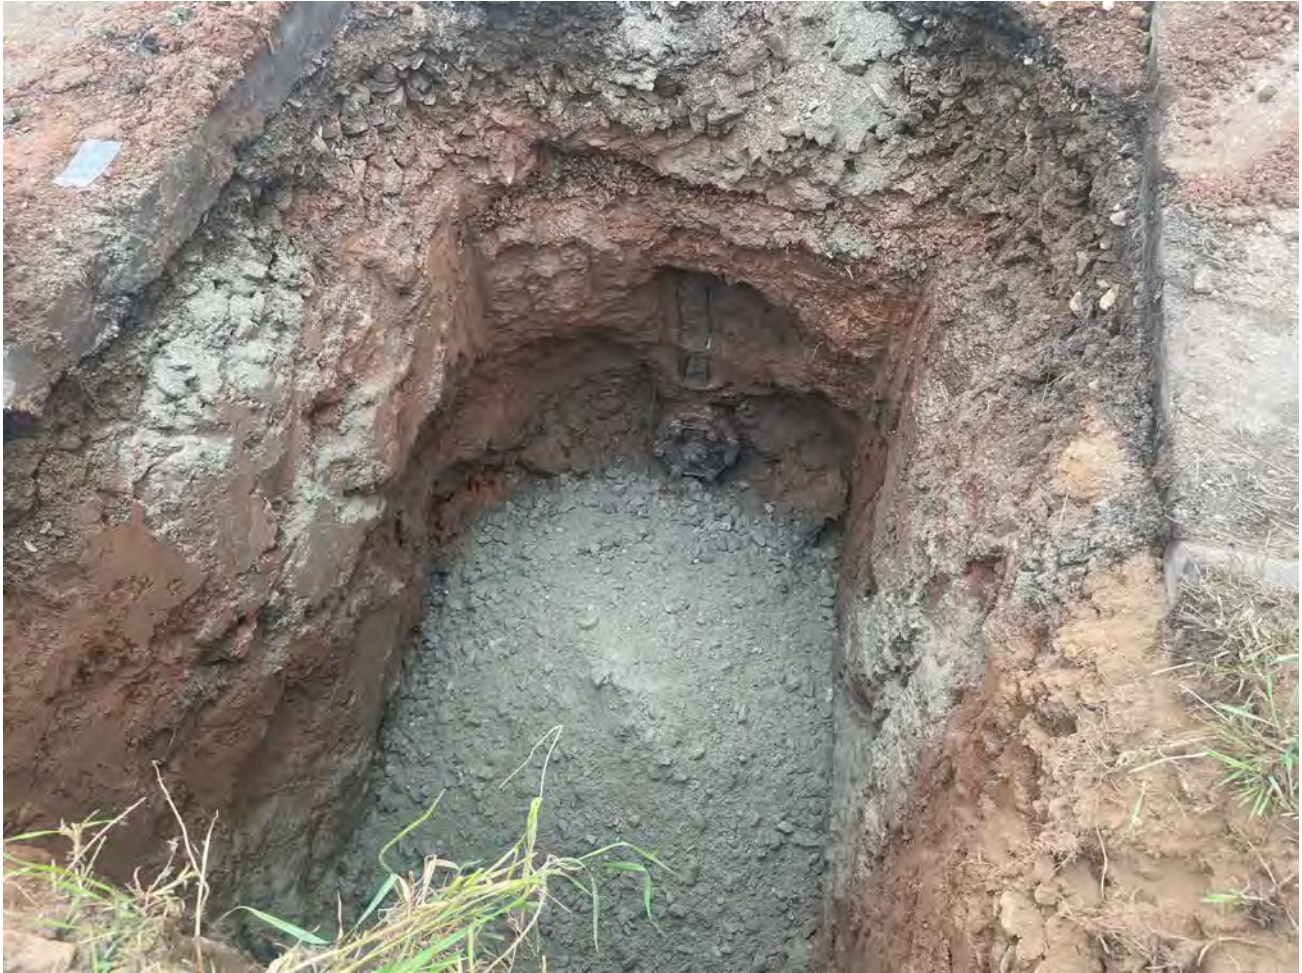
0942: Ludlow has placed a 6" DIP plug onto the gate valve located at Station 604+31. Ludlow is currently backfilling the excavation with -3" gravel and is compacting it with a jumping jack in 1' lifts.

**Picture 4: DIP plug that Ludlow placed on the gate valve located at Station 604+31 on Watch Hill Drive in Middletown. View to the north.**

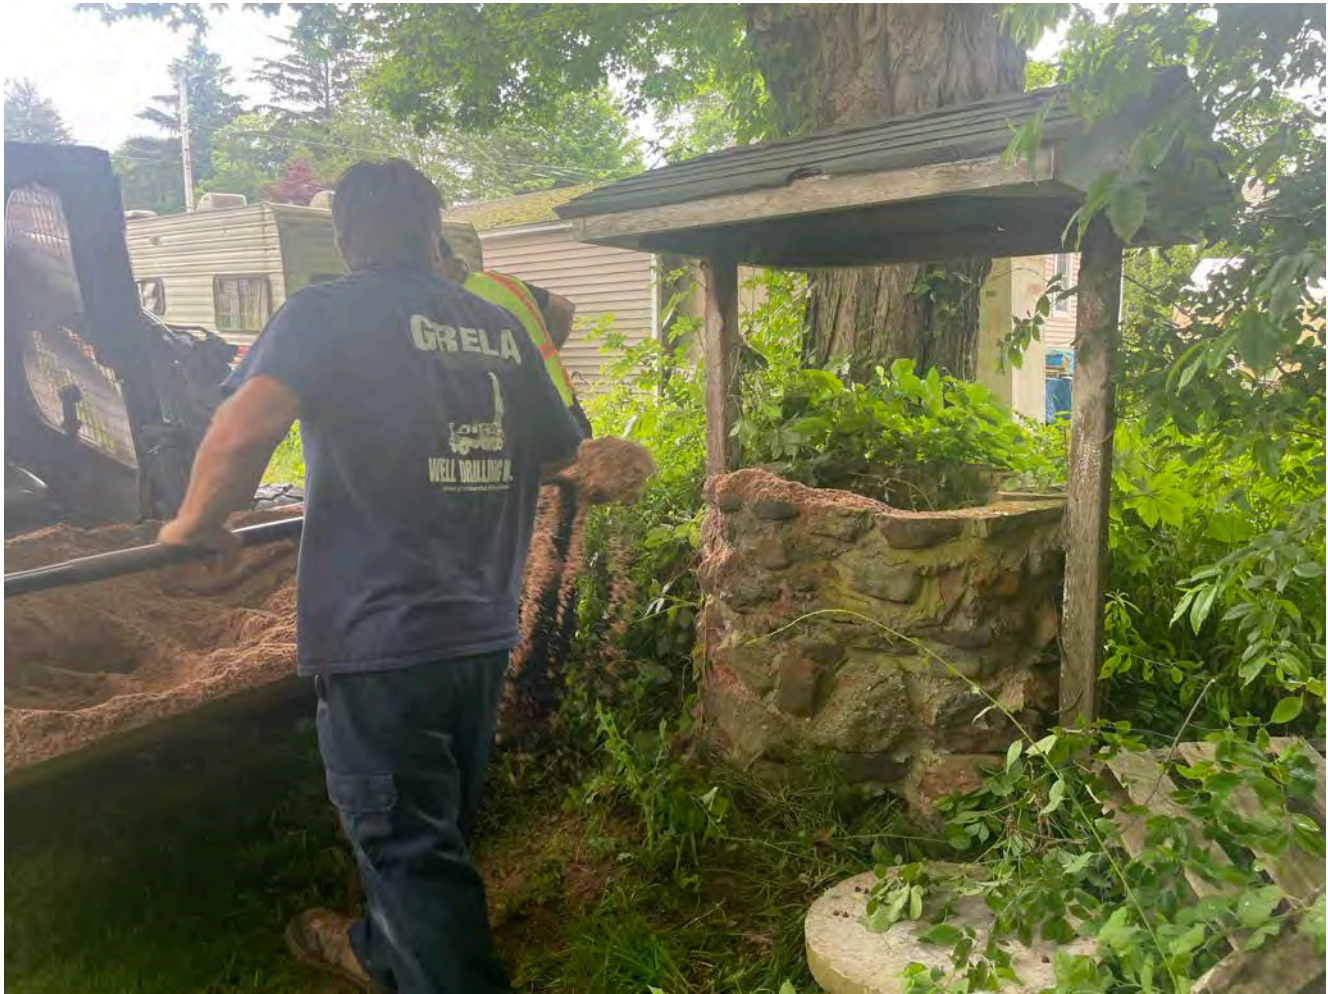
1136: Grela has finished decommissioning the dug well located on the south side of the 176 Maple Avenue residence.

Picture 5: Grela placing sand into the dug well located on the south side of the 176 Maple Avenue property as part of well decommissioning activities. View to the southeast.

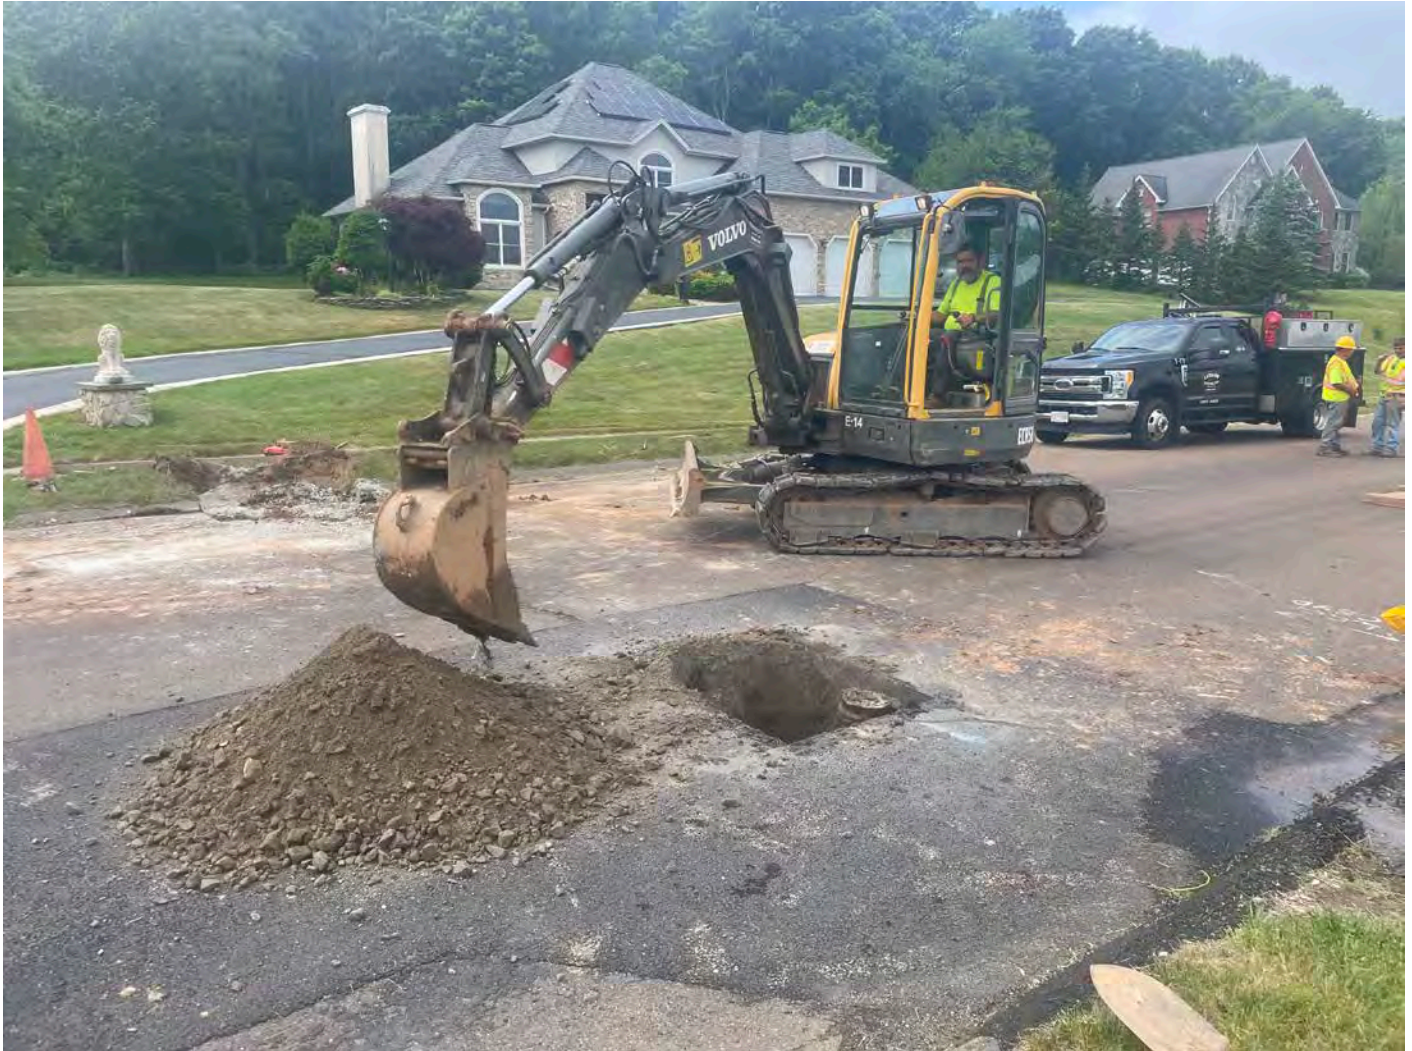
1114: Ludlow begins to excavate around the road box next to the new hydrant at Station 604+31 on the north side of Watch Hill Drive to realign it over the gate valve stem.

1203: Ludlow has finished realigning the road box at Station 604+31 on watch Hill Drive.

**Picture 6: Ludlow excavating to realign a road box on the north side of Watch Hill Drive at Station 604+31. View to the southwest.**

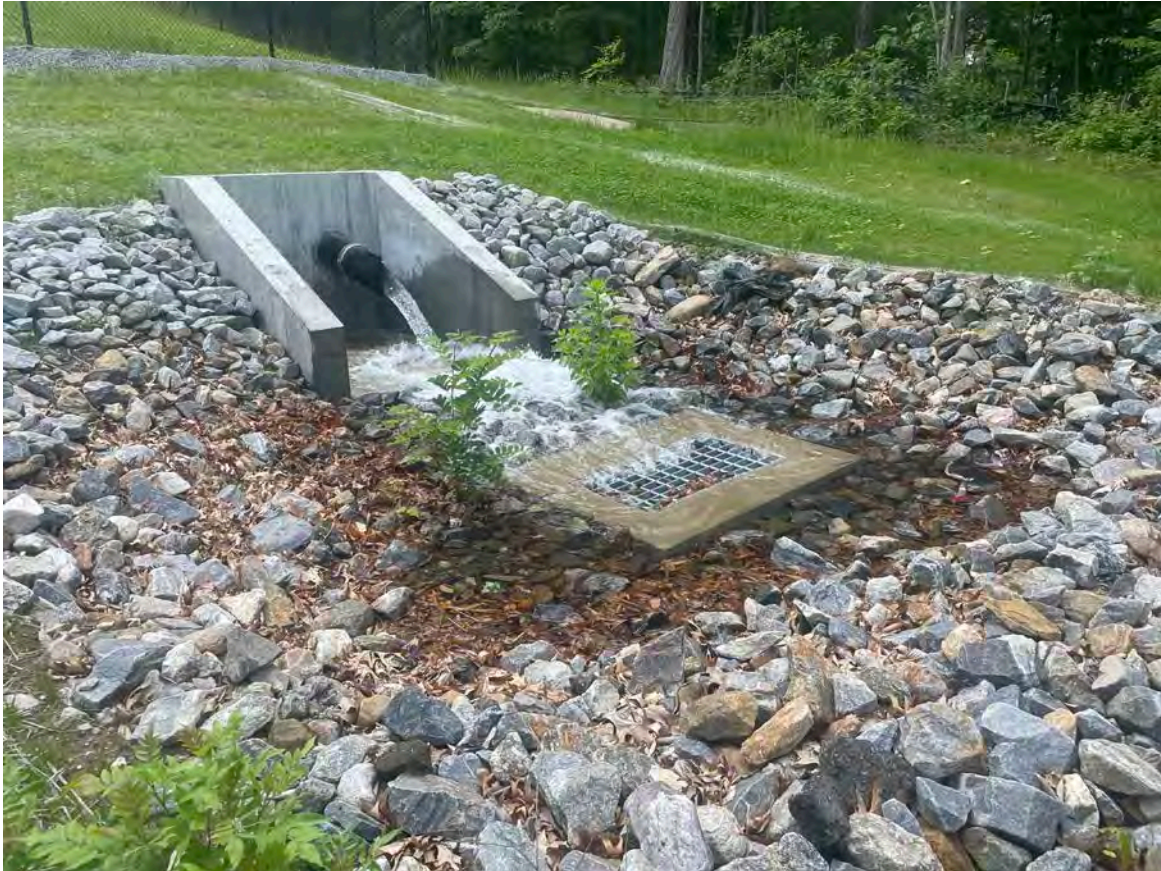
**Picture 7: Water exiting the headwall located at Station 11+72 as Ludlow drains the water tank located east of the Shared Access Driveway in Middletown. View to the southeast.**

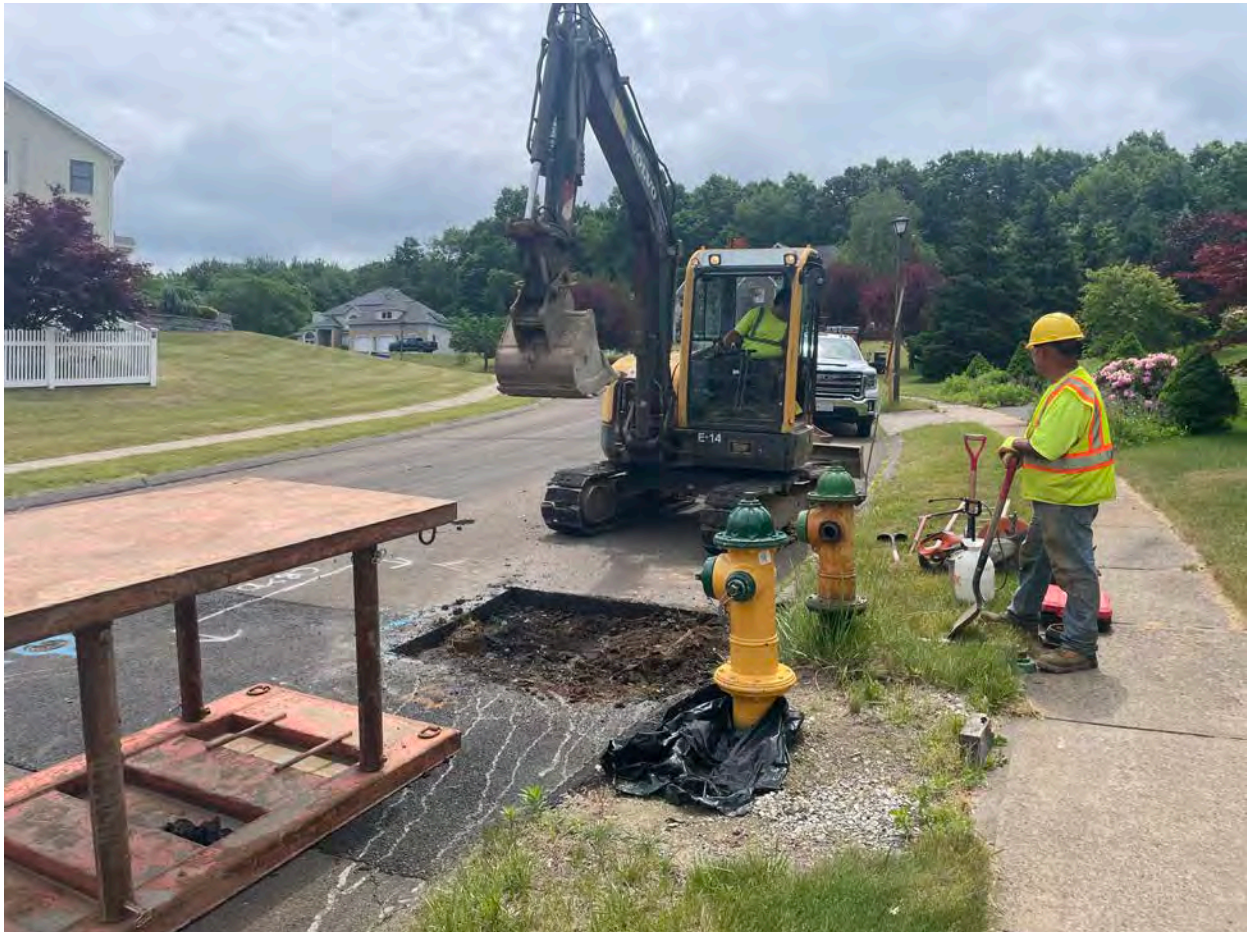
1212: Ludlow is excavating at Station 607+12 on Watch Hill Drive to remove an existing hydrant and remove the 6" DIP water line its connected to.

Picture 8: Ludlow excavating to remove an old hydrant at Station 607+12 on Watch Hill Drive in Middletown. View to the south.

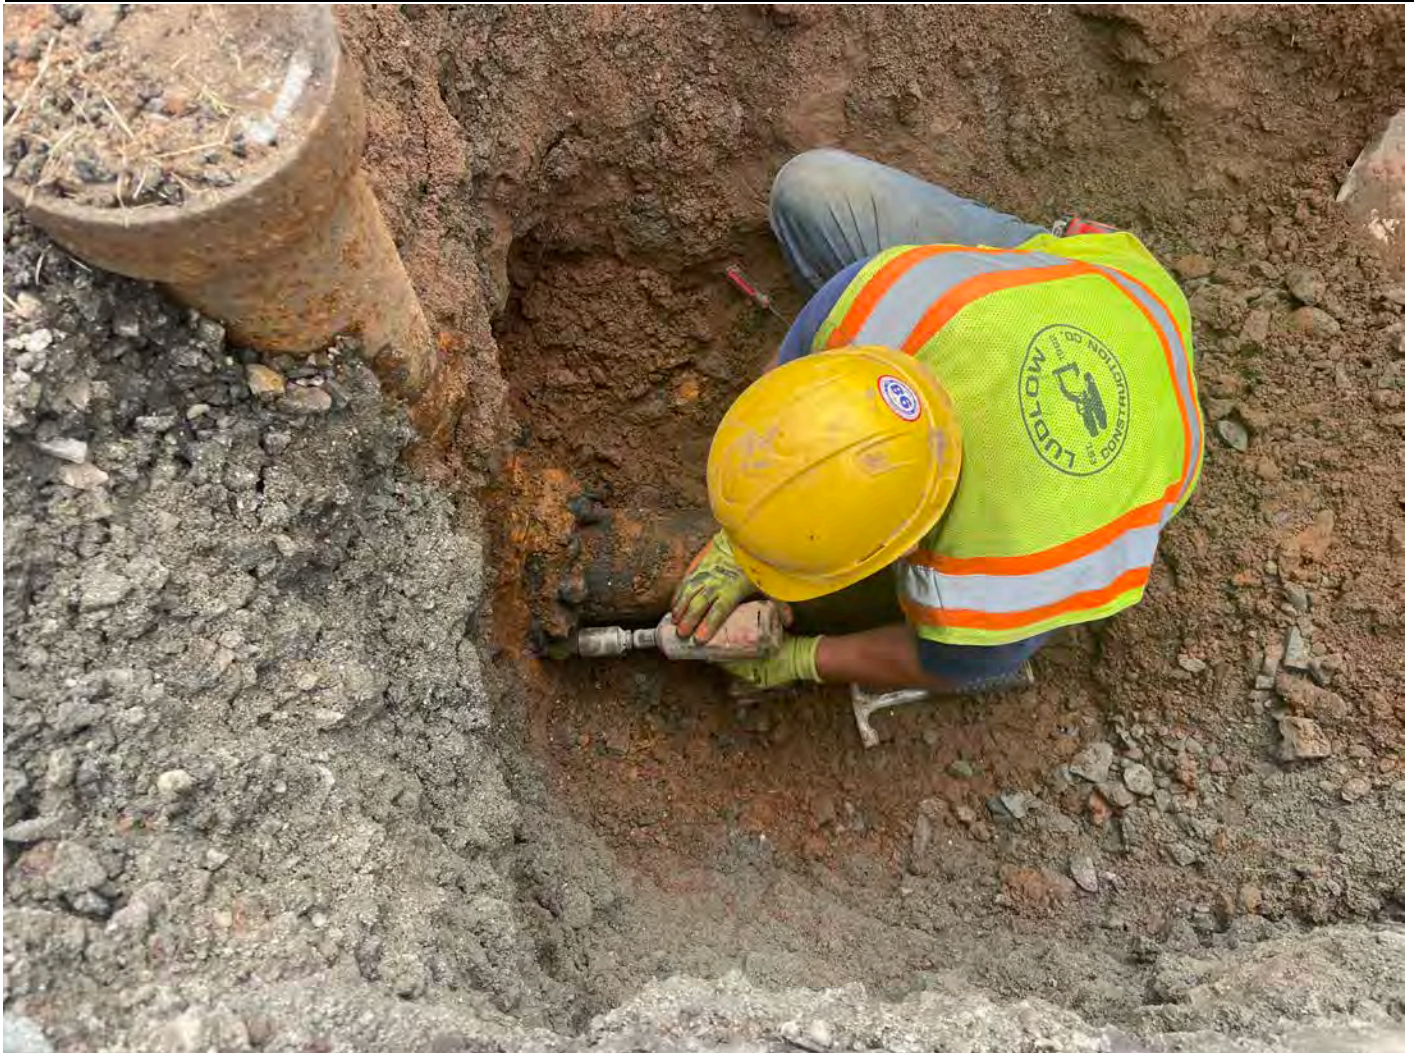
1245: Ludlow has daylighted the 6" DIP water line at Station 607+12 where it connects to a 6" gate valve. Ludlow is currently unbolting the pipe where it connects to the gate valve.

Picture 9: Ludlow unbolting a section of 6" DIP from a gate valve located at Station 607+12 as they continue to decommission the old hydrant located at the same station. View to the south.

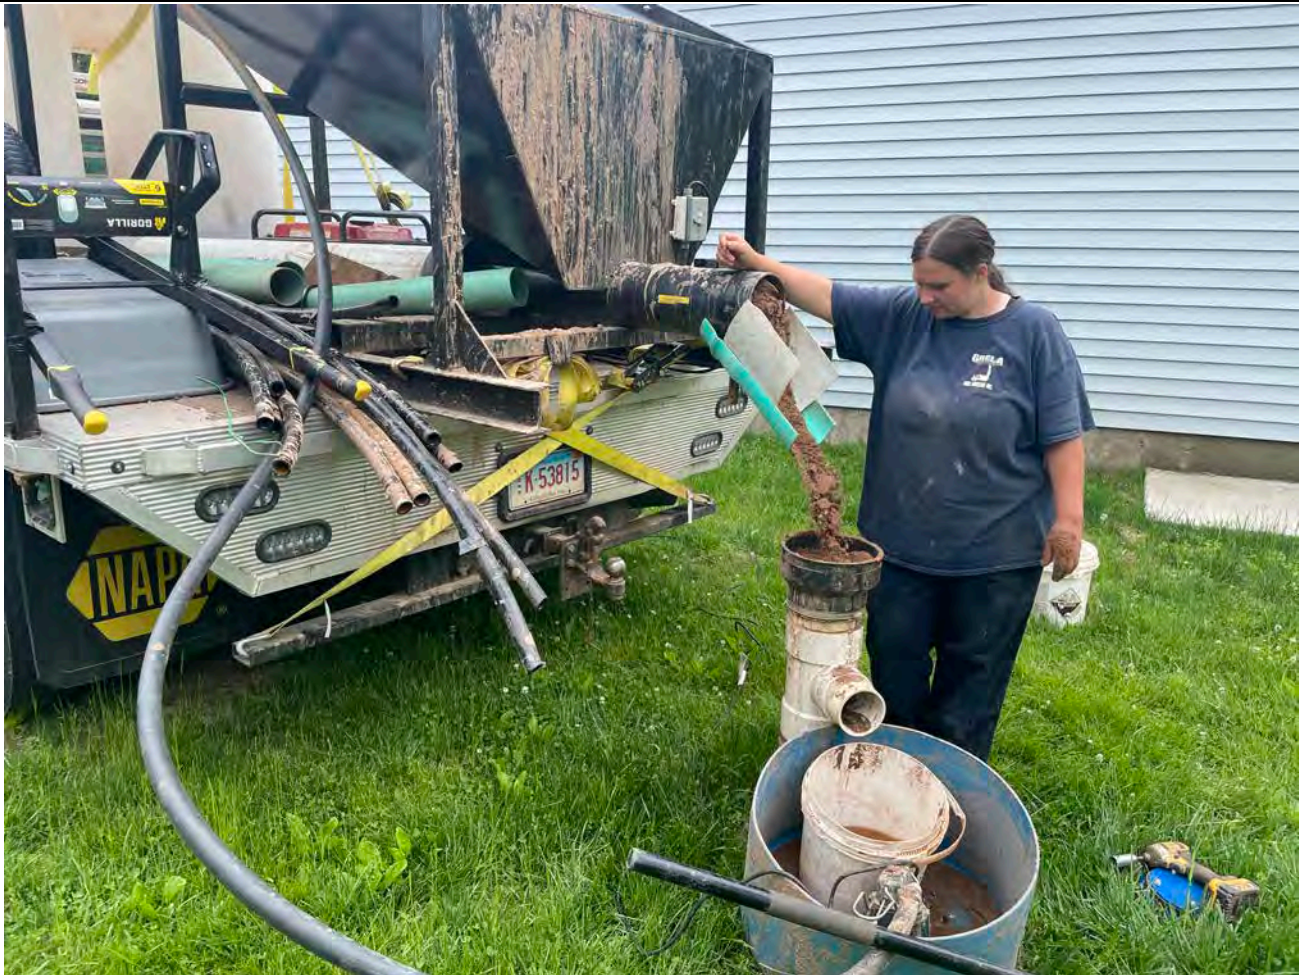
1330: Grela is placing in sand into the well located on the south side of the 212R Maple Avenue property as part of well decommissioning activities.

Picture 10: Grela placing sand into the well located on the south side of the 212R Maple Avenue property as part of well decommissioning activities. View to the southeast.

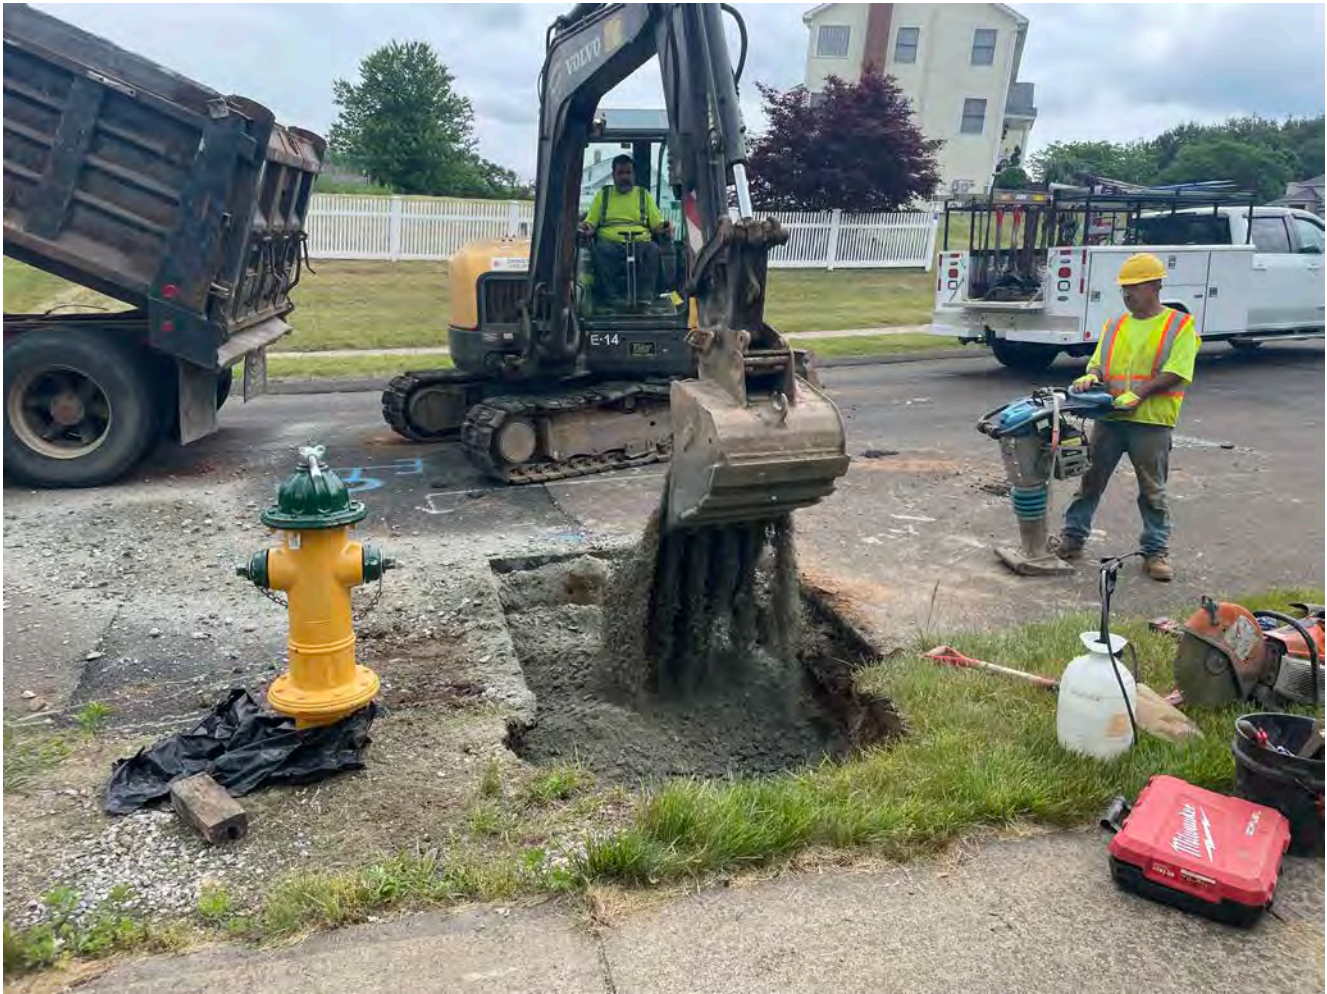
1342: Ludlow is backfilling the excavation at Station 607+12 with -3" gravel that they are compacting in 1' lifts. The hydrant has been removed and a 6" DIP plug has been placed on the gate valve.

Picture 11: Ludlow backfilling the excavation they made during the removal of a hydrant Station 607+12 on Watch Hill Drive. View to the southeast.

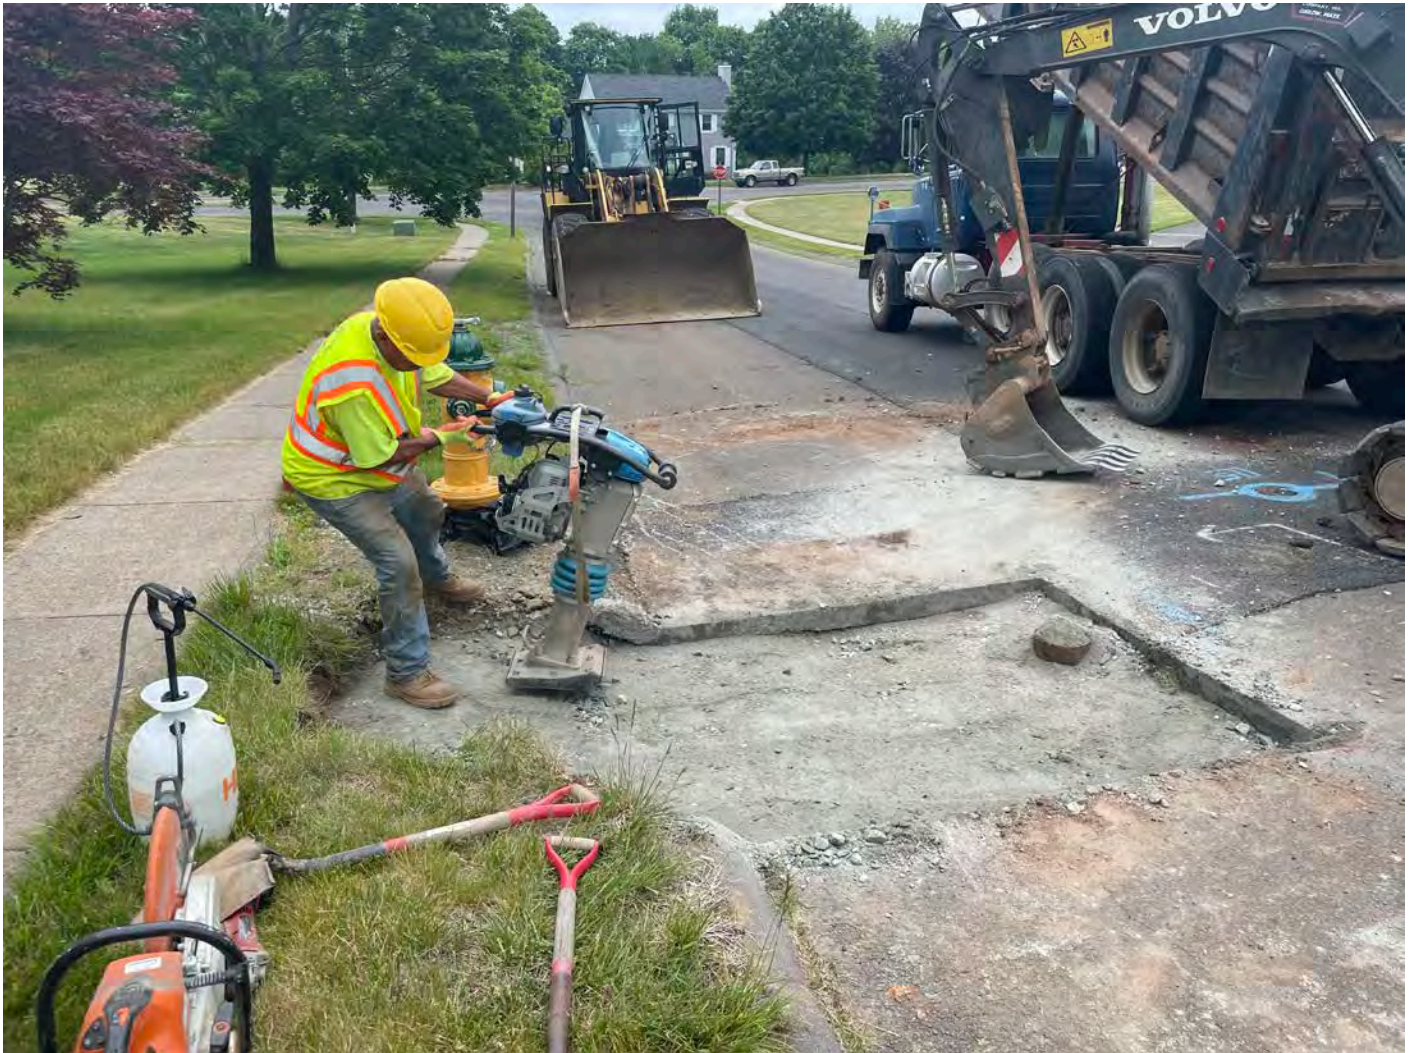
Picture 12: Ludlow backfilling the excavation they made during the removal of a hydrant Station 607+12 on Watch Hill Drive. View to the north.
