Daily Report

Project:	Durham Meadows Pipeline Installation	Date:	June 27, 2022
Location:	Maple Avenue and Maiden Lane, Durham	Day of Week:	Monday
Project #:	AECOM: 6061487	Report No:	455
Contractor:	Ludlow Construction	Page:	1 of 7

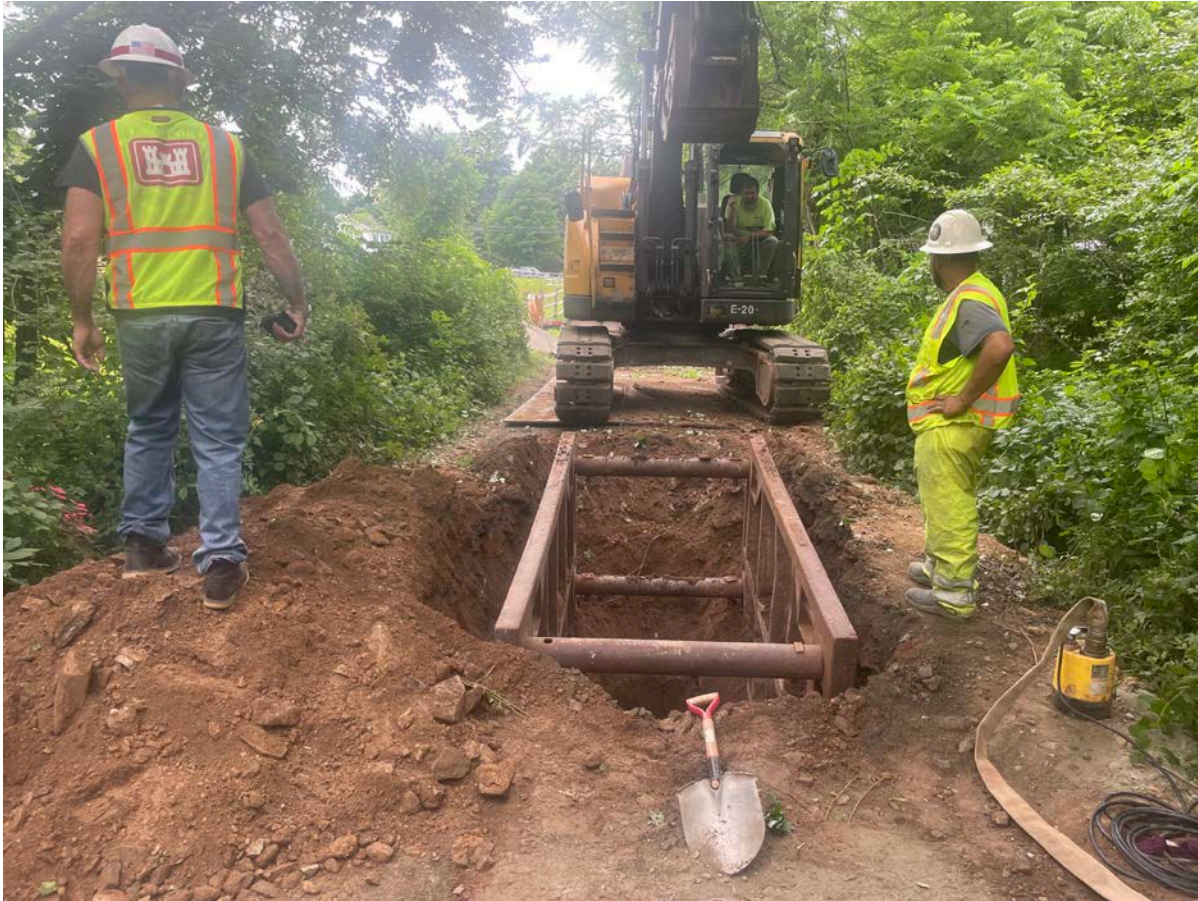
0952: Ludlow continues efforts to install a 2" copper water service line at the 114 Maiden Lane property. Ludlow is currently excavating on the south side of the Ball Brook culvert located on the 114 Maiden Lane driveway. Ludlow has placed a trench box in the excavation.

Picture 1: Trench box that Ludlow has just placed into an excavation they made on the north side of the Ball Brook Culvert located on the 114 Maiden Lane, Durham, driveway as they continue to install a 2" copper water service line. View to the south.

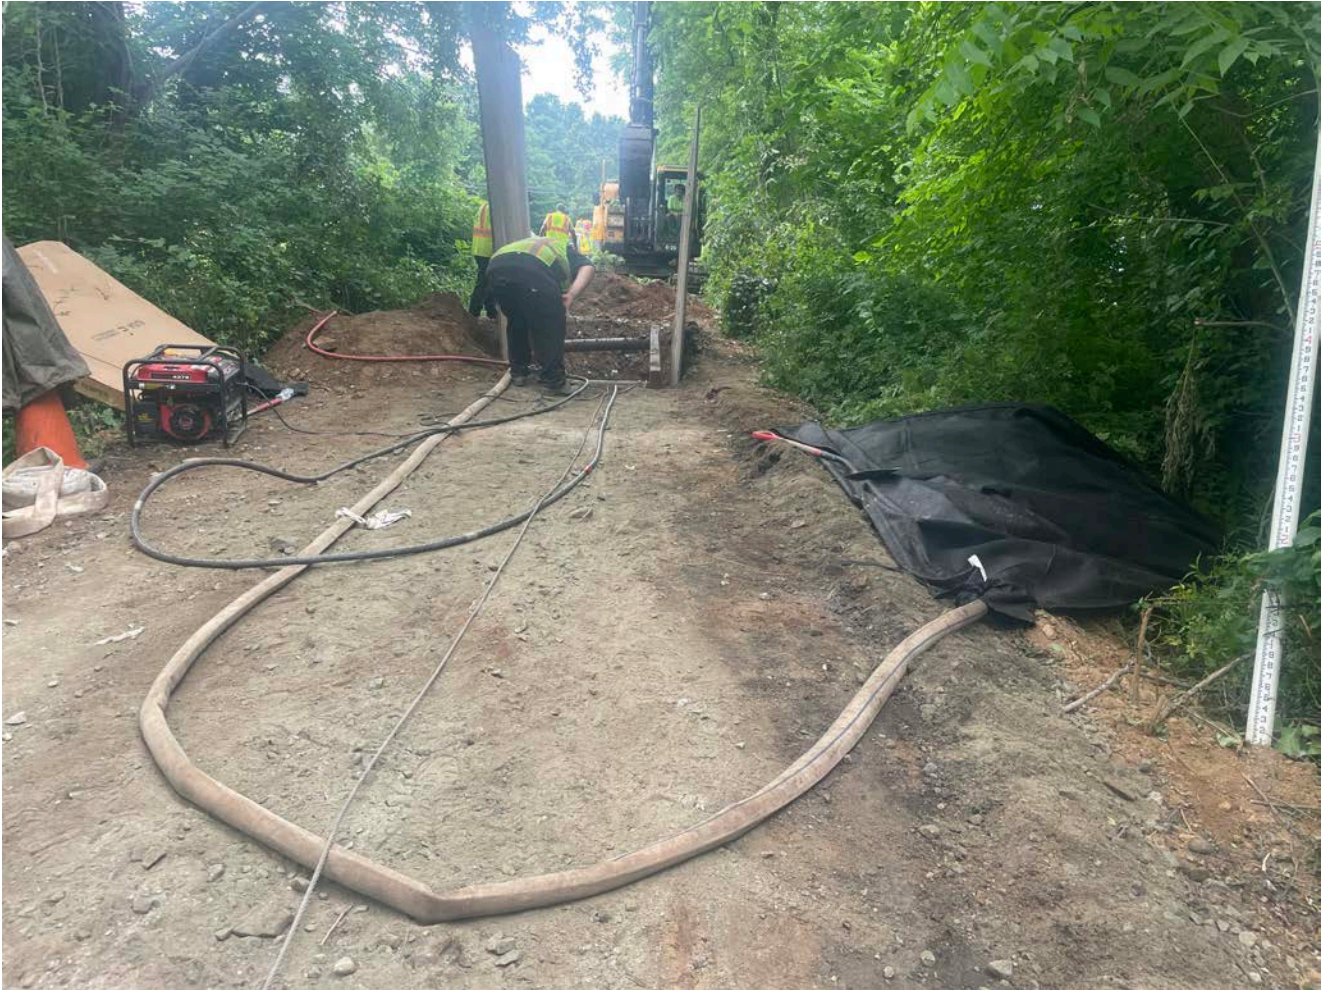
0955: Ludlow is pumping water from the hole they excavated on the south side of the Ball Brook culvert. The water is being pumped into a filter bag they placed on the west side of the driveway.

Picture 2: Ludlow pumping water from the excavation they made on the north side of the 114 Maiden Lane, Durham, driveway as they work to install a 2" copper water service line. The water is being pumped to the west side of the road through a filter bag. View to the south.

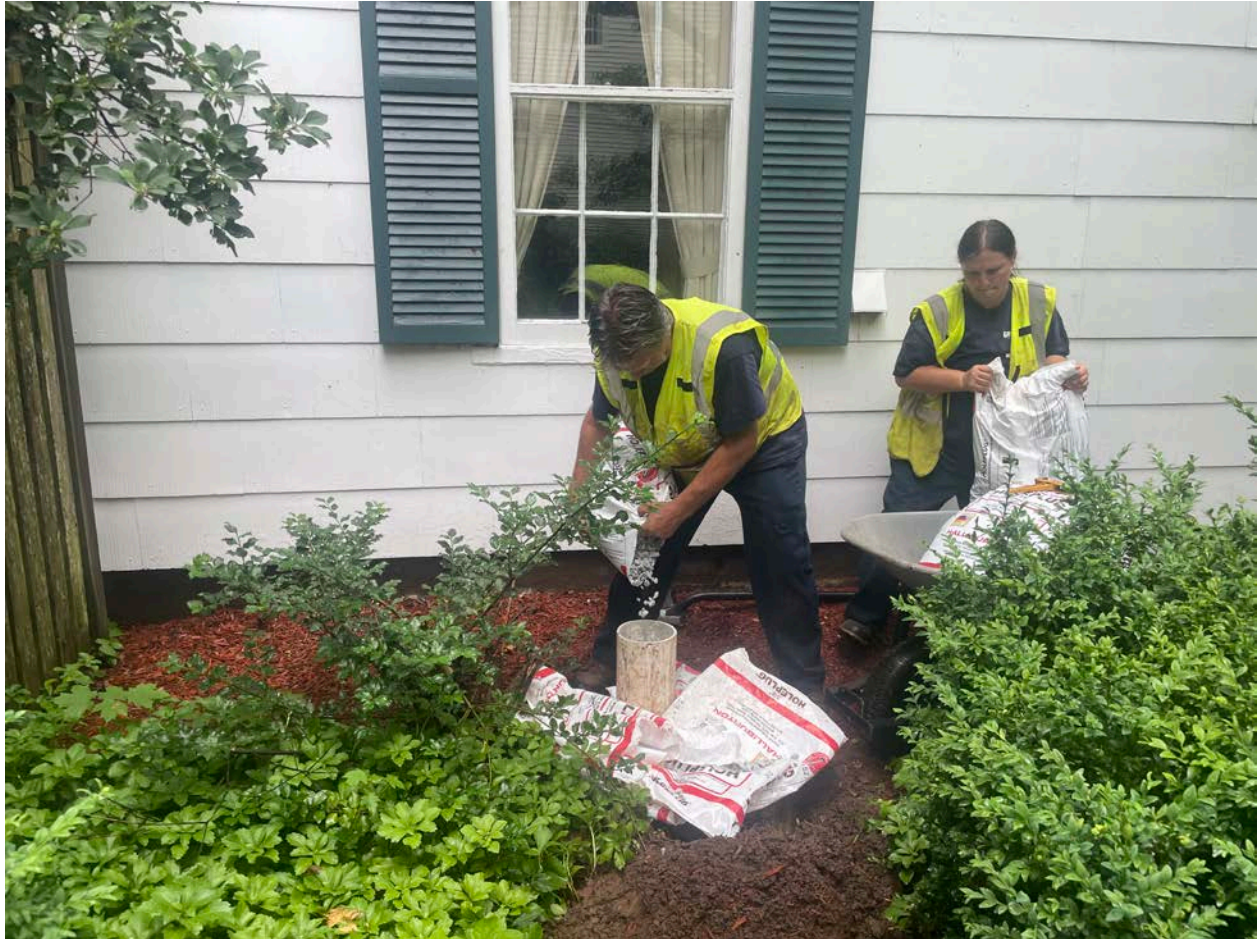
1227: Grela has finished placing sand into the well located on the south side of the 252 Main Street residence and has begun to place bentonite chips into the well to complete well decommissioning activities.

Picture 3: Grela placing bentonite chips into the well located on the south side of the 252 Main Street, Durham, residence as part of well decommissioning activities. View to the north.

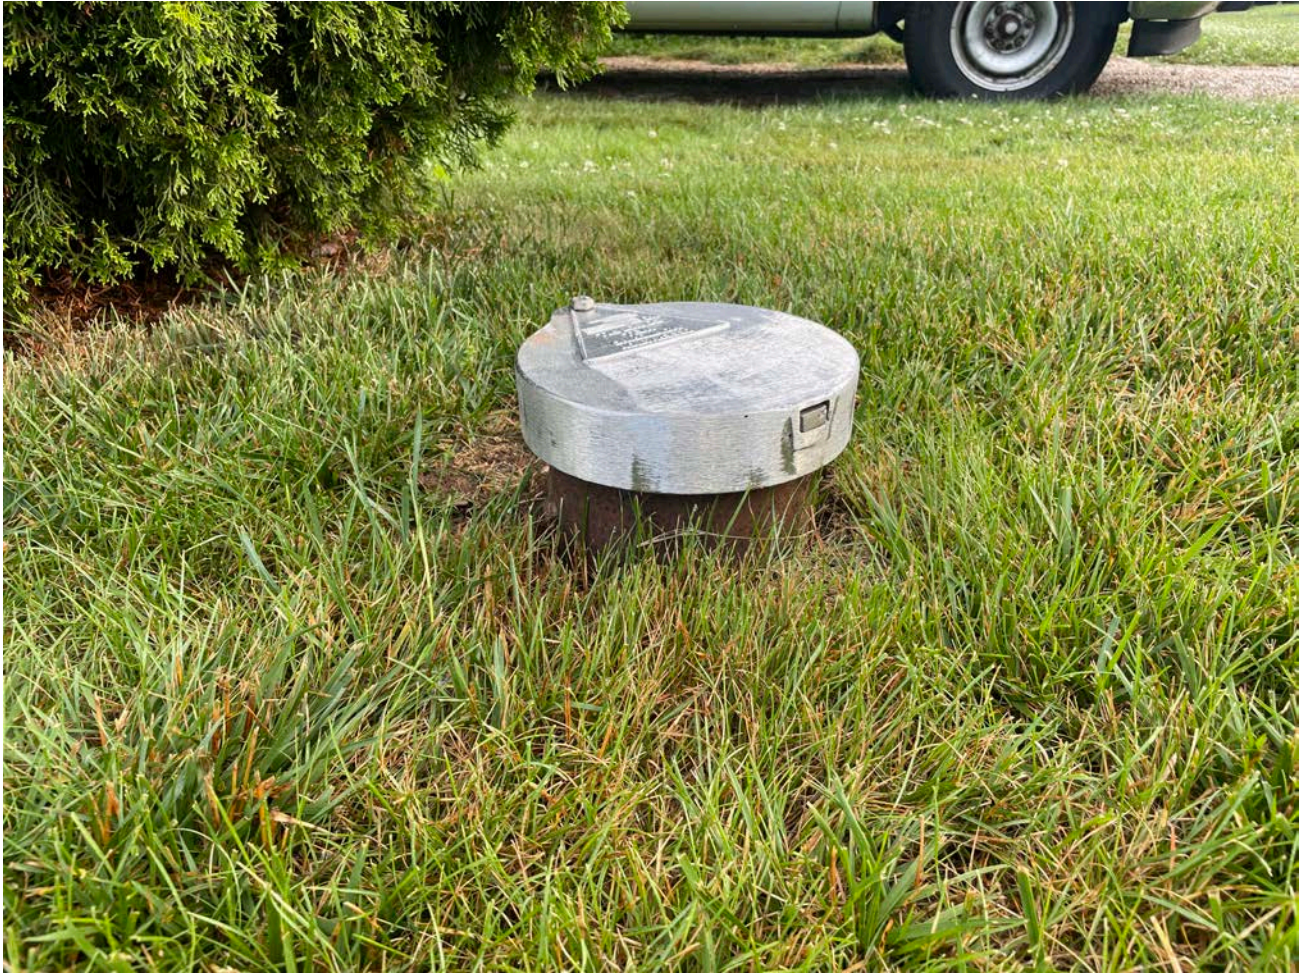
1123: Grela has placed a lockable lid onto the top of the well casing located to the north of the 166 Maple Avenue, Durham, residence

Picture 4: Lockable cap that Grela placed on top of the casing of the well located on the north side of the 166 Maple Avenue, Durham, property. View to the northwest.

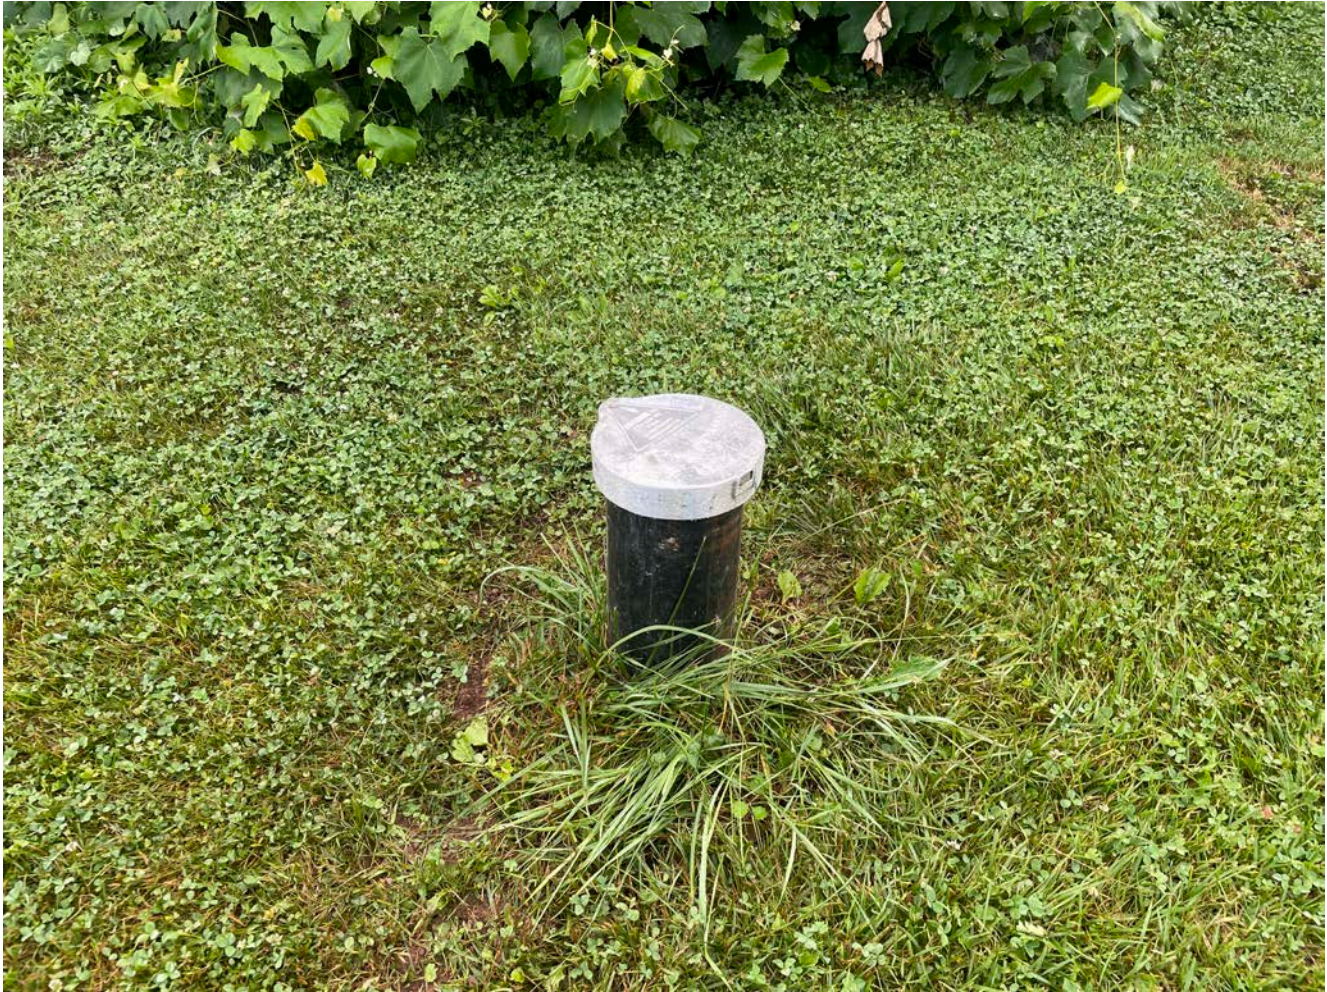
1331: Grela is working on the well casing located on the south side of the 110 Maple Avenue residence, welding a new section of steel riser to the existing well casing. Grela also placed a lockable lid onto the top of the new well riser.

Picture 5: Lockable cap that Grela placed on top of a new section of steel riser that they welded onto the well located on the south side of the 110 Maple Avenue, Durham, property. View to the north.
