## Daily Report

<b>Project:</b>	Durham Meadows Pipeline Installation	<b>Date:</b>	September 12, 2022
<b>Location:</b>	Main Street, Pickett Lane, and Maple Avenue, Durham; S. Main Street, Middletown	<b>Day of Week:</b>	Monday
<b>Project #:</b>	AECOM: 6061487	<b>Report No:</b>	507
<b>Contractor:</b>	Ludlow Construction	<b>Page:</b>	1 of 18

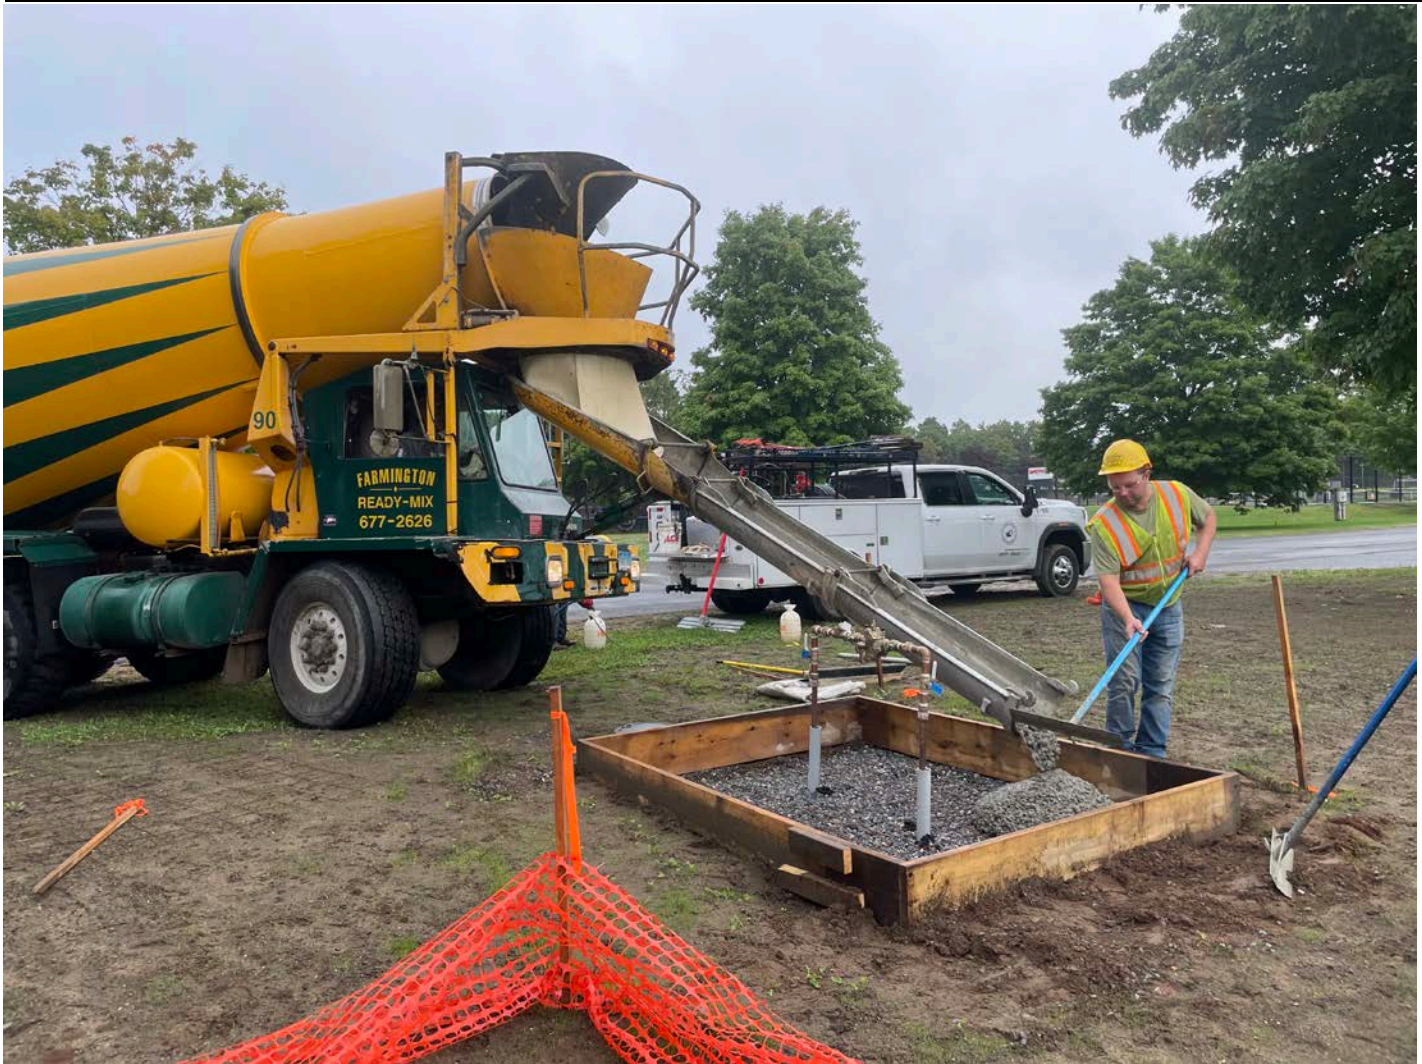
0820: Farmington Ready Mix begins to place concrete within the form that was set around the backflow preventer located at Station 517+73. The base of the form has ¾" stone and 4"-wire mesh reinforcement.

**Picture 1: Farmington Ready Mix placing 4000 PSI concrete into a form that was built around the backflow preventer located on the south side of Pickett Lane, Durham, at Station 517+73. View to the northeast.**

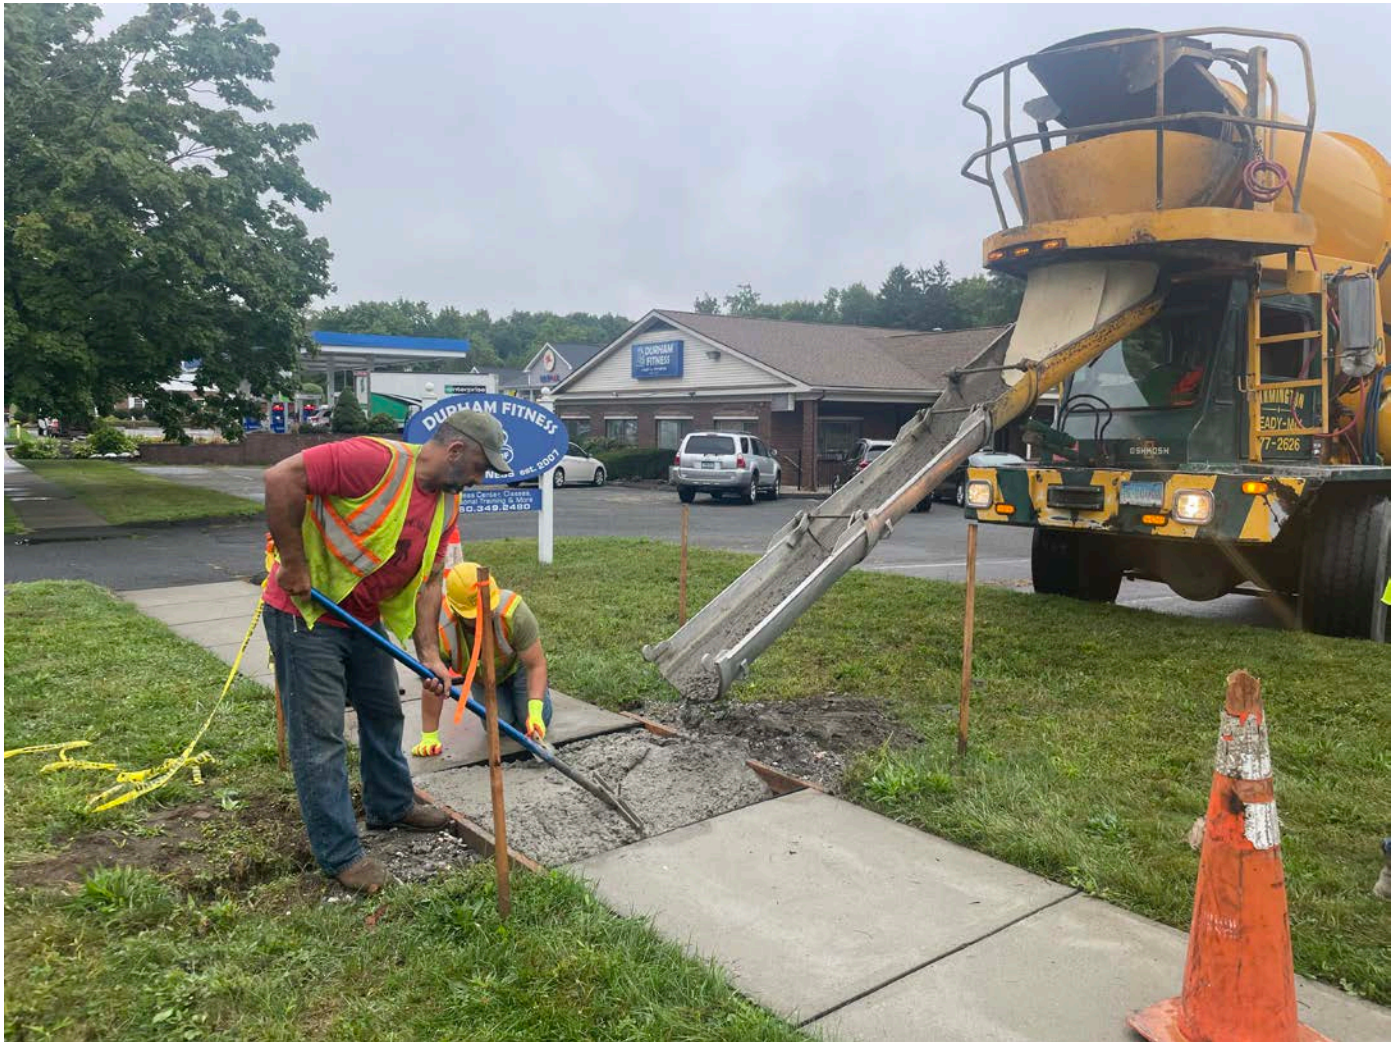
0839: Farmington Ready Mix is pouring 4000 psi concrete into a single panel of the sidewalk located between 331 and 339 Main Street, Durham.

Picture 2: 4000 PSI concrete being placed on a section of the sidewalk located between 331 and 339 Main Street in Durham. View to the southwest.

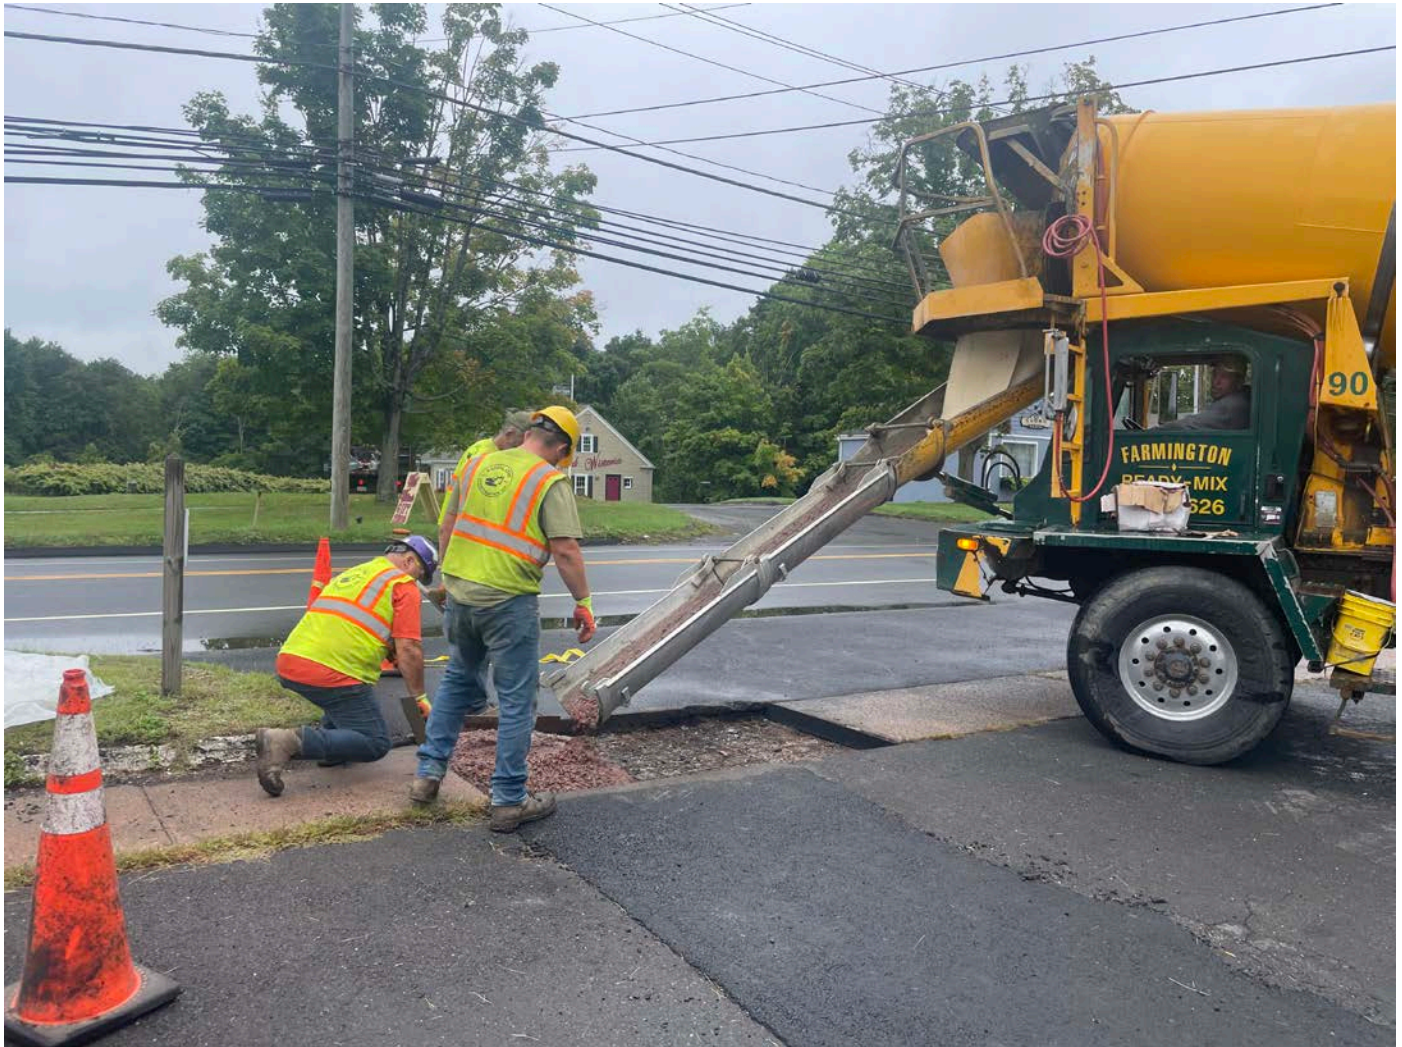
0908: Farmington Ready Mix is pouring tinted 4000 psi concrete on a section of the sidewalk located in front of the 336 Main Street, Durham, property.

Picture 3: 4000 PSI concrete being placed on a section of the sidewalk located in front of 336 Main Street in Durham. View to the southeast.

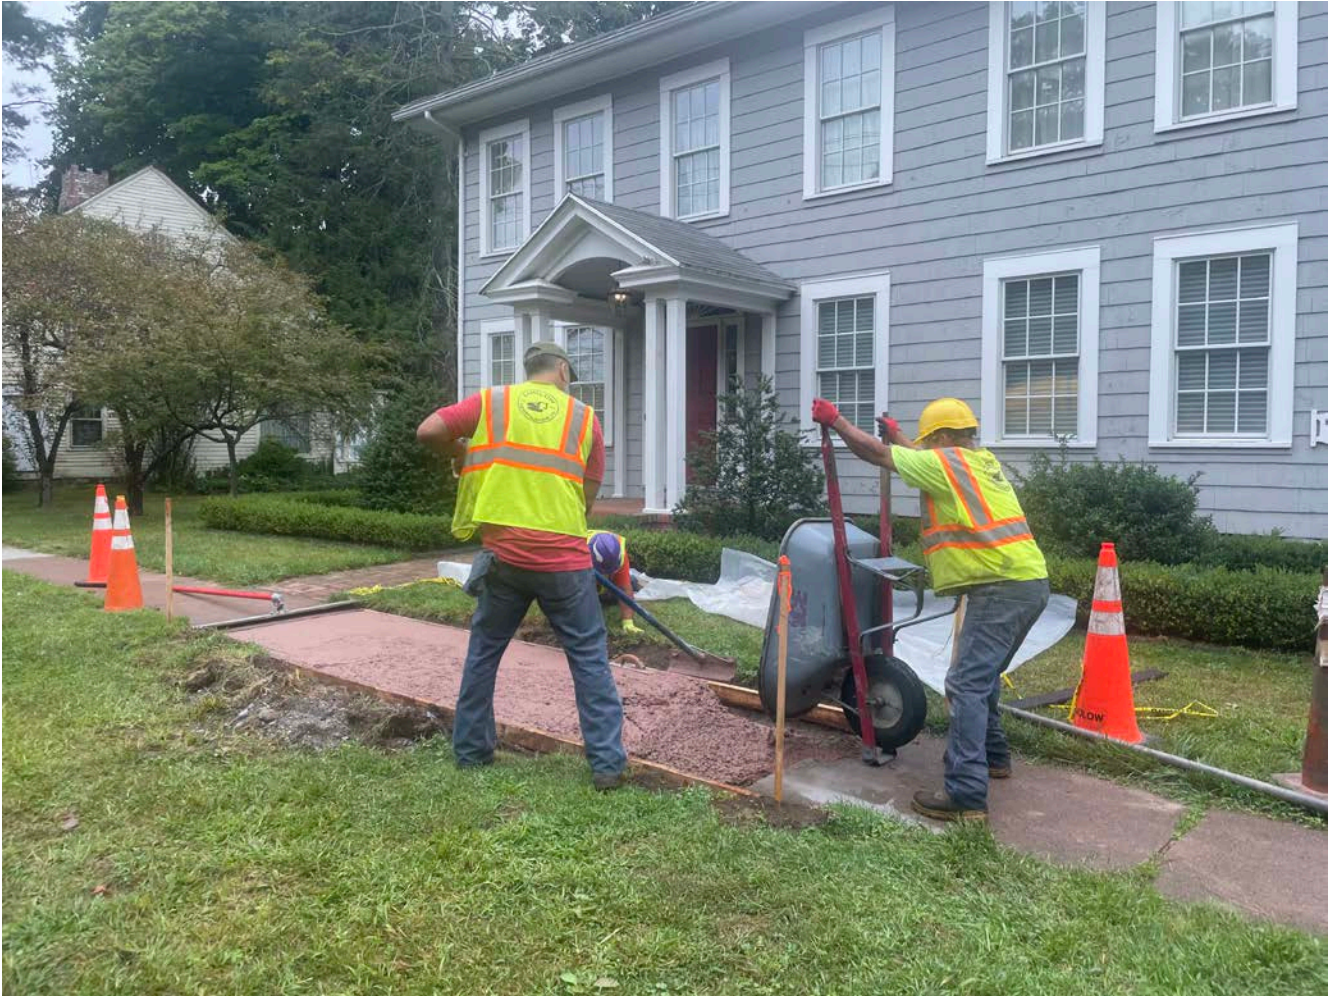
0922: Farmington Ready Mix is pouring tinted 4000 psi concrete on a section of the sidewalk located in front of the 293 Main Street, Durham, property.

Picture 4: Ludlow placing 4000 PSI concrete on a section of the sidewalk located in front of the 293 Main Street residence in Durham. View to the northeast.

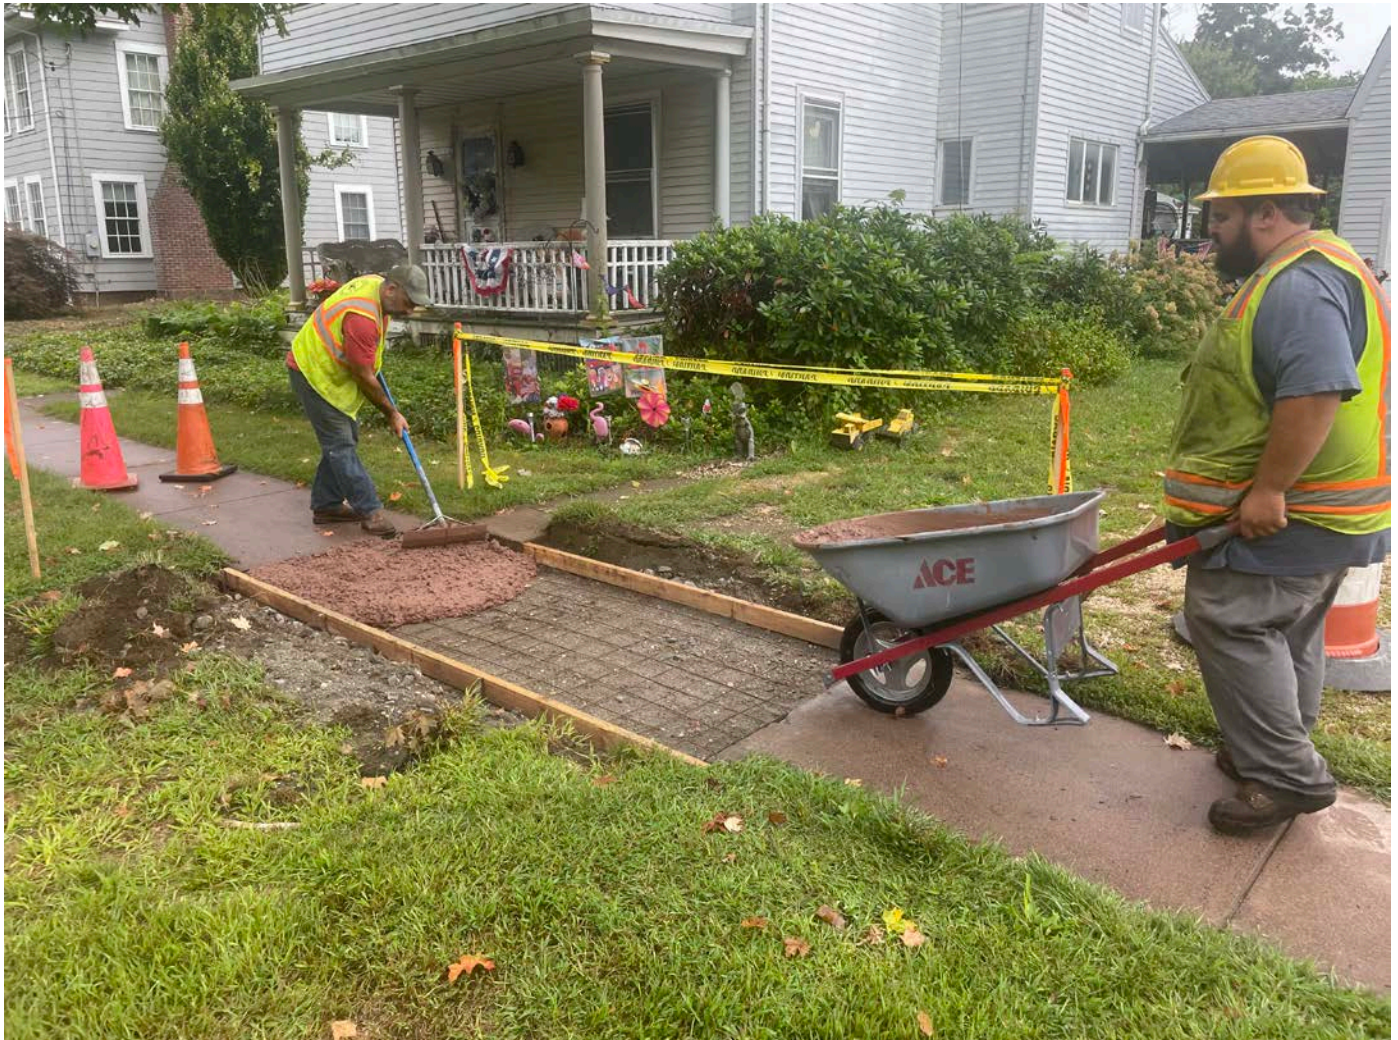
0927: Farmington Ready Mix is pouring tinted 4000 psi concrete on a section of the sidewalk located in front of the 289 Main Street, Durham, property.

Picture 5: Ludlow placing 4000 PSI concrete on a section of the sidewalk located in front of the 289 Main Street residence in Durham. View to the northeast.

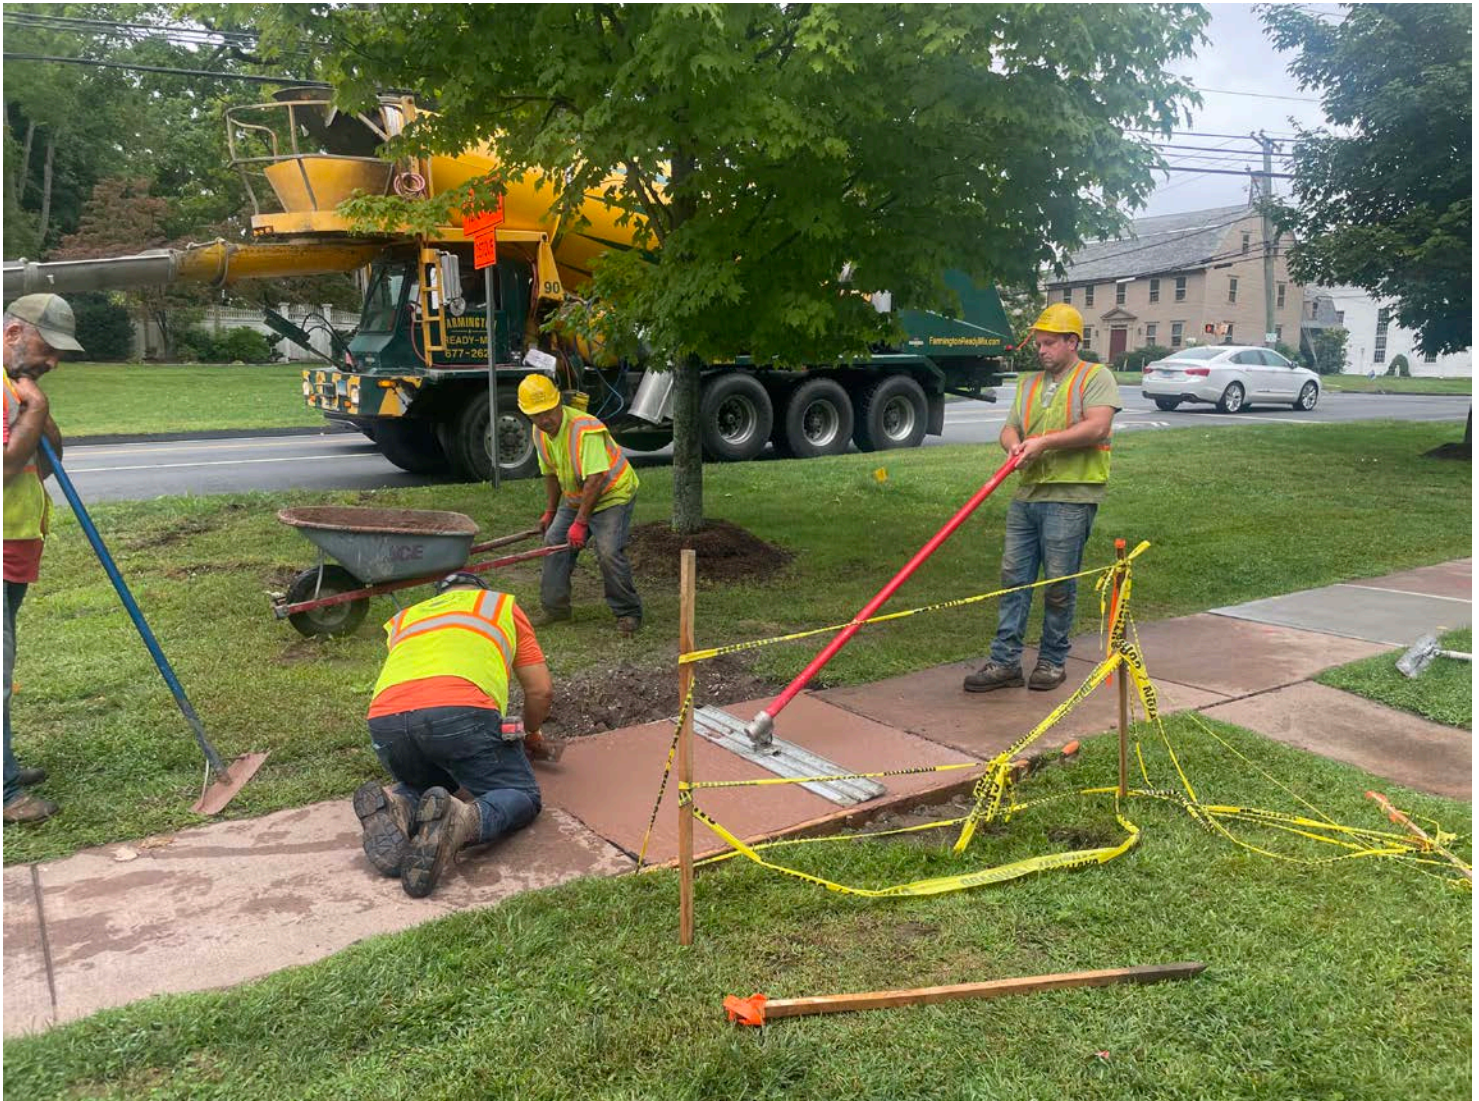
Picture 6: Ludlow leveling 4000 PSI concrete that they placed on a section of the sidewalk located in front of the 215 Main Street residence in Durham. View to the northwest.

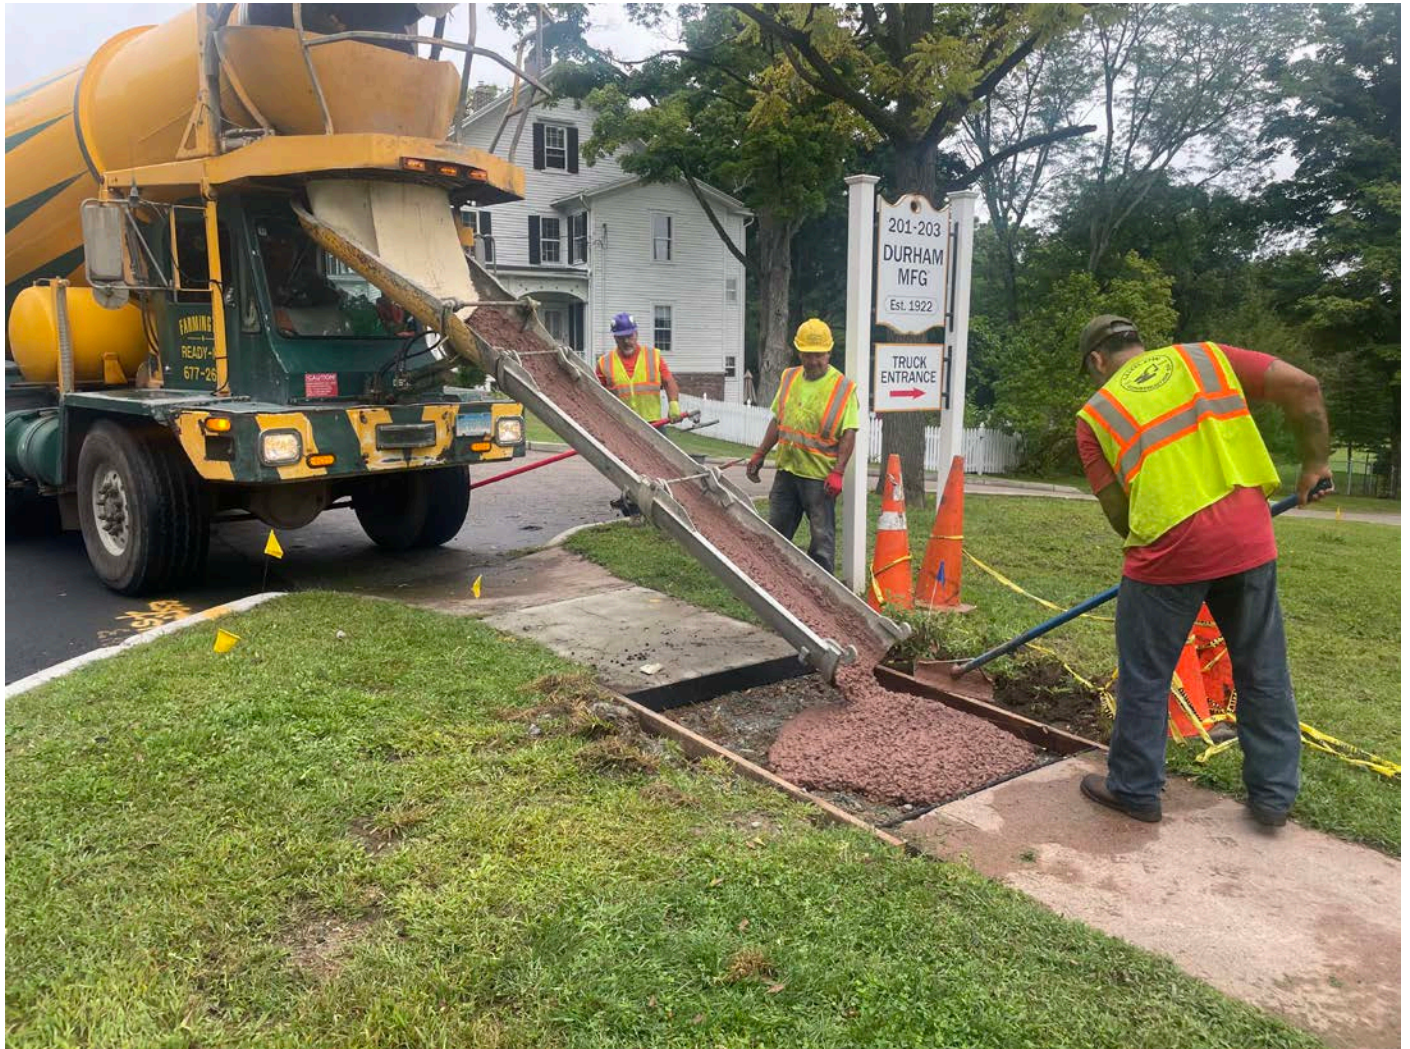
Picture 7: Ludlow placing 4000 PSI concrete on a section of the sidewalk located in front of the 201-203 Main Street property in Durham. View to the northeast.

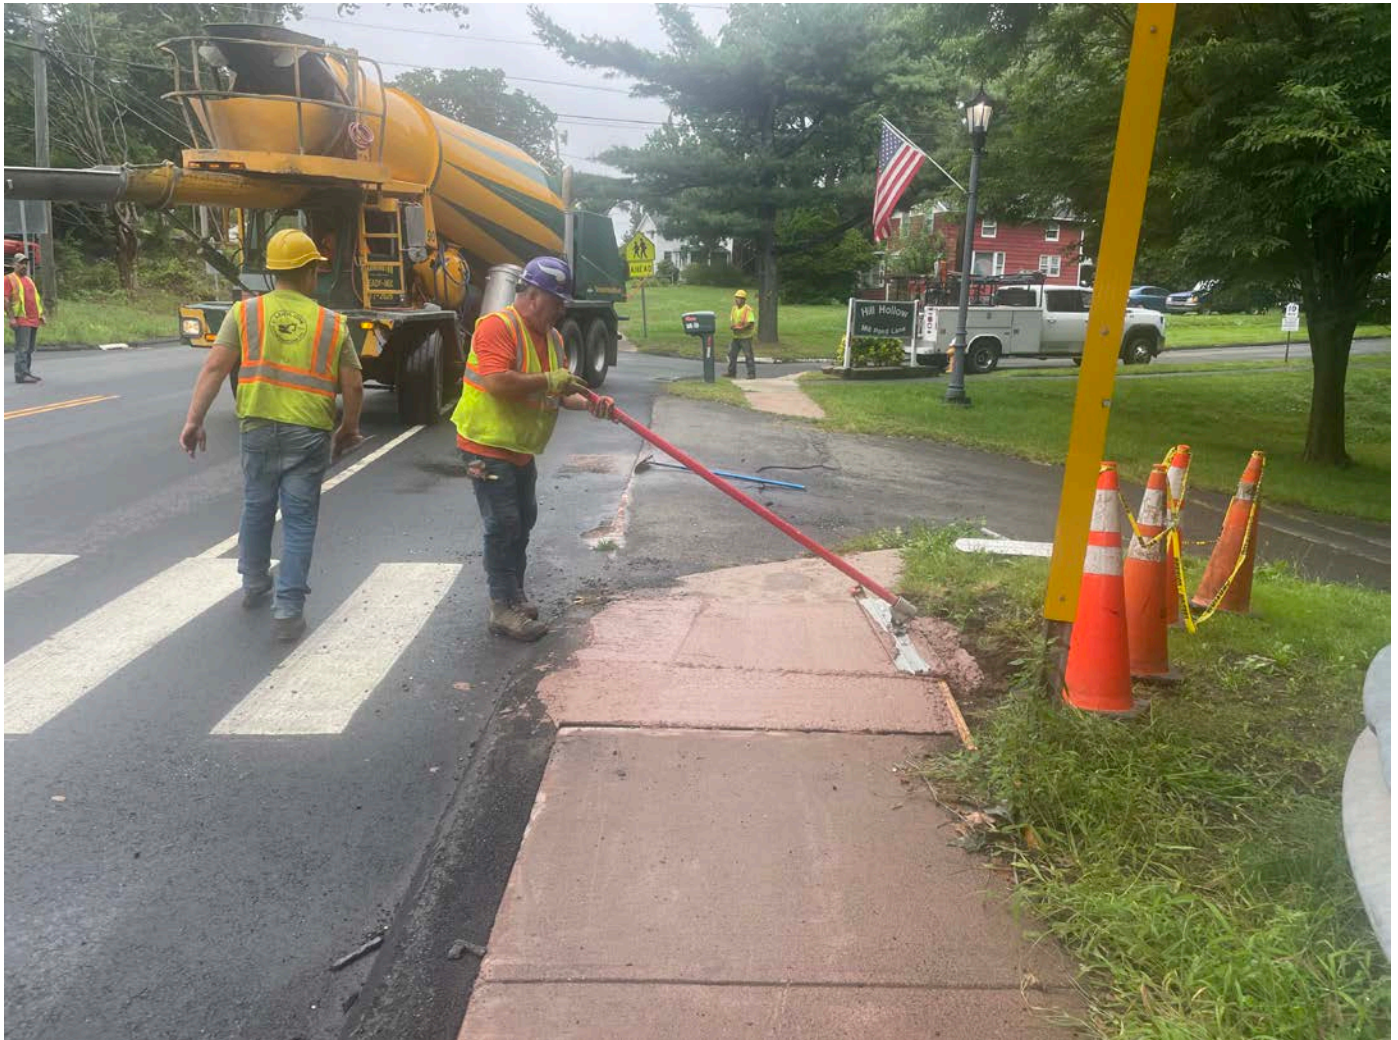
Picture 8: Ludlow leveling 4000 PSI concrete that they placed on a section of the sidewalk located in front of the 153 Main Street residence in Durham. View to the north.

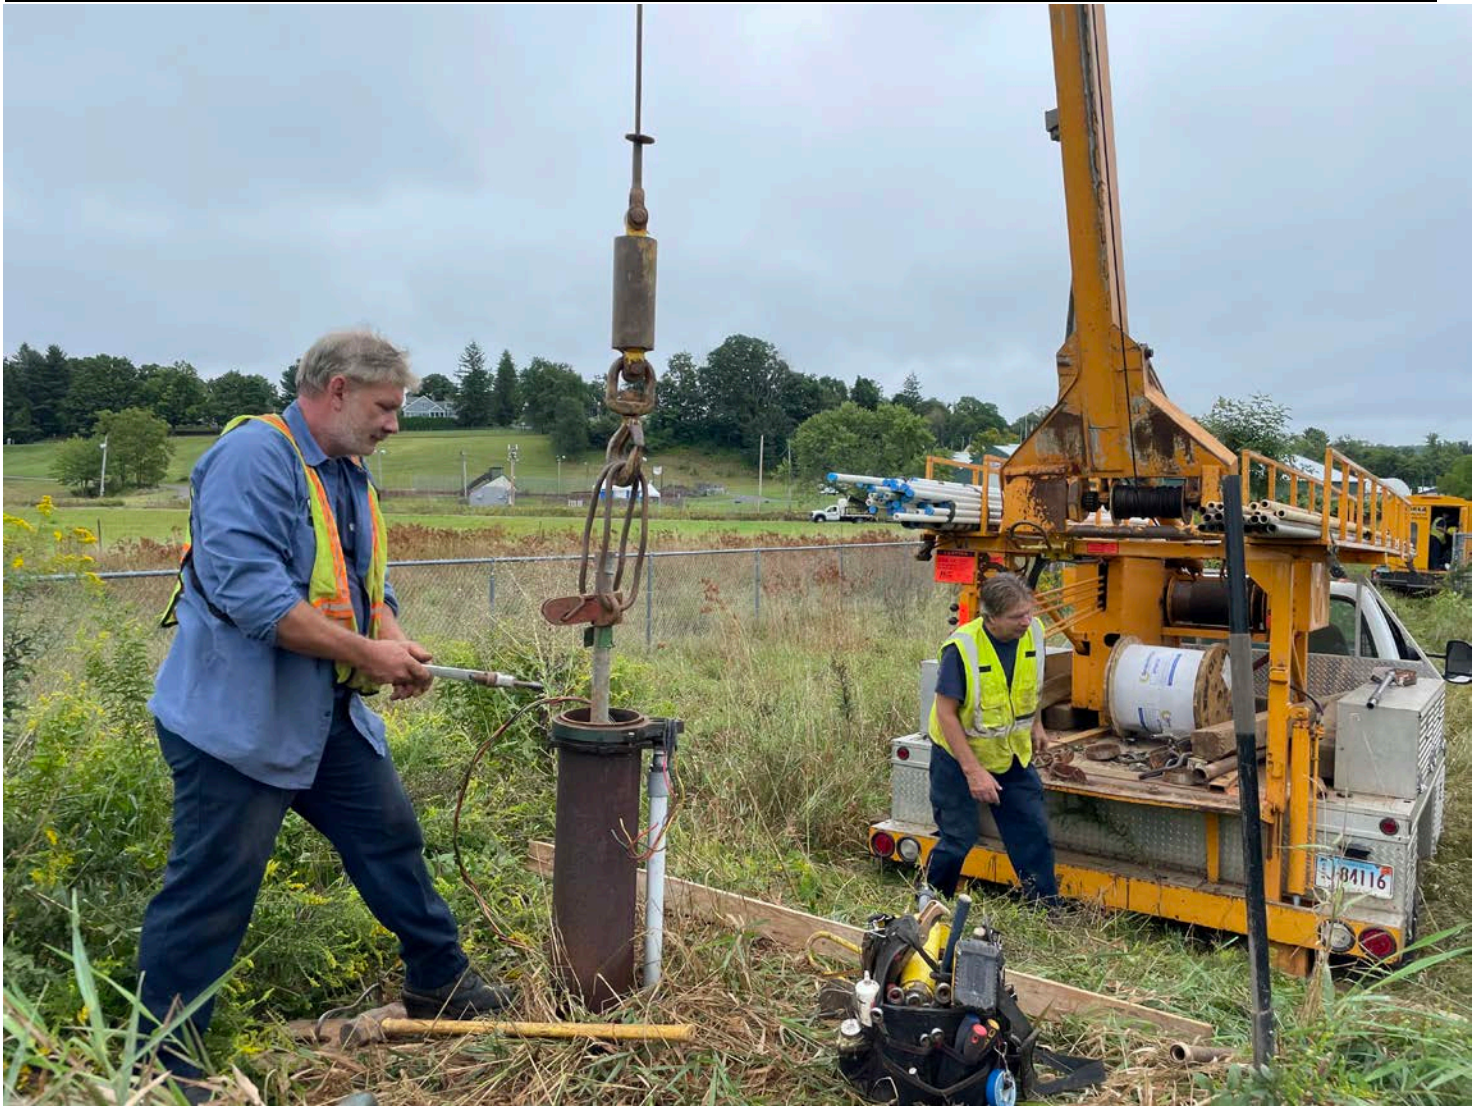
1101: Grela was unable to pull the pump on the easternmost of the two wells located at the Durham fairgrounds as the pitless adapter appears to be stuck.

Picture 9: Grela attempting to pull the pump from the easternmost of the two Durham Fairground wells. View to the east.

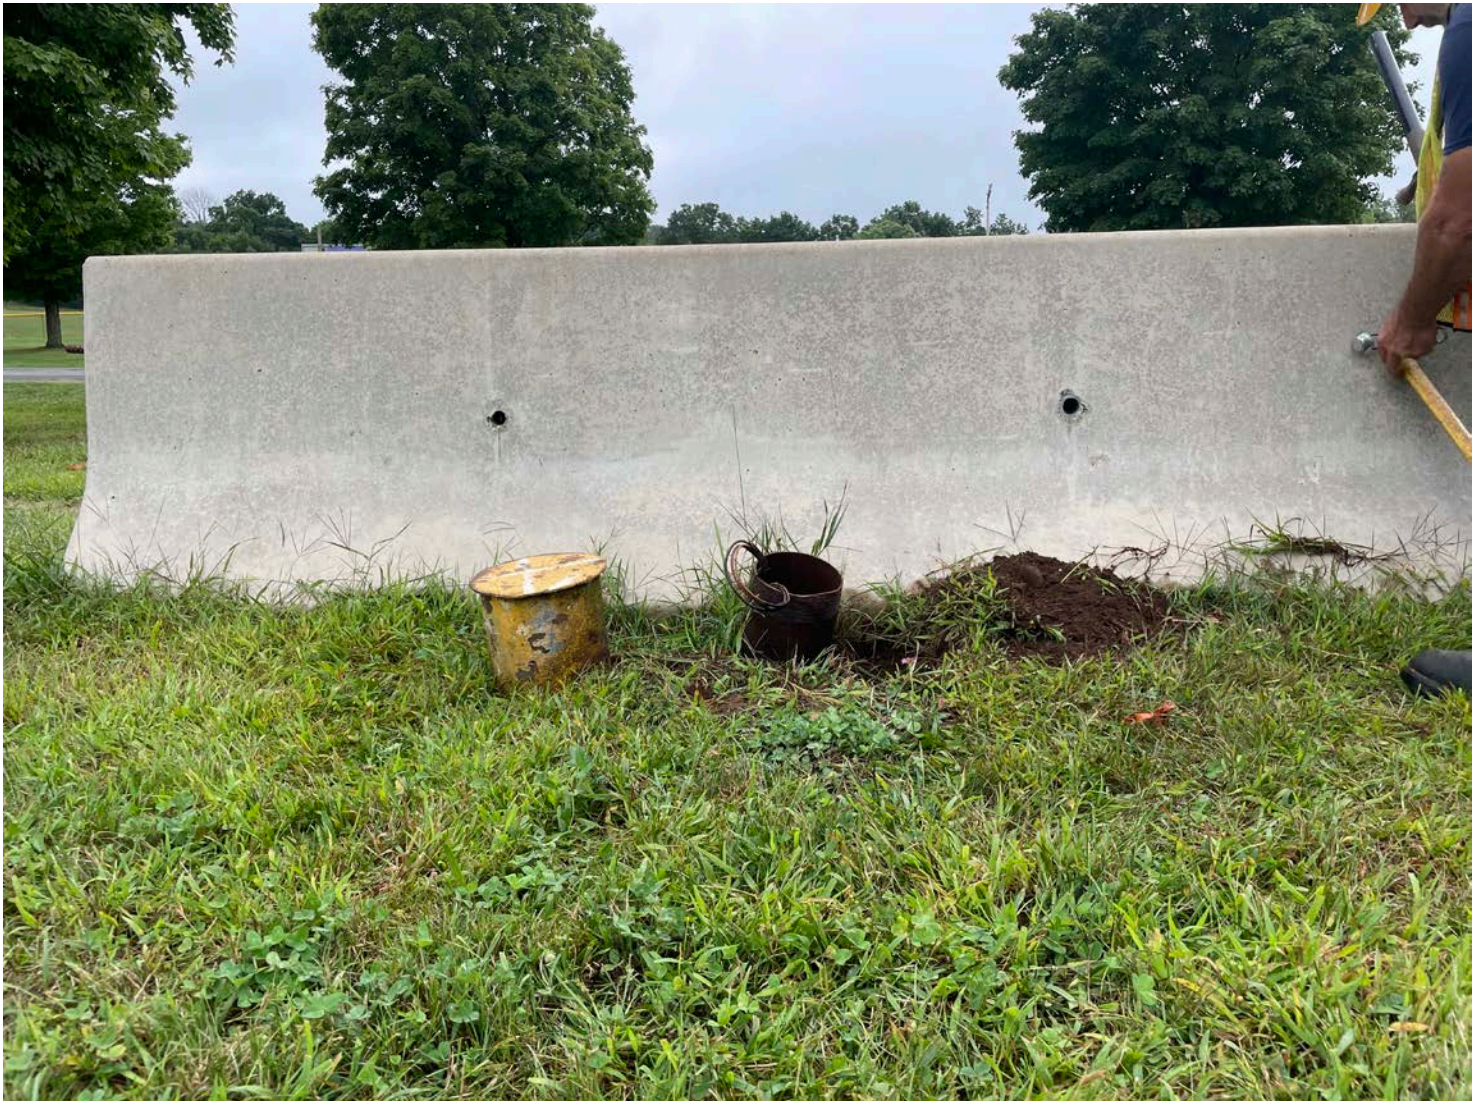
1116: Grela discovers that ~8' of the steel casing of the well located on the north side of Pickett Lane at Station 518+50 has been shifted off of the remainder of the well casing. Grela was unable to remove the pump from this well today.

Picture 10: Well casing located 45' north of Pickett Lane, Durham, at Station 518\_50. Grela was unable to pull the pump from this well as the casing had been previously damaged. View to the west.

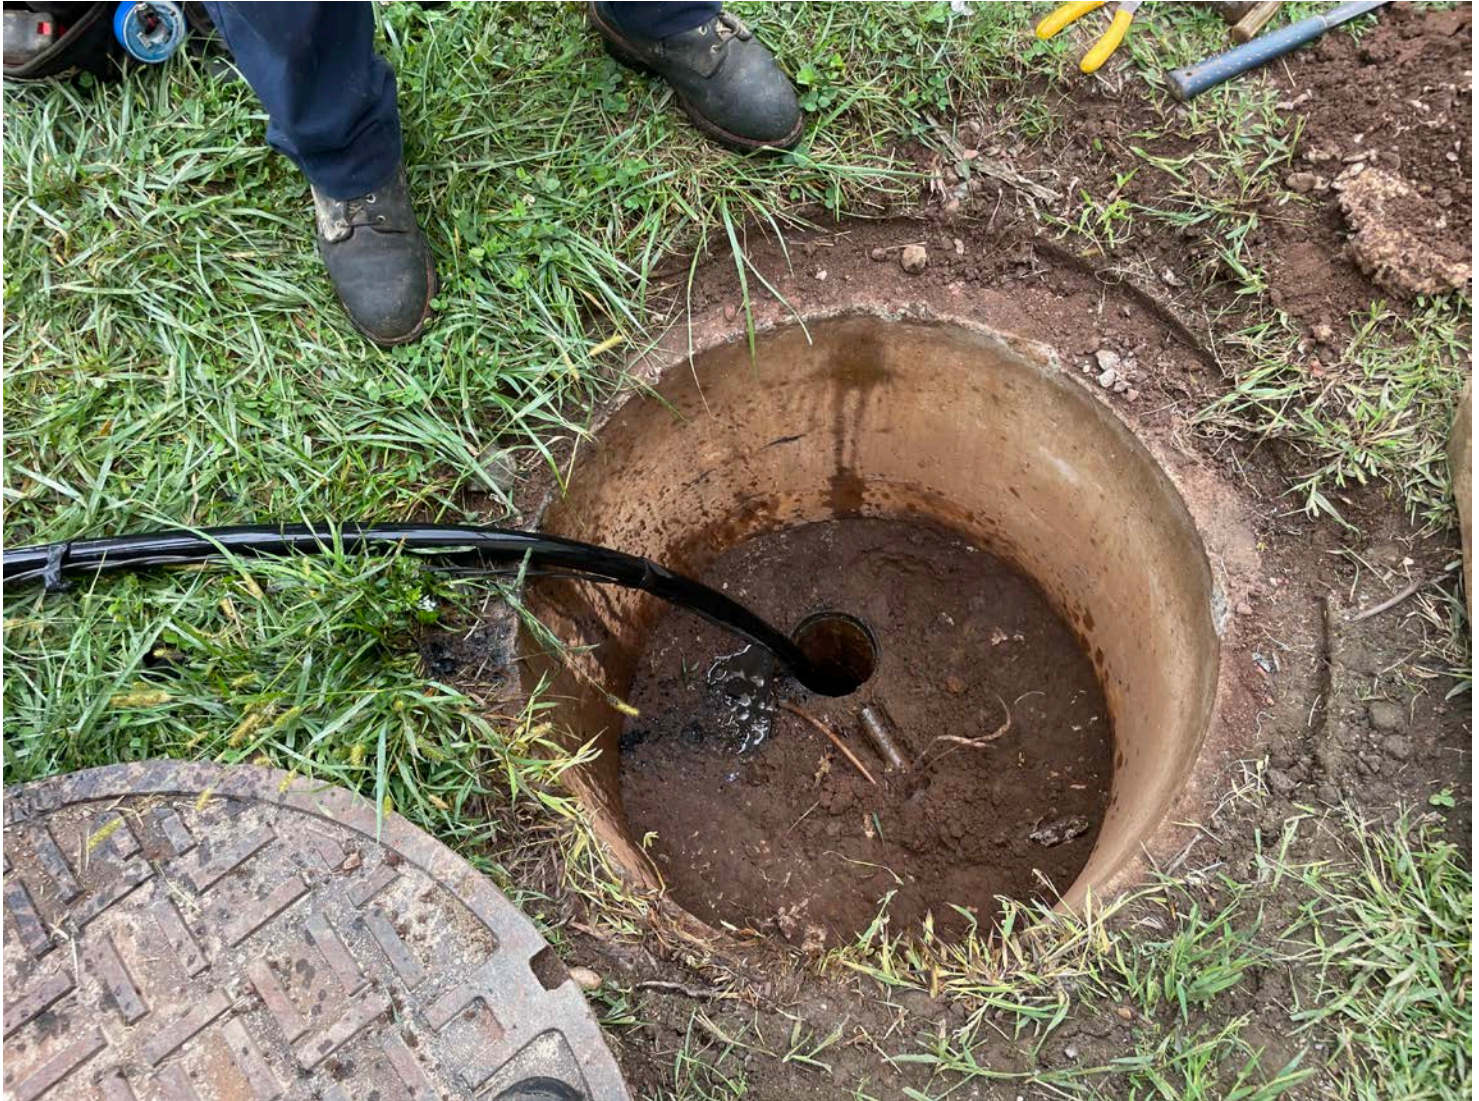
1147: Grela is in the process of pulling the pump from the well located on the south side of the recreation center located next to the pickle ball court on Pickett Lane.

**Picture 11: Well located on the west side of the recreation center located on the north side of Pickett Lane, Durham, next to the pickleball courts where Grela is pulling the pump from the well. View to the west.**

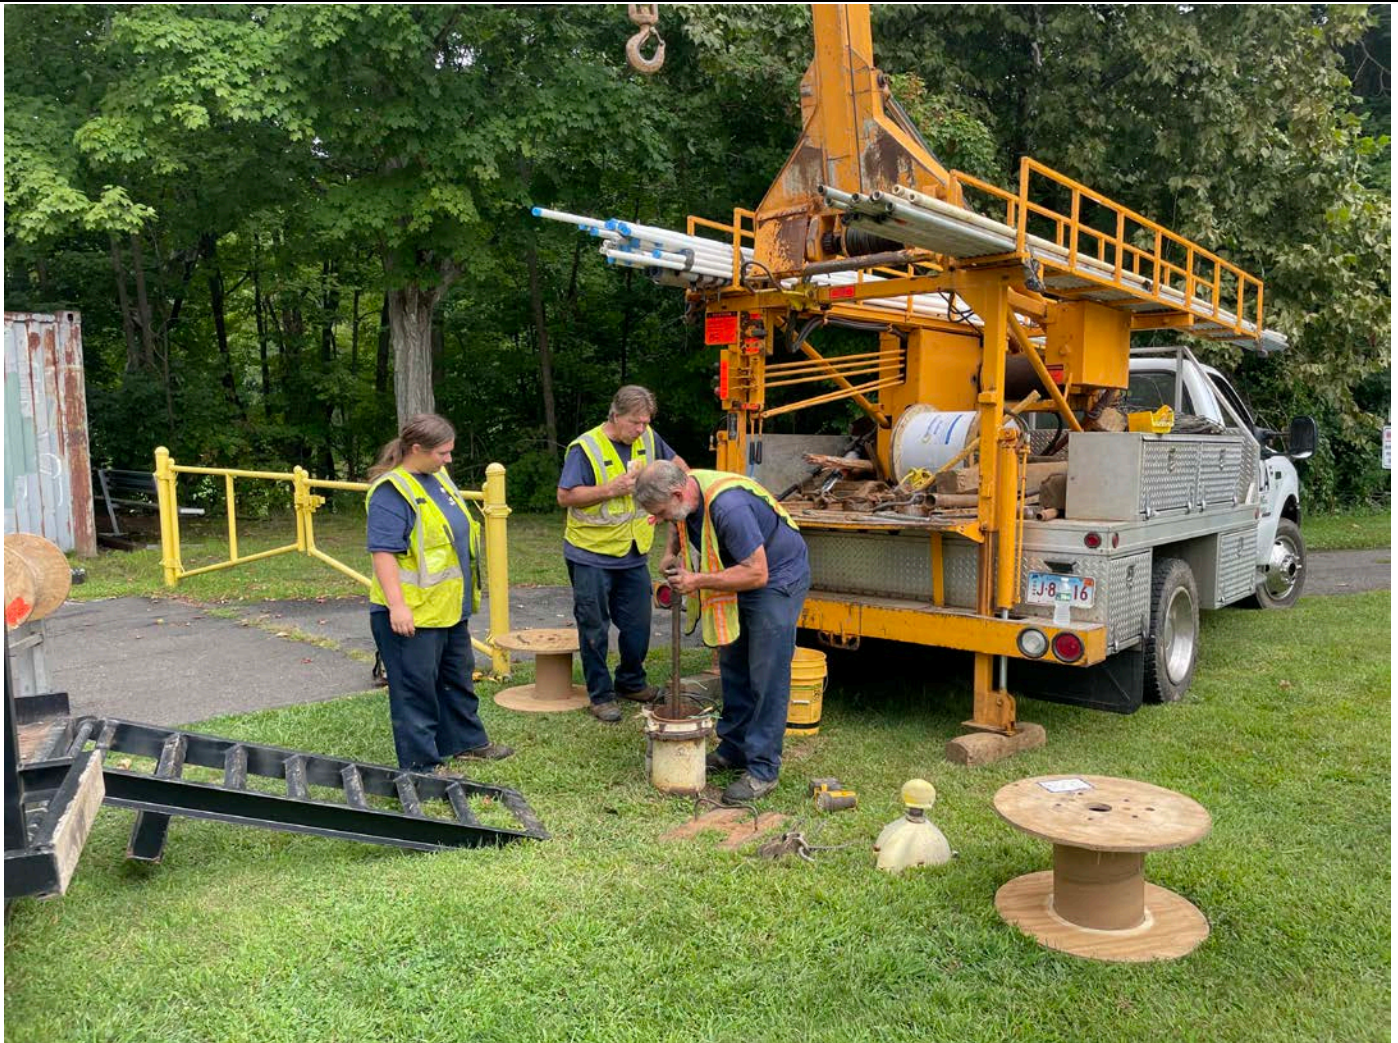
1252: Grela is in the process of pulling the pump from the well located on the north side of Coginchaug Regional High School (CRHS).

Picture 12: Grela preparing to pull the pump from the well located on the north side of the Cuginchaug Regional High School on Pickett Lane, Durham. View to the northeast.

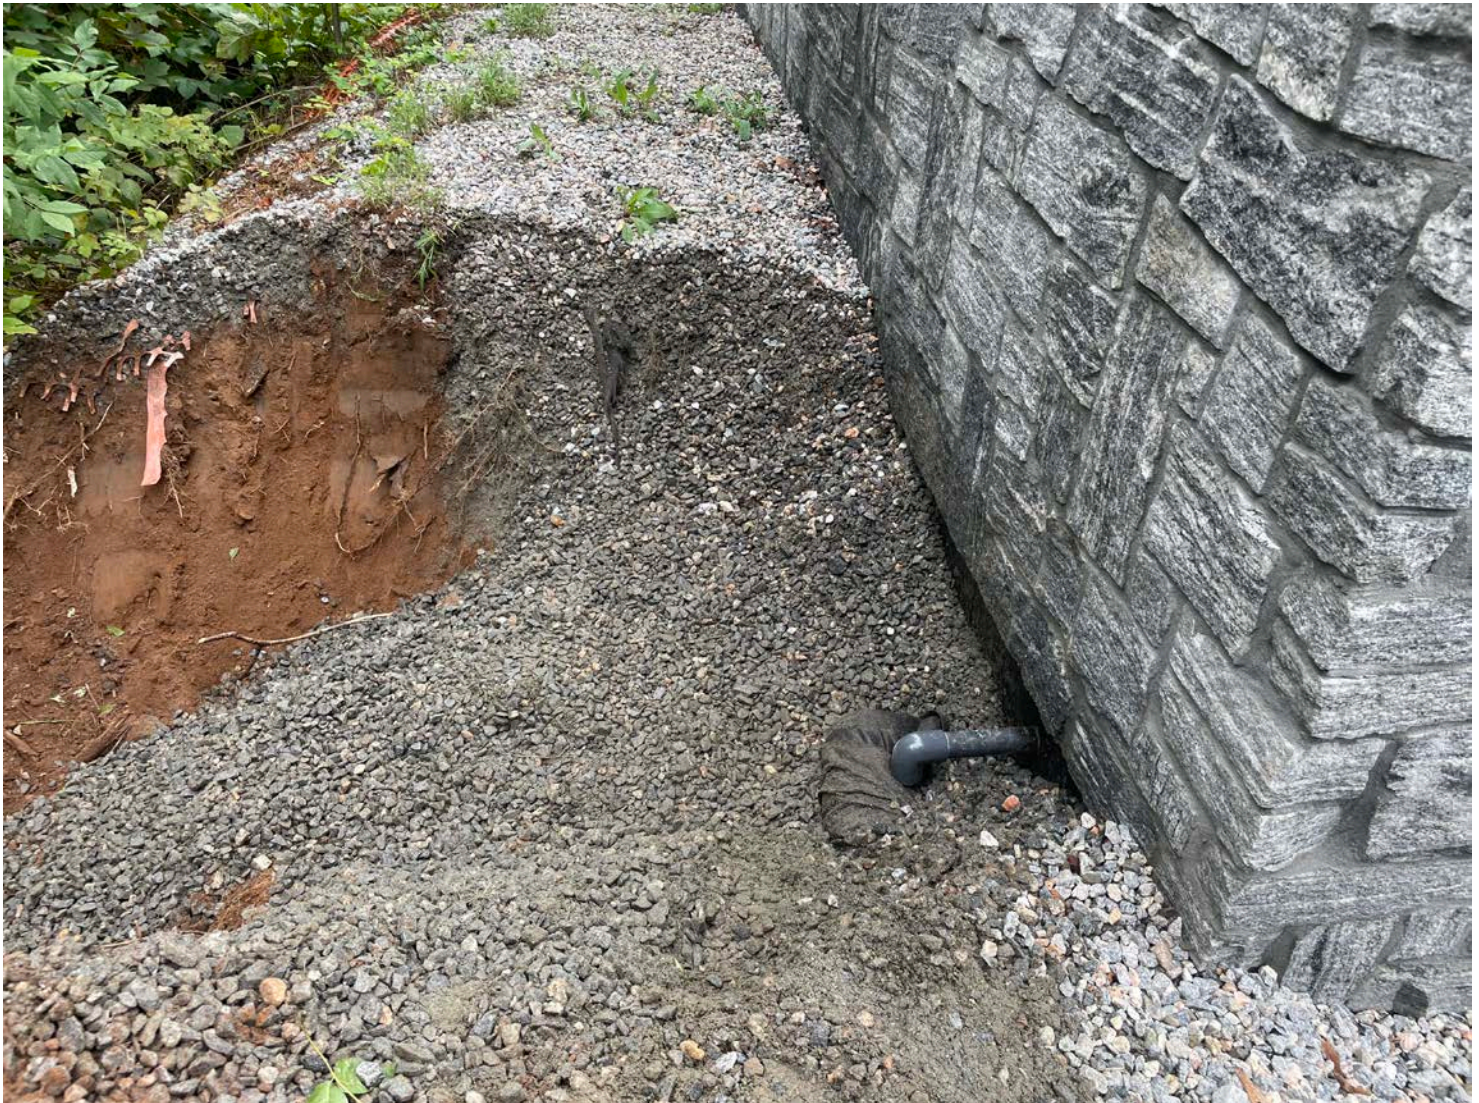
1243: Ludlow is in the process of excavating on the northeast corner of the Water Meter Building to daylight the sump pump discharge pipe.

**Picture 13: Sump pump discharge pipe that Ludlow daylighted on the northeast corner of the Water Meter Building located on S. Main Street in Durham. View to the south.**

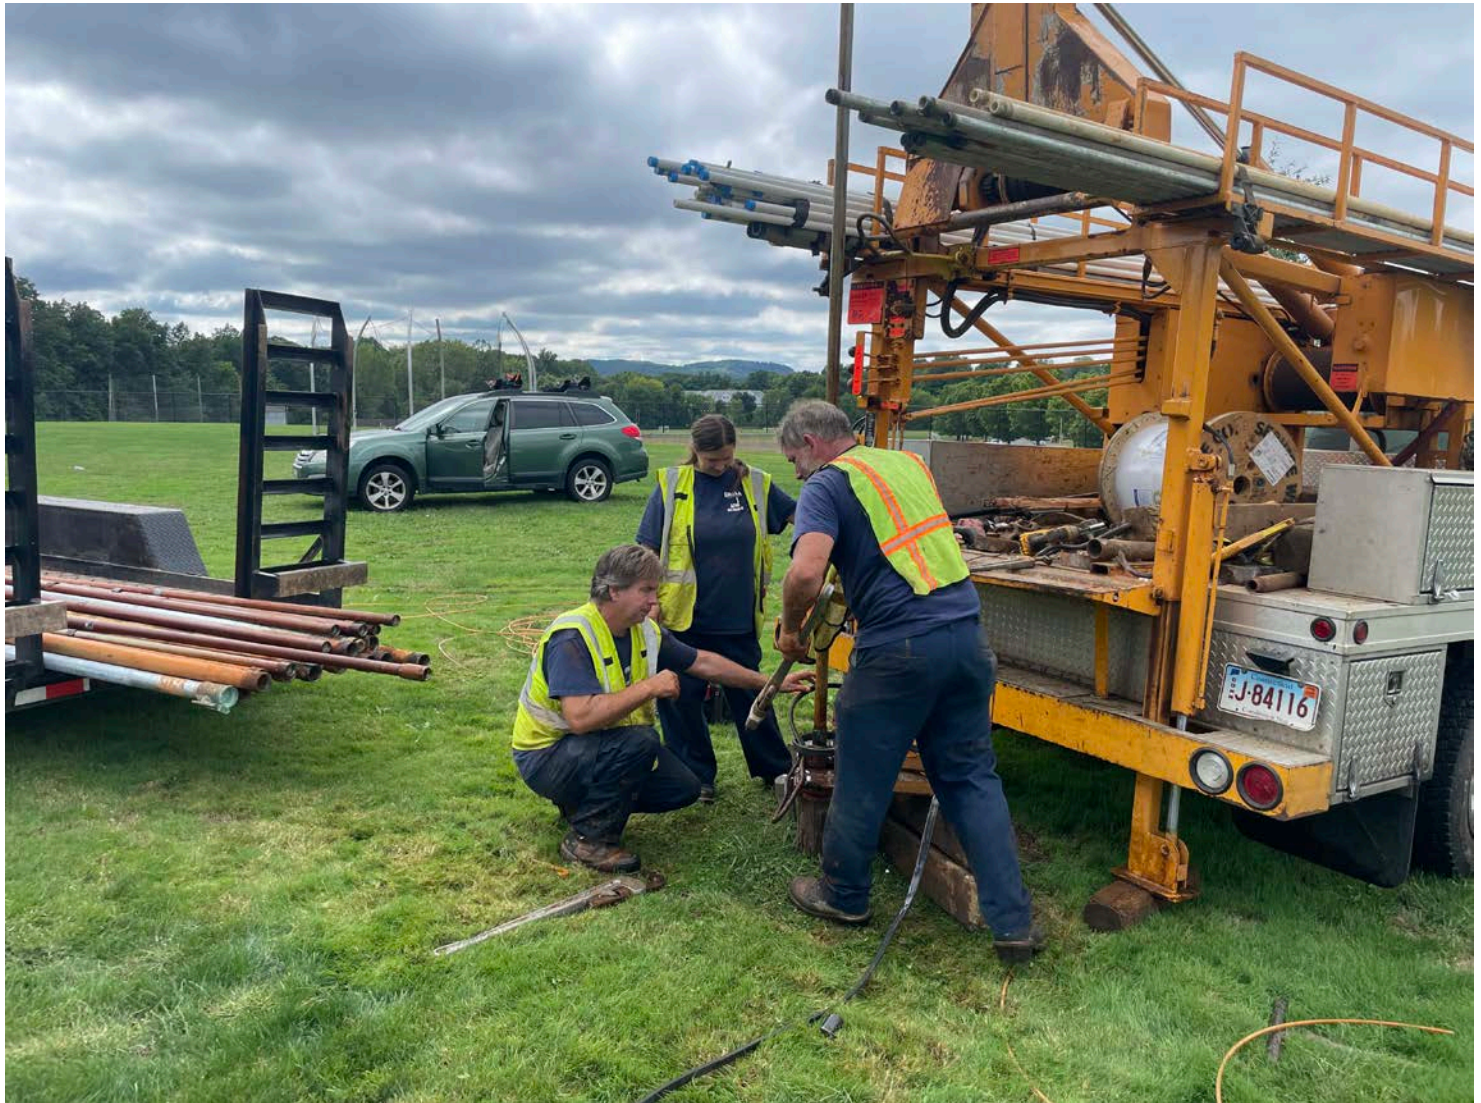
1431: Grela is pulling the pump from the well located on the west side of the CRHS soccer field.

**Picture 14: Grela preparing to pull the pump from the well located on the west side of the Coginchaug Regional High School soccer field on the south side of Pickett Lane, Durham. View to the west.**
