## Daily Report

<b>Project:</b>	Durham Meadows Pipeline Installation	<b>Date:</b>	September 12, 2022
<b>Location:</b>	Main Street, Pickett Lane, and Maple Avenue, Durham; S. Main Street, Middletown	<b>Day of Week:</b>	Monday
<b>Project #:</b>	AECOM: 6061487	<b>Report No:</b>	507
<b>Contractor:</b>	Ludlow Construction	<b>Page:</b>	1 of 18

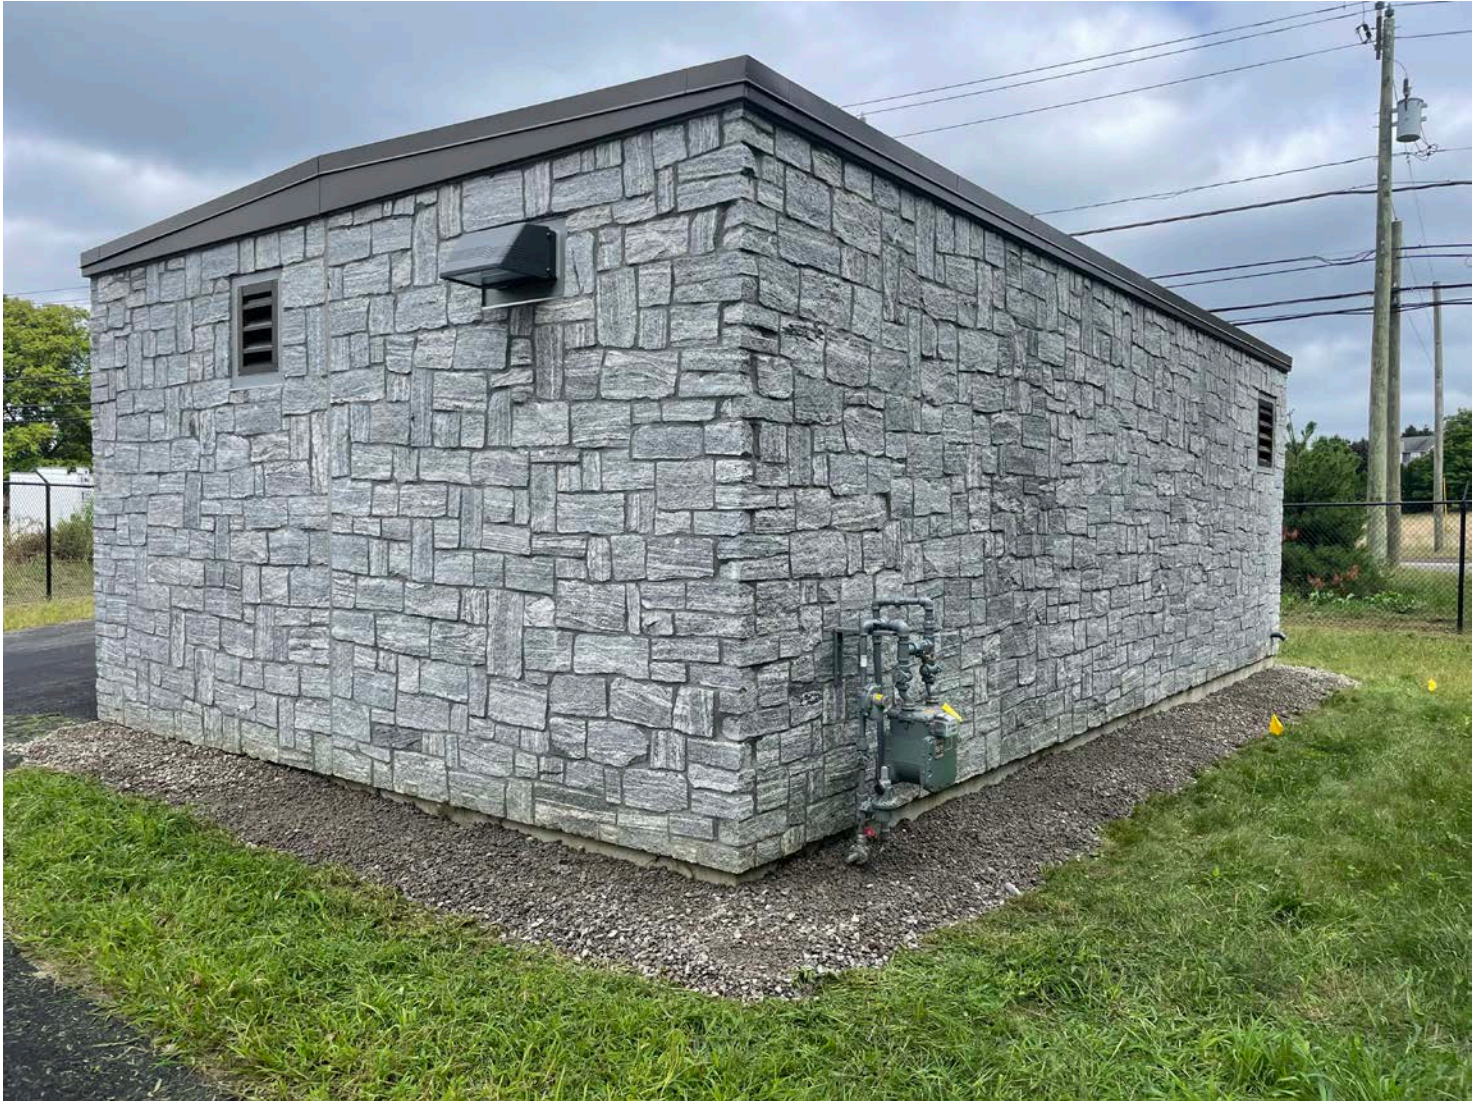
1444: Ludlow has finished placing geofabric and ¾" rock around the perimeter of the booster station.

Picture 15: View of the Booster Station located on S. Main Street in Middletown where Ludlow placed geofabric and 3/4" stone along the perimeter of the building. View to the northeast.
