# **Final 2005 ANNUAL REPORT**

## **WETLAND & UPLAND HABITAT RESTORATION AND LONG TERM ADAPTIVE MONITORING AND MAINTENANCE PROGRAM**

### **AREA OF CONTAMINATION (AOC) 57 DEVENS, MASSACHUSETTS**

**January 2007**

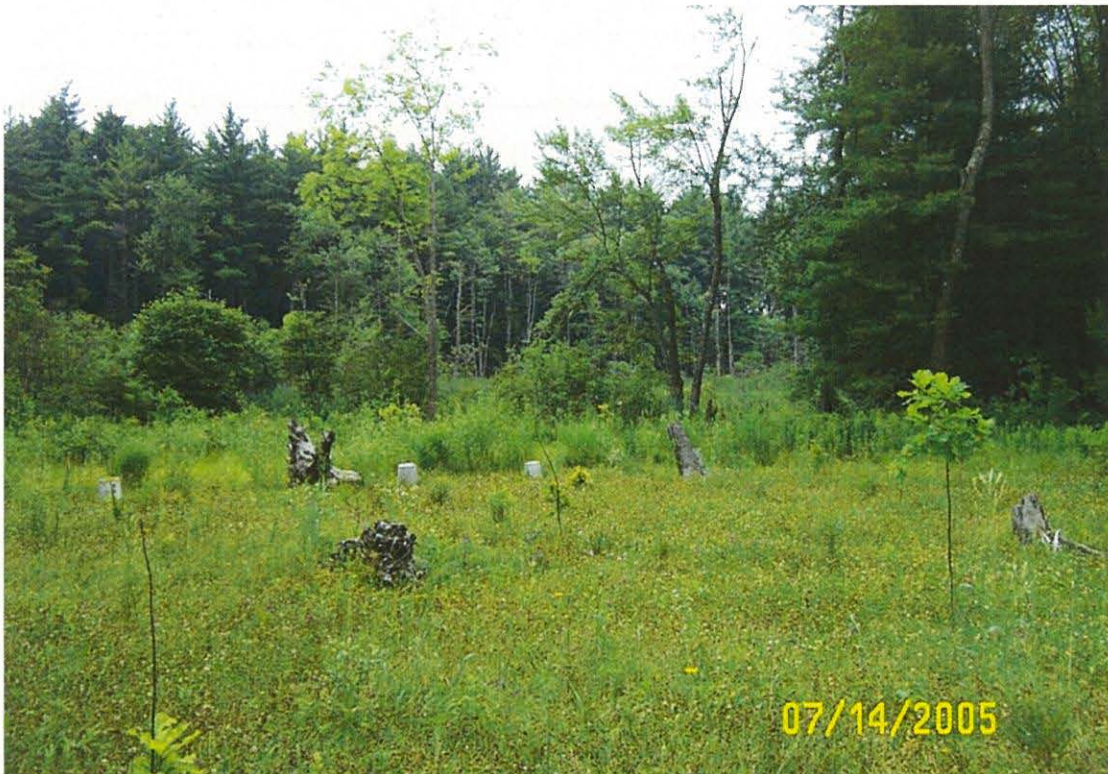
AOC 57 Area 2: Bordering Vegetated Wetland at base of upland slope (July 14, 2005).

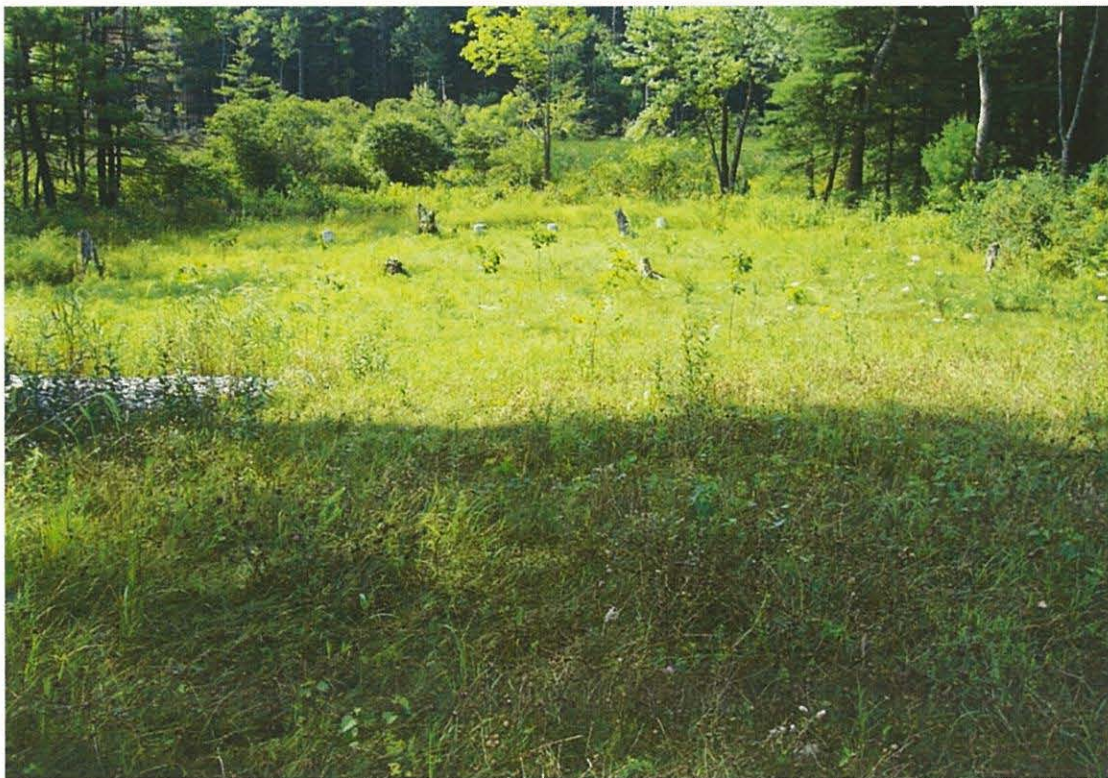
AOC 57 Area 2: Overview of Area 2 from top of restored upland slope (July 14, 2005).

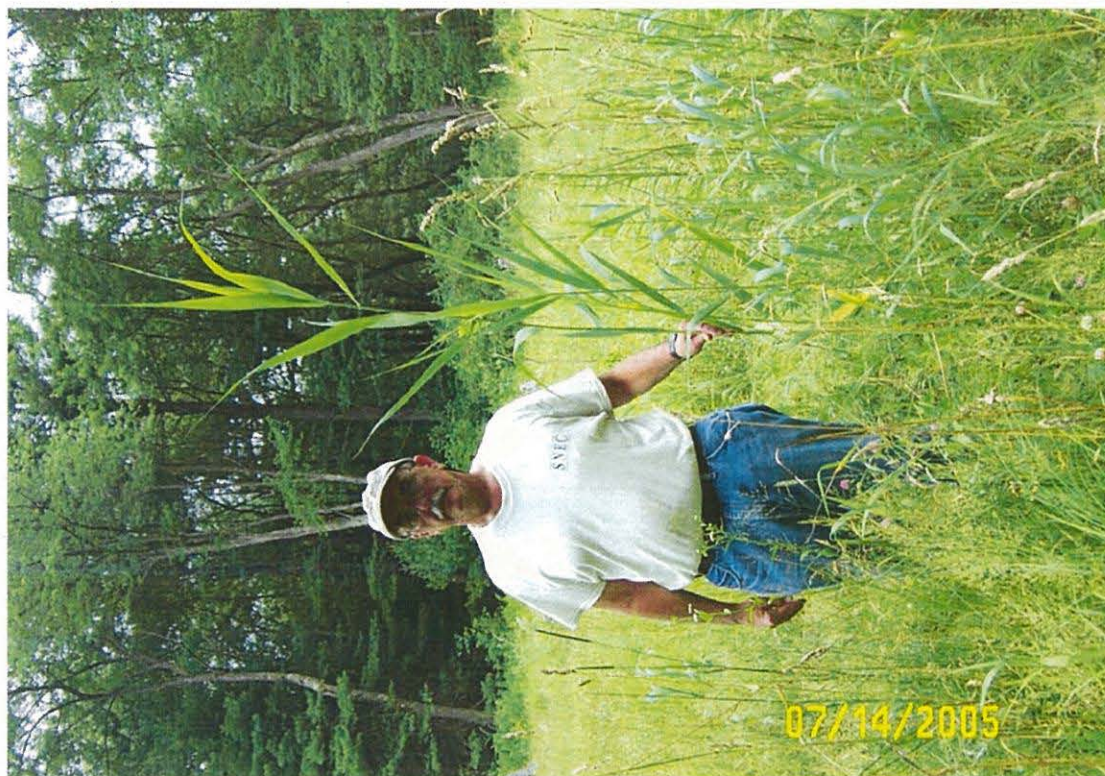
AOC 57 Area 2: Stand of invasive common reed, *Phragmites*, prior to treatment (July 14, 2005).

Any residual *Phragmites* observed in the Late Spring/Early Summer 2006 field inspection will be treated systemically with herbicide. Any purple loosestrife encountered along will be hand-pulled and left on-site if not in seed and if in seed it will be removed from site for disposal.

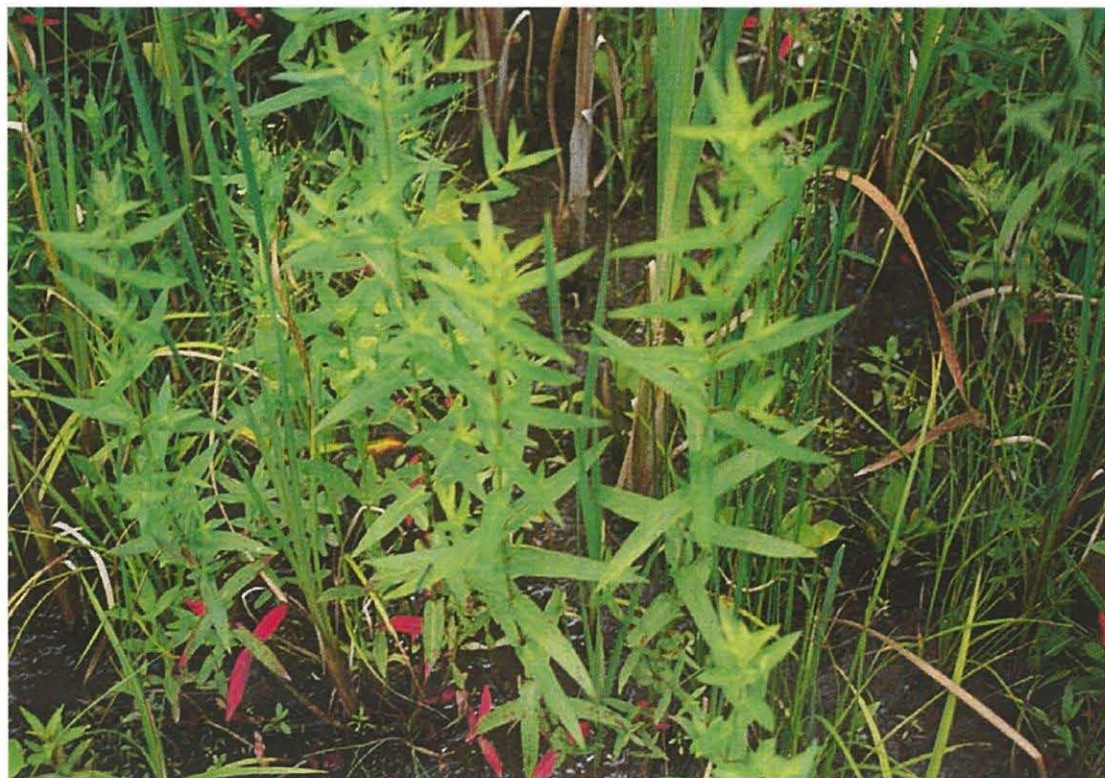
AOC 57 Area 2: Close-up of vegetation in Bordering Vegetated Wetland (July 14, 2005).

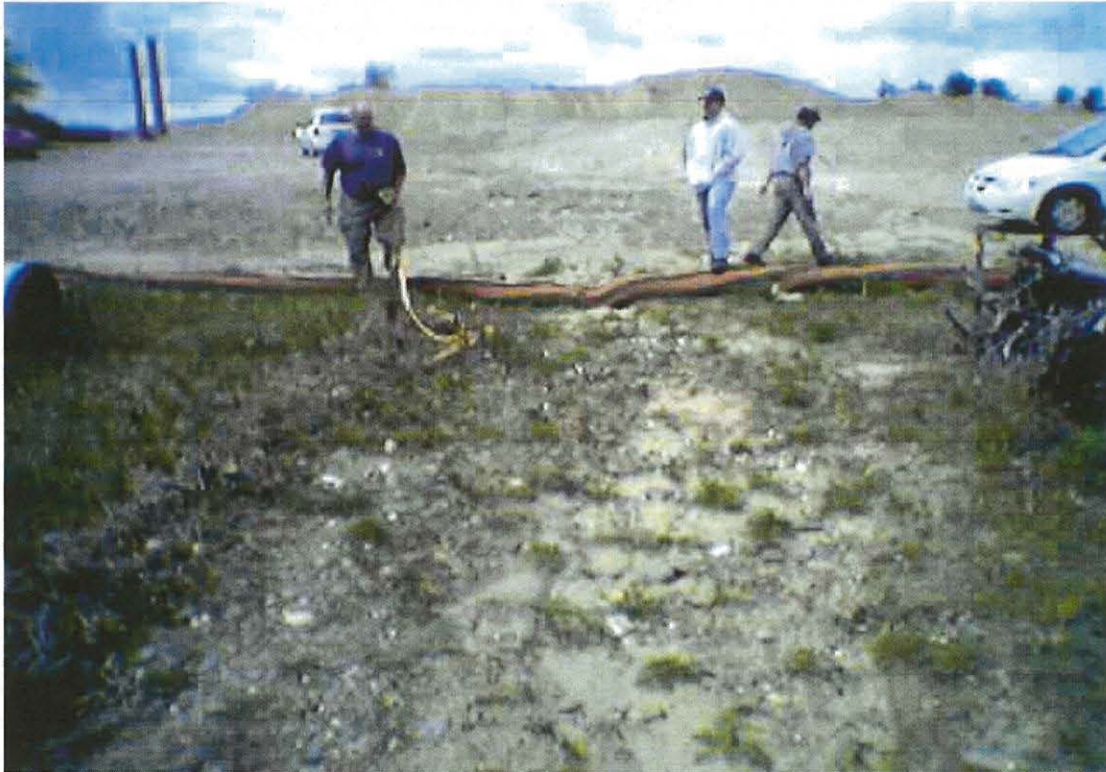
On May 19, 2005 the CENAE Groundwater LTMP Team observed an additional erosion onto the Area 2 upland as the erosion control tube apparently failed as observed by the undermining that occurred over the winter 2004-2005 (see Appendix B – Photos). They took immediately corrective action by filling the area that was undermined with nearby rock. This was confirmed during the May 23, 2005 RAB Meeting and the Army BEC consequently contacted MassDevelopment to correct this problem. MassDevelopment subsequently installed an unvegetated soil berm above the existing erosion control tube parallel to the Area 2 upland. However, the berm did not extend completely to the eastern Area 2 upland site boundary as observed during the July 14, 2005 field inspection. As a result the erosion and sedimentation continued to occur. There was a layer of silt covering the base of the wetland vegetation and the potential existed for further degradation as a result of a significant storm event since the erosion had formed a discernable discharge pathway along the upland slope to the base of the wetland. These concerns were again expressed during the September 22, 2005 regulator site visit and MassDevelopment subsequently installed a new erosion control tube immediately adjacent to the existing tube and extended and deepened the area in front of the berm that runs parallel to Area 2 to beyond the eastern site boundary. These corrective measures were checked on November 1, 2005 after a period of heavy rains and seemed to be functioning properly.

AOC 57 Area 2: Erosion of upgradient stockpiled soils onto the restored upland as a result of the failed erosion control tube as observed by the Groundwater LTM Team (May 19, 2005).

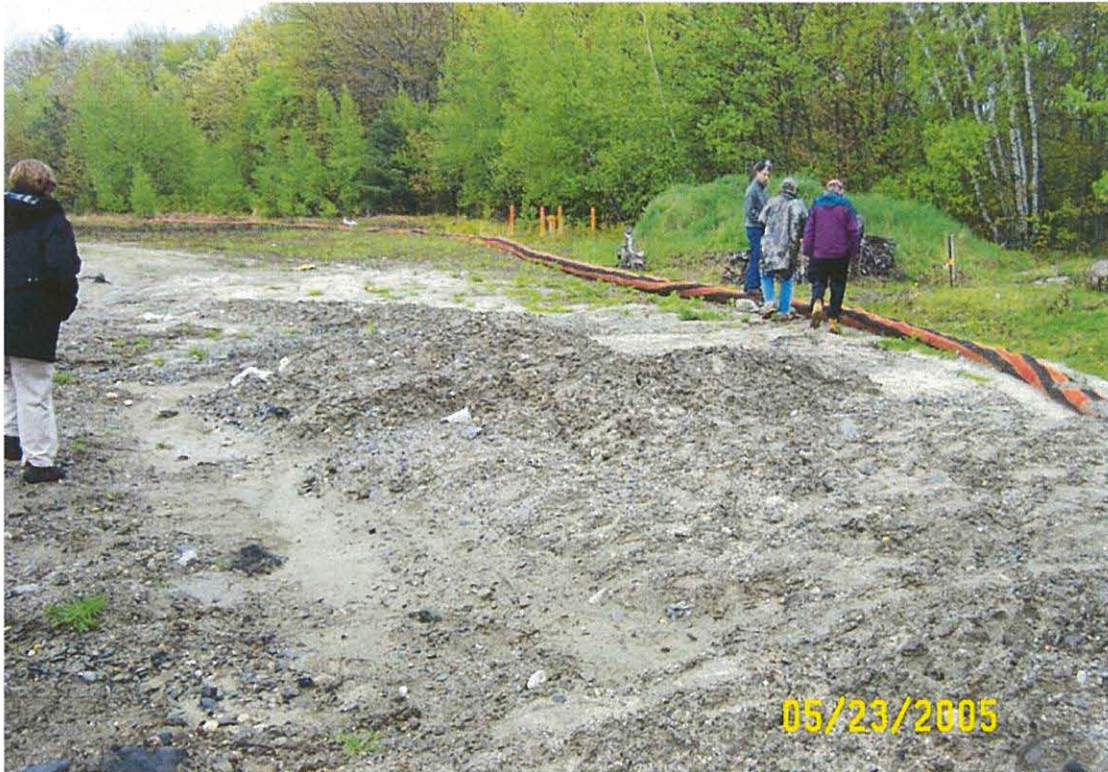
AOC 57 Area 2: Site inspection of the failed erosion control measures at the top of Area 2 by the Restoration Advisory Board (May 23, 2005).

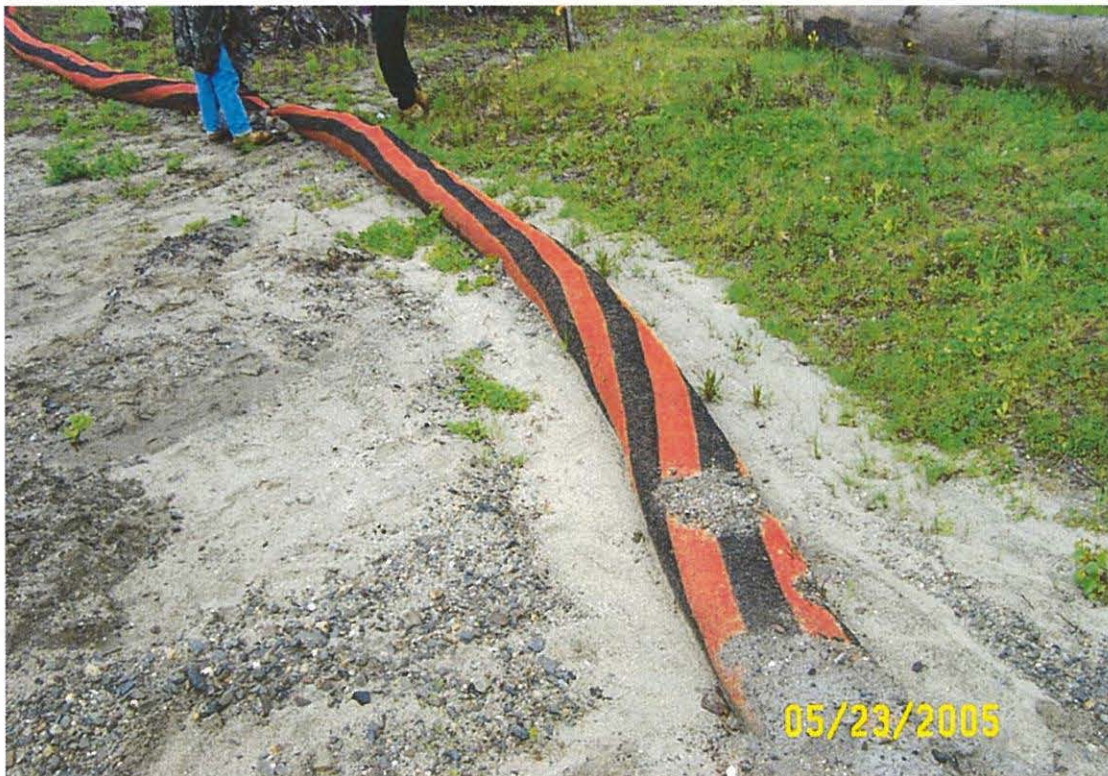
AOC 57 Area 2: Close-up showing the failed section of the erosion control tube and sedimentation from upgradient soil stockpiles (May 23, 2005).

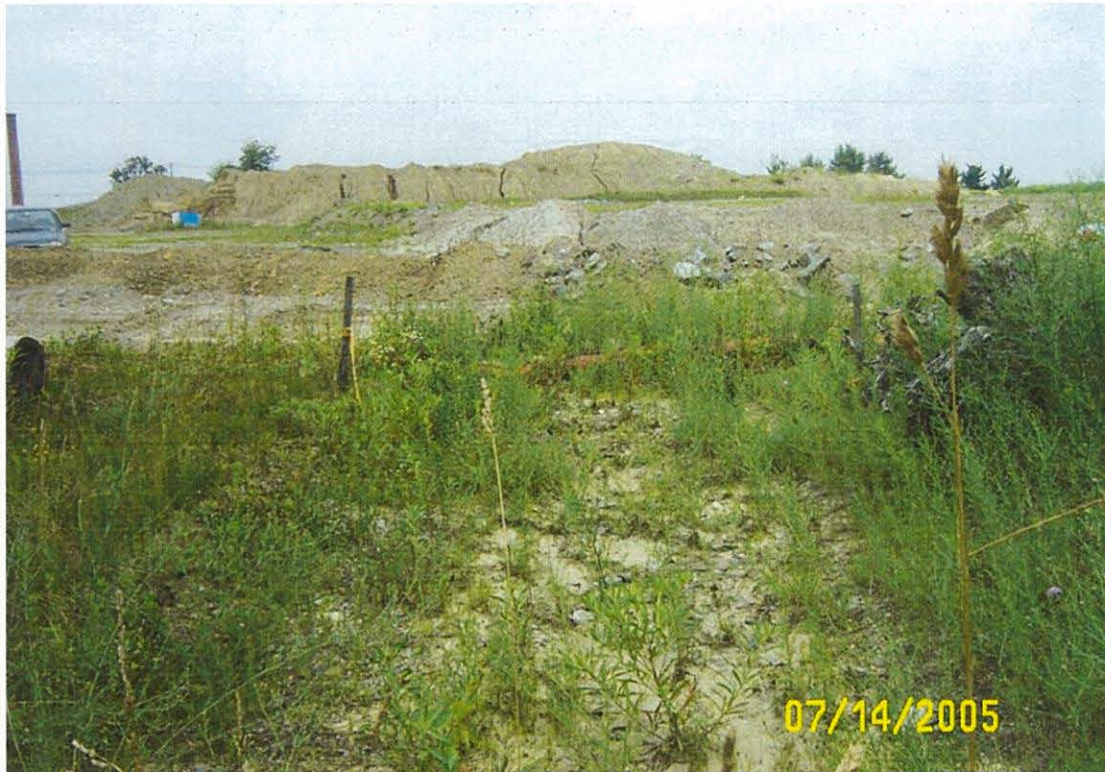
AOC 57 Area 2: Degraded upland area at top of restored slope immediately downgradient of the existing erosion control tube with the newly erected unvegetated berm by MassDevelopment in the background with the soil stockpiles in the far background.

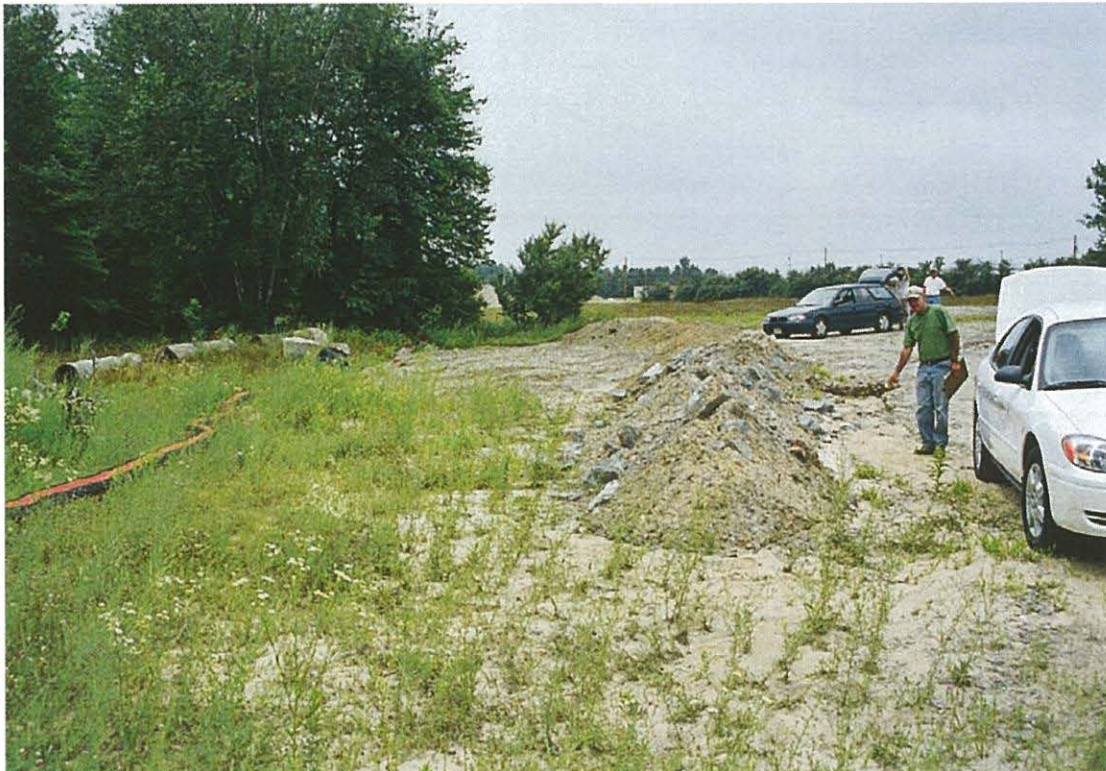
AOC 57 Area 2: Close-up of newly constructed unvegetated berm installed parallel to the erosion control tube that only extended to the eastern edge of the site (July 14, 2005).

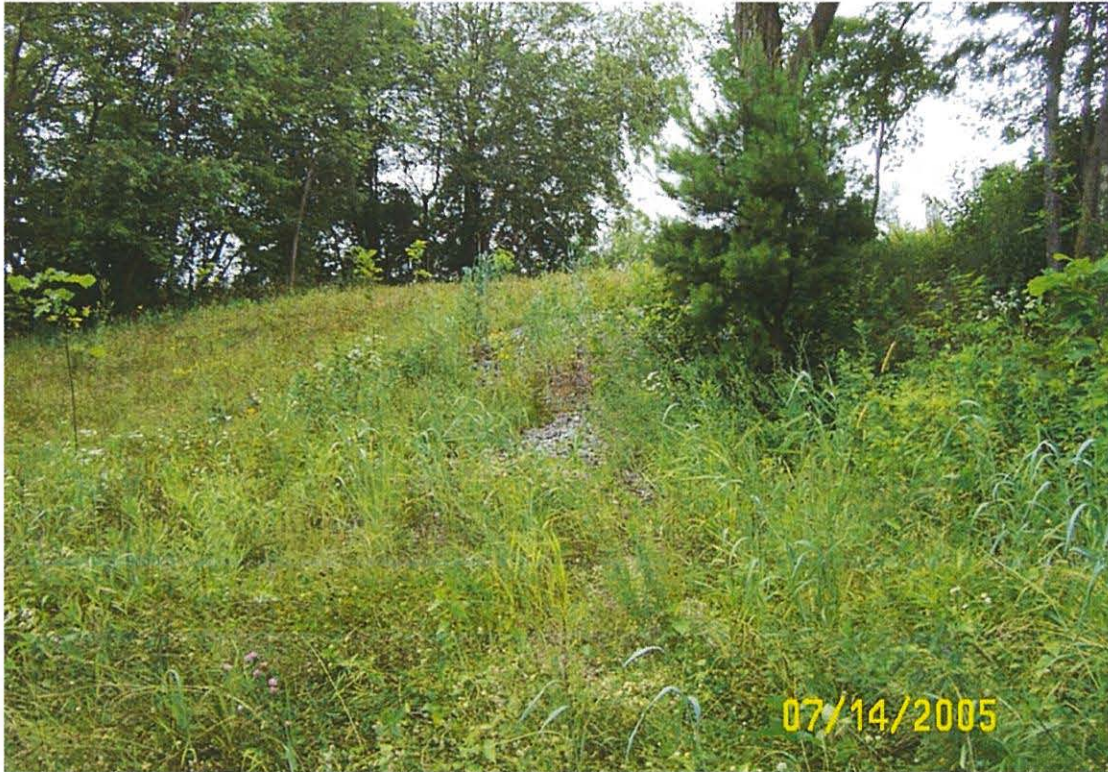
AOC 57 Area 2: Area immediately below the drainage channel established to protect the slope from erosion and armored with rip rap stone on the east side of the slope showing indications of erosion and sedimentation (July 14, 2005).

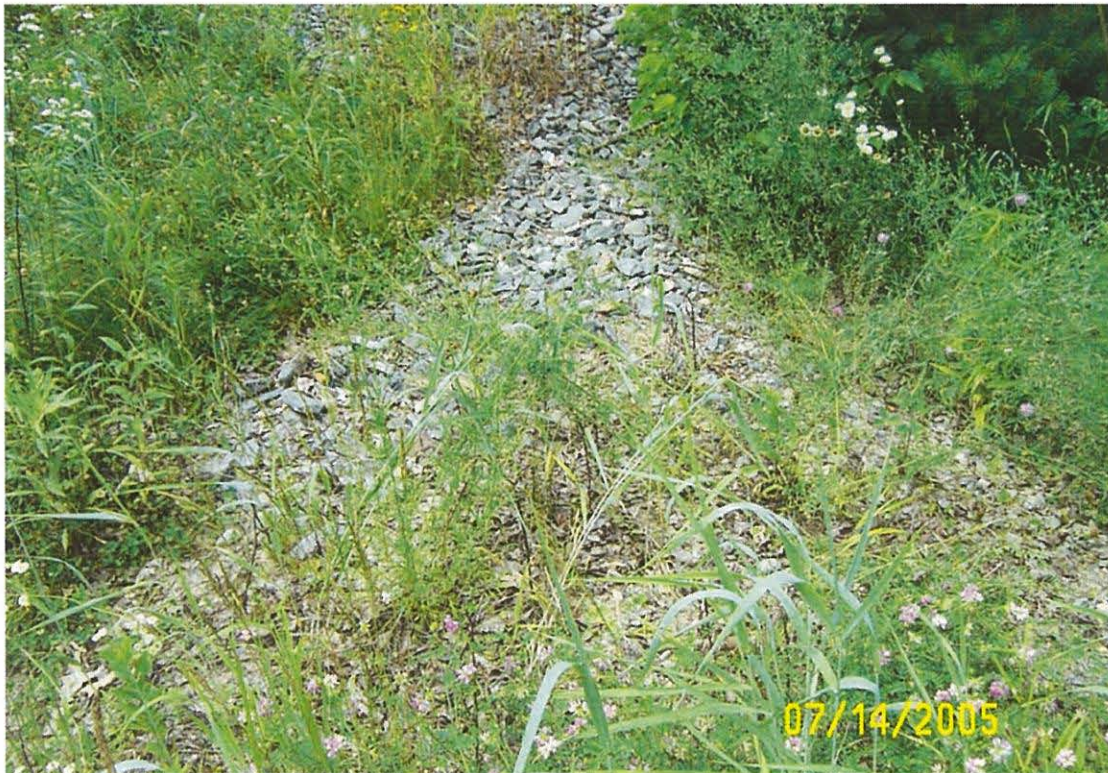
AOC 57 Area 2: Close-up of base of established drainage channel to protect upland slope and adjacent wetland from erosion and sedimentation showing indications of erosion and sedimentation (July 14, 2005).

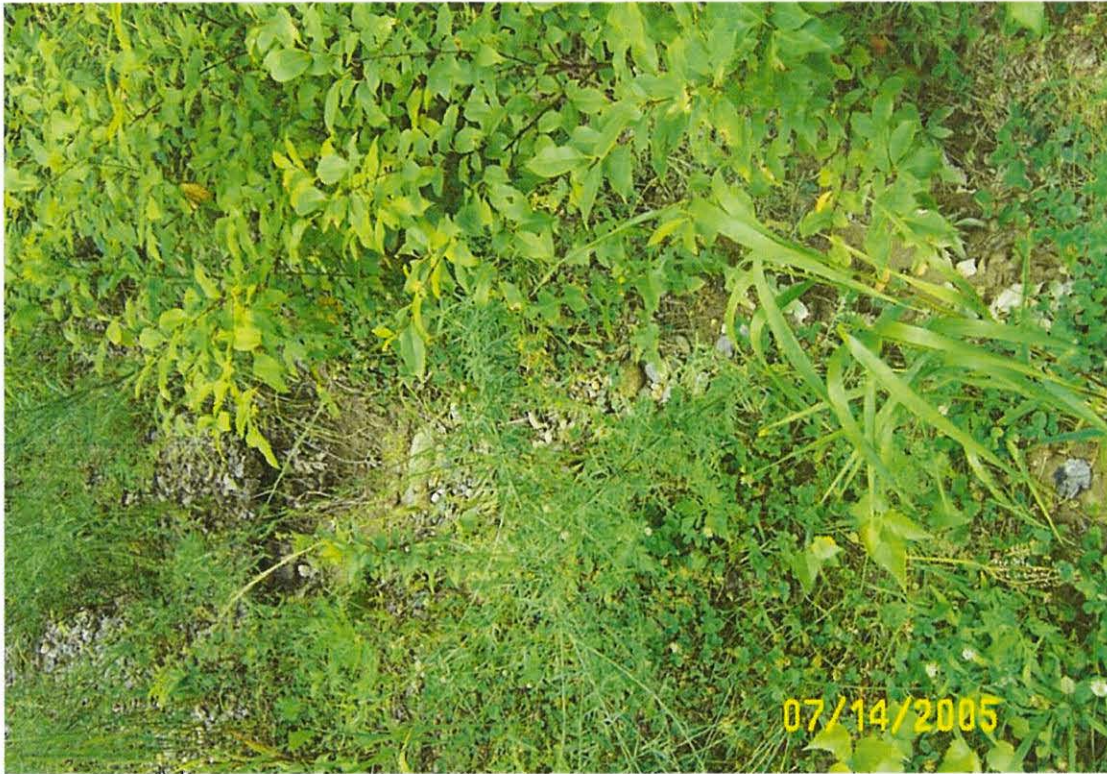
AOC 57 Area 2: Observed eroded drainage channel pathway (left to right) from base of the established rip rap drainage channel resulting in observed siltation to the existing bordering vegetated

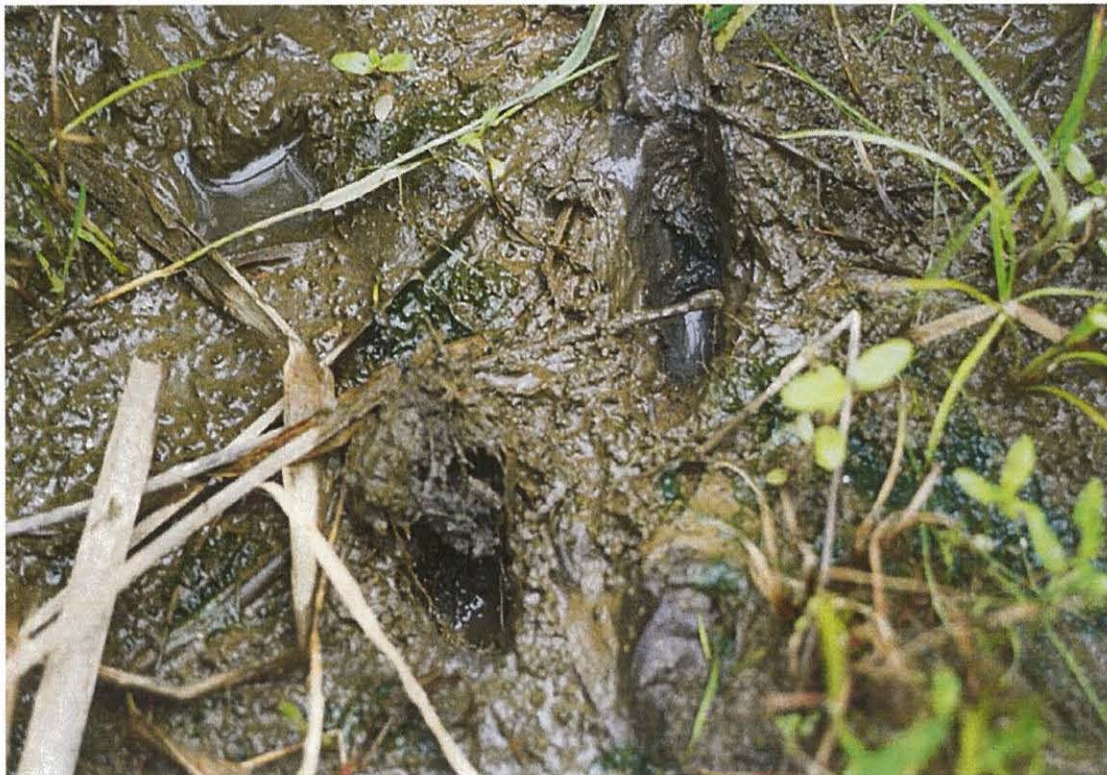
AOC 57 Area 2: Close-up of a finger scoop of wetland sediment showing the underlying hydric soil (darker color) covered by a layer of fine silt (lighter brown color) as a result of erosion from

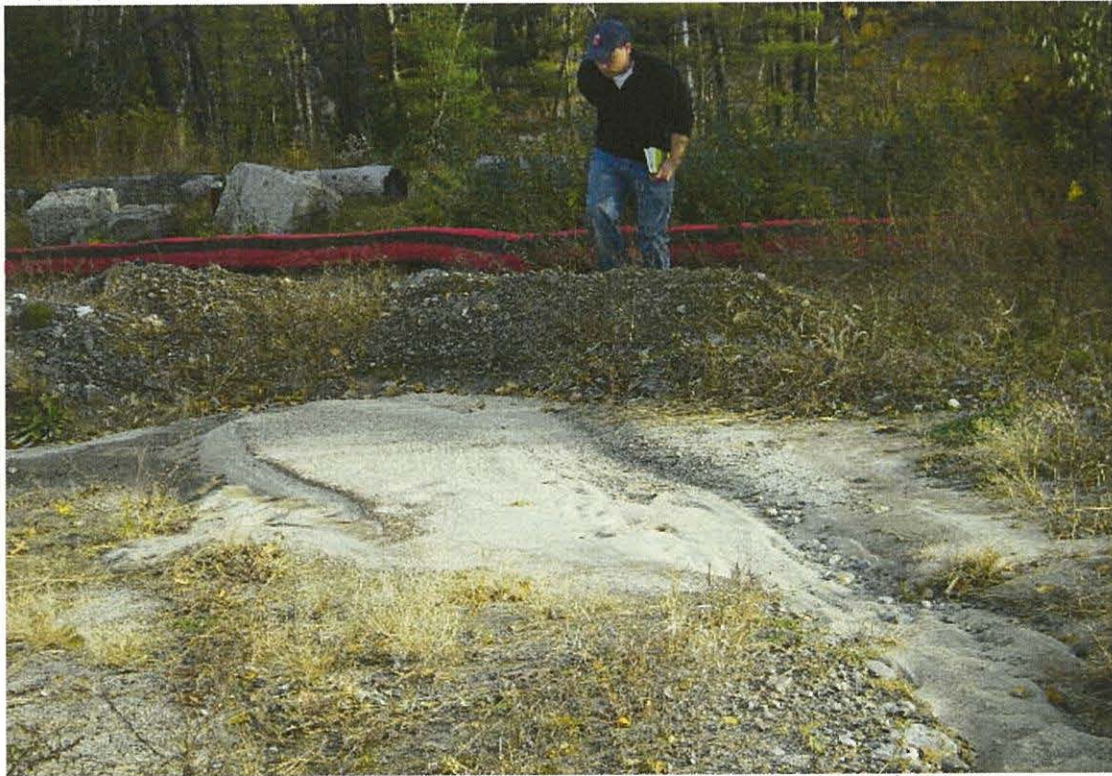
AOC 57 Area 2: Upgradient view of unvegetated berm after heavy rains (November 1, 2005).

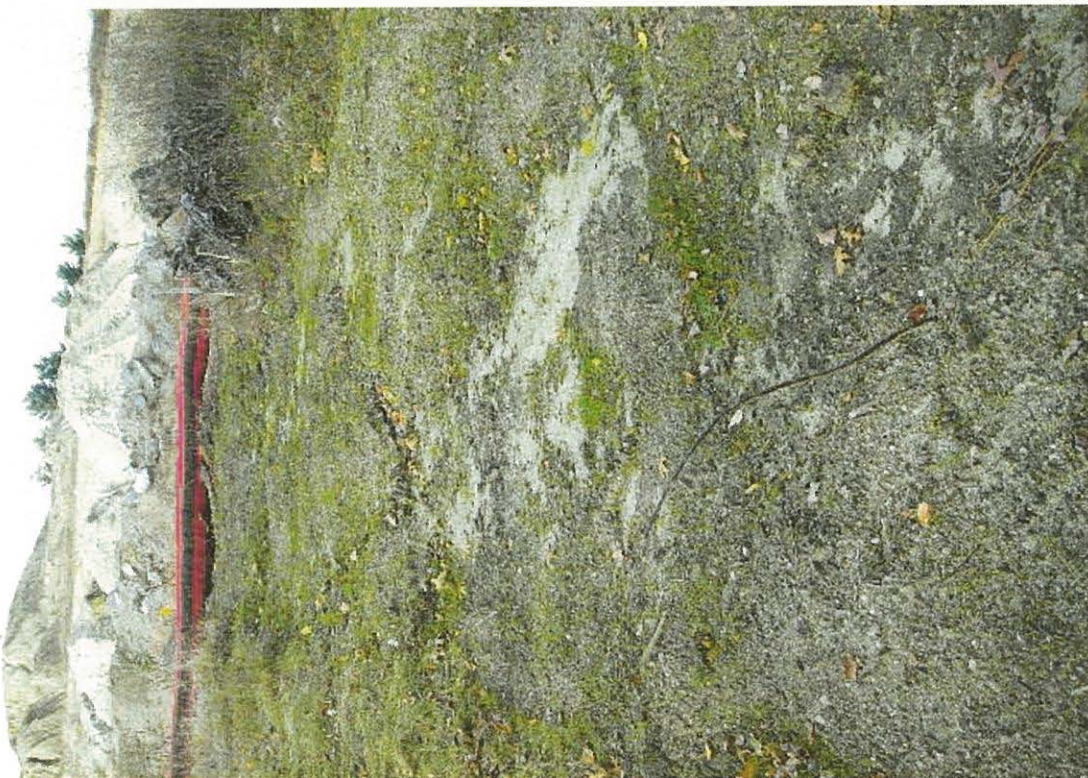
AOC 57 Area 2: Revegetation of upland slope impacted by erosion and sedimentation.

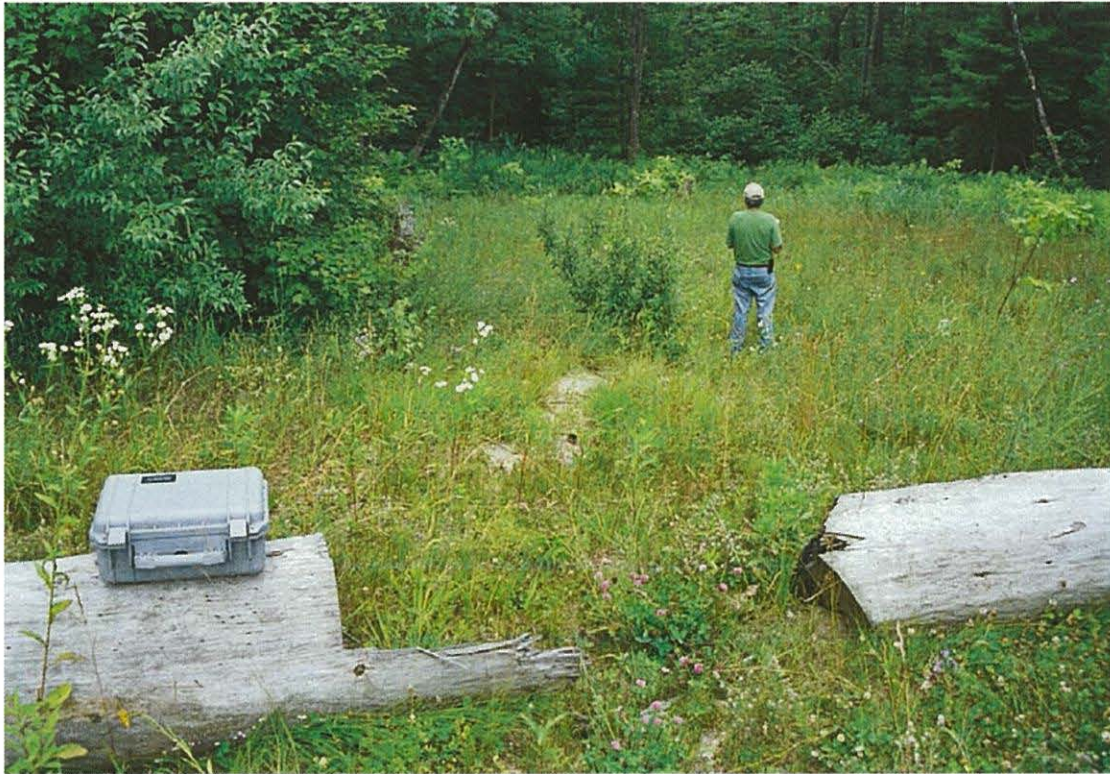
AOC 57 Area 3: Overview of restored upland slope adjacent to Bordering Vegetated Wetland in the background (July 14, 2005).

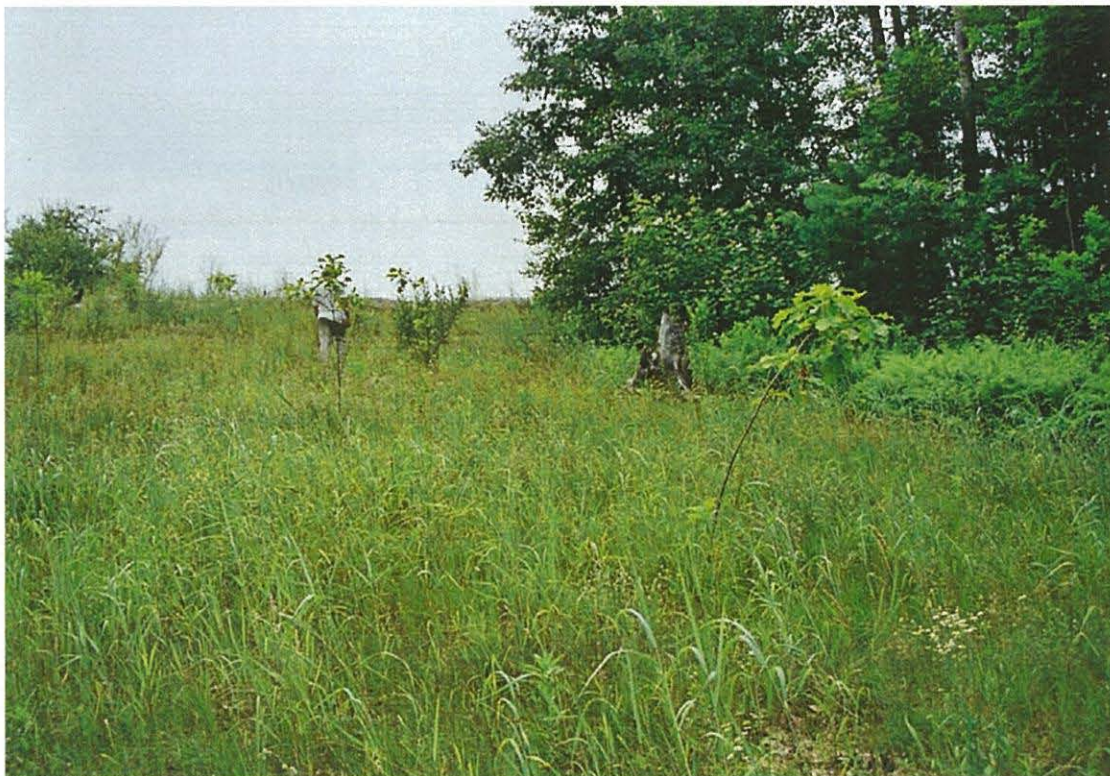
AOC 57 Area 3: Restored upland slope vegetation and coverage (July 14, 2005).

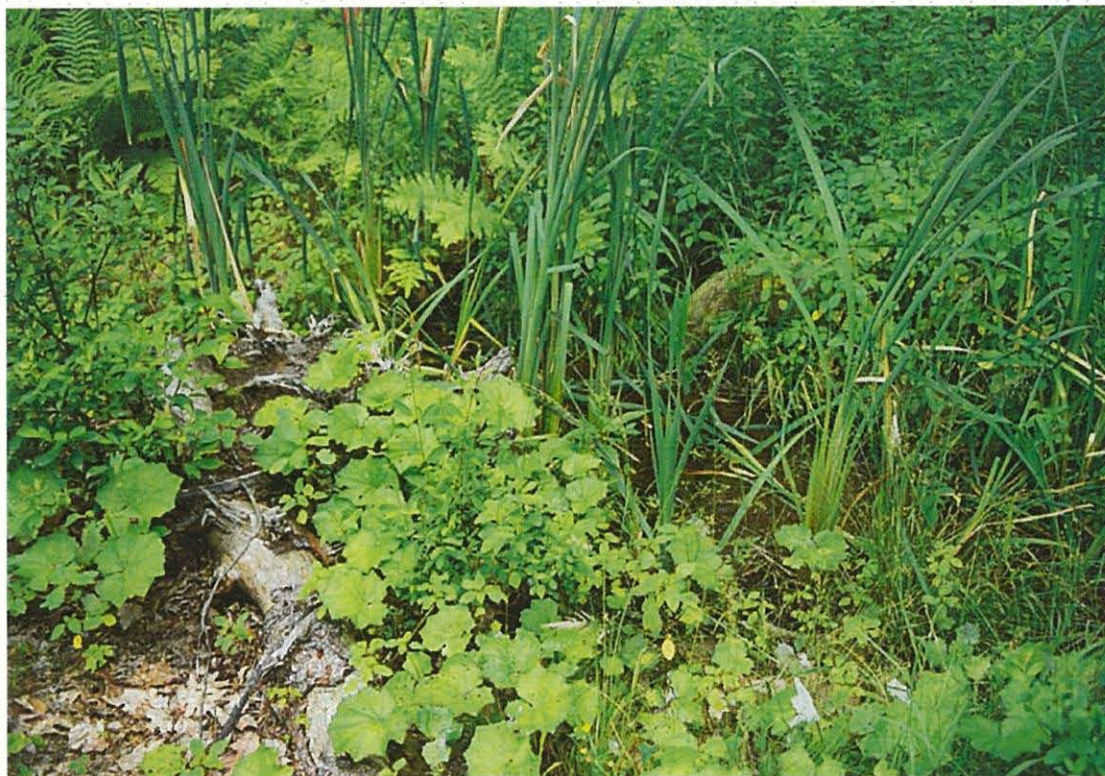
AOC 57 Area 3: Close-up of vegetation in Bordering Vegetated Wetland (July 14, 2005).

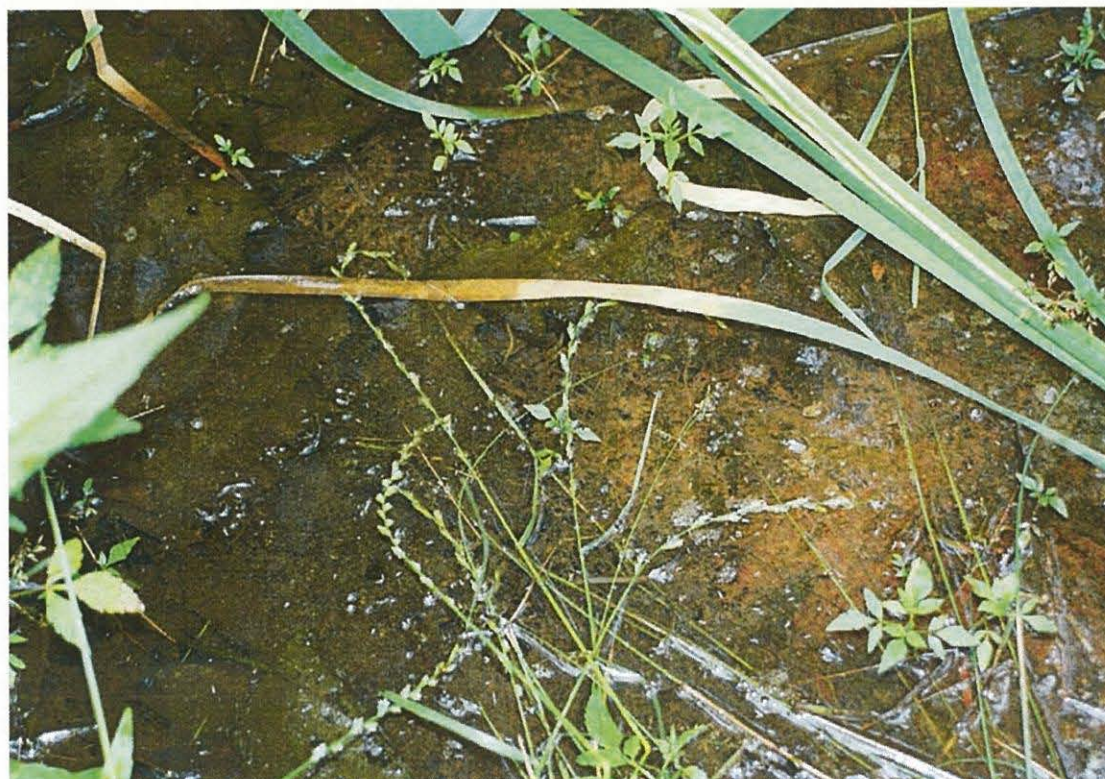
AOC 57 Area 3: Close-up of standing water in Bordering Vegetated Wetland (July 14, 2005).

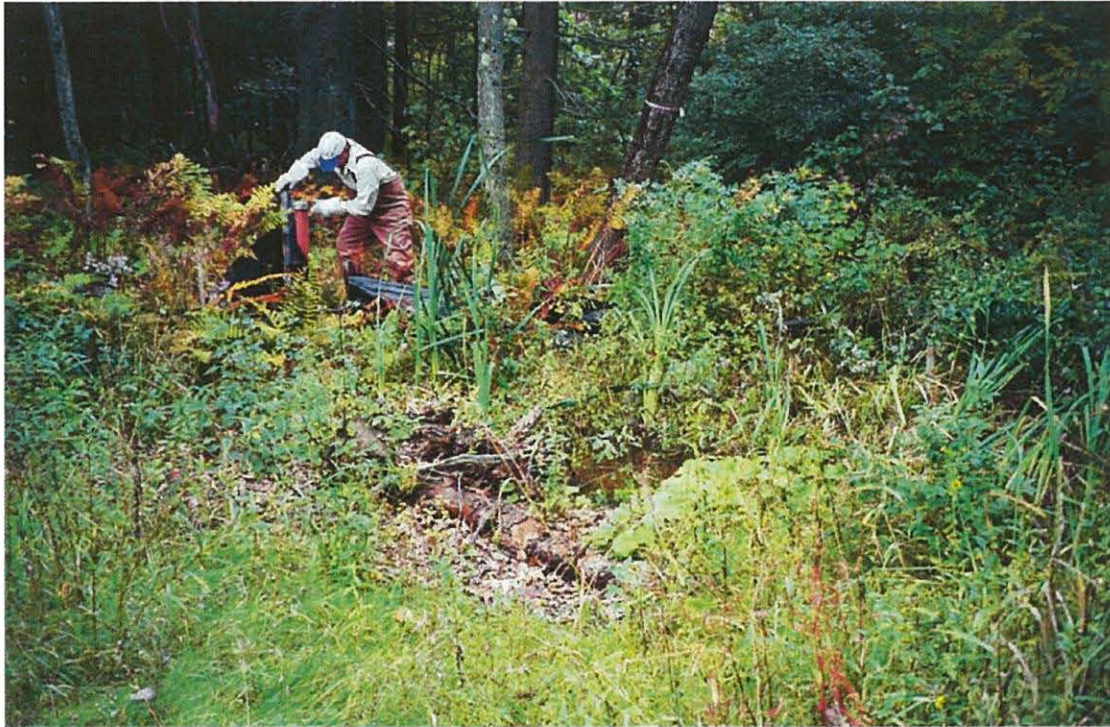
AOC 57 – Area 2: Restoration Work – Silt Fence Removal (July 2004)

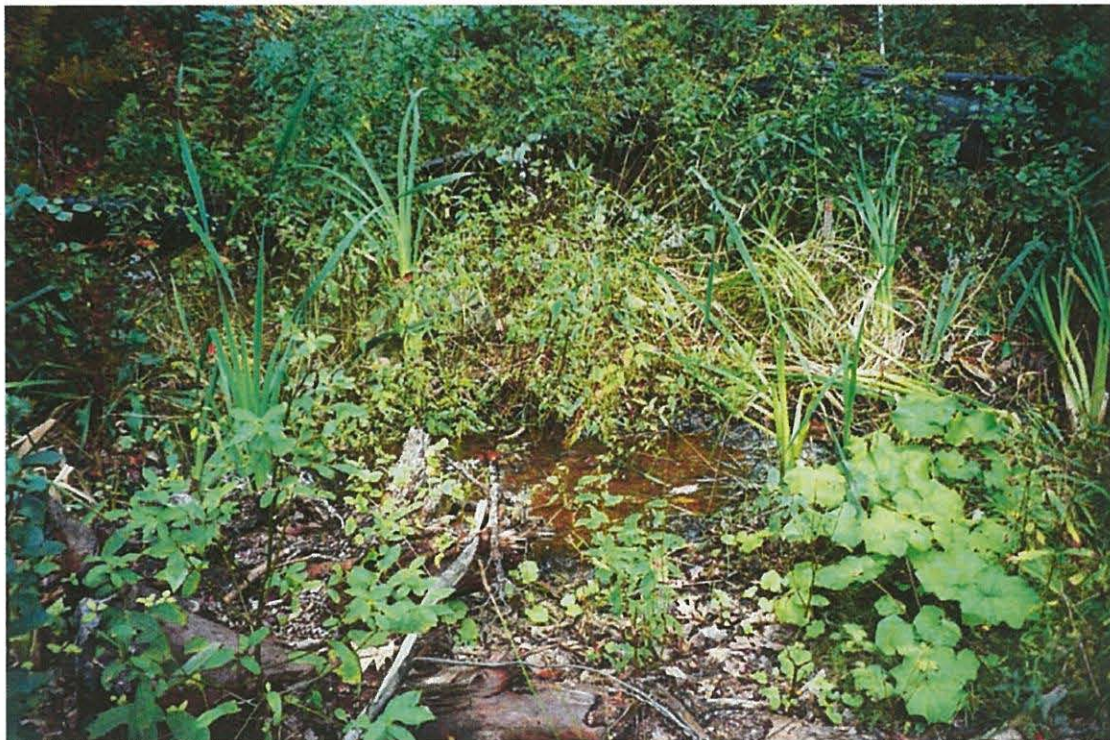
AOC 57 – Area 2: Edge of Wetland With Layer of Fine Silt (July 2004)

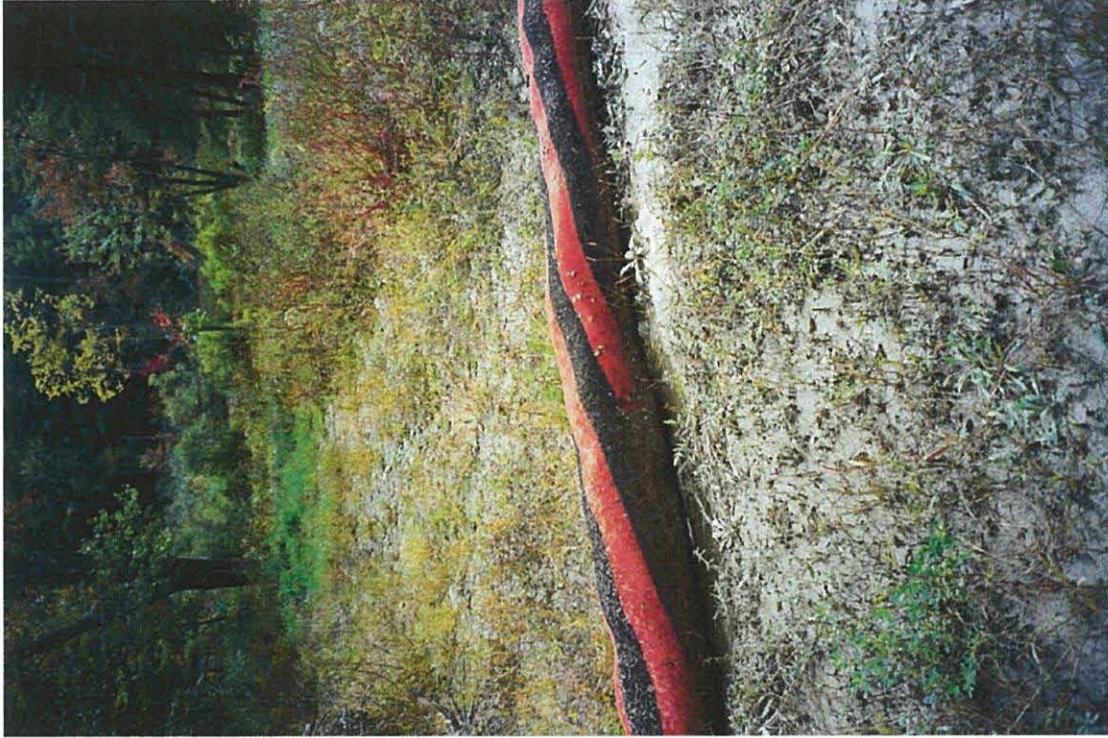
AOC 57 – Area 2: Silt Barrier/ Siltation (July 2004)

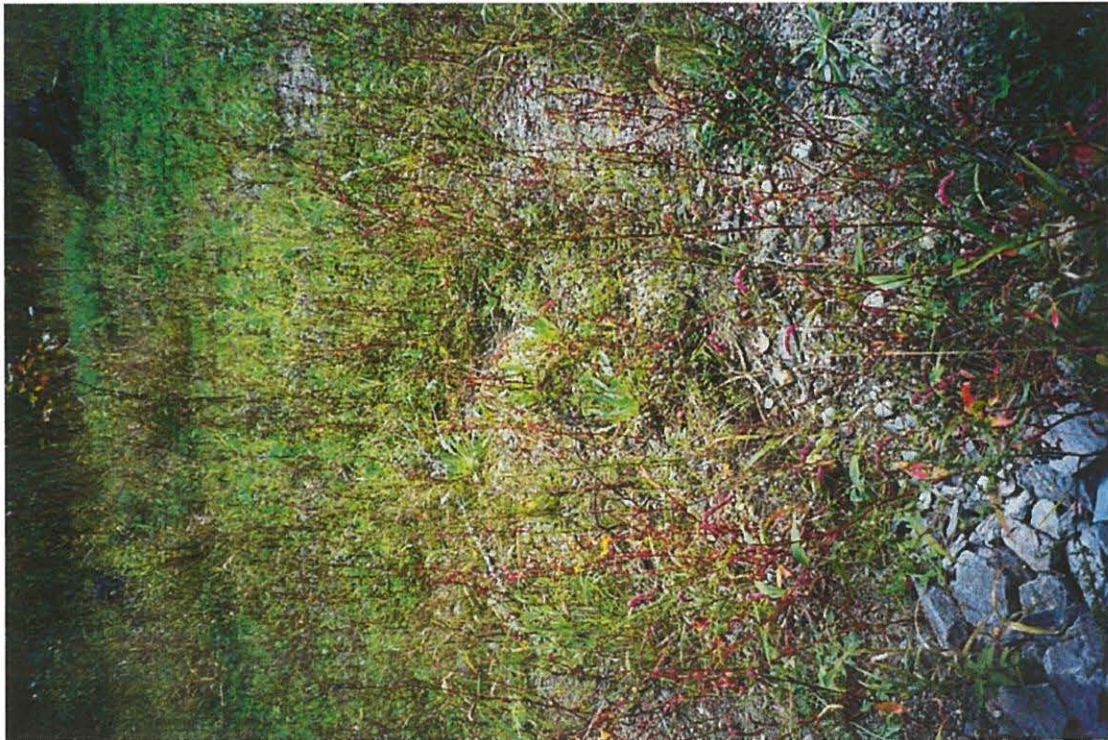
AOC 57 – Area 2: Siltation on Upland Slope (July 2004)

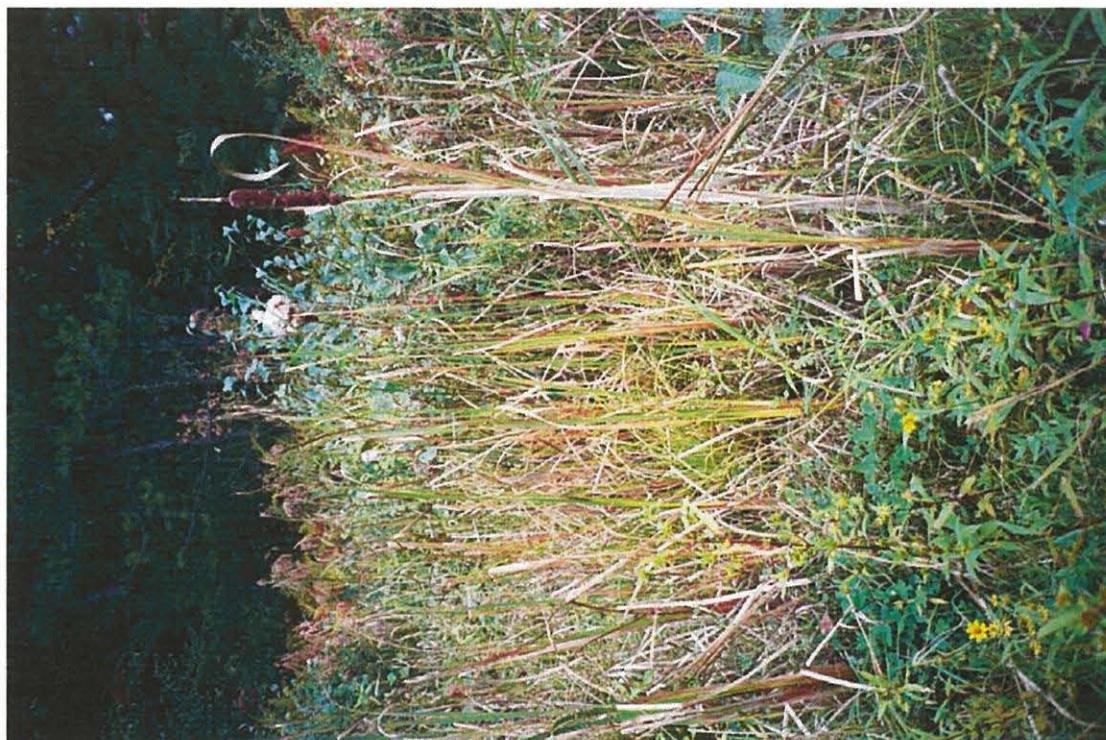
AOC 57 – Area 3: Wetland Vegetation (July 2004)

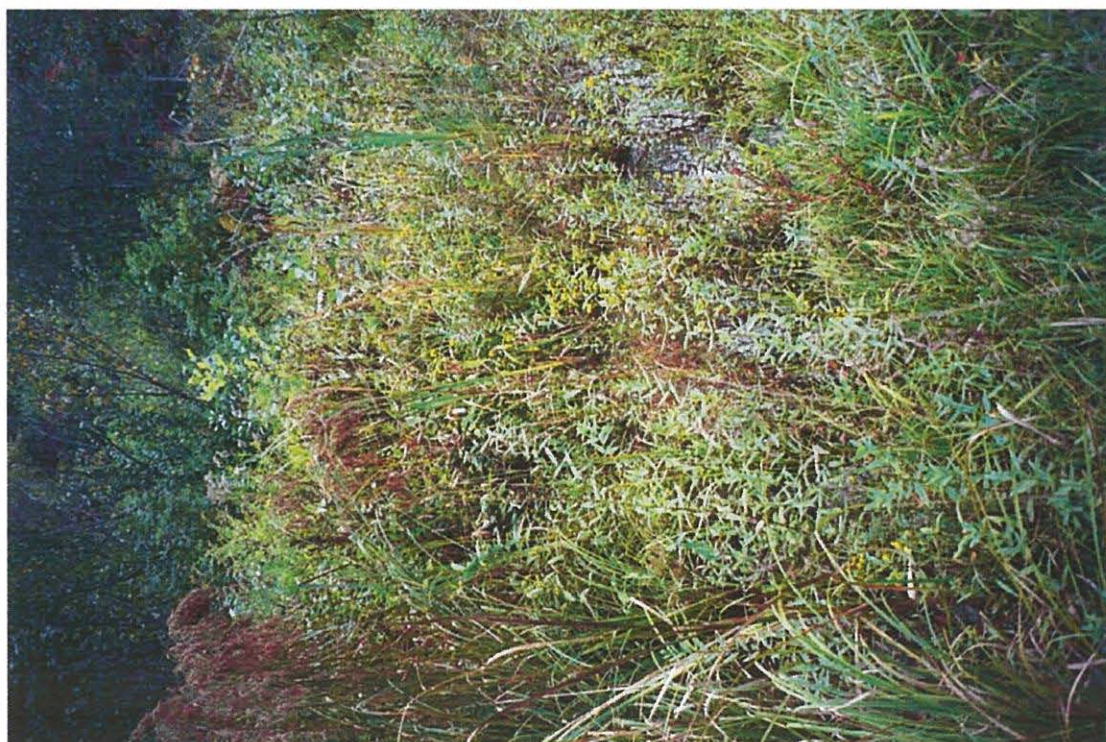
AOC 57 – Area 3: Wetland Vegetation (July 2004)
