# **Final 2005 ANNUAL REPORT**

## **WETLAND & UPLAND HABITAT RESTORATION AND LONG TERM ADAPTIVE MONITORING AND MAINTENANCE PROGRAM**

### **AREA OF CONTAMINATION (AOC) 57 DEVENS, MASSACHUSETTS**

**January 2007**

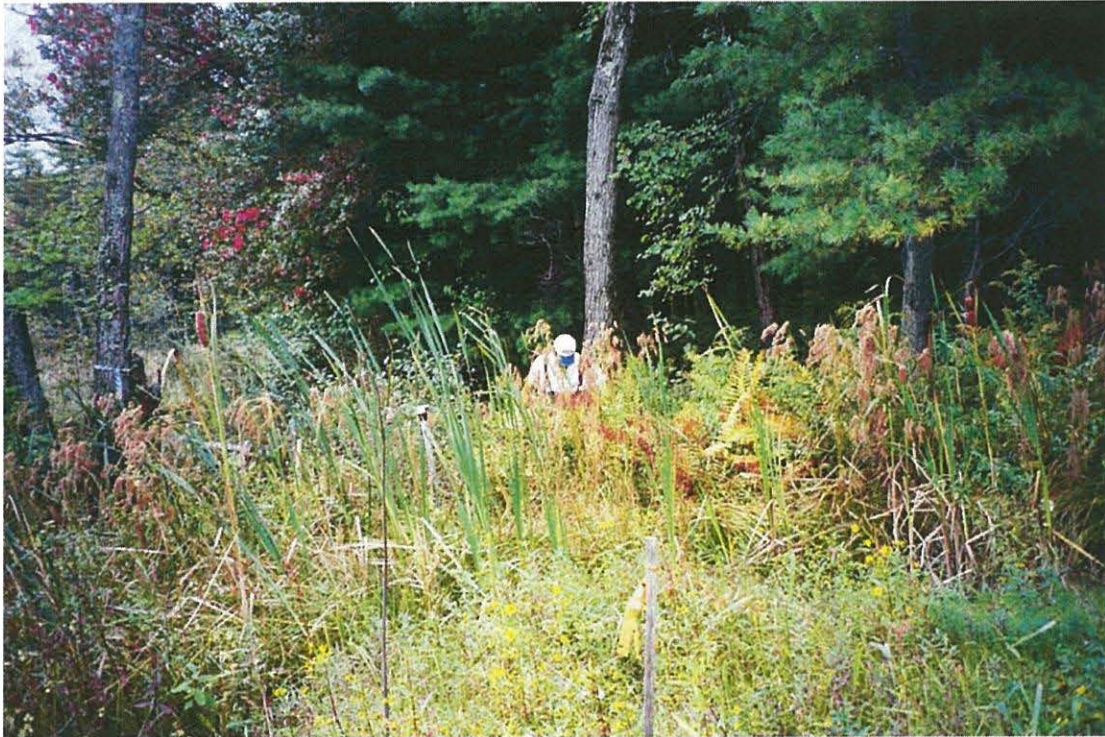
**AOC 57 – Area 3: Restoration Work, Silt Fence Removal (July 2004)**

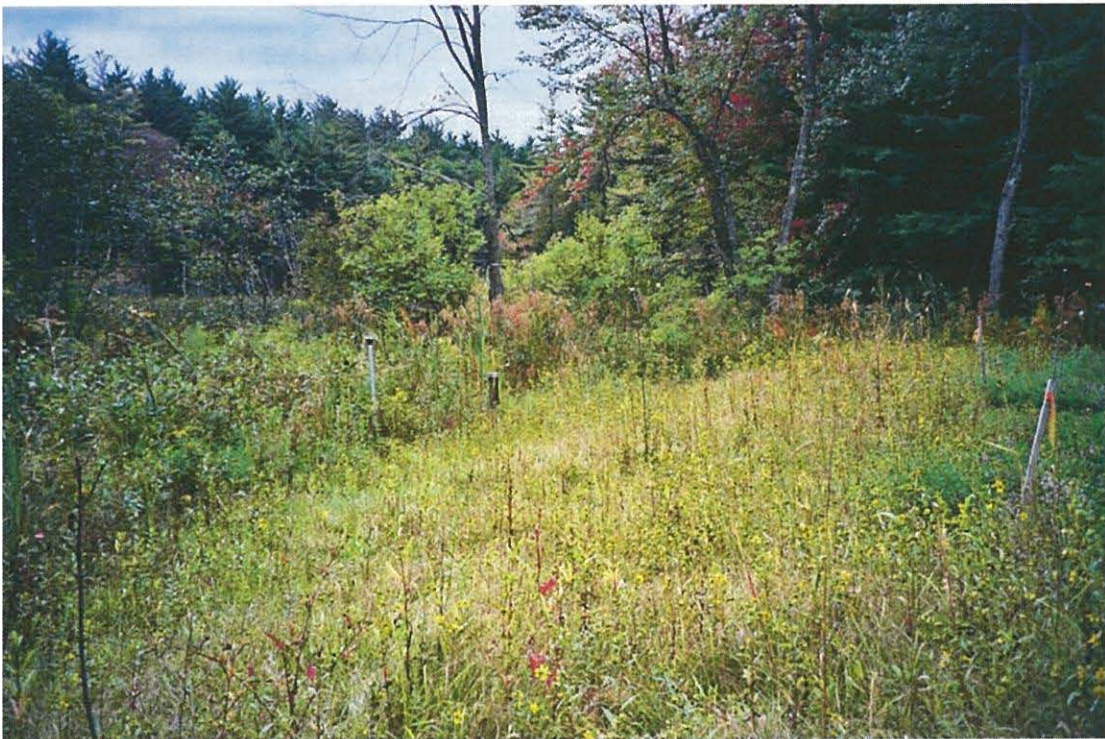
**AOC 57 – Area 3: Wetland Transition Area (July 2004)**

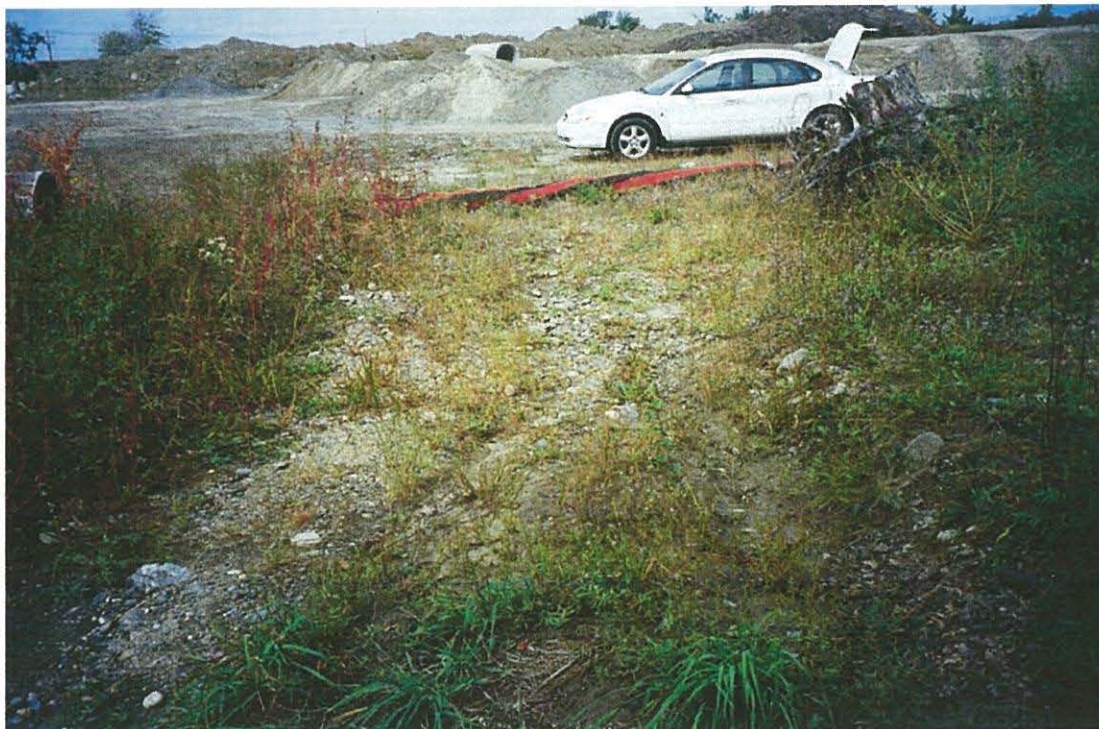
AOC 57 – Area 2: Silt Barrier/ Siltation on Upland Slope (July 2004)
