**US Army Corps
of Engineers®**
New England District

2006 ANNUAL REPORT

WETLAND & UPLAND HABITAT RESTORATION AND LONG TERM ADAPTIVE MONITORING AND MAINTENANCE PROGRAM

AREA OF CONTAMINATION (AOC) 57 DEVENS, MASSACHUSETTS

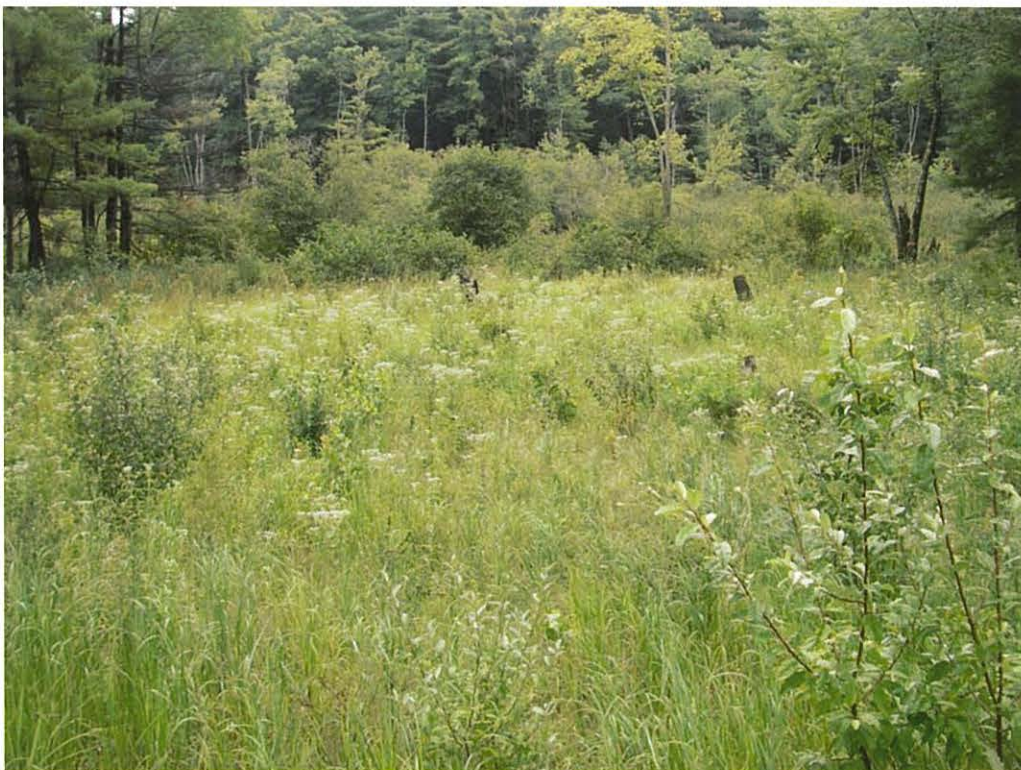
AOC 57 Area 2: Overview from top of restored upland slope with restored Bordering Vegetated Wetland in the background (August 28, 2006).

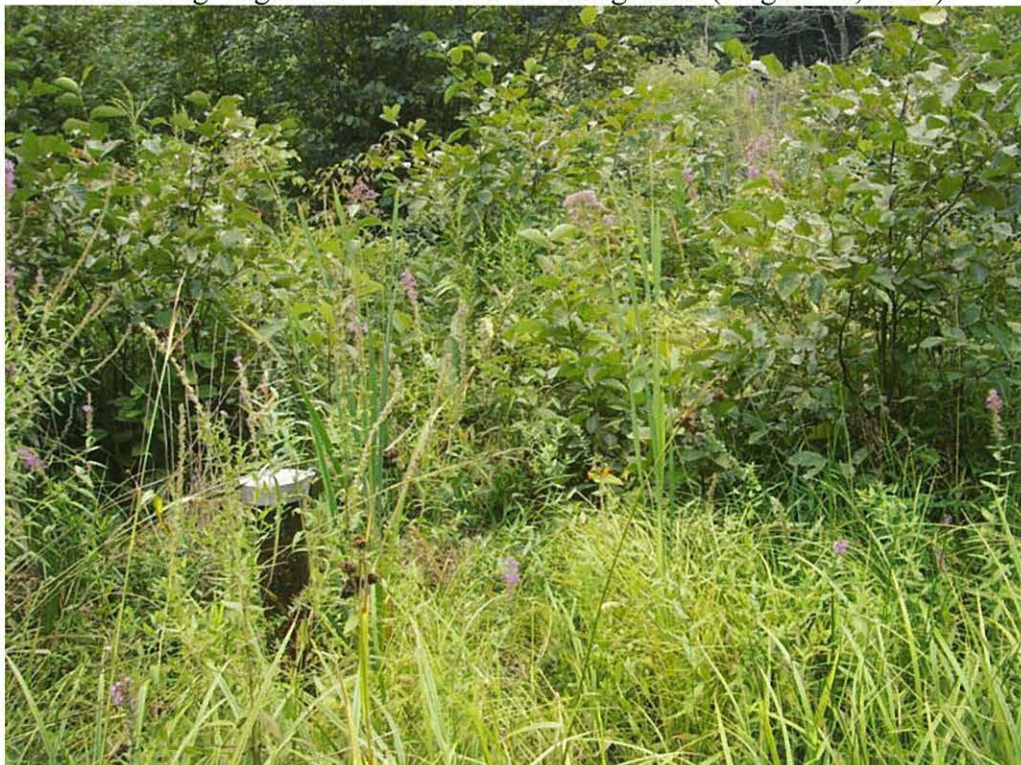
AOC 57 Area 2: Close-up of Bordering Vegetated Wetland at base of upland slope (August 28, 2006).

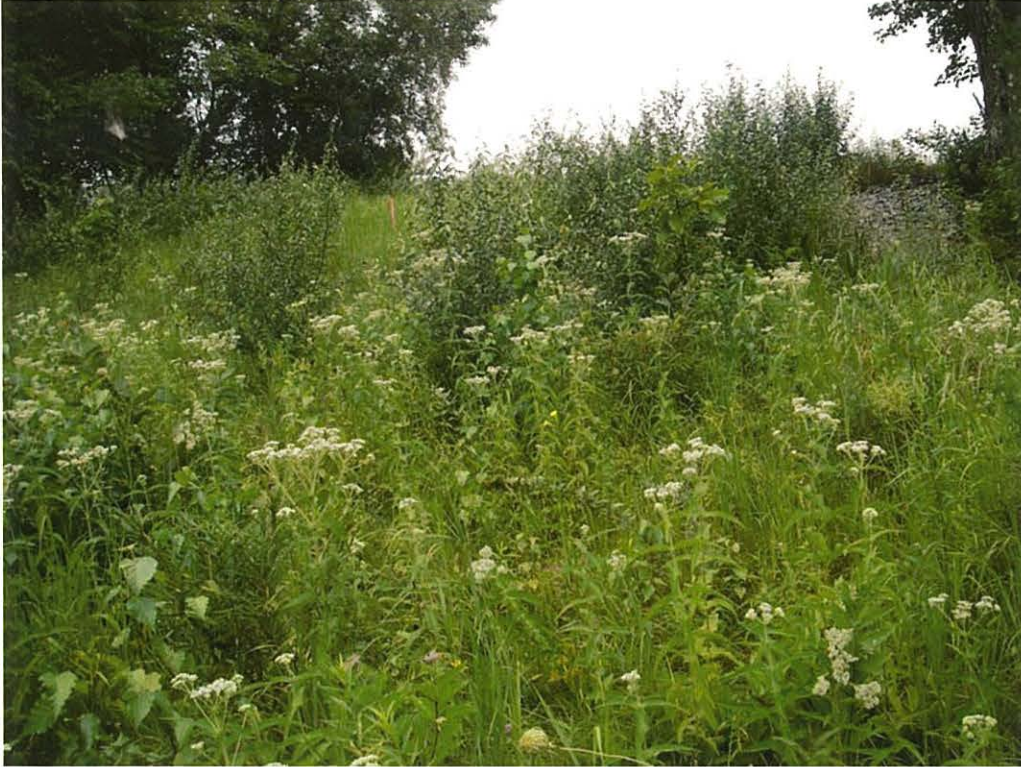
None of the three exotic/invasive plant species of concern were observed on the upland portion of Area 2. However, the dramatic appearance of the invasive shrub, autumn olive (*Elaeagnus umbellata*), as a rapid colonizer from the existing adjacent non-forested upland areas has resulted in competition with the planted oak community and other native species. Autumn olive grows in full sun and does not do well in dense forest environments as it thrives in a variety of soil and moisture conditions and invades open woodlands, fields, grasslands, and disturbed habitats (Somers et al. 2006). A few black locust (*Robinia pseudoacacia*) saplings, an invasive tree that grows in full sun to partial shade, but is intolerant of dense shade, were also observed. Consequently the autumn olive seedlings and saplings were eradicated by cutting at ground level and herbicide (25% Rodeo with Side-kick) was rubbed on the remaining stump surface. A total of 327 autumn olive seedlings/saplings were treated: 200 on September 18, 2006 and 127 on September 25, 2006 along with a few black locust saplings.

AOC 57 Area 2: Upland slope looking north with shrub community dominated by Autumn olive (August 28, 2006).

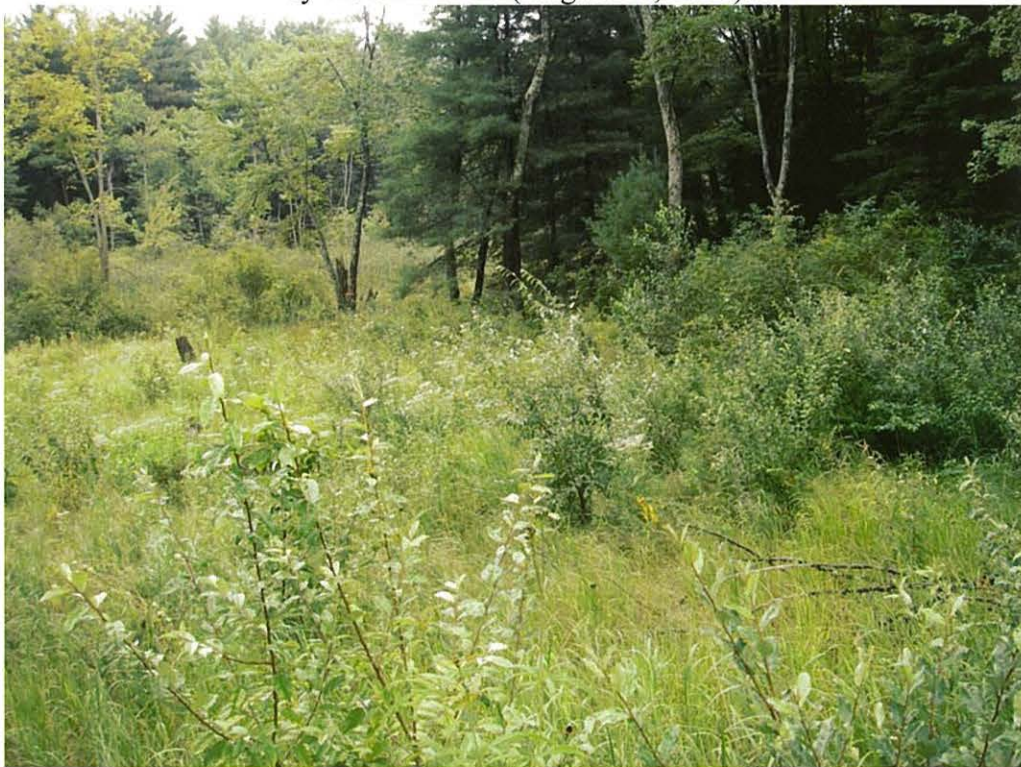
AOC 57 Area 2: West side of restored upland slope with encroachment of Autumn olive from the adjacent forest on the right (August 28, 2006).

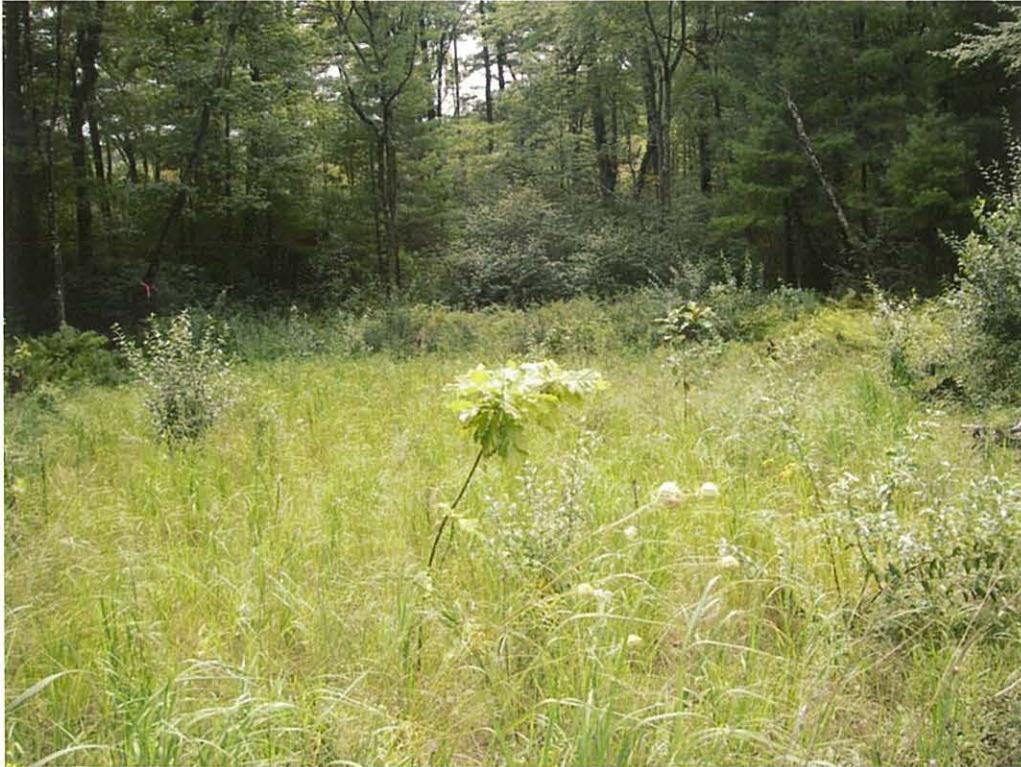
AOC 57 Area 3: Restored upland slope with the Bordering Vegetated Wetland edge in the background (August 28, 2006).

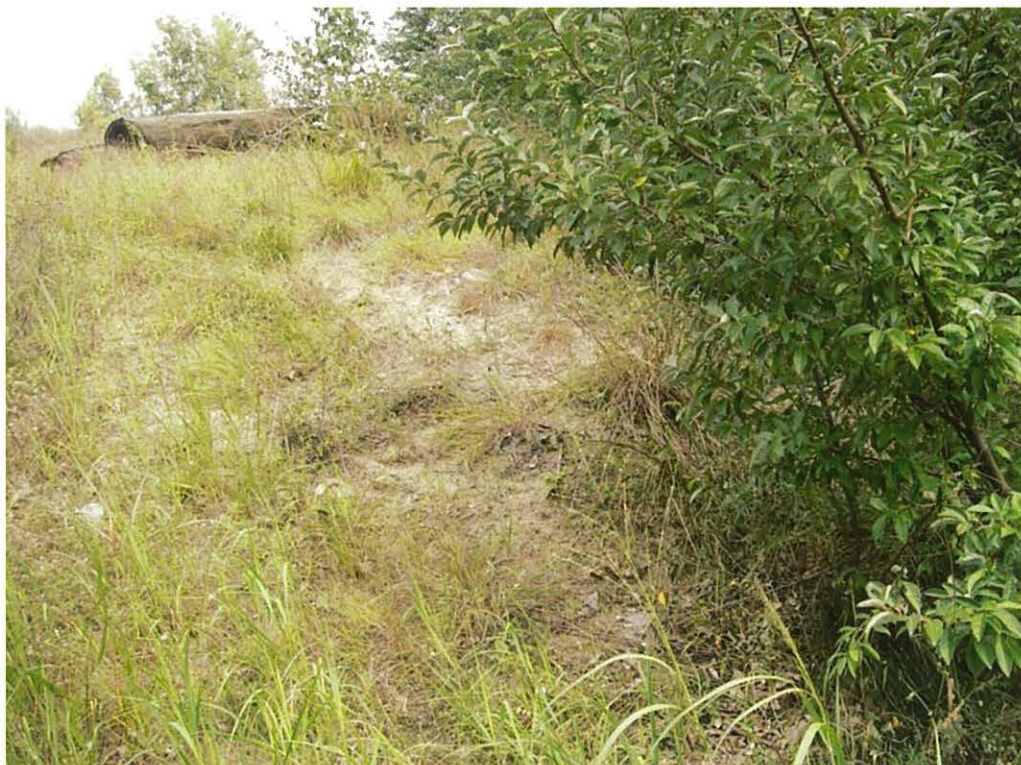
None of the three exotic/invasive plant species of concern were observed on the upland portion of Area 3. However, the appearance of the invasive shrub, autumn olive, as a rapid colonizer from the existing adjacent non-forested upland areas has resulted in competition with the planted oak community and other native species albeit the increase was not as dramatic (dominant) as in Area 2. Consequently the autumn olive seedlings and saplings were eradicated by cutting at ground level and herbicide (25% Rodeo with Side-kick) was rubbed on the remaining stump surface. A total of thirty-nine (39) autumn olive seedlings/saplings were treated on September 25, 2006.

AOC 57 Area 3: Upland slope looking north dominated by Autumn olive on the west or right side (August 28, 2006).

To encourage the growth of the planted oaks, fertilizer spikes should be placed at the drip edge of the canopy of each tree along with continued treatment of the invasive shrub, autumn olive. This should encourage the growth of the oaks to out-complete the autumn olive and eventually shade and retard autumn olive growth. Any purple loosestrife directly encountered will be hand-pulled and left on-site if not in seed and if in seed it will be removed from site for disposal to keep the purple loosestrife under control to allow the native wetland plants to dominate the vegetative community.

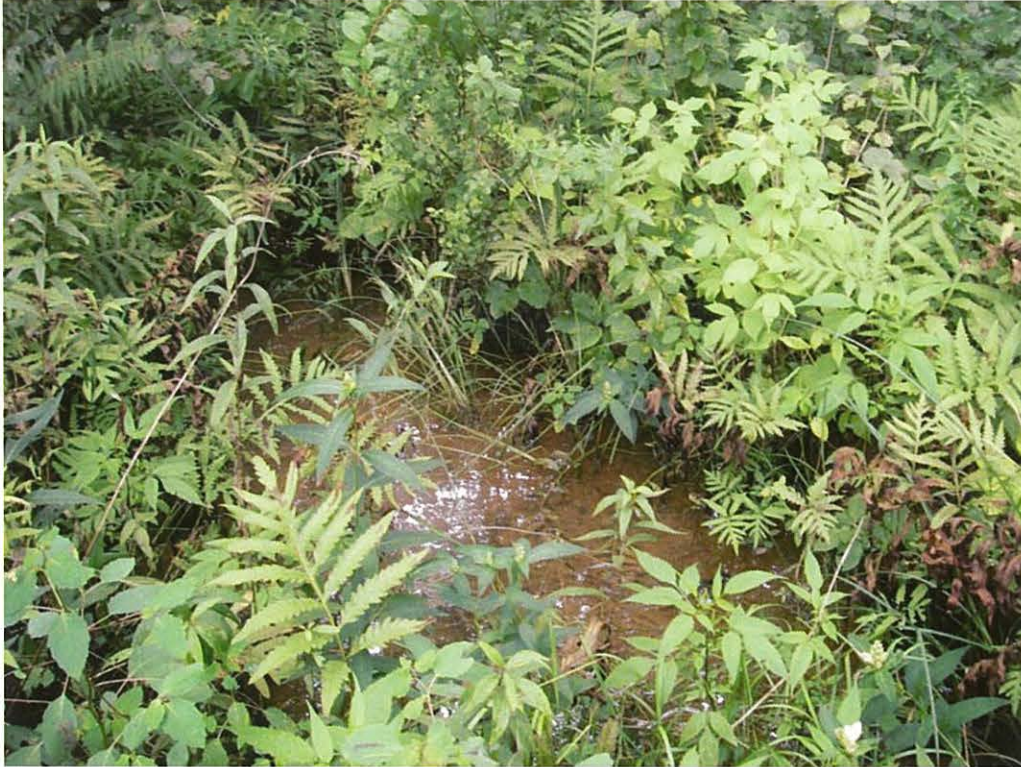
AOC 57 Area 3: Bordering Vegetated Wetland edge vegetation with standing water (August 28, 2006).

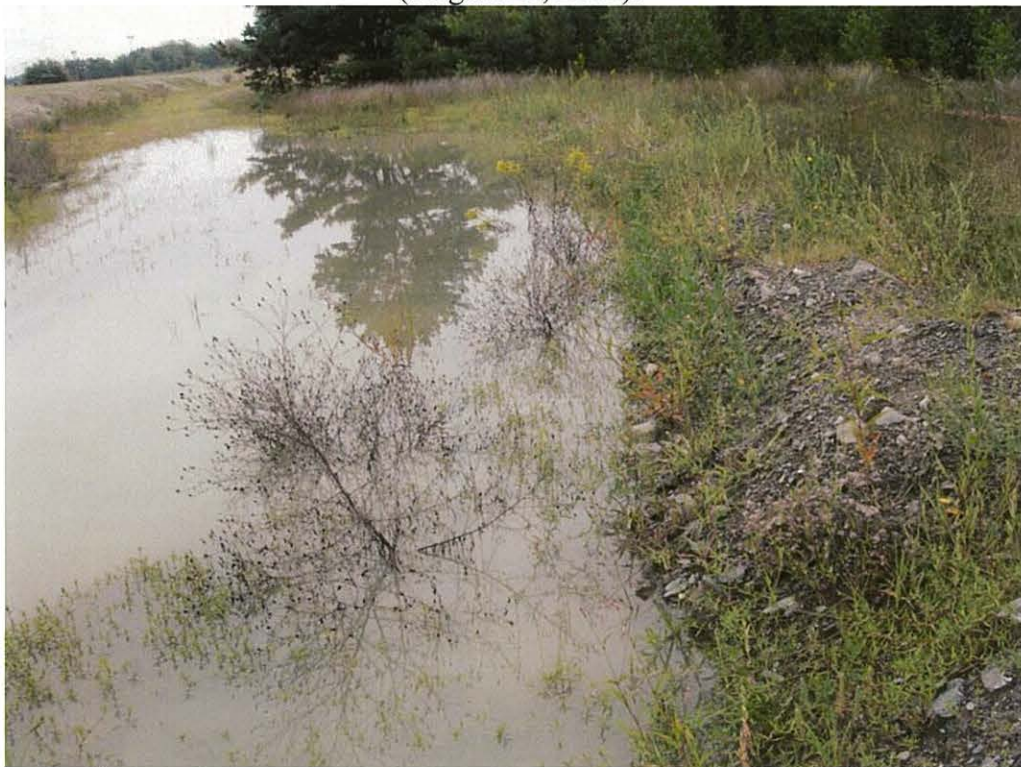
AOC 57 Area 2: Pool of storm water in front of berm installed in 2006 parallel to erosion control tube (top right corner) to well beyond the eastern edge of Area 2 (August 28, 2006)

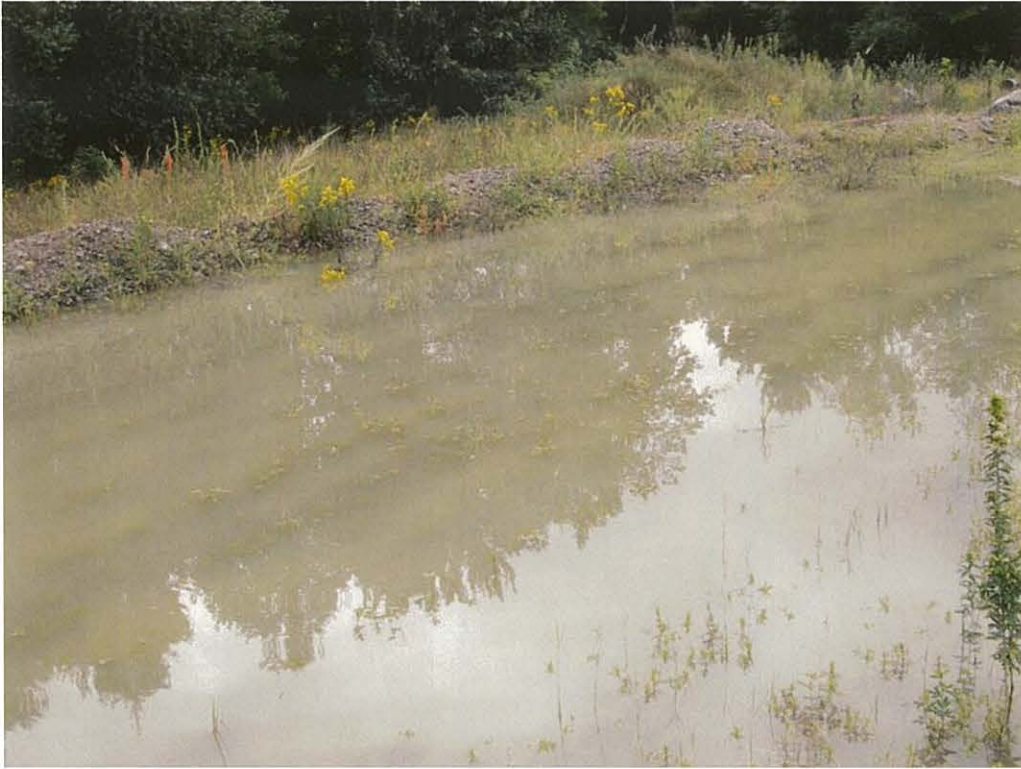
AOC 57 Area 2: Close-up of pool of storm water retained by berm with restored upland portion in top right corner (August 28, 2006).

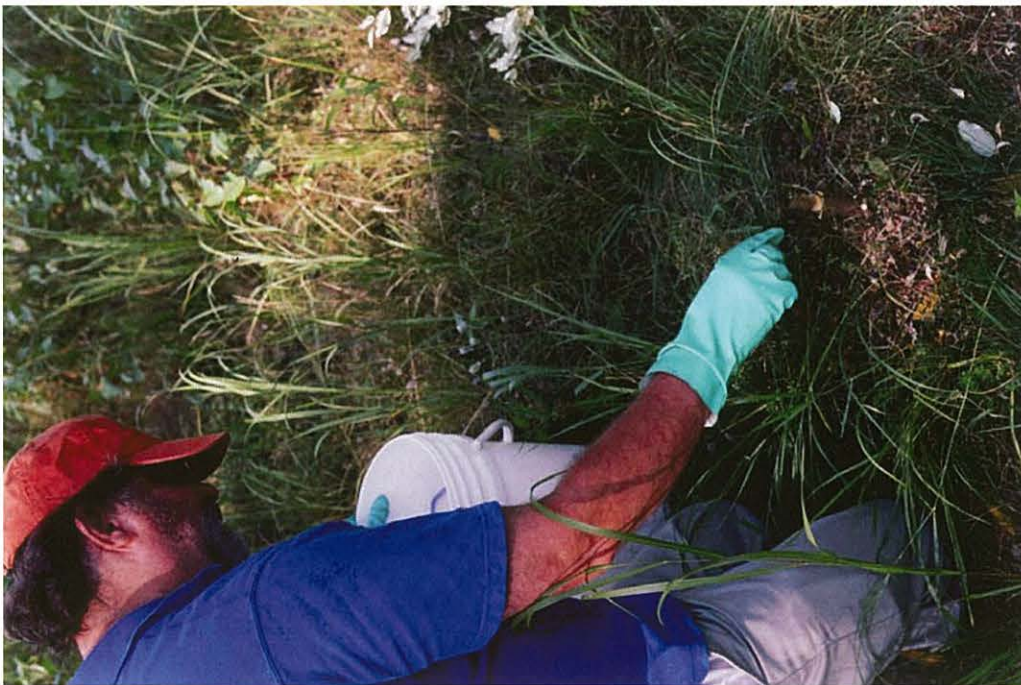
AOC 57 Area 2: Treatment of Autumn olive cut stumps with herbicide (September 18, 2006).

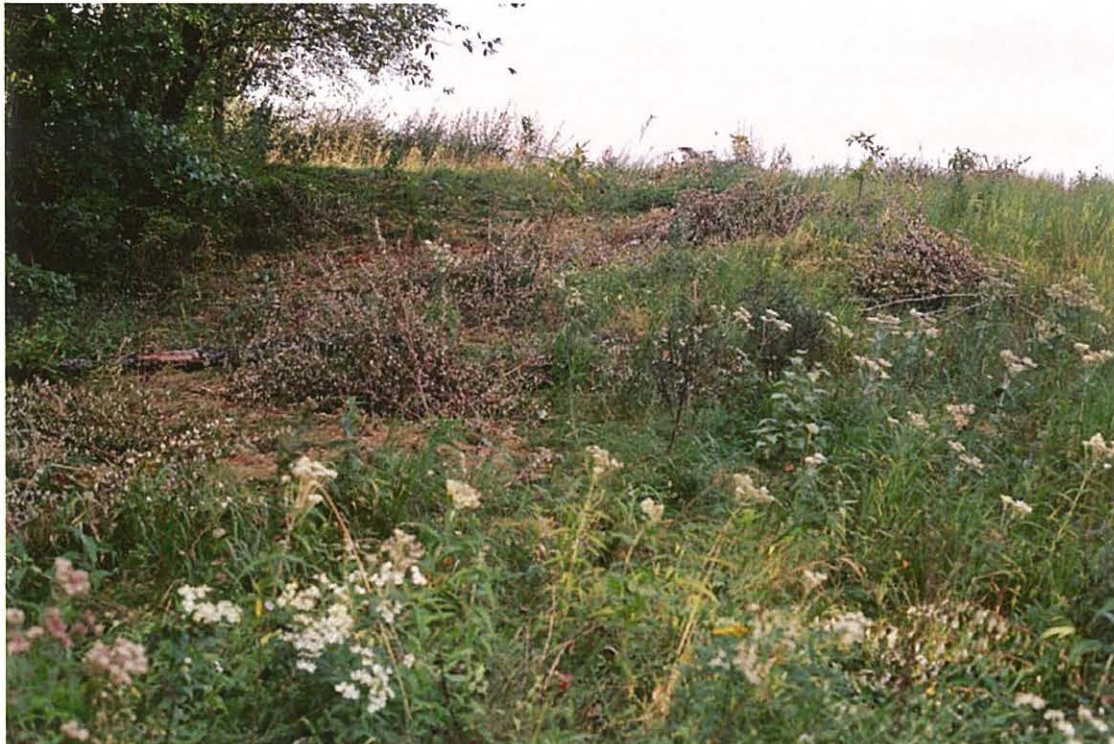
AOC 57 Area 2: Upland slope looking north after treatment of Autumn olive and placement cut shrubs into brush piles for wildlife habitat (September 25, 2006).

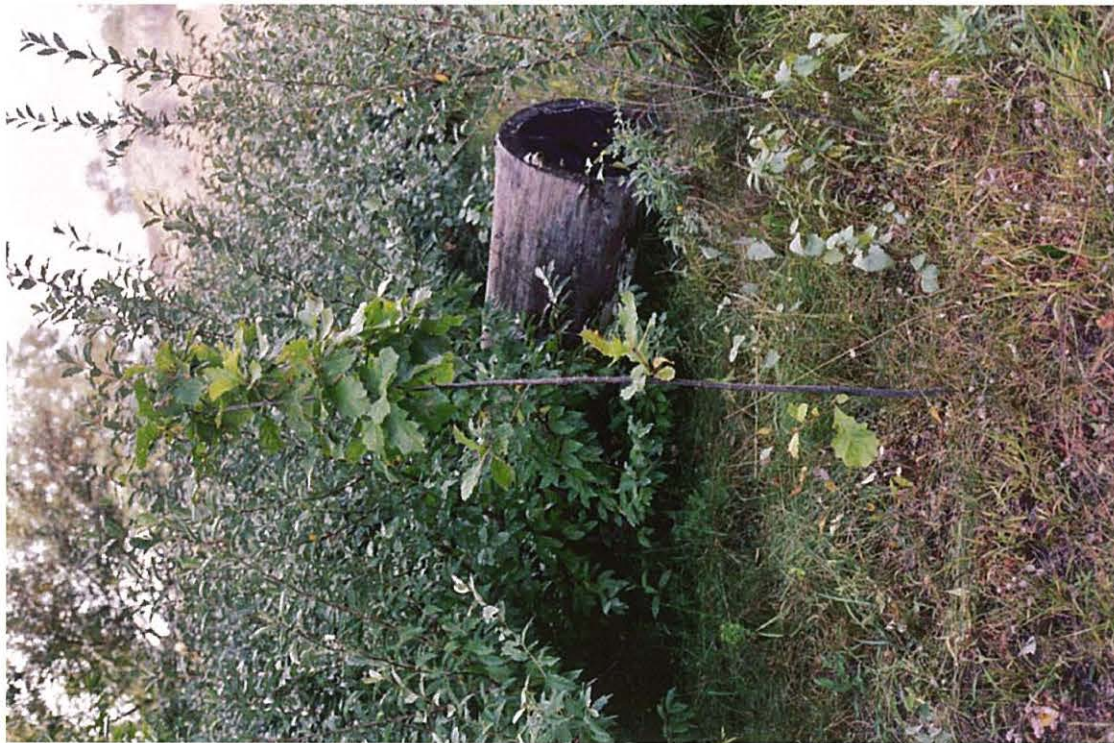
AOC 57 Area 2: Planted oak tree after removal of the surrounding Autumn olive shrubs (September 25, 2006).

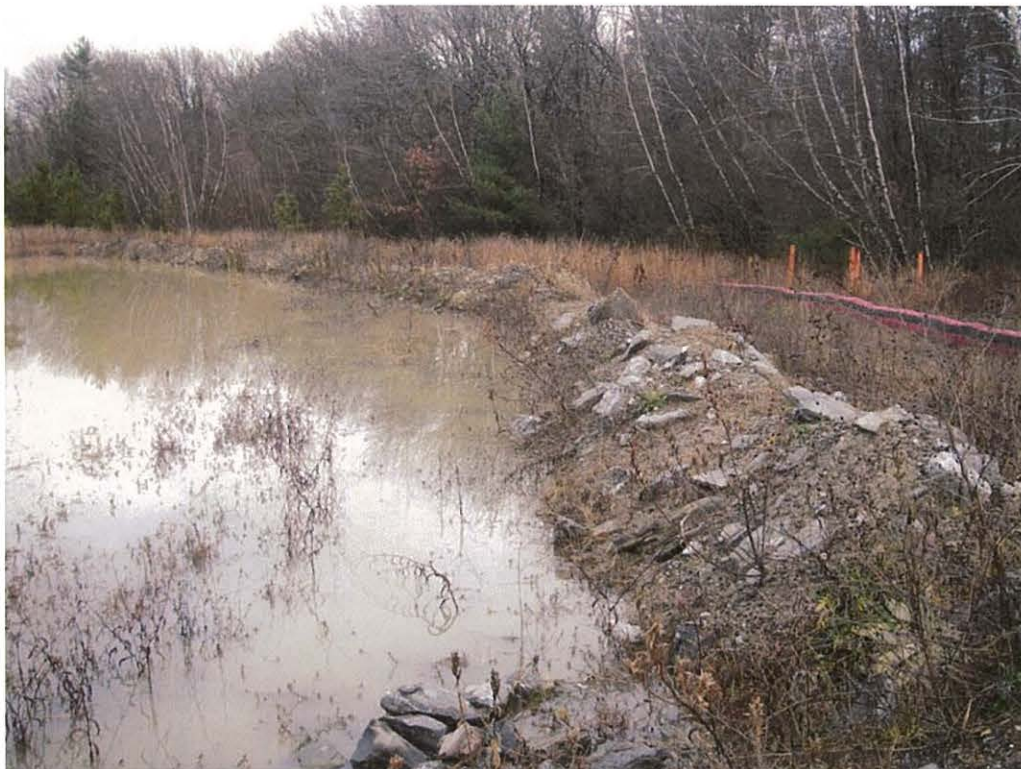
AOC 57 Area 2: Pool of storm water in front of berm installed in 2006 parallel to erosion control tube (top right corner) to well beyond the eastern edge of Area 2 (November 14, 2006).

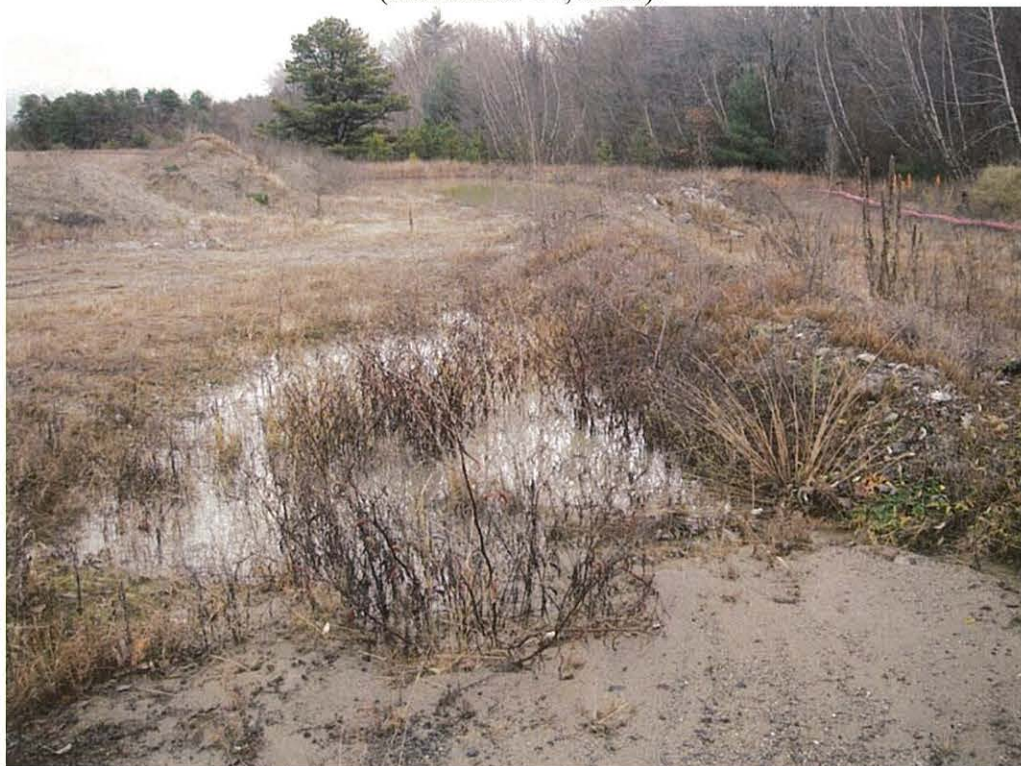
AOC 57 Area 2: Pool of storm water and recent erosion at the eastern edge of Area 2 immediately in front of berm installed in 2006 (November 14, 2006).

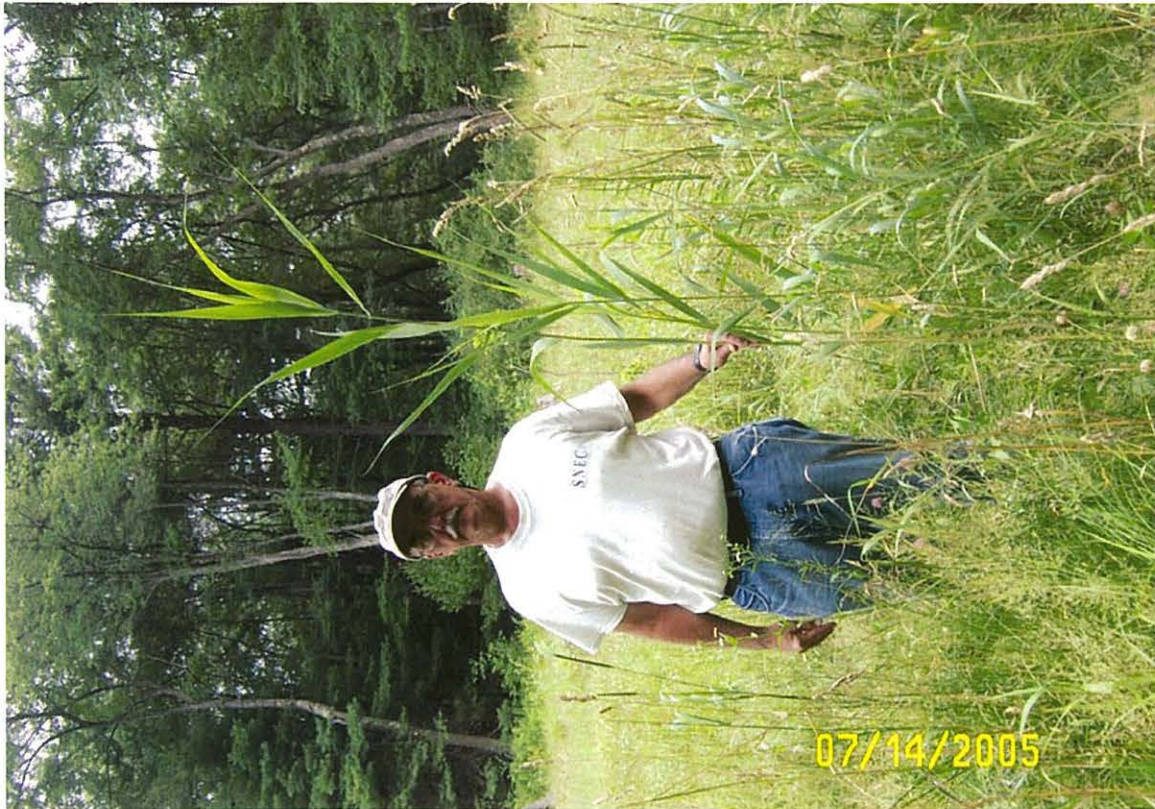
Inspections in 2004 and 2005 detected *Phragmites* which were subsequently flagged and treated. No *Phragmites* was observed during 2006. Purple loosestrife was abundant and several plants directly encountered were pulled within the restored portion. The adjacent wetlands are covered with purple loosestrife and are thus a continuing source to Area 2. It is virtually impossible to eradicate purple loosestrife once established so our objective during the program is to keep it under control by hand removal when directly encountered.

AOC 57 Area 2: Stand of invasive common reed, *Phragmites*, prior to treatment (July 14, 2005).

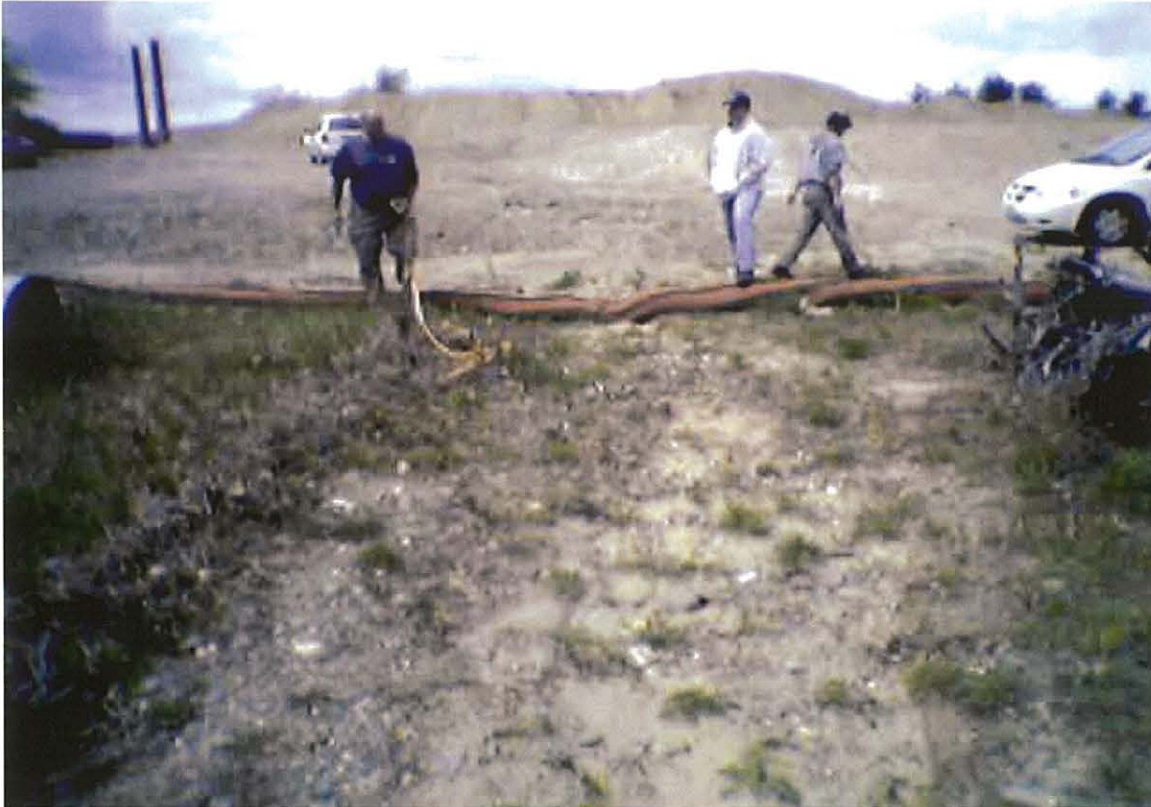
AOC 57 Area 2: Erosion of upgradient stockpiled soils onto the restored upland as a result of the failed erosion control tube as observed by the Groundwater LTM Team (May 19, 2005).

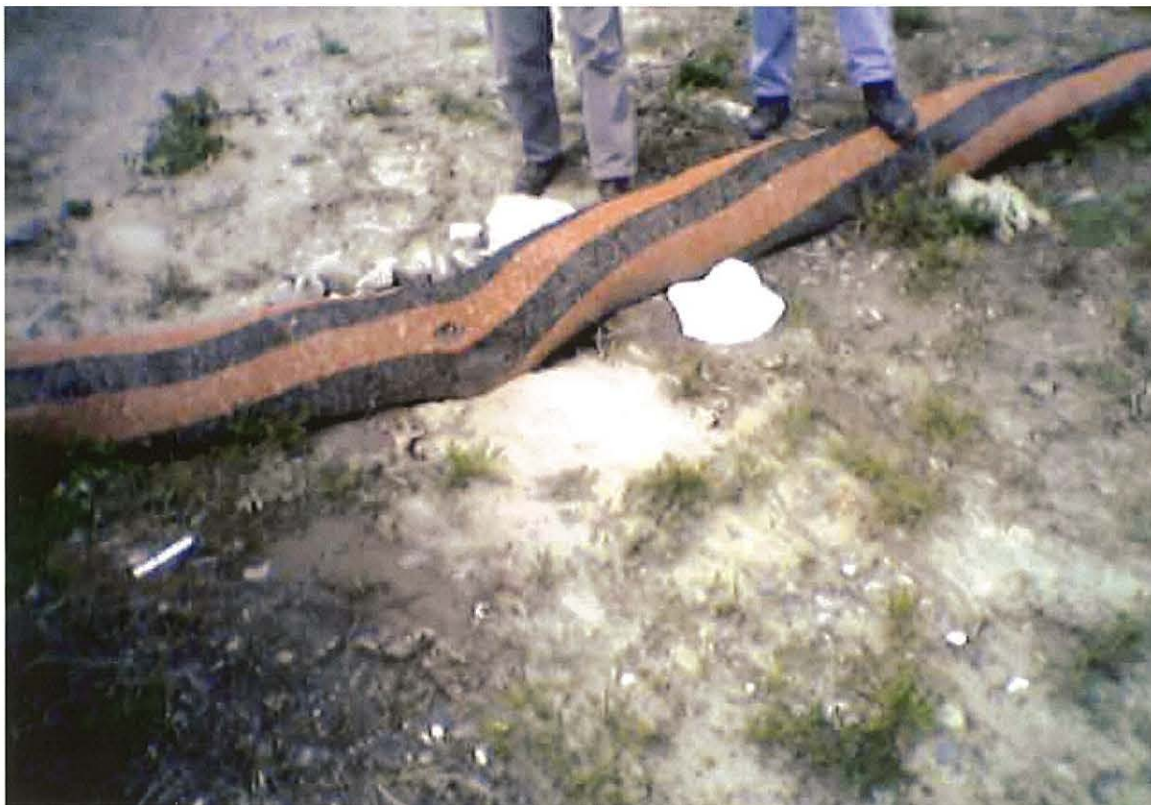
AOC 57 Area 2: Immediate corrective action taken by the Groundwater LTM Team to block the undermining by filling with nearby rock (May 19, 2005).

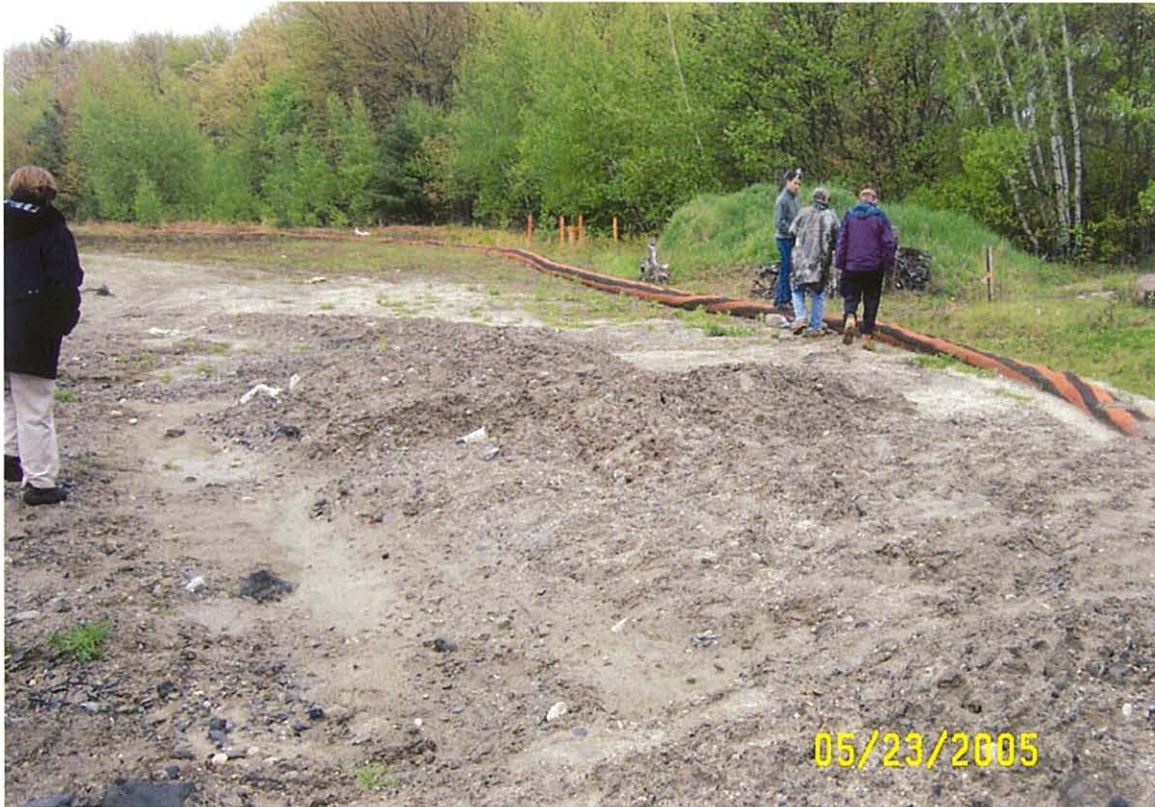
AOC 57 Area 2: Site inspection of the failed erosion control measures at the top of Area 2 by the Restoration Advisory Board (May 23, 2005).

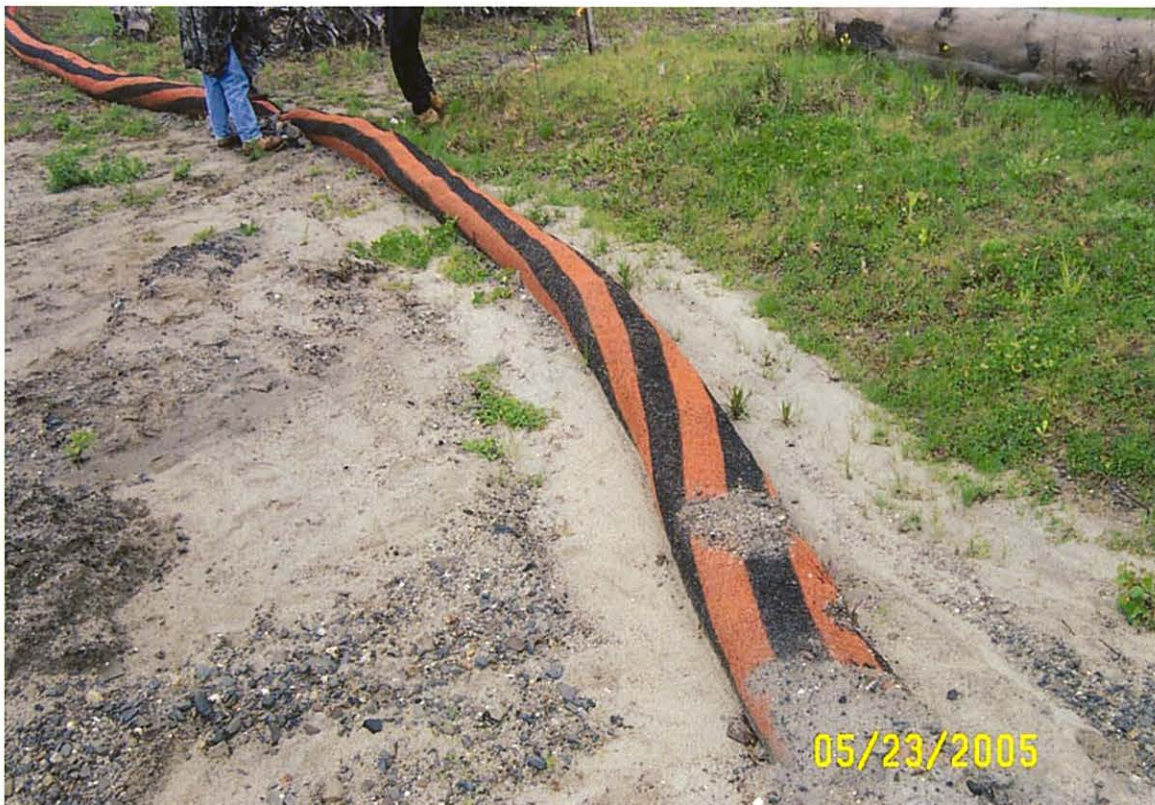
AOC 57 Area 2: Close-up showing the failed section of the erosion control tube and sedimentation from upgradient soil stockpiles (May 23, 2005).

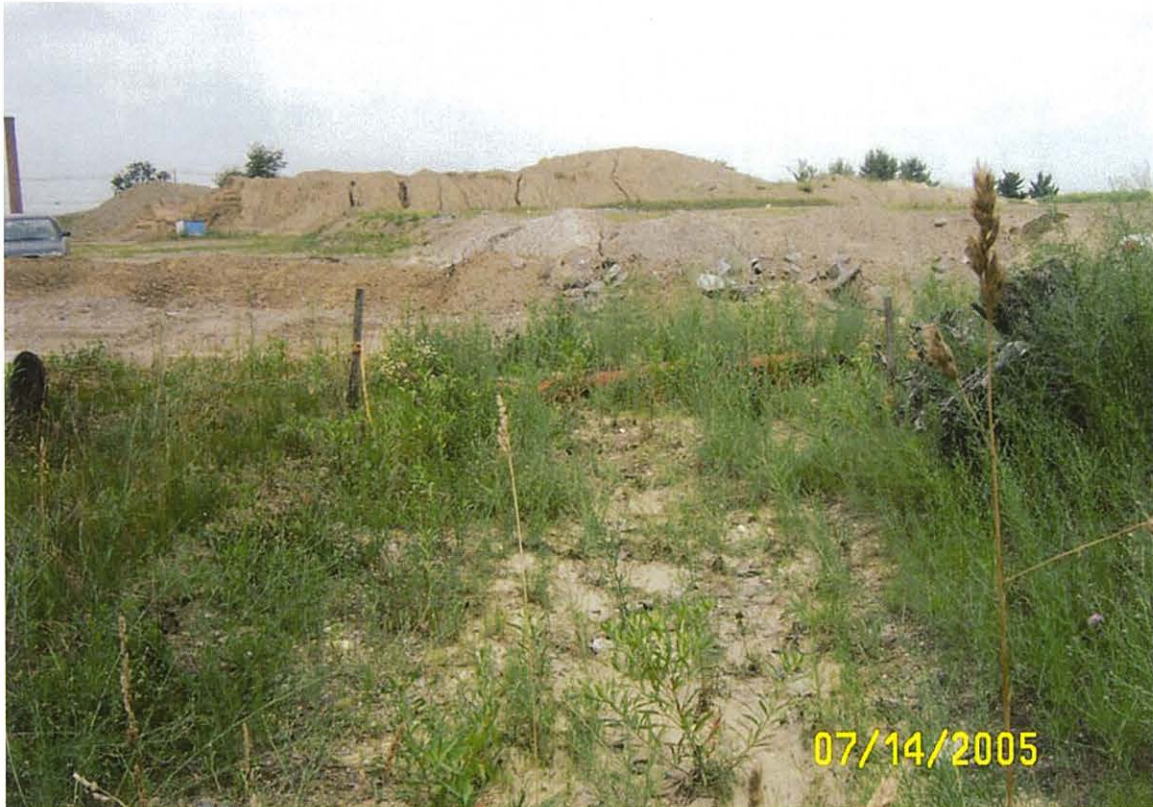
AOC 57 Area 2: Degraded upland area at top of restored slope immediately downgradient of the existing erosion control tube with the newly erected unvegetated berm by MassDevelopment in the background with the soil stockpiles in the far background.

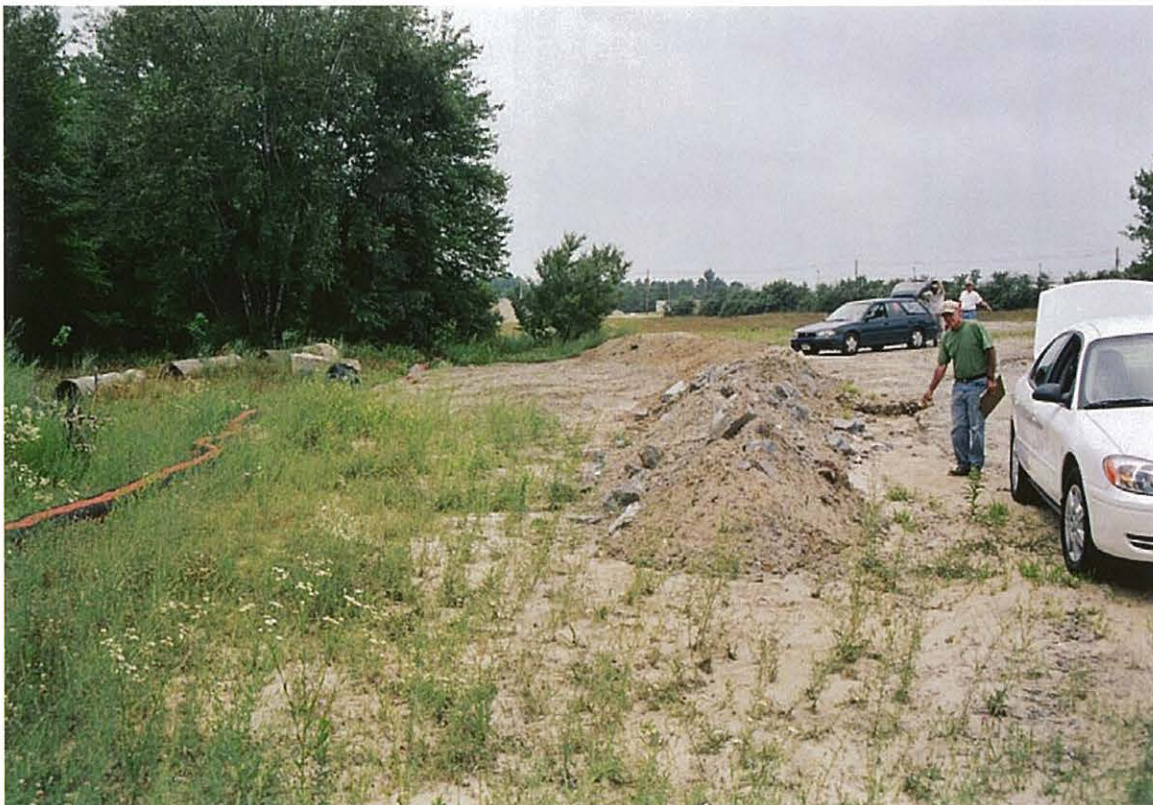
AOC 57 Area 2: Close-up of newly constructed unvegetated berm installed parallel to the erosion control tube that only extended to the eastern edge of the site (July 14, 2005).

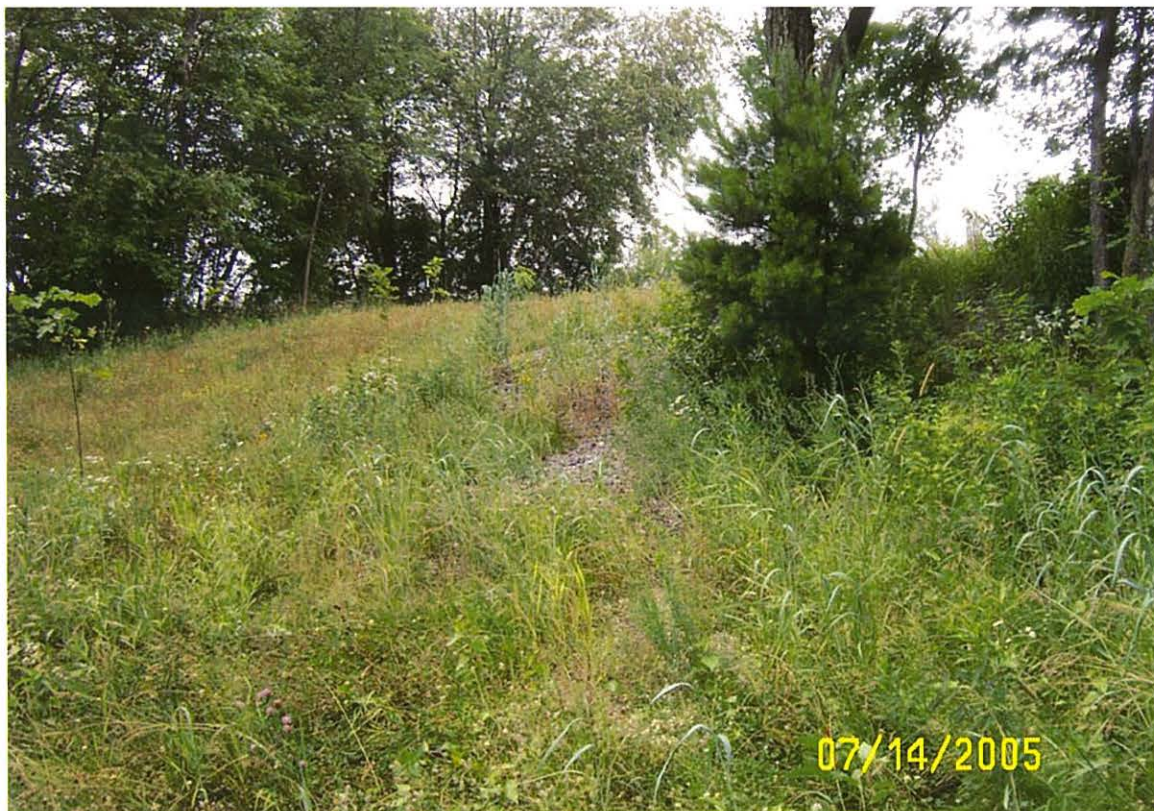
AOC 57 Area 2: Area immediately below the drainage channel established to protect the slope from erosion and armored with rip rap stone on the east side of the slope showing indications of erosion and sedimentation (July 14, 2005).

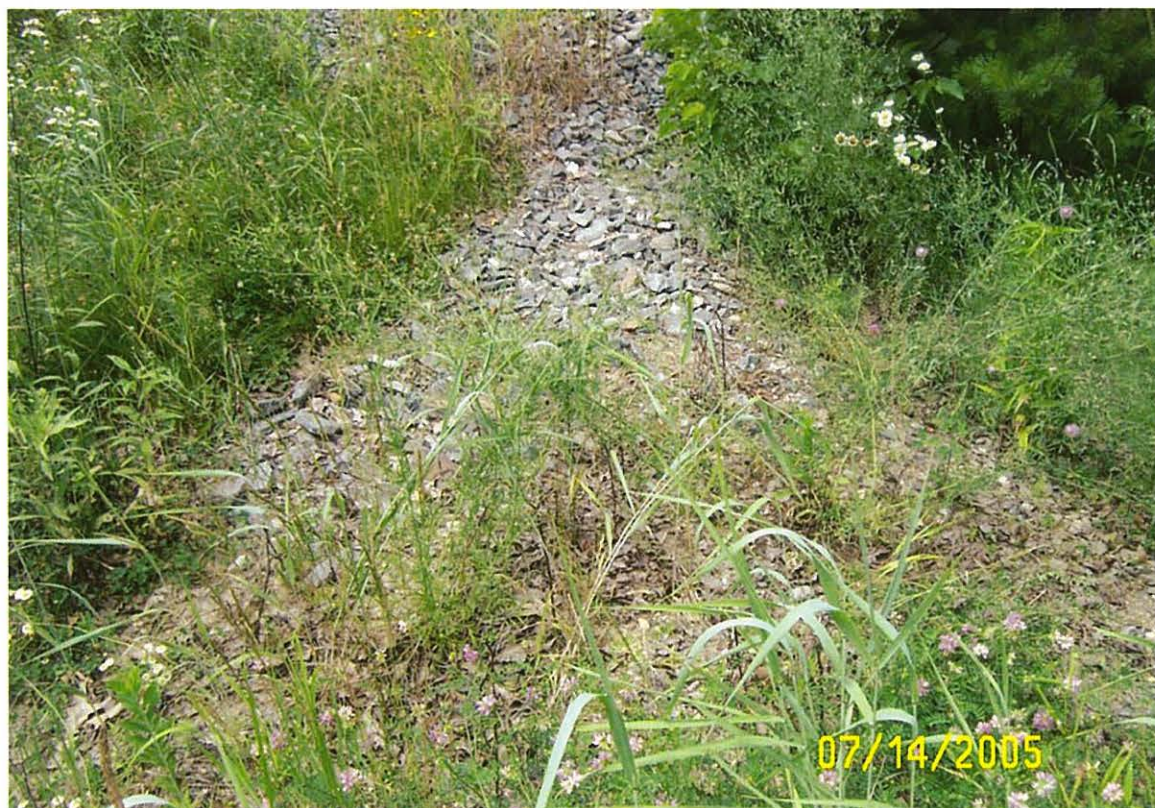
AOC 57 Area 2: Close-up of base of established drainage channel to protect upland slope and adjacent wetland from erosion and sedimentation showing indications of erosion and sedimentation (July 14, 2005).

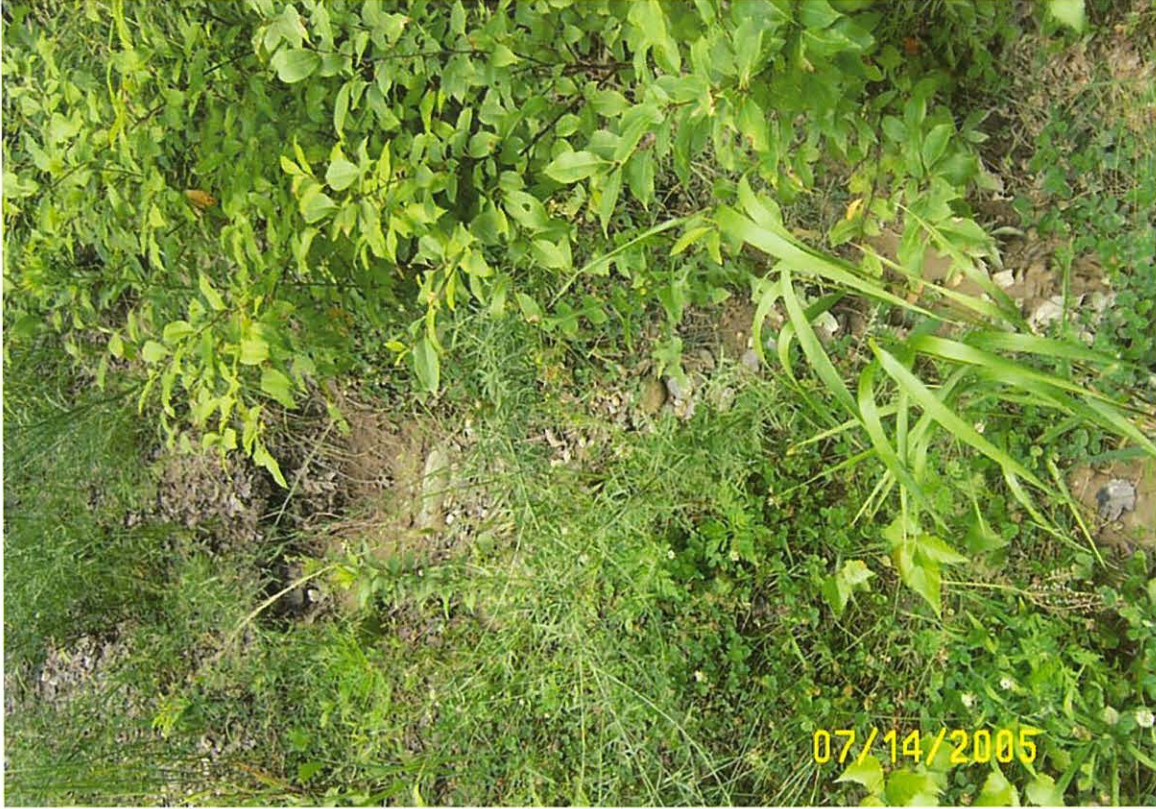
AOC 57 Area 2: Observed eroded drainage channel pathway (left to right) from base of the established rip rap drainage channel resulting in observed siltation to the existing bordering vegetated

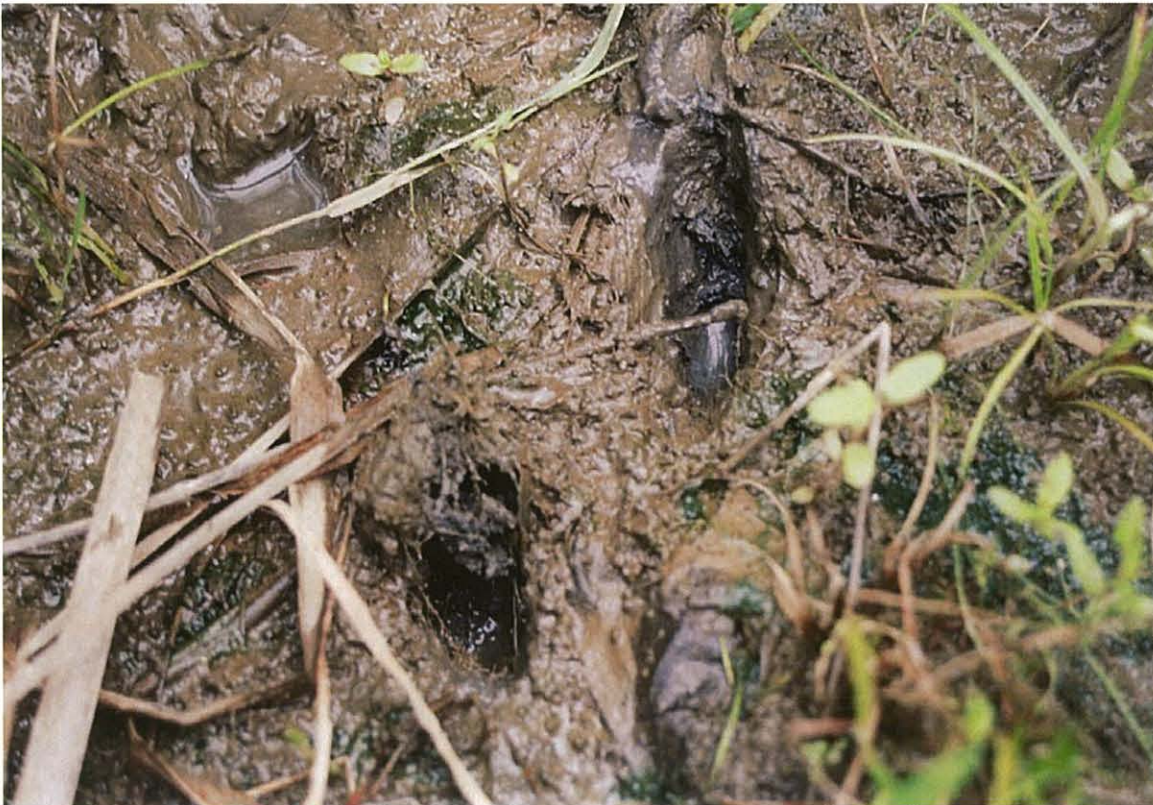
AOC 57 Area 2: Close-up of a finger scoop of wetland sediment showing the underlying hydric soil (darker color) covered by a layer of fine silt (lighter brown color) as a result of erosion from
