**US Army Corps
of Engineers®**
New England District

2006 ANNUAL REPORT

WETLAND & UPLAND HABITAT RESTORATION AND LONG TERM ADAPTIVE MONITORING AND MAINTENANCE PROGRAM

AREA OF CONTAMINATION (AOC) 57 DEVENS, MASSACHUSETTS

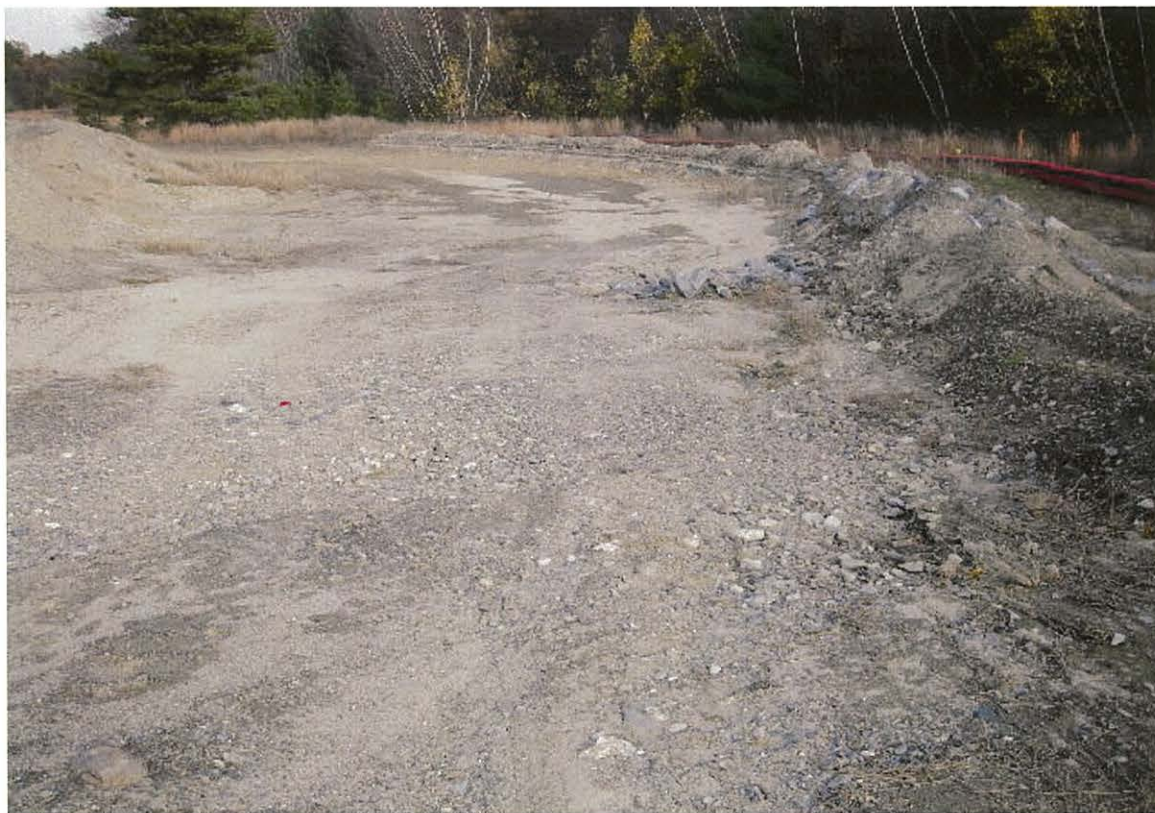
AOC 57 Area 2: Extension of the unvegetated berm installed parallel to the erosion control tube to well beyond the eastern edge of the site (November 1, 2005).

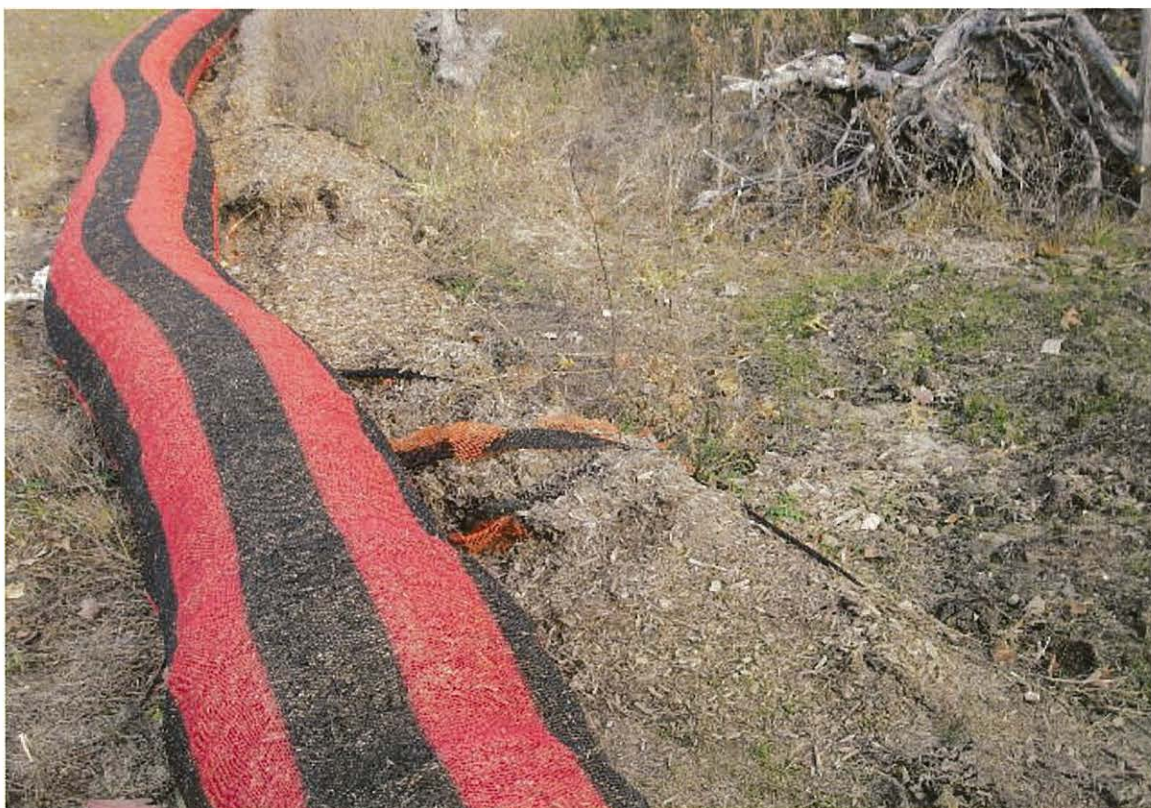
AOC 57 Area 2: Close-up of the newly installed erosion control tube (red & black stripes) to replace the degraded erosion control tube (orange & black stripes) (November 1, 2005).

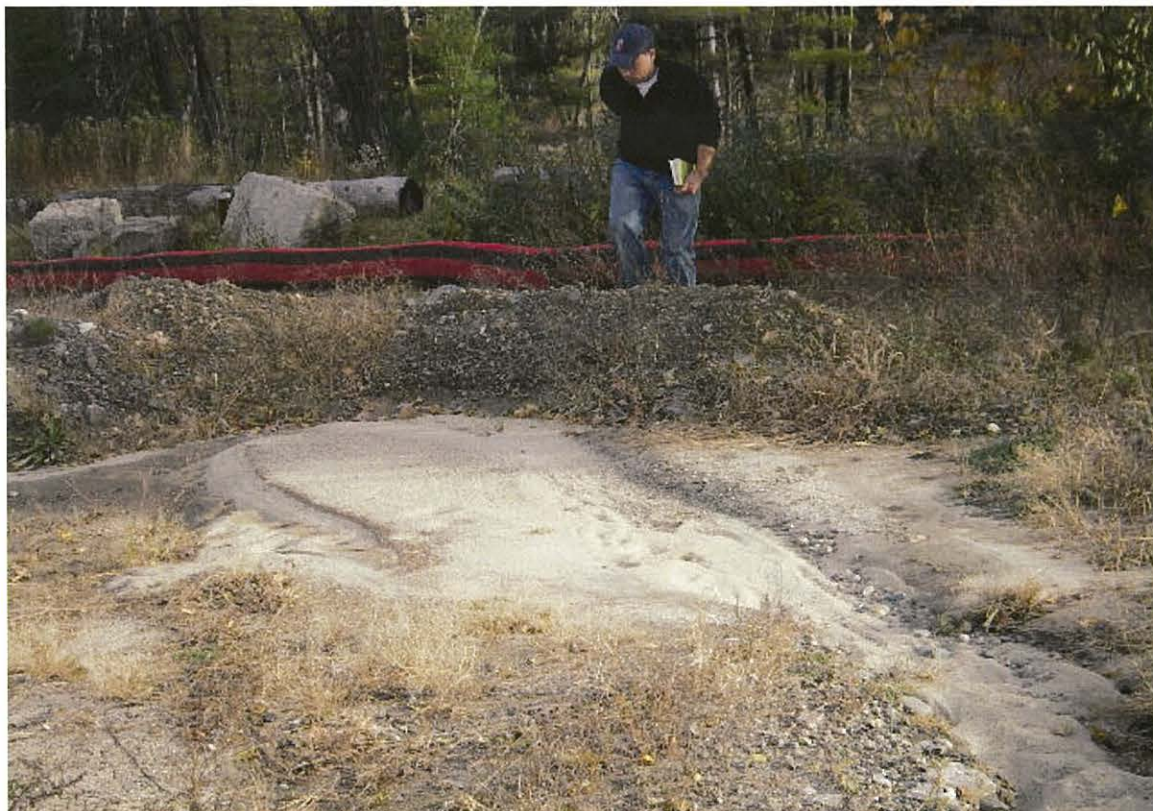
AOC 57 Area 2: Upgradient view of unvegetated berm after heavy rains (November 1, 2005).

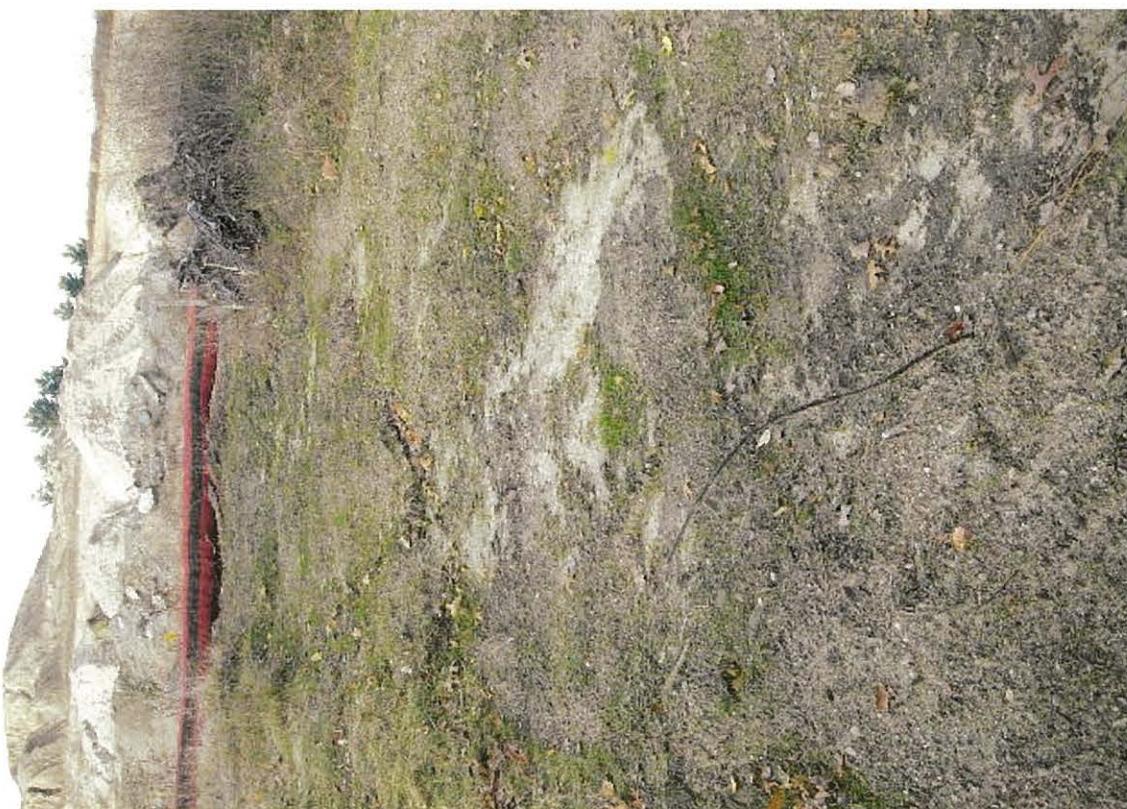
AOC 57 Area 2: Revegetation of upland slope impacted by erosion and sedimentation.

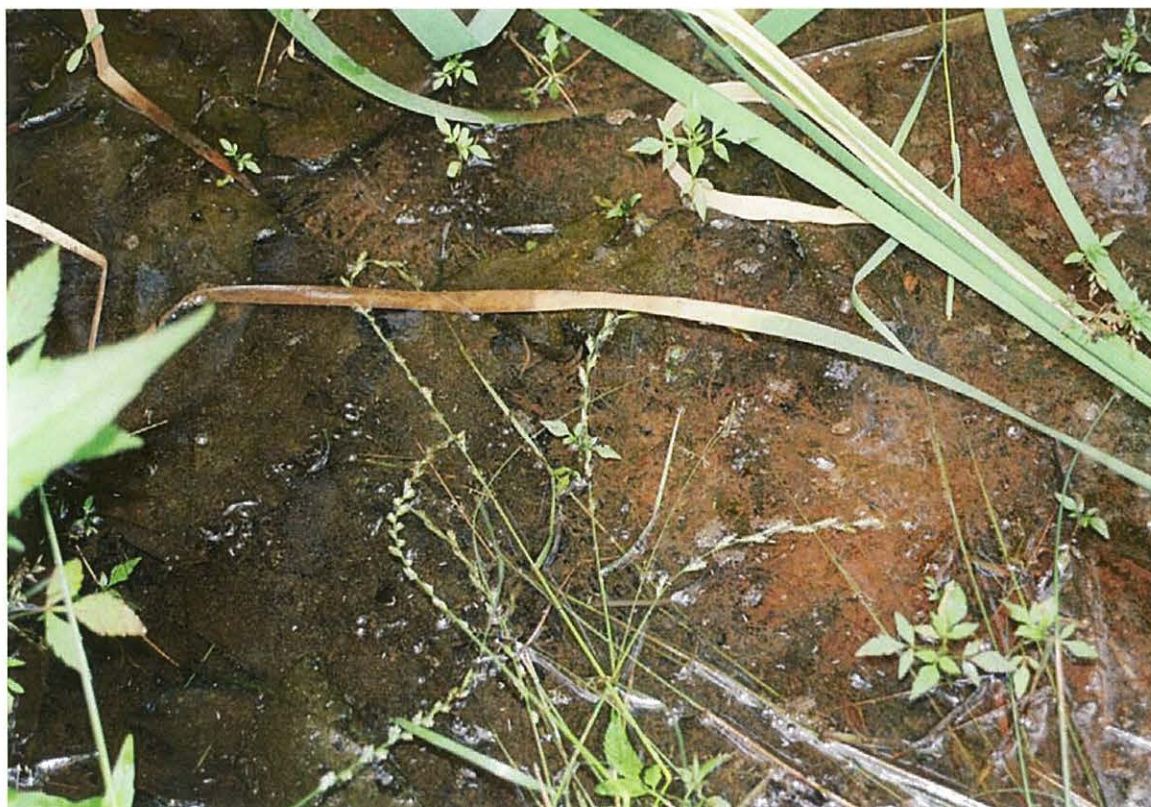
AOC 57 Area 3: Close-up of standing water in Bordering Vegetated Wetland (July 14, 2005).

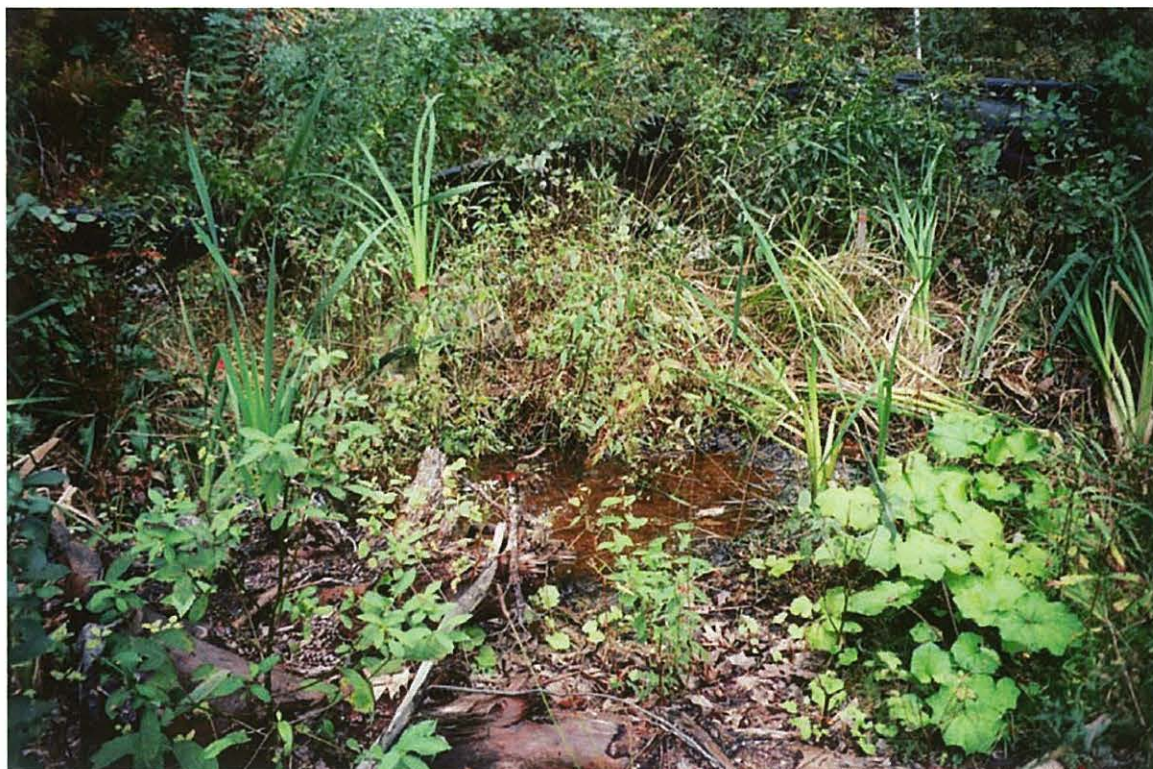
AOC 57 – Area 2: Edge of Wetland With Layer of Fine Silt (July 2004)

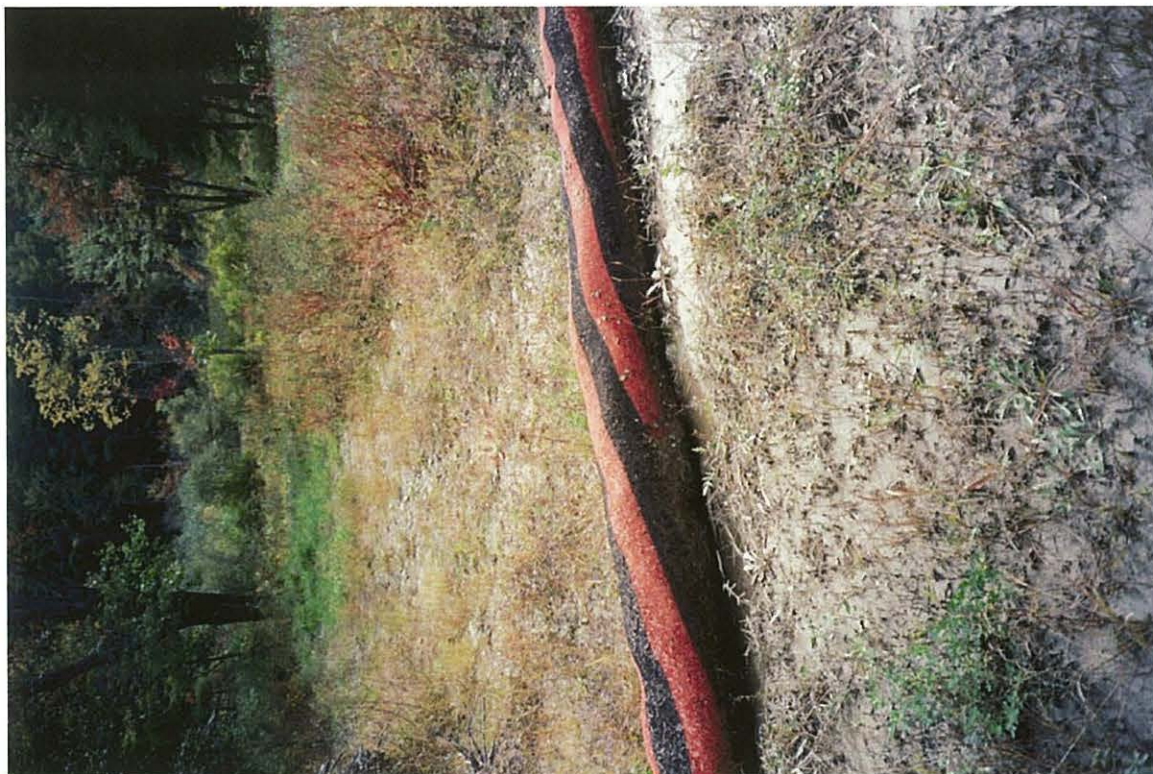
AOC 57 – Area 2: Silt Barrier/ Siltation (July 2004)

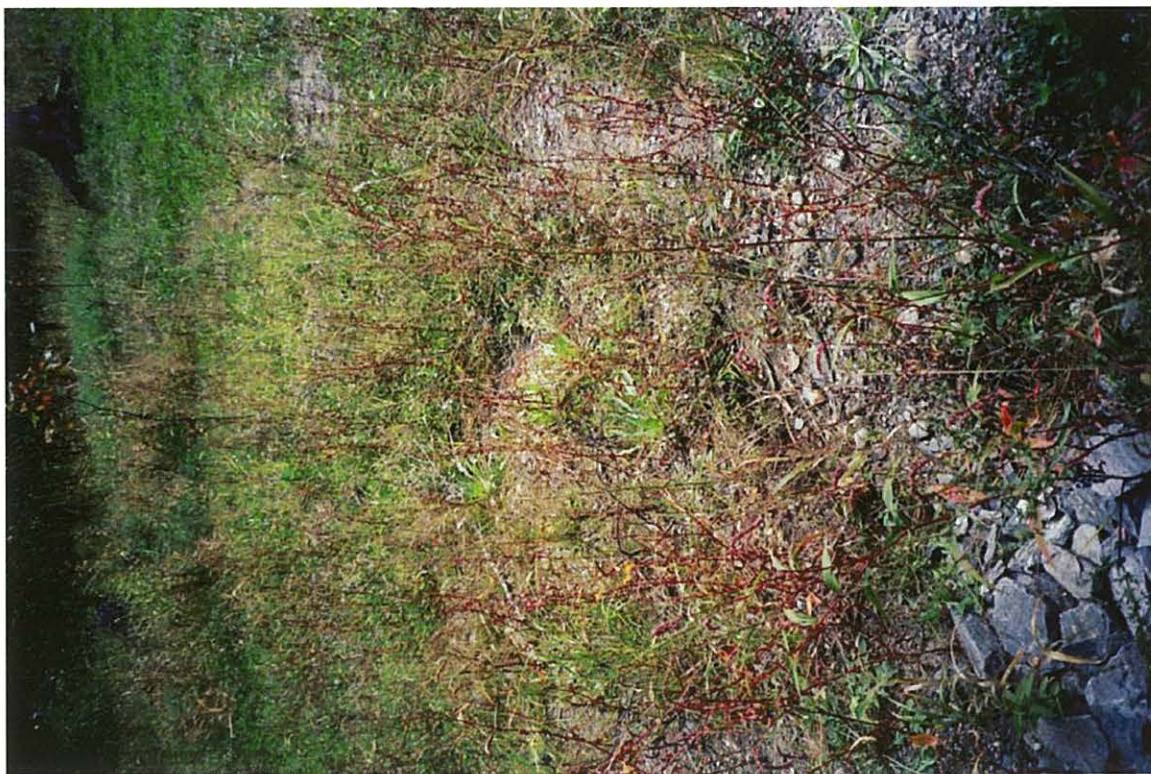
AOC 57 – Area 2: Siltation on Upland Slope (July 2004)

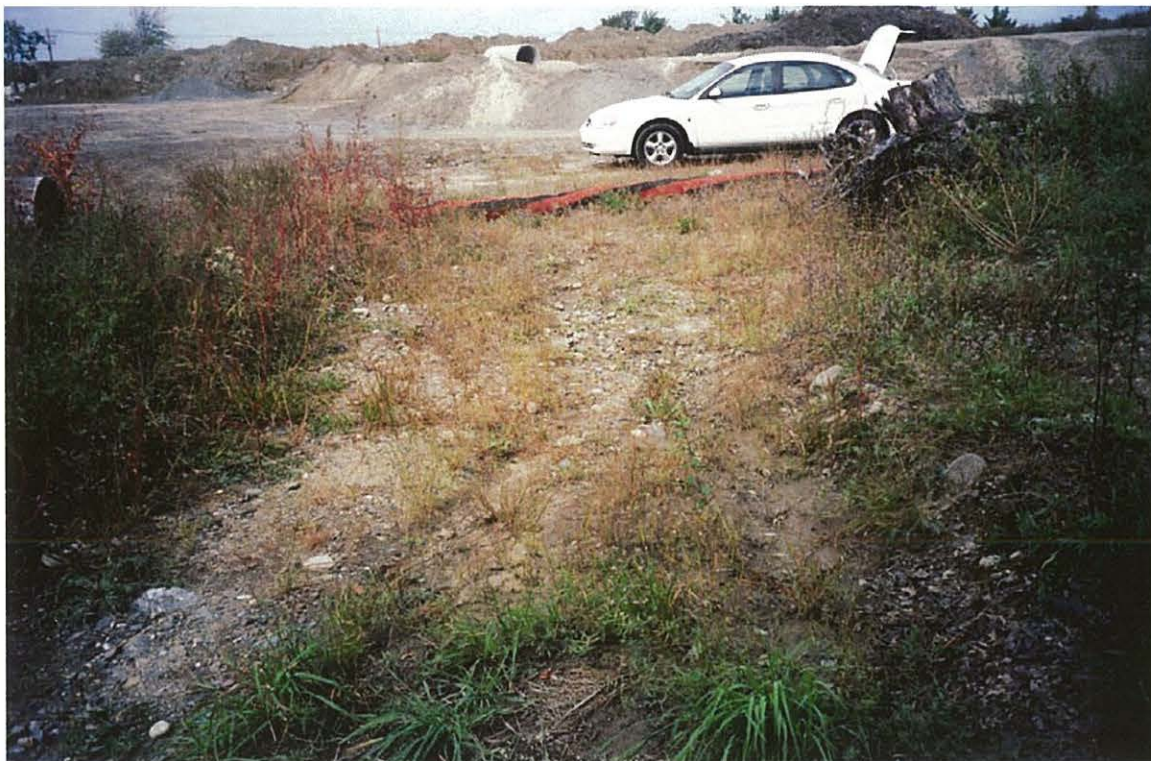
AOC 57 – Area 2: Silt Barrier/ Siltation on Upland Slope (July 2004)
