New York Ordnance Works – Baldwinsville, New York

Historical Photographic Analysis

FINAL REPORT | JANUARY 2020
Prepared for USACE New England District

New York Ordnance Works Baldwinsville, New York Historical Photographic Analysis

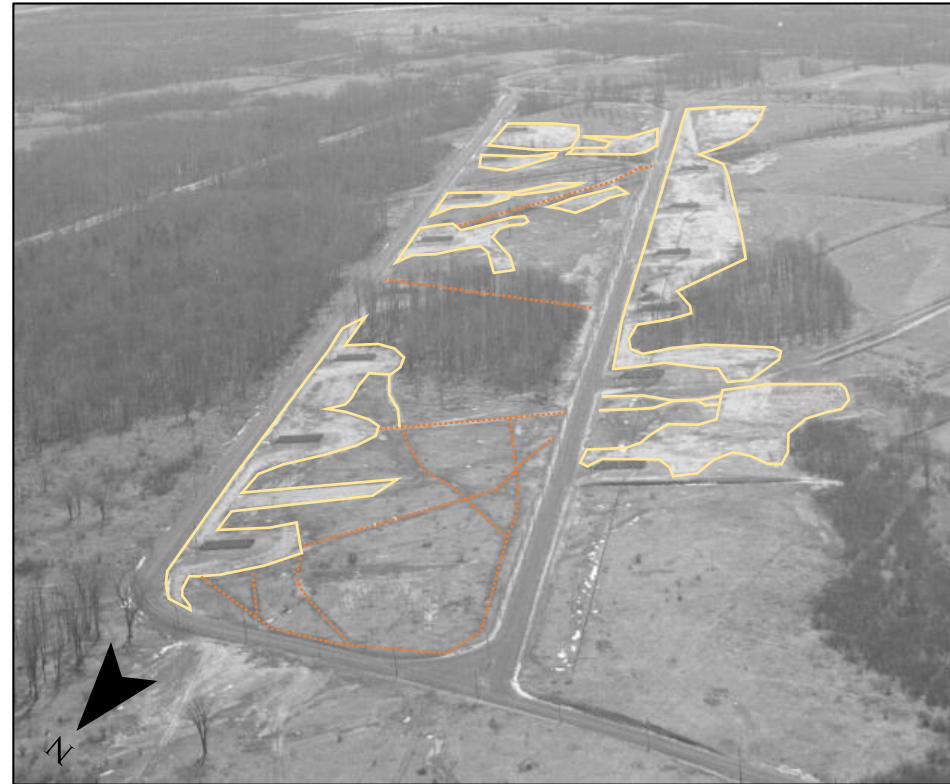
April 18, 1943 Oblique Photograph of Bunker Area
Source: National Archives at College Park

By 1943, 14 bunkers were constructed, along with access roads. Disturbed ground associated with the construction of the bunkers and roads is observed. A small area of forest was removed, enough for the construction of the bunkers and roads, however much of the forest remains.

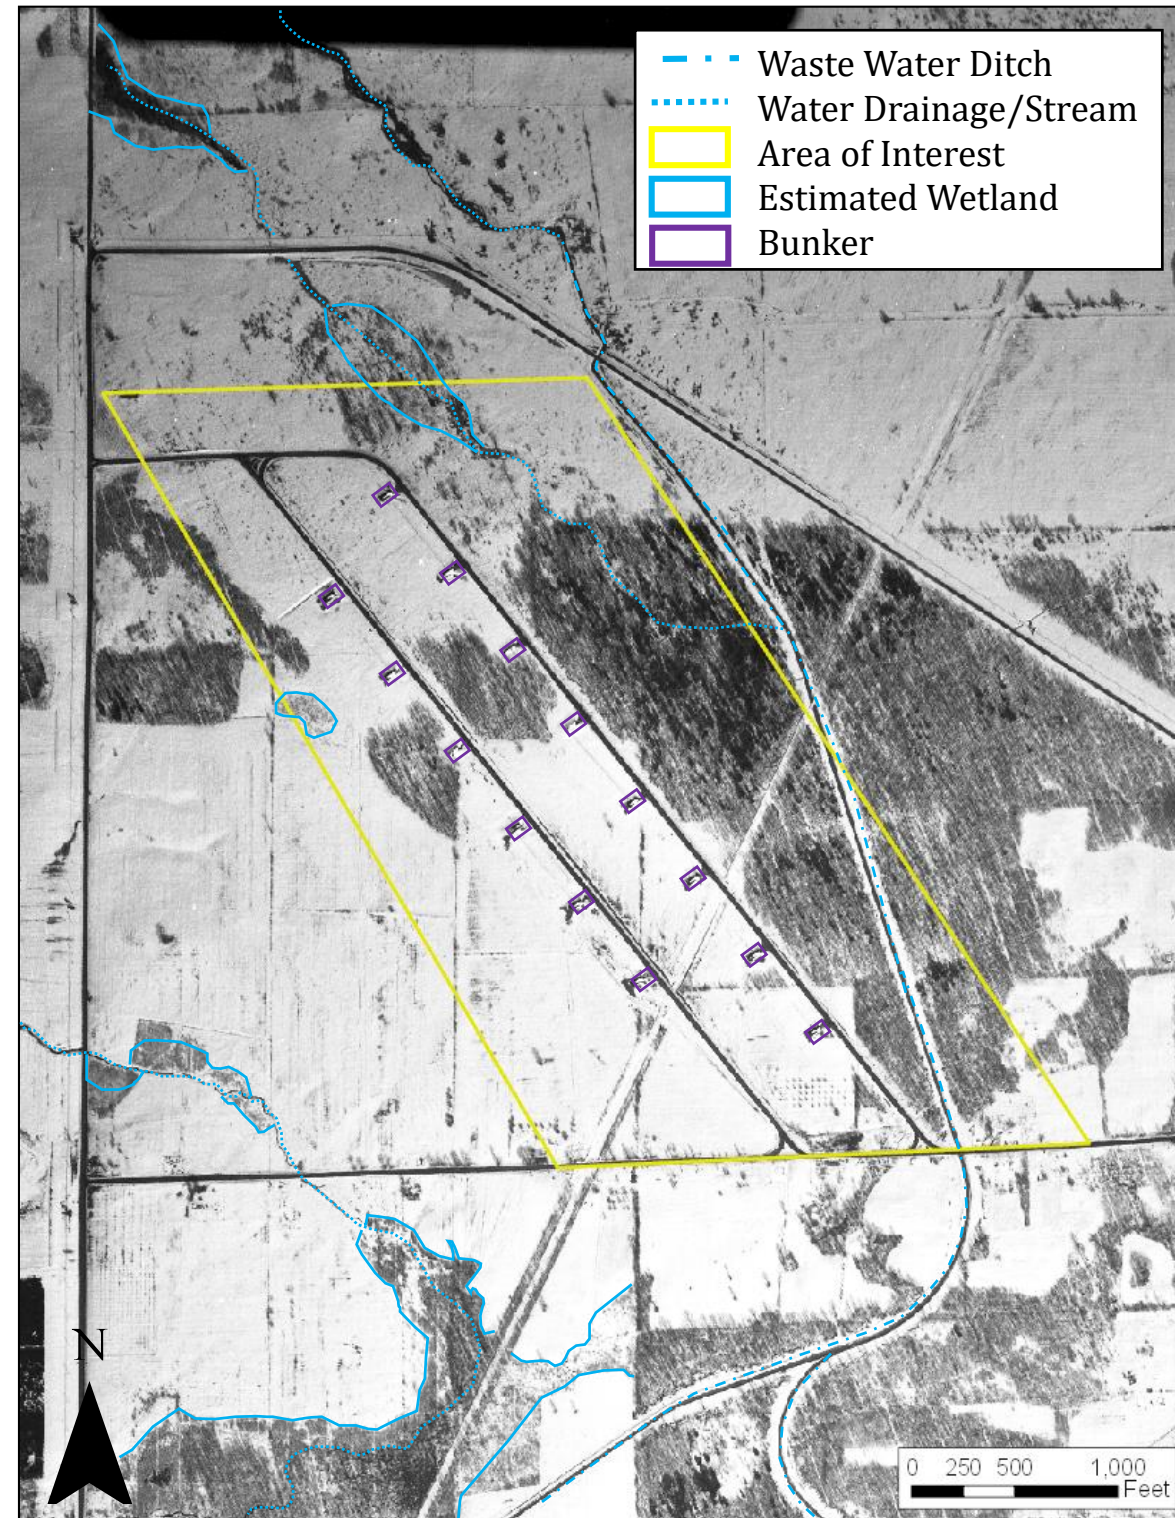
February 25, 1944

The roads around the bunker area have been cleared of snow, indicating active use. The tracks present between some of the bunkers in 1943 are no longer present, reinforcing that the roads running parallel to the bunkers are being used to access them.

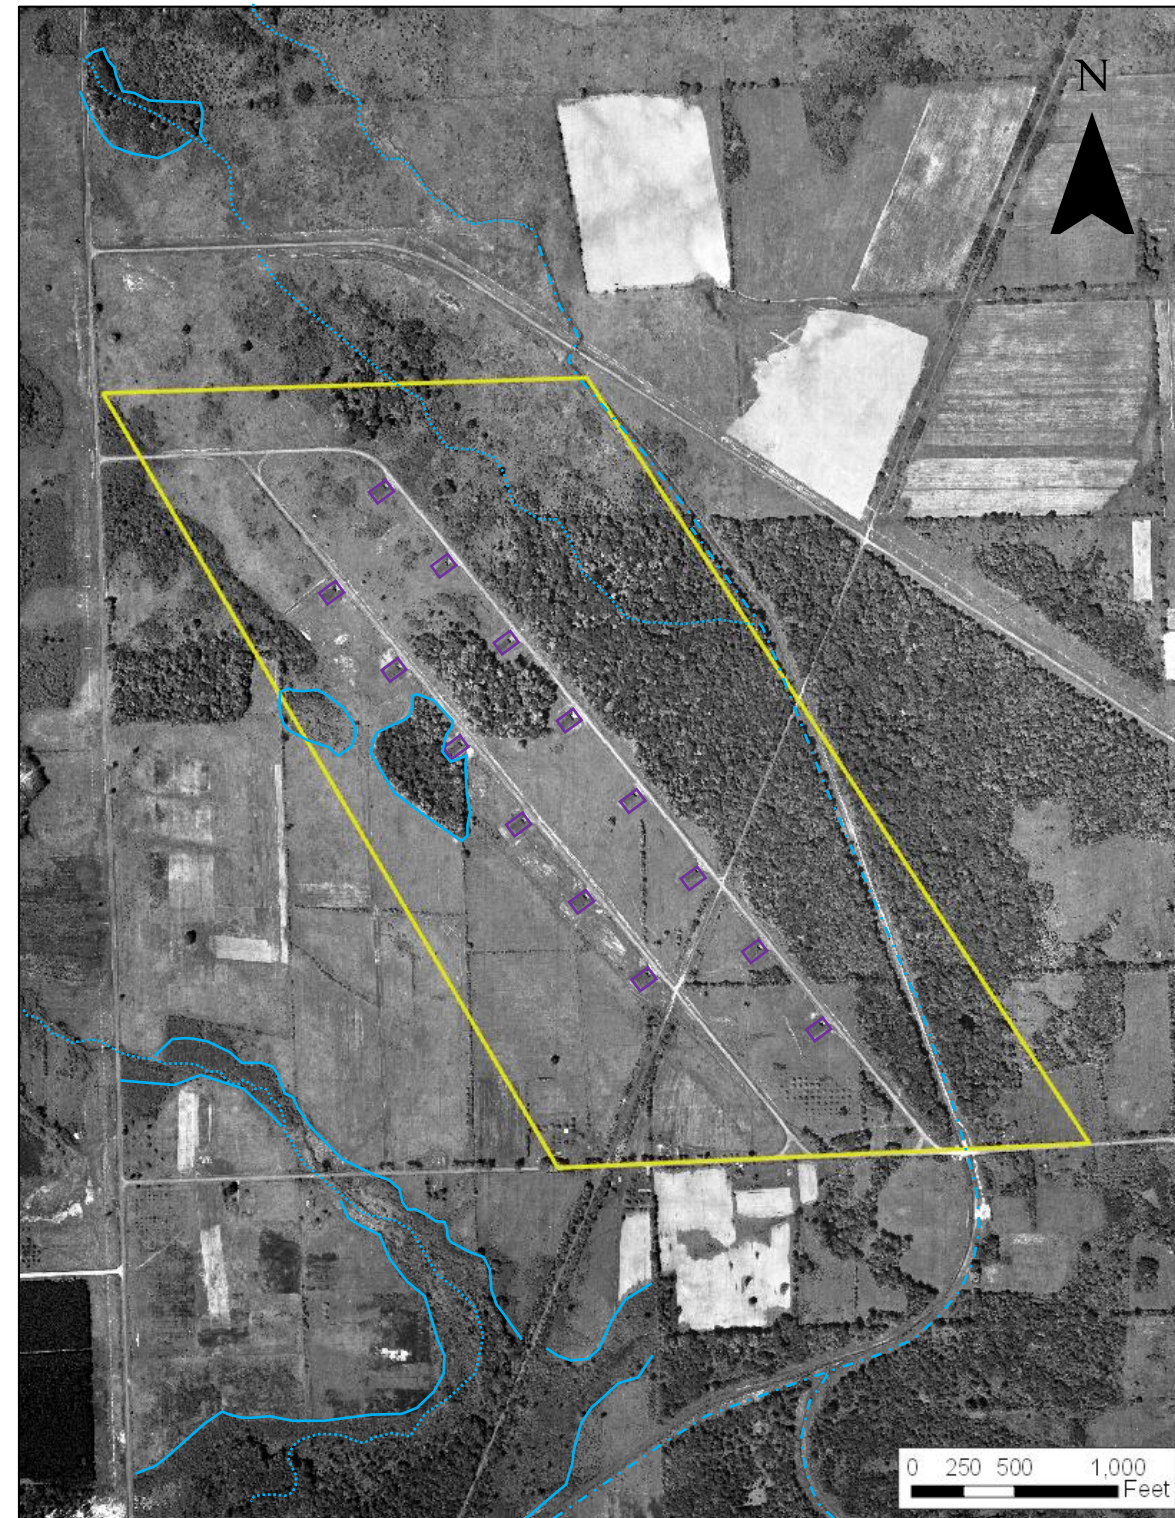
June 01, 1949

All of the bunkers are still present. No significant changes are observed.

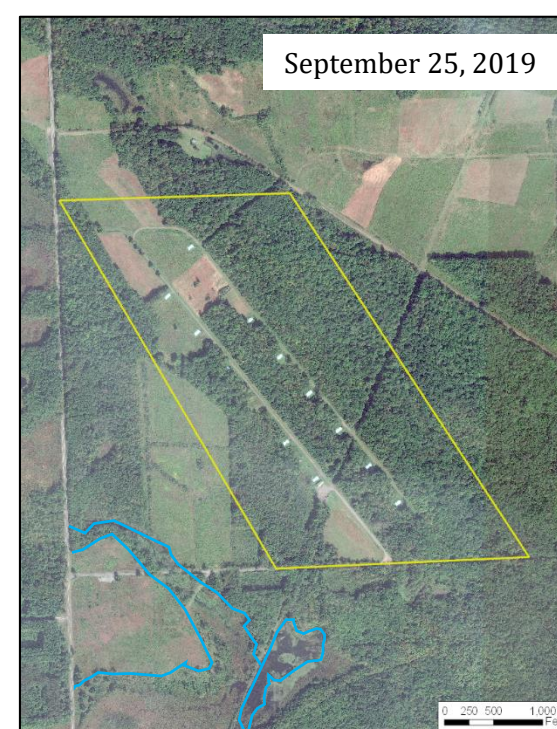
No significant changes are observed within the Bunker Area between 1951 and 2019. Although there has been significant revegetation in this area, the bunkers are still in place in 2019. The area is still surrounded by an agricultural landscape.

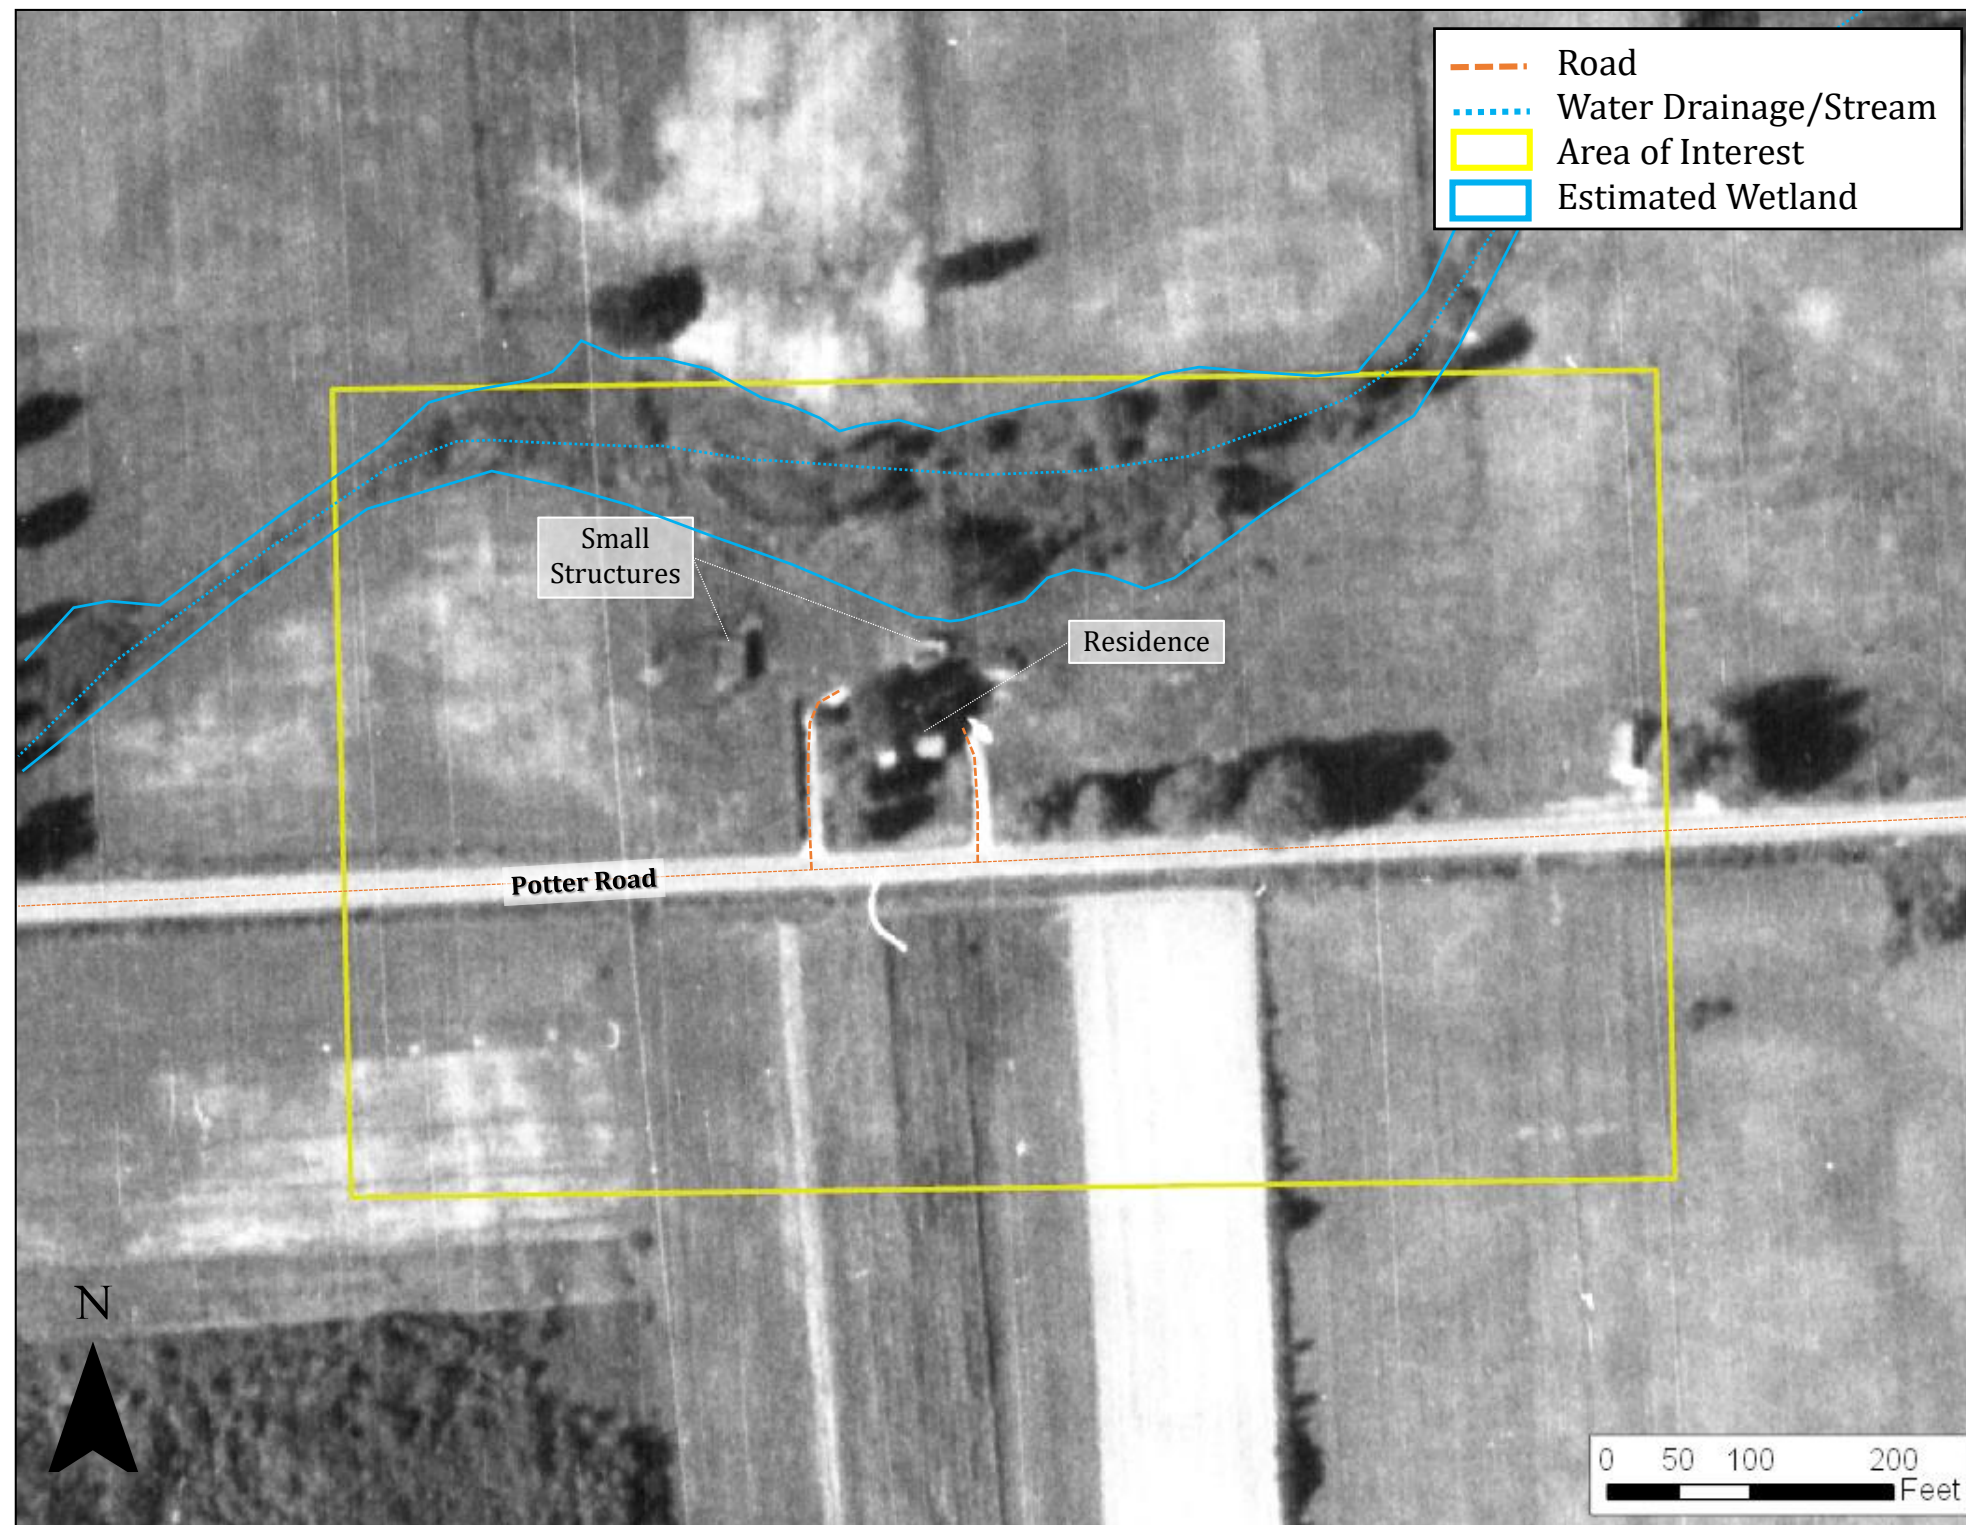
September 05, 1938

In 1938, the future “Landfill Area” is the location of a residential home and associated small structures, surrounded by agricultural land. A creek runs west-east to the north of this area.

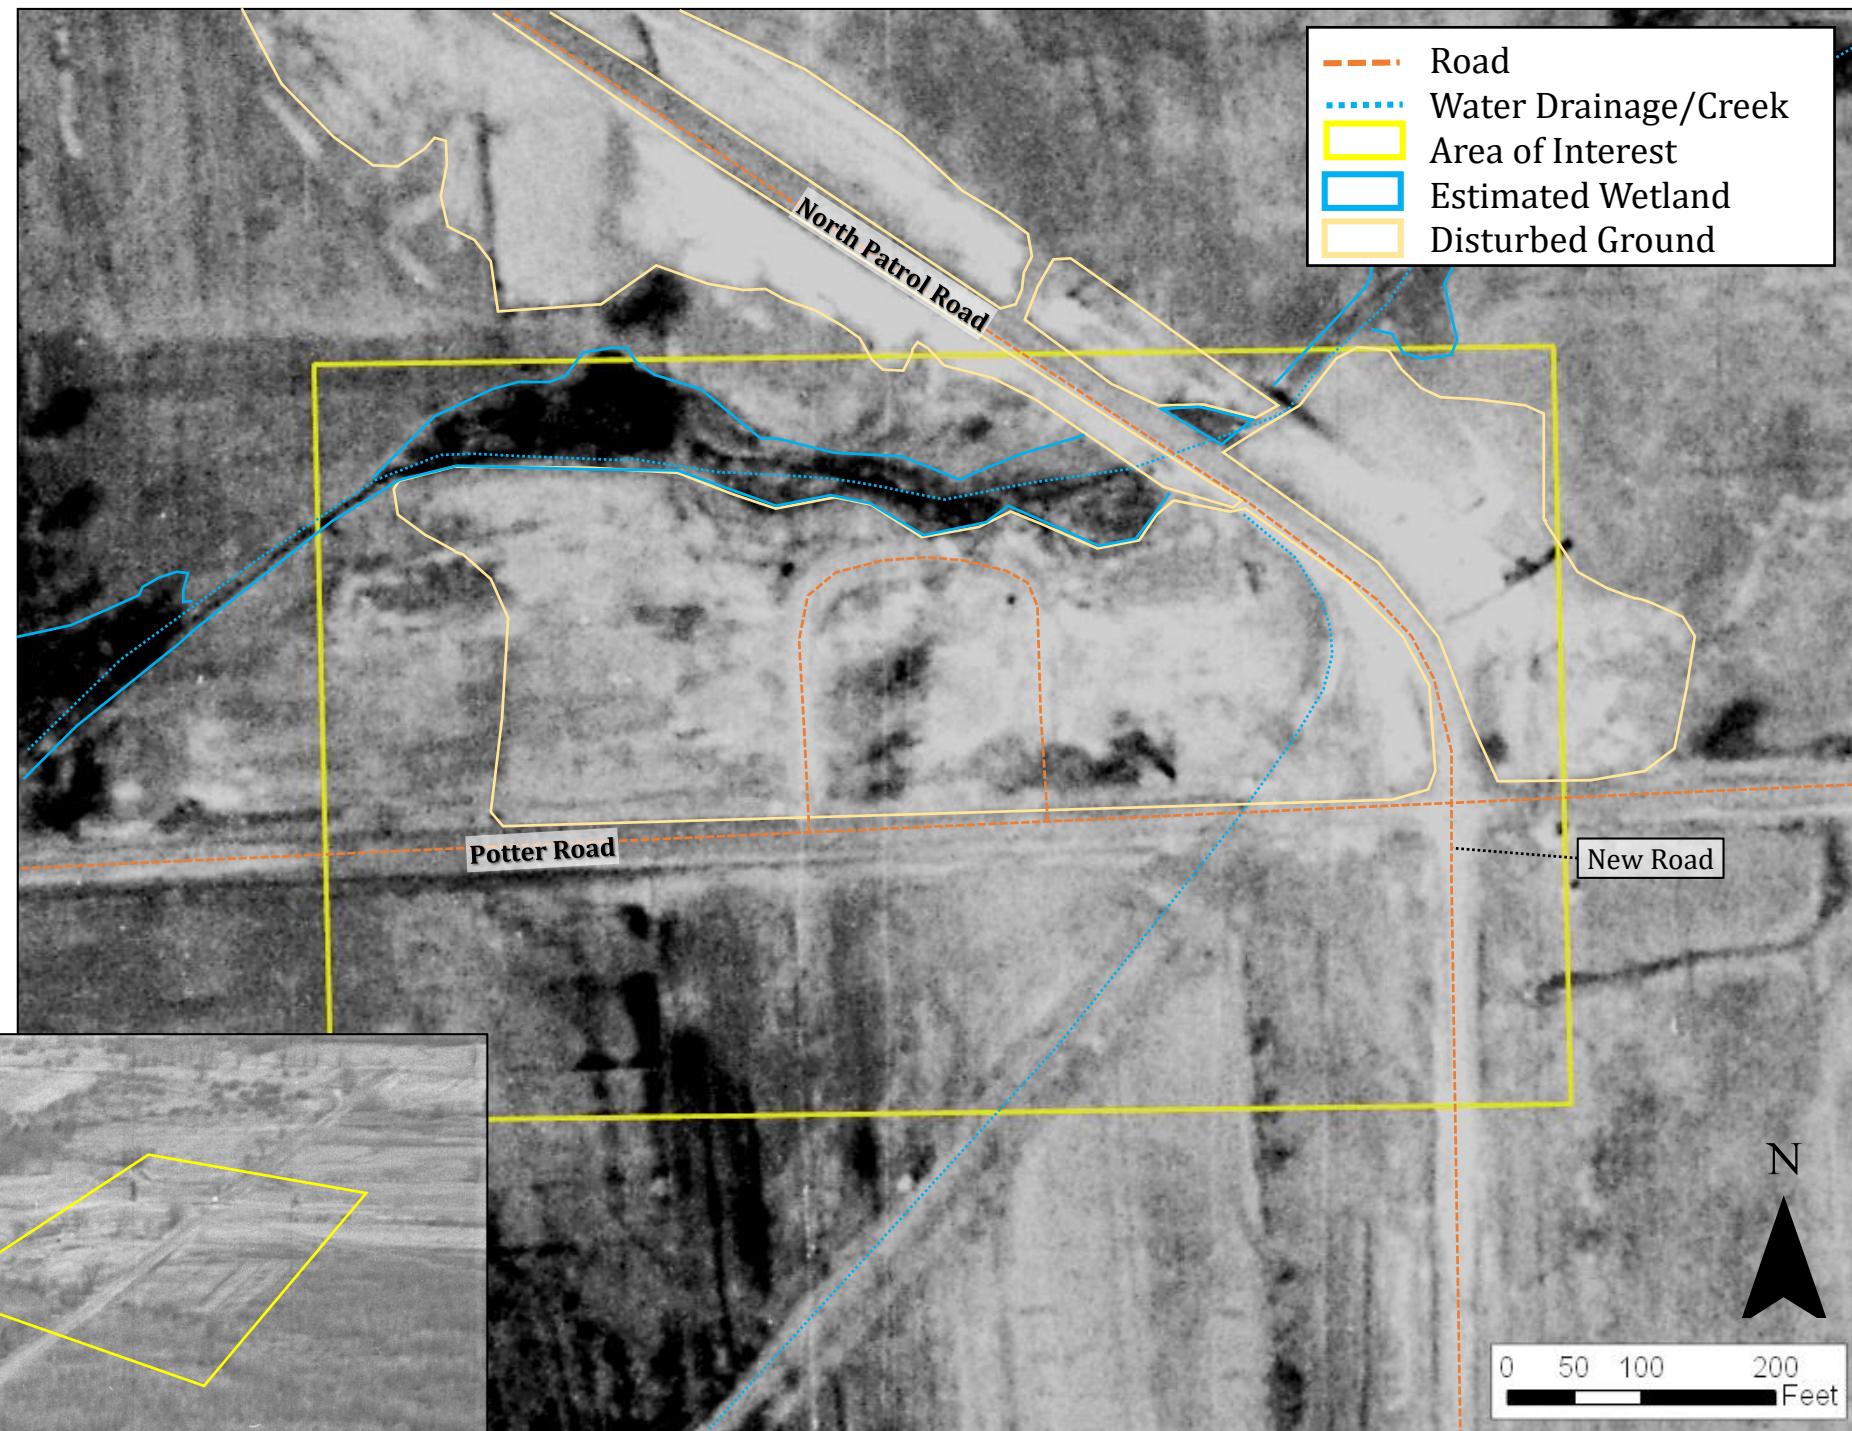
April 11, 1943

By 1943 the structures have been cleared. Disturbed ground associated with this clearing as well as the construction of a new road (North Patrol Road) is present. A linear feature running diagonal through the southeastern part of the area appears to be a drainage path.

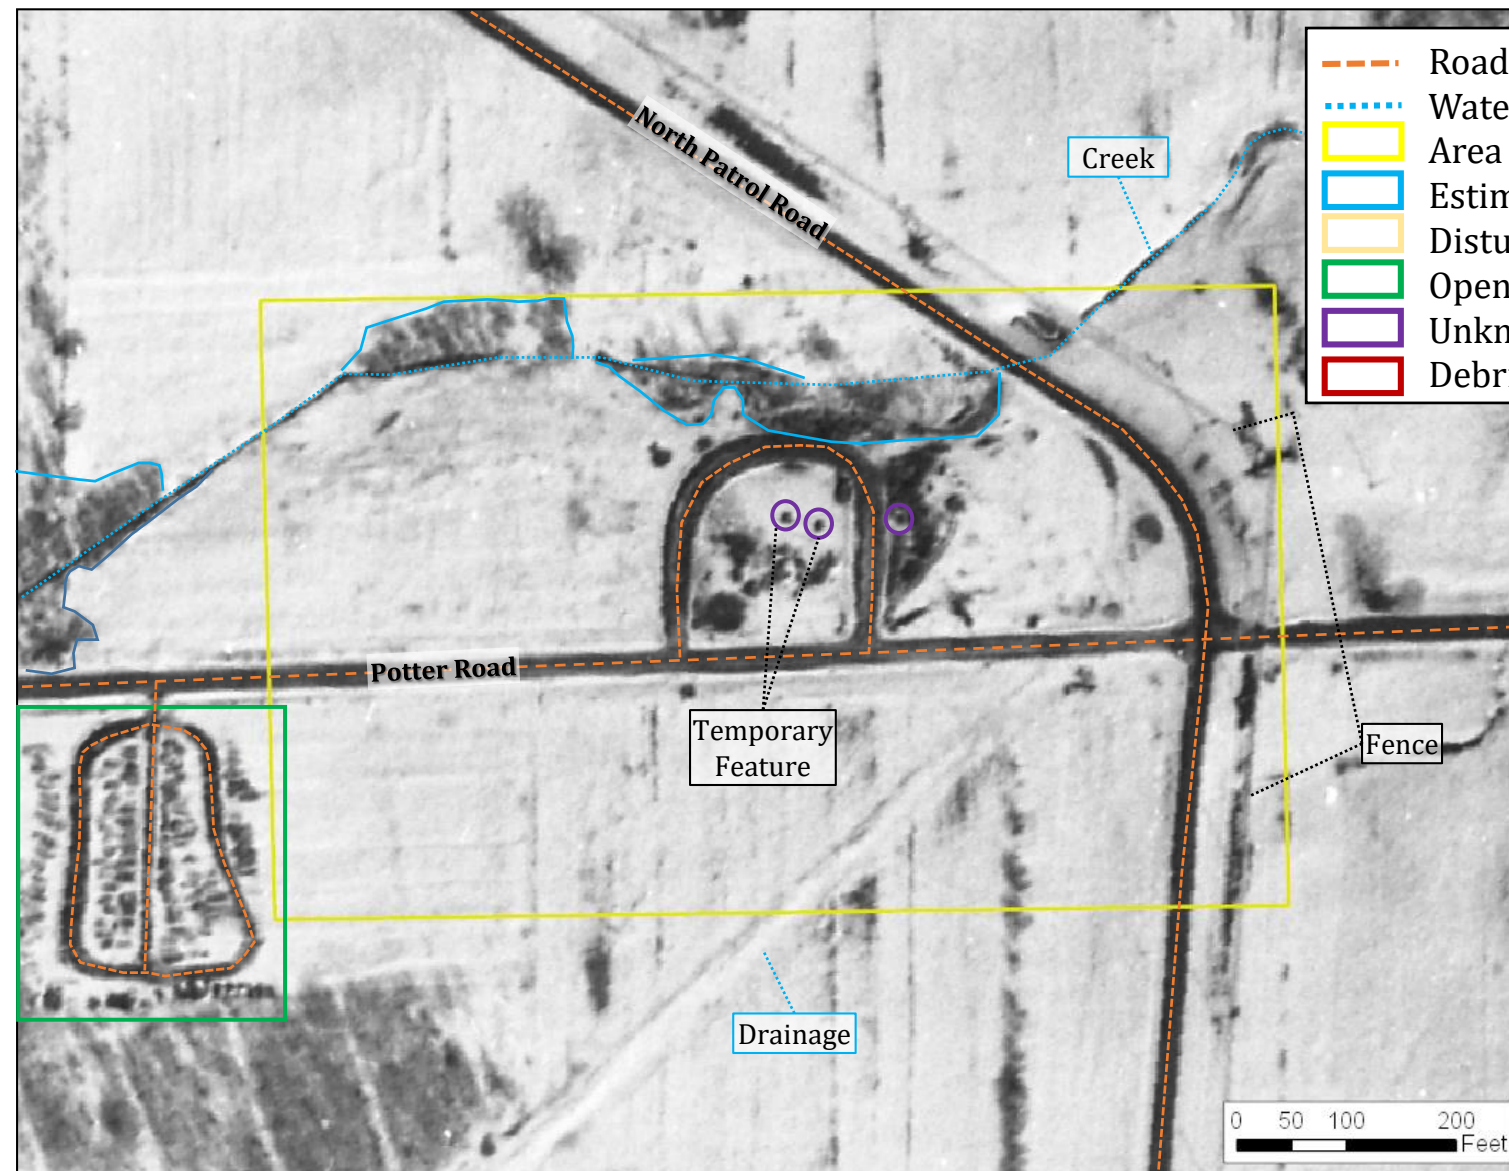
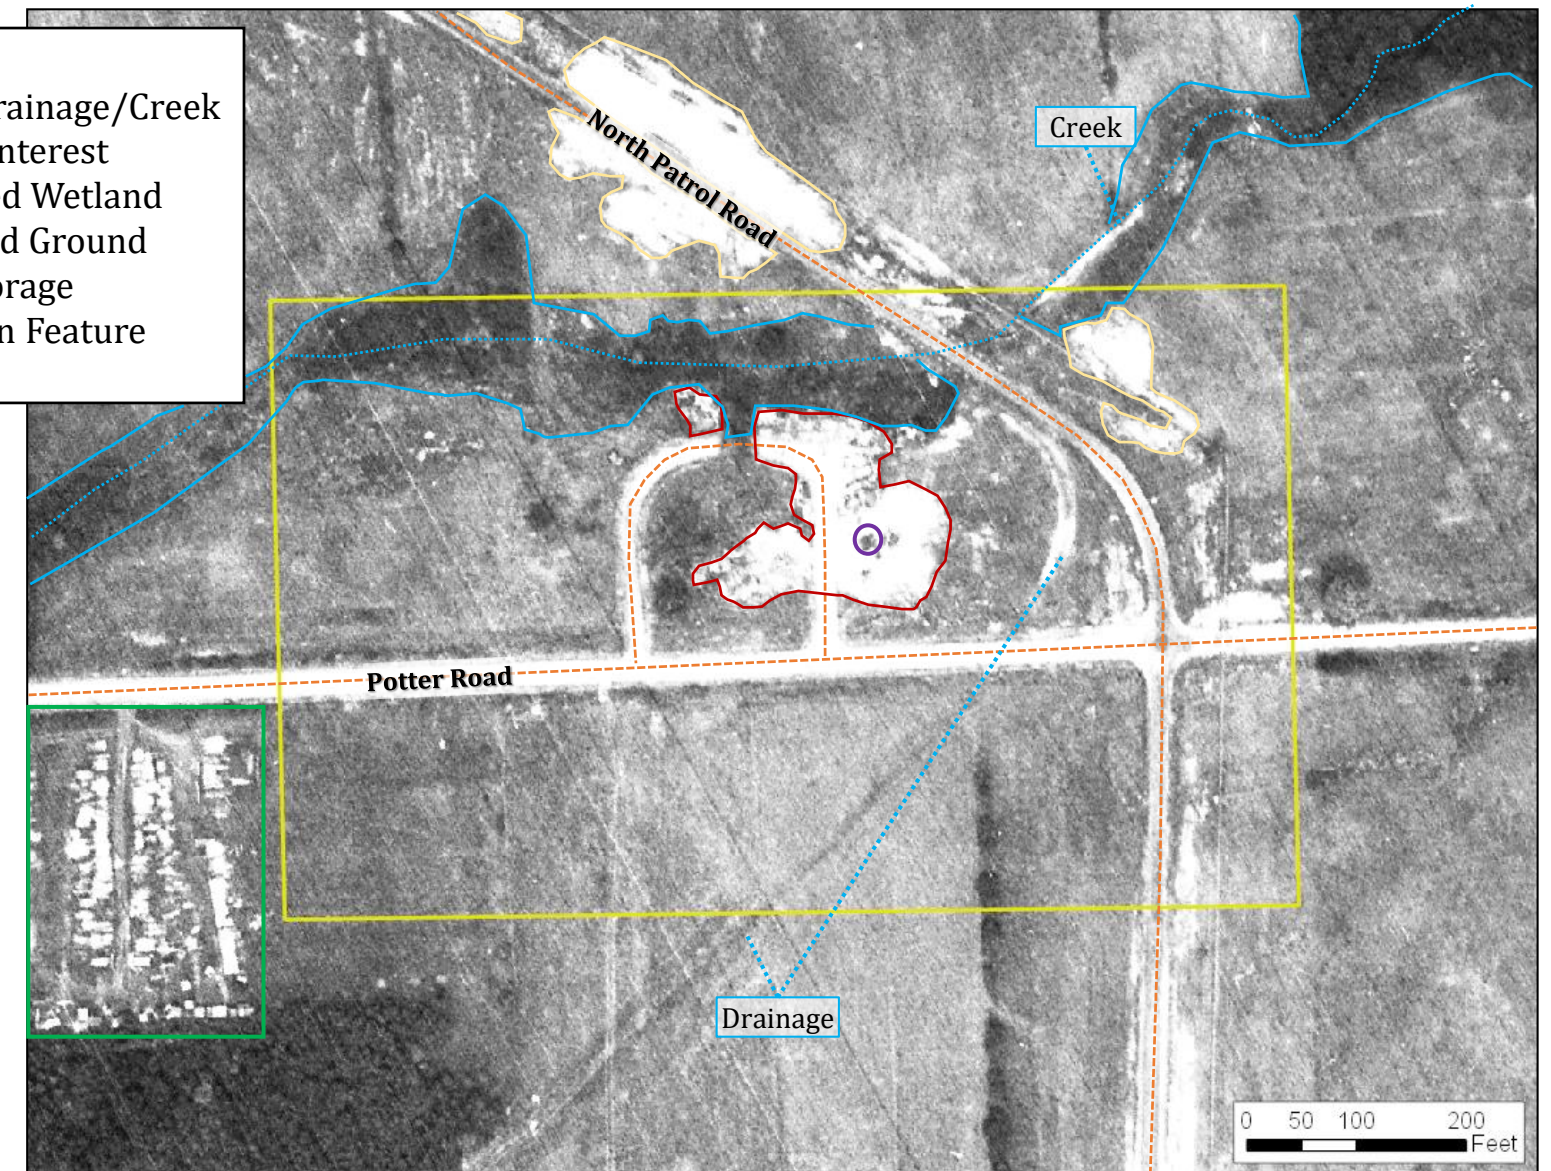
An area of open storage is observed southwest of the landfill area. There are three small unknown features present within the landfill site – two are temporary and are only seen in February 1944, and the third remains in future photographs. A fence line runs along the eastern side of North Patrol Road.

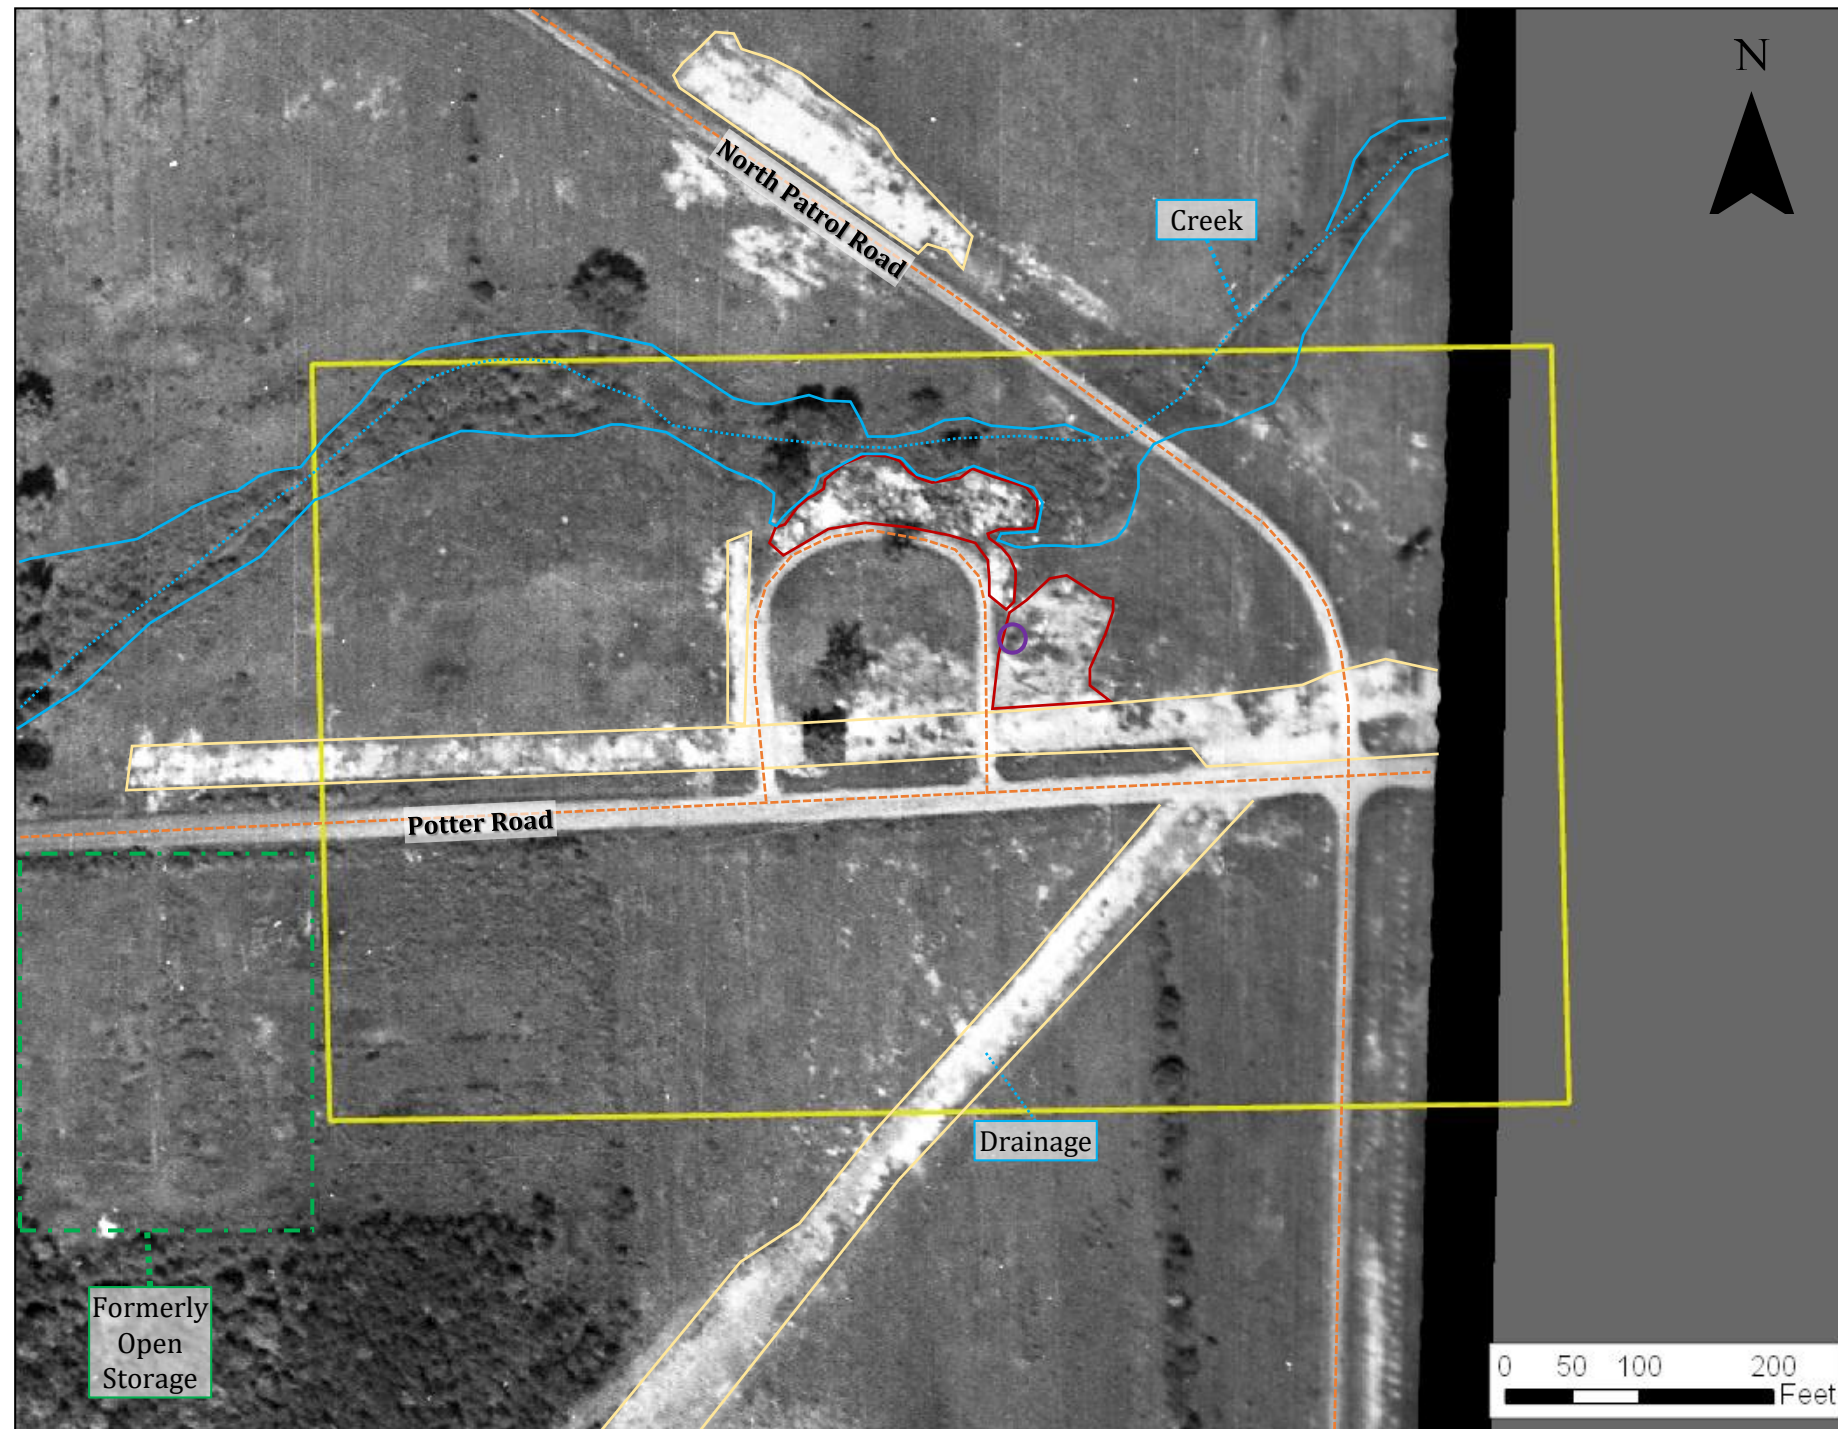
June 01, 1949

Between 1944 and 1949, the open storage area that was present to the southwest of the landfill ceased activity and while some debris is still present, the area is mostly cleared and vegetation is moving in. A linear swath of disturbed/cleared ground appears parallel to the roadway, and also along the water drainage path running diagonally to the south. This disturbance may indicate the fill of the existing drainage area. Disturbed ground continues to be present to the north on North Patrol Road. Debris and mounds of material are still present and expand alongside the creek.

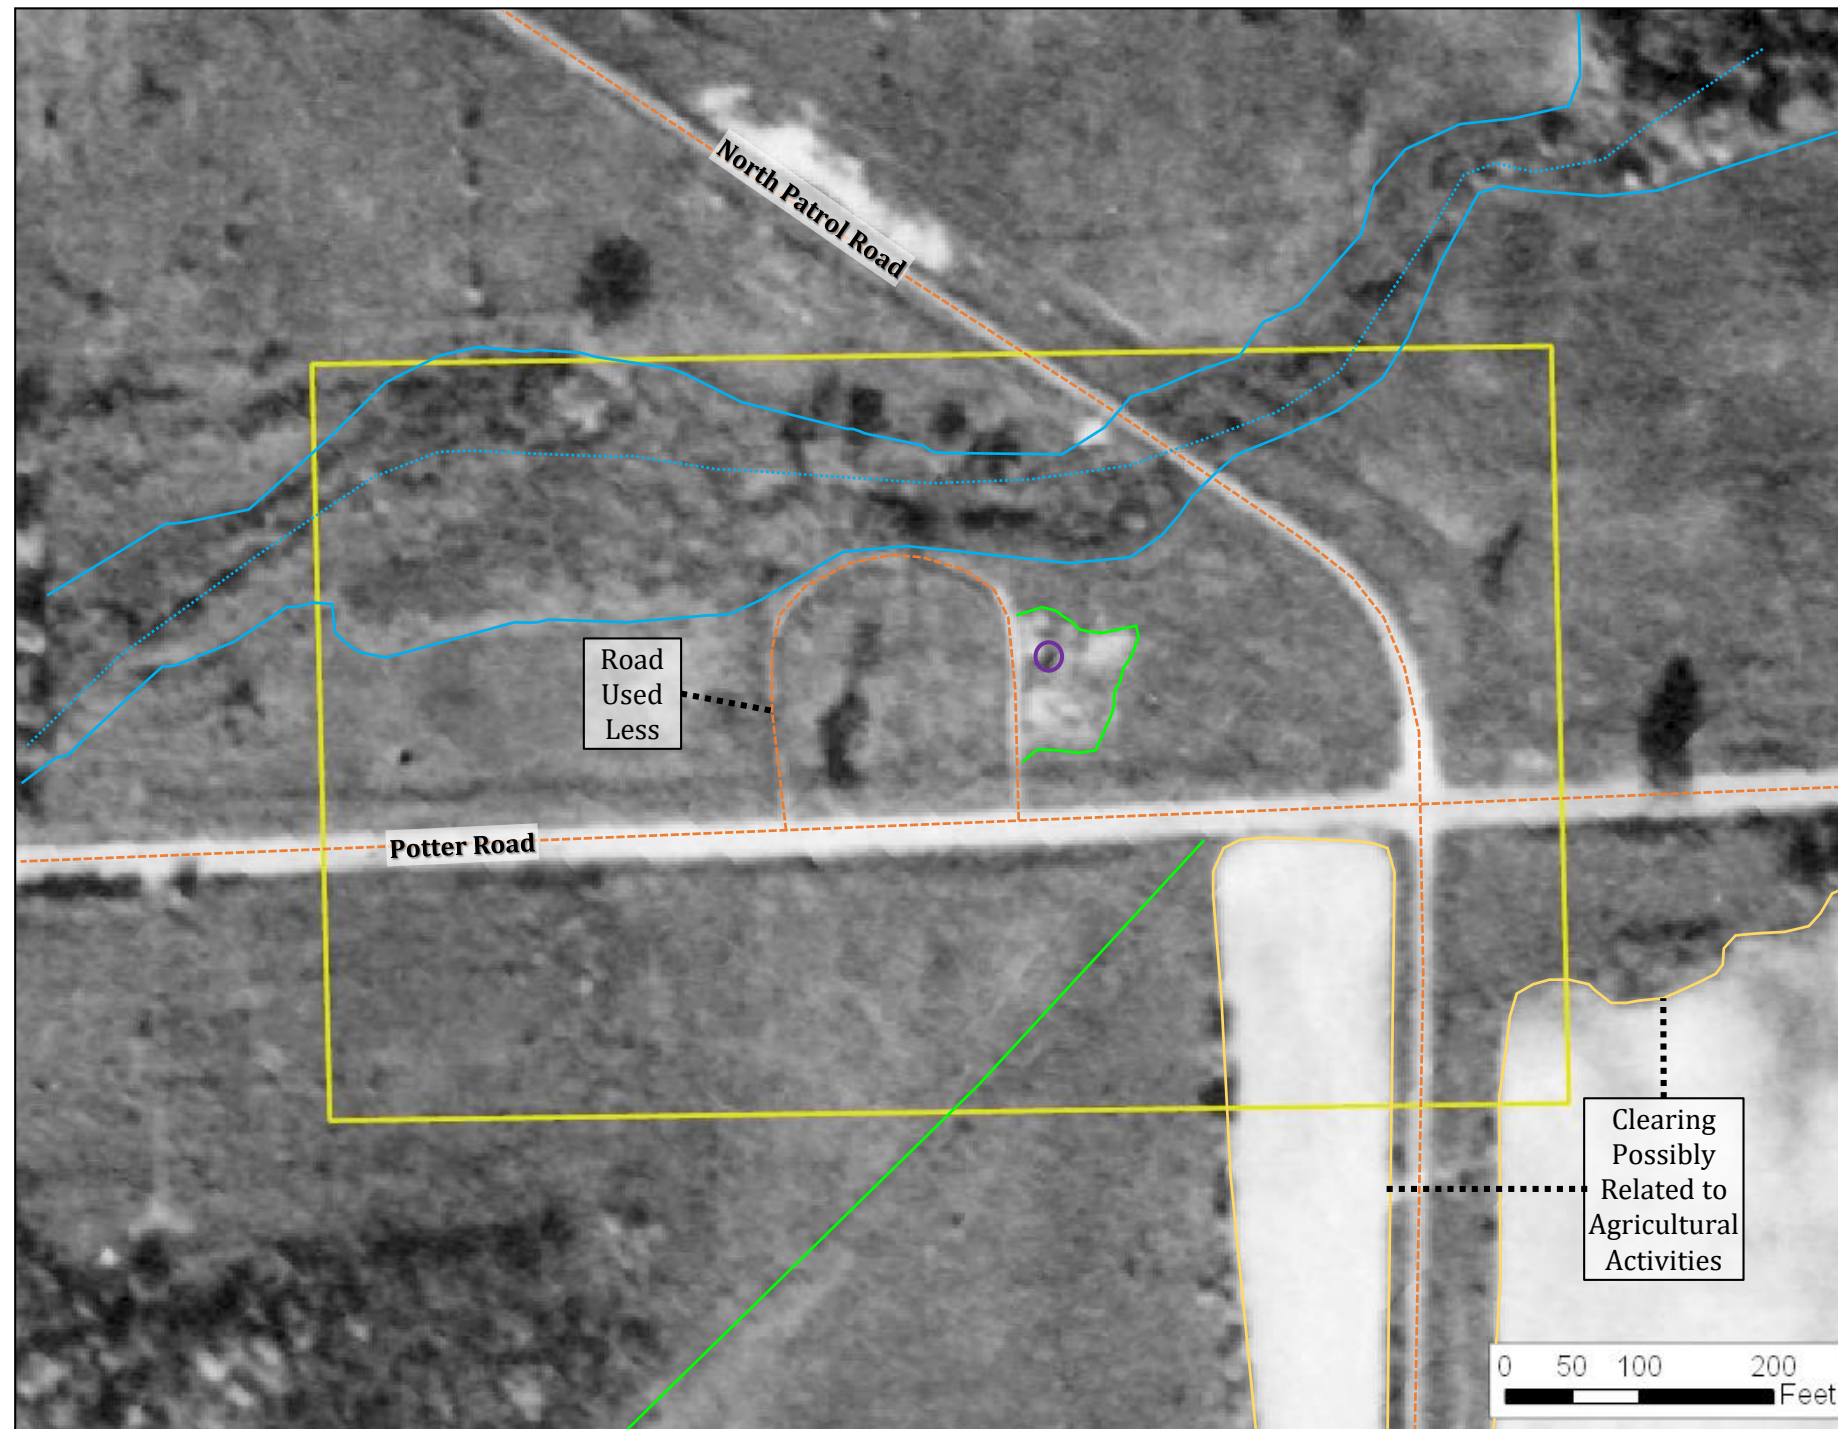
October 05, 1951

The turnaround (u-shaped) road within the landfill is no longer active and vegetation overgrowth is observed on and around the former road. A ground scar is present to the right of this road. The spatial resolution of this image prevents confirmation of ground scarring and debris extent. A ground scar has taken the place of the diagonal water drainage path, confirming backfill. Two large clearings are present, possibly related to agricultural activities.

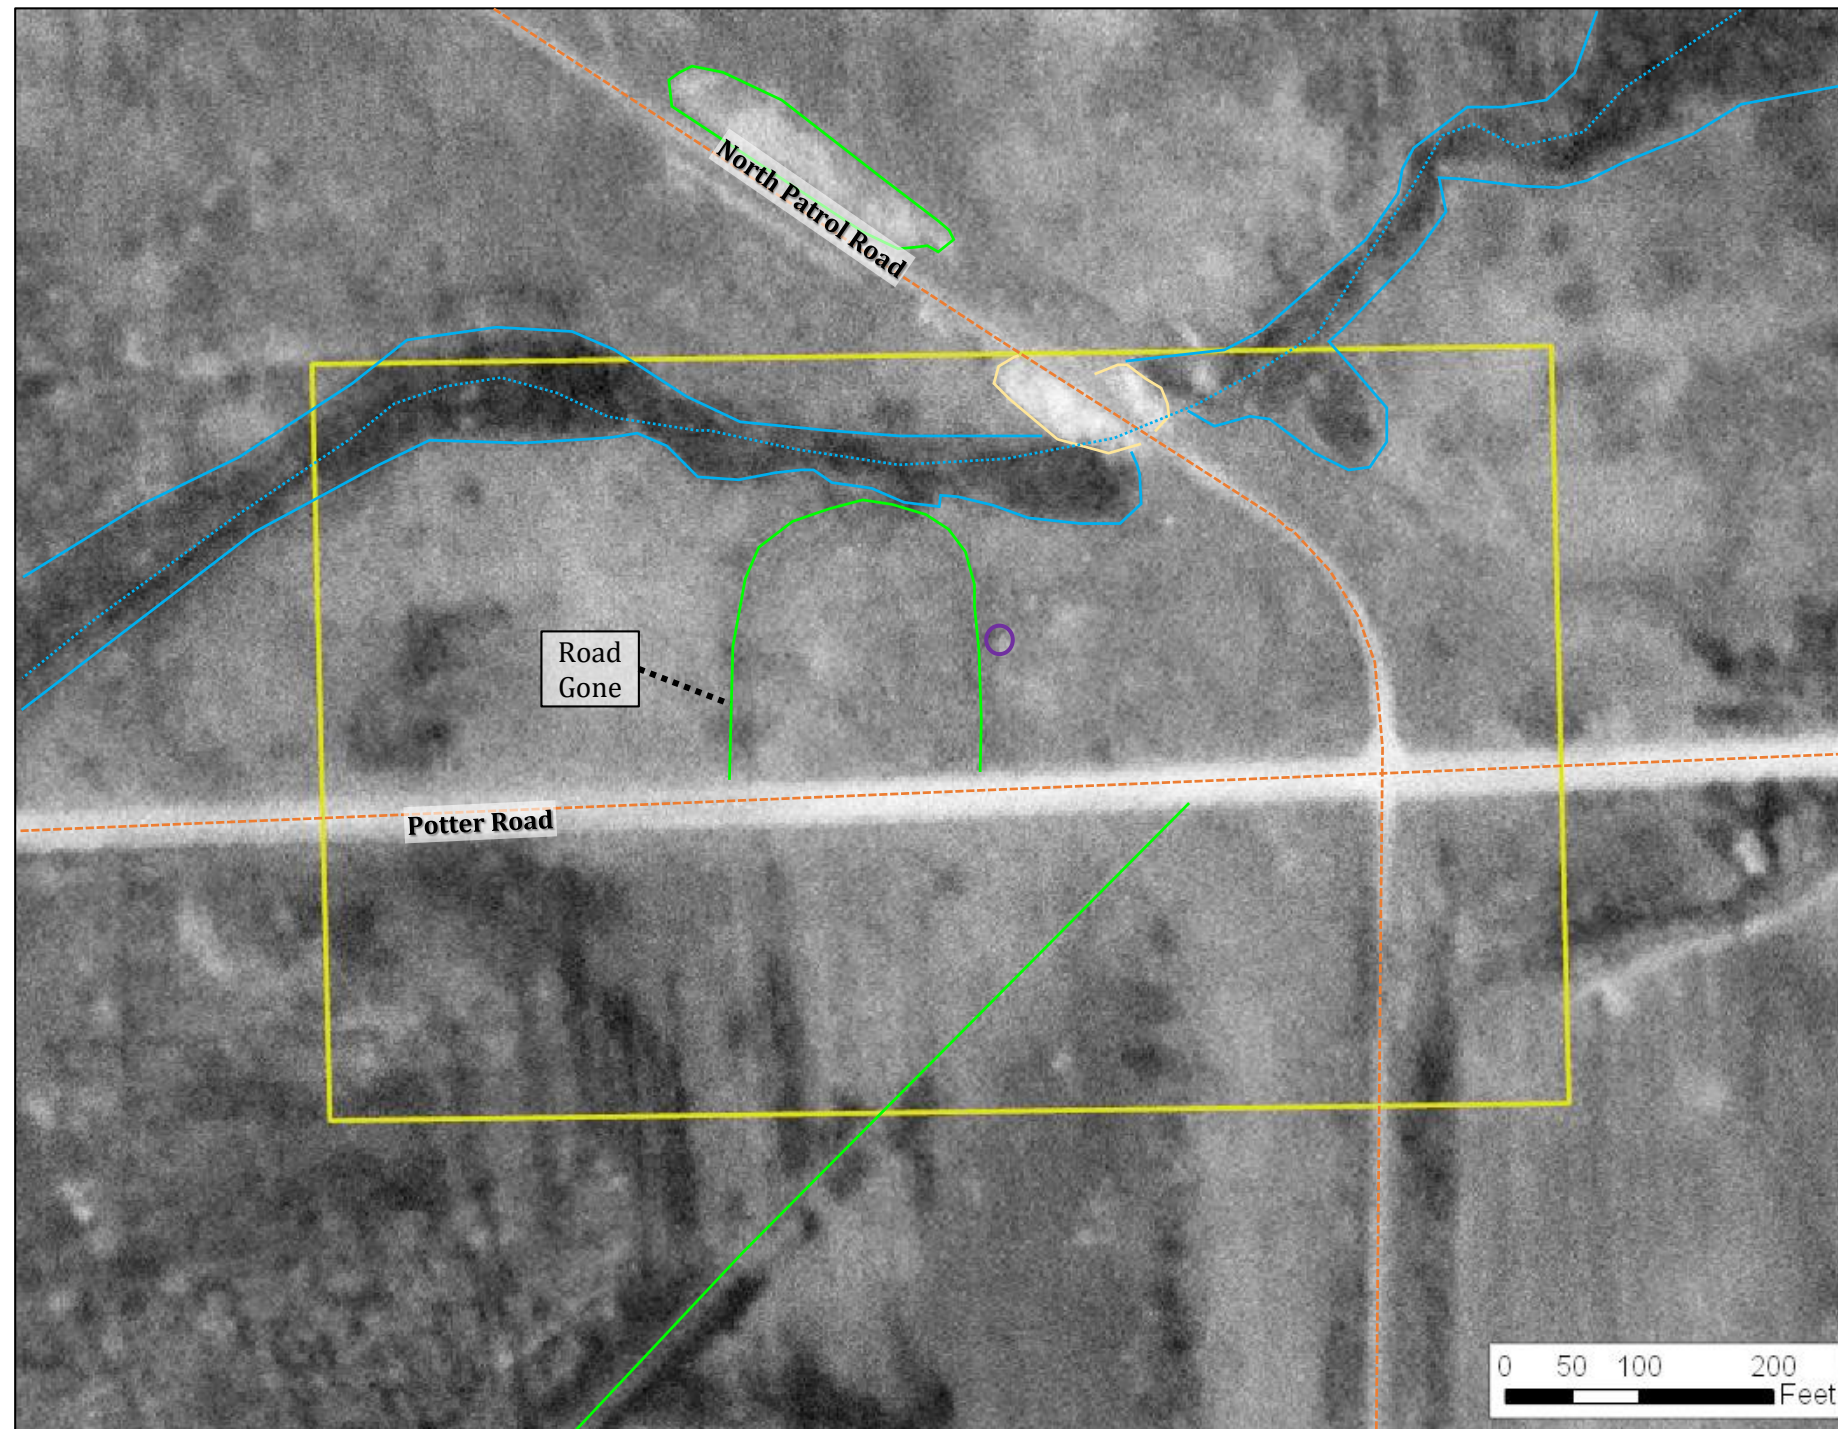
May 07, 1956

Ground scars are visible where the turnaround (u-shaped) road and the drainage trench previously existed.

Disturbed ground and possible mounded material are observed at the intersection of the creek and North Patrol Road.

There is no other recent activity observed in or around the landfill area, aside from the use of North Patrol and Potter Roads.
