New York Ordnance Works – Baldwinsville, New York

Historical Photographic Analysis

FINAL REPORT | JANUARY 2020
Prepared for USACE New England District

New York Ordnance Works Baldwinsville, New York Historical Photographic Analysis

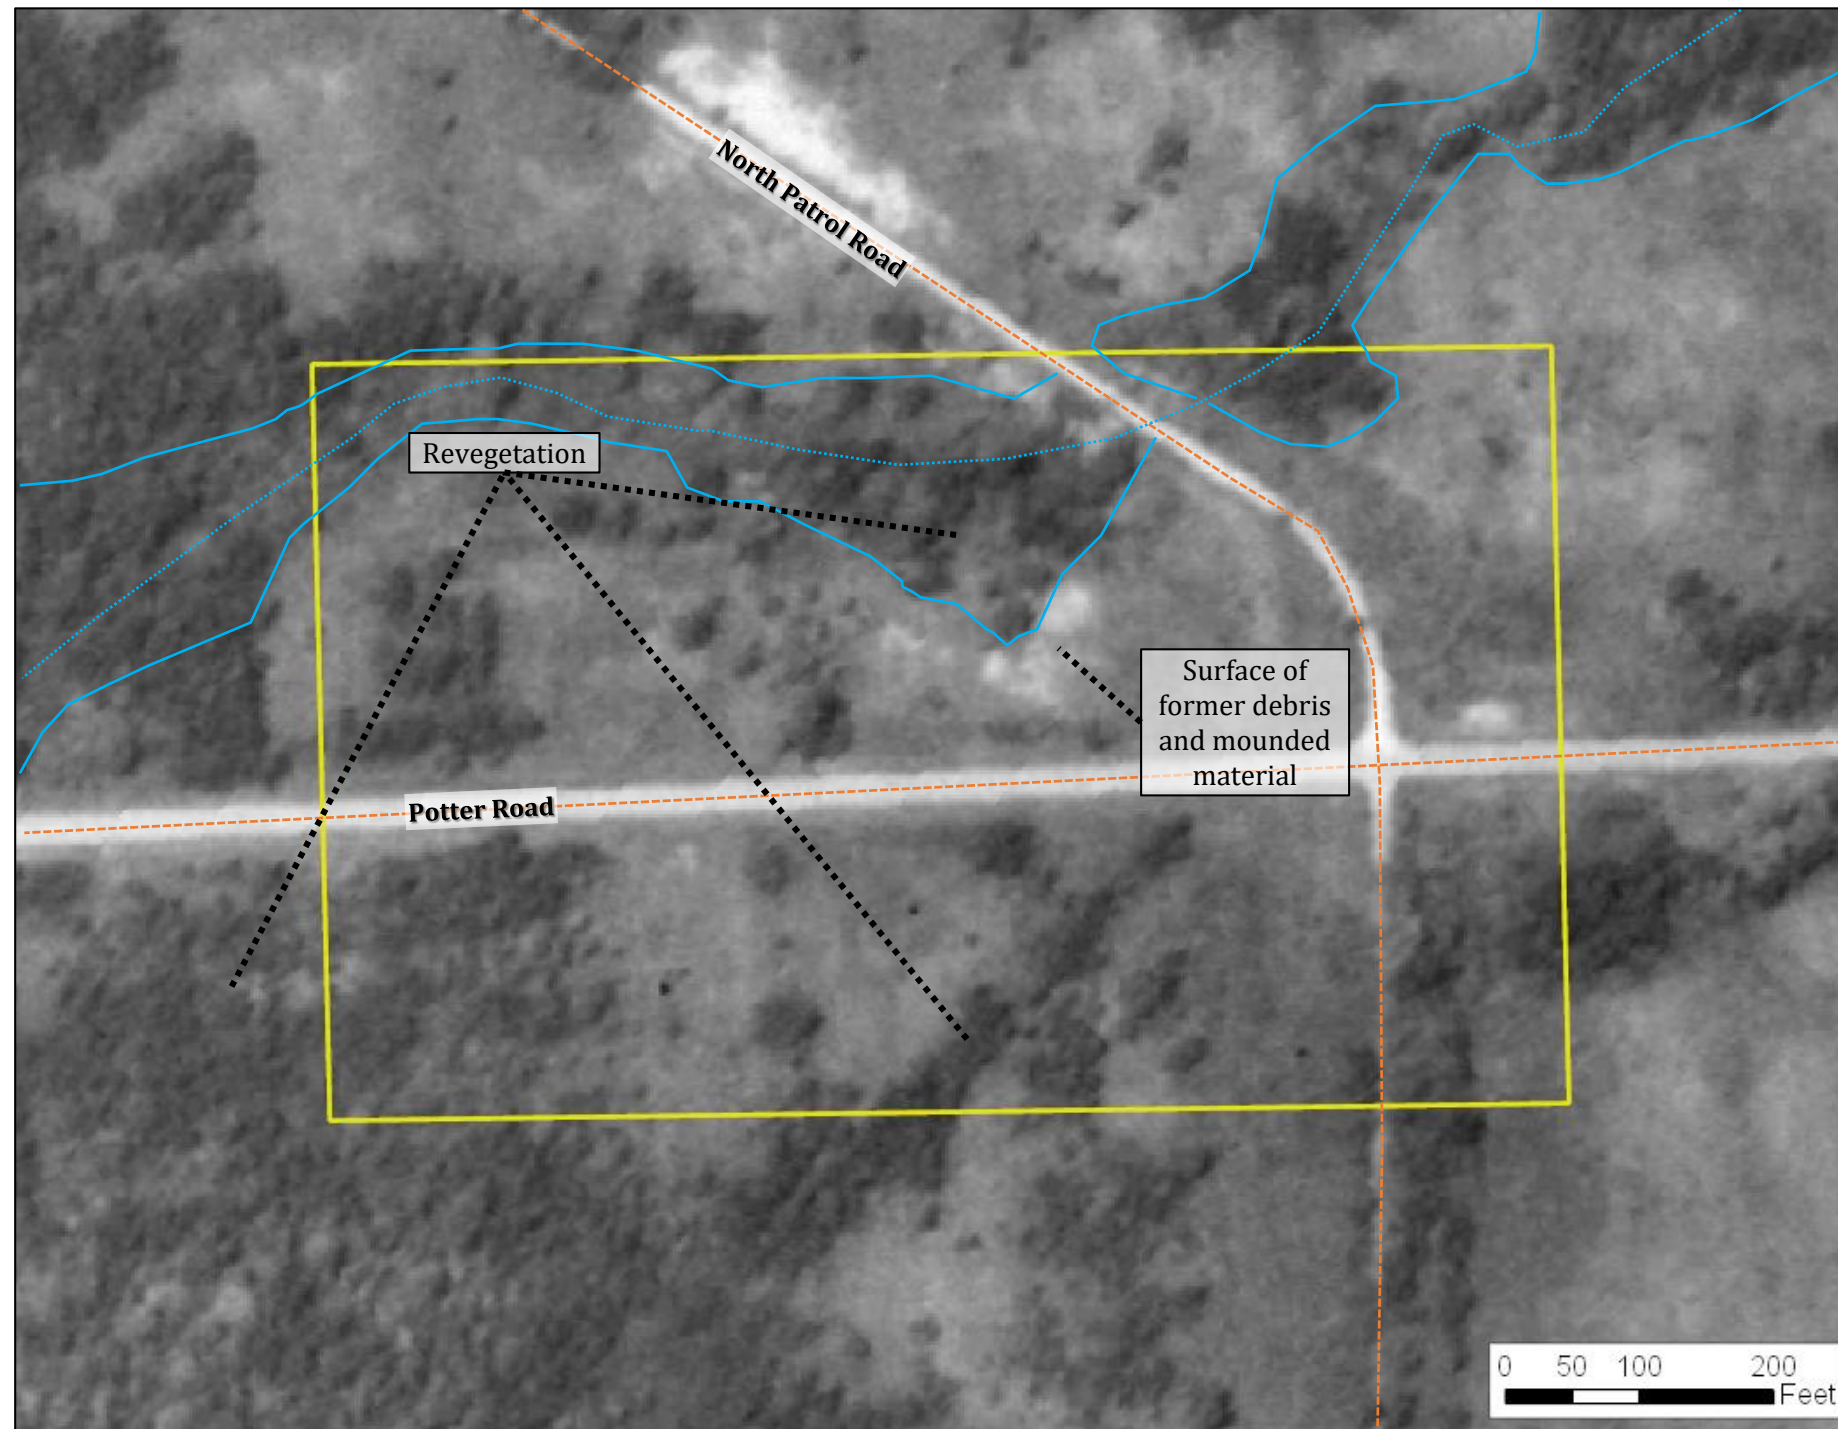
June 22, 1966

The area of mounded material last observed in 1951 is visible again. There are no new tracks leading to the area so this is likely due to erosion at the surface.

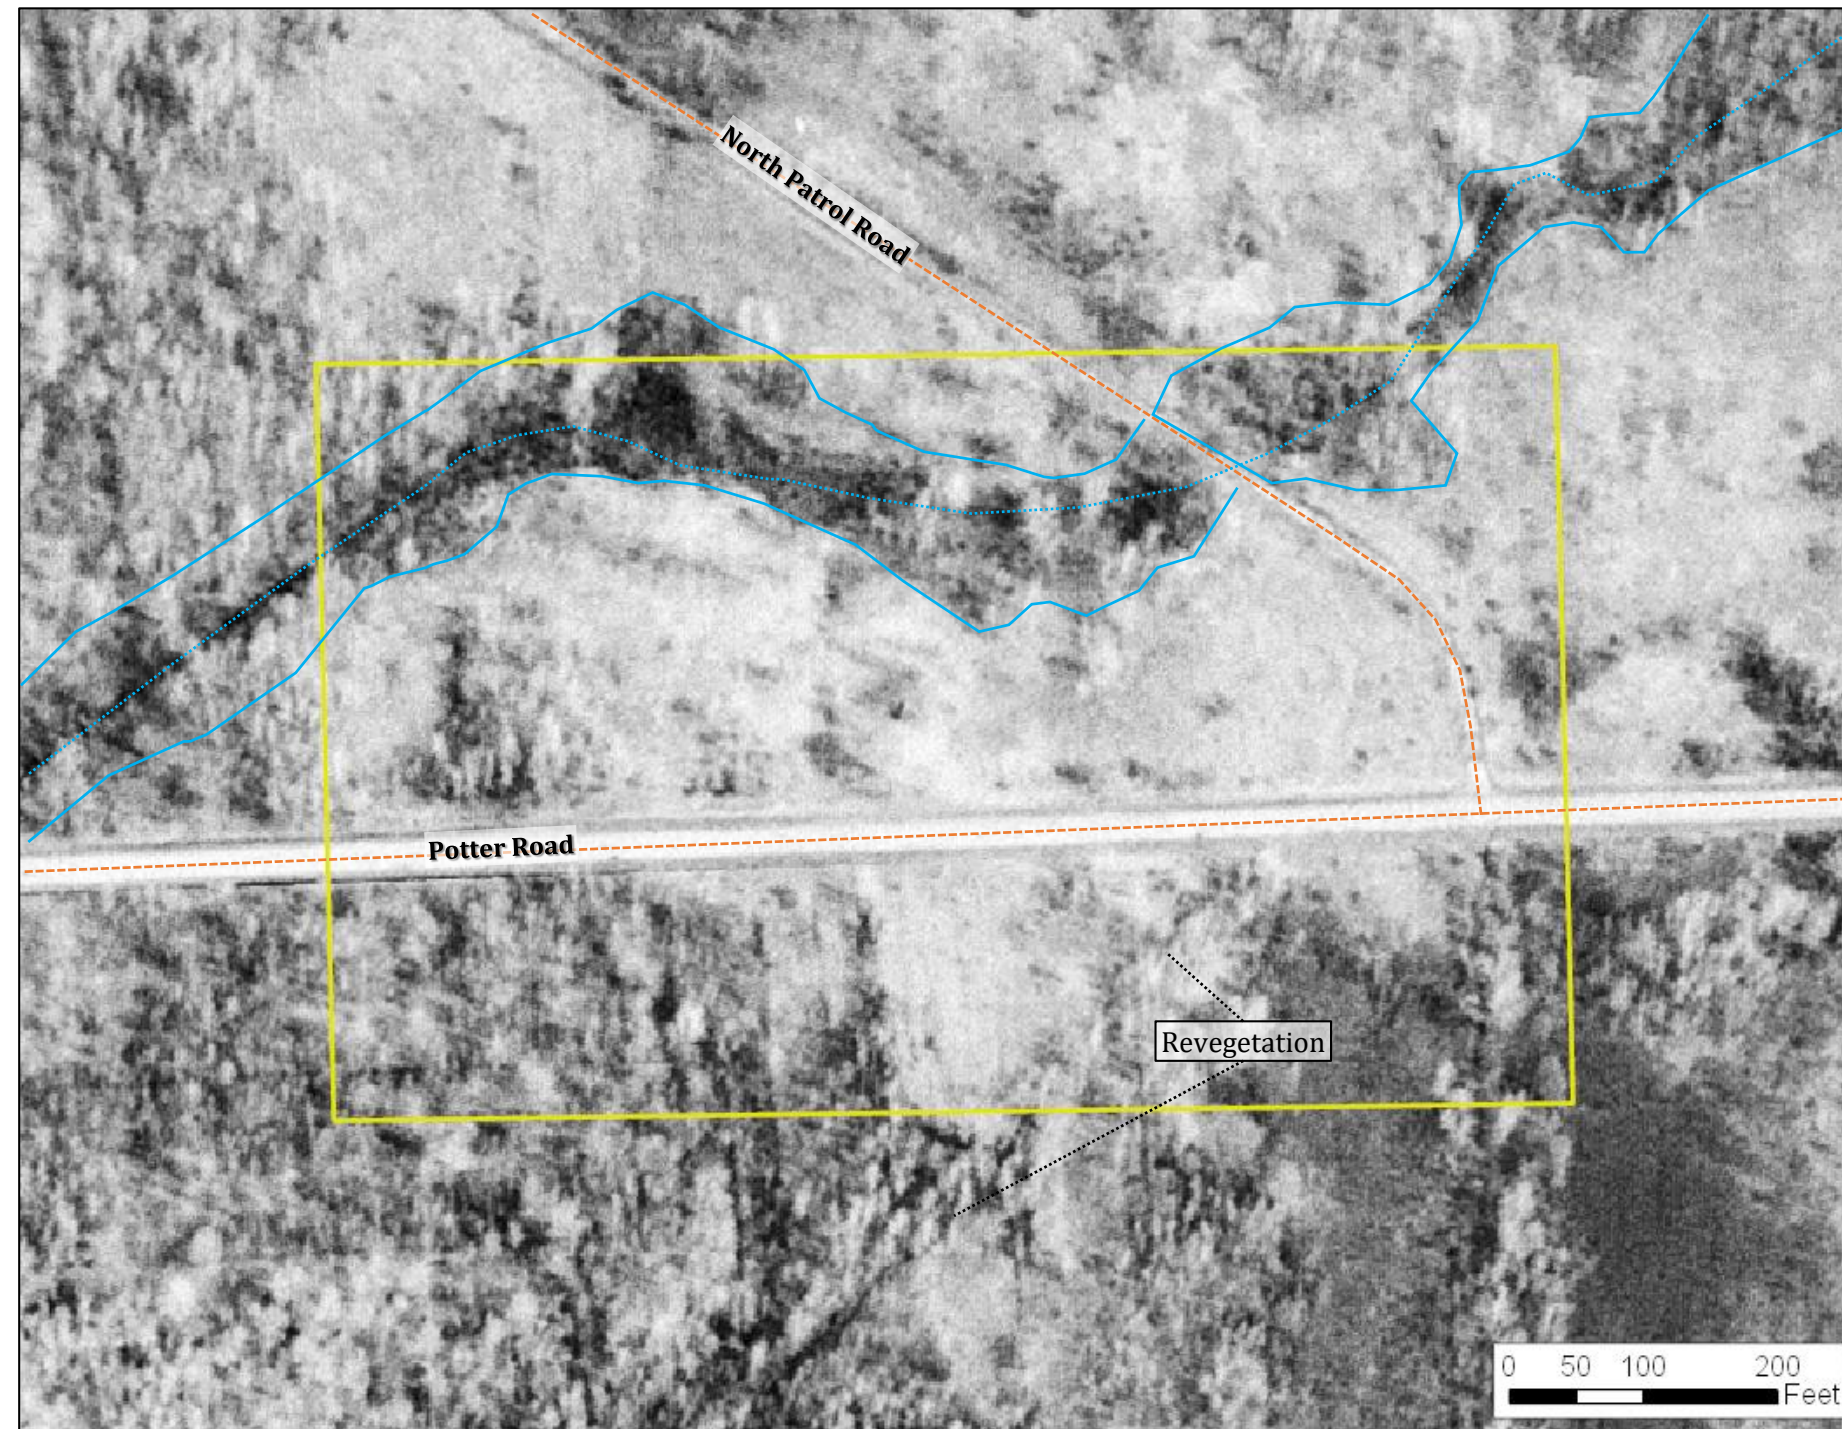
Aside from continuing vegetation regrowth, there is no new activity visible on or around the site, aside from the continued use of North Patrol and Potter Roads.

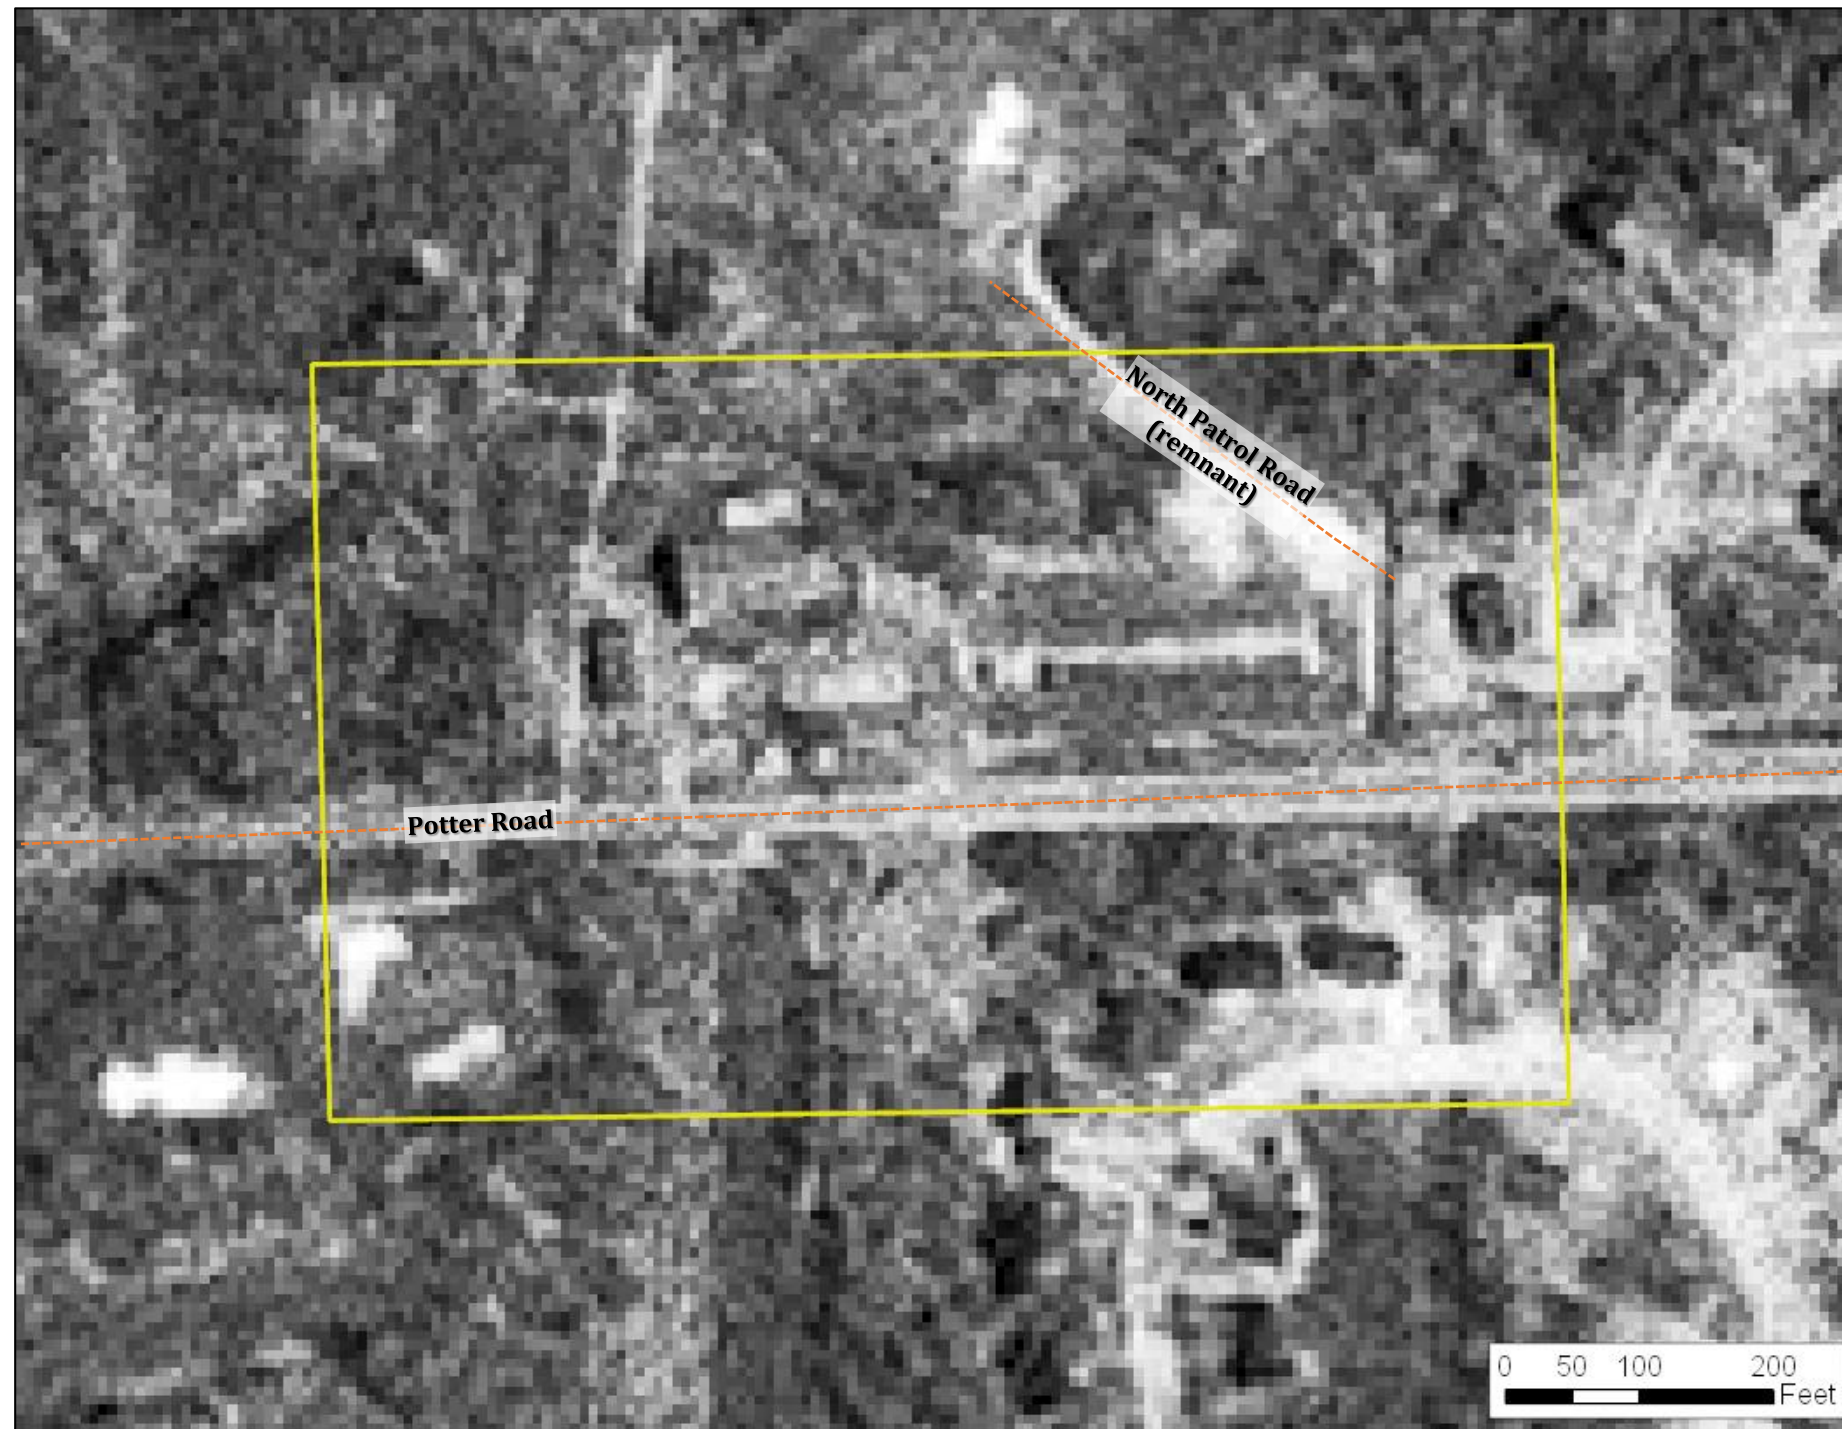
The poor spatial resolution of the 1981 and 1982 aerial photographs prevent confirmation of specific features, but they do reveal construction activities and new housing developments in the area. Development appears to have covered most of North Patrol Road and parts of the creek have been diverted.

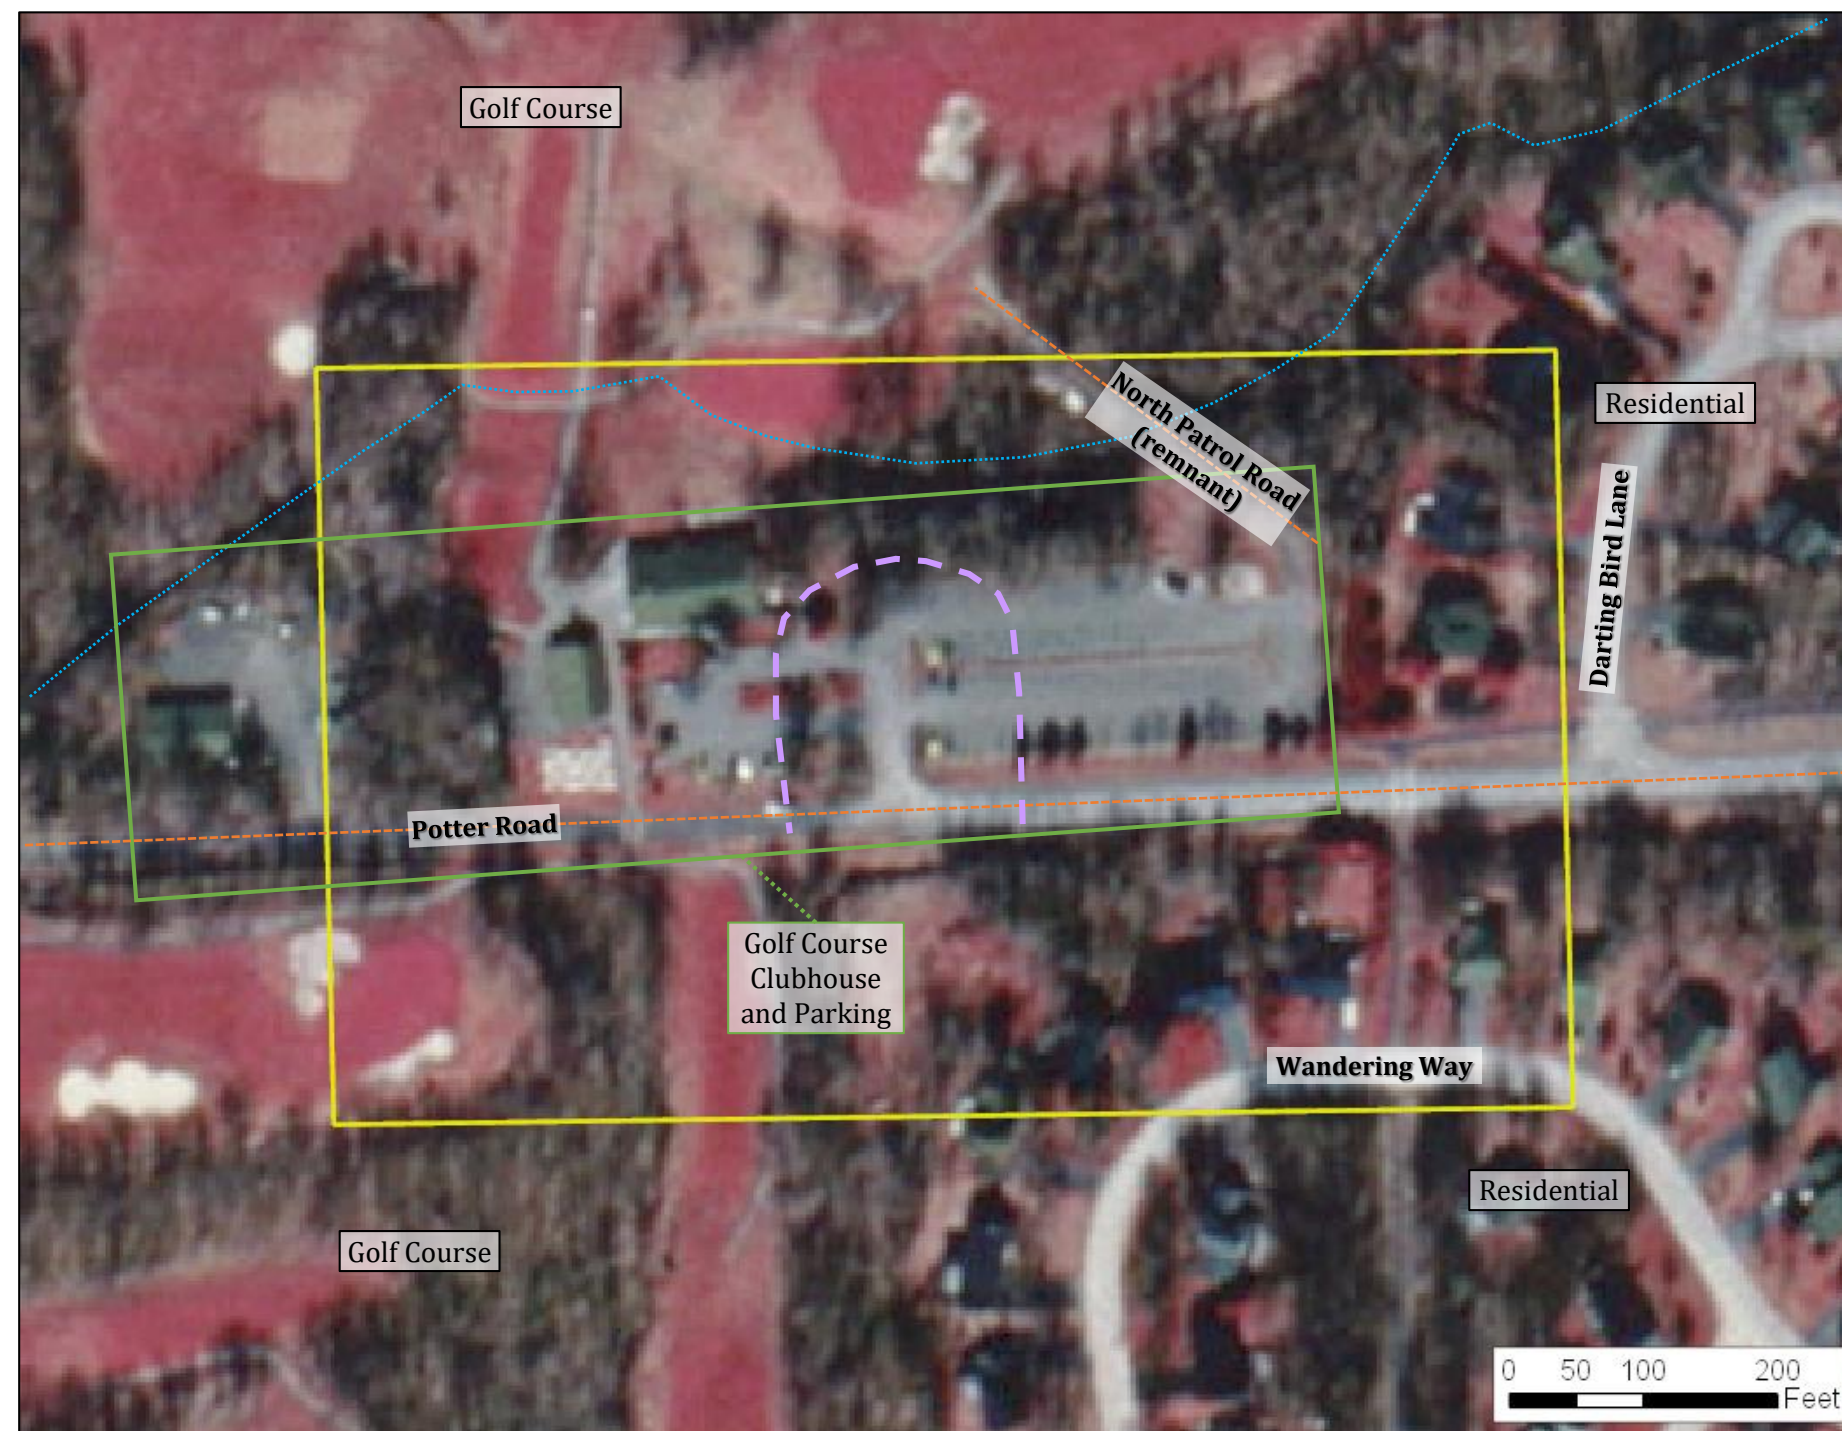
Housing development and the construction of a golf course and associated structures (clubhouse, parking lots, and storage buildings) have replaced the former landfill area.

An approximated vector of the former turnaround (u-shaped) road is placed on this image for reference.

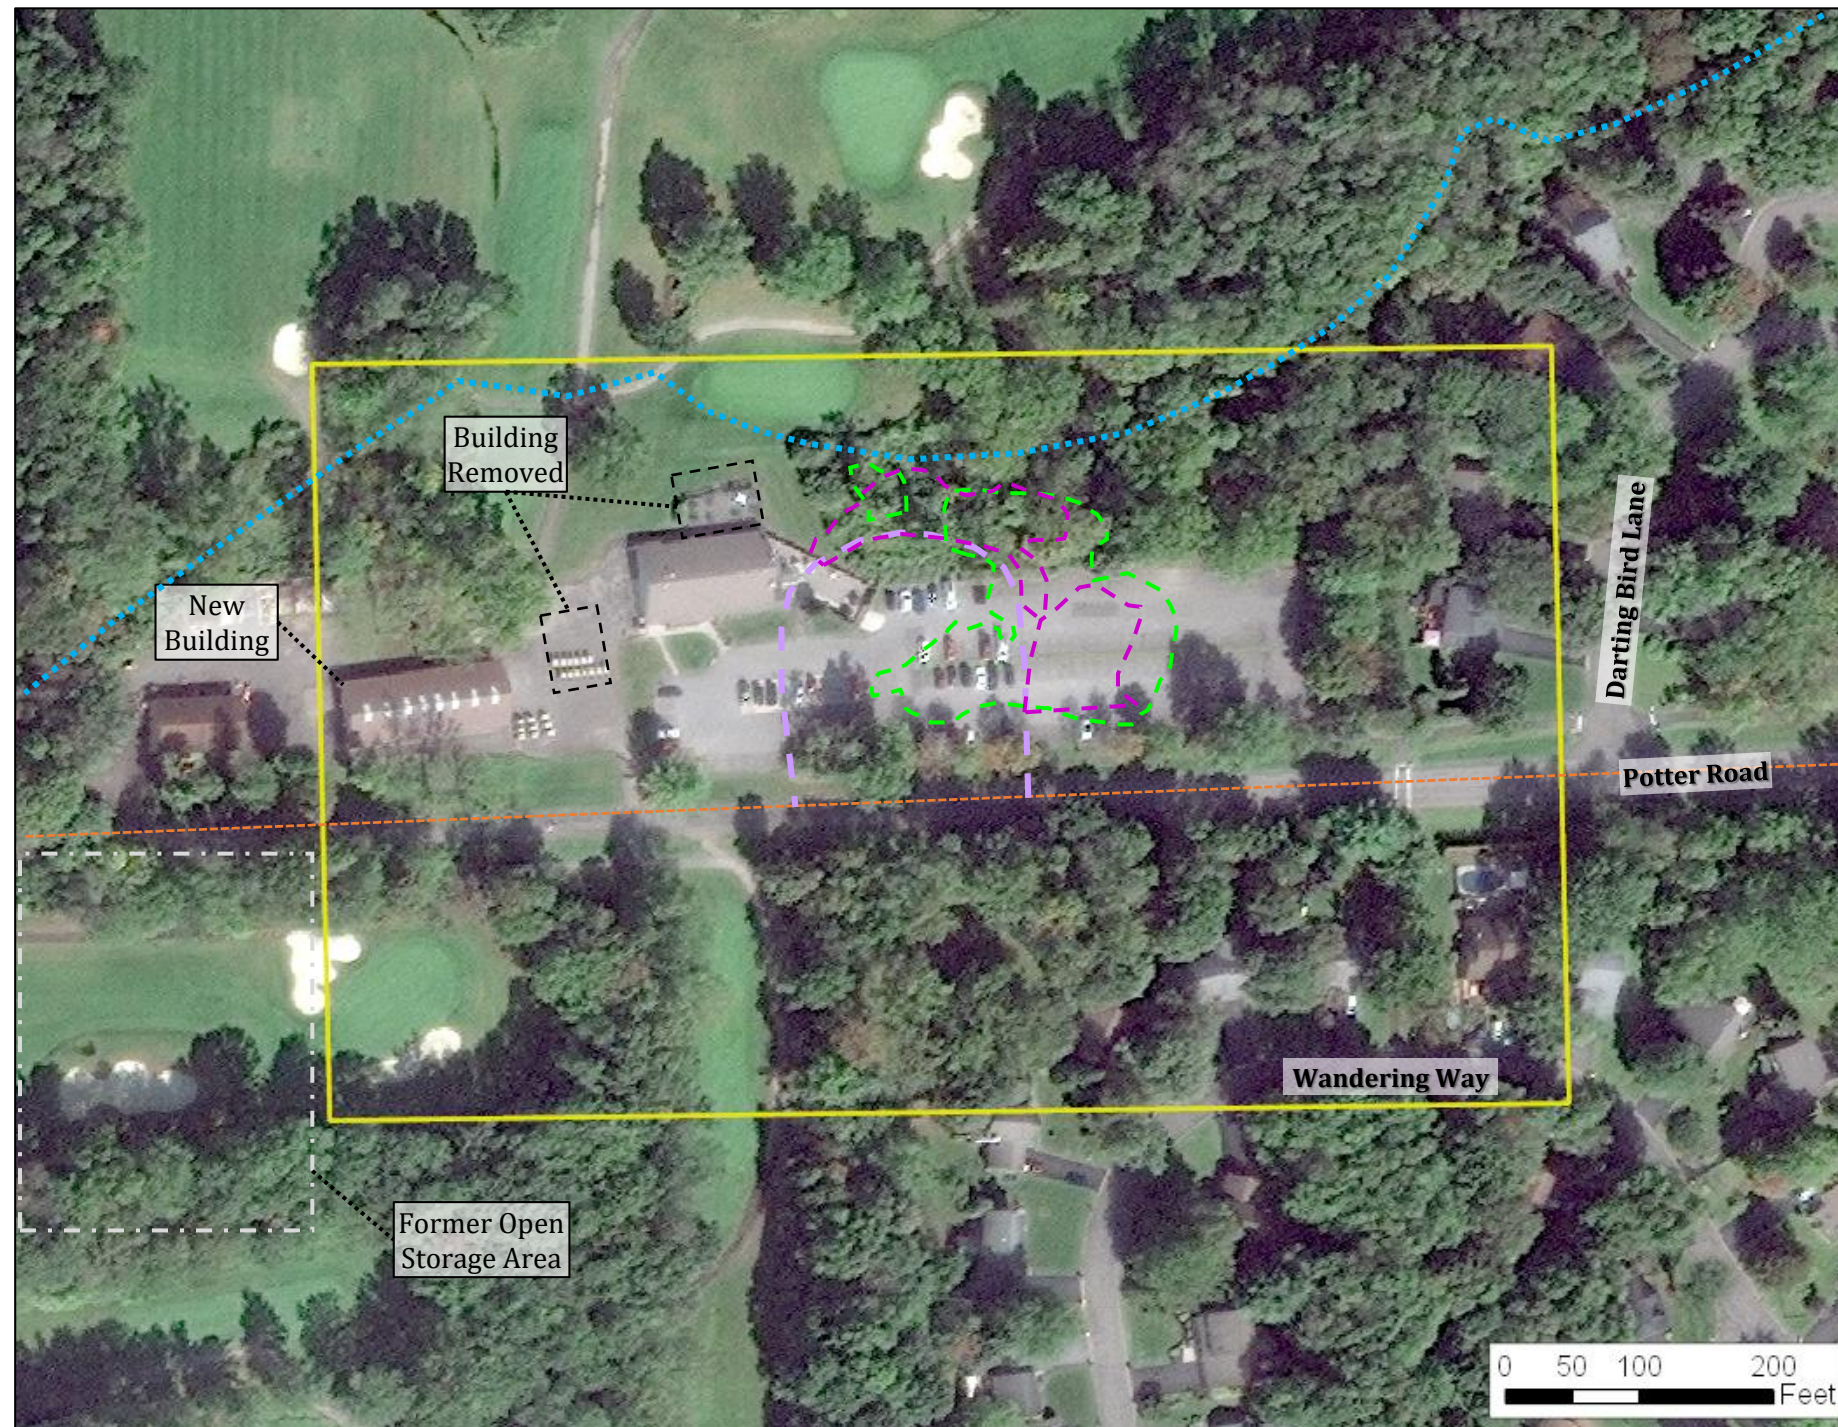
Previous buildings have been removed and one new building is observed in the area of the Clubhouse.

The extent of observable dumping was located under and north of what is now a parking lot.

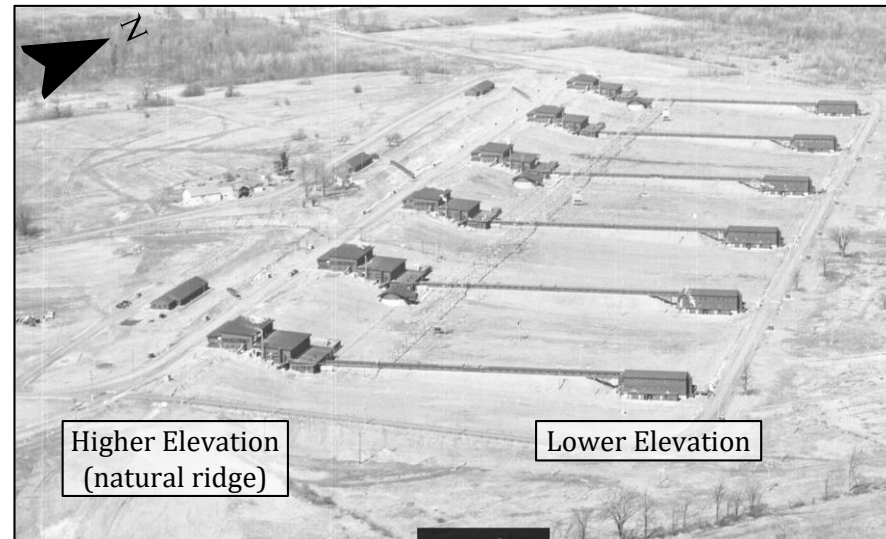
April 18, 1943 Oblique Photographs of Ammonium Picrate Area Showing the Six Ammonium Picrate Production Lines
Source: National Archives at College Park

The construction of six production lines has been completed. A waste water ditch has been constructed running parallel to the Ammonium Picrate area toward the river. An area, southwest of the site, encompassing a former hill appears to be used for fill material (borrow pit). An access road is visible leading to the borrow pit from the Ammonium Picrate area. A dump/storage area is observed northeast of the study area.

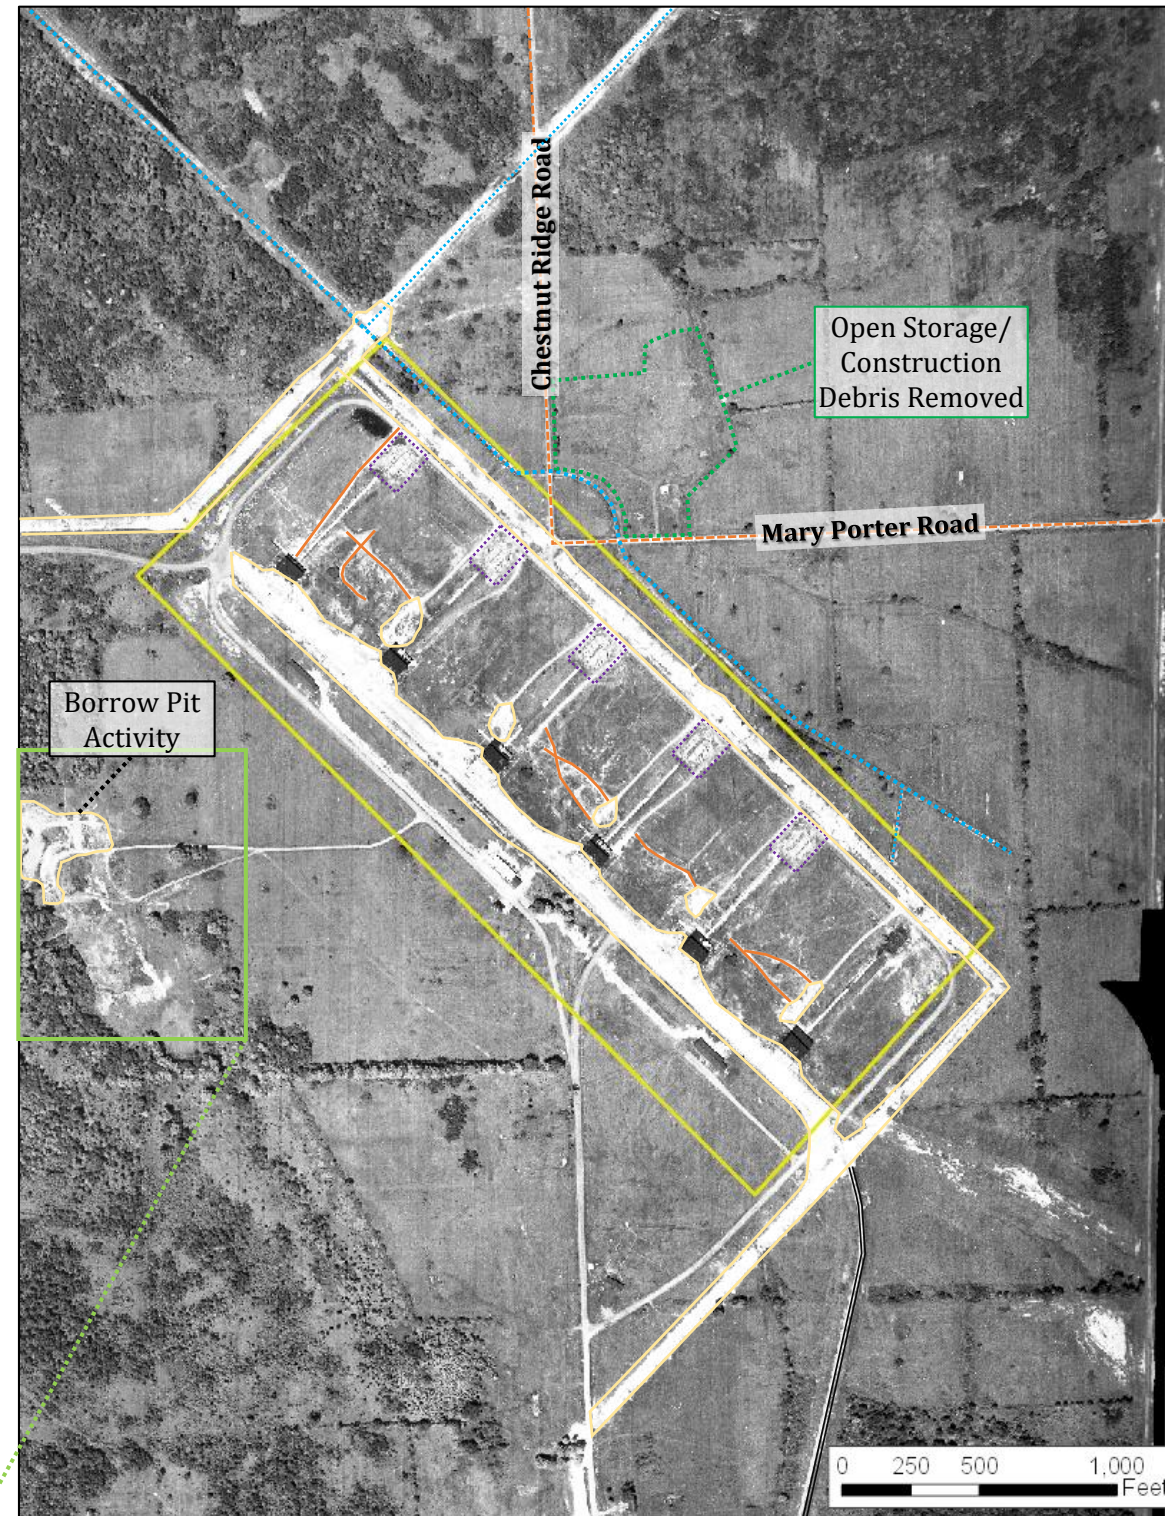
Some of the buildings have been removed, with just foundations remaining. The road to the borrow pit remains active and possible dumping is observed. The open storage/dump area northeast of the site has been cleared of debris and storage. The area is active.

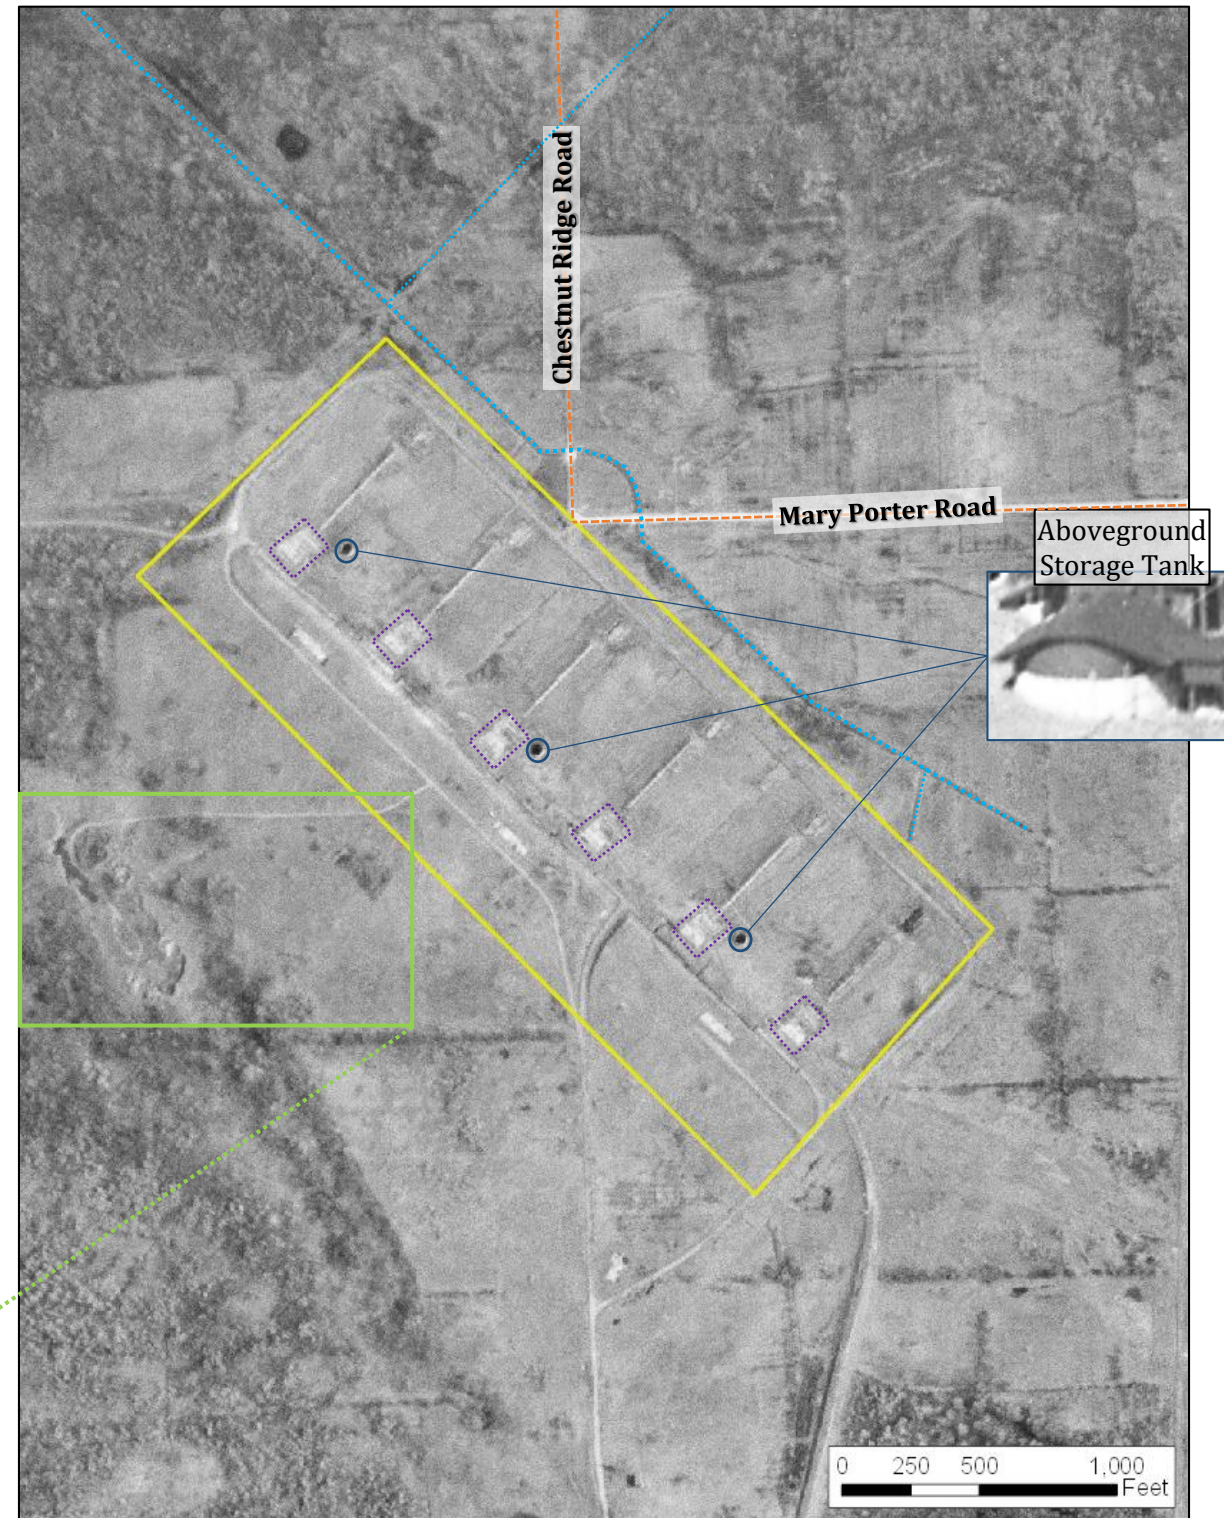
By 1956, more Ammonium Picrate buildings have been removed, although their foundations remain. The housing structures have been removed from the three above ground storage tanks within the Ammonium Picrate Area, exposing their cylindrical structures. An enlargement of the borrow pit area shows a varied landscape that could include a mix of borrowing and dumping activity.

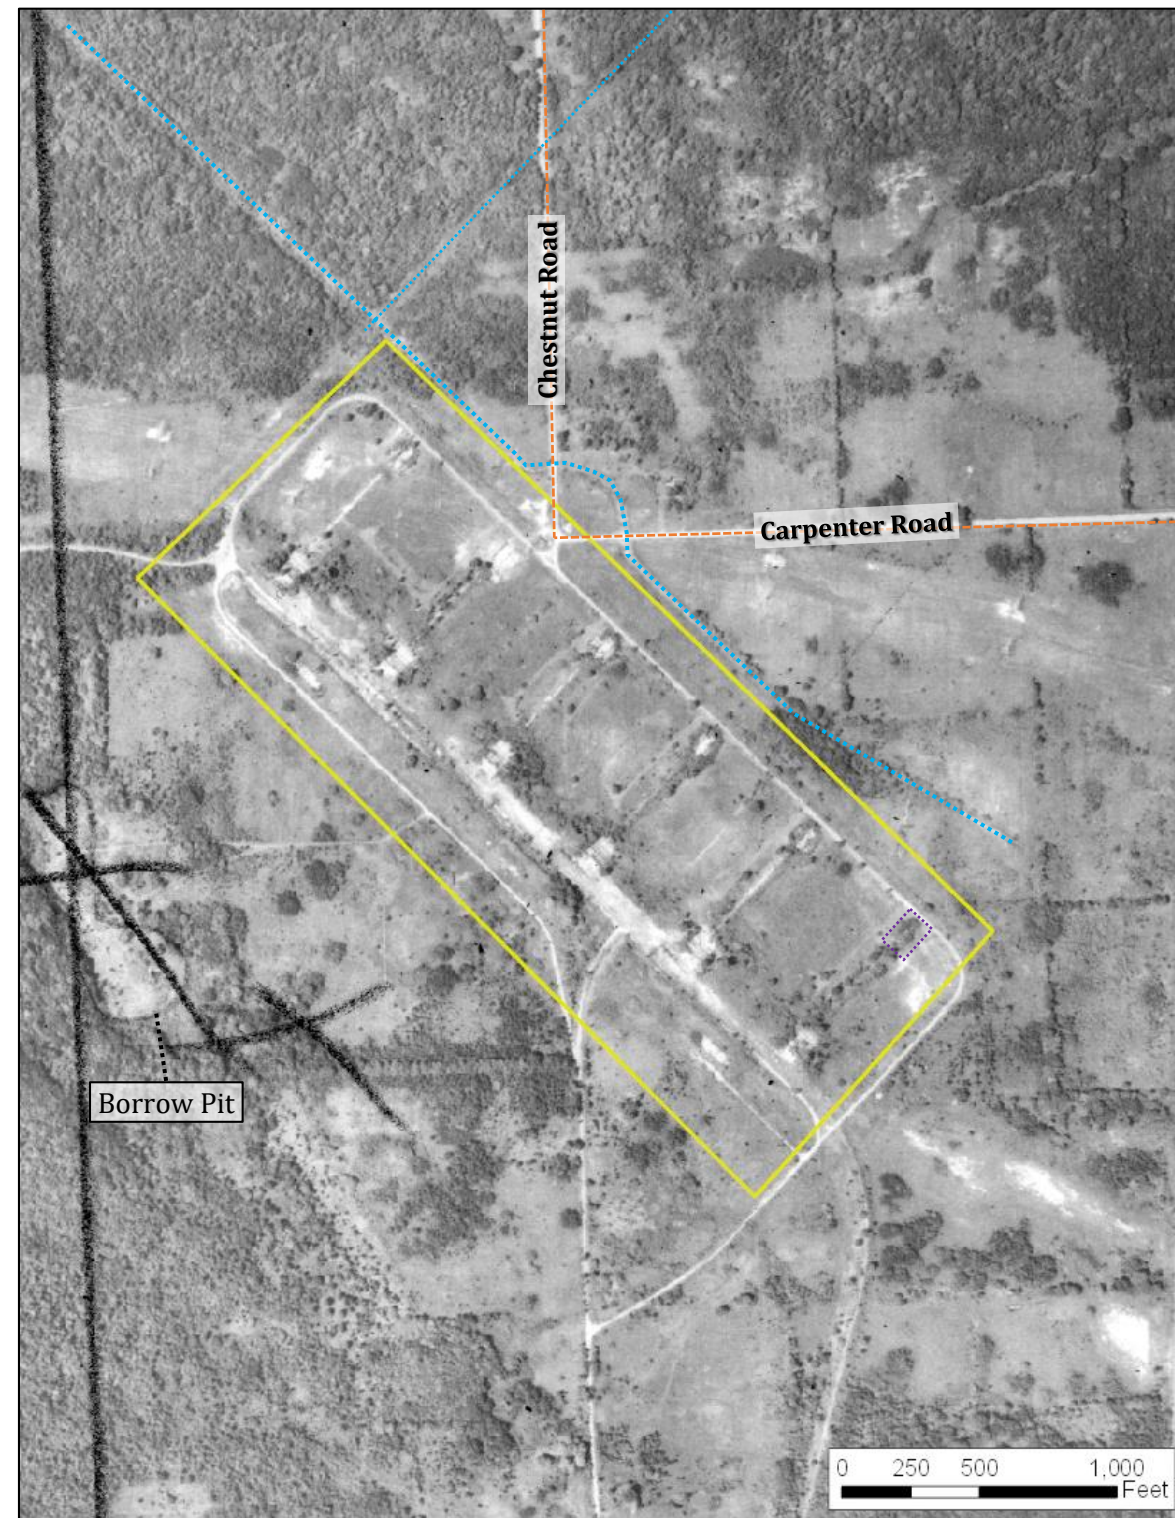
Note: There are penciled annotations on the aerial print. These markings include an outline around the borrow pit.

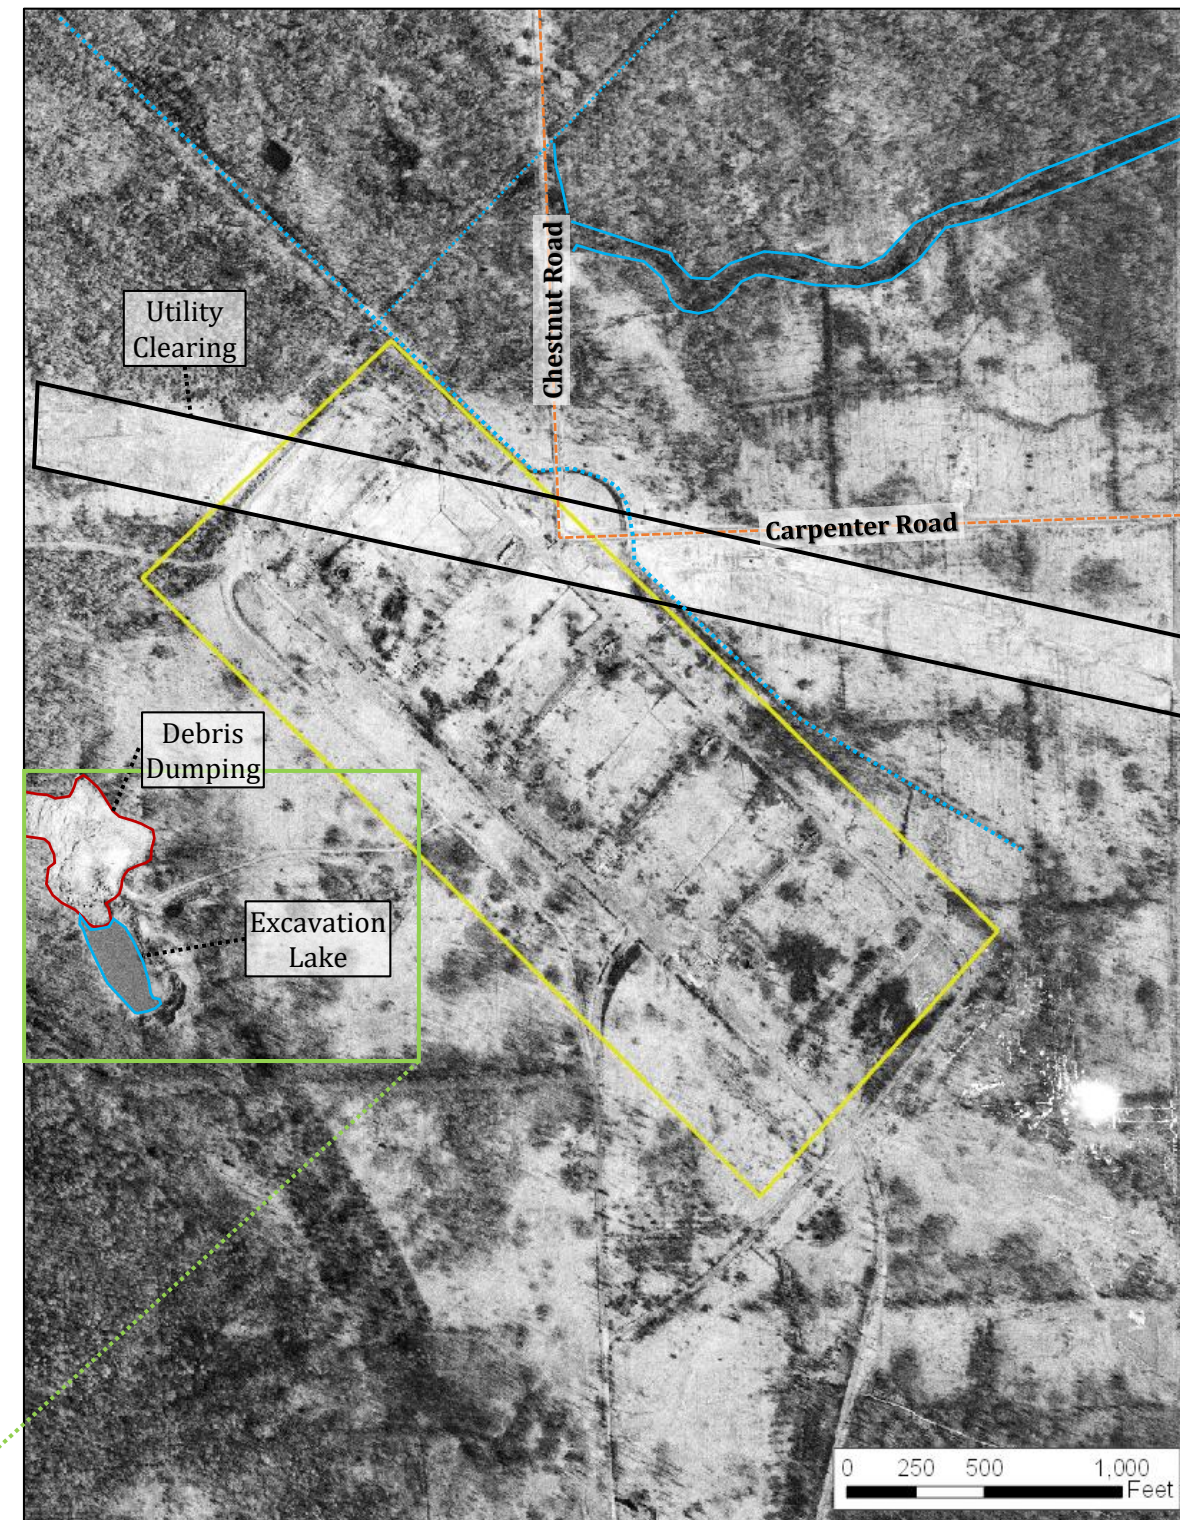
Water has filled part of the borrow pit, forming an excavation lake. To the north of this lake, large mounds of material are observed that were not visible in previous years.

A utility clearing is visible crossing northwest to southeast through the northern section of the former Ammonium Picrate area.
