New York Ordnance Works – Baldwinsville, New York

Historical Photographic Analysis

FINAL REPORT | JANUARY 2020
Prepared for USACE New England District

New York Ordnance Works Baldwinsville, New York Historical Photographic Analysis

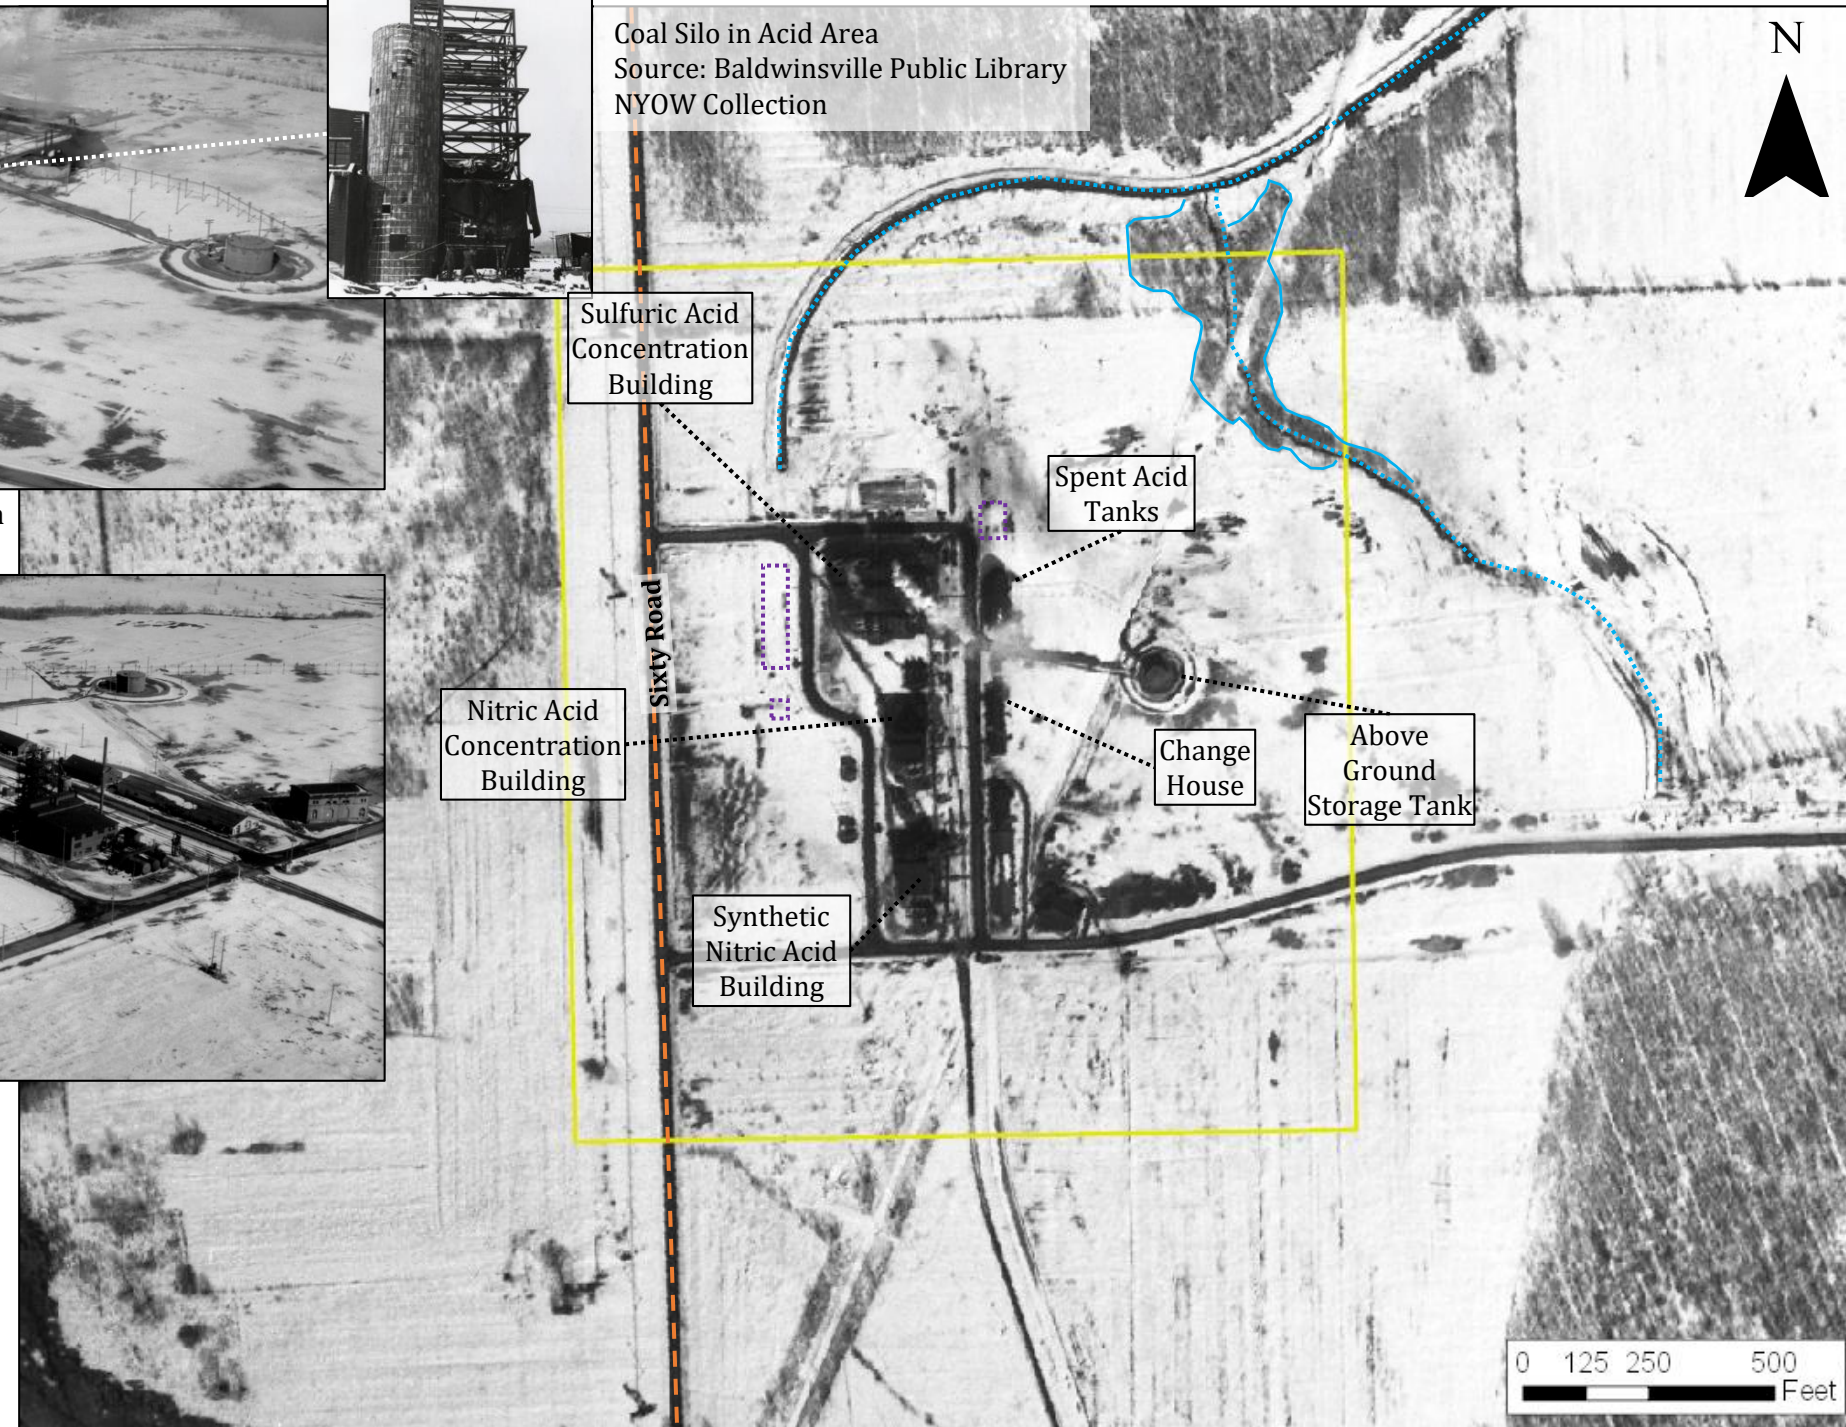
Some structures have been removed between 1944 and 1949. A small area of debris is near the intersection of newly disturbed ground (see enlargement below). Much of the linear shaped disturbed ground in this photograph aligns with known locations of pipeline, therefore this could be the product of removing existing pipeline.

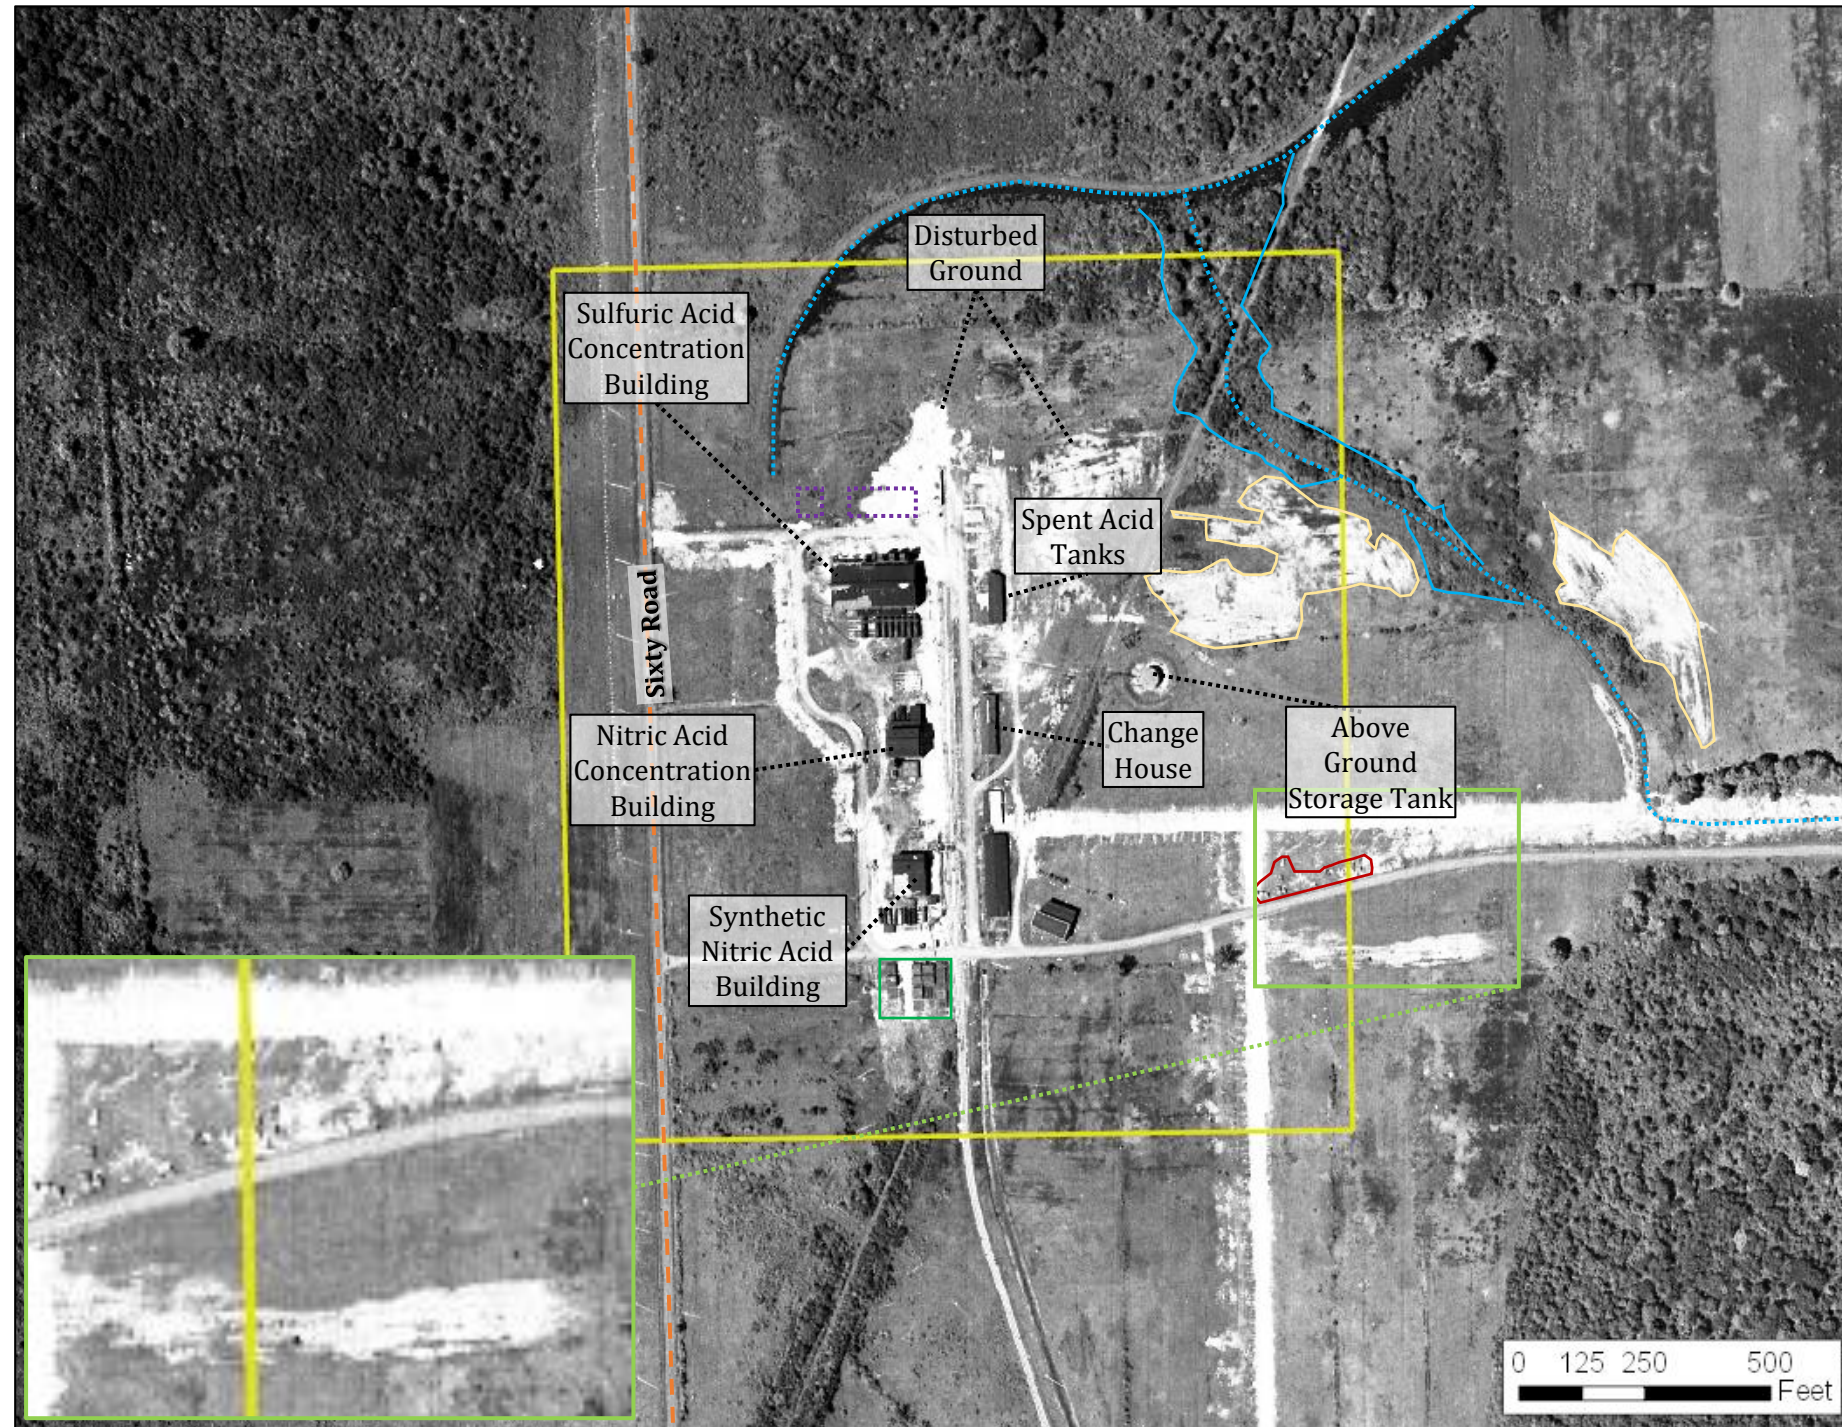
Numerous structures have been removed by 1951. The foundations remain for some of these features. The roof over the spent acid tanks has been removed, however the tanks remain.

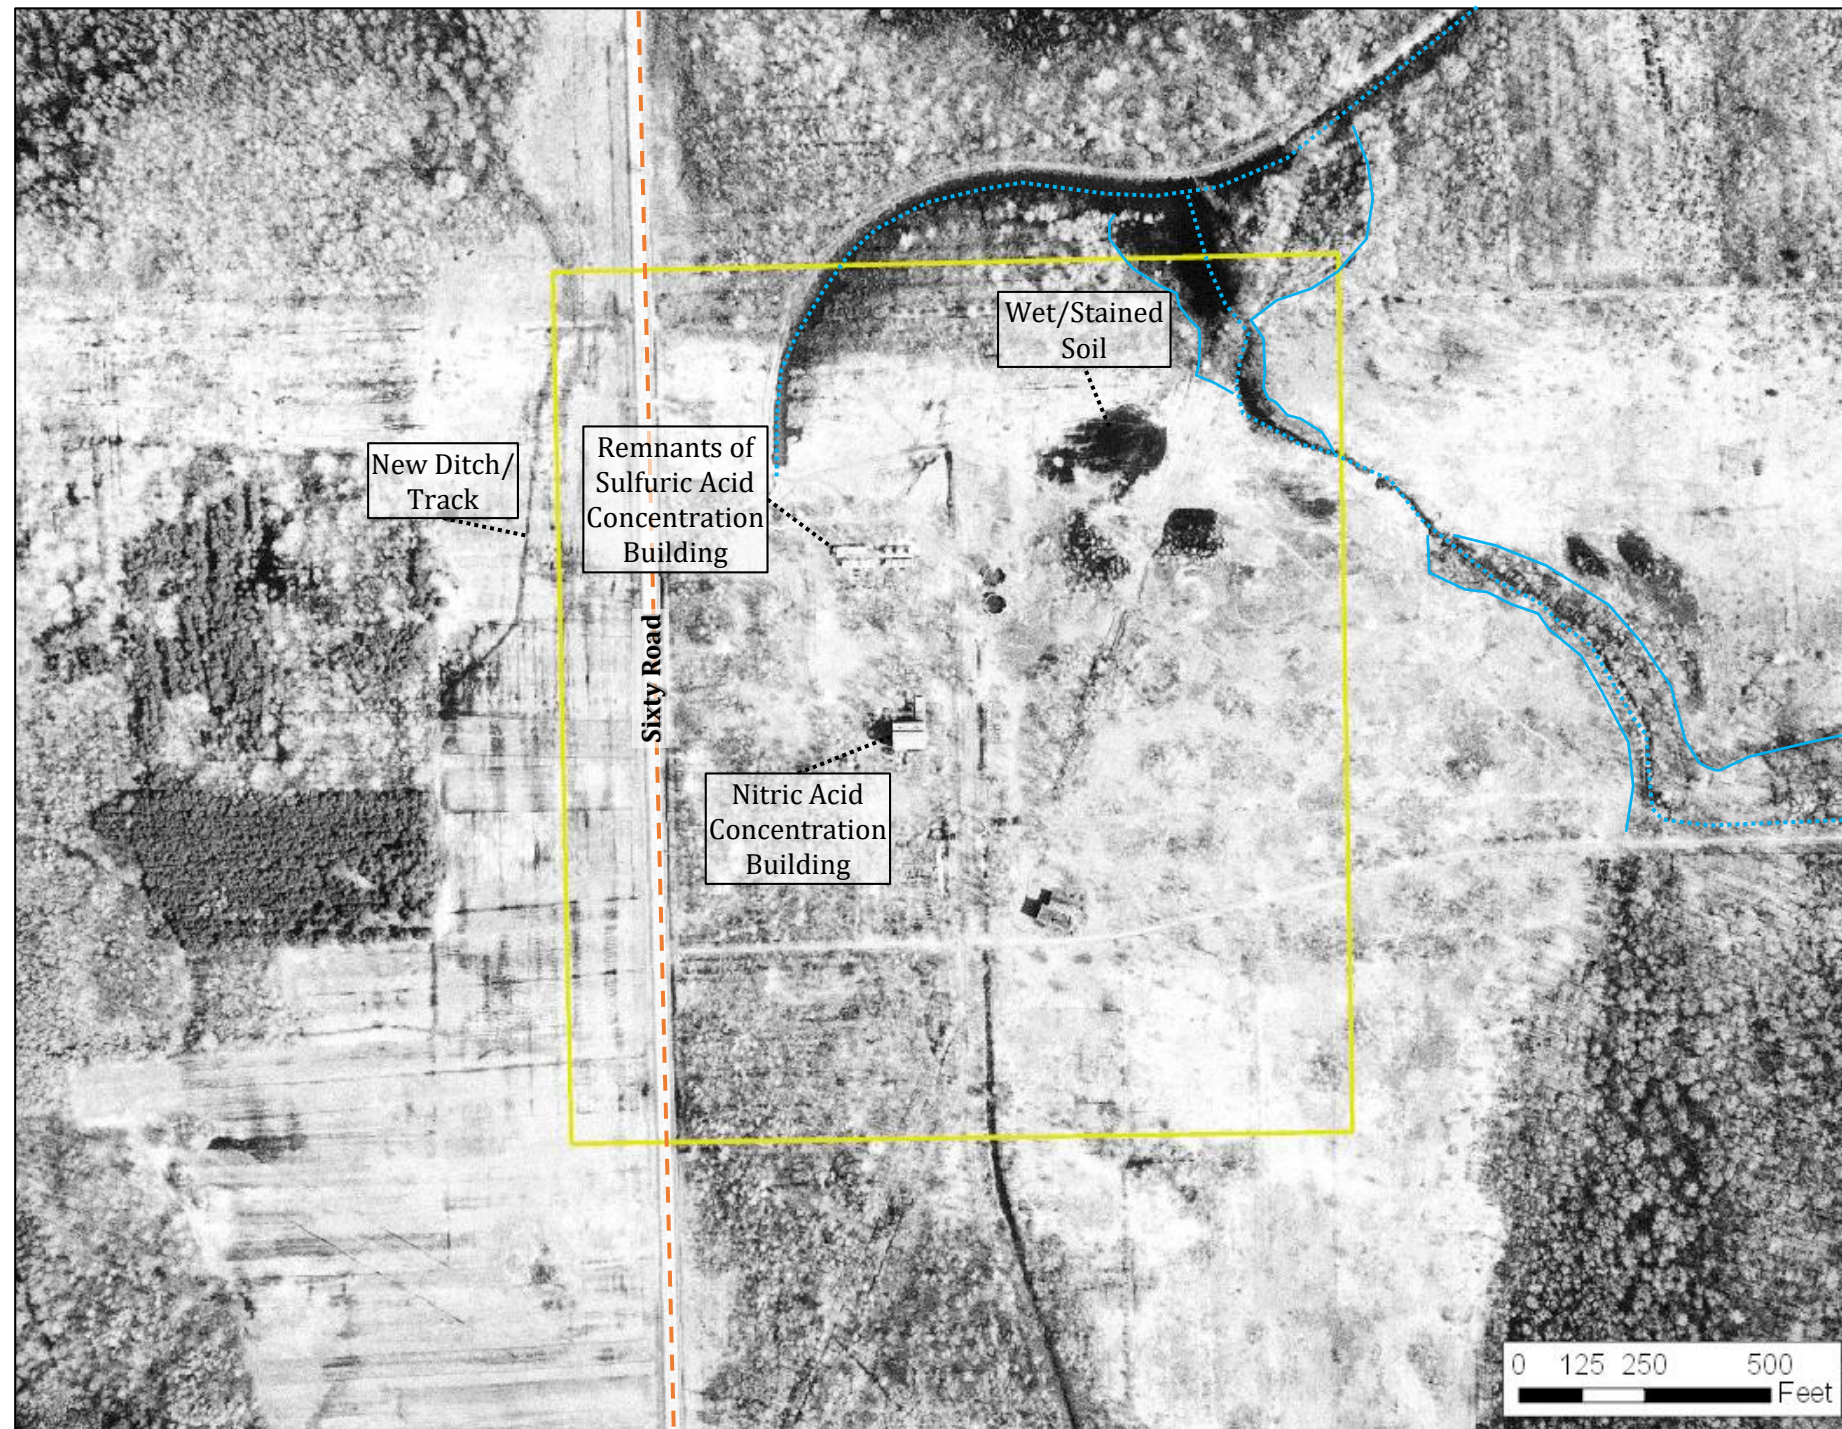
This image has poor spatial resolution, but one more building appears to have been removed (the foundation remains), and the remnants of the remaining former Acid Area structures are still visible. Continued regrowth of vegetation is observed.

A new road/track is visible from the east and leading alongside the former Acid Area boundary to the road running east-west through the former Acid Area.

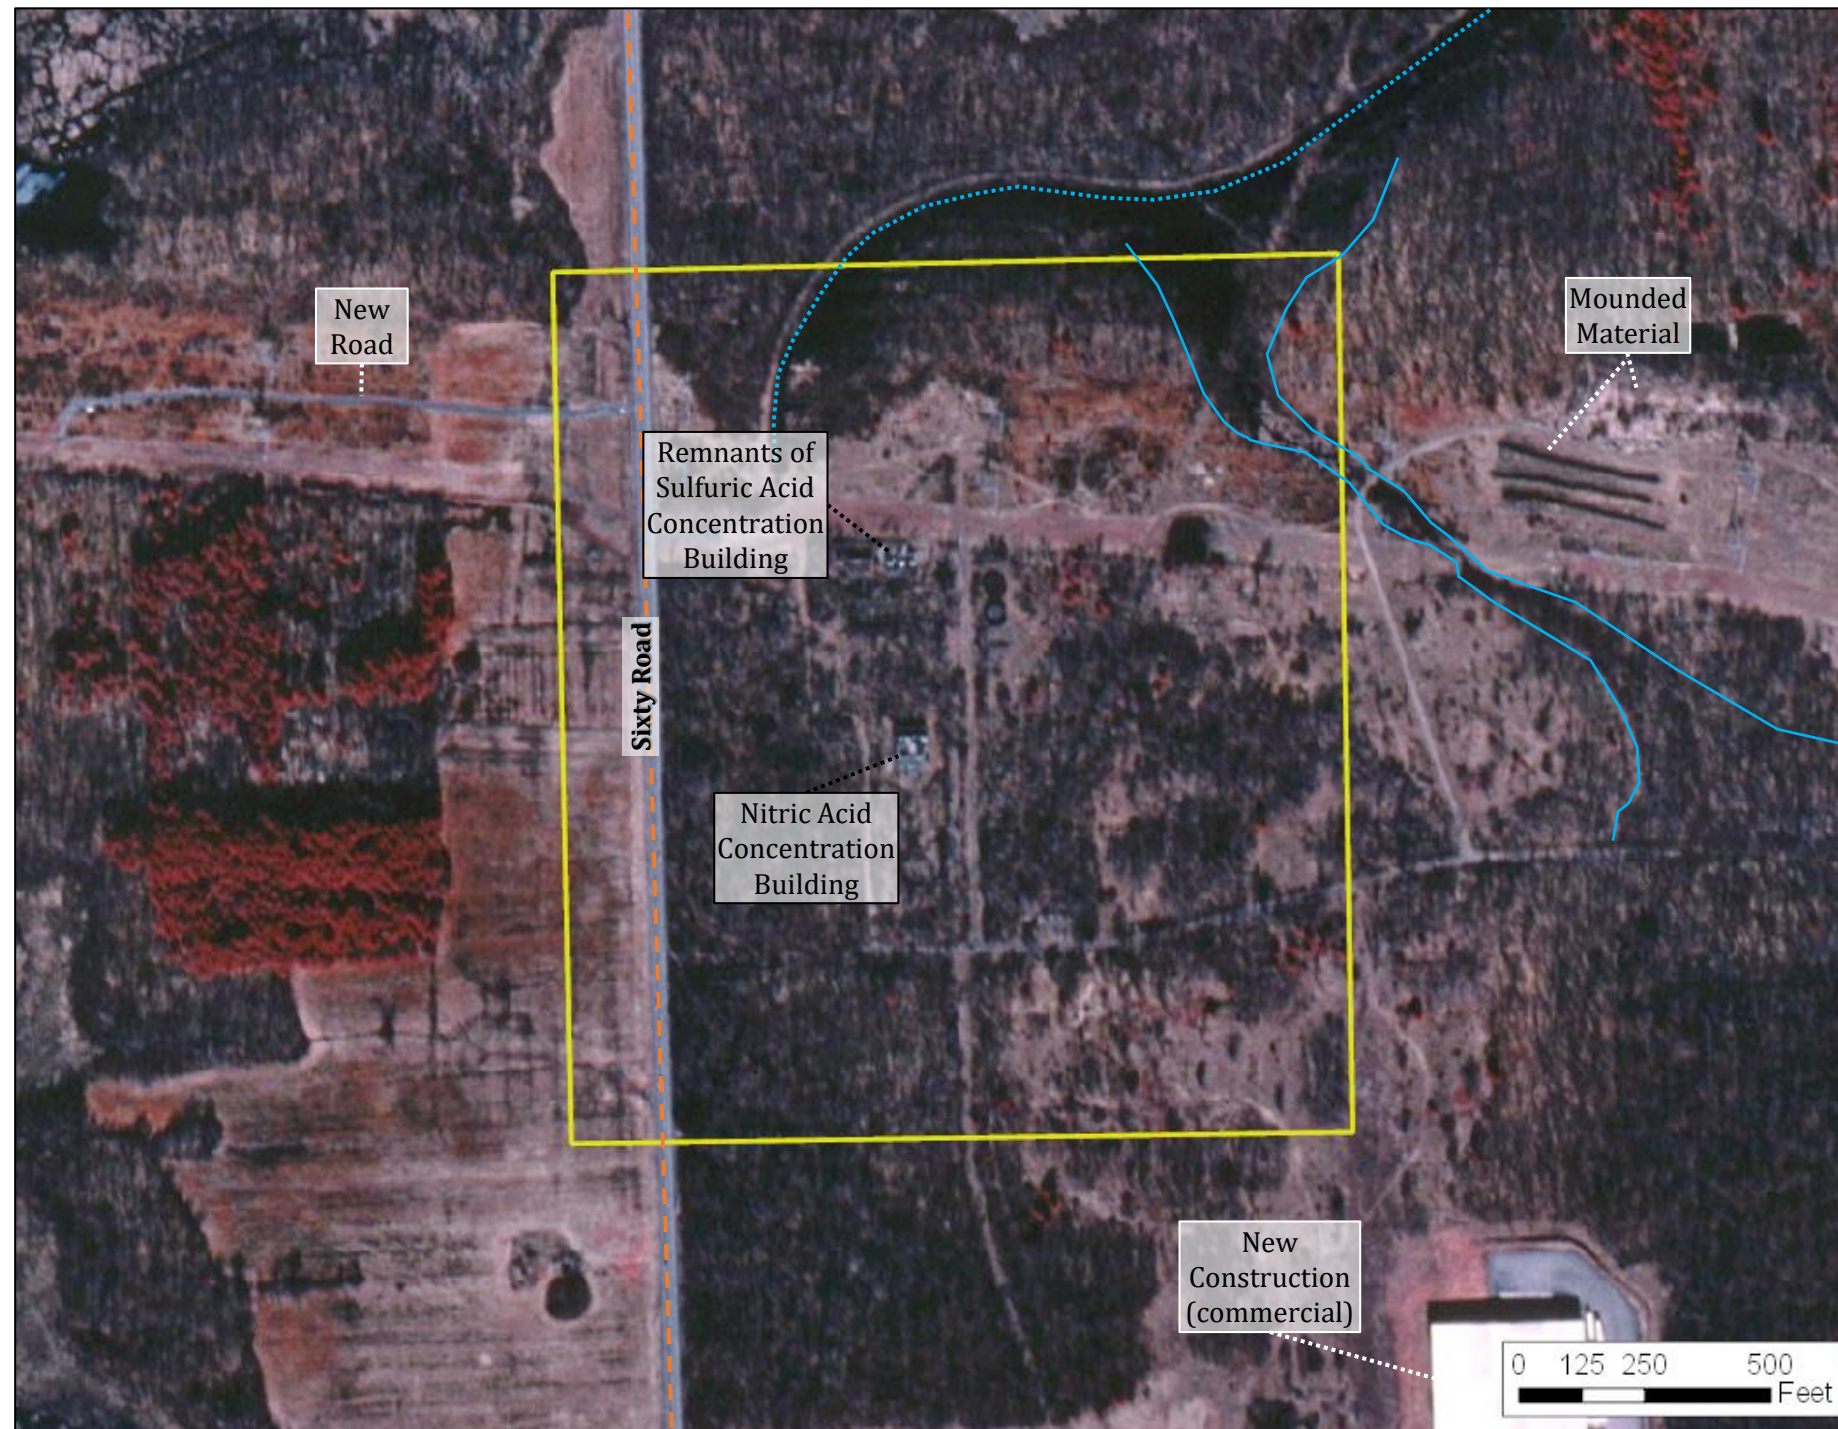
The spent acid tanks were removed between 1995 and 2003. Other related structures remain within the Acid Area.
