LETTER REPORT

SUBJECT: Letter Report, Sign Inspection and UXO Awareness Training, Martha's Vineyard

MMRP Sites

This annual Long Term Monitoring report documents activities carried out on Martha's Vineyard in accordance with the LUC Implementation Plan (LUCIP) and Performance Work Statement for contract W912DR-15-D-0015-0003.

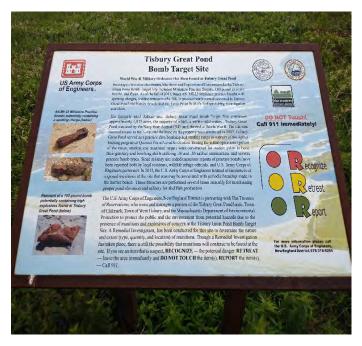
1. Summer Beach entrance.

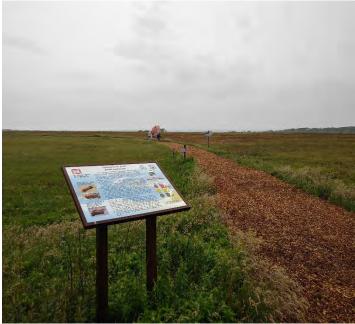
2. Summer Beach, sign facing east.

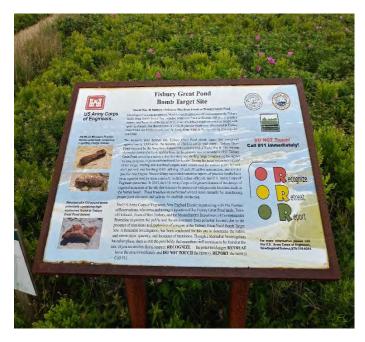
3. Winter Beach entrance.

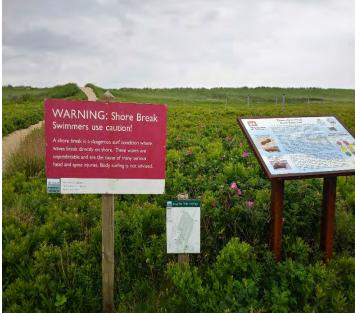
4. Winter Beach approach, sign facing north.

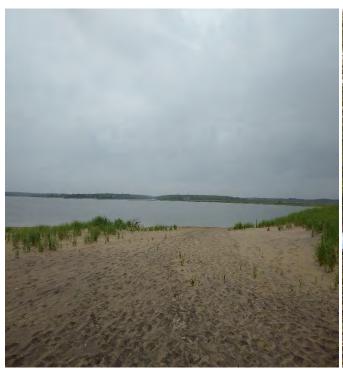
Western Beach	N/A	N/A	N/A	Sign is missing (likely due to erosion). Confirmed situation from last inspection. RECOMMEND: replace sign if appropriate location identified (photo 5)		
Main Entrance from parking lot	N/A	N/A	N/A	Sign is located near parking lot. Overall very good condition. No erosion issues. RECOMMEND: no action

5. Western Beach sign missing.

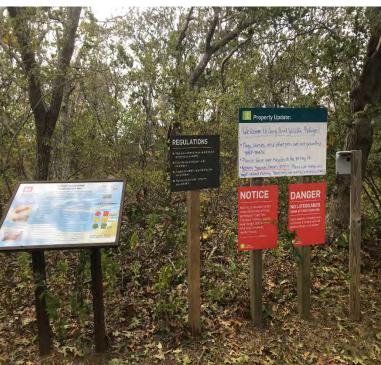
6. Main Entrance from parking lot sign.

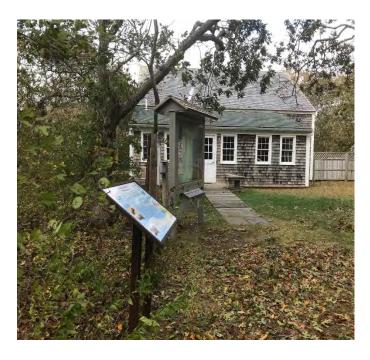
7. General area of Main Entrance sign.

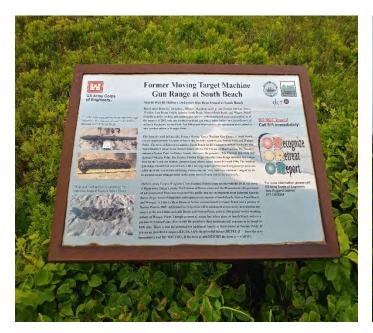
7. Entrance 1, Sign facing east.

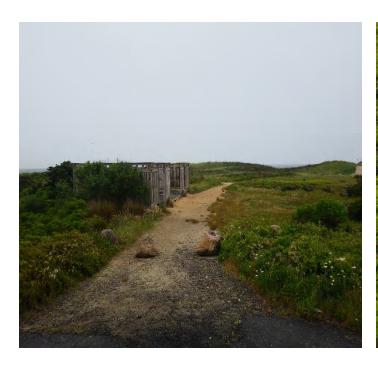
9. Entrance 2, sign missing.

I. Site Information						
Site Name: Martha's Vineyard MRSs	Date(s) of Inspection: June 26 and 27, 2019						
Location and Region: Ma	Location and Region: Martha's Vineyard, MA						
	II. Site Conditions						
Location (vicinity of sign)	Site Conditions of Note (e.g., significant erosion since last site inspection, observations of munitions, or other observations that impact LUC implementation) Notes: (include photograph documentation)						
Tisbury Great Pond							
Area of Western Beach Sign	Area of sign has undergone severe erosion (sign was washed away prior to April 2018).	See photos 5&6.					
Area of Entrance to Winter Beach Sign	Area showed no sign of erosion.	No findings that impact LUC implementation. See photos 3&4.					
Area of Summer Beach Entrance Sign	Area showed no sign of erosion.	No findings that impact LUC implementation. See photos 1&2.					
South Beach							
Area of Beach Entrance 1 & 2, and Right Fork Signs	Area showed no sign of erosion. Beach Entrance 2 sign missing but likely due to vandalism, not erosion.	No findings that impact LUC implementation. See photos 7-8, 9, 14-16.

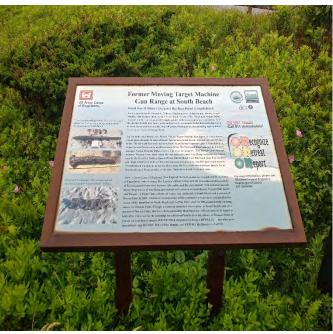
10. Entrance 3, sign facing east.

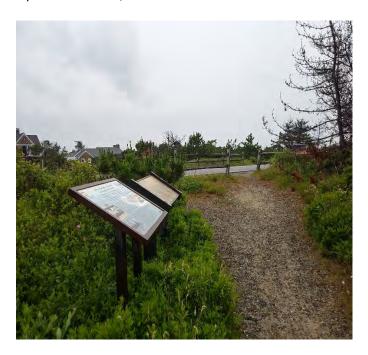
11. Entrance 3, side view.

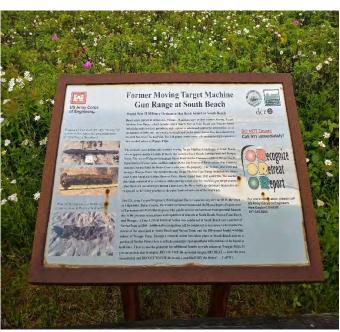
12. Left Fork, sign facing east.

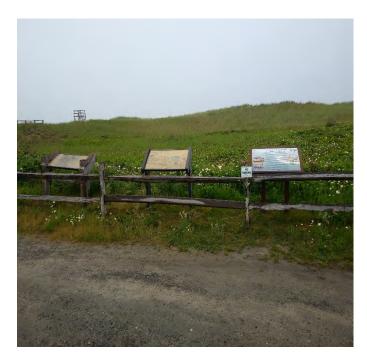
13. Left Fork approach.

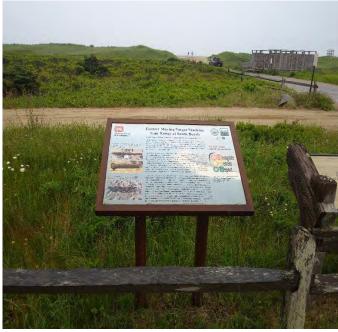
14. Right Fork, sign facing north.

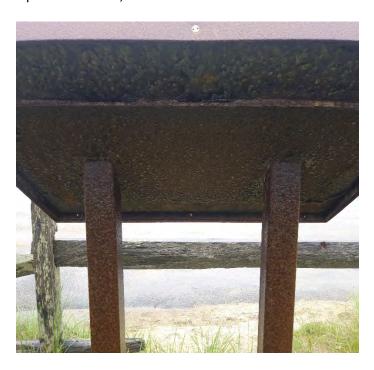
15. Right Fork, showing underside.

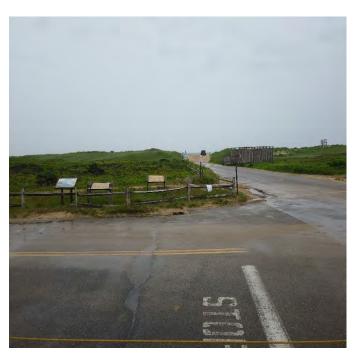
16. Right Fork, approach view.

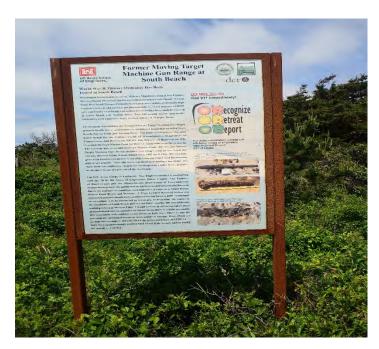
17. Left Fork Deflation, sign facing east.

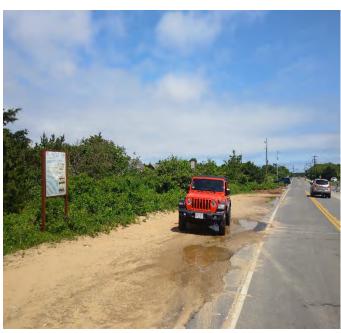
18. Left Fork Deflation, looking south.

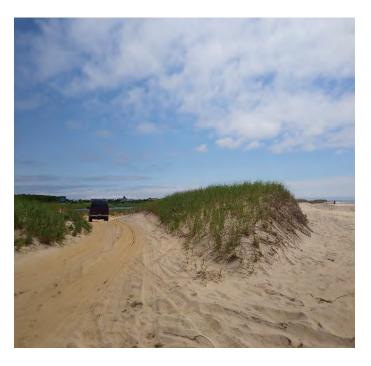
19. Norton Point Entrance 2, sign missing.

Area of Left Fork, Left Fork Deflation, and Beach Entrance 3 Signs	Area showed no sign of erosion.	No findings that impact LUC implementation. See photos 10-11, 12-13, 17-18.					
Area of Norton Point Trail Entrance Sign	Sign missing apparently due to erosion.	See photo 19.					
Area of Wasque Tire Inflate and Swimming Trail Signs	Area of signs has undergone severe erosion. Both signs had been washed away prior to 2018.	See photos 20&23.					
Area of Wasque Gate house and Fishing Trail Signs	Minimal to no signs of erosion.	No findings that impact LUC implementation. See photos 21, 22, 24, 25.					
Cape Poge							
Area of Dyke Bridge Sign	Minimal to no signs of erosion.	No findings that impact LUC implementation. See photo 26.					
Area of Little Neck Sign	Minimal to no signs of erosion.	No findings that impact LUC implementation. See photos 27&28.

South Beach Left Fork	Very Good	Cleaning, wiped down with Windex	Cleaning, June 26, 2019	Sign is located south of Atlantic drive and beach trail, at beach entrance #4, facing north. Overall very good condition. No erosion issues. RECOMMEND: no action
South Beach Right Fork	Very Good	Cleaning, wiped down with Windex	Cleaning, June 26, 2019	Sign is located adjacent to road and beach trail, facing north. Overall very good condition. No erosion issues. RECOMMEND: no action
Left Fork Deflation	Very Good	Cleaning, wiped down with Windex	Cleaning, June 26, 2019	Sign is located west of Katama Rd, facing east, across from the tire pumping station. Overall very good condition. No erosion issues. RECOMMEND: no action
Norton Point Trail Entrance Sign 2	N/A	N/A	N/A	Sign is missing (likely due to erosion). Confirmed situation from last inspection. RECOMMEND: replace if appropriate location identified (photo 19)

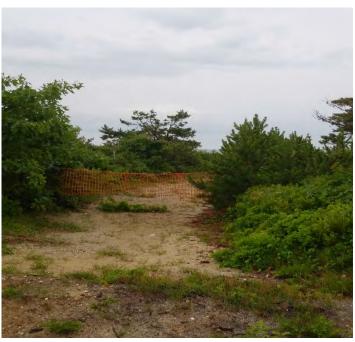
20. Wasque Tire Inflation Area, blocked off approach to missing sign.

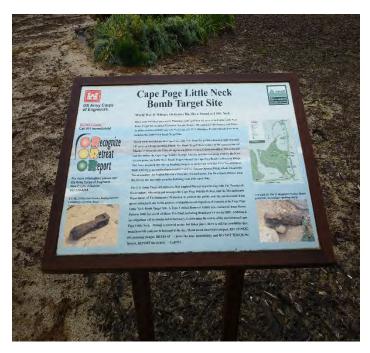
21. Wasque Gate House, sign facing south.

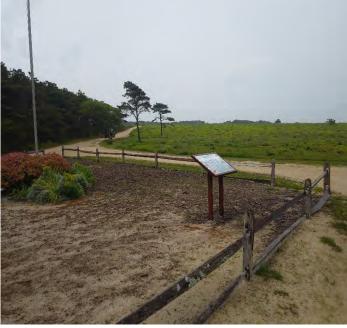
22. Wasque Gate House, side view.

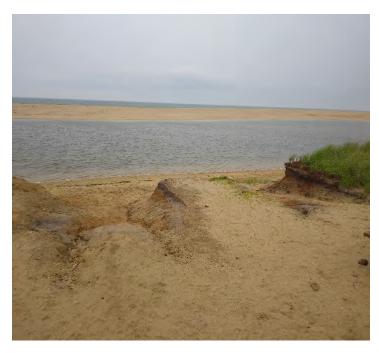
23. Wasque Swimming Trail, sign missing.

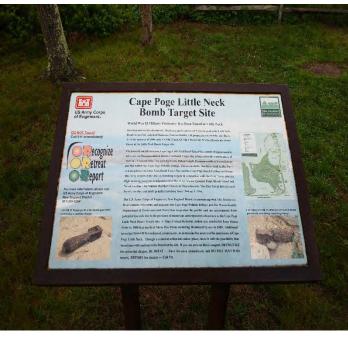
24. Wasque Fishing Trail, sign facing north.

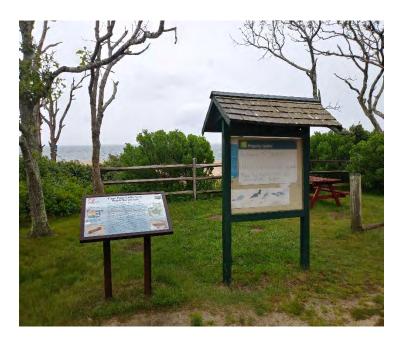
25. Wasque Fishing Trail approach.

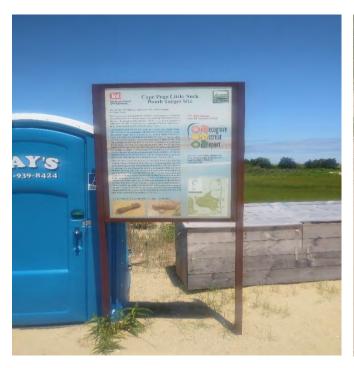
26. Dyke Bridge, sign facing south.

27. Little Neck, sign facing south.

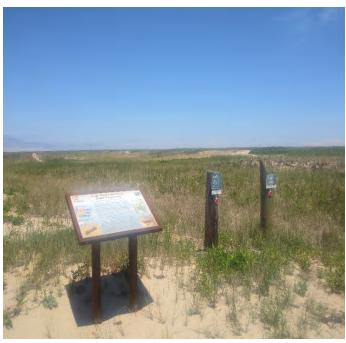
28. Little Neck, sign approach.
