September 2022

2022 SOIL COVER MONITORING AND MAINTENANCE SUMMARY REPORT

**GSA PROPERTY DOMA001902
670 ARSENAL STREET
WATERTOWN, MASSACHUSETTS**

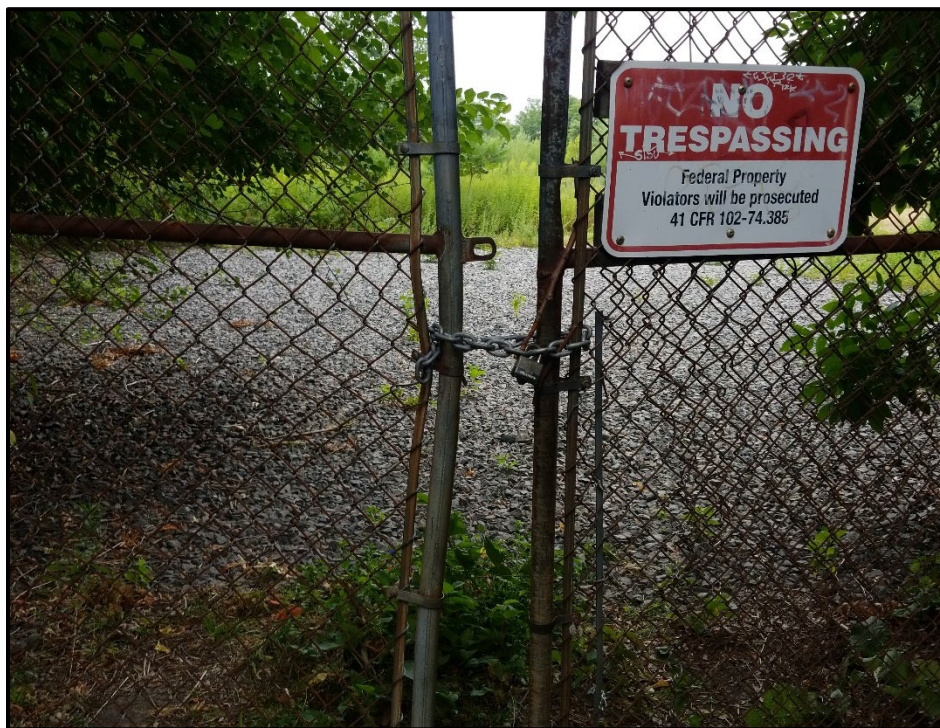
During the site visit, the USACE observed that the perimeter fence, i.e., the second/interior gate, was padlocked and there was no evidence of trespasser activity. The USACE did not have the key to the padlock; therefore, the USACE representatives cut the chain to access the Property to complete the required inspection activities. Upon completion of the soil cap inspections, the USACE representatives took the chain, with the existing lock still attached, and wound it through the chain link fence to appear secured. USACE informed the DCR of the status of the lock via electronic mail on 22 August 2022. The entrance gate was observed to be in poor condition as the frame and chain link are warped and not flat (see Photograph 1). The USACE also observed the abandoned transformer on a utility pole located on Arsenal Street, which was previously identified during the 2021 soil cap inspection (see Photograph 2).

Photograph 1. Entry gate looking east; chain cut to allow USACE access to complete annual inspection activities (22 August 2022).

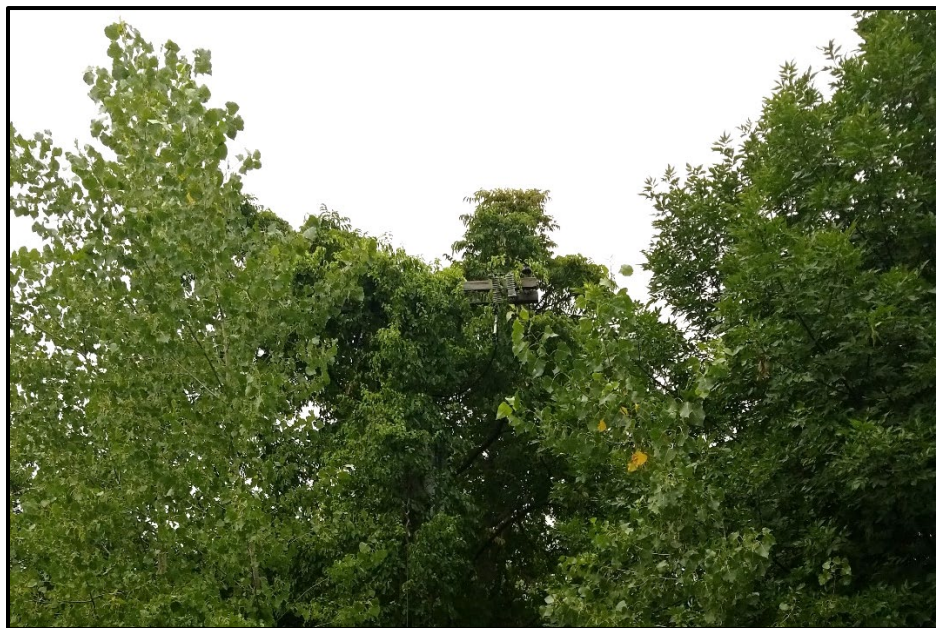
Photograph 2. Old power transformer on utility pole covered by vegetation. Appears to be more overgrown compared to 2021 inspection (22 August 2022).

1. Remove encroaching phragmites in eastern & southern swales
2. Remove cattails in the east/northeast section of the eastern swale.
3. Clear catch basin/drain of phragmites debris in a 3-5 ft radius.
4. Remove phragmites on east side of fence that abuts Greenough Blvd.
5. Remove small trees at gate located at northeast corner of property along Greenough, Blvd
6. Remove overhanging saplings, branches, & shrubs along the northwestern and northeastern swales.
7. Provide USACE with copy of main gate key or allow for daisy-chaining of USACE lock to allow for inspection access.
8. Assess condition of transformer on utility pole near the main gate.

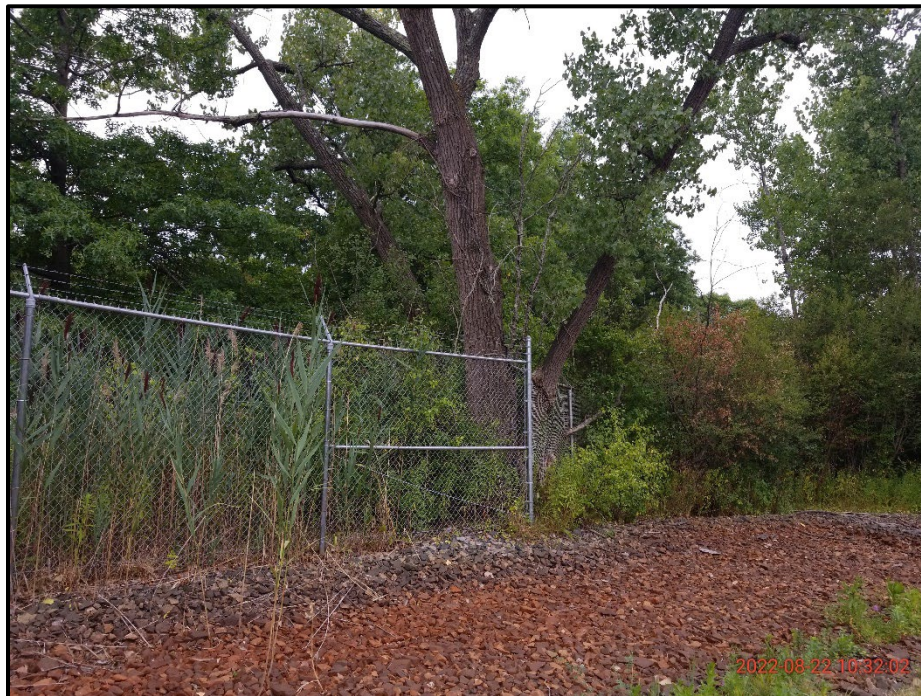
A large tree was observed growing through the perimeter fence at the southern end of the drainage swale adjacent to Greenough Boulevard (see Photograph 3). Ongoing construction of a biotechnology facility on Coolidge Avenue was noted looking north from the Site (see Photograph 4).

The drainage swale appeared to be mostly dry around the entirety of the cap. USACE observed dense phragmites growth along the eastern and southern portions of the swale (Photographs 3, 16, 17, 18, and 19).

Photograph 3. Southern swale looking south; large tree growing through perimeter fence (22 August 2022).

- Clear the catch basin grate and surrounding swale clear of debris and vegetation;
- Remove the trees growing in front of the Greenough Boulevard access gate.
- Trim back the vegetation that is overhanging the drainage swale.
- Remove the growth of *Phragmites*, cattails, and trees growing in or near the swales and treat with herbicide in accordance with the O&M plan.

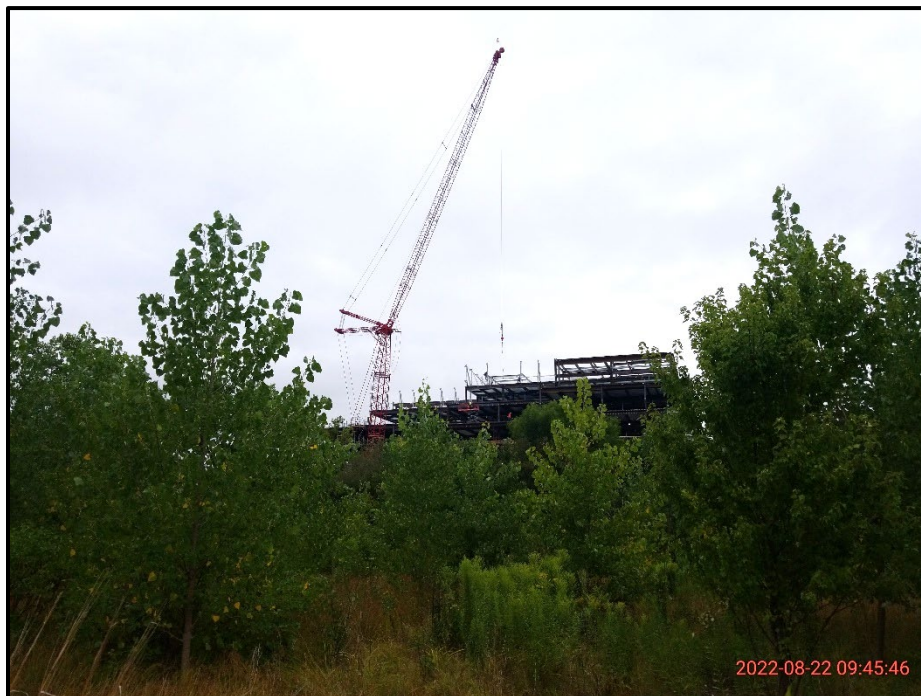
Photograph 4. Looking north; active construction of biotechnology facility (22 August 2022).

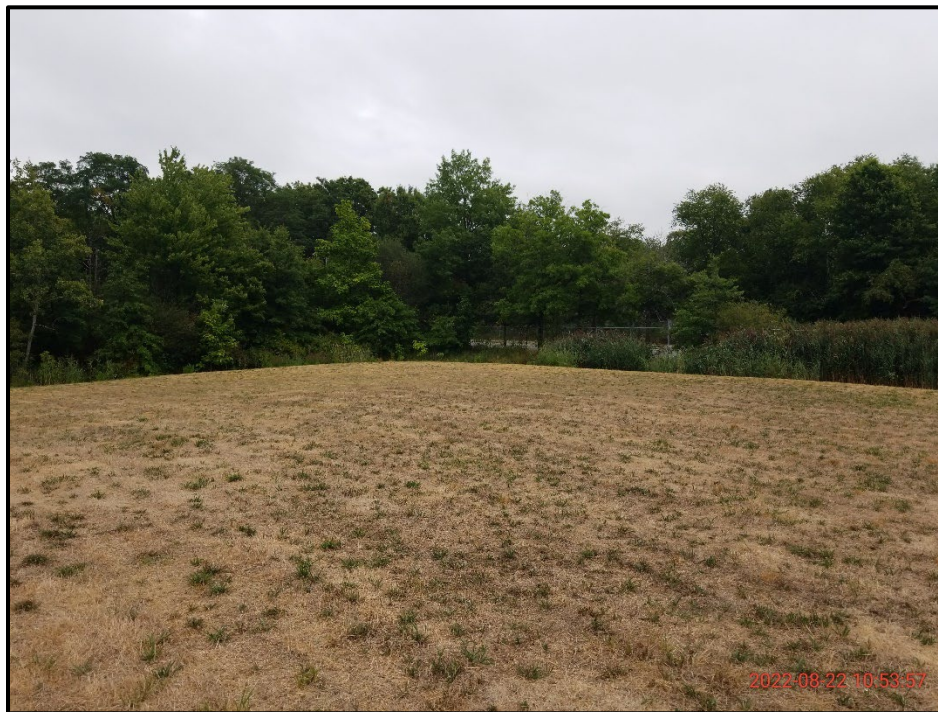
On 22 August 2022, the soil cap was observed to be intact (see Photographs 5, 6, and 7). The USACE did not note issues with the integrity of the soil cap, specifically there was no erosion, settlement, cracks, holes, or tire ruts in the soil cap. Also observed in 2021, USACE identified one minor depression at the foot of the eastern slope; however, the USACE believes it is too shallow to warrant remediation at this time (Photograph 8). The USACE also observed two small relic animal burrows on the soil cap (see Photograph 9). Both burrows were observed to be shallow and unused, therefore, they did not appear to require remediation at this time.

Photograph 5. Top of soil cap looking northeast; dry conditions and significant phragmites growth adjacent to Greenough Boulevard evident (22 August 2022).

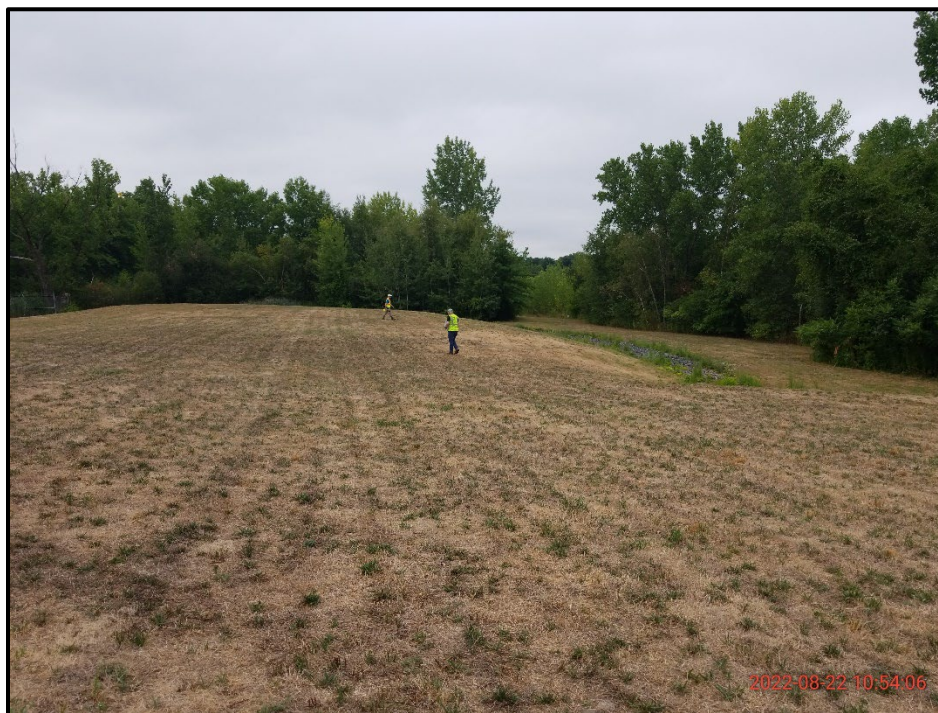
Photograph 6. Top of soil cap looking southeast (22 August 2022).

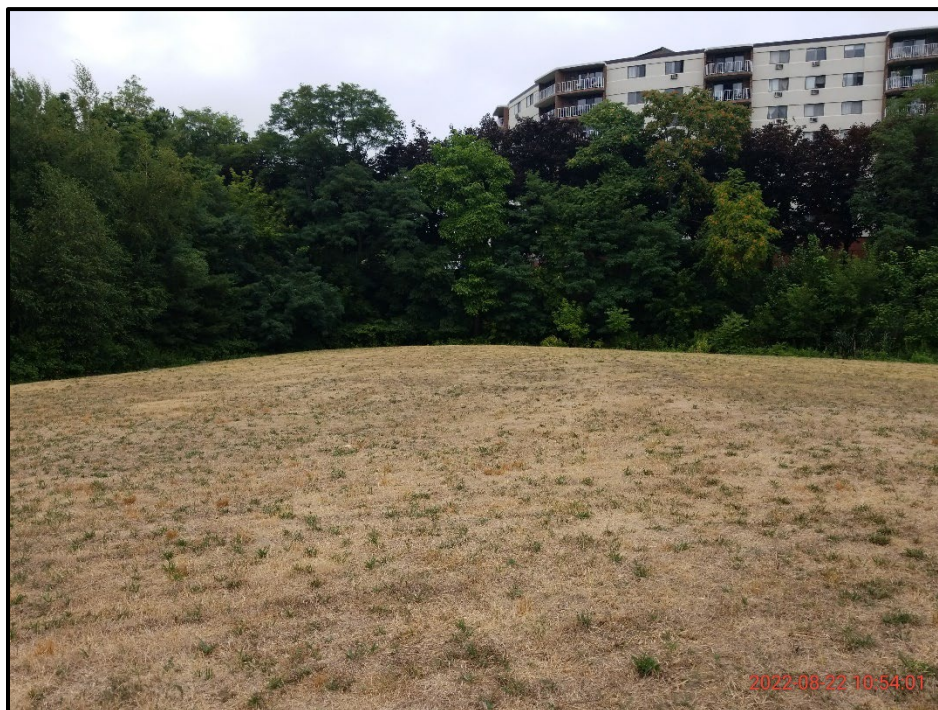
Photograph 7. Top of soil cap looking northwest (22 August 2022).

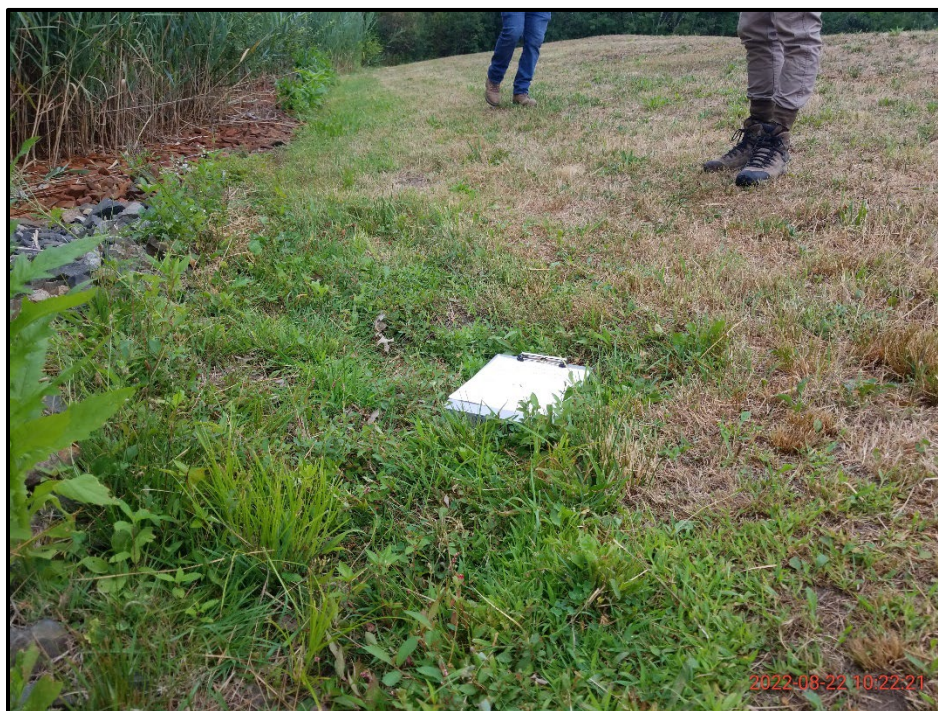
Photograph 8. Slight depression in the grass cover of the soil cap adjacent to the eastern drainage swale (22 August 2022).

1. SETTLEMENT (LOW SPOTS) Yes <input checked="" type="checkbox"/> No <input type="checkbox"/> Location (also indicate on map): Areal Extent: 2 ft x 2 ft Depth: 0.5 ft	- same minor depression observed in prior inspections along SW toe of cap, 0.5 ft deep - no action needed

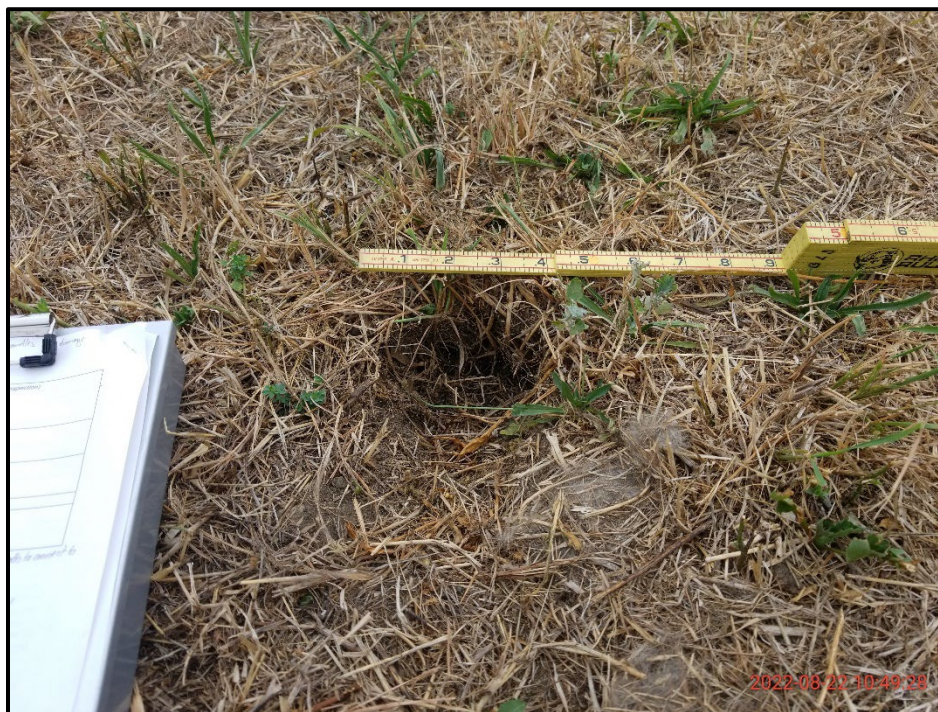
Photograph 9. One of two small relic burrows identified on the soil cap. (22 August 2022).

4. HOLES Yes <input checked="" type="checkbox"/> No <input type="checkbox"/> Location (also indicate on map): Areal Extent: 0.3 ft wide Depth: 0.5 ft Suspected Cause (e.g. rodent, other): rodent	- ^{active} burrow - one small burrow observed - relic (filled) burrows also observed - no action needed

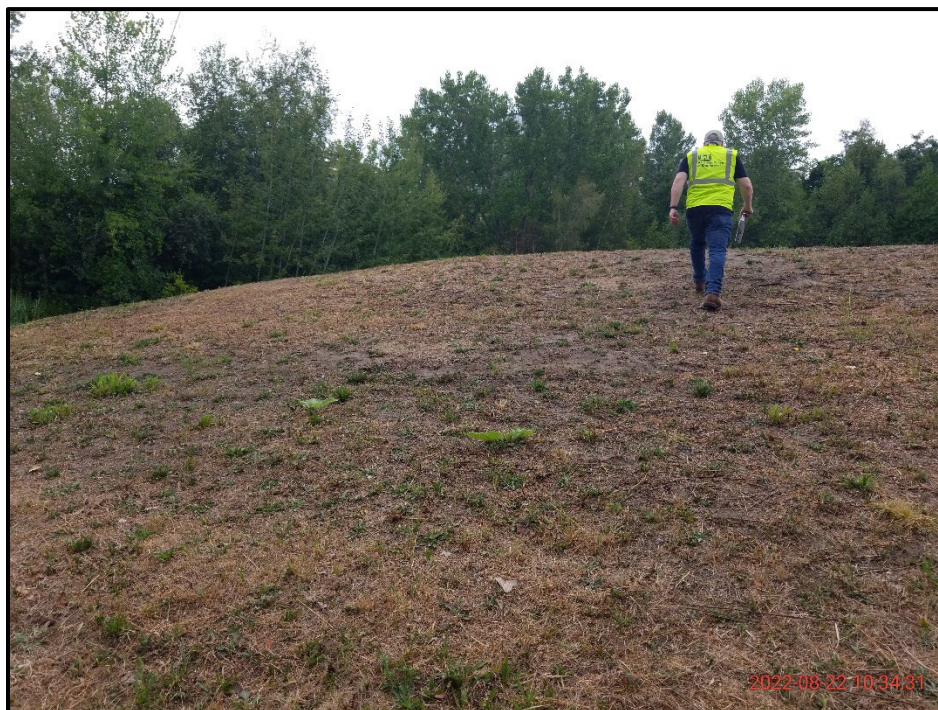
On 22 August 2022, the USACE observed the grass to be in healthy, but dry condition due to the ongoing drought. However, grass was observed to be sparse along the slope of the southern perimeter of the soil

cap (see Photograph 10). This area was previously noted in the 2021 soil cap inspection report. Although the area is dry, the bare patch appears to be comparable in size to the 2021 observation.

Photograph 10. Bare patches near crest of southern section (looking northwest) of the soil cap (22 August 2022).

2. SPARSE COVER AREAS? Yes <input checked="" type="checkbox"/> No <input type="checkbox"/> Location (also indicate on map): Length: 5 ft Width: 10 ft	- same area identified in SEP 2021 inspection - also minor bare patches in northern section after mowing

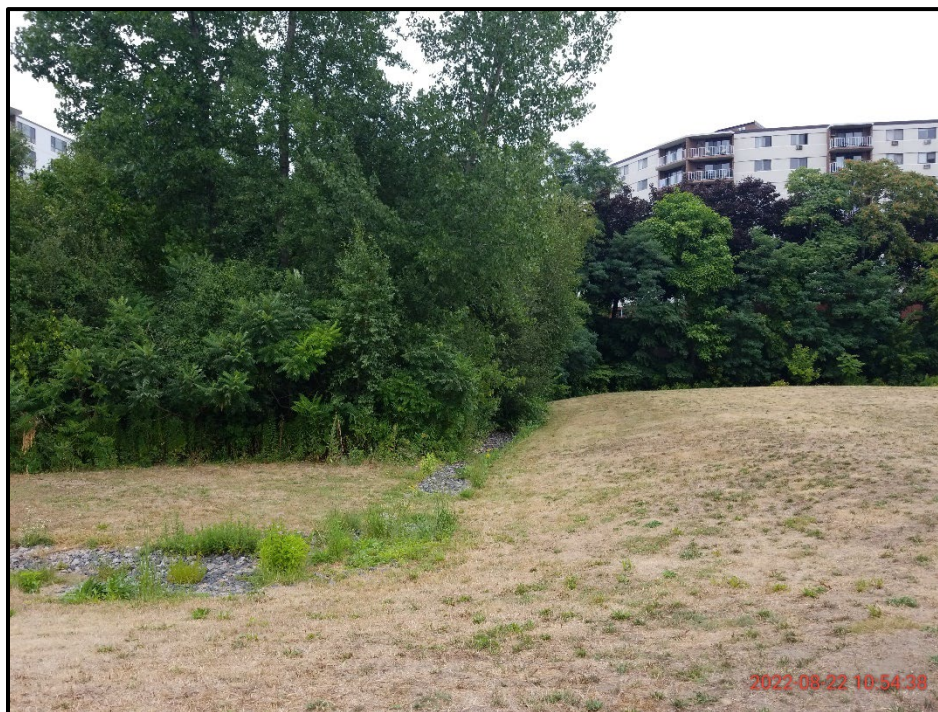
Along the northwest portion of the drainage swale, the USACE observed saplings, dead branches, and other vegetation overhanging the swale (see Photograph 11). Immediately adjacent to the riprap of the swale in this area, 2-3-inch-wide woody roots were observed (see Photograph 12).

Photograph 11. Overhanging vegetation along northwestern swale (22 August 2022)

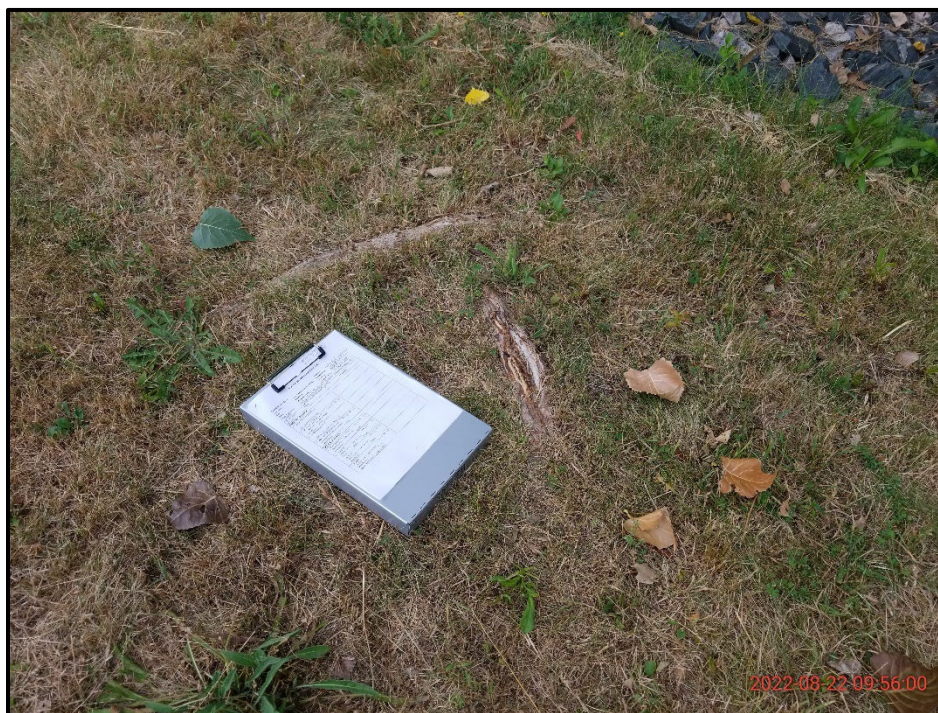
Photograph 12. Woody tree root (2-3 inches wide) observed adjacent to northwestern swale and overhanging vegetation noted in Photograph 1 (22 August 2022)

3. WESTERN SWALE Settlement: Yes <input type="checkbox"/> No <input checked="" type="checkbox"/> Location (also indicate on map): Ponding: Yes <input type="checkbox"/> No <input checked="" type="checkbox"/> Location (also indicate on map):	no settlement or ponding observed tree roots (up to 3 inch diameter) observed near swale and placed boulders; no action needed

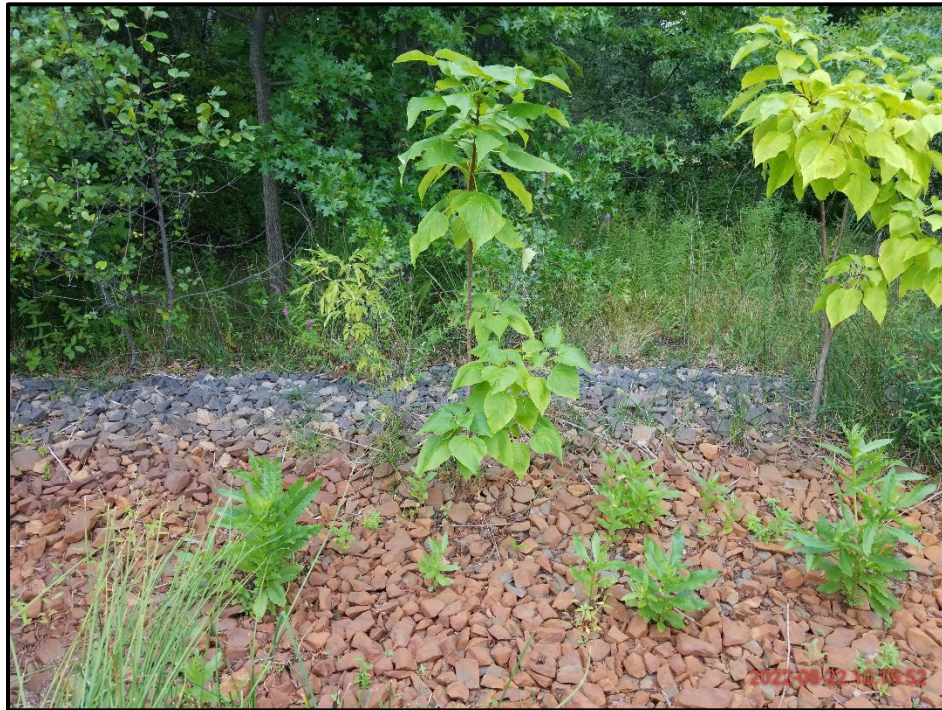
Along the northeast portion of the swale, the USACE observed that a tree had taken root (see Photograph 13) and cattails (see Photograph 14) are growing in the swale. Along this section of the drainage swale, looking south towards Greenough Boulevard, the USACE observed a tree/shrub encroaching on the swale (see Photograph 15).

Photograph 13. Northern drainage swale showing woody vegetation growth in swale riprap (22 August 2022)

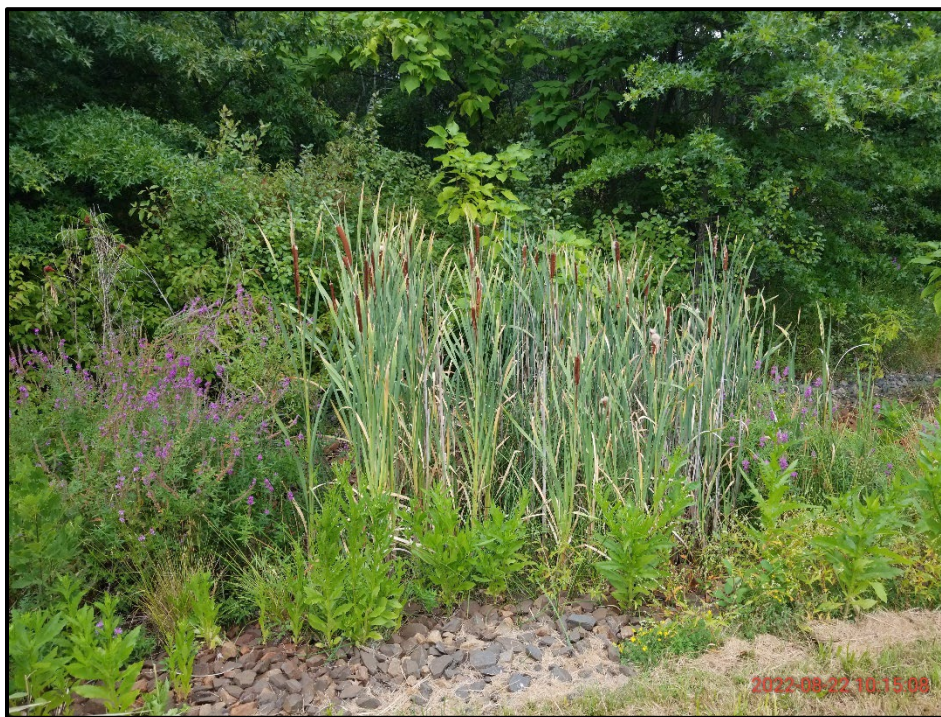
Photograph 14. Northern drainage swale looking northeast showing vegetation growth in swale (22 August 2022)

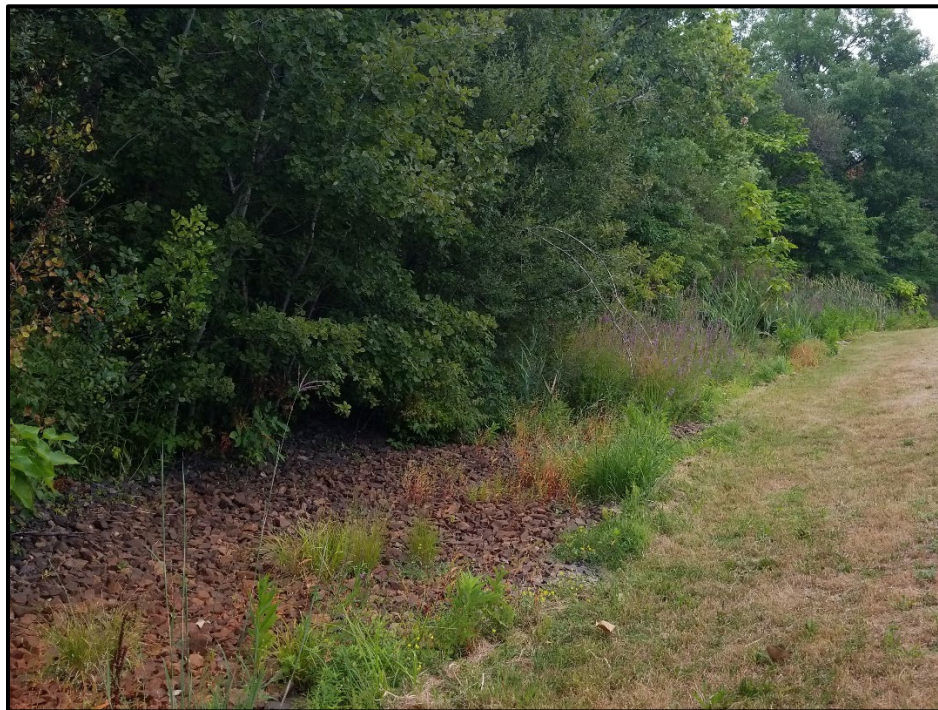
Photograph 15. Northern drainage swale with dense vegetation growth looking southwest towards Greenough Boulevard (22 August 2022)

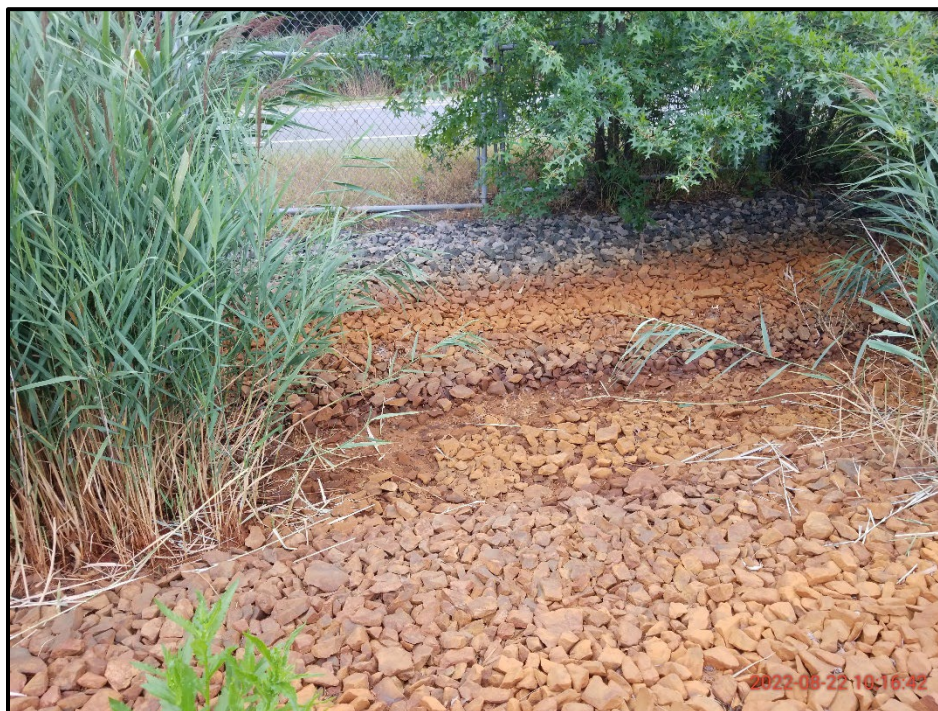
Similar to the 2021 inspection, the USACE observed the access gate located along Greenough Boulevard is blocked by trees growing along the edge of the eastern drainage swale (see Photograph 16).

Photograph 16. Phragmites growth in drainage swale and tree growth blocking exterior of northeastern gate adjacent to Greenough Boulevard. (22 August 2022).

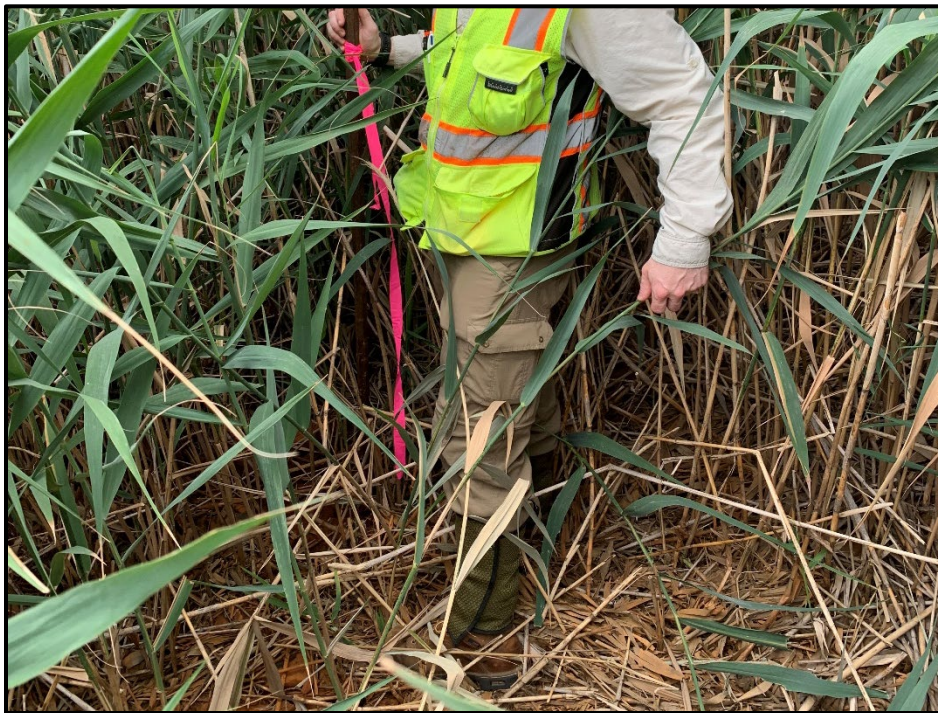
The catch basin was observed to be surrounded by dense phragmites growth. The USACE inspector attempted to clear the catch basin drain with a metal pry bar (see Photograph 17).

Photograph 17. Dense phragmites growth in eastern swale over the catch basin (22 August 2022).

- catch basin is partly to mostly clogged w/ heavy vegetation and sediment
 - USACE attempted to clear catch basin grate w/ pry bar found on site

No maintenance was performed during this reporting period by the USACE with the exception of the effort made to clear the catch basin using the pry bar as shown in Photograph 17.

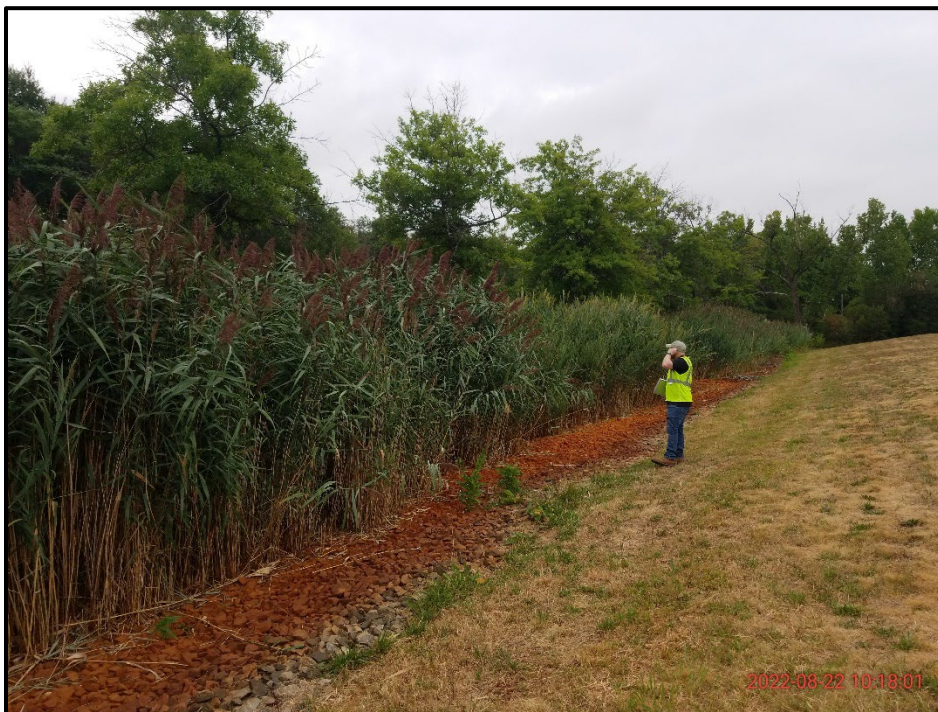
Photograph 18. Dense phragmites growth along eastern unmaintained drainage swale (22 August 2022).

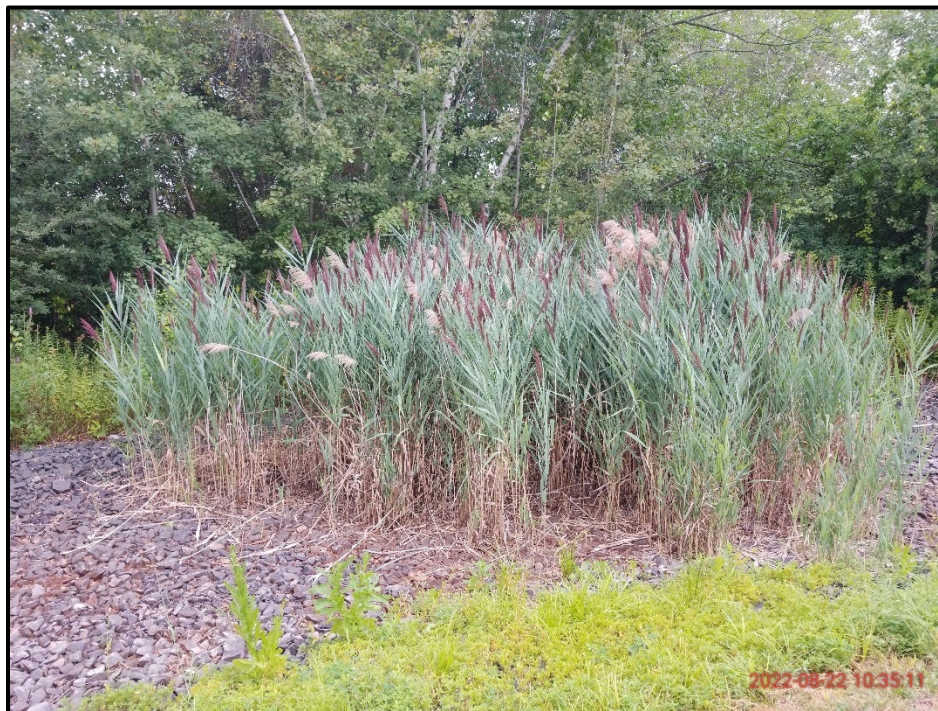
Photograph 19. Phragmites growth in the southern section of the drainage swale looking southwest (22 August 2022).
