September 2023

## **2023 SOIL COVER MONITORING AND MAINTENANCE SUMMARY REPORT**

**GSA PROPERTY DO1MA001902  
670 ARSENAL STREET  
WATERTOWN, MASSACHUSETTS**

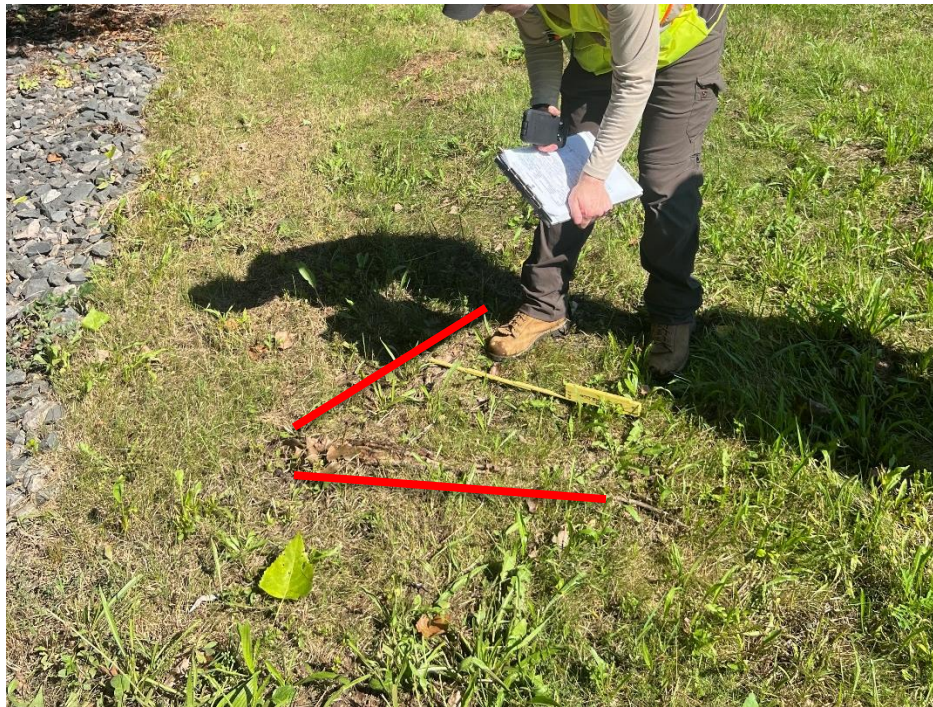
Along the northwest portion of the drainage swale, USACE observed saplings, dead branches, and other vegetation overhanging the swale (see Photograph 3). Immediately adjacent to the riprap of the swale in this area, 2-4-inch-wide woody roots were observed (see Photographs 1 and 2).

**Photo 1:** Looking northwest along northwestern swale; note tree roots (2-4 inches in diameter) encroaching cover.

- Remove the growth of *phragmites*, cattails, and trees growing in or near the swales and treat with herbicide in accordance with the O&M plan. This includes removal of saplings from northeastern swale and eastern swale by gate to Greenough Blvd and the visible tree roots adjacent to northwestern swale.
- Remove encroaching *phragmites* to allow for inspection and repair of check dams and to maintain a functional catch basin
  - The drainage swale's check dams retain water for several days after precipitation events and should be cleaned. During regular mowing activities and swale maintenance completed by MassDCR, the check dams and receiving catch basin

Recommendations: ① Remove encroaching phragmites to allow for inspection and repair of check dams and to maintain a functional catch basin.  
② Remove saplings from northeastern swale and eastern swale by gate to Greenough Blvd.  
③ Remove visible tree roots (2-4 in. diam) from cap adjacent to northwestern swale.  
④ Consider seeding bare patches with appropriate grass seed to prevent future erosion.

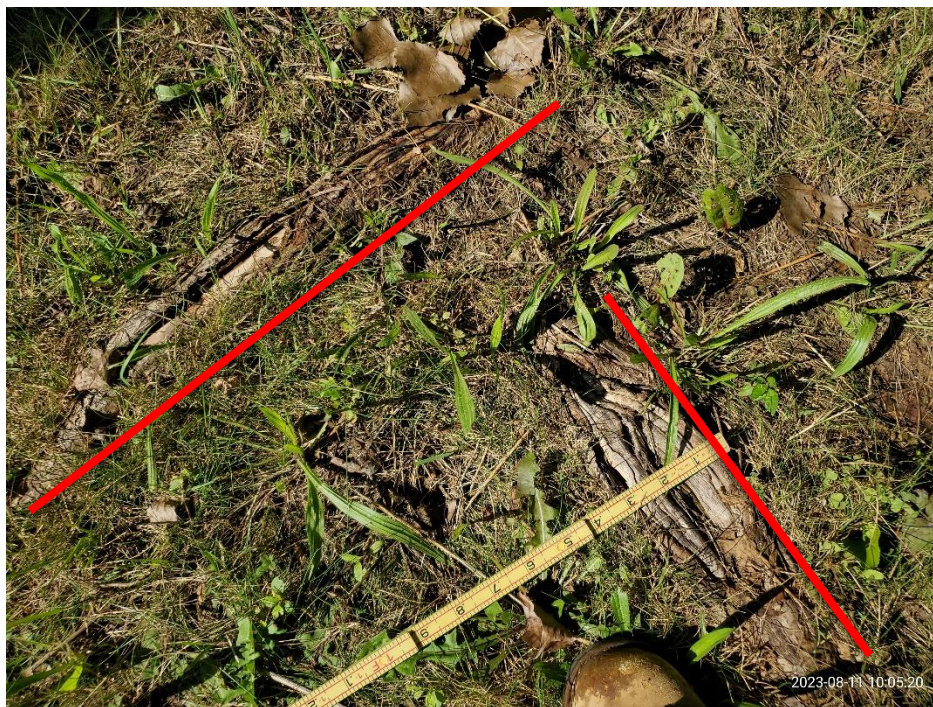
**Photo 2:** Closeup of tree roots (2-4 inches in diameter) encroaching cover shown in Photo 1.

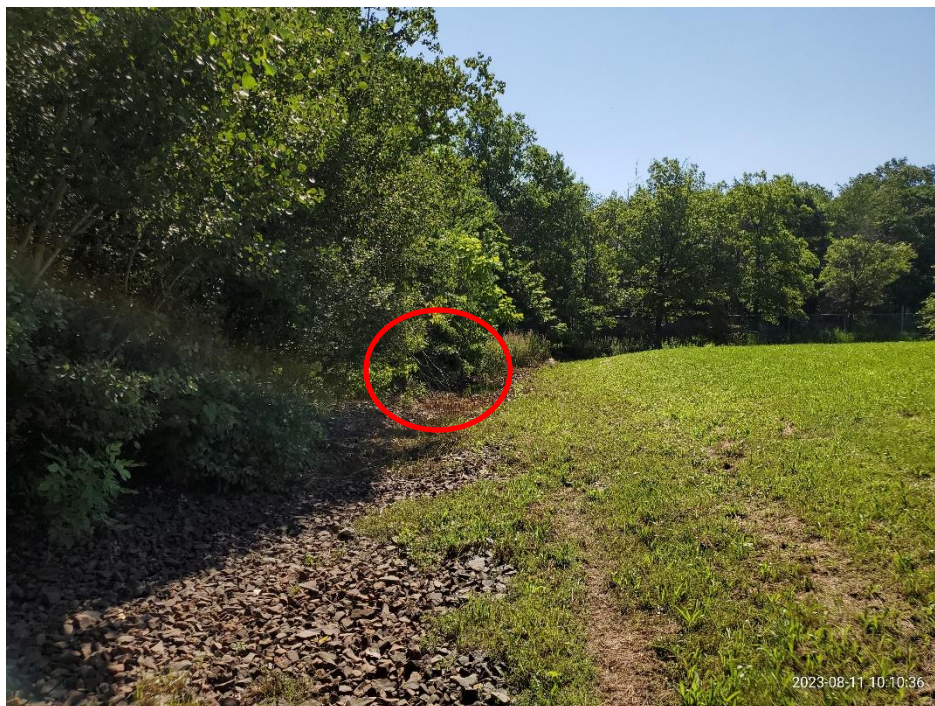
**Photo 3:** Looking southwest along northern swale towards Greenough Blvd; note overhanging saplings, dead tree limbs in center of image, and vegetation growth throughout riprap. Dead grass (potentially tracks from mowing) noted on the right side of the photo but minor and no indication of resulting erosion/cap exposure noted.

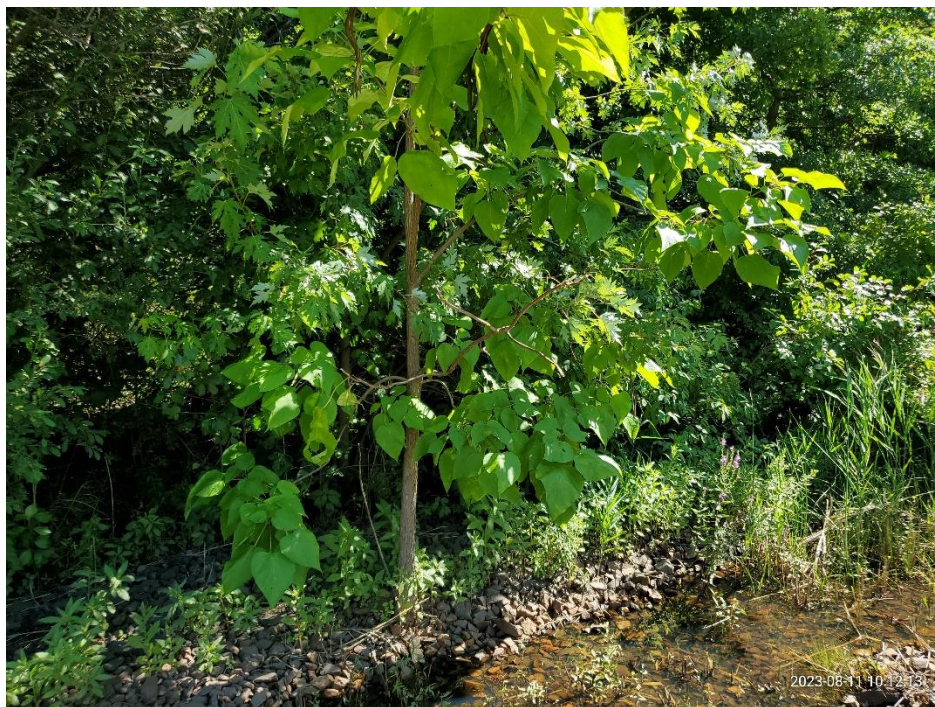
Along the northeast portion of the swale, USACE observed that a tree had taken root (see Photograph 4) and cattails are growing in the swale (see Photograph 5).

**Photo 4:** Northern swale looking northeast; note woody vegetation growth in riprap.

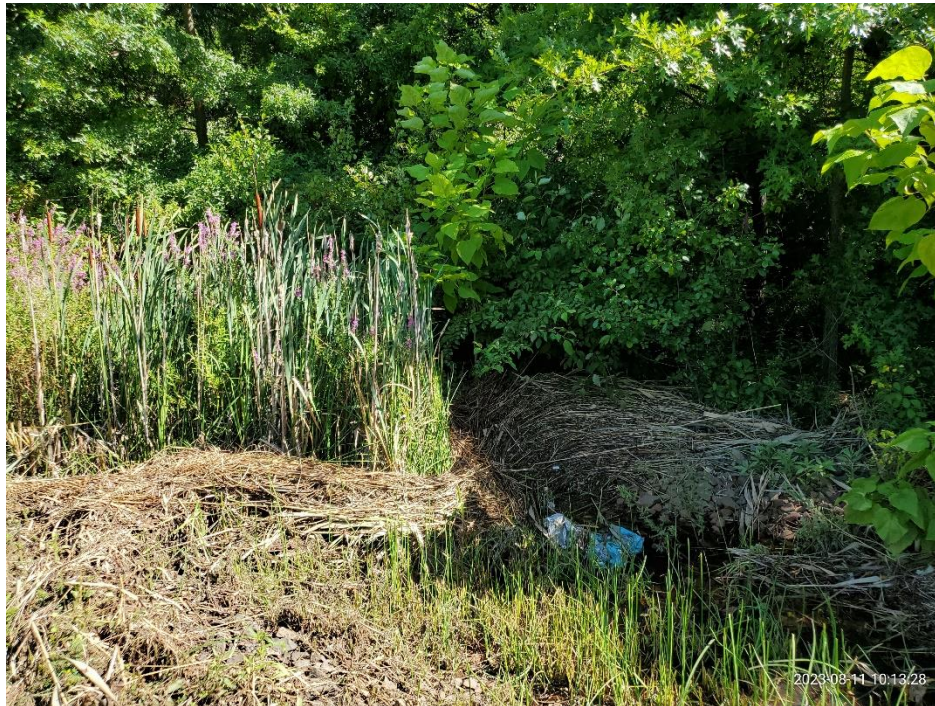
**Photo 5:** Northern swale looking northeast; note vegetation (cattails, purple loosestrife, etc.) growth in riprap.

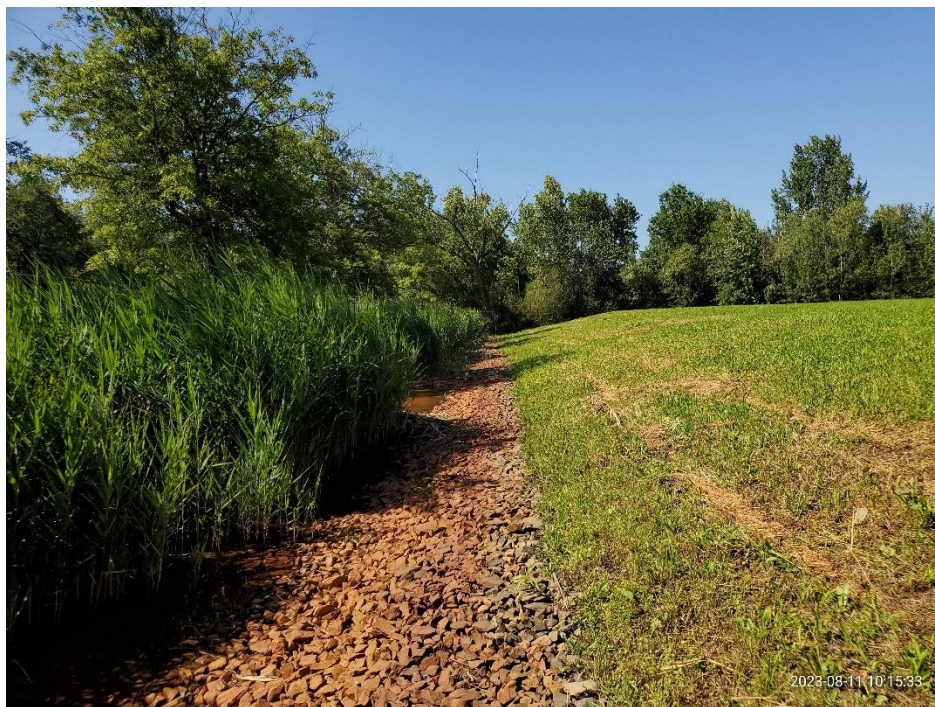
USACE observed the access gate located along Greenough Blvd. is blocked by trees growing along the edge of the eastern drainage swale (see Photograph 7). Growing along the swale adjacent to Greenough Blvd., USACE also observed dense *phragmites* (see Photograph 6).

**Photo 6:** Looking southeast along eastern swale; note *phragmites* growth in riprap obscuring property fence along Greenough Blvd. and partly wet condition of swale.

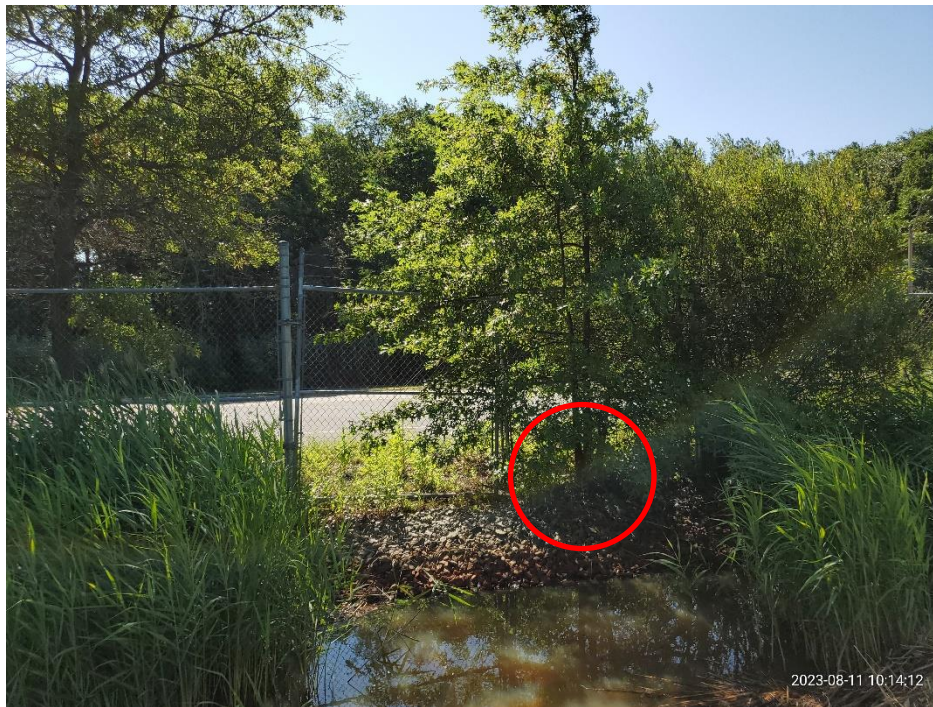
**Photo 7:** Eastern swale looking southeast towards Greenough Blvd; note *phragmites* growth in riprap, tree growth along northeastern gate in center, and wet condition of swale.

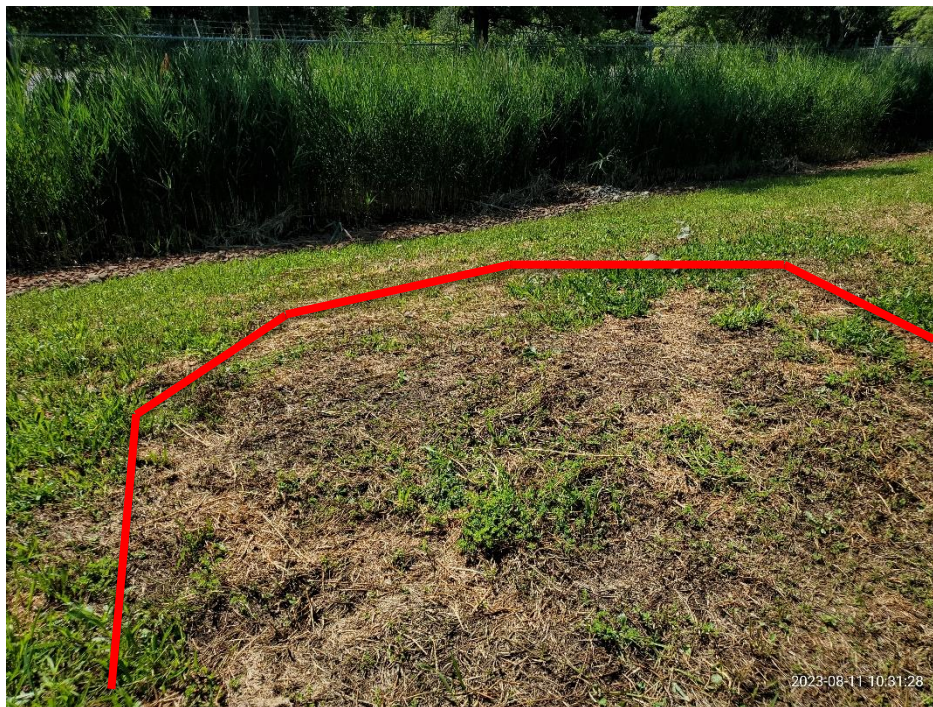
USACE observed the grass to be in healthy condition. Grass was observed to be sparse along the slope of the southern perimeter of the soil cap (see Photograph 8). This area was previously noted in the 2022 soil cap inspection report. The bare patch appears to be comparable in size to the 2022 observation.

**Photo 8:** Soil cap looking south towards Greenough Blvd.; note bare patches.

- Consider seeding bare patches with appropriate grass seed to prevent erosion.
- Mow remaining long grass identified in Photograph 12 of Attachment A.

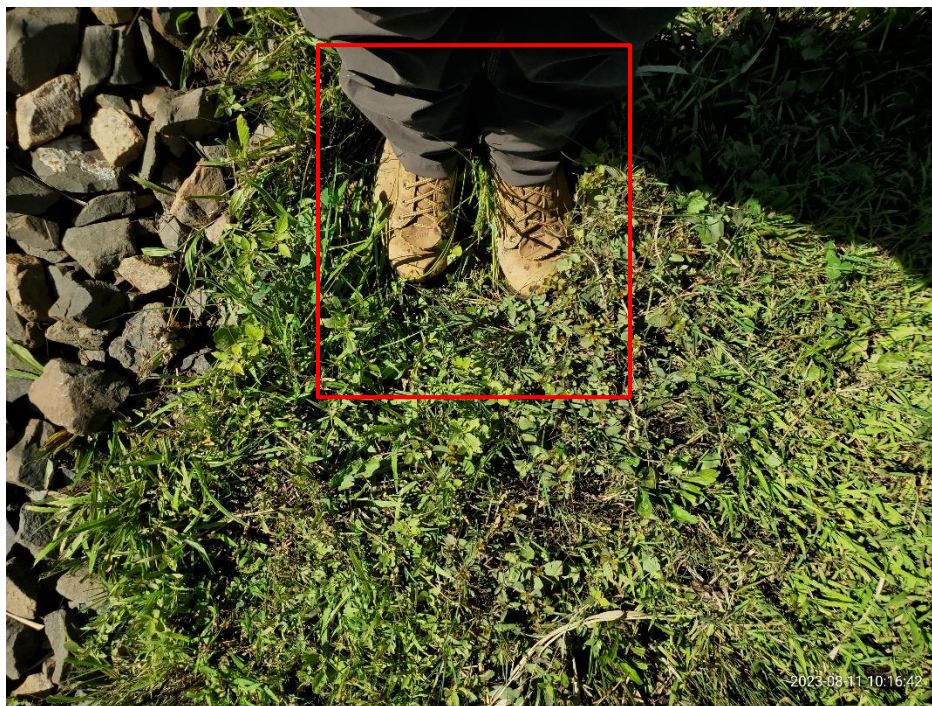
During the inspection, the soil cap was observed to be intact (see Photographs 13, 14, and 15). USACE did not note issues with the integrity of the soil cap. No erosion, settlement, cracks, holes, or tire ruts in the soil cap were noted. Also observed in 2022, USACE identified one minor depression at the foot of the eastern slope; however, USACE believes it is too shallow to warrant action at this time (Photograph 9).

**Photo 9:** Eastern swale at soil cap toe looking down; note slight depression in grass cover consistent with prior inspections; boots are in depression; continue to monitor.

1. SETTLEMENT (LOW SPOTS) Yes <input checked="" type="checkbox"/> No <input type="checkbox"/> Location (also indicate on map): Areal Extent: <u>2x2 ft</u> Depth: <u>0.5 ft</u>	• same minor depression observed in prior inspections • continue to monitor, but no action needed

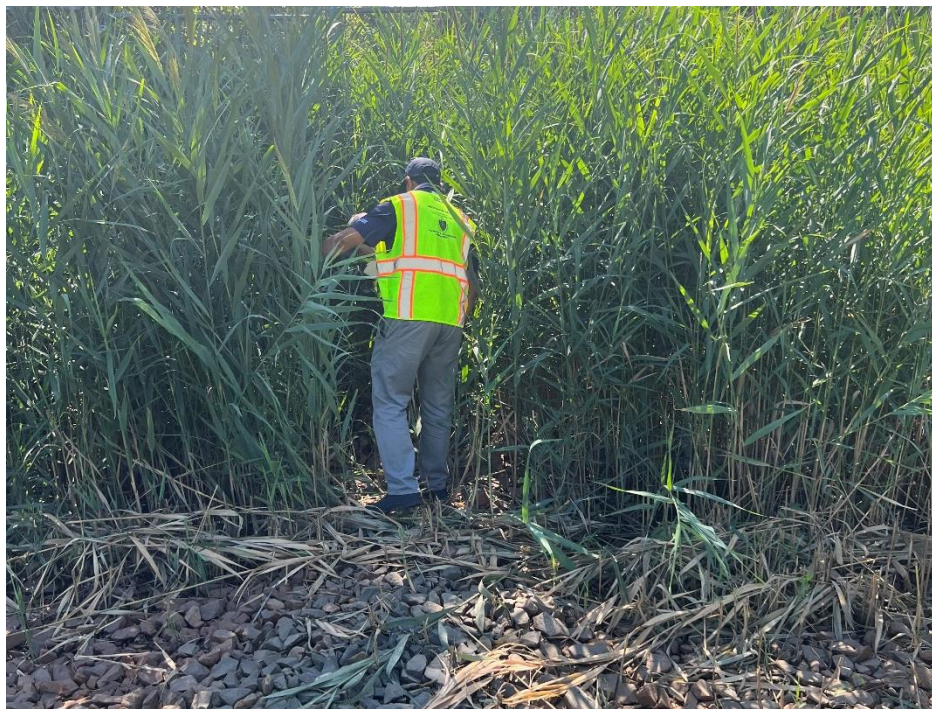
**Photo 10:** Eastern swale looking southeast towards Greenough Blvd; note dense *phragmites* growth; DCR Engineer and USACE Inspector (obscured) are assessing flow after clearing catch basin drain.

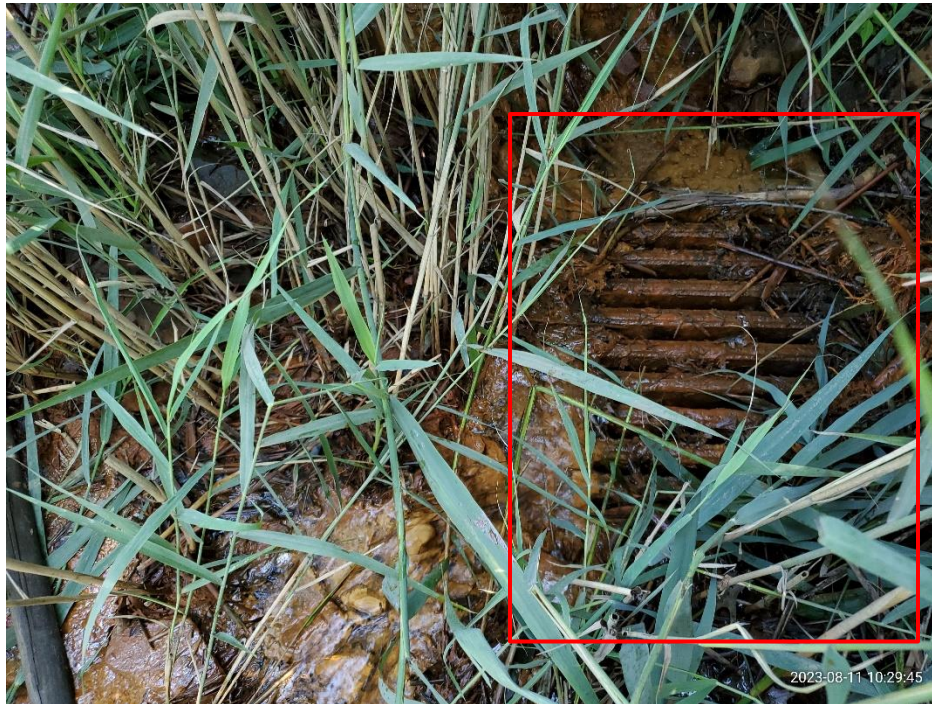
Similar to the 2022 inspection, the catch basin was observed to be surrounded by *phragmites* growth. USACE located the catch basin grate and found the surface water pooled in the swale to be actively draining (see Photographs 10 and 11). Although the majority of the swale was observed to be dry, standing water was observed behind check dams along Greenough Blvd.

**Photo 11:** Eastern swale near Greenough Blvd. looking down at catch basin drain cover; note heavy vegetation and sediment buildup; drain functioned well once cleared.

should be inspected and serviced if needed, including camera inspection of the pipe under Greenough Blvd.

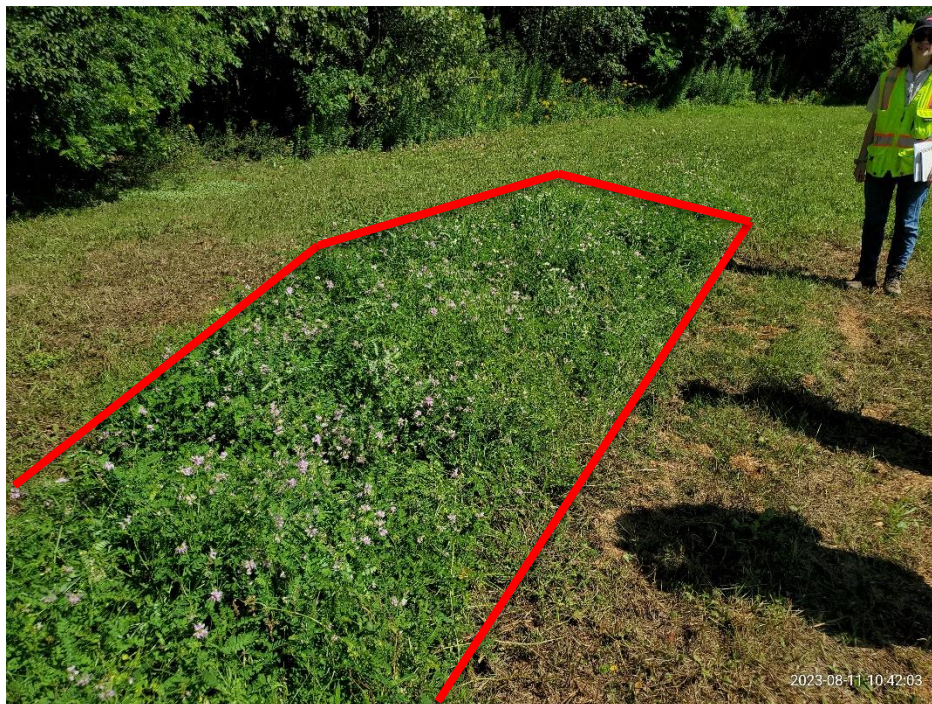
**Photo 12:** Entrance path near southwestern swale looking north; note unmown section of grass; may have been rabbit nesting area but should be mowed.

ITEM	REMARKS
<b>VEGETATIVE COVER</b>	
1. AVERAGE GRASS HEIGHT <u>0.2 ft</u> Estimated Height (inches): <u>1-3 in.</u>	• mowing performed before inspection • small overgrown area should be cleared • may be rabbit nesting area

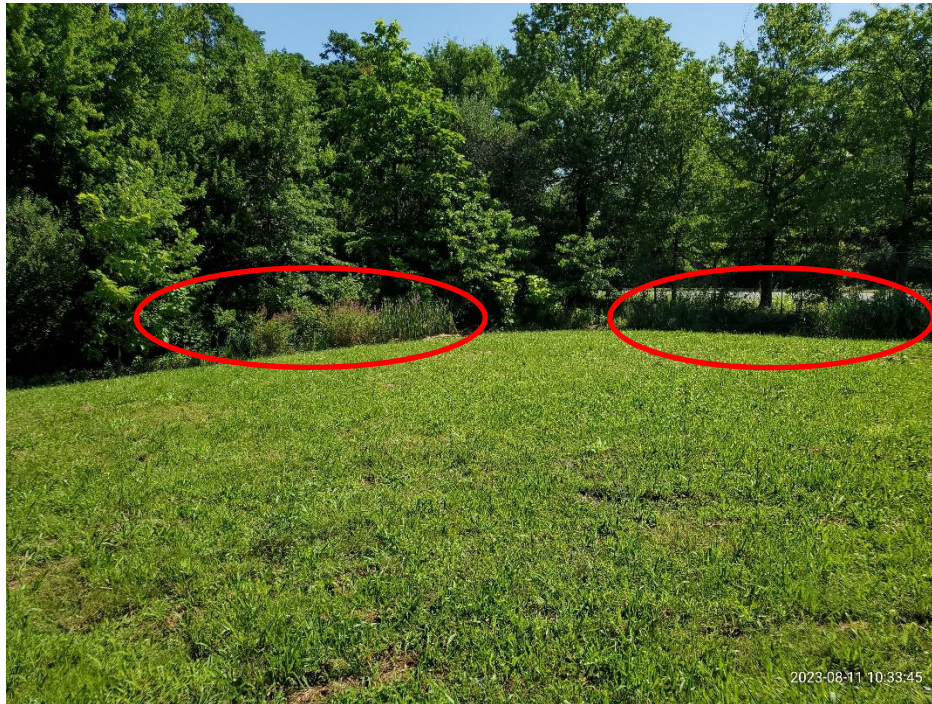
**Photo 13:** Top of soil cap looking northeast; note good condition of grass cover and *phragmites* growth in center of photo and to the right in the eastern swale along Greenough Blvd.

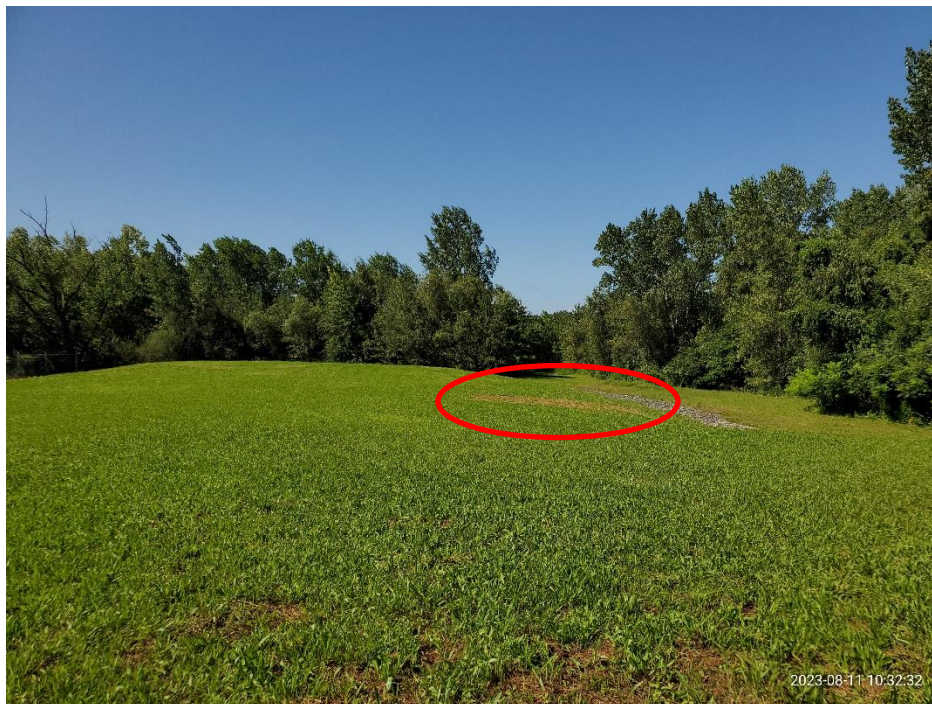
**Photo 14:** Top of soil cap looking southeast; note good condition of grass cover and minor bare spot in center of image.

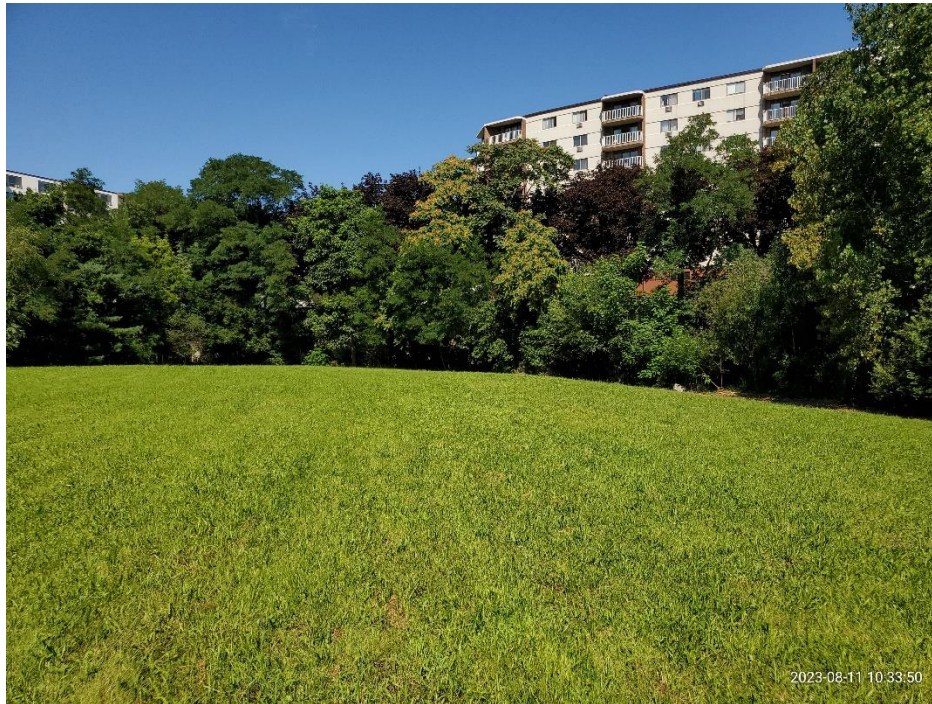
**Photo 15:** Top of soil cap looking northwest; note good condition of grass cover.

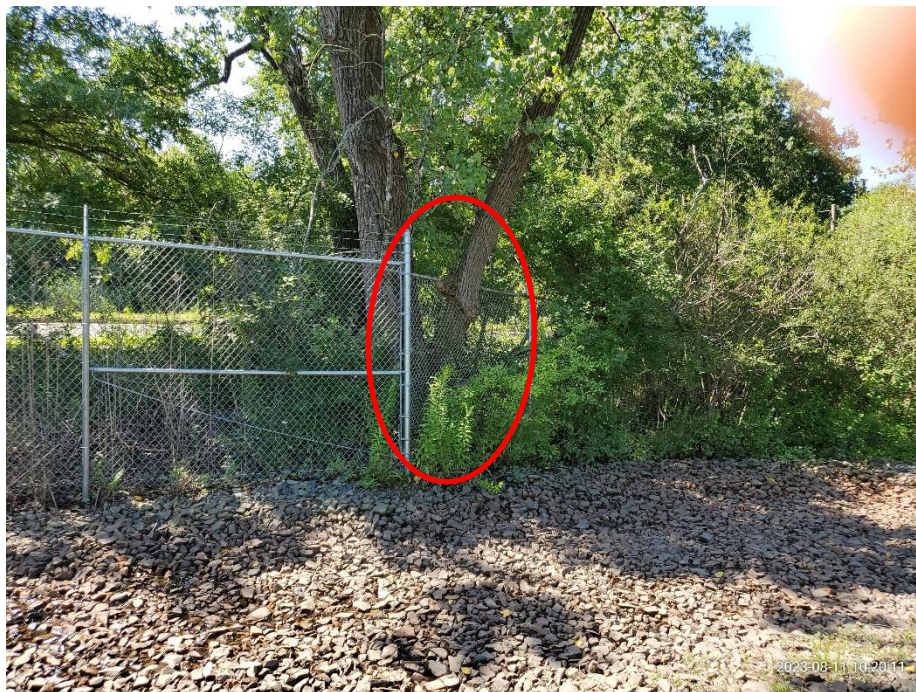
A large tree was observed growing through the perimeter fence at the southern end of the drainage swale adjacent to Greenough Blvd. (see Photograph 16). Ongoing construction of a biotechnology facility on Coolidge Avenue was noted looking north from the site.

**Photo 16:** Southern swale looking south; note large tree growing through fence along Greenough Blvd and dry condition of swale in this section.

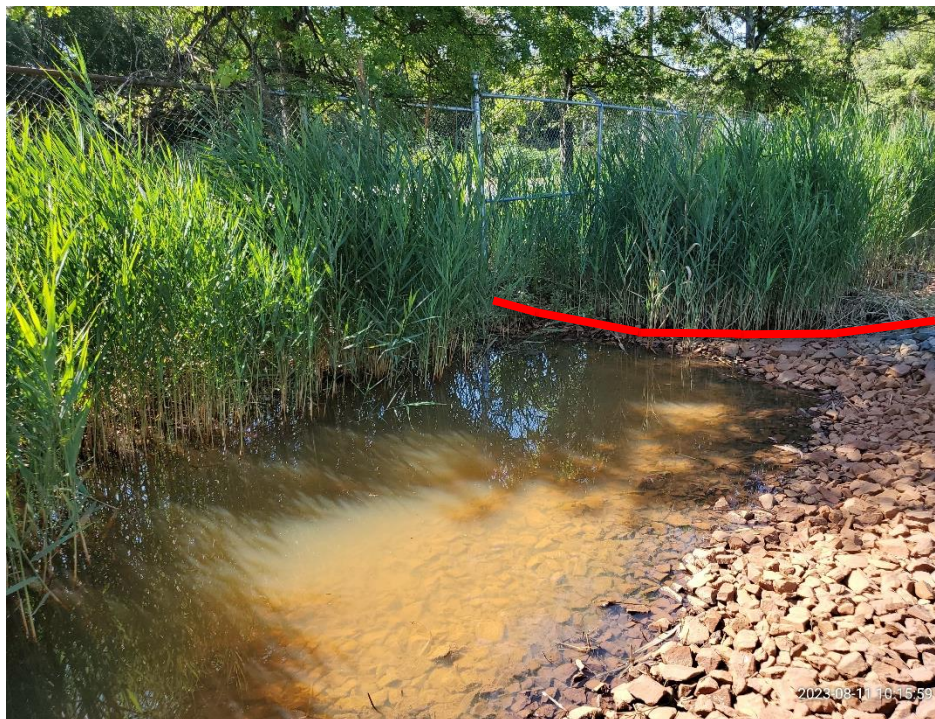
**Photo 17:** Eastern swale looking south towards Greenough Blvd.; note *phragmites* growth and apparent slumping of check dam that may differ from designed condition.

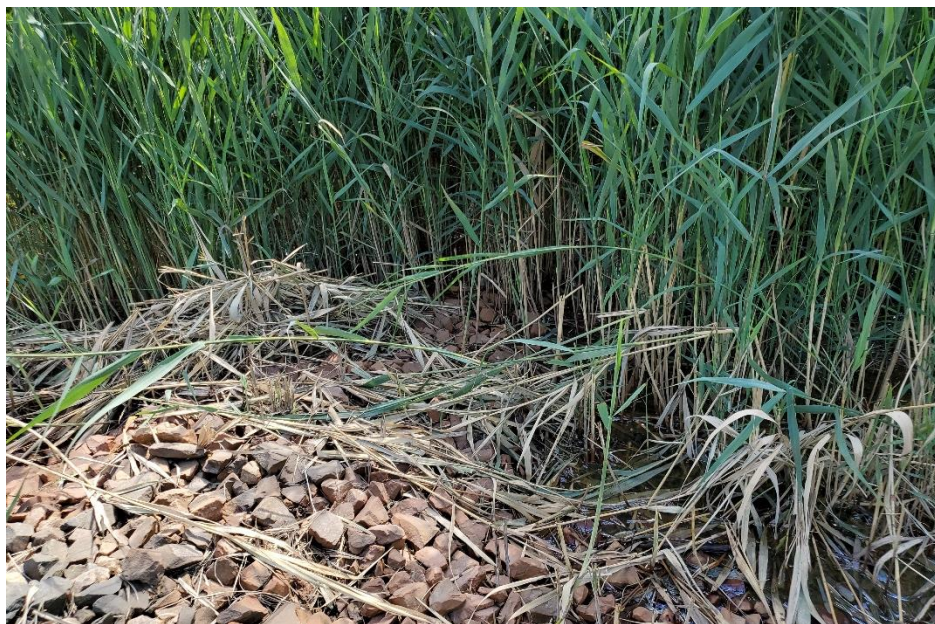
**Photo 18:** Eastern swale looking southeast towards Greenough Blvd; note heavy vegetation obscuring inspection of check dam; vegetation should be cleared to ensure check dams function as designed.

4. INVASIVE TREES/SHRUBS? Yes <input checked="" type="checkbox"/> No <input type="checkbox"/> Location (also indicate on map): Areal Extent: <u>300x10 ft</u> Height: <u>6-8 ft</u>	• phragmite growth along Greenough Blvd should be cleared to better assess slumping in check dams • tree roots 2-4 in. diameter northwestern edge of cap
<b>GROUND SURFACE</b>
