SECOND FIVE-YEAR REVIEW REPORT FOR WATERTOWN ARSENAL - D01MA0019 Project 02

MIDDLESEX COUNTY, MASSACHUSETTS

U.S. Army Corps of Engineers New England District

EXECUTIVE SUMMARY

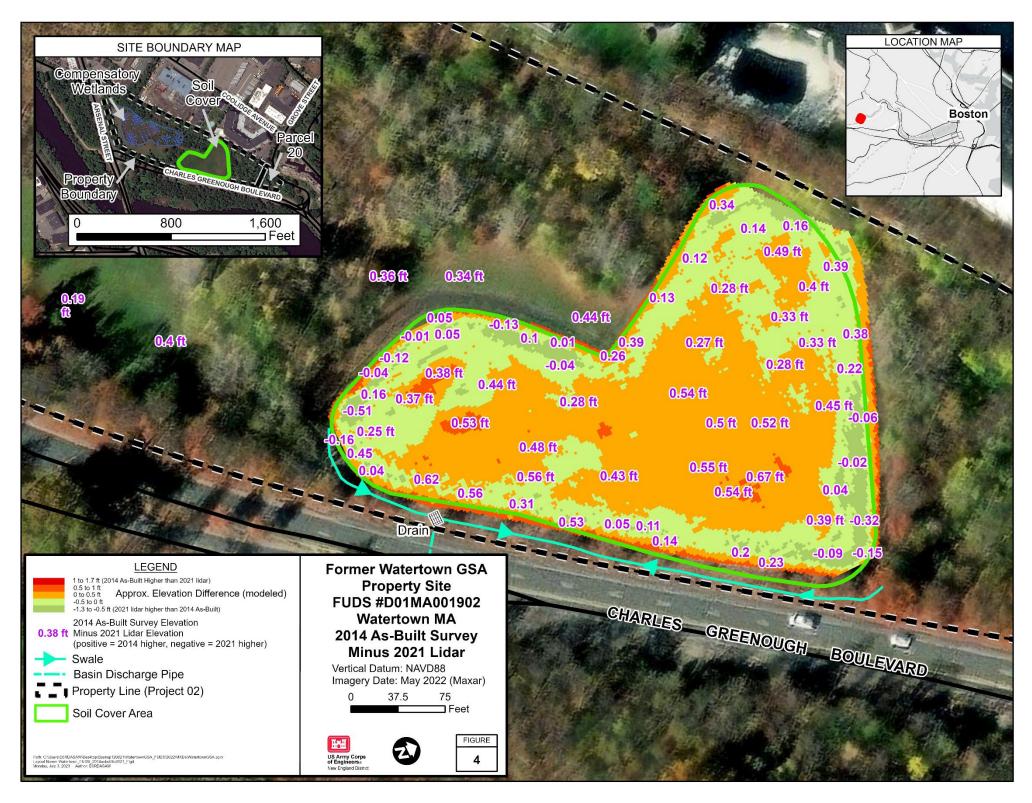
Figure 4. Elevation change (delta) from 2014 to 2021 (Holmberg & Howe, 2014, USGS, 2021, Maxar, 2022). Positive values show potential Soil Cover settlement.

The soil cover integrity has not been compromised, but several depressions noted in the DEM analysis were found during the inspection (Appendix E). Soil cover inspections show no indication that the filter fabric warning layer has been penetrated by burrowing rodents or any other potential intrusive threats and no active or abandoned animal burrows were noted during the 31 March 2023 FYR site walk.

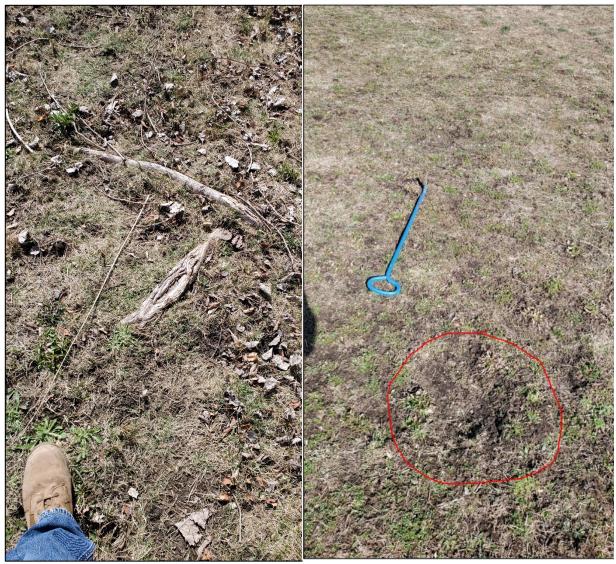
Photo 4. Daylighting Tree Roots. Uncertain if these are under or outside the membrane.

- Observed potential disturbances such as the tree roots should be removed and noted during annual inspection and maintenance activities.
- Six Swale Check Dams The drainage swale's check dams retain water for several days after precipitation events and should be cleaned. During regular mowing activities and swale maintenance completed by MassDCR, the check dams and receiving catch basin should be inspected and serviced if needed, including camera inspection of the pipe under Greenough Blvd.

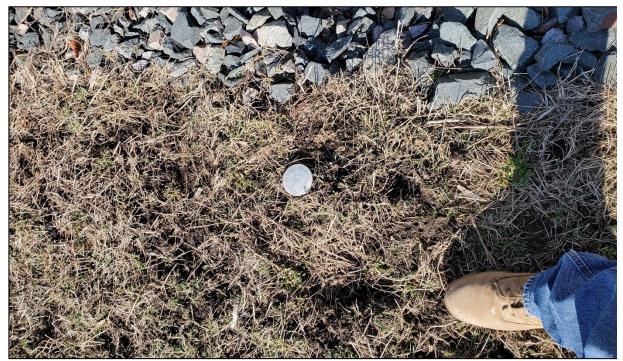
Photo 6. Disk marking soil cover extent. Over half of the original disks appear to be missing.

- Elevation Verification Complete a site survey by a MA licensed surveyor to better quantify low spots in the swale and to confirm the soil cover perimeter. At the time of the survey, survey markers should be replaced where necessary.

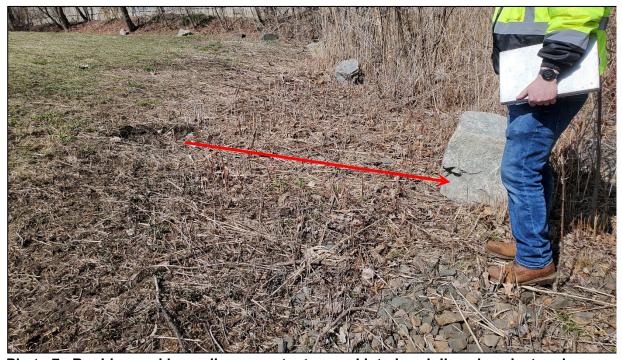
Photo 7. Boulder marking soil cover extent moved into brush line since last review.

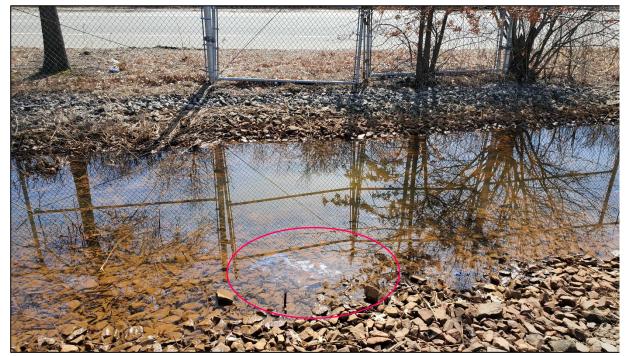
Photo 8. Possible depression in Eastern Drainage Swale at the northeast gate, limiting surface water discharge. No inlet grate or off-site discharge pipe present. Sheen in center foreground appears to be organic material, not petroleum.

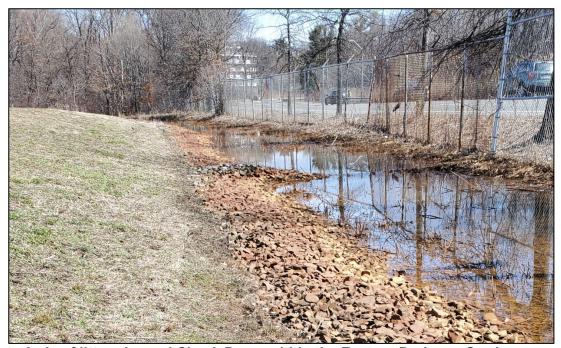
Photo 9. Leaf litter-clogged Check Dams within the Eastern Drainage Swale; some check dams appear to have had stone material removed from their centers to expedite surface water discharge.

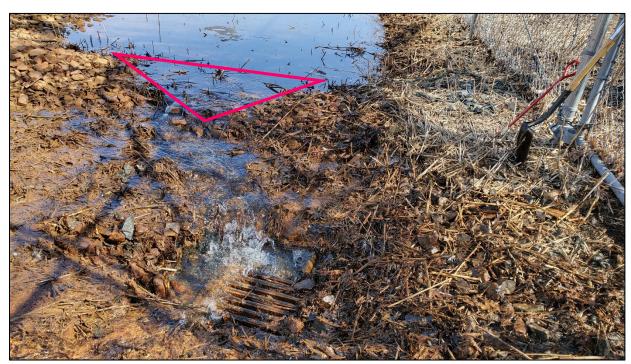
Photo 11. Eastern Drainage Swale Inlet Grate at the end of the site inspection. Triangle shows material removed from the upstream check dam, looking northeast.

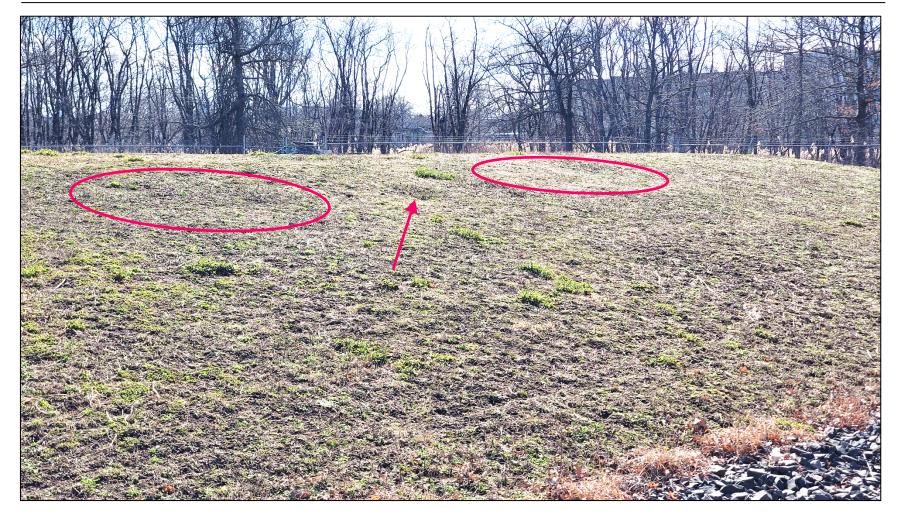
Photo 12. Southwestern portion of the soil cover showing minor depressions less than 0.9 feet deep. View is looking east.

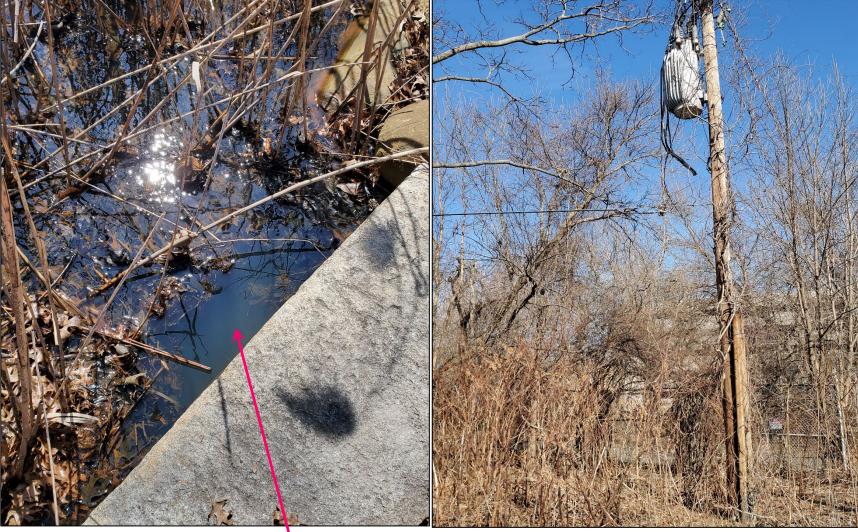
Photo 13. GSA stormwater discharge pipe (submerged) southeast of Greenough Boulevard.
