# Camden and Rockland Water Company

**File No.:** 199201515

**City and State:** West Rockport, ME

## MITIGATION SITE FIELD DATA FORM

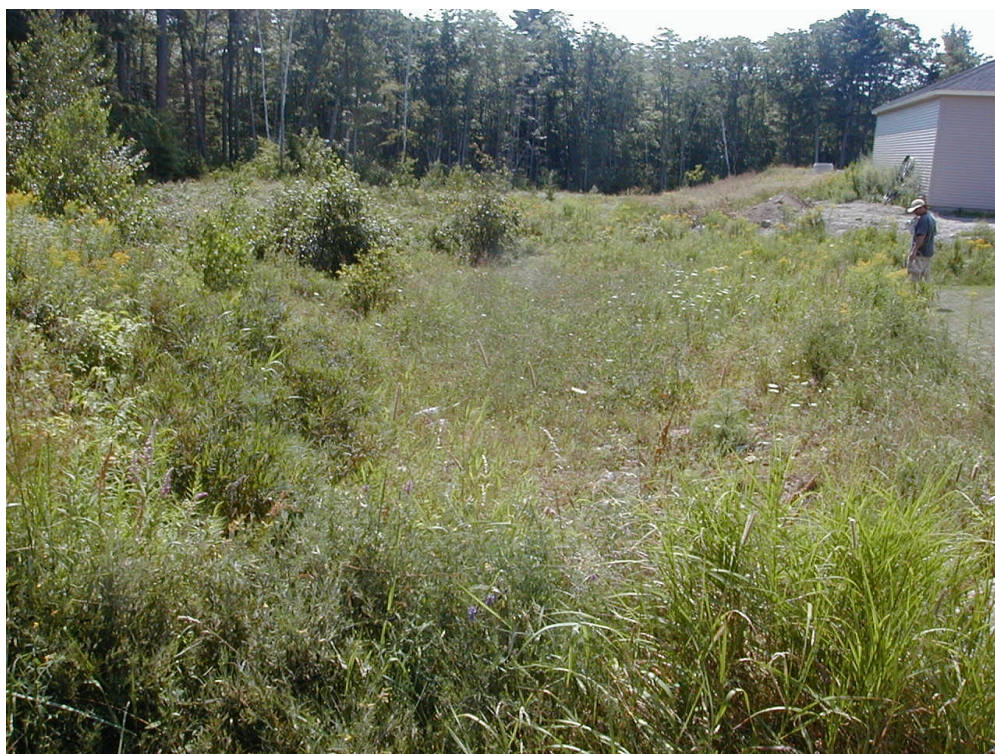
The restoration part of this mitigation site consists of two small parcels of land. The site to the west of the buildings is very dry and lacks wetland vegetation in much of the site. The soil is sandy and has high chroma. Erosion at the site has been stabilized. This parcel looks more like a watercourse than a wetland. Its primary function is sediment trapping. *Alnus rugosa* volunteers were growing up to ten feet high.

Looking south from culvert outlet into wetland restoration area R-4, most of which is not wetland

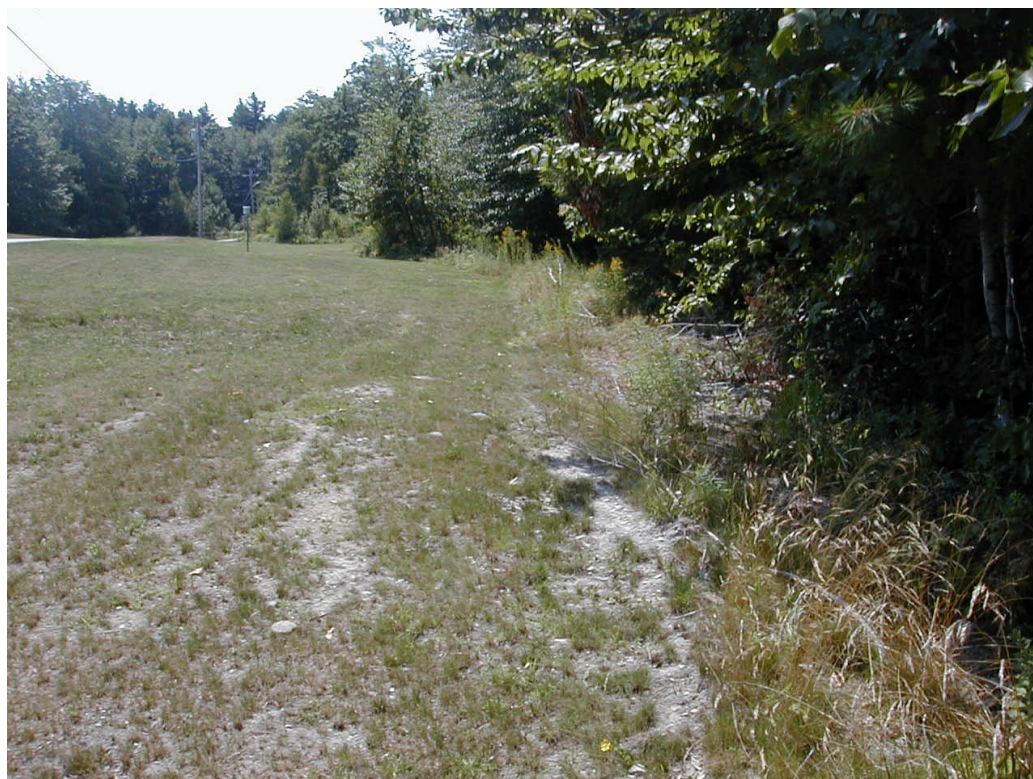
The site east of the buildings is a five-foot wide strip. It is wetter than the western part and contains a mix of wetland plants and grasses. The site is supposed to be continuous but is split into two parts as the result of mowing and what appears to be a bulldozed or plowed section that has left the ground bare.

Looking south at wetland restoration area R-1—the mowed area, which is not wet.

A silt fence should be removed from the eastern site. Nonnative plants should not have been planted for mitigation purposes. A springtime visit should be conducted to determine if these sites have wetland hydrology earlier in the growing season.
