Waste Management – Phase 7

File No.: 199200602

MITIGATION SITE FIELD DATA FORM

199200602 Waste Management Phase 7 Norridgewock, ME 8/15/02

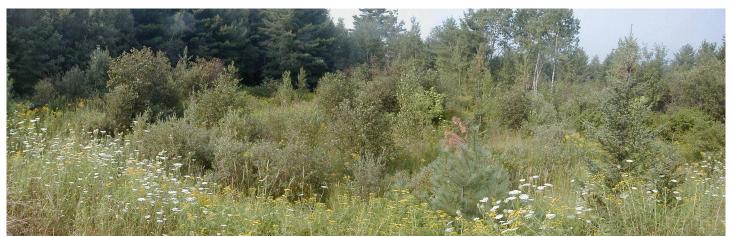
Site 1 is the most open of the sites, characterized by a PEM wetland.

Site 1 from near the road to the northeast looking south, southwest, and west. Edge of site is at the tree line.

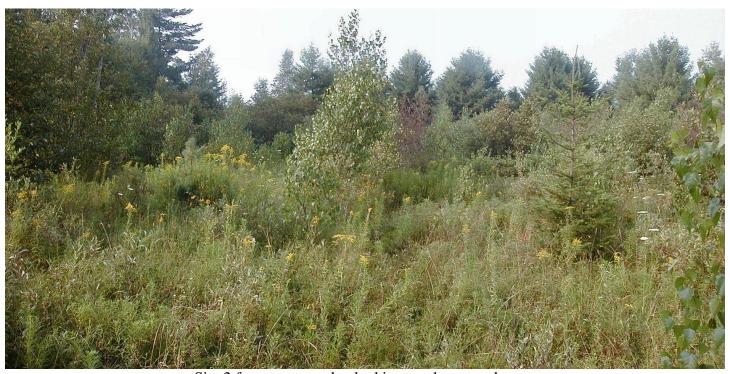
Site 2 was scrub shrub over pit and mound topography. Approximately half the site was a wetland, while the other half contained dry upland vegetation. The dividing line is the first contour line away from the road (see map).

Site 2 from eastern edge looking southwest and west. Edge of site is at the treeline in the distance and at the far left.

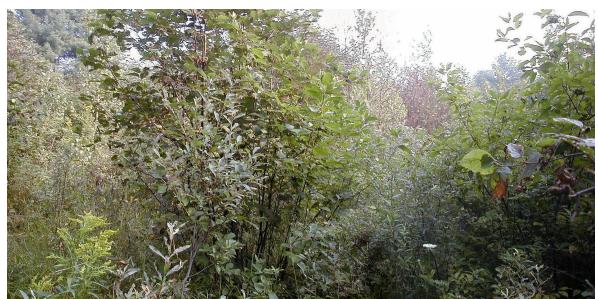
Site 2 looking northeasterly from the southwestern edge. Everything visible except the large *Pinus strobus* on the far left and in the distance on the right is in the site.

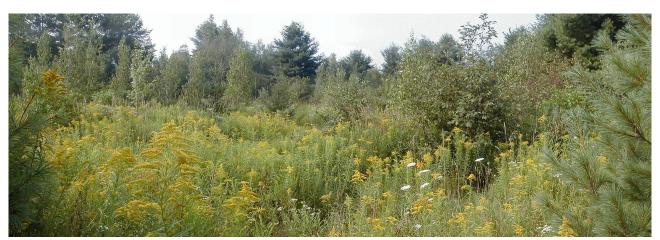
Site 3 consisted of a wet meadow and an emergent section. Shrubs for Sites 2 and 3 were 10-20" high.

Site 3 from the midpoint of the slope down to the northern edge of the site looking south and west. Site extends to the trees in the distance.

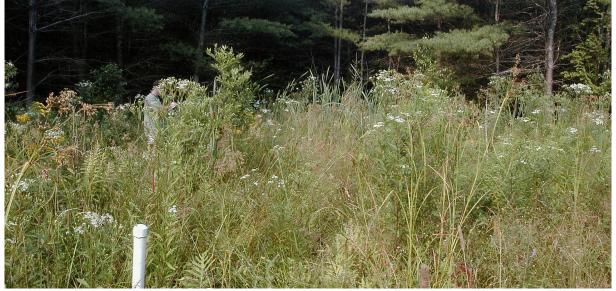
A siltation fence was found in Site 3 that needs to be removed. This site was also probably smaller than it was supposed to be; it was missing a narrow section that was supposed to connect the northern lobe to the rest of the site (see map), and it was missing a narrow band that was supposed to extend up towards the road.

Site 3 looking west and northwest from the western lobe of the site. Note the monitoring well in the foreground and the edge of the site (dark area). The person is at the edge of the mitigation site.

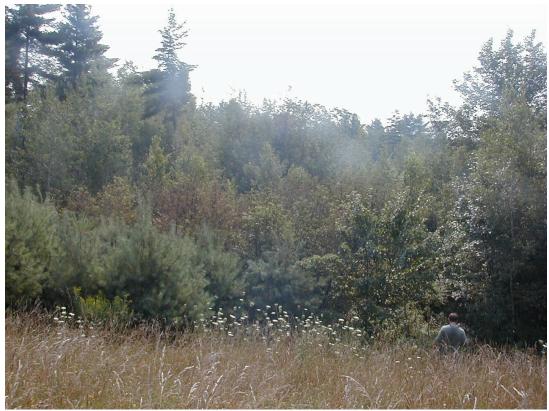
We looked in vain for Site 4 of this site. We found a monitoring well in the place where the site was supposed to be, but dense woody debris and the maturity of living trees suggested that this site had been wetland prior to the time when the mitigation site was built. Further discussion with the consultant in charge of this site is in order to determine if this site, which represents approximately 20% of the site, was built.

Site 4 (possibly) looking southeast from the top of a steep slope.

The site seemed too mature to be a mitigation site but it is in the correct location and is certainly wet.

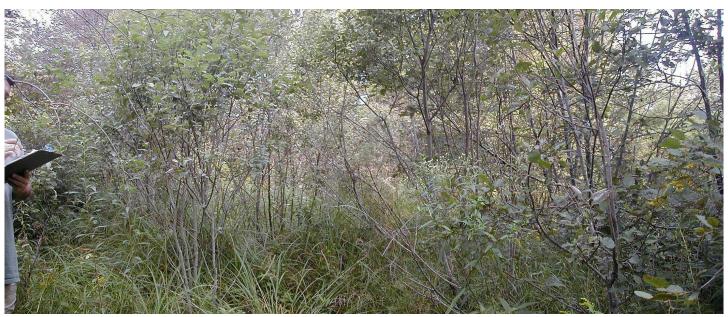
Site 5 looking easterly from west side.

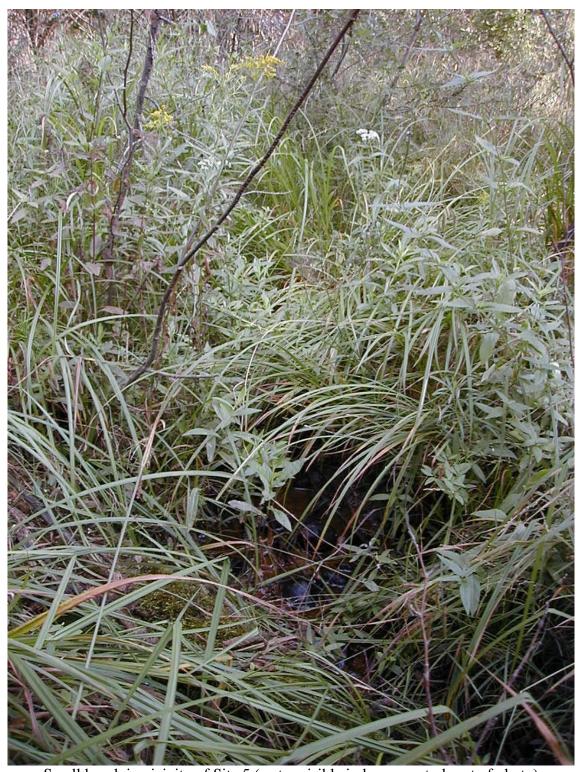
Small brook in vicinity of Site 5 (water visible in lower central part of photo)
