**MAINE DEPARTMENT OF TRANSPORTATION**

**2006 POST - CONSTRUCTION  
MONITORING REPORT:**

**Woodstock, Route 26 Stream Relocation Project**

**Year 1 of 5**

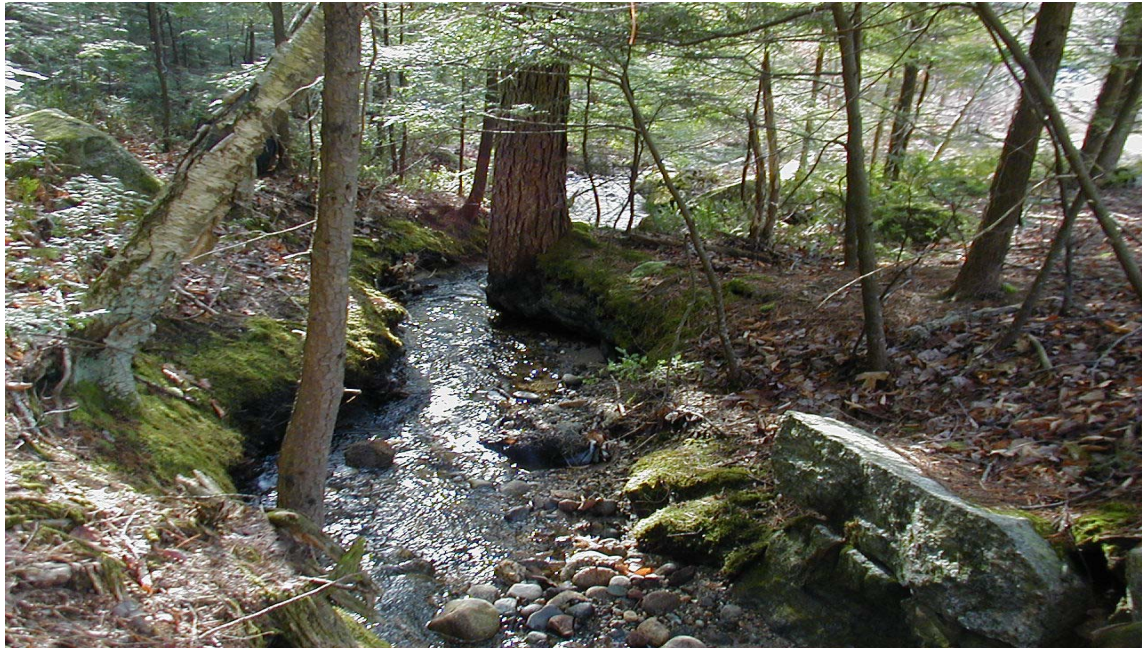
Existing channel at Station 2+345 L

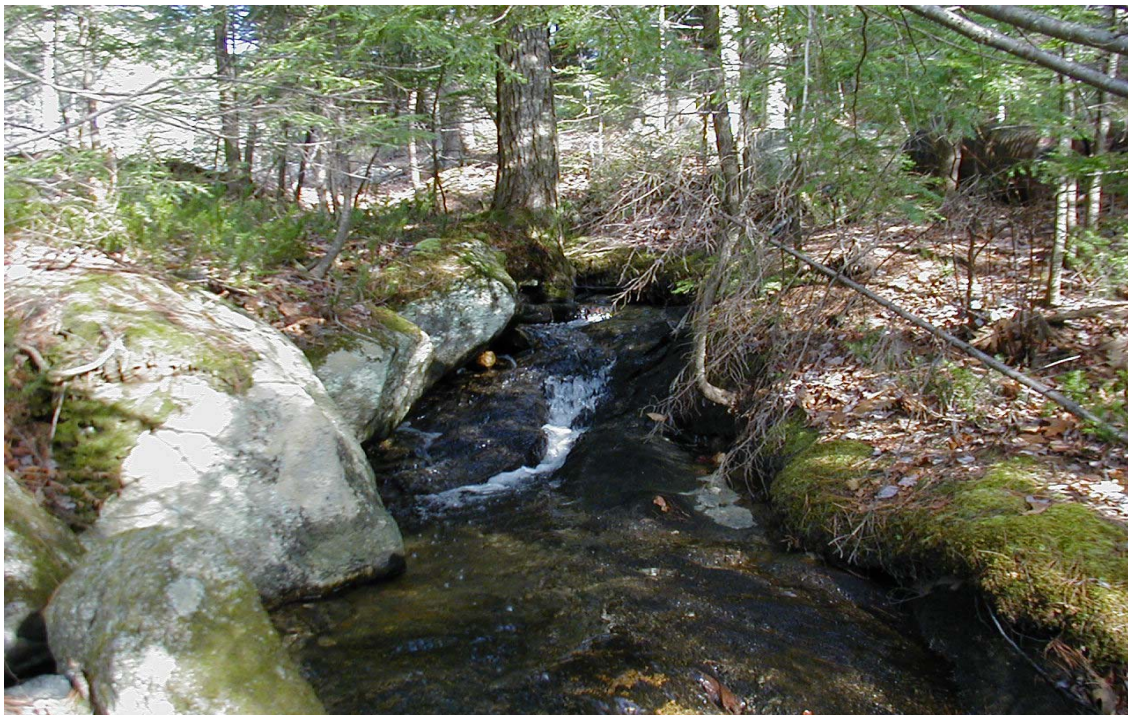
Existing channel drop point at Station 2+345

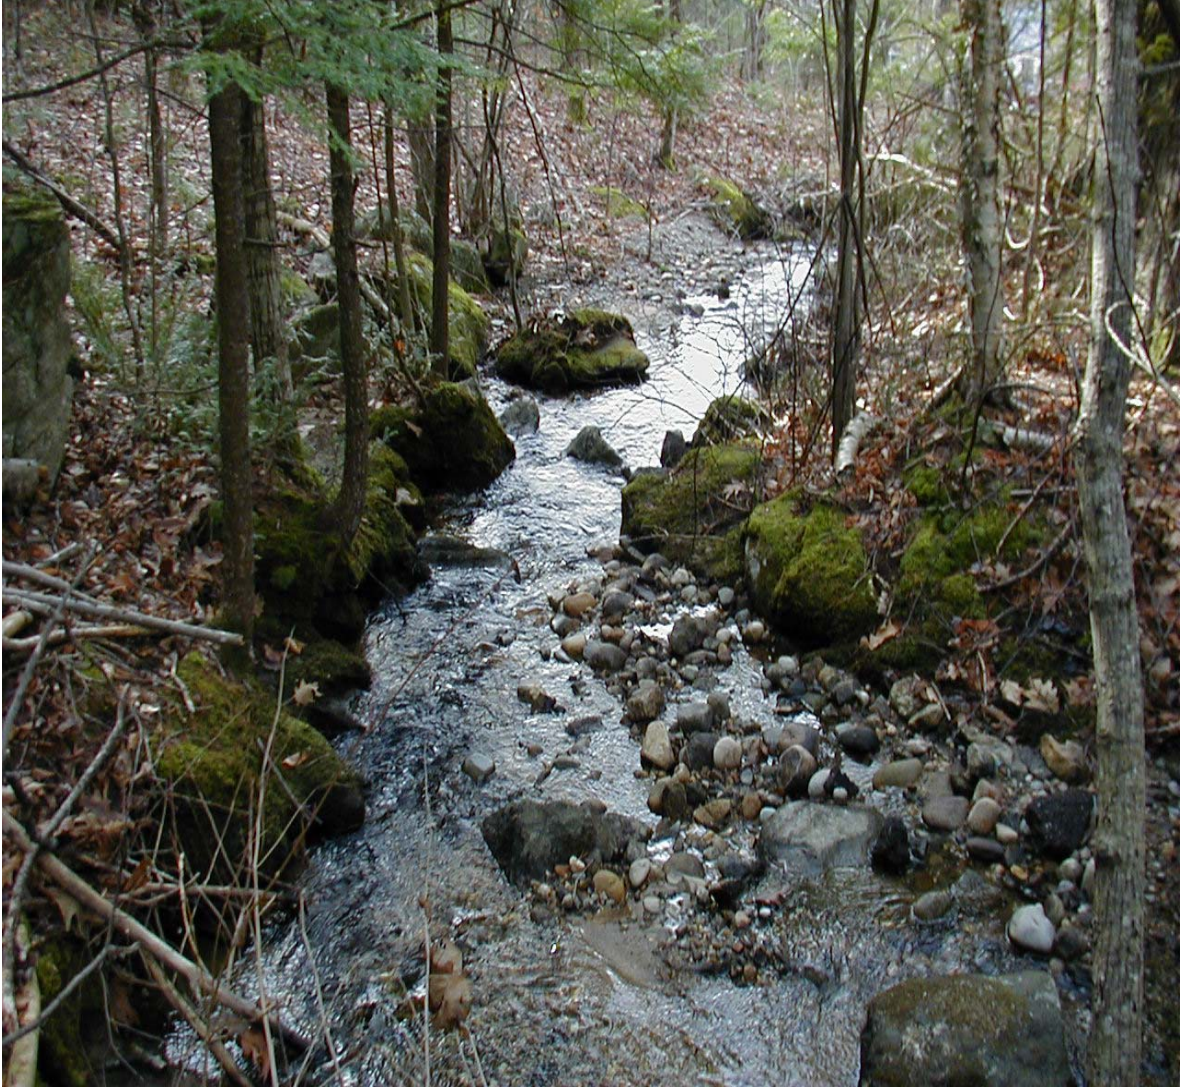
Existing channel at Station 2+380 L

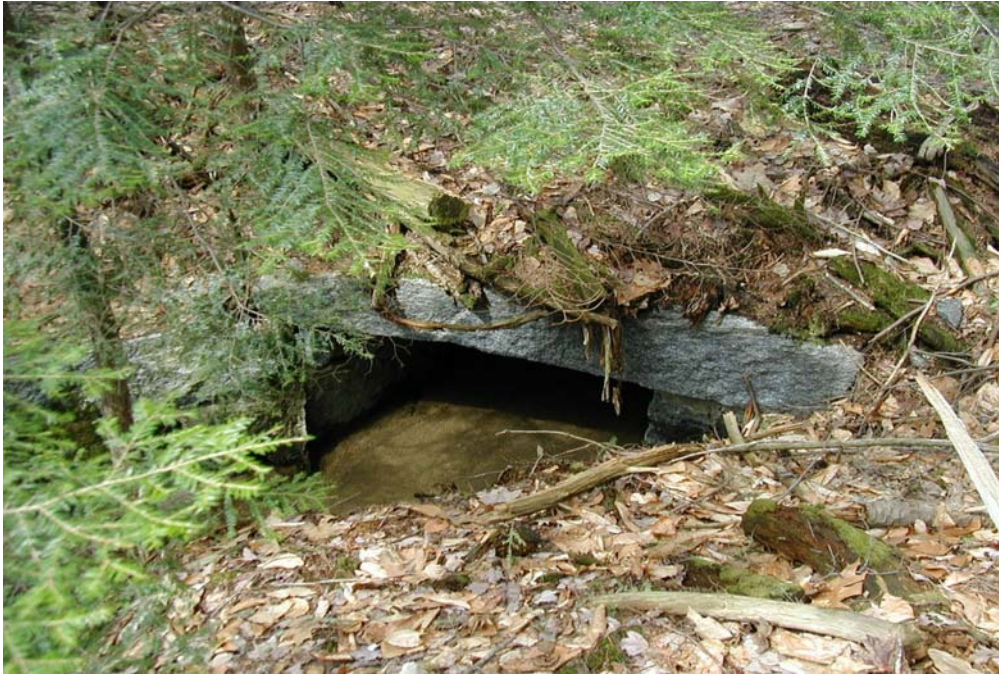
Granite culvert at Station 2+340 L

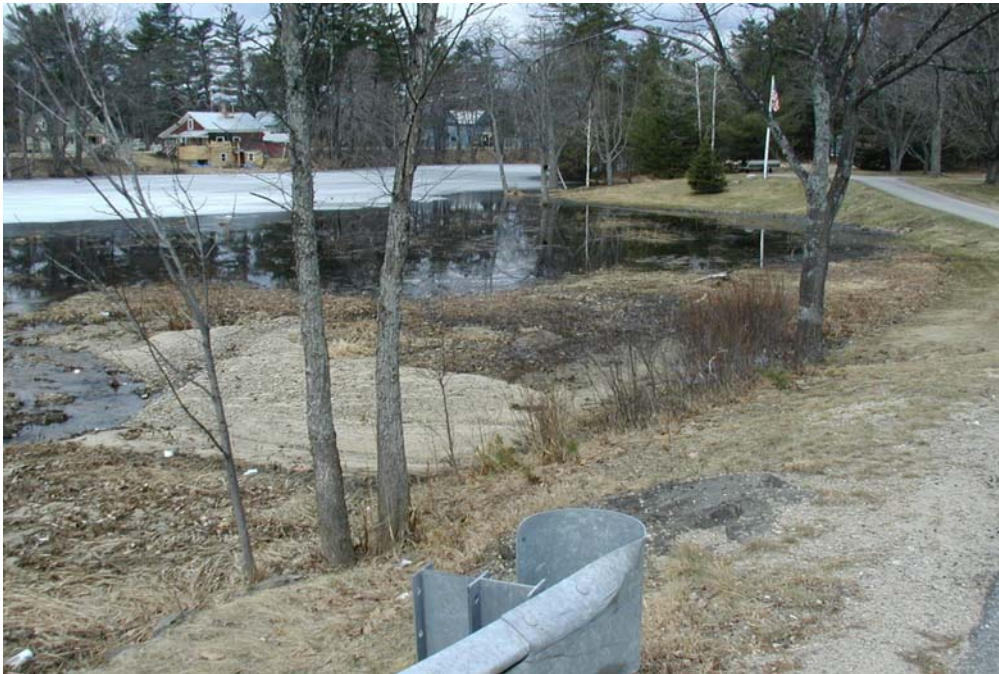
Prior to sediment dredging, the pond site was acting as a sediment trap for road sand and there was a considerable alluvial deposit at the end of the culvert that drained the road ditches. The road project installed a sediment basin, above the pond outlet, to capture this material. The restoration work removed the sediment plume down to existing wetland substrate, and re-developed a pit and mound microtopography and installed riparian plantings. The presence of invasive species to include common reed (*Phragmites australis*), purple loosestrife (*Lythrum salicaria*) and buckthorn (*Frangula alnus* syn. *Rhamnus frangula*) was reviewed and none were present. The site was monitored for siltation and was found to be stable with no sediment from the restoration site or the culvert. The 178 riparian plantings were all found to be in acceptable condition.

Sediment plume at culvert outlet into pond at Station 2+480 R

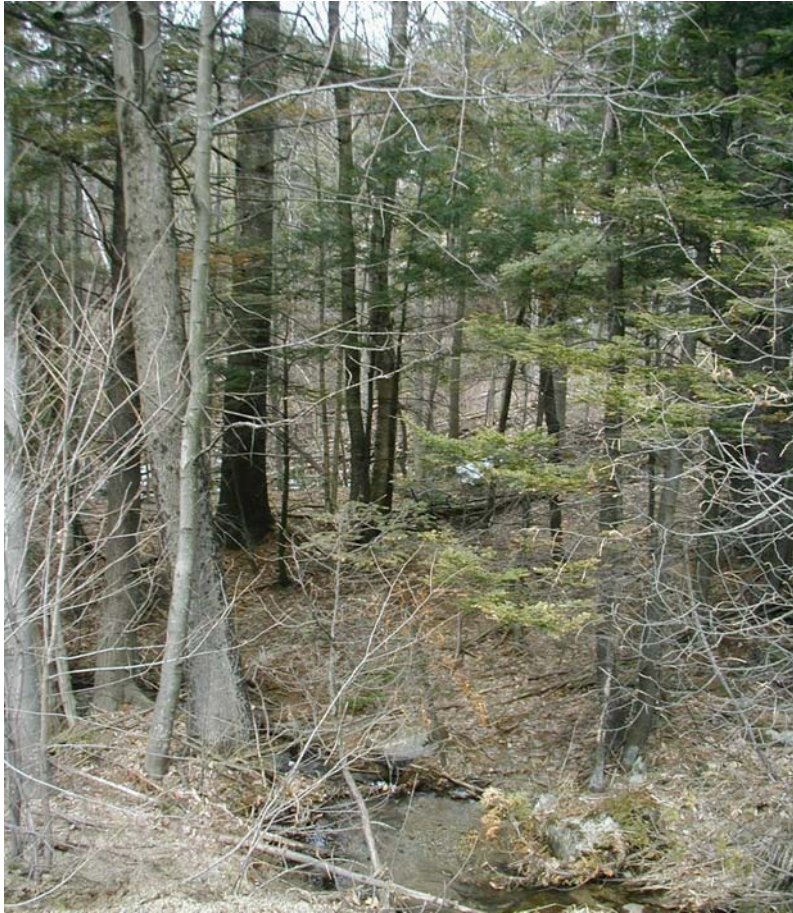
Stream channel at Station 2+160 R

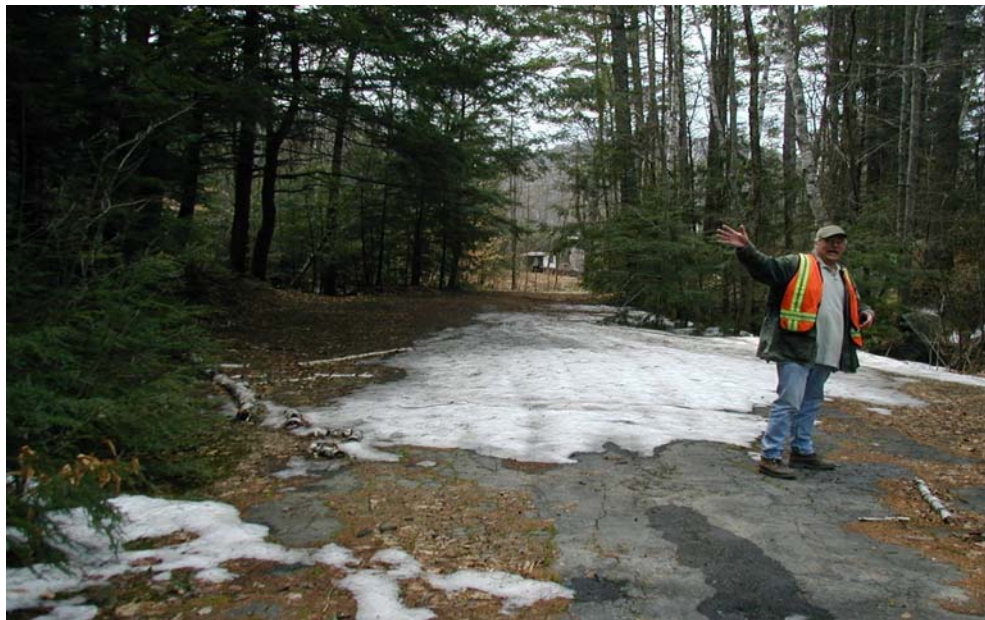
Old road bed and site of granite culvert at Station 2+300 L

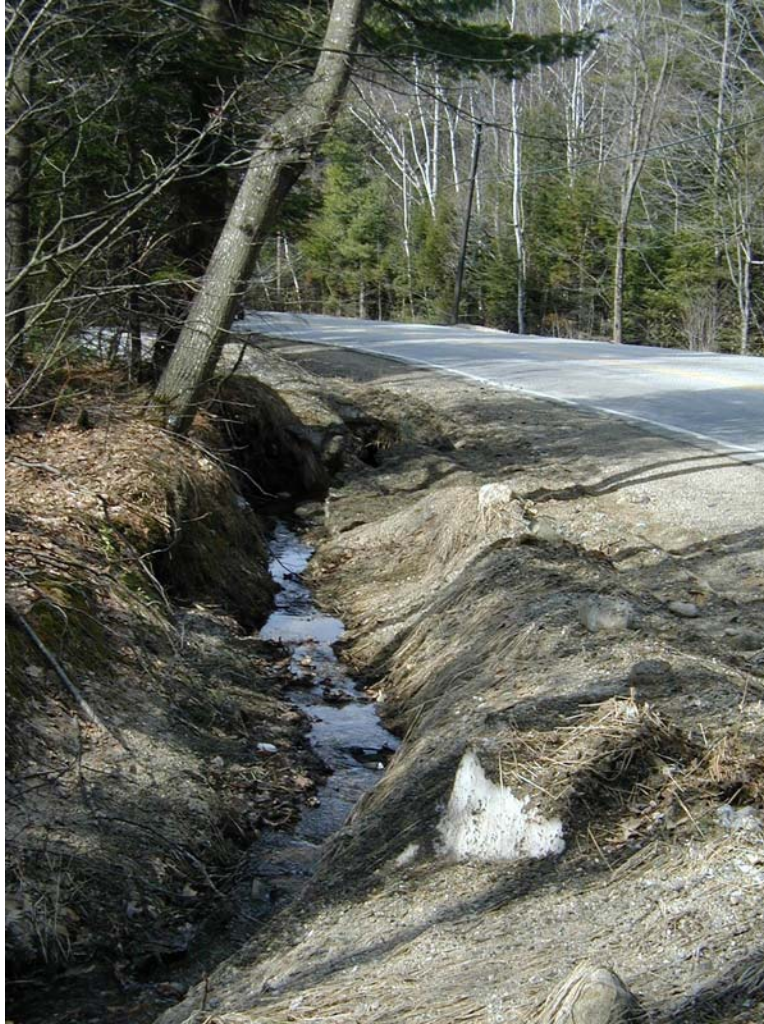
Rte 26 road ditch stream at Station 2+270 L

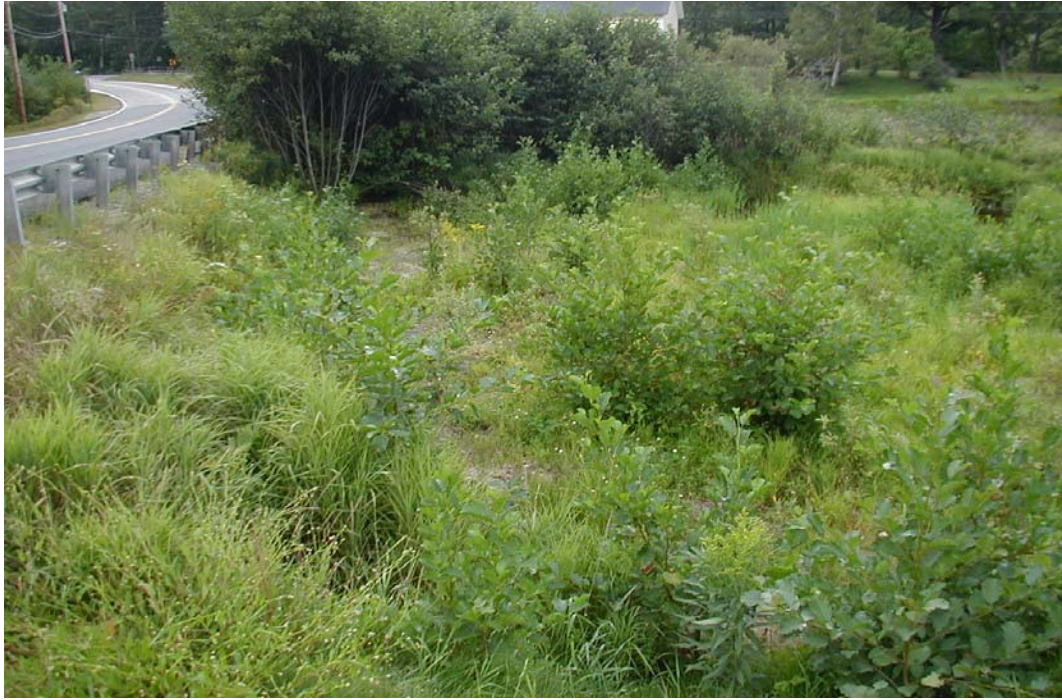
Restored pit and mound topography at pond area Station 2+480 R

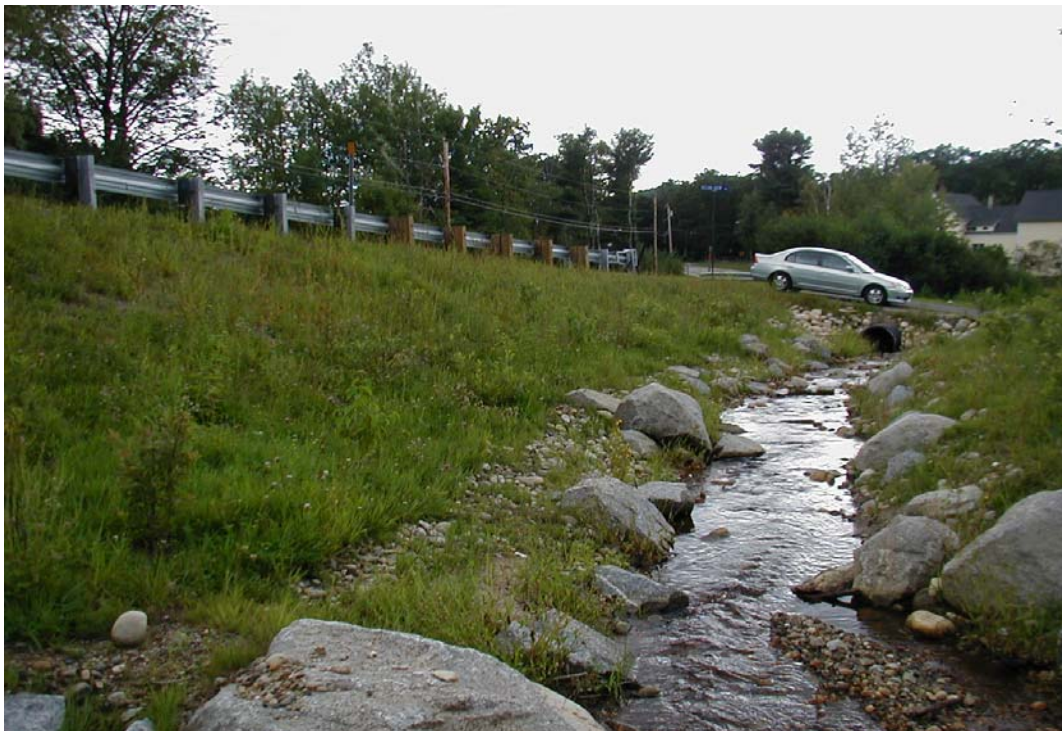
Restored stream channel at Station 2+460 R

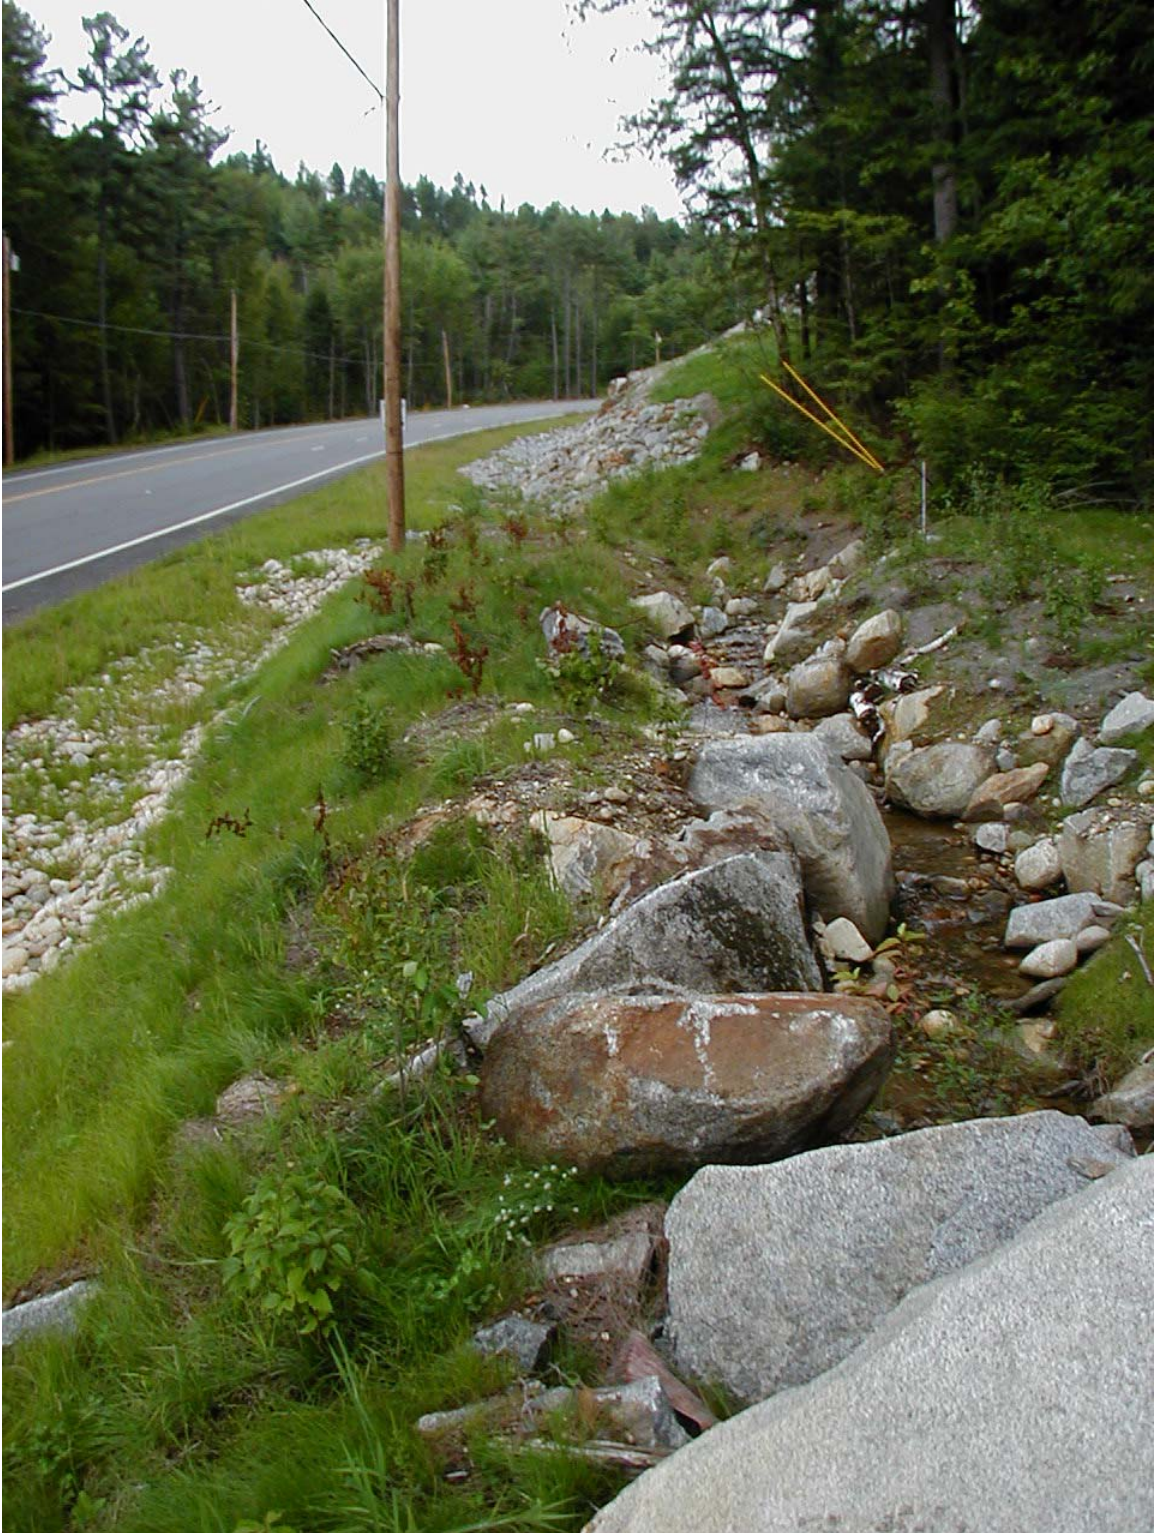
Restored stream channel in old road bed at Station 2+320 L

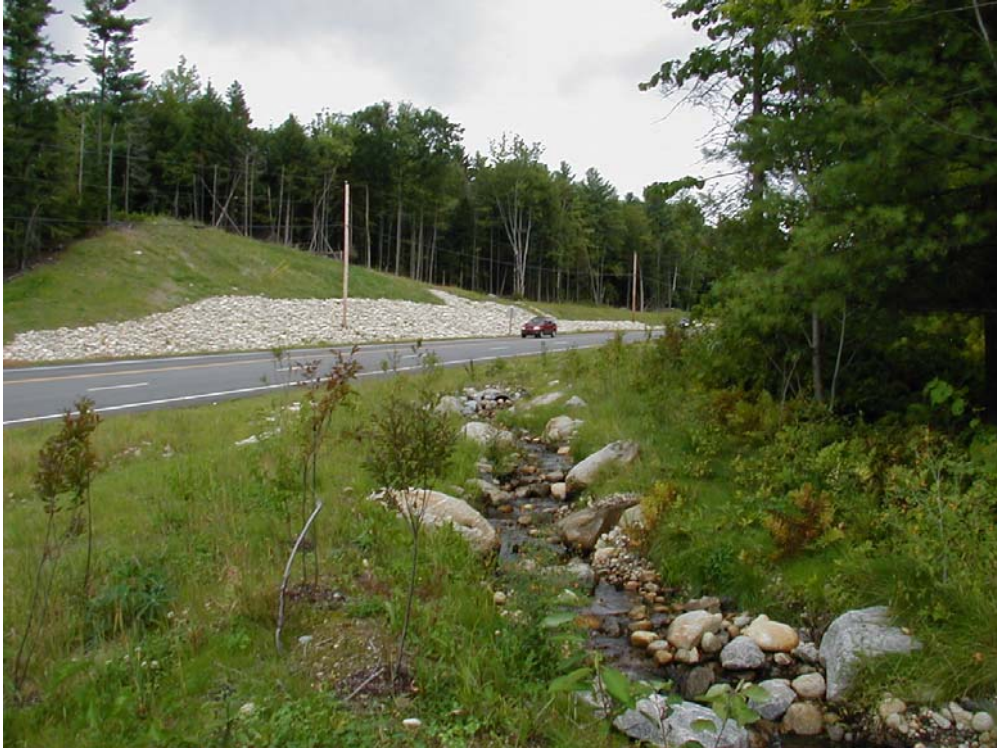
New stream channel at Station 2+080 L

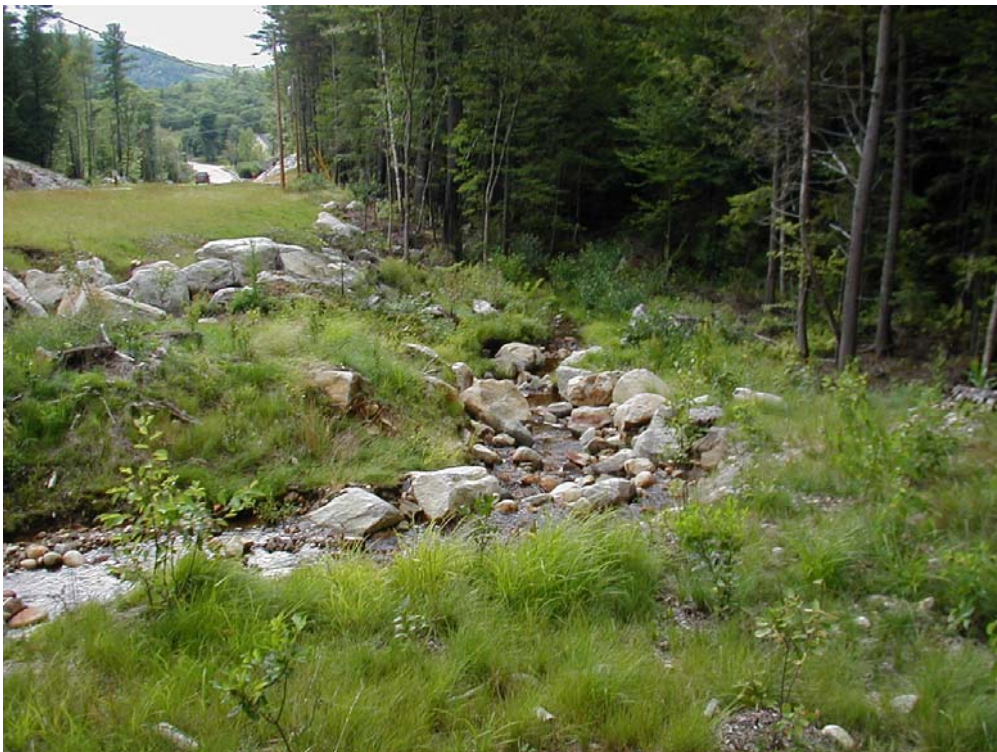
New stream channel at Station 2+160 R

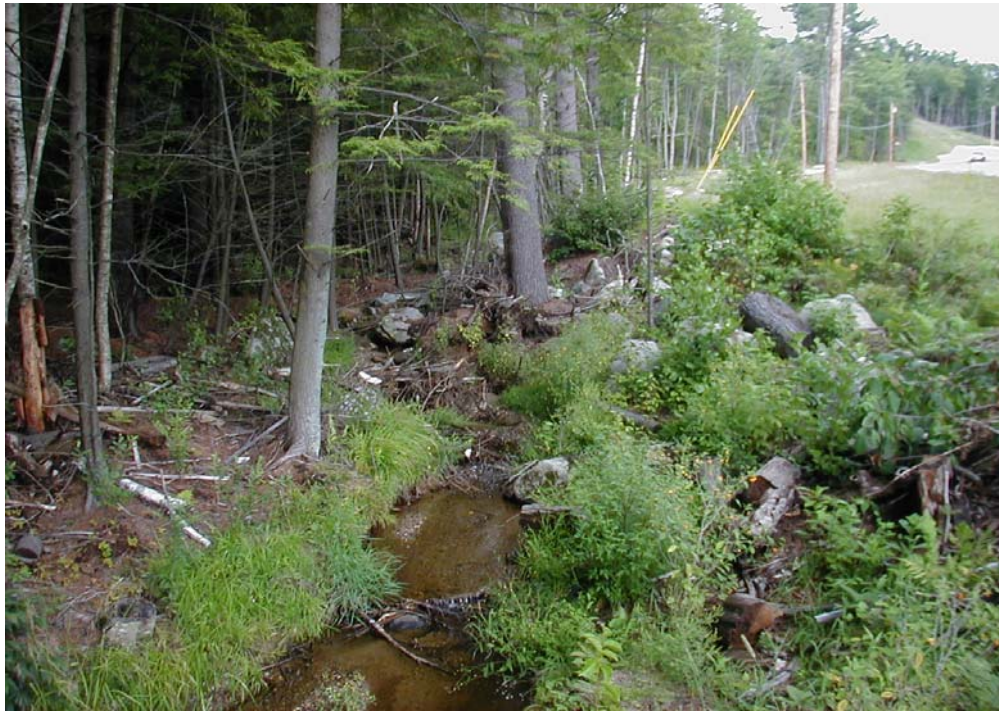
New stream channel at Station 2+280 R

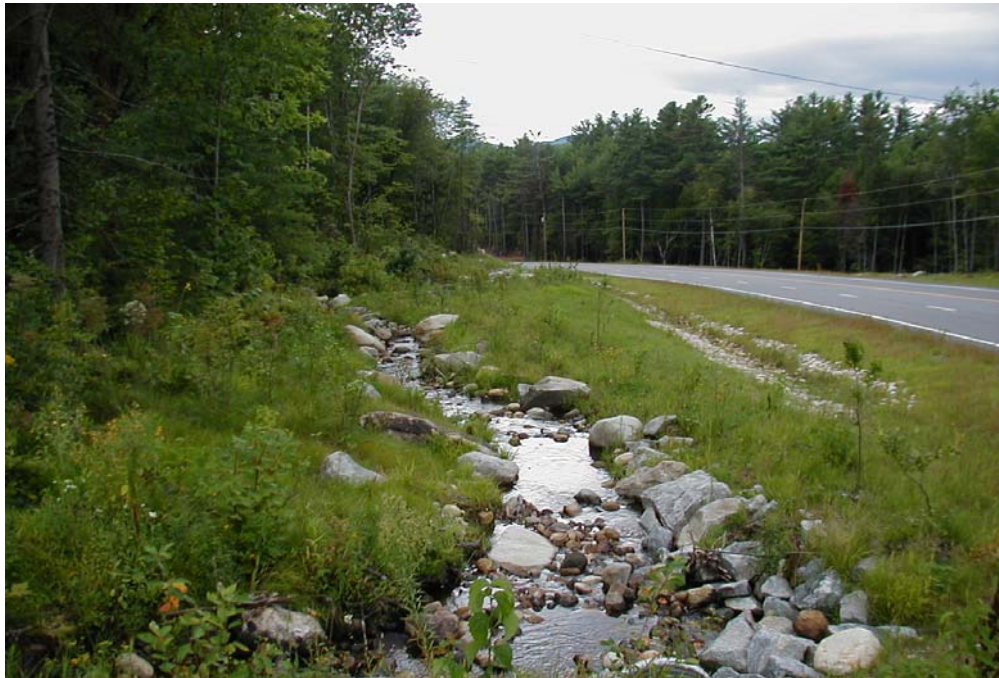
New stream channel at Station 2+100 L
