2009 Monitoring Report For Barkers Brook, Newry, Maine

Prepared For: Maine Department of Transportation

Report No.: 02-07-08(2)

Date: March 29, 2010

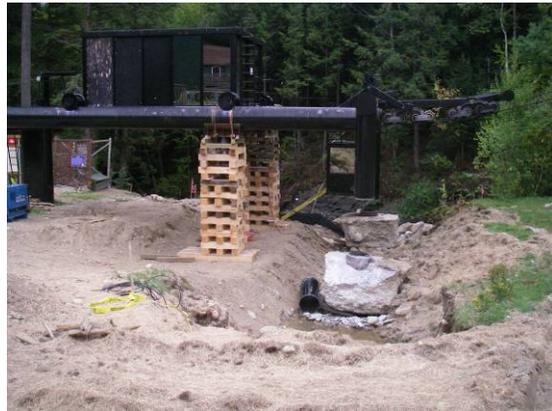
On July 11, 2007, just months prior to construction of this project, a significant rainfall event occurred within the Barker's Brook watershed. Pat Cole, an engineer with the Town of Bethel, described the event as a 500-Year to 1000-Year rain event, with a localized intensity of 7-9 inches of rain in 2 hours. During this event an earthen dam used to impound water on the Sunday River Ski Resort for snowmaking purposes breached. The dam was constructed in-stream on Barkers Brook. According to Mr. Cole, the breach resulted in the complete loss of the dam structure to erosion and in the creation of a "gorge" downstream of the dam. The failure contributed a massive volume of sediment to the channel and floodplain from the ski hill to just above the project site.

This sedimentation was observed by Parish Staff in September 2007, just weeks prior to the channel construction. Our staff noted a thick layer of sandy material on the floodplain, sand embedded in the stream gravels and in large depositional features within the channel. Floodplain deposition was in excess of 12 inches in many areas and occasionally exceeded 18 inches. In addition to the sandy deposits, a large number of woody debris jams had developed. This deposition and excess sediment was observed to extend from the ski area to approximately 1 mile upstream of the project site.

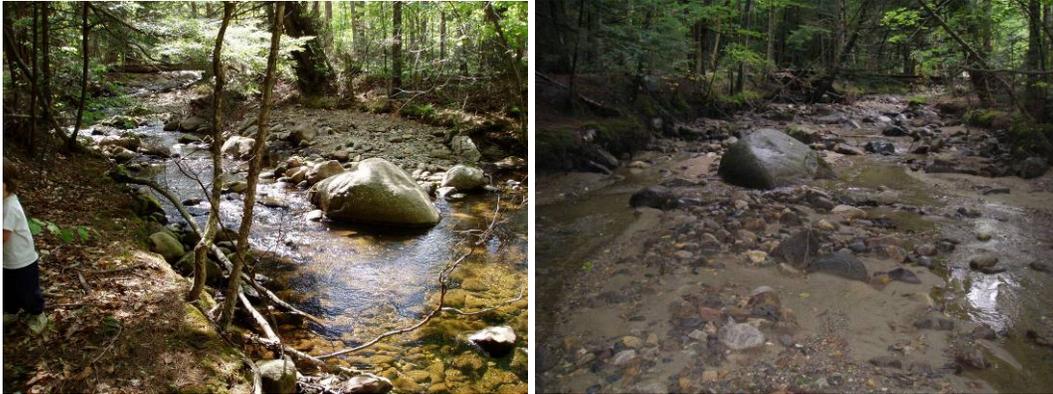
These photographs of the same location on Barkers Brook show the extent of the instream sedimentation as a result of the July 2007 storm; the first was taken in 2003 at the time of the watershed assessment and the second was taken in September of 2007. Photographs are approximately 0.5 miles upstream of the project site.

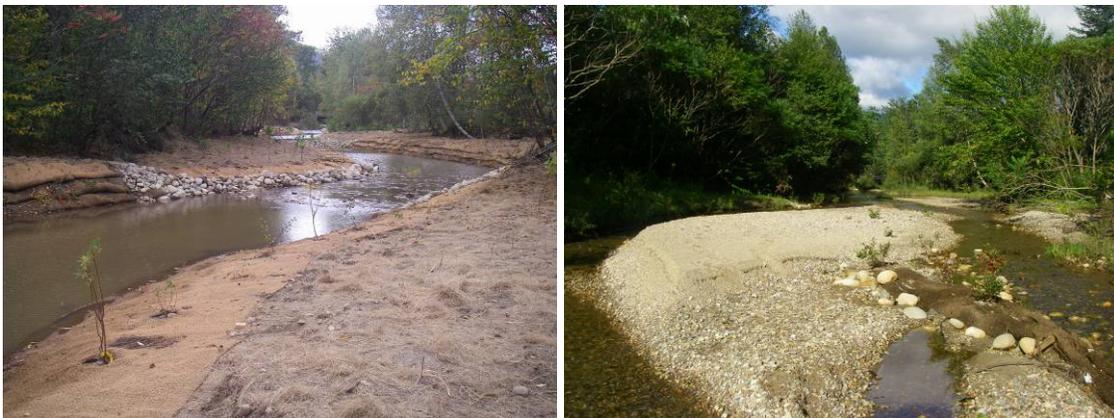
Designs, performance goals and standards for the Barkers Brook Restoration Project were based on the watershed conditions as documented in 2003. The restoration project was constructed in September of 2007 as originally designed, despite the newly observed change to the condition of the upper watershed. The sediment stored in the upper watershed began impacting the project site almost immediately upon completion of construction. By October of 2007, just one month after construction, the pools had completely filled in with sand. By the following summer, in August of 2008, sand and gravel stored in the upper watershed had moved into the project reach causing the channel to aggrade throughout the reach and avulse in several locations (i.e. fill up with sediment and relocate, thereby changing its planform geometry). The newly deposited instream sediments and bar formations were soft and unconsolidated. By fall of 2009 the channel bed had coarsened and hardened; however, most all of the constructed pools and riffles remained buried below the new channel or below new bar formations. While some bank treatments have held up well, others are either completely abandoned by the new channel, buried to the top of the bank, or are failing because the re-aligned channel subjects them to forces greater than they were designed to withstand.

These photographs show the view looking upstream from Station 5+40. They demonstrate the dramatic changes to the channel planform, grade, and cross-sectional geometry between September of 2007 and September of 2009.

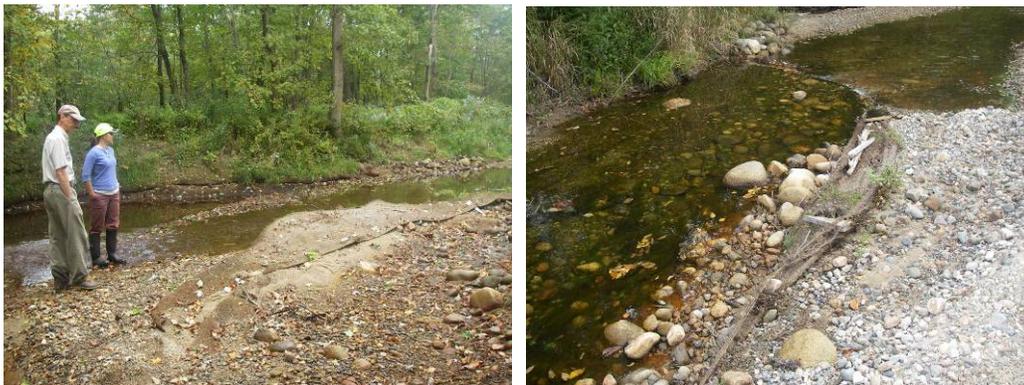
These photographs show examples of where remnants of bank construction using coir cloth were impeding the natural flow of water and sediment in Barkers Brook. MDOT staff removed the fabric in these and other similar areas in September of 2009.

7) Corrective Measures Taken. In September of 2009 MDOT undertook corrective measures to remove coir fabric that was no longer functioning as indented or was threatening the stability of the stream. Fabric was removed where the stream had relocated such that it crossed directly over a constructed bank treatment location or where leaving the fabric in place would be detrimental to the recovery of the stream.
