# MITIGATION REPORT TRANSMITTAL AND SELF-CERTIFICATION

DEPARTMENT OF THE ARMY PERMIT NUMBER: NAE-2009-462
PROJECT TITLE: Woodstock Academy Athletic Complex Expansion

TITLE: Woodstock Academy Mitigation Report

## Mitigation Report Project Overview Form

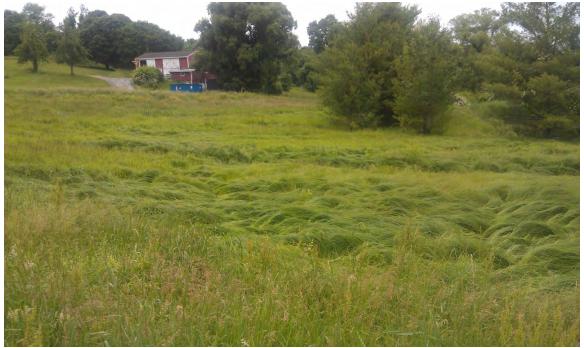
Photo at WMMA #1 (see plan sheet for photo location) on 6/13/2013

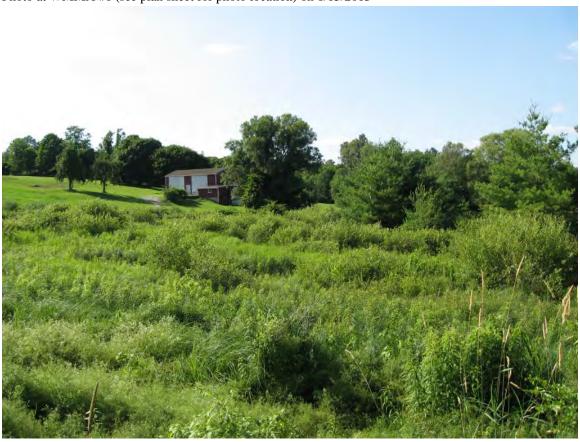
For reference a photo from 7/10/2009 from approximately WMMA#1 showing the shrub grow in the area prior to the establishment of the mitigation mowing.

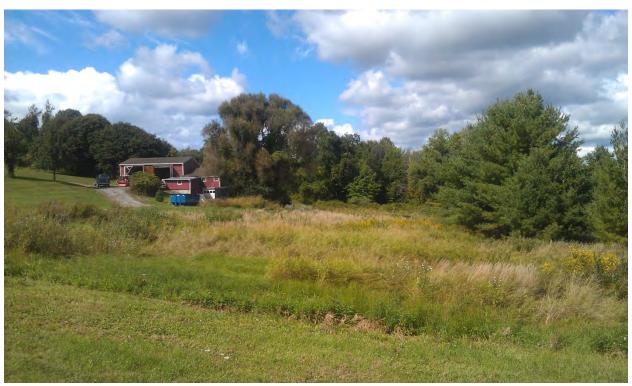
Photo at WMMA#1 on 9/16/2013

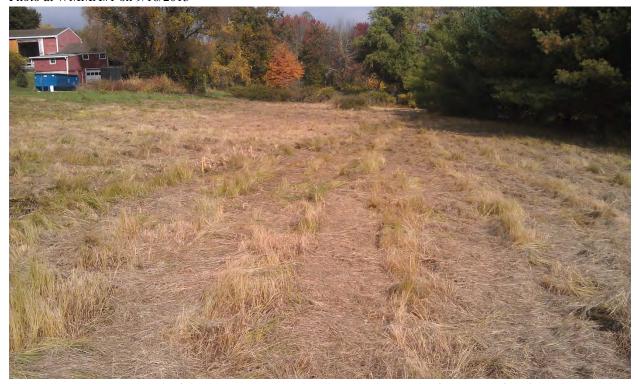
No bare soil from mowing was observed during any of the field inspections. During the June 2013 monitoring some of the areas of cut and treated multiflora were sparsely vegetated. Occasional presence of *Phalaris arundinacea* and *Lythrum salicaria* were noted in 2013 monitoring. These invasives were not dominant and present as occasional individual plants similar to conditions before mowing in 2012. They do not appear to threaten the dominance of native plants in the wet meadow based on the 2013 monitoring.

Photo taken 10/12/2013 north of the WMMA#1 photo location showing detail of ground surface following mowing

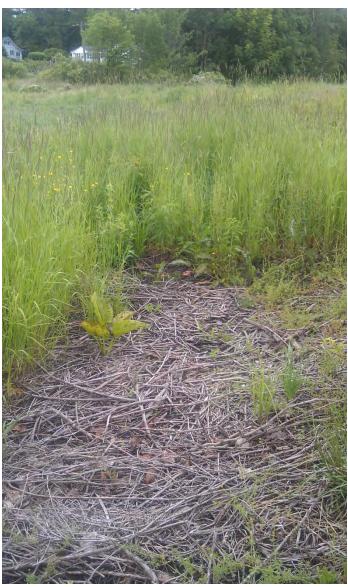
Detail of an herbicide treated multiflora rose area on 6/13/2013

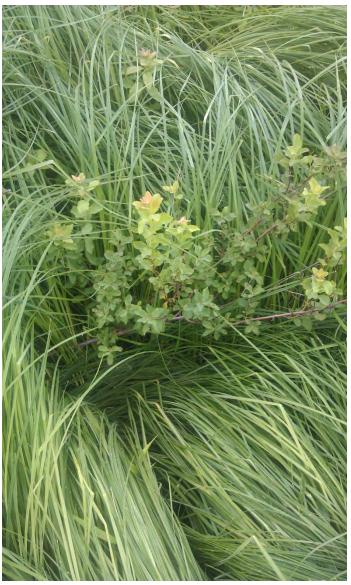
Mitigation monitoring in this area found some stump regrowth of shrubs but regrowth was limited to water sprouts from the cut stumps and do not significantly contribute to the percent cover of the area. In the upland buffer of this mitigation area; *Rosa multiflora* and *Lonicera* sp. were cut and treated during the initial mowing. Herbicide treatment limited regrowth and continued annual mowing is expected to limit the establishment of all woody species.

Detail of Spirea regrowth from cut stem in wet meadow area (6/13/2013)

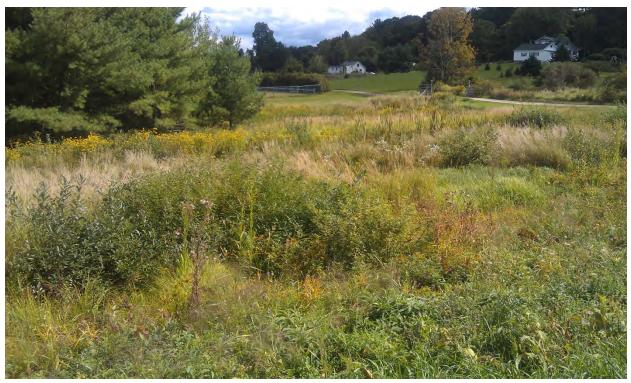
Detail of vegetation on 9/16/2013. Note greater volume of *Salix* stem regrowth at the foreground left and golden rod along a ditch.

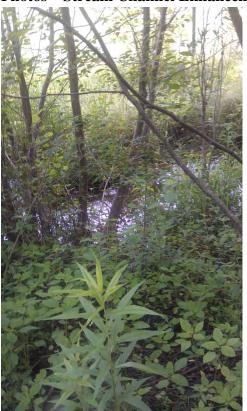
Photo in mitigation area under mature alders in the SCEA which has 100%+ woody canopy cover and the herbaceous layer is dominated by the native *Impatiens capensis*.

This photo is at the reference plot. (Photo 6/13/2013)

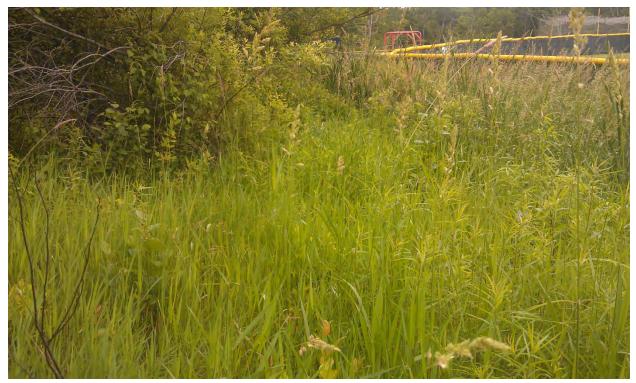
The performance standard for this area is derived from the NAE Mitigation Standards and is 60% cover by noninvasive hydrophytes of which 15% are woody species. Currently portions of the SCEA do not meet that standard because reed canary grass (*Phalaris arundinacea*) has a coverage of greater than 60% of areas lacking shrub cover. The goal of this mitigation is to provide a biological control which should be more effective than continued herbicide treatment on a long-term basis. Portions of the SCEA contain mature alder and willow shrub stands which have little or no reed canary grass, thus the goal is to allow the remaining areas to achieve similar vegetation coverage. The planted areas are developing toward that goal after the first growing season but have not yet achieved sufficient canopy coverage.

Photo at SCEA#1 (see plan for location) an open canopy area which was planted in 2012 dominated by reed canary grass in the spring of 2013 (6/13/13)

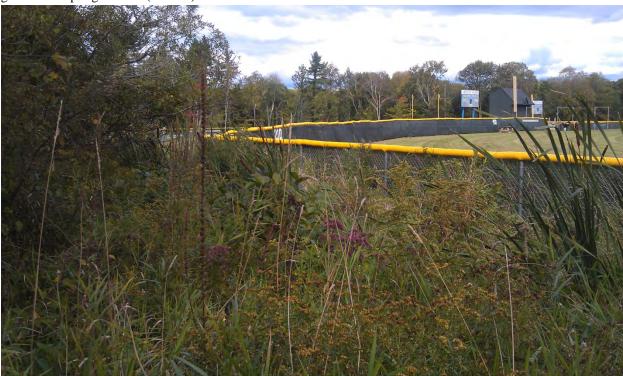
Photo at SCEA#1 on 9/16/2013, native herbaceous cover has increase in the fall, also a single flower stalk of purple loosestrife is visible (left center). Planted alder has increased its height although it is difficult to make out in the photo

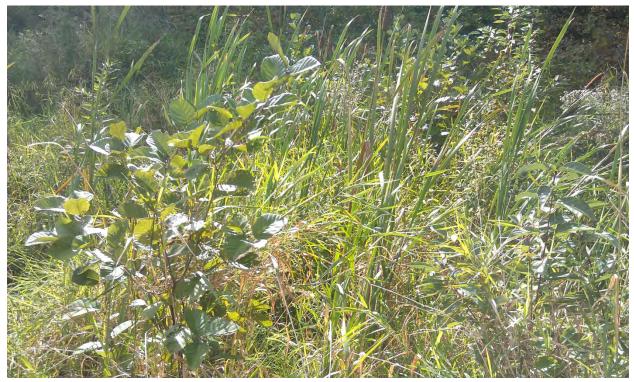
This photo is looking approximately westward across the channel in the mitigation area. Several planted shrubs are visible including and alder (foreground left) dogwood (foreground right) and additional plants in the rear of the photo. This photo was take 9/16/2013 and shows that the planted shrubs have gained in height over 2013.

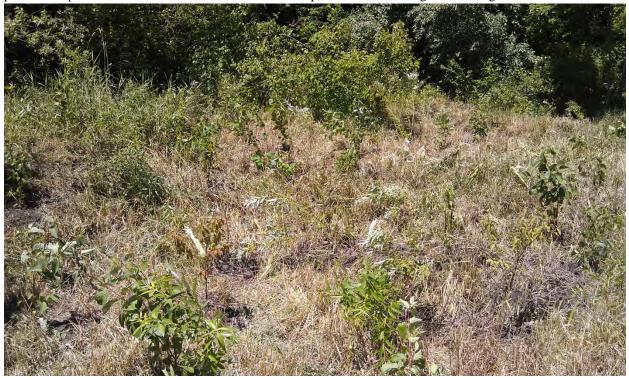
For reference this photo is from 6/15/2012 showing a portion of the mitigation area immediately following planting
