Third Annual Monitoring Report Tidal Wetland Restoration 159 Long Neck Point Road, Darien, CT NAE-2007-1130 December 15, 2014

1) Project Overview

This is the third year of a five year monitoring program designed to monitor the restoration of an approximate ½± acre tidal wetland within a protected cove at 159 Long Neck Point Road in Darien, CT.

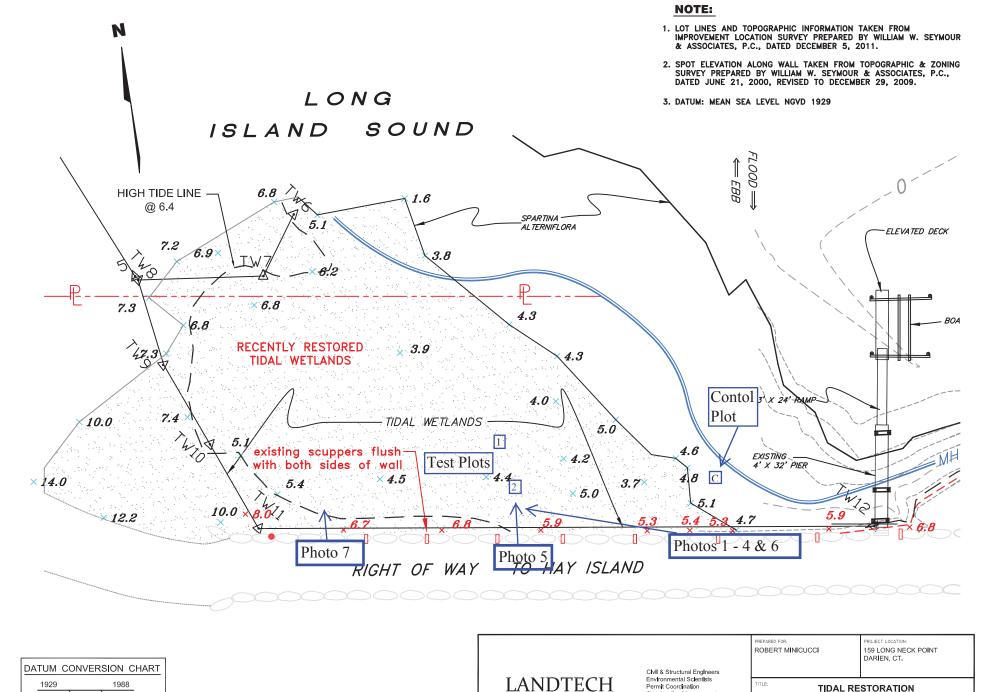
MONITORING PLAN

Approved Tidal Wetland Restoration Plan
Revised to Show Photograph Views and Plot Locations Referenced in Report.

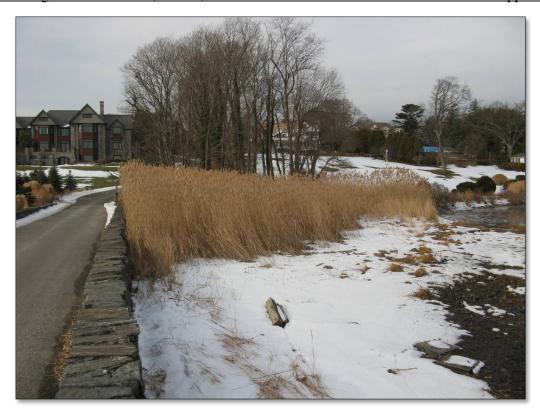
Photo 1 – Tidal restoration area facing west. Photo Taken January 6, 2011 Prior to Restoration Work. Photo shows Phragmites Population and Ground Elevation.

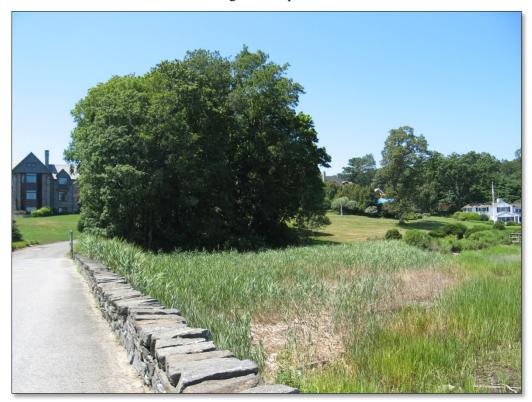
Photo 2 – Phragmites Population in Tidal Restoration Area on July 26, 2011 after Initial Herbicide Application but Prior to Regrading.

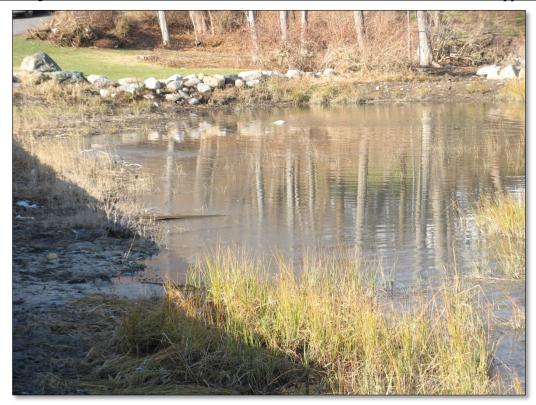
Photo 3 - Post Restoration, Facing West on November 28, 2012.

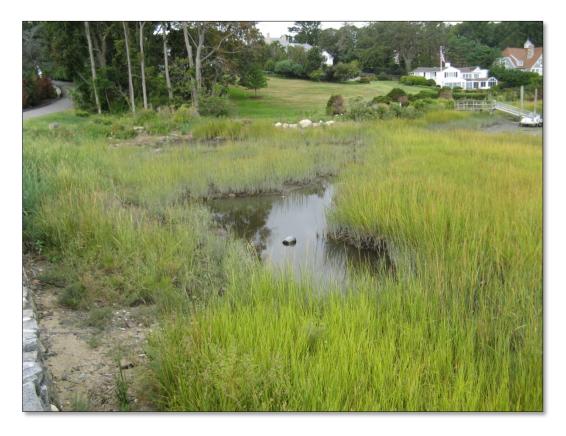
Photo 4 – Spartina Starting to Recolonize the Wetland on September 13, 2013. Phragmites Population Present along Waterward Side of Wall.

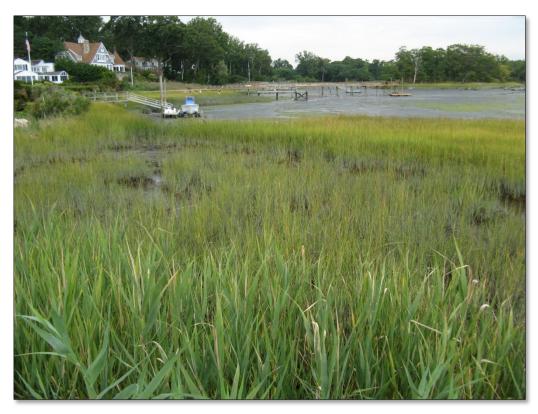
Photo 5 – Facing North on September 13, 2013. Phragmites Along Wall in Foreground, Recolonizing Spartina population in Middle and Undisturbed Spartina Population in Background.

Stake for Test Plot #2 is Observable Just Beyond the Phragmites Population.

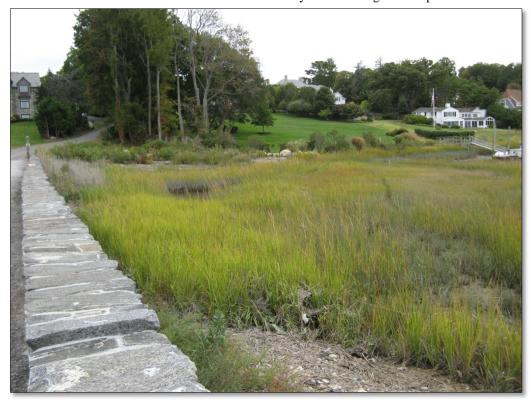
October 2, 2014 – The invasive Phragmites population was dead, some stalks remained but no seed heads were present. Spartina density within the 2 one square meter test plots were reinspected. The stake from the control plot was missing but since it was in a mature and established population, we don't expect to see much variability year to year. Therefore we will not be creating a new control station.

Photo 6 – Facing West on October 2, 2014. Dead Phragmites Located Along Wall in Upper Left of Photo.

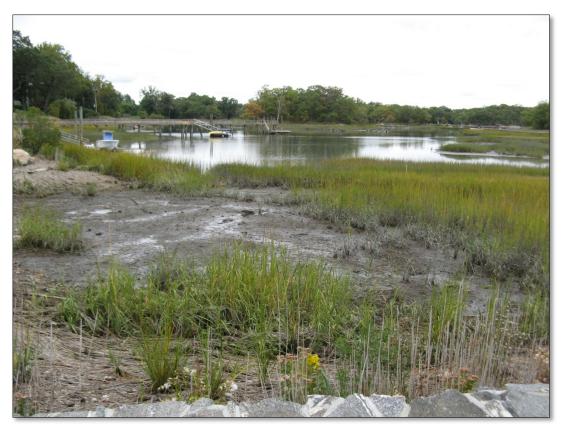
During the May27th site visit, the *Spartina alterniflora* population covered approximately 60% of the restoration area. A small depression located in the southwestern portion of the restoration area continued to support little to no Spartina growth. The Phragmites population was severely stressed (brown and approximately 4 feet high) or dead within 10 to 15 feet of the wall. A small lobe of the population encroached further north along the edge of the depression.

Photo 7 - Western Portion of Wetland Facing North on October 2, 2014. Dead Phragmites in Foreground. Spartina Slowly Colonizing the Lower Elevation areas in middle of Photo.

No remedial actions were needed this year. Next year we plan to install plugs of Spartina within the slightly deeper area that has not been colonized. These plugs would be intended to accelerate the establishment of a Spartina population in this area.

We will be inserting plugs of Spartina alterniflora into the western portion of the restoration area which is slow to colonize.
